STREAM MITIGATION PLAN

CAVINESS SITE RANDOLPH COUNTY, NORTH CAROLINA

STATE PROJECT NUMBER: 8.U492107
TIP NUMBER: U-2524WM

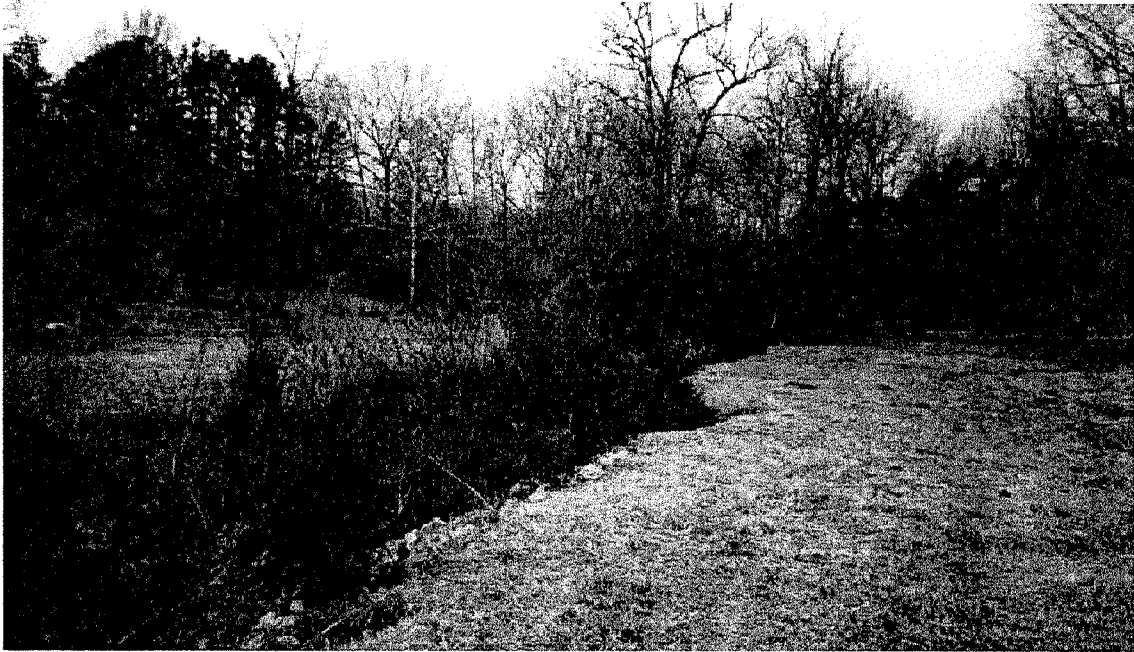
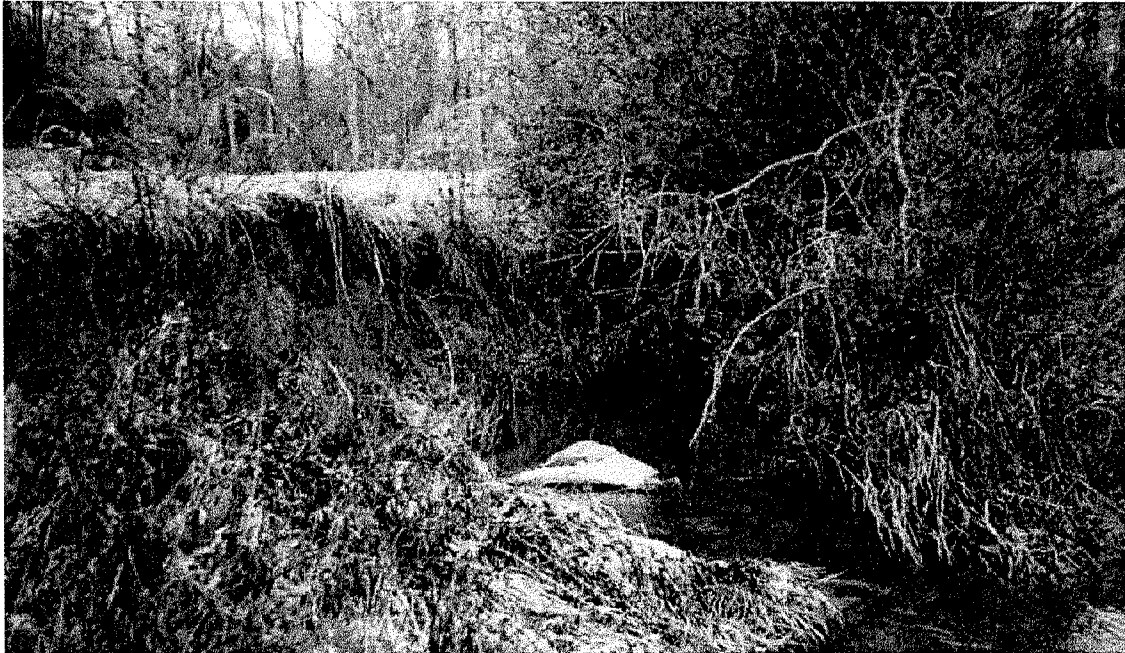
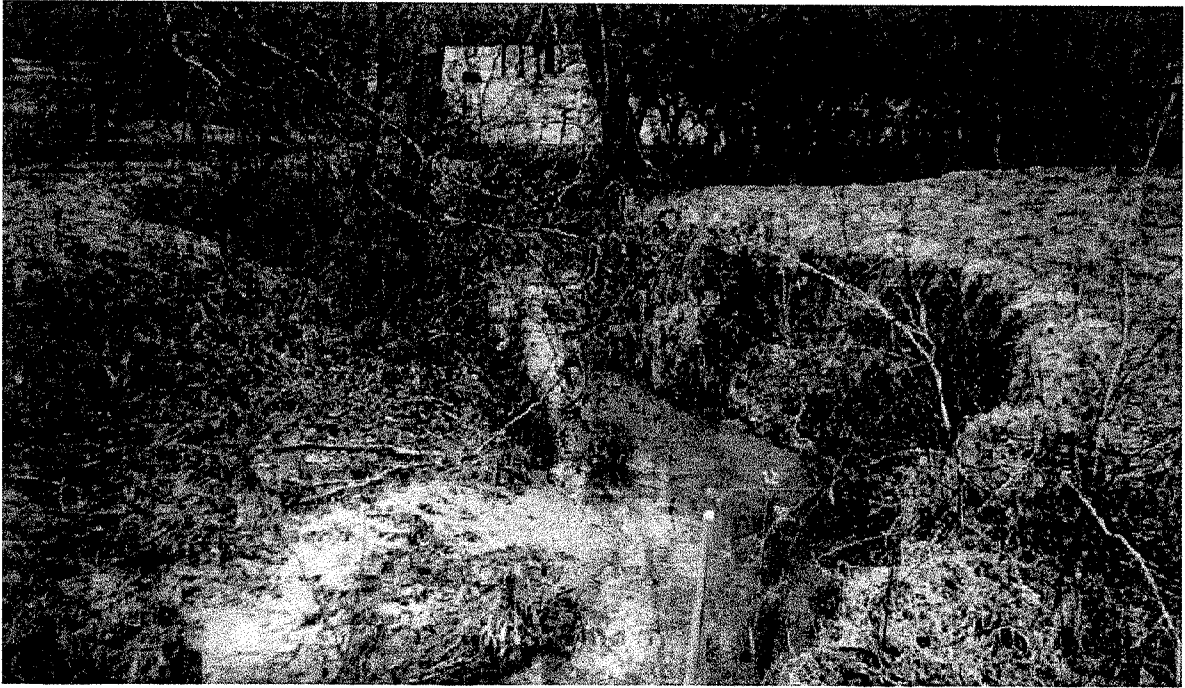
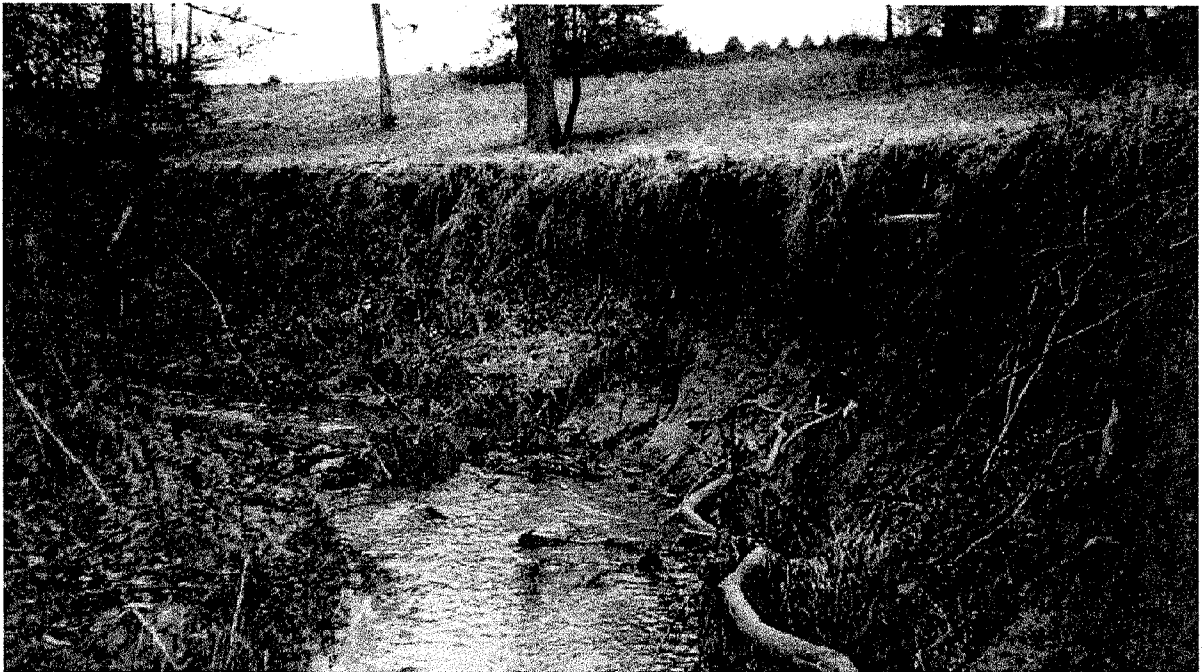
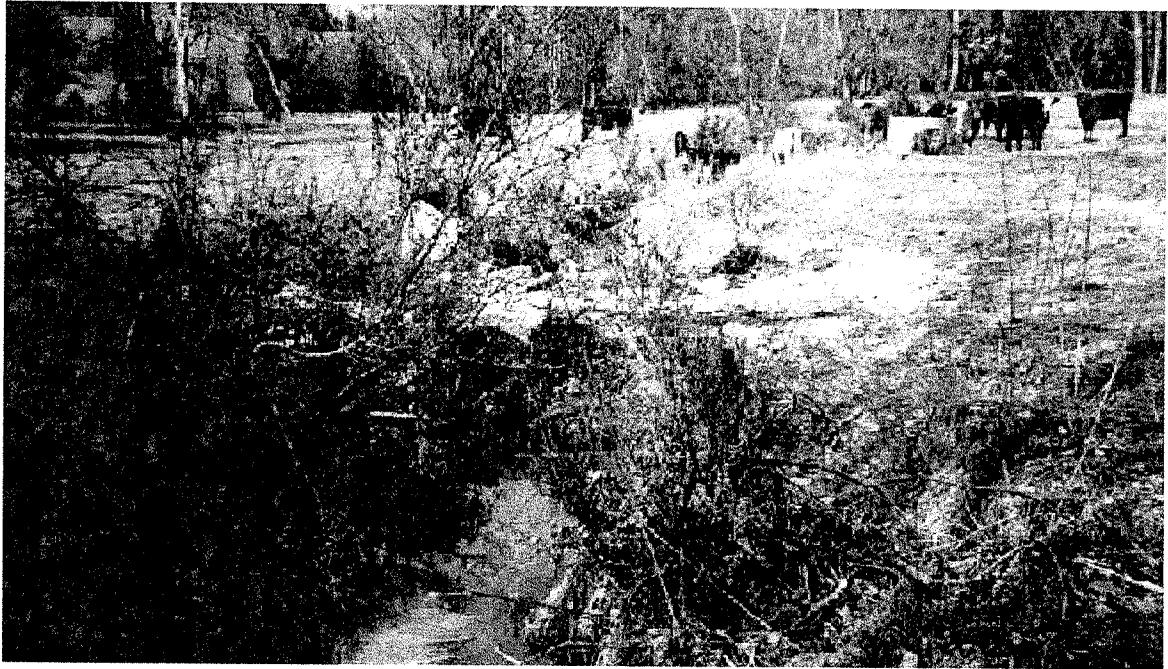
The streambed of the lower reach of Tibbs Run appears to have degraded several feet below the historic stream grade (Photographs 1 through 5, Appendix G). As a result, the historic floodplain has been largely abandoned and the channel banks exhibit signs of excessive erosion. This reach of the stream is bounded along both sides by currently active pasturelands. No riparian overhanging tree canopy is present along the majority of this stream segment, thus stream shading is severely limited. In areas subject to direct cattle grazing, the riparian vegetation consists of opportunistic, first-successional, herbaceous vegetation. The natural channel pattern and dimensions have been significantly altered by a combination of manual regrading and stream incursions by cattle. There are many locations where the channel banks are bare and unstable. The features typically associated with normal stream processes, such as riffles and pools, are evident in a few locations. However, the natural process of meander development is occurring within the incised channel, thereby resulting in bank scour. The bed material along this reach of Tibbs Run consists primarily of sand, silt and gravel. Occasional outcrops of weathered bedrock and cobble form a few riffle sections. Additionally, the erosion along the ephemeral tributary that drains from the outlet of the pond on the southwest corner of the property is impacting water quality and channel stability by contributing an excessive sediment load to Tibbs Run.

The profile of lower reach of Tibbs Run is incised below the historic stream grade by approximately two feet. This bed degradation has resulted from changes in the flow regime, manual regrading and disturbances caused by livestock incursions. The headcutting of the profile has extended upstream from NC 42 approximately 800 feet to profile station 25+00. Despite this incision the channel has not become completely entrenched. The combination of the low width/depth ratio and the high entrenchment ratio results in this reach being classified as a type E channel. However, the low sinuosity and the bank height ratios of 1.1 to 1.3 are adversely affecting the stability and function of the stream. In many locations it is evident that the channel is attempting to establish a larger belt-width by meandering within the confines of the existing banks. This has resulted in significant bank retreat in numerous locations characterized by near vertical bank slopes and exposed soil surfaces. The lack of significant riparian vegetation throughout the majority of this reach means that poor rooting depth offers no protection from near bank shear stress once bank retreat has initiated. Only the cohesive nature of the alluvial bank material and areas where more modest bank angles allow for establishment of vegetation offer any resistance to erosive forces. Without intervention the evolutionary trend for Tibbs Run will consist of a headward extension of the channel incision, which will likely result in the formation of a type G channel. The lower reach and ultimately the entire length of Tibbs Run on the Caviness site will continue to widen and possibly form a type F channel before near bank shear stress is reduced to the point that natural stabilization processes can begin. This evolutionary trend will result in significant sediment loads being transported downstream.

Photograph 1. Tibbs Run – Downstream of Section TR1

Photograph 2. Tibbs Run – Downstream of Section TR1

Photograph 3. Tibbs Run – Section TR2

Photograph 4. Tibbs Run – Section TR3

Photograph 5. Tibbs Run – Section TR4

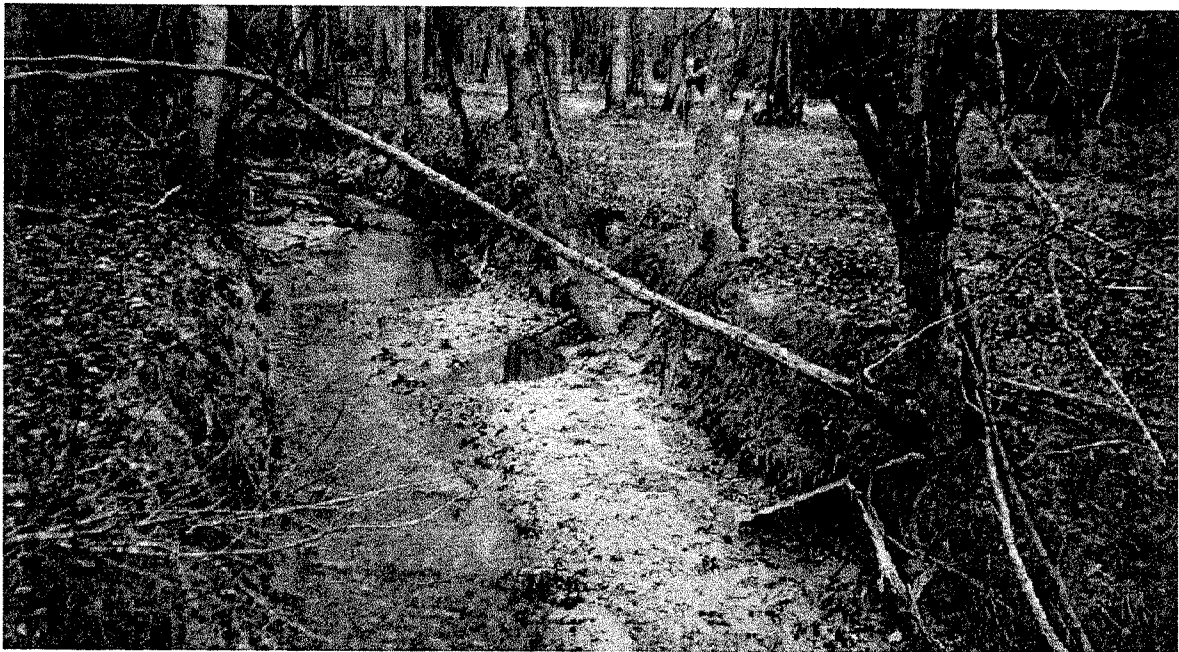
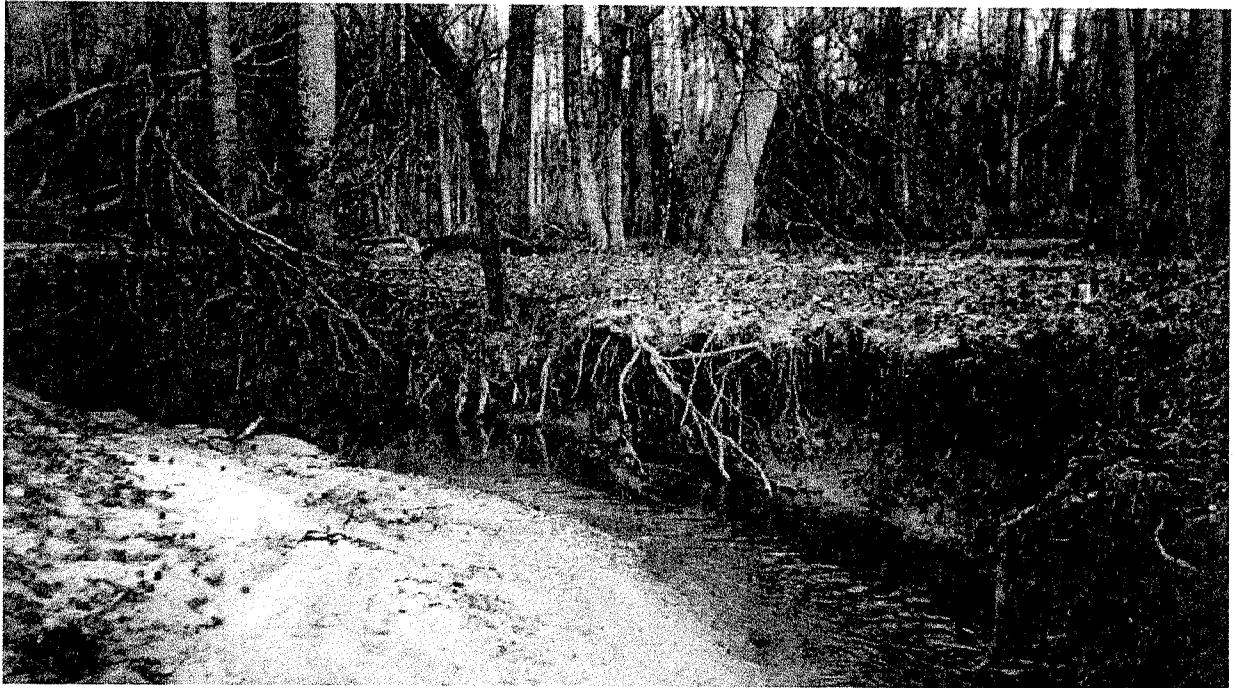
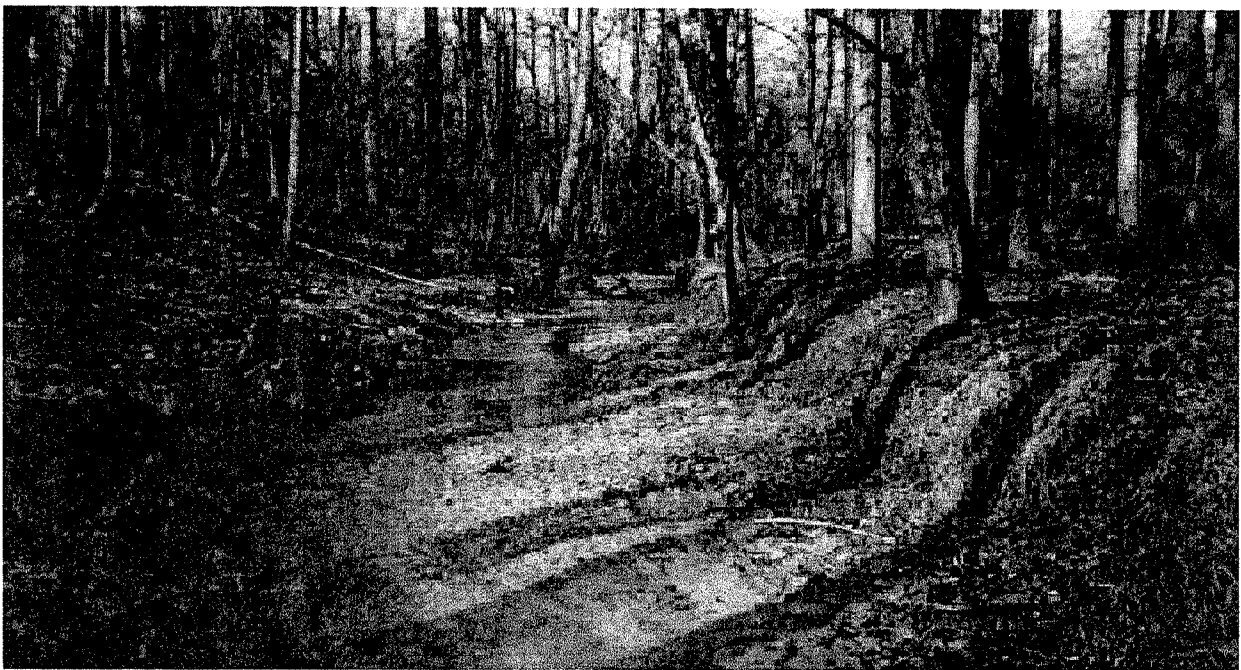
The streambed of the upper reach of Tibbs Run appears to be only slightly incised and has retained much of its natural pattern (Photographs 6 through 8, Appendix G). Although this stream segment and the adjacent floodplain are subject to unrestricted cattle grazing, a mature riparian overhanging tree canopy is present along much of the reach. This canopy provides for effective shading along most of the stream segment. Portions of the relic channel remain in a few locations on the floodplain and display the characteristic plan form of a type E stream with tortuous sinuosity. The bed material consists of sand, silt and gravel. At the time of investigation, evidence of stream incursions by cattle was less widespread than the lower reach. Further upstream, north of the Caviness Site, the stream emerges from a heavily wooded tract of land and it was initially anticipated that this reach would serve as a reference for portions of the restoration plan. However, recent logging has resulted in disturbance to the channel and the reach is no longer suitable for a reference reach survey.

The profile of the upper reach is only slightly incised and the channel transitions several times between a type E channel and a type C channel. Although this reach displays some of its historic pattern and the bank height ratio remains near 1.0, there are many deficiencies exhibited by the channel that are adversely affecting natural stream functions and aquatic habitat. Those sections of the stream that classify as a type C channel display width/depth ratios greater than twenty. This high ratio signifies a departure from desirable conditions. As a result of the high width, sediment is precipitating out and forming depositional features within the channel bed. Additionally, alterations in the pattern, from either manual regrading or channel evolutions, have resulted in portions of the reach that have little to no sinuosity. The effects of sediment deposition and changes in the pattern have combined to form a thalweg profile with shallow, poorly spaced pools and wide, fairly flat riffles. In locations where there are meanders, the radii of curvature are generally too small and in several cases the distance from bend-to-bend is not properly proportioned to the bankfull width. Those sections of the stream that classify as a type E channel, on the contrary, are in relatively stable condition. However, due to their location within this disturbed reach, natural stream functions have been compromised by increased sediment load and profile reversal.

Photograph 6. Tibbs Run – Section TR6

Photograph 7. Tibbs Run – Section TR7

Photograph 8. Tibbs Run – Section TR8

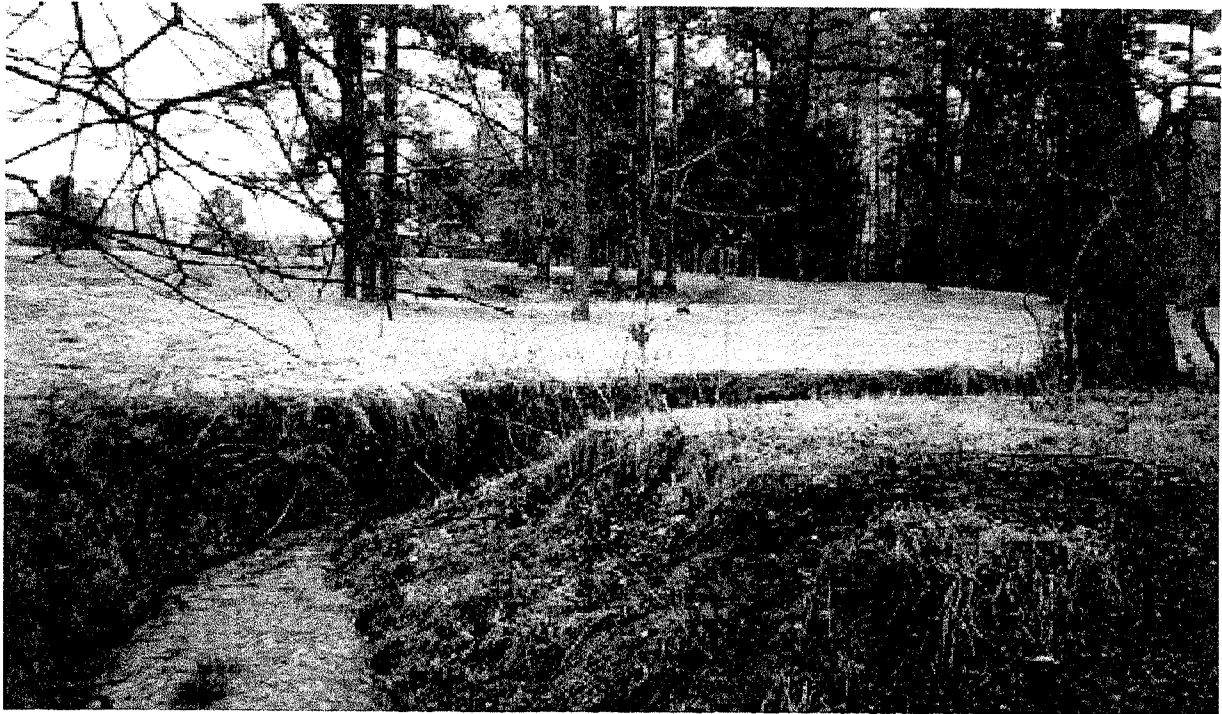
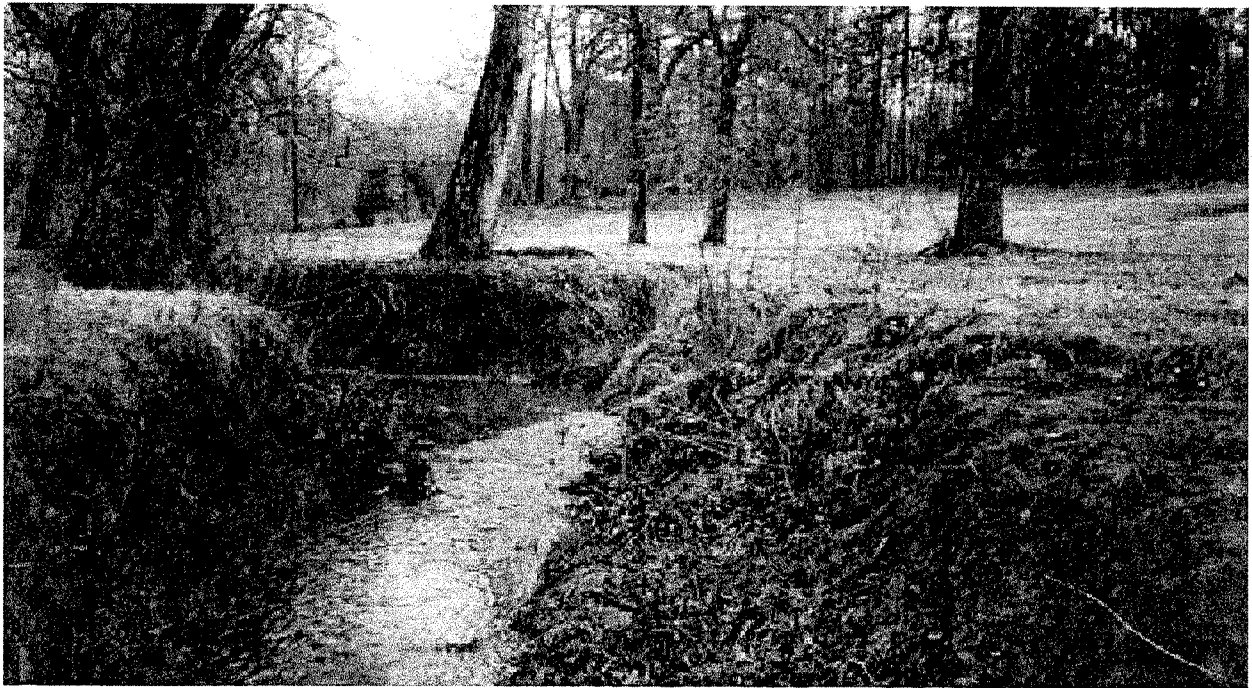
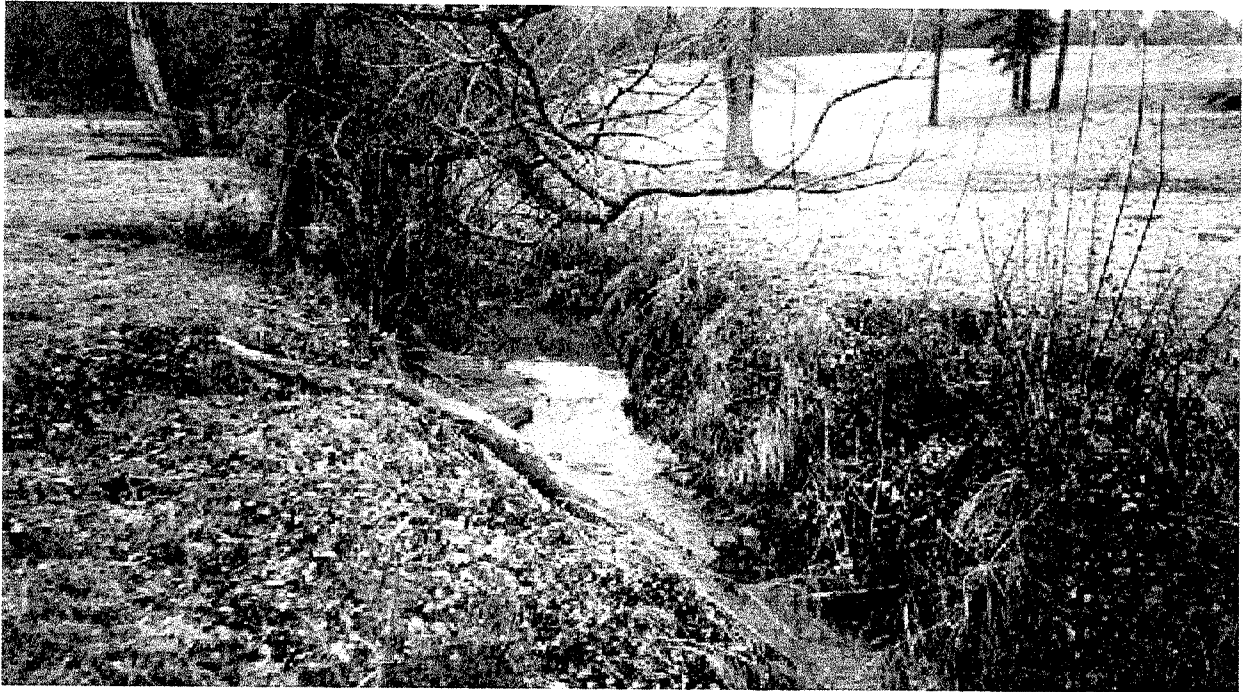
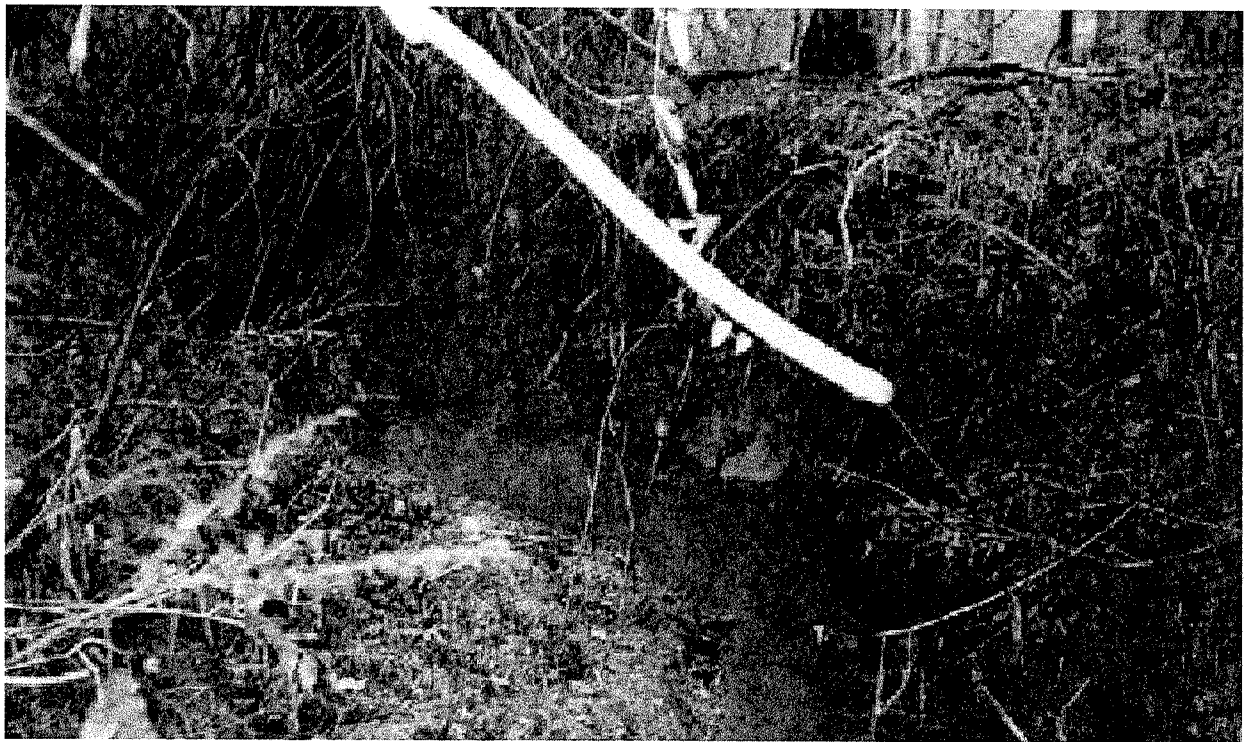
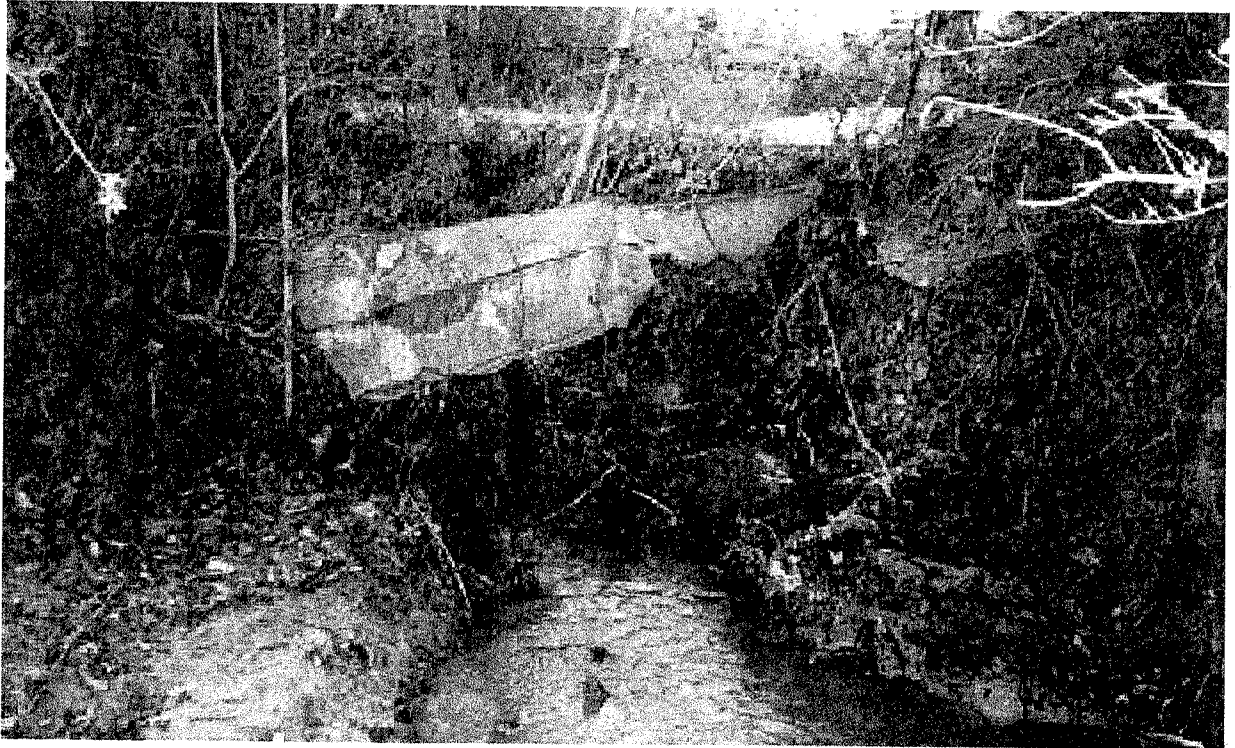
The streambed of the West Branch has degraded several feet below the historic stream grade (Photographs 9 through 13, Appendix G). As a result, the historic floodplain has been abandoned and the channel banks exhibit signs of excessive erosion. The West Branch is bounded along both sides by currently active pasturelands. No riparian overhanging tree canopy is present along the majority of this stream segment, thus stream shading is severely limited. In areas subject to direct cattle grazing, the riparian vegetation consists of opportunistic, first-successional, herbaceous vegetation. The natural channel pattern and dimensions have been significantly altered by a combination of manual regrading and stream incursions by cattle. There are many locations where the channel banks are bare and unstable. The features typically associated with normal stream processes, such as riffles and pools, are evident only at the downstream end of the West Branch. The bed material consists primarily of sand, silt and gravel. Occasional outcrops of weathered bedrock and cobble form a few riffle sections.

The profile of the West Branch begins only slightly incised at the upstream end of the project site and the incision gradually increases in the downstream direction. At the confluence with Tibbs Run, the existing profile is approximately two to three feet below the historic stream grade. The entire reach of the West Branch is classified as a type E channel, however, the stream is characterized by general instability. At the upstream end (cross section WB5 and WB4) the meanders display evidence of rapid bank retreat. The lack of riparian vegetation has resulted in poor rooting depth and exposed banks. The bank height ratio throughout the middle and lower portion of this reach ranges from 1.2 to 1.5. The bank angles range from 60 to 90 degrees. Factors that are acting to limit a rapid evolutionary change in the channel include the cohesive nature of the bank material and the presence of nick points in the bed which include several bedrock outcrops and a 42 inch concrete pipe. Despite these resistive factors the stream is evolving towards a type G channel.

Photograph 9. West Branch of Tibbs Run – Section WB5

Photograph 10. West Branch of Tibbs Run – WB4

Photograph 11. West Branch of Tibbs Run – Section WB3

Photograph 12. West Branch of Tibbs Run – Section WB2

Photograph 13. Confluence of Tibbs Run and West Branch
