**CEDAR CREEK STREAM AND WETLAND RESTORATION
PROJECT
MONITORING REPORT
MONITORING YEAR 4
FINAL**

SAMPSON COUNTY, NORTH CAROLINA
CONTRACT No. 005011 - PROJECT No. 95718
USACE ACTION ID No. 2012-00389 – NCDWR PROJECT No. 2013-0186

**Cedar Creek
Sampson County, North Carolina
DMS Project ID 95718**

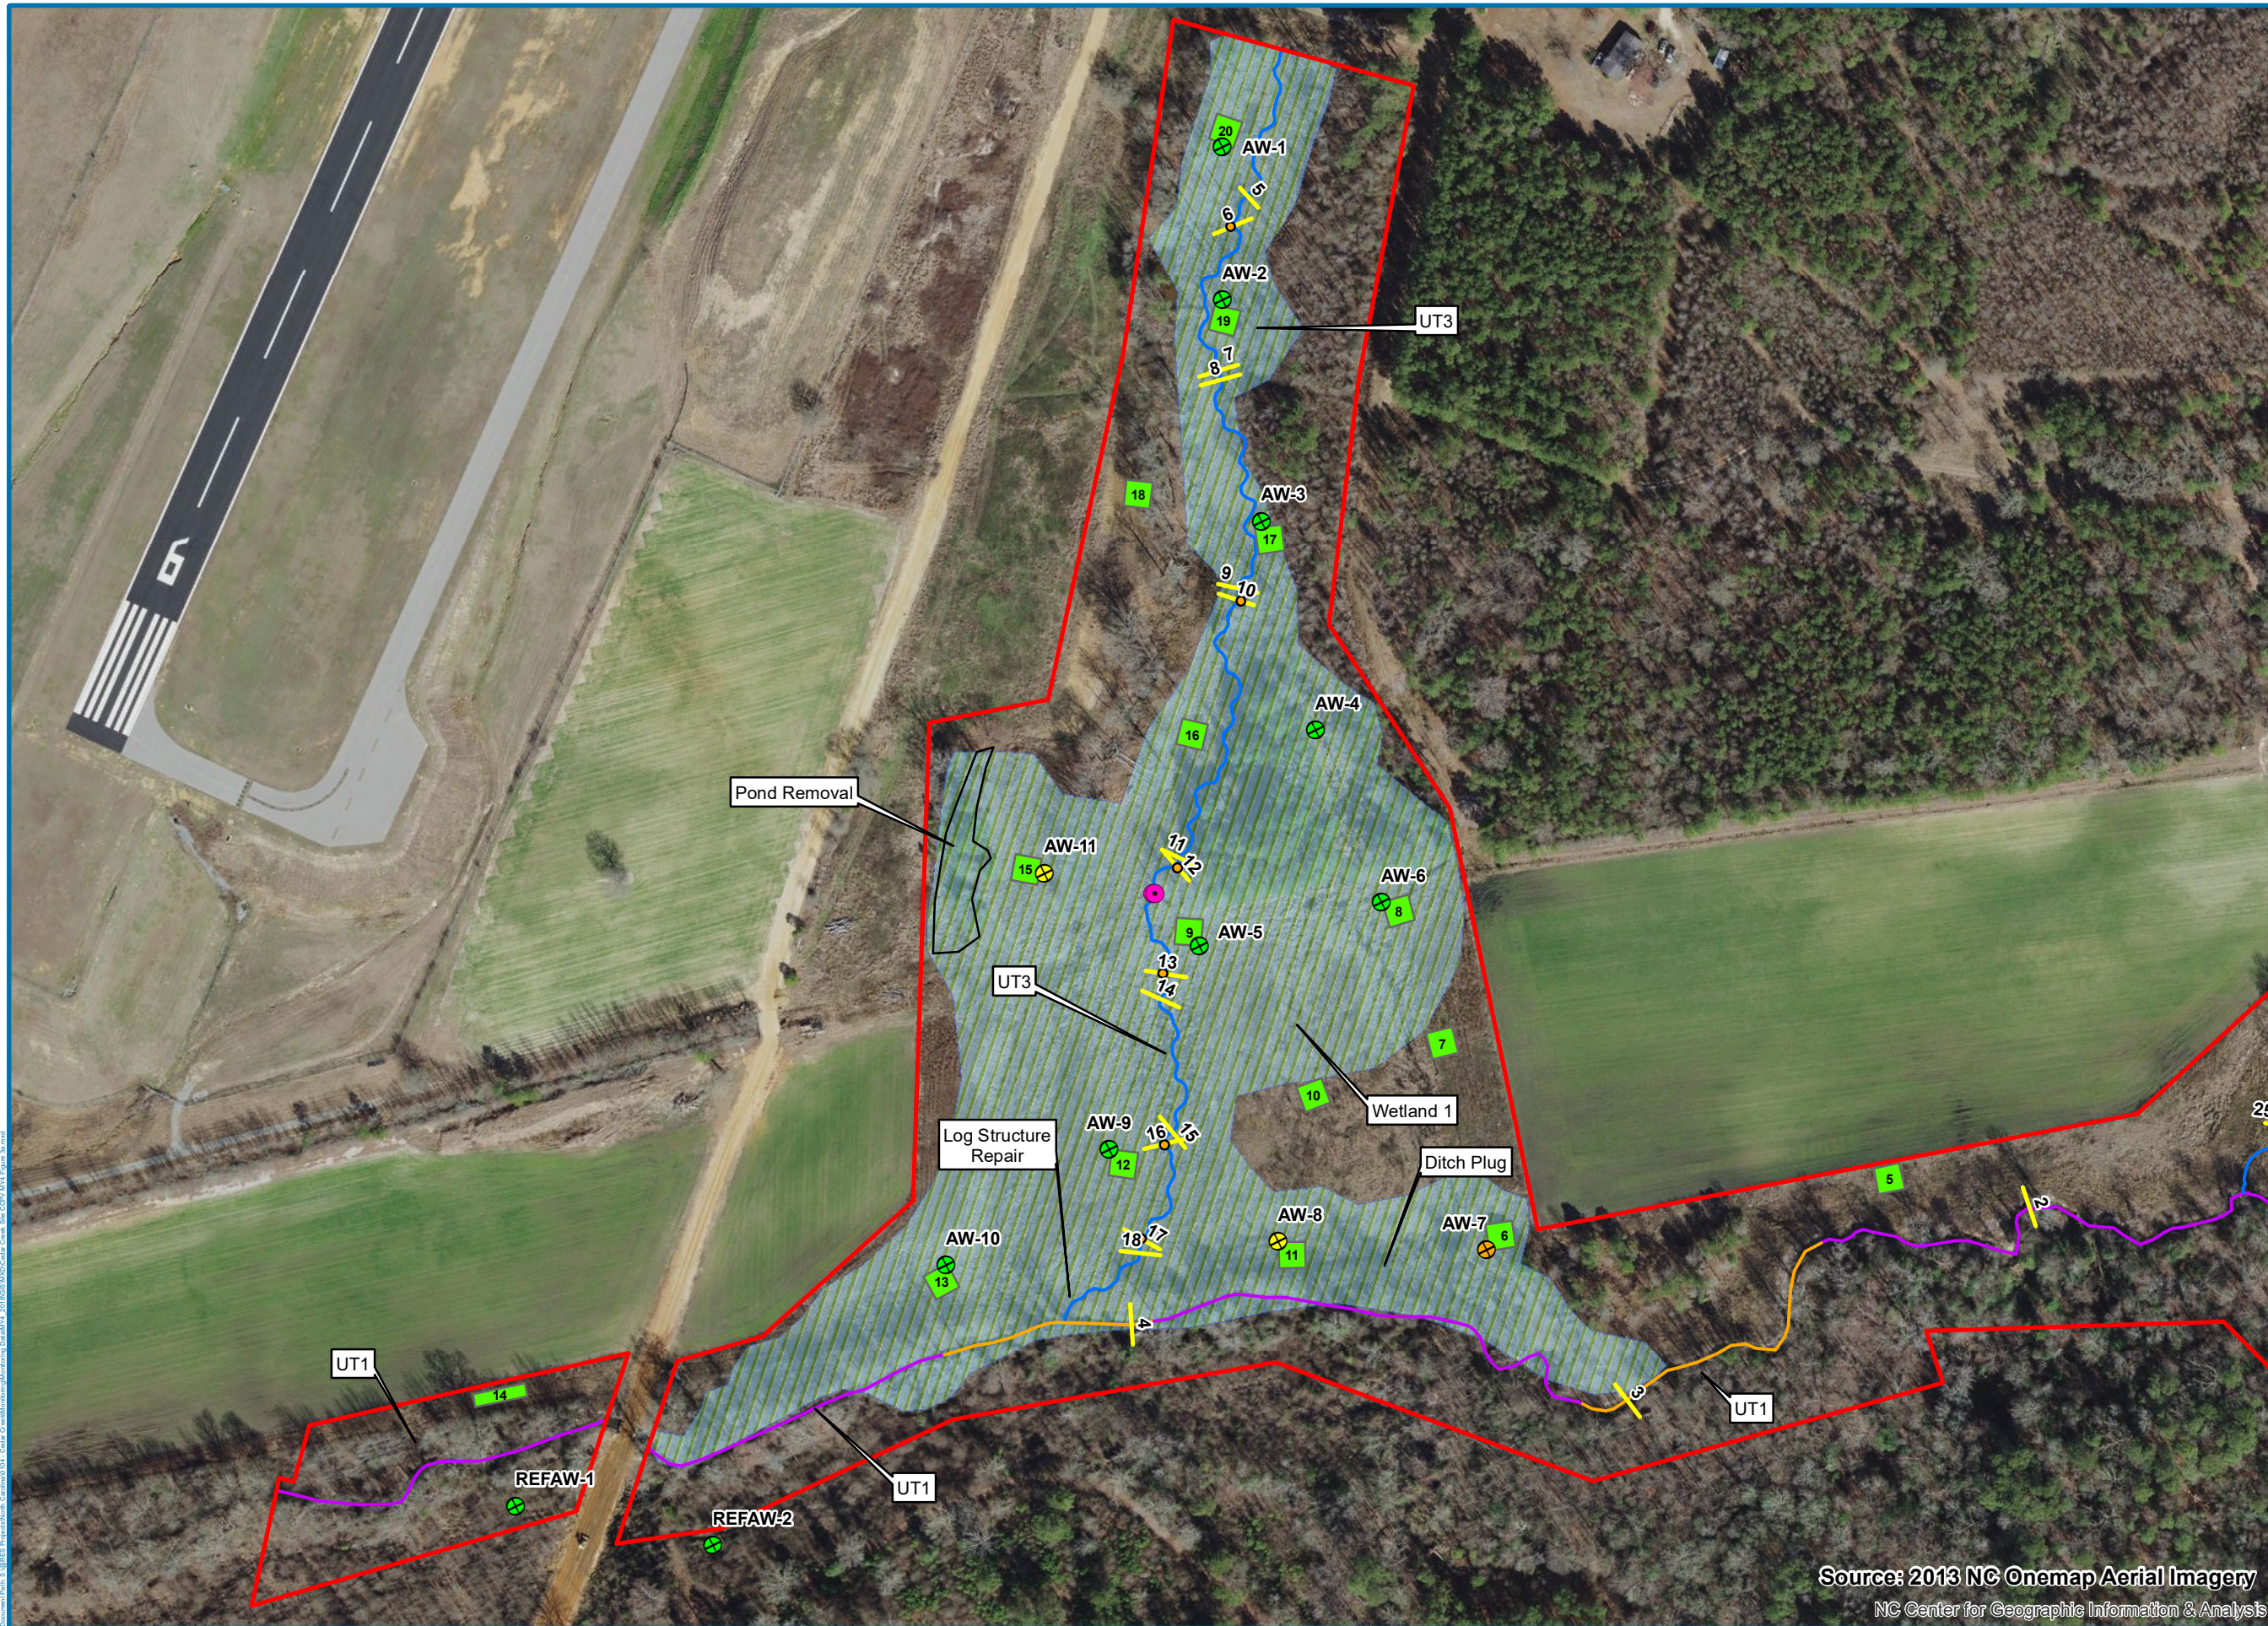
Figure 3. Current Conditions Plan View Map (CCPV)

One vegetation problem area remained during the Year 4 monitoring period. The vegetation problem area is mapped on the Current Conditions Plan View (CCPV) as part of the annual monitoring report. The vegetation problem area (VPA1) consists of a 0.5-acre area of invasive species Chinese Privet (*Ligustrum sinense*) at the upstream portion of UT-1. Invasive treatment (cutting and spraying) was completed again in August 2018 and will continue as necessary in following years. The other vegetation problem area reported in MY3 was a small sparse herbaceous vegetation area along UT-2 above the stream crossing (Sta. 4+00). This area was reseeded, mulched, and replanted in October 2018.

| Feature Category | Station Numbers | Suspected Cause; Repair | Photo Number |
|---|---|---|---|
| VPA1 | UT1 @ 1+00 to 2+25 | One patch of Chinese Privet present along the right bank on the most upstream easement corner of UT1. Treatments will continue as needed. | N/A |

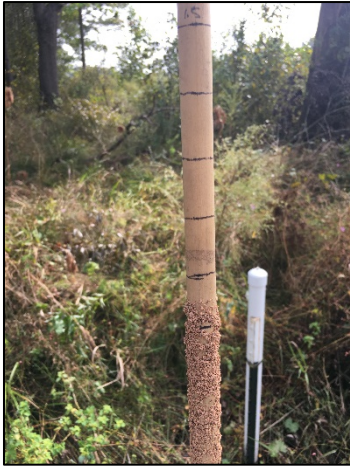
Crest Gauge 1 Reading 1.05 ft (9/15/2018)

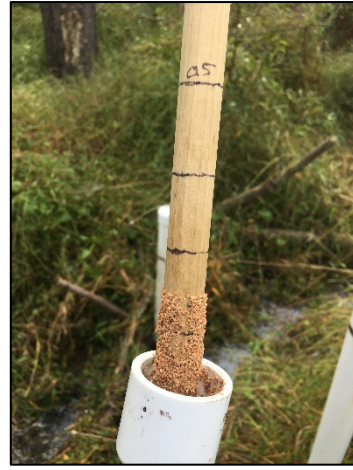
Crest Gauge 3 Reading 0.25 ft (9/15/2018)
