Chavis Park, Garner Branch Stream Restoration Project

North Carolina Department of Environment
and Natural Resources
Division of Water Quality Wetland Program
Stream and Riparian Area Restoration
Raleigh, North Carolina

February 26, 2002

Garner Branch Stream Restoration Project

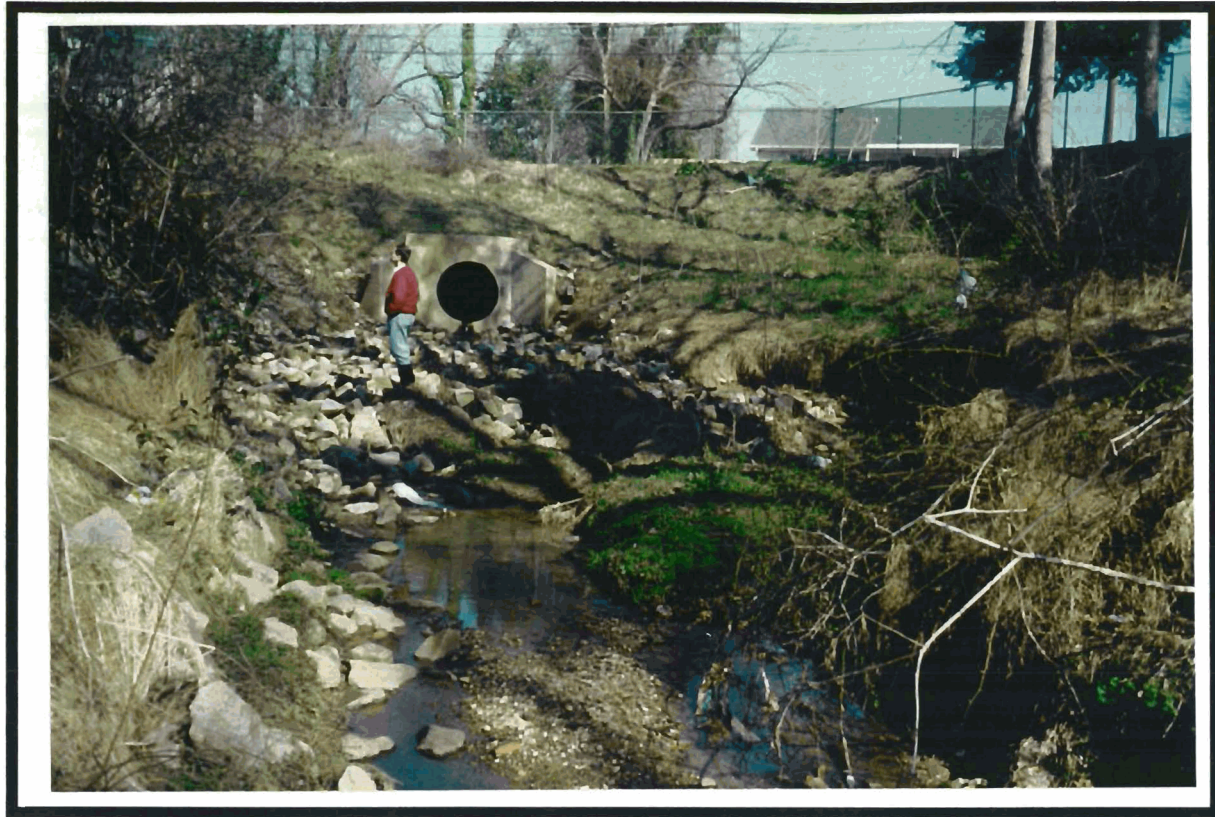
Culvert Under Lenoir Street Upstream Project Limit

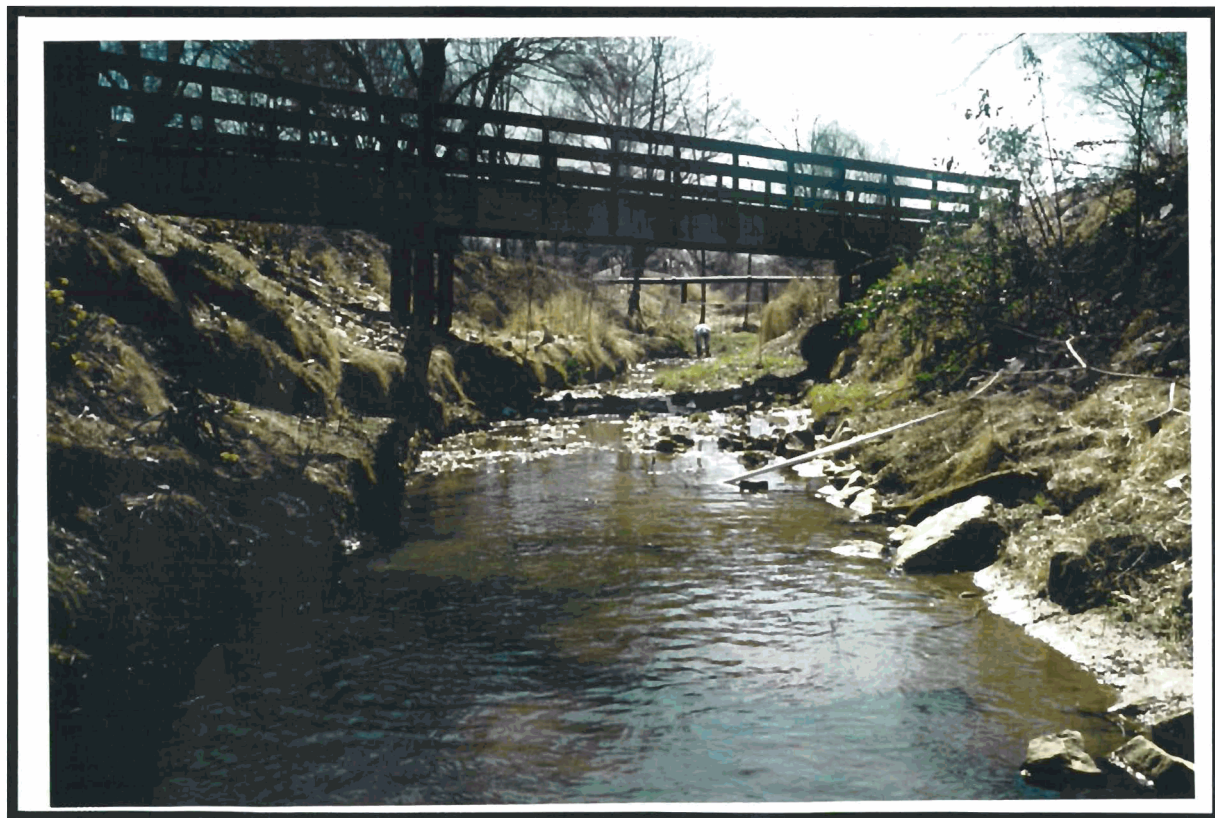
Over Widened Stream Segment Just Downstream of the Culvert

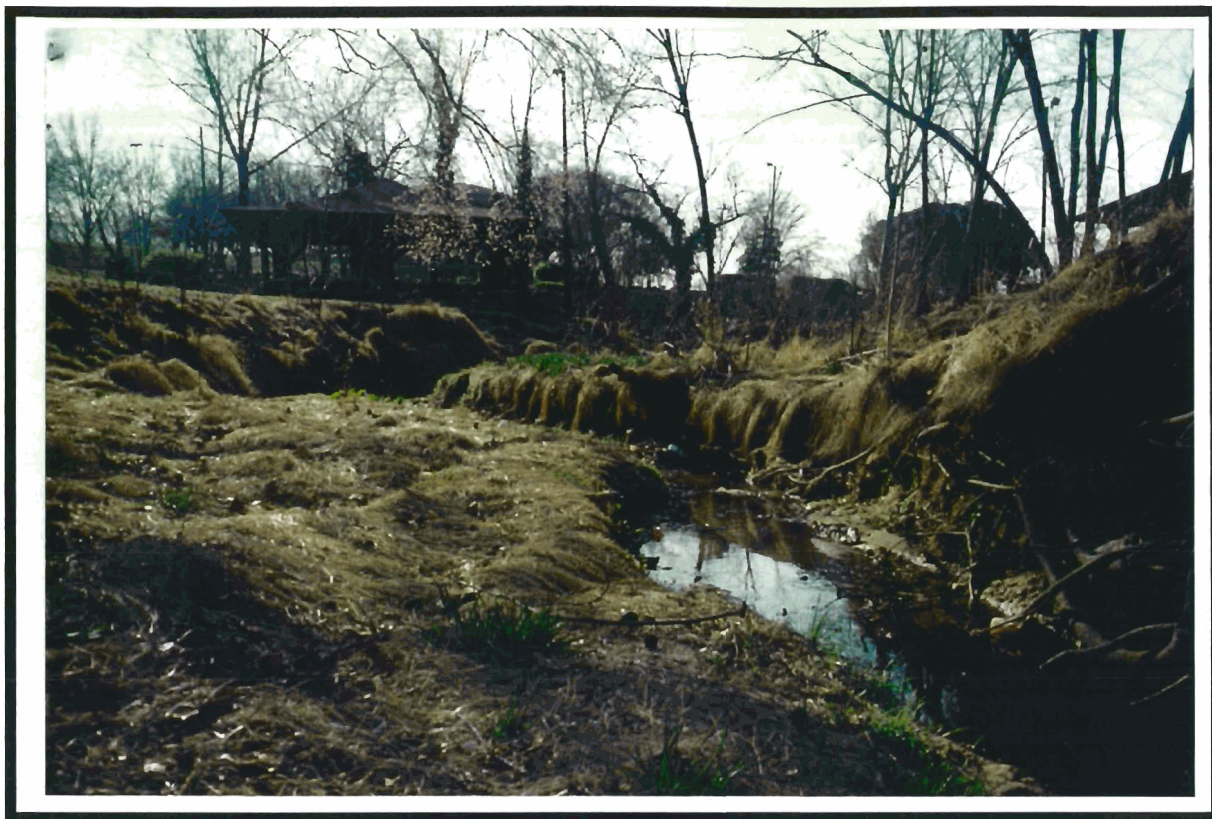
Stream Reach Upstream of Stone Bridge

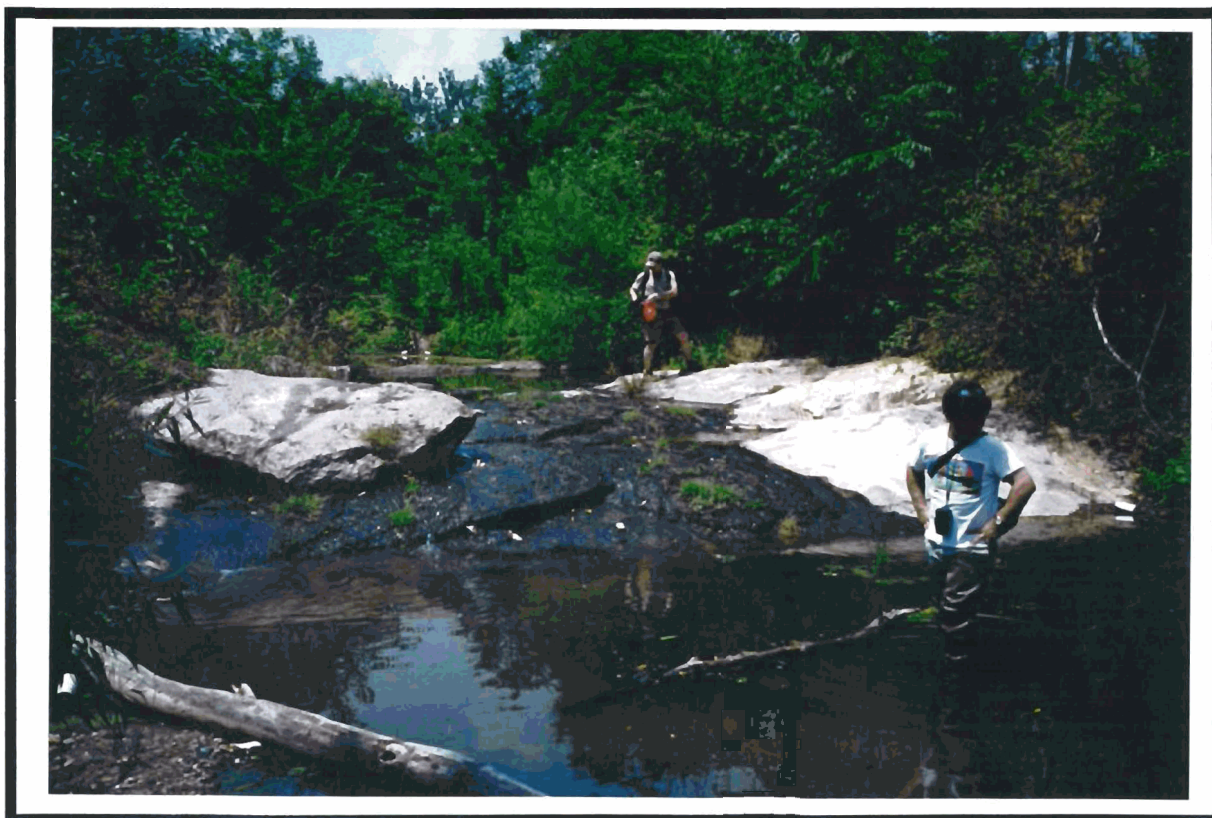
Rock Outcrop Just Upstream of Culverts Under MLK Blvd.
