# County Line Creek High Vista Estates and Golf Course Stream Restoration

Executive Summary of Design  
*Henderson/Buncombe County, North Carolina*

November 2001  
011795006

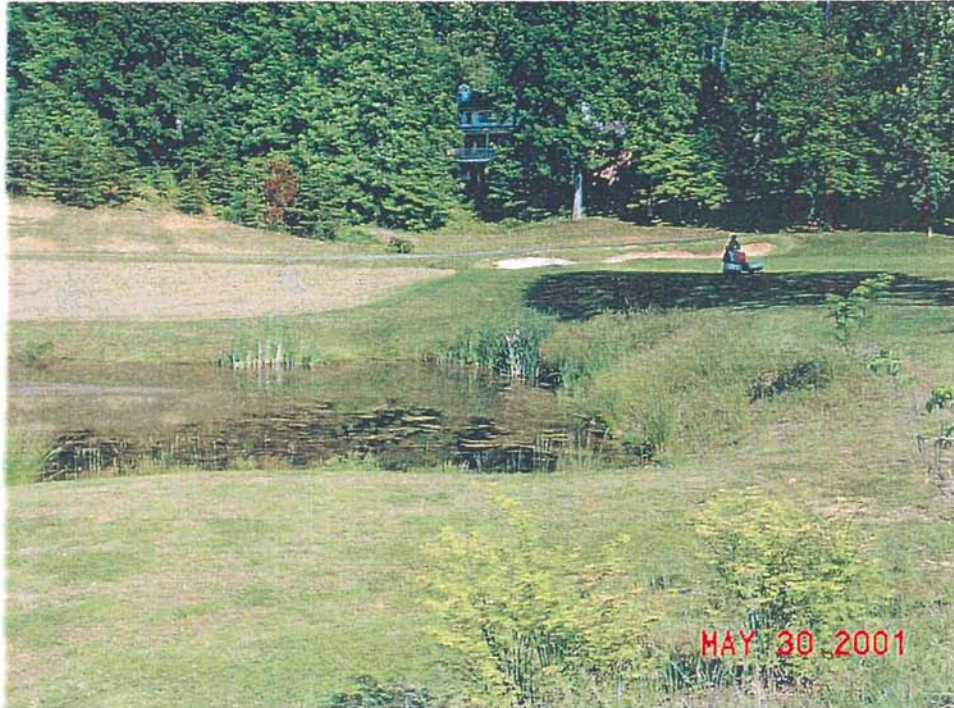
Photo 1: Begin Project – Pond area at 11<sup>th</sup> green

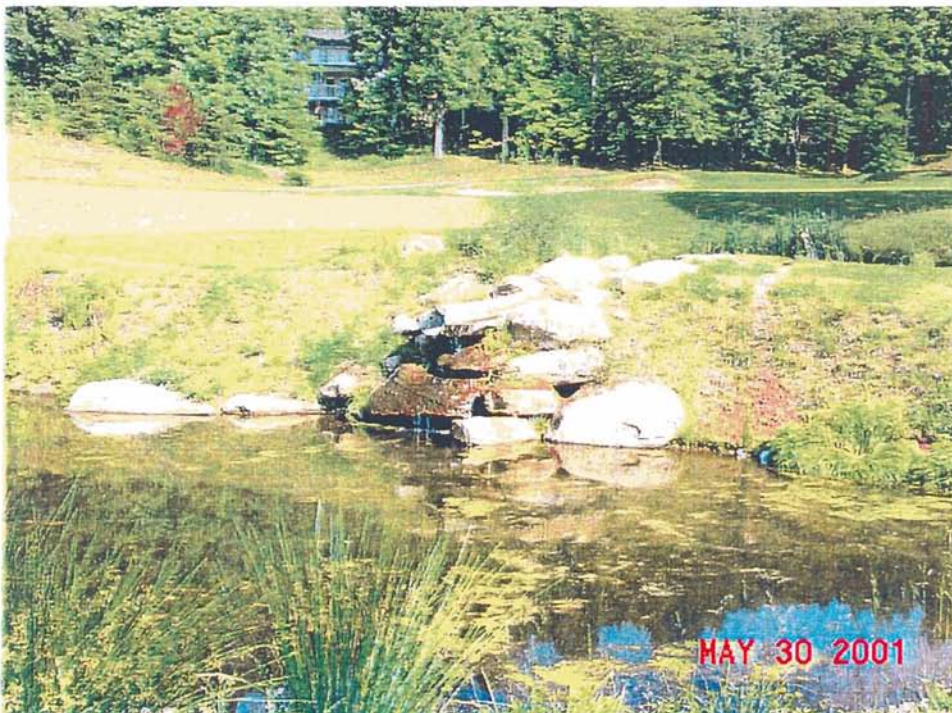
Photo 2: Begin Project – Pond area

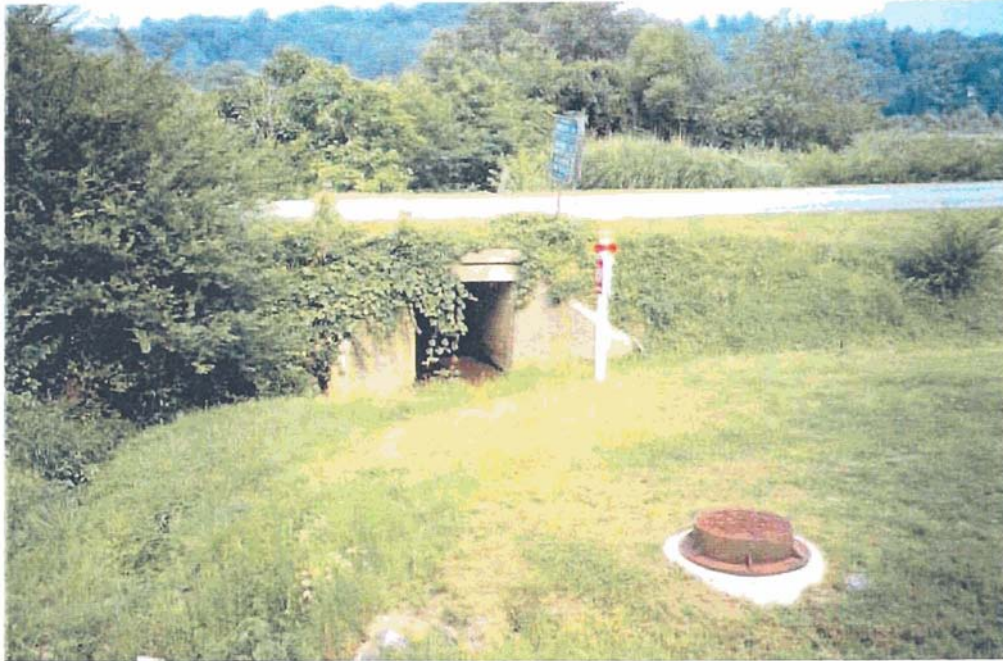
Photo 3: Box Culvert at NC 191

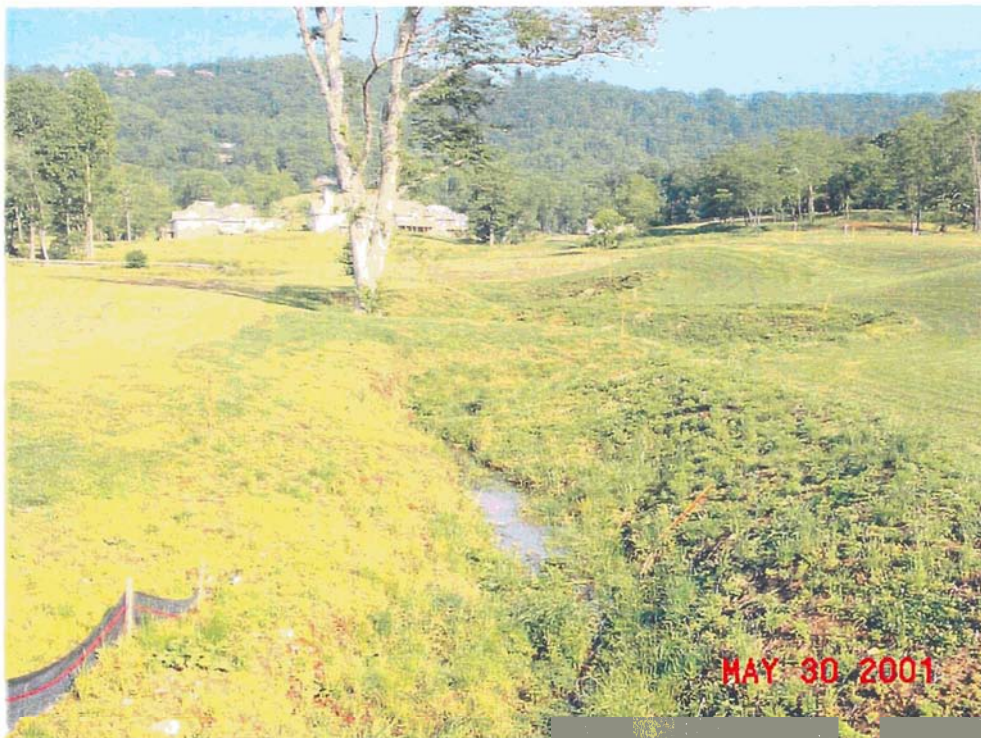
Photo 4: Looking downstream from tributary confluence – vegetation typical

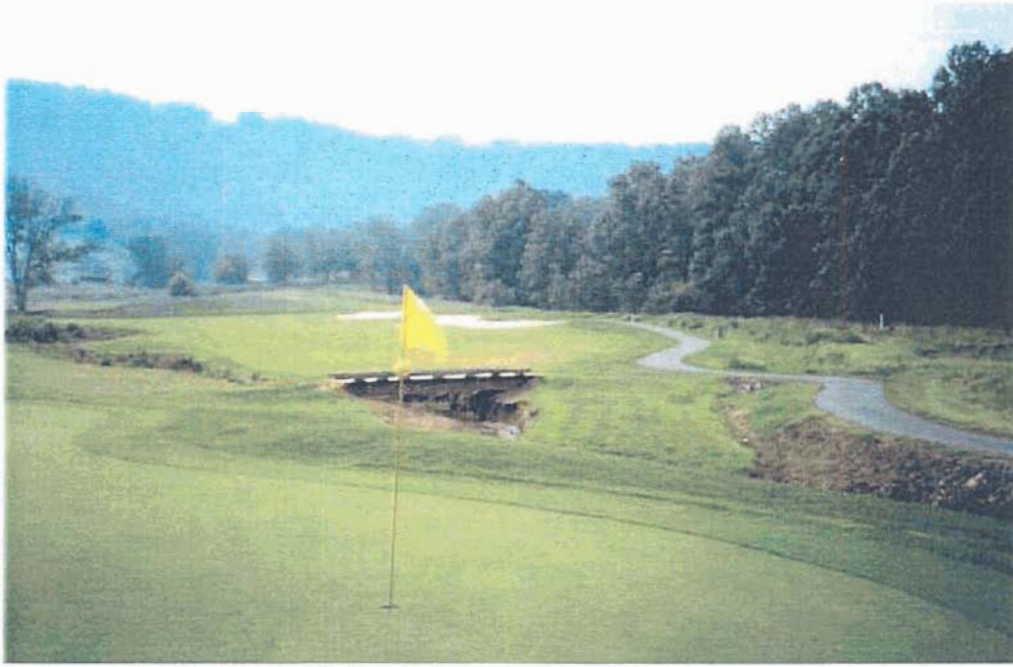
All adjacent structures and utilities are shown on the Preliminary Restoration Plan. There are five golf cart crossings (4 bridges, 1-48" RCP culvert) and two road crossings (both 60" RCP culverts). The stream runs along the edge of the fairway along the 12<sup>th</sup> hole (Photo 4). It continues between the fairway and the 12<sup>th</sup> green. The stream then runs under High Vista Falls Road. The 13<sup>th</sup> fairway crosses the stream twice. The stream then runs between the 13<sup>th</sup> green and the irrigation pond. It flows under Fairway Falls Road (twin 60" RCP culverts) and leaves the project site by flowing under NC 191 (twin 60" RCP culvert) (Photos 5,6, and 7).

Photo 5: 13<sup>th</sup> green looking upstream

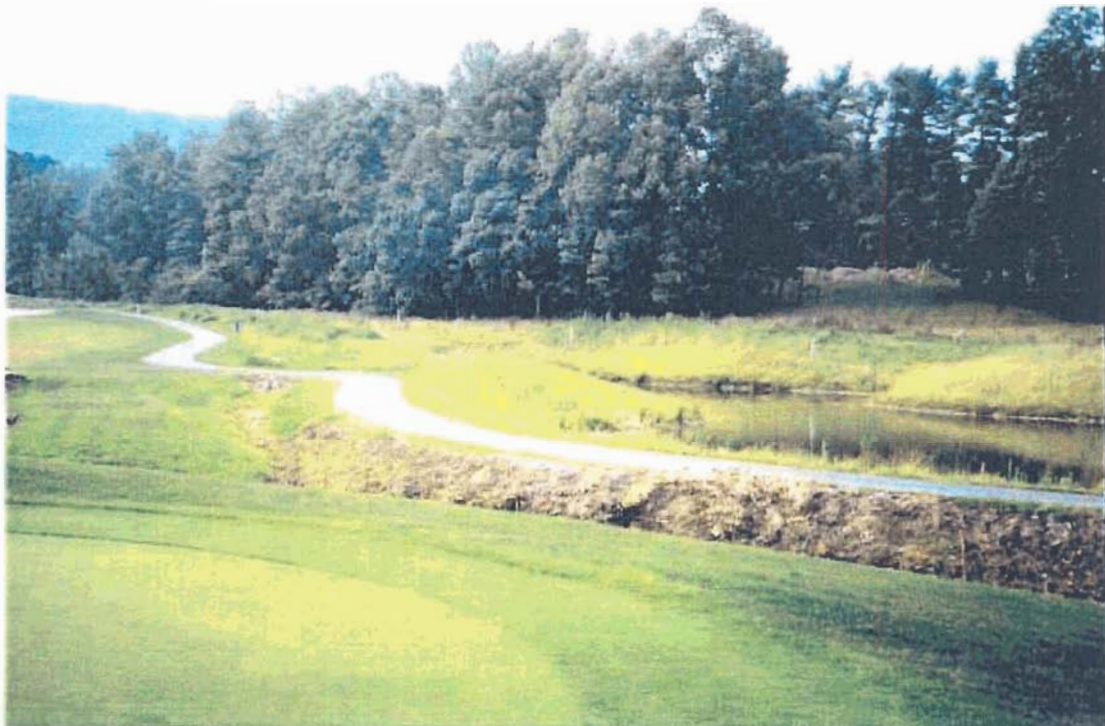
Photo 6: Looking upstream at 13<sup>th</sup> green

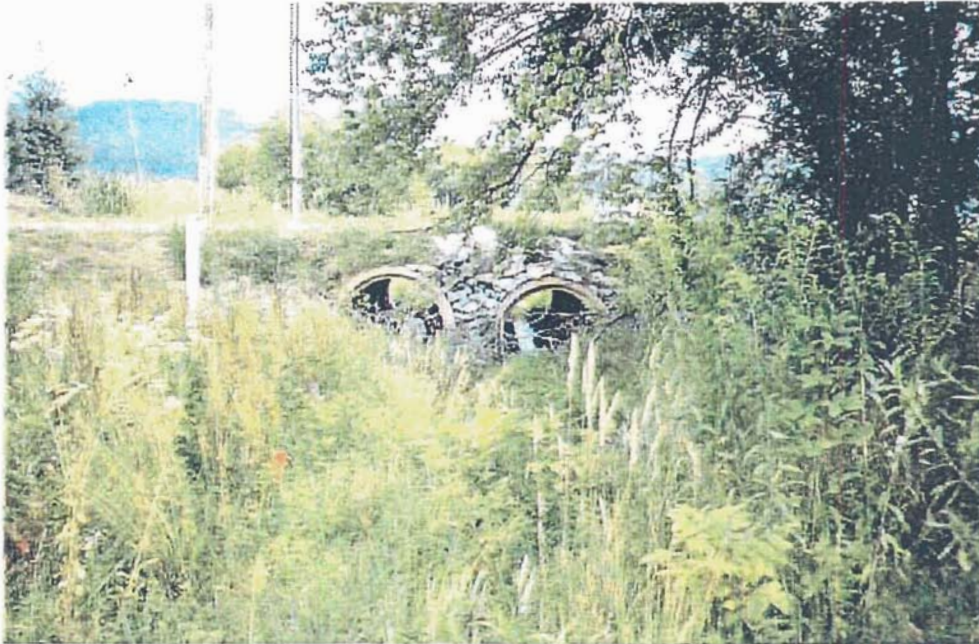
Photo 7: 2-60" RCP at end project (Fairway Falls Rd.)

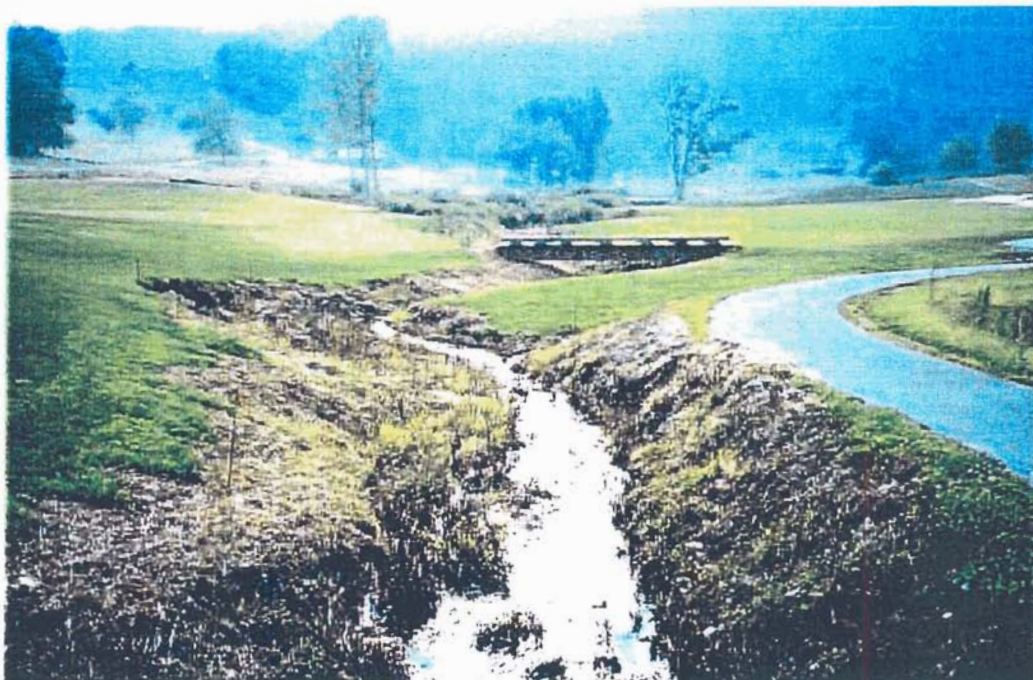
Little to no vegetation is observed along the stream that runs within the golf course area (Photo 8). Small sections of patchy brush and weedy vegetation exist along the stream reach. This vegetation is observed between 200 to 500 feet downstream of the pond, at the 11<sup>th</sup> green (Photo 9). Along the last 200 feet of stream upstream of NC 191, there is a fairly stable section consisting of woody vegetation and small to medium diameter trees (Photo 10). In addition, there is a densely vegetated area along the tributary that confluences with County Line Creek at approximately 700 feet downstream of the pond, above the 12<sup>th</sup> green (Photos 11 and 12).

Photo 8: Looking upstream - eroded banks typical

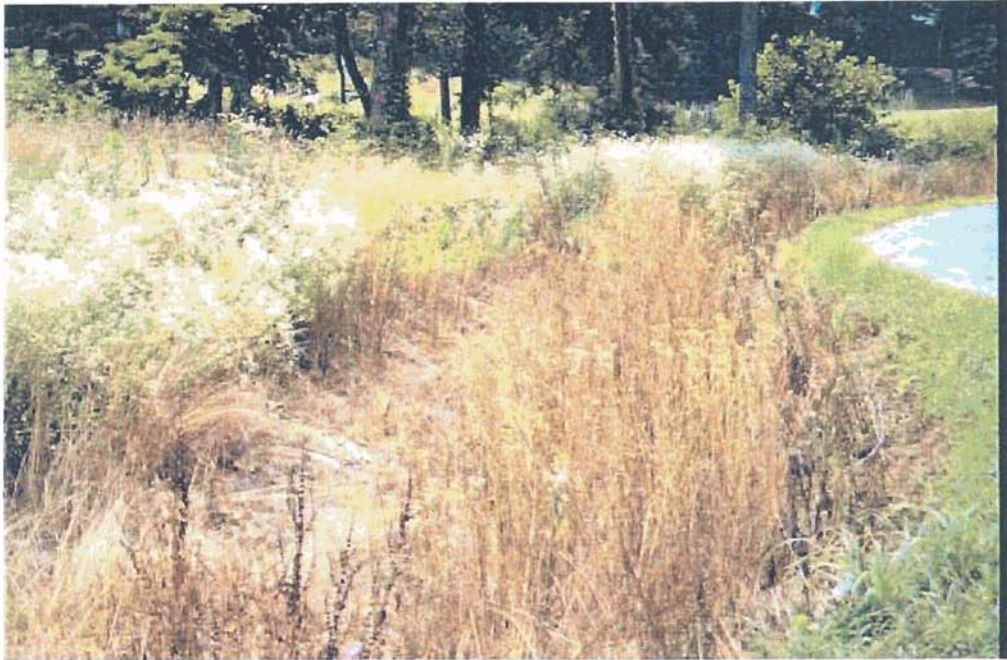
Photo 9: Good vegetation adjacent to 12<sup>th</sup> fairway (Sta. 5+00 to 10+00)

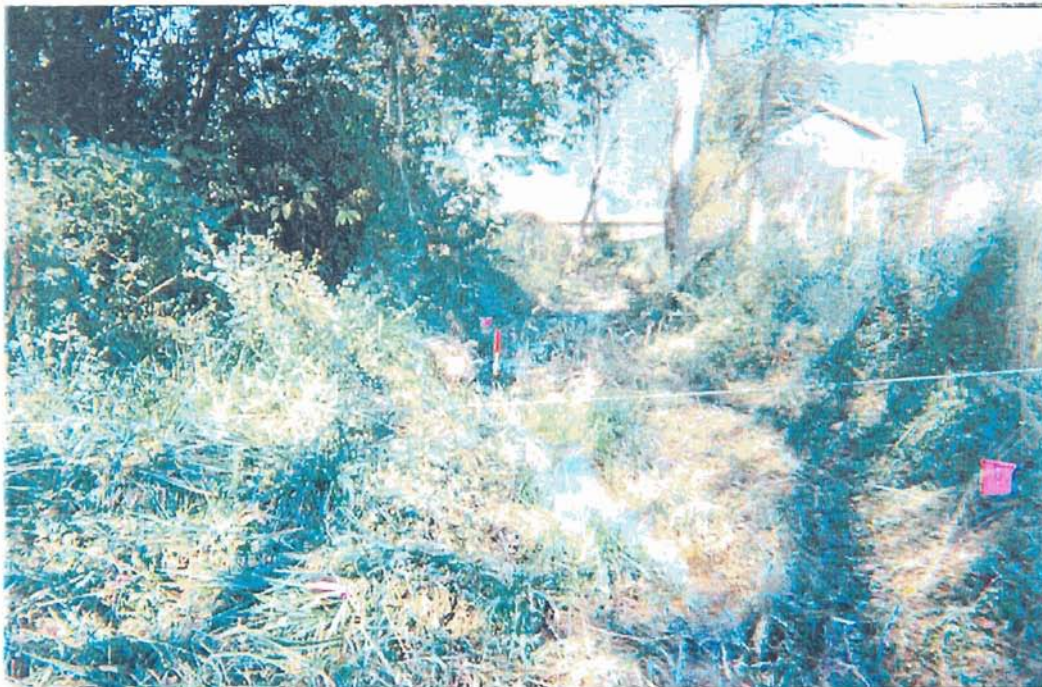
Photo 10: Stable d/s section used as reference

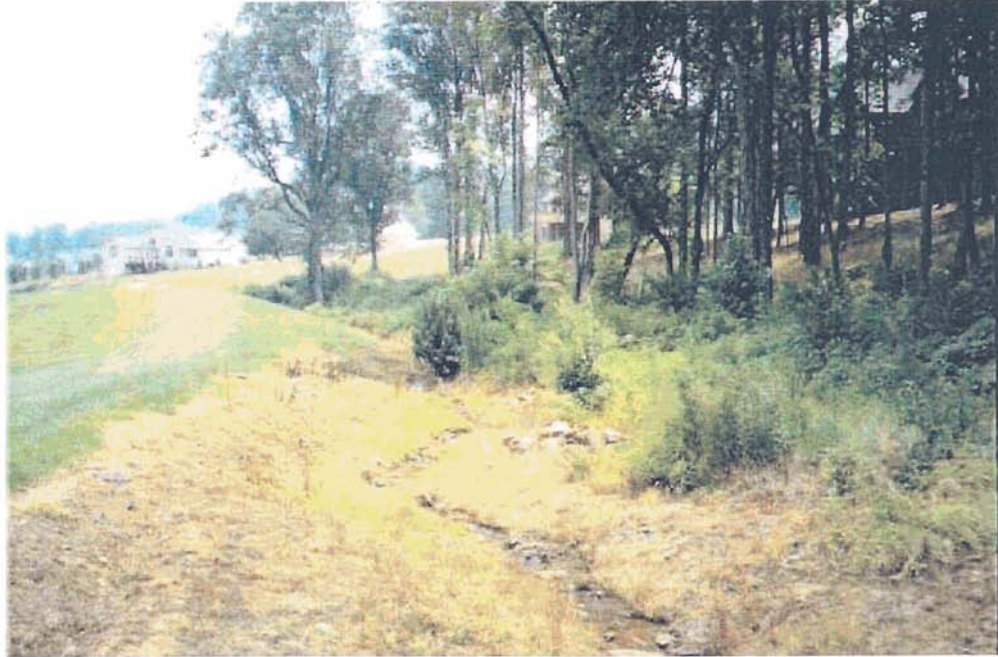
Photo 11: Vegetated area looking downstream (Sta. 7+00)

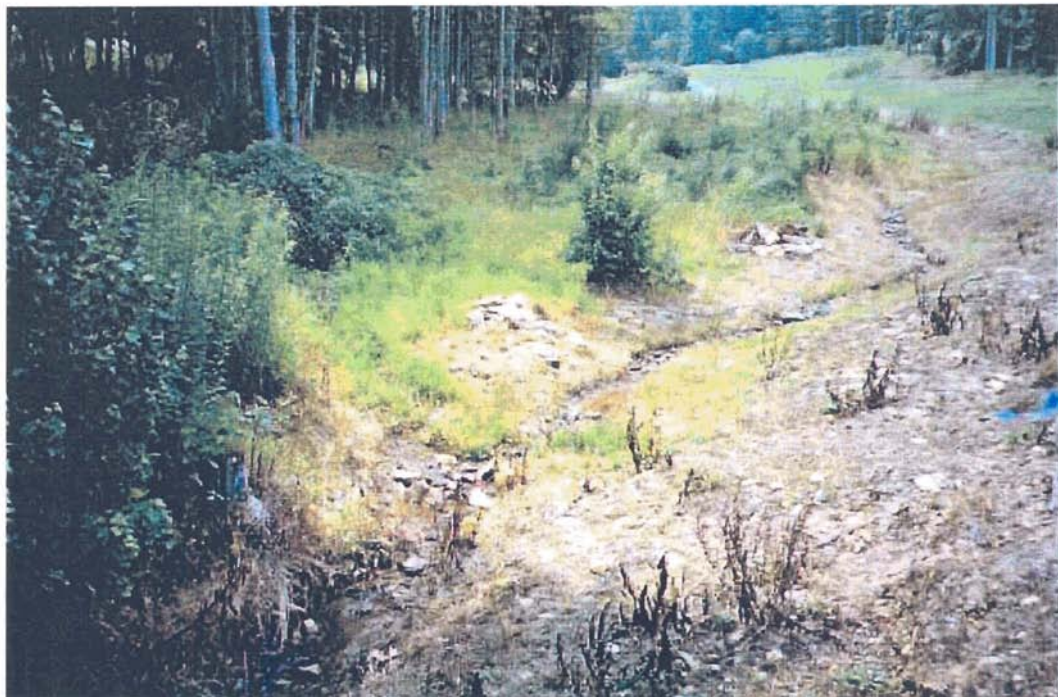
Photo 12: Stable area u/s of 12<sup>th</sup> green – looking upstream

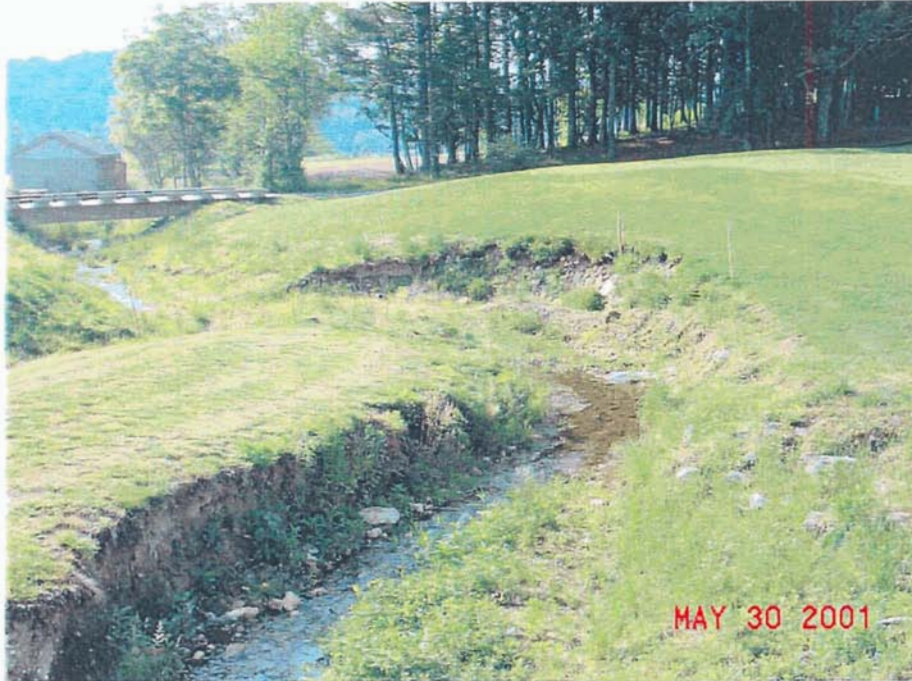
Photo 13: Eroded banks at 13<sup>th</sup> green – looking d/s

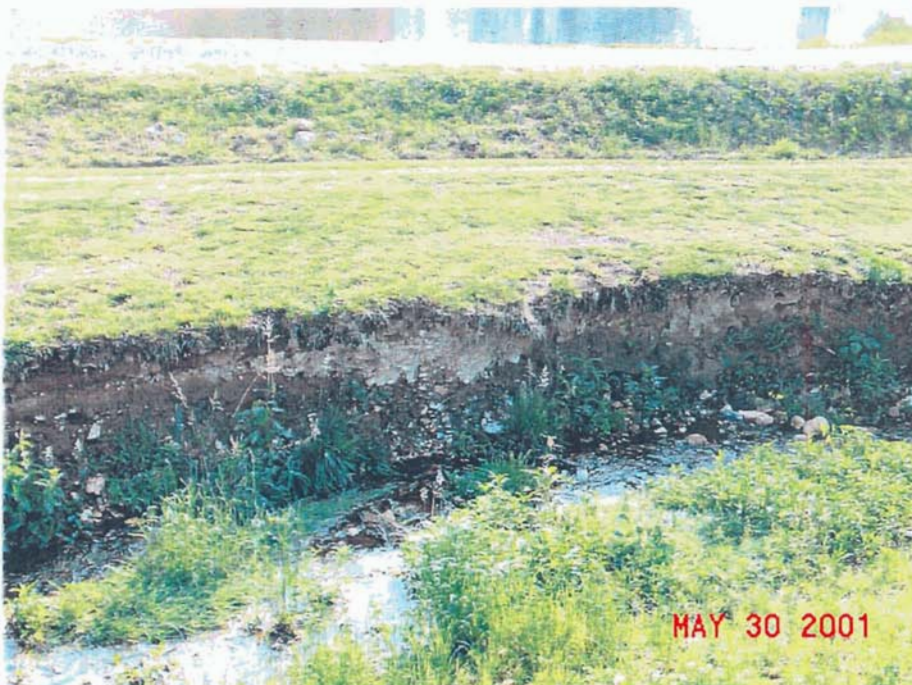
Photo 14: Severe erosion at greens

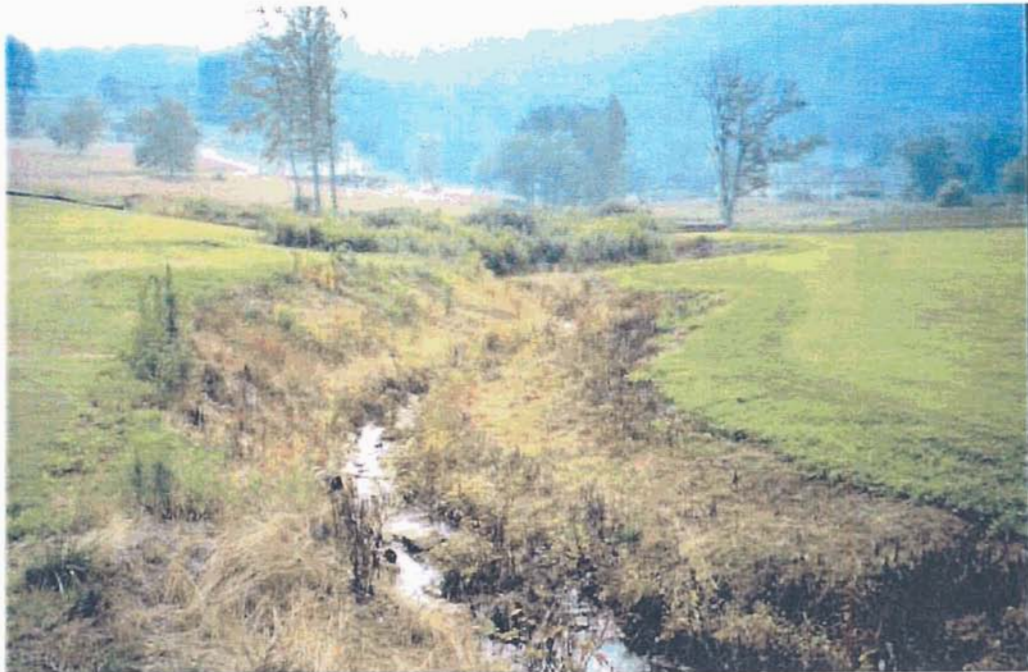
Photo 15: Little to no vegetation – typical section b

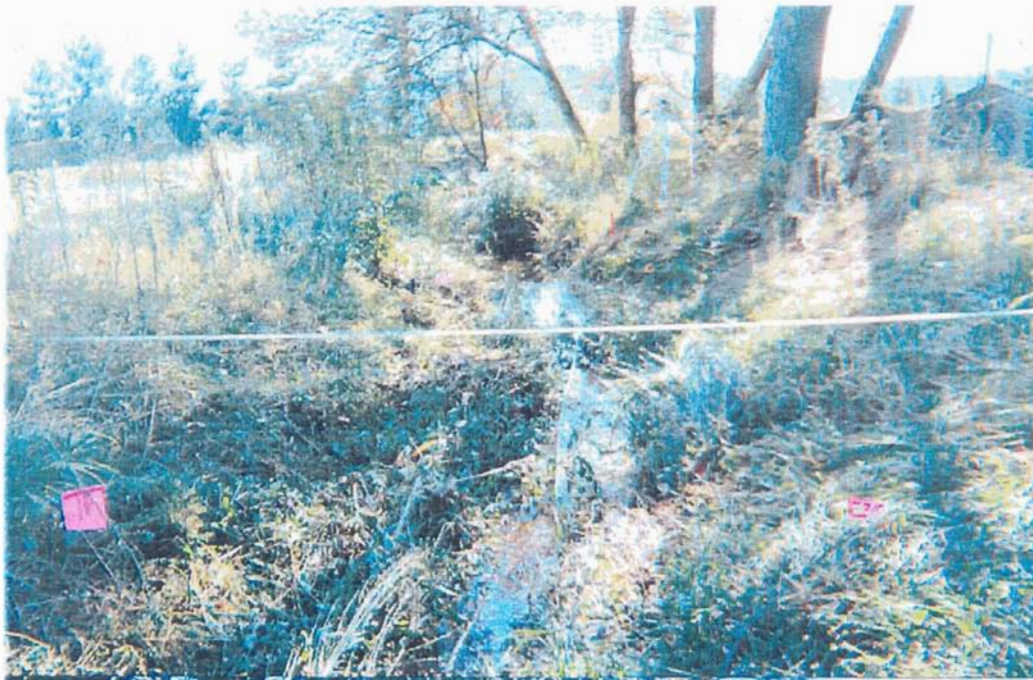
Photo 16: Reference 2 – Stable downstream section of County Line Creek

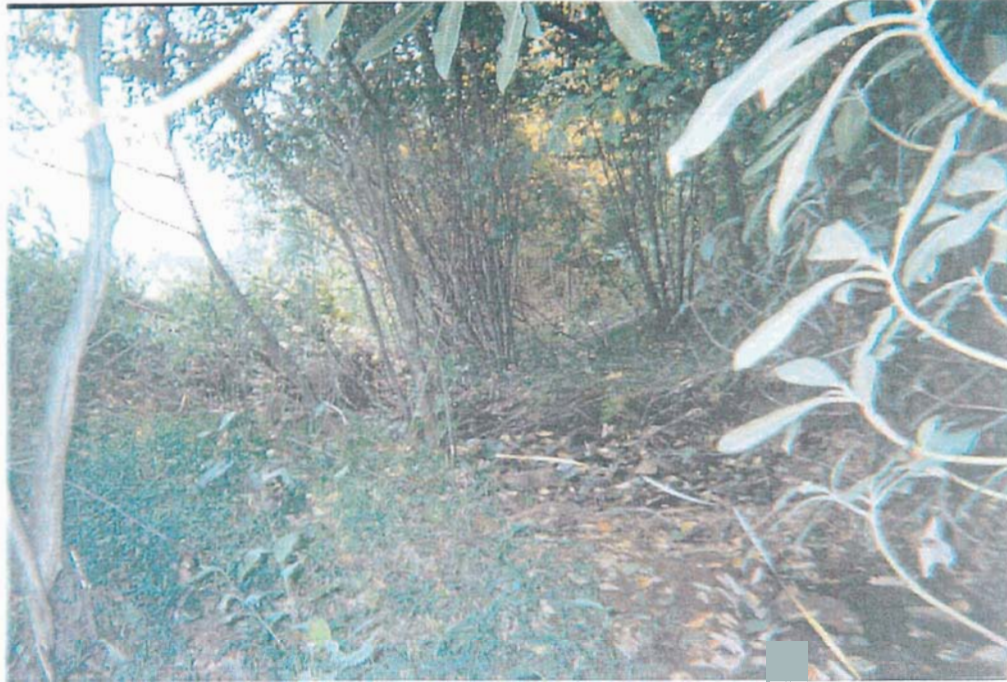
Photo 17: Reference 2 – Tributary to County Line Creek looking d/s

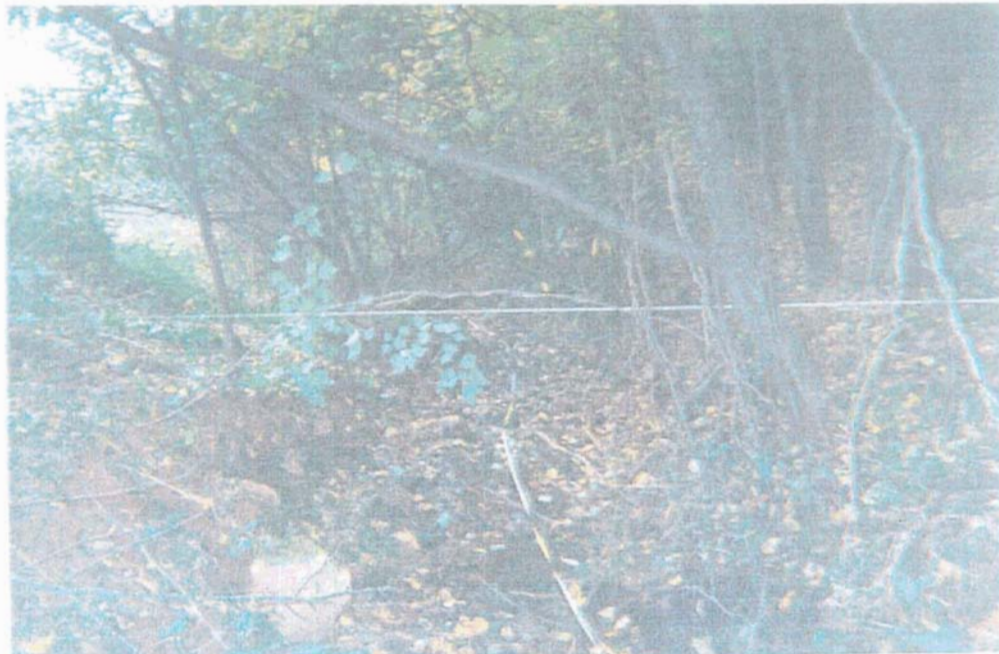
Photo 18: Reference 2 – Upstream tributary, upstream of 11<sup>th</sup> green
