# *Stream Restoration Plan*

## **Third Fork Creek in Forest Hills Park Durham, North Carolina**

**February 2003**

**KCI Associates of North Carolina, P.A.**  
**Landmark Center I, Suite 200**  
**4601 Six Forks Road**  
**Raleigh, North Carolina 27609**

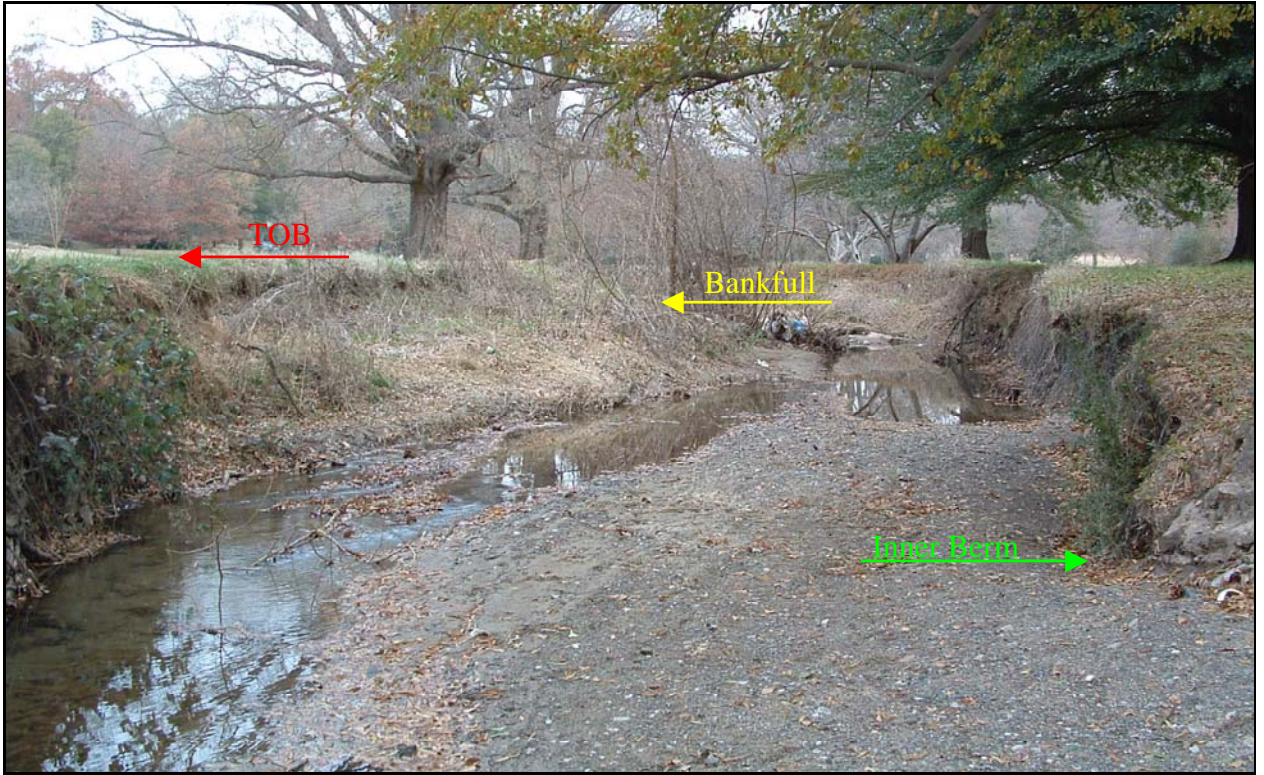
Typical bankfull indicators in upstream section.

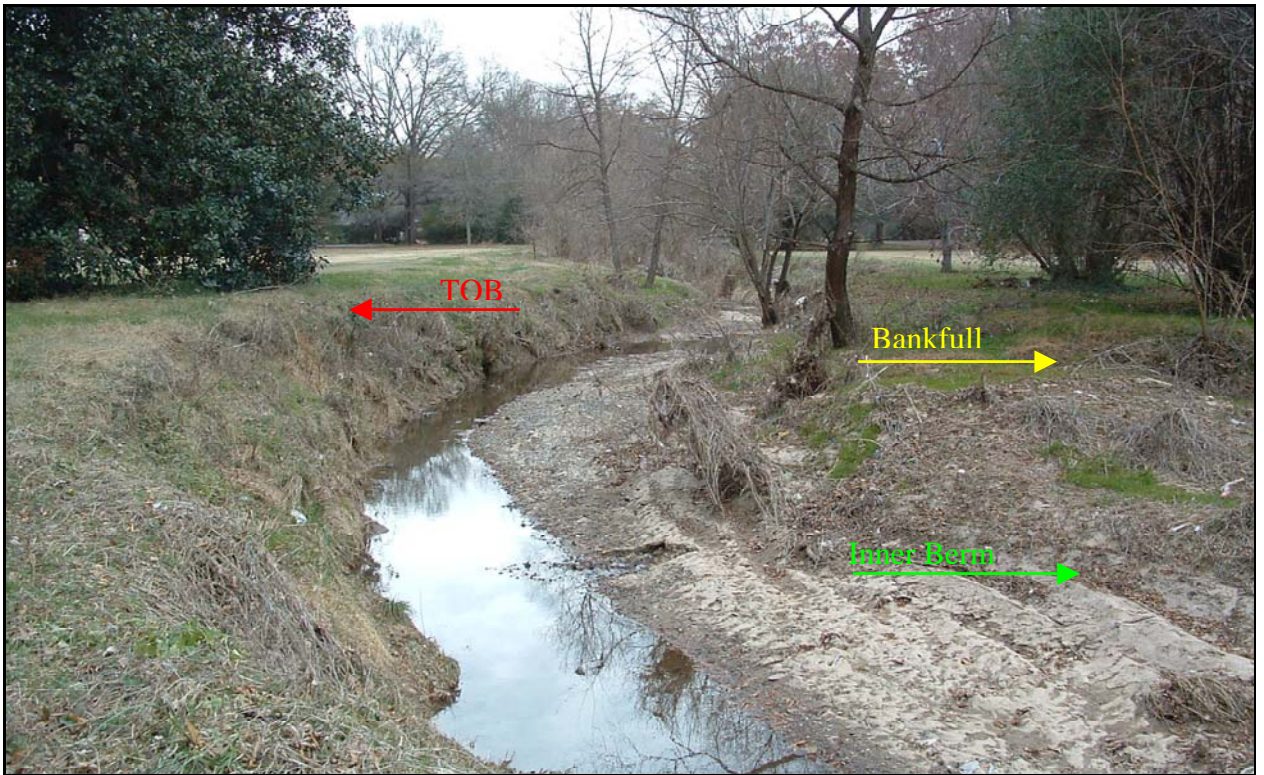
Typical bankfull indicators in downstream project area.

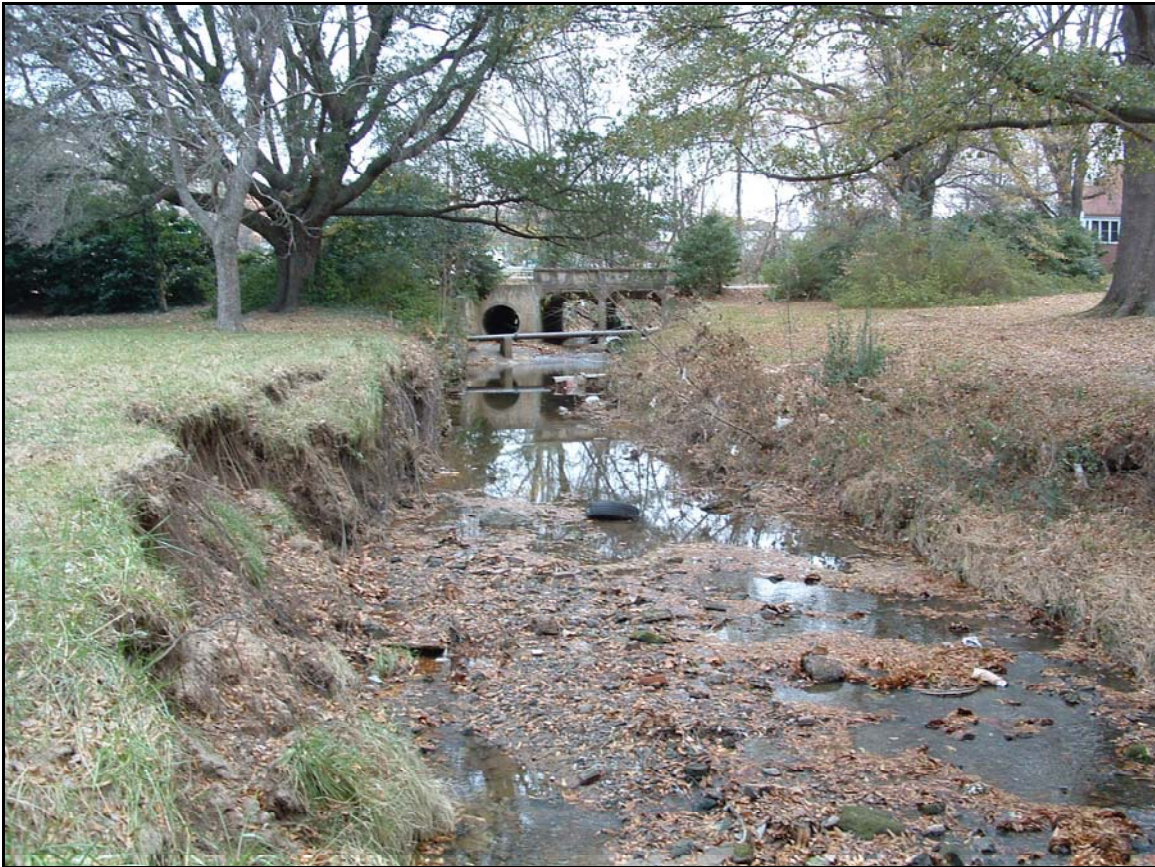
Upstream Project limits. (East Forest Hills Drive culvert/pipe, looking upstream.)

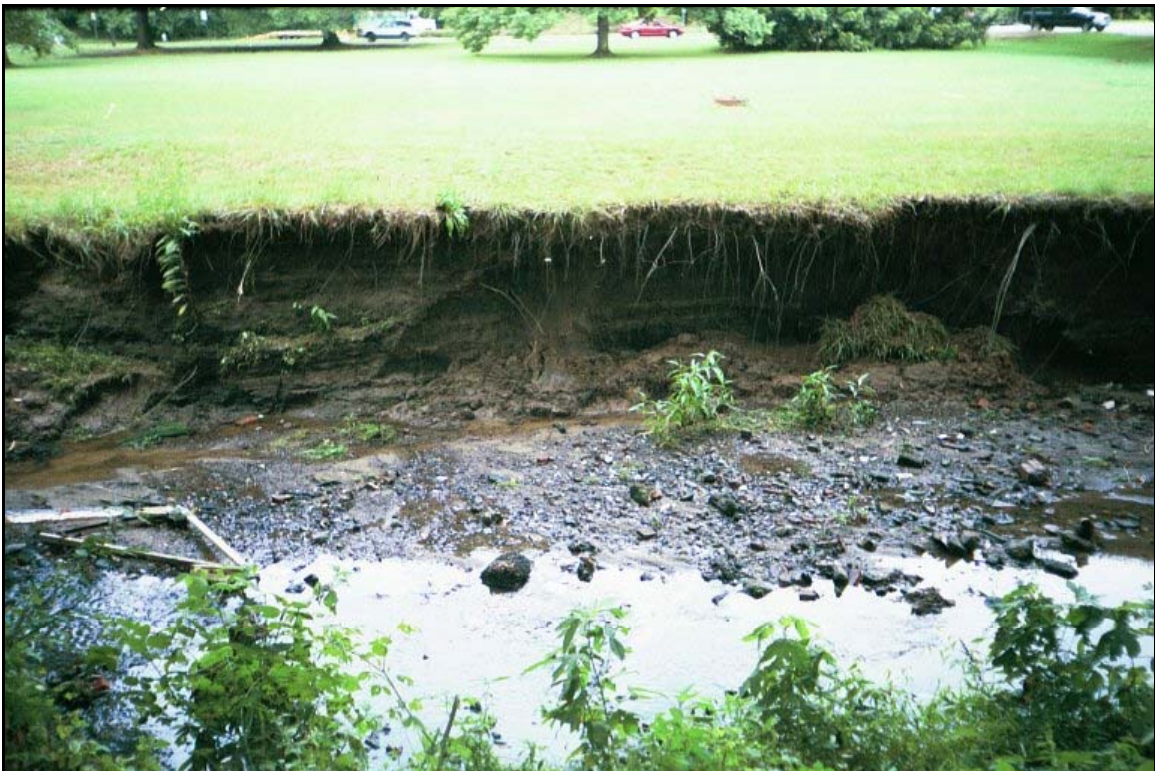
Severely eroded streambank. (Right bank at Sta. 11+50.)

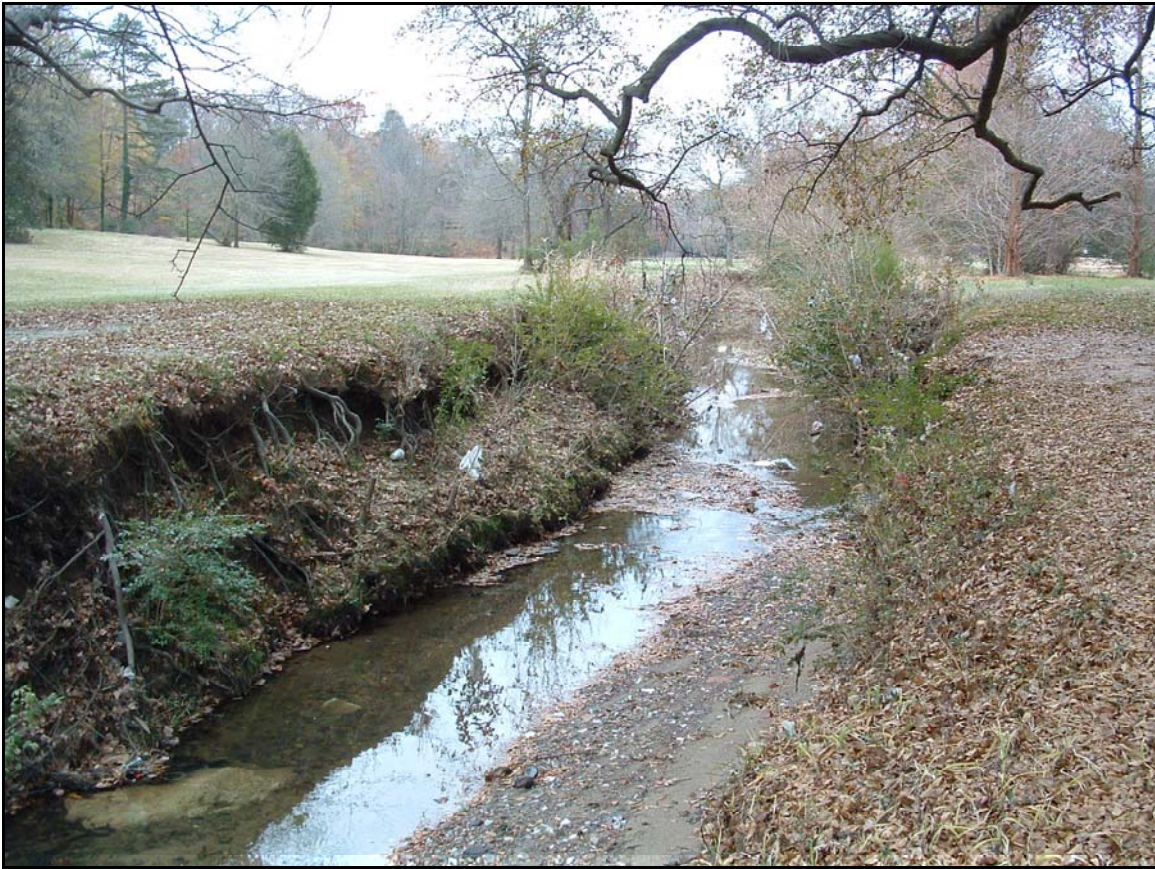
Incised stream section in upstream project area. (Near Sta. 13+00, looking downstream.)

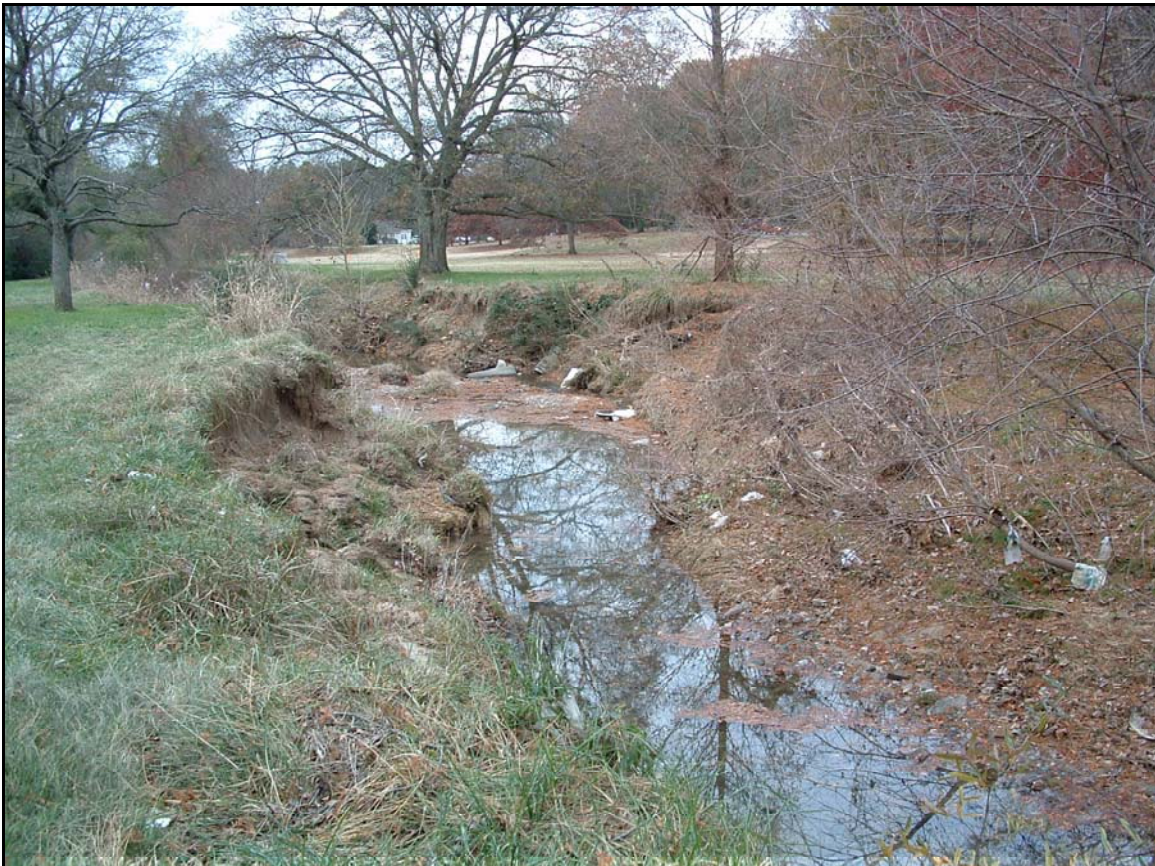
Typical degraded stream section in upstream project area. (Near Sta. 15+40, looking downstream.)

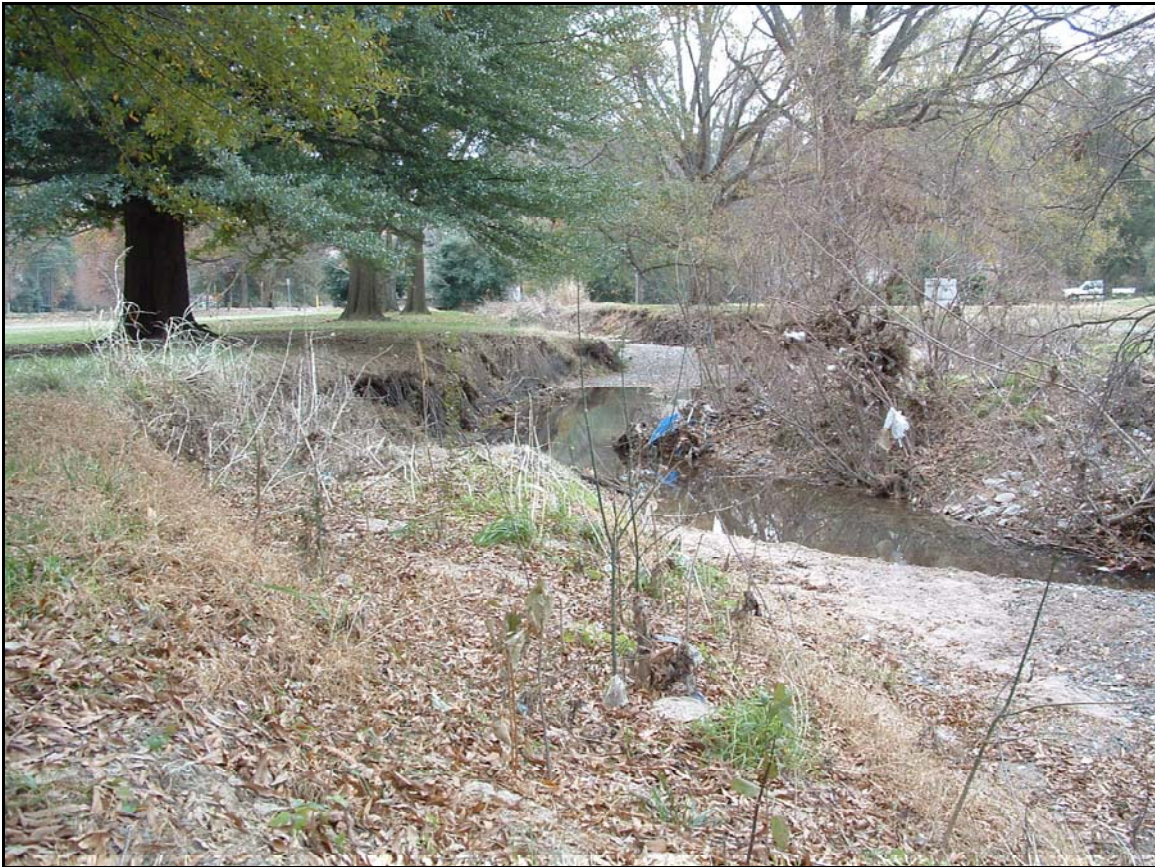
Typical section with eroding banks and developing lateral bars. (Sta. 23+00, looking downstream.)

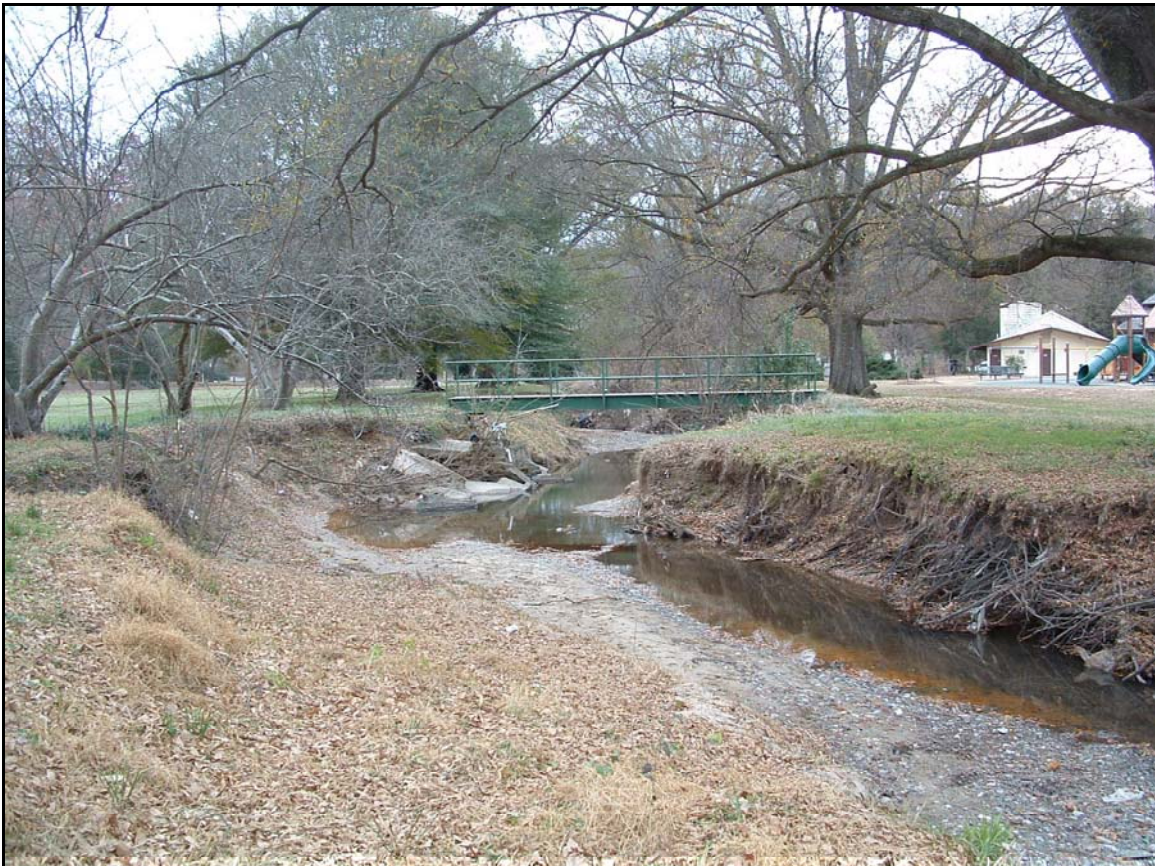
Existing concrete pedestrian bridge, to be removed. (Sta. 24+90, looking downstream.)

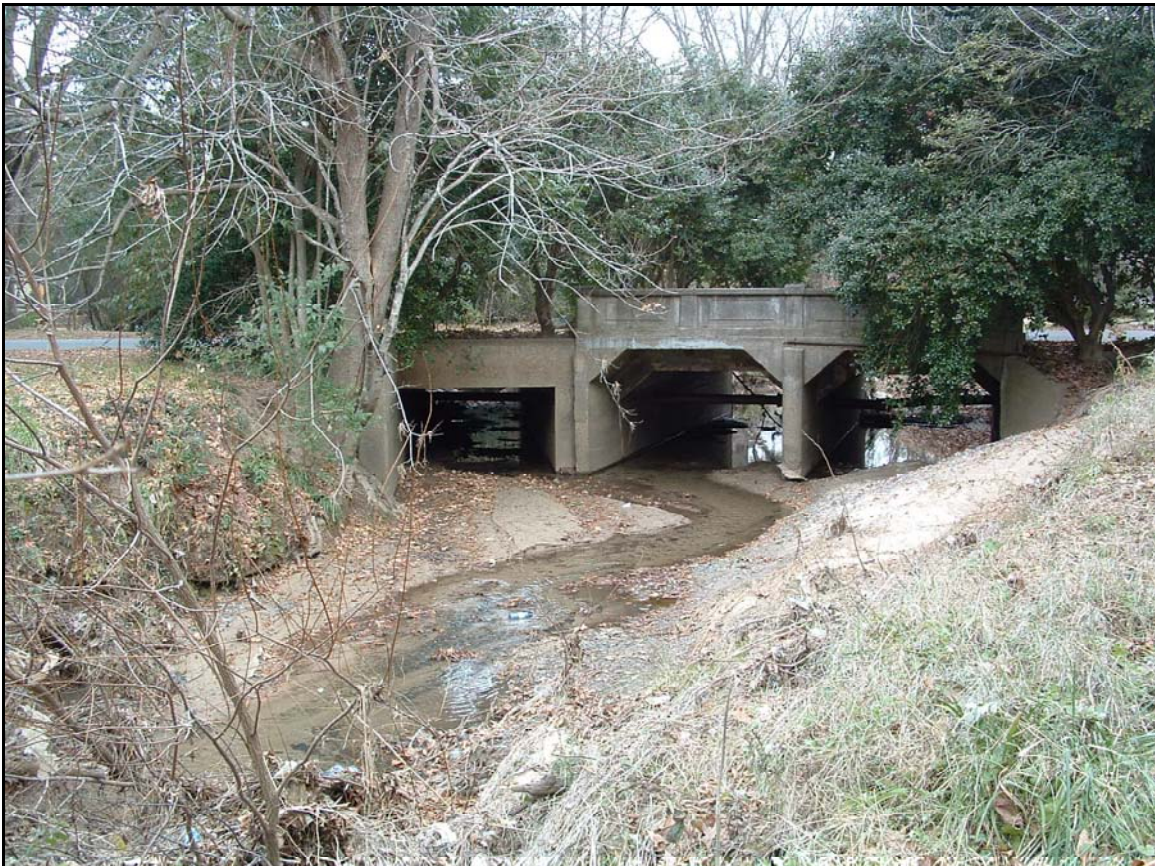
Second East Forest Hill Drive stream crossing box culverts. (Sta. 30+00, looking downstream.)

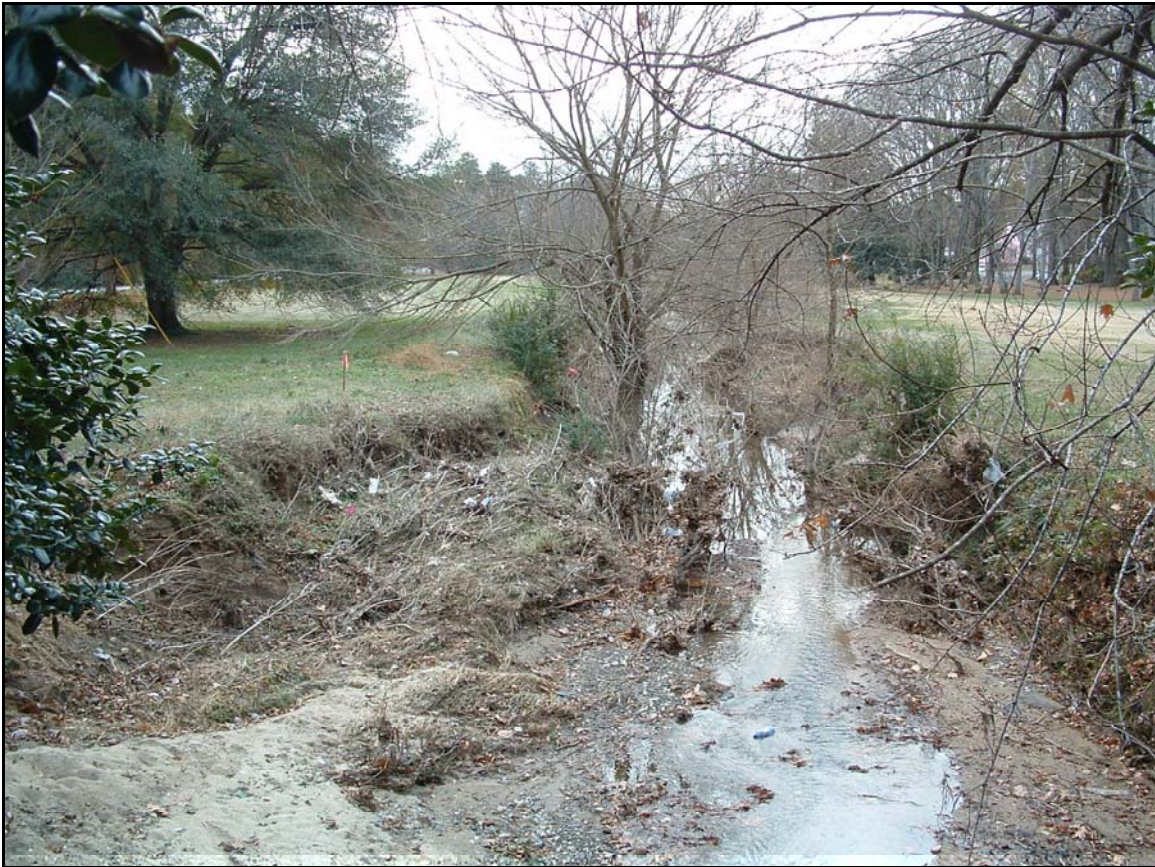
Degraded section downstream of E. Forest Hills Dr. crossing. (Sta. 30+50, looking downstream.)

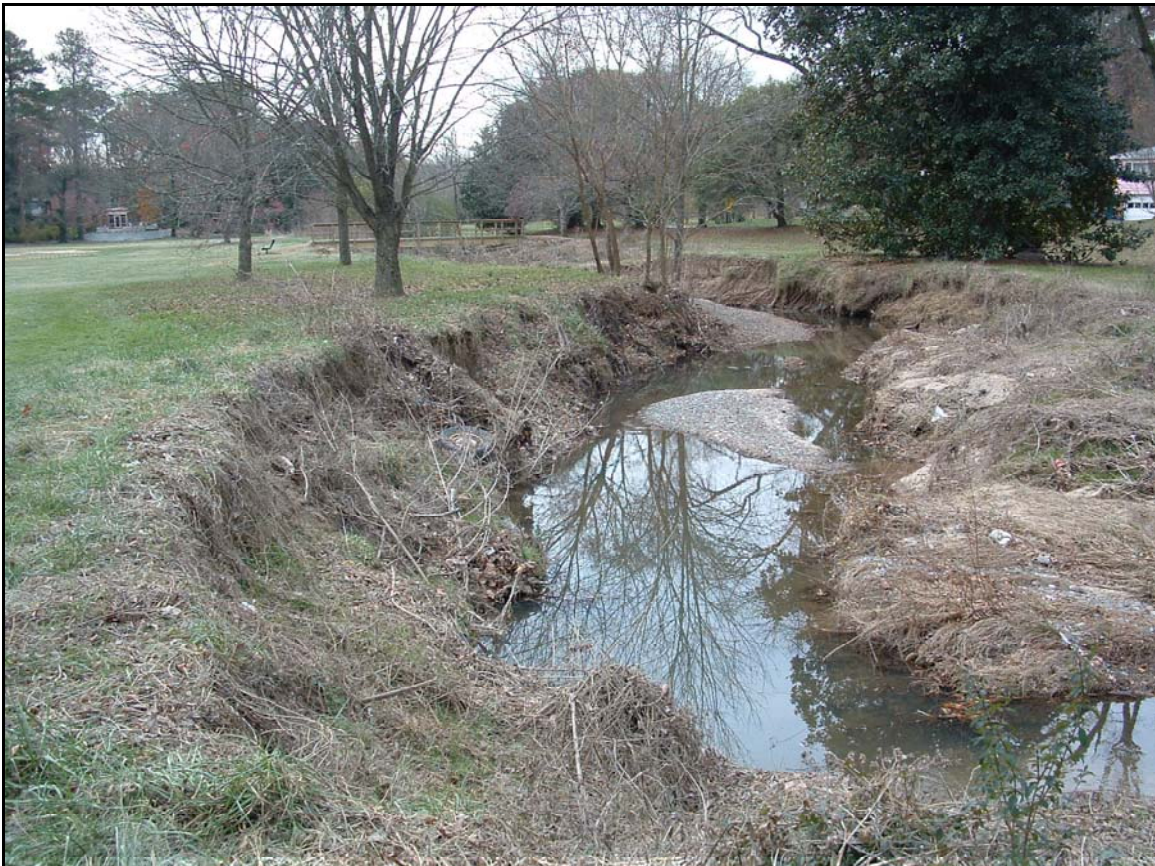
Typical degraded section in downstream project area. (Sta. 34+00, looking downstream.)

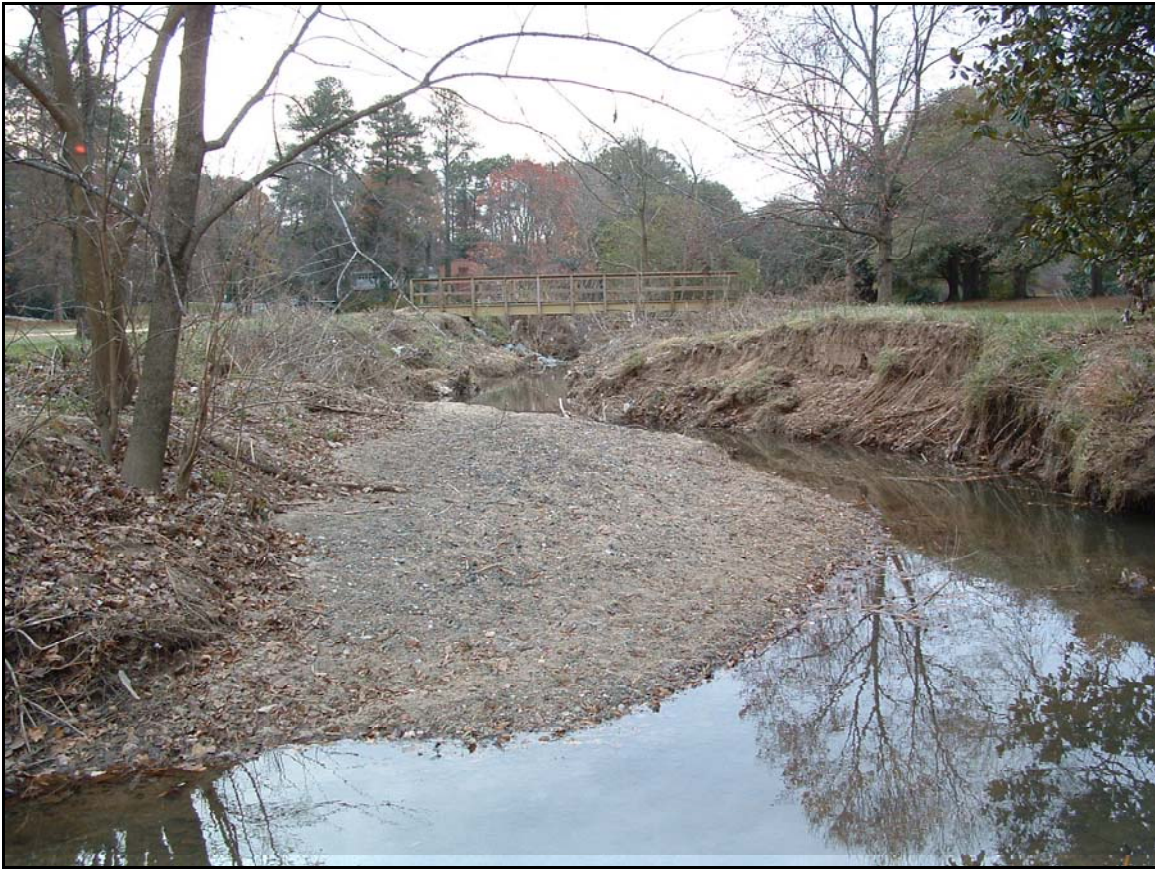
Existing steel/wood pedestrian bridge, to remain. (Sta. 38+40, looking downstream.)

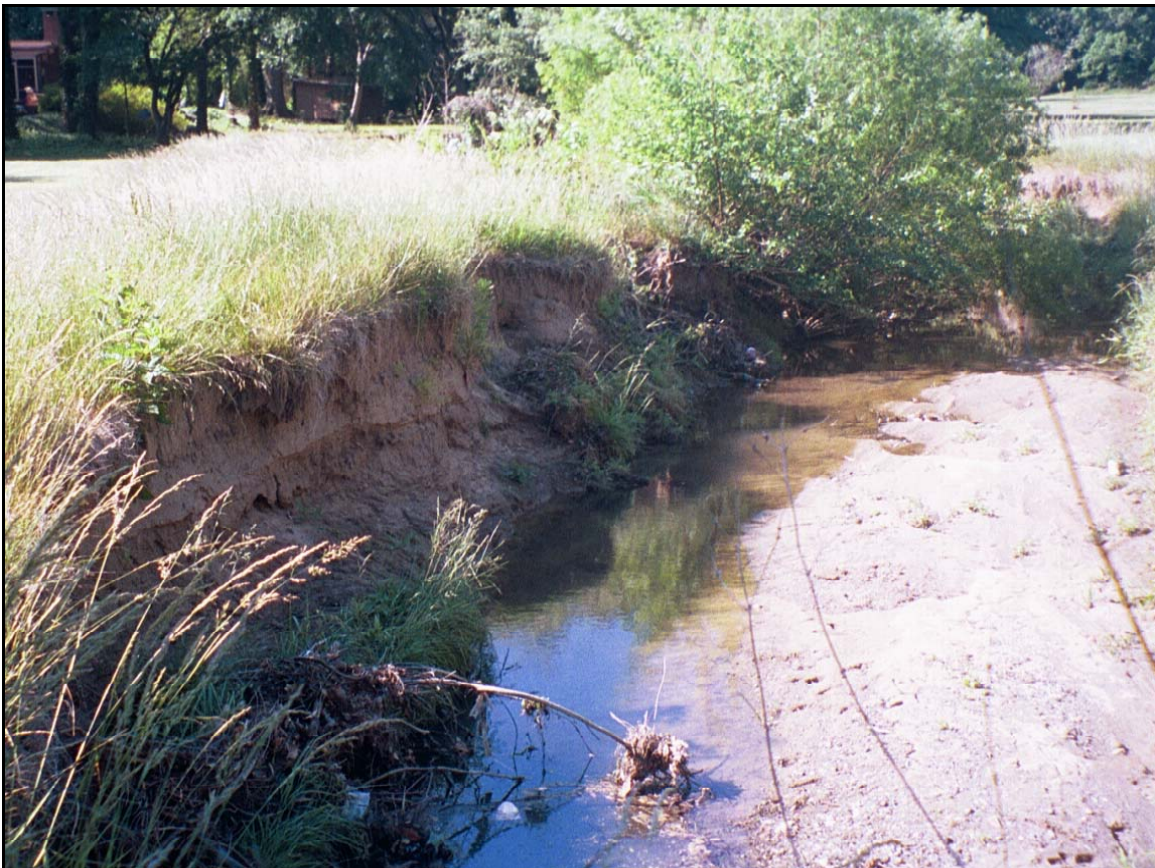
Typical degraded section in downstream project area. (Near Sta. 40+25, looking downstream.)
