Haw Branch Wetland and Stream Restoration Project – Mitigation Plan Report

Onslow County, North Carolina

June 2006

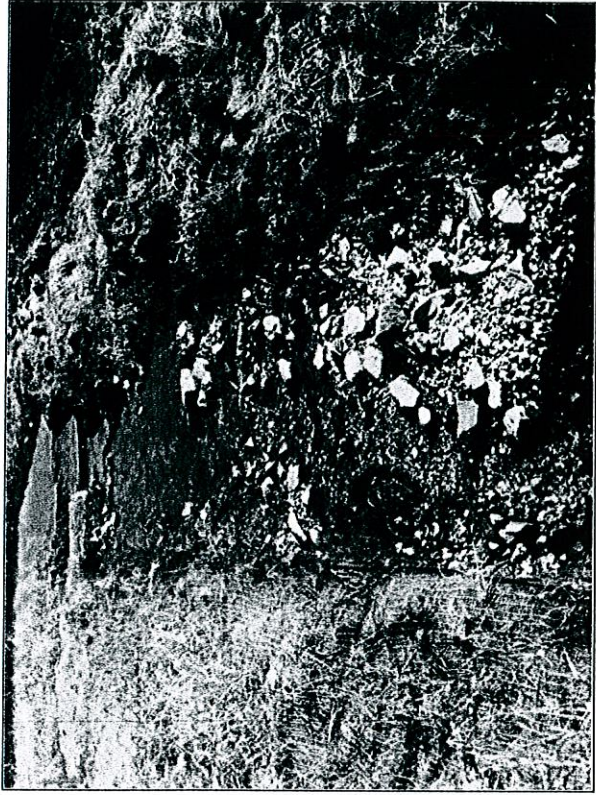
Constructed Riffle - UT2

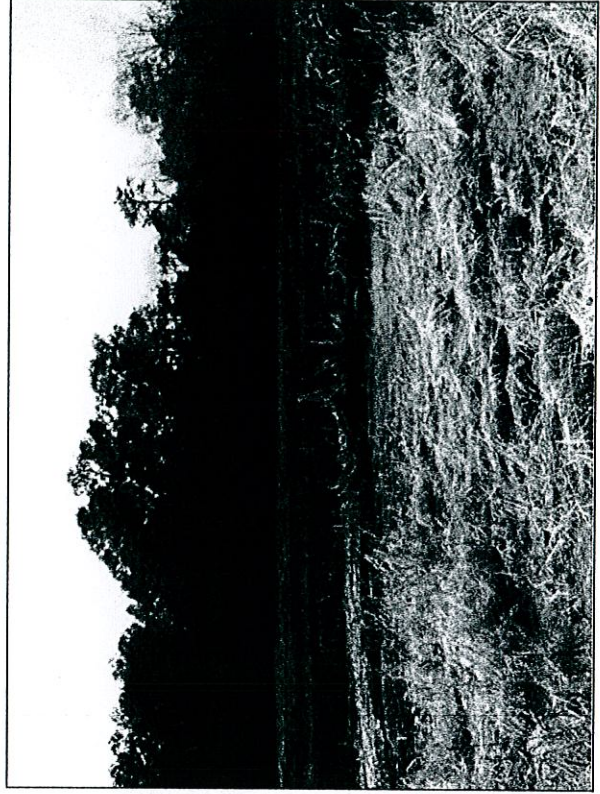
Rootwads - UT1

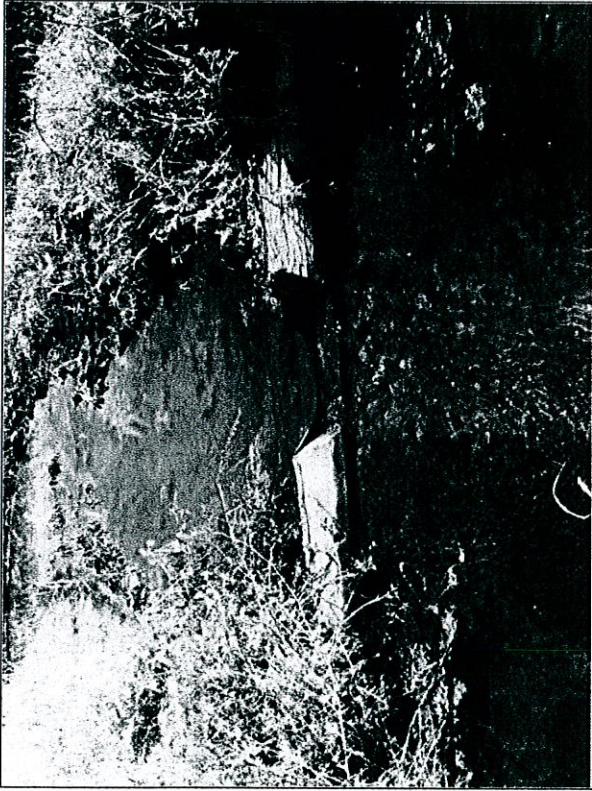
Log Weir - UT1

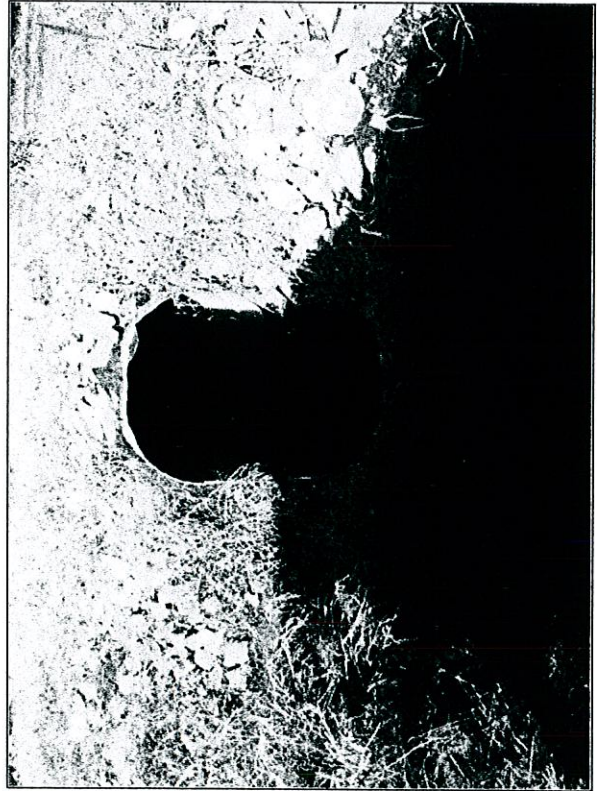
Culvert - UT1

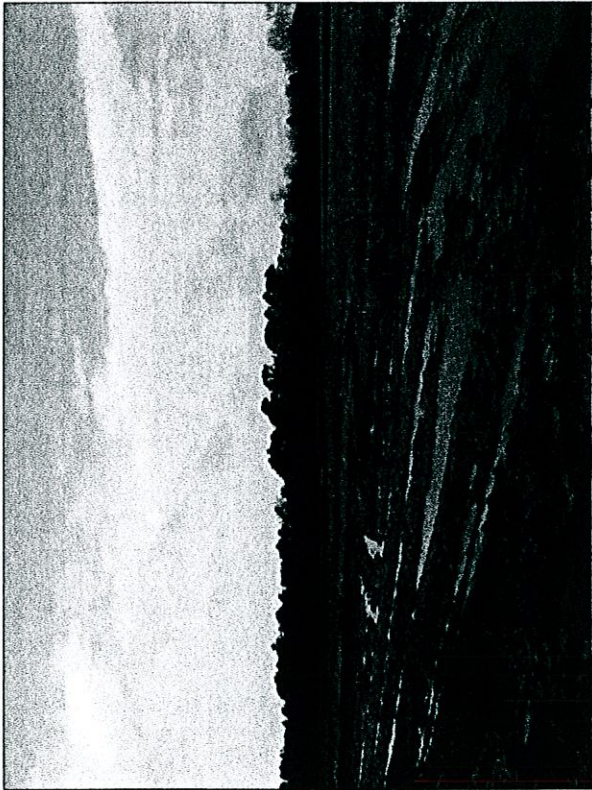
Microtopography in Wetland Areas

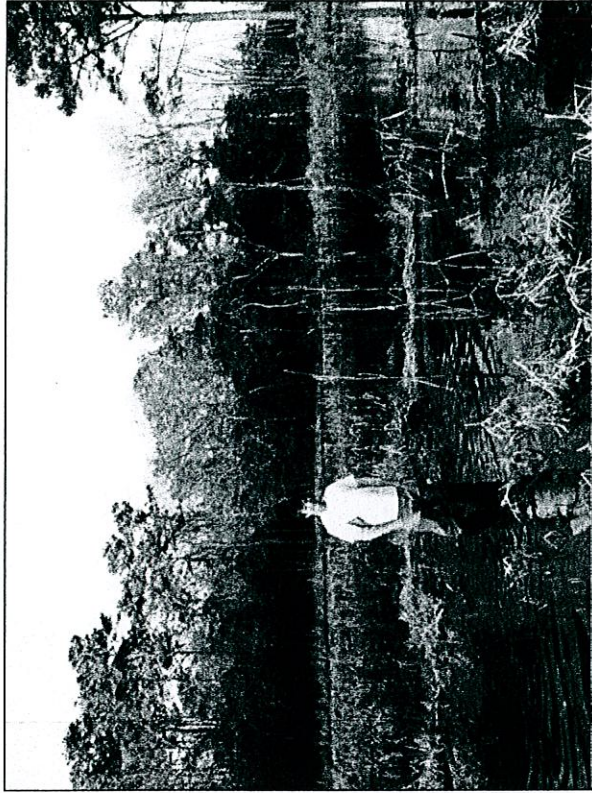
In the several months following construction completion (prior to site planting), conditions have been very wet on the site. More normal rainfall patterns have led to several observed out of bank events and significant areas of shallow standing water across the site. The reduced drainage capability and increased surface storage have resulted in significantly wetter conditions on the site than were observed prior to wetland restoration activities. These visual observations indicate that site hydrology has been restored to a naturally functioning wetland system.

Flooded Conditions – UT1

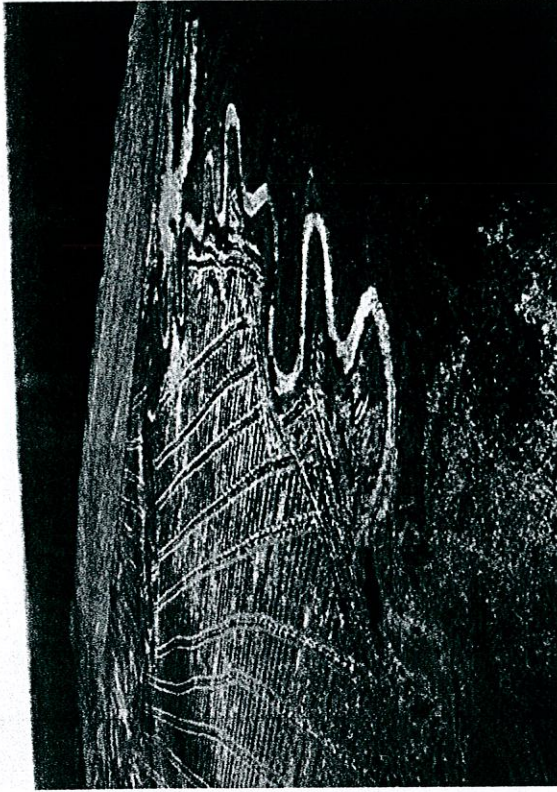
Flooded Conditions - UT2 & UT1

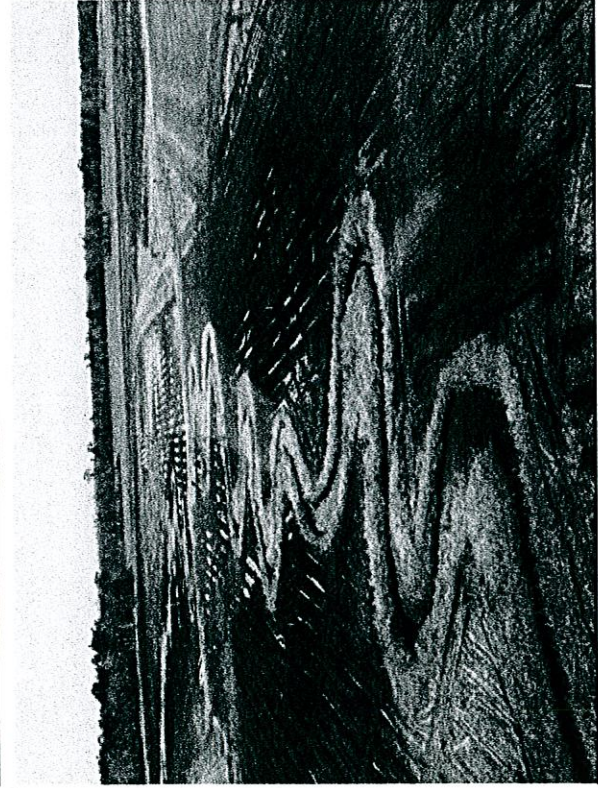
Stream Pattern - UT1

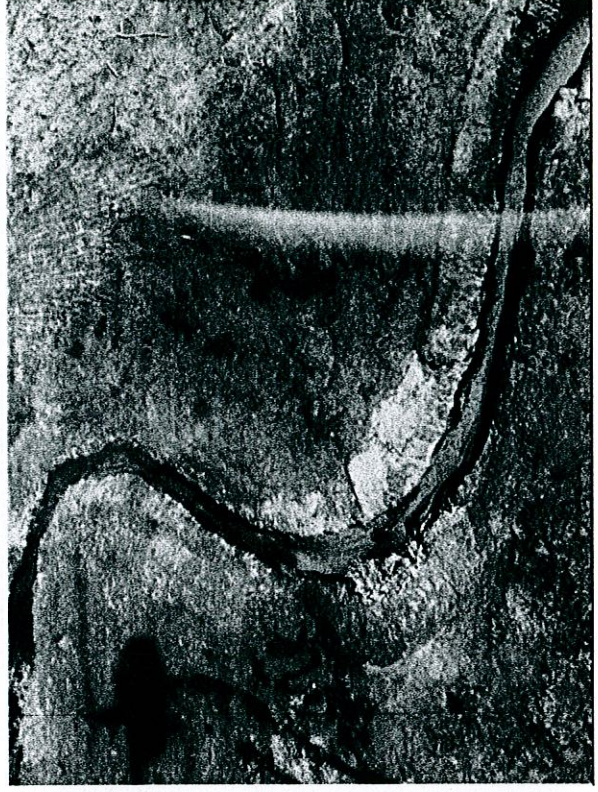
Bedload Movement - UT3
