**Johnson Site
Iredell County, North Carolina**

Stream Restoration Plan

February 2006

Prepared by: KCI Associates of North Carolina, P.A.

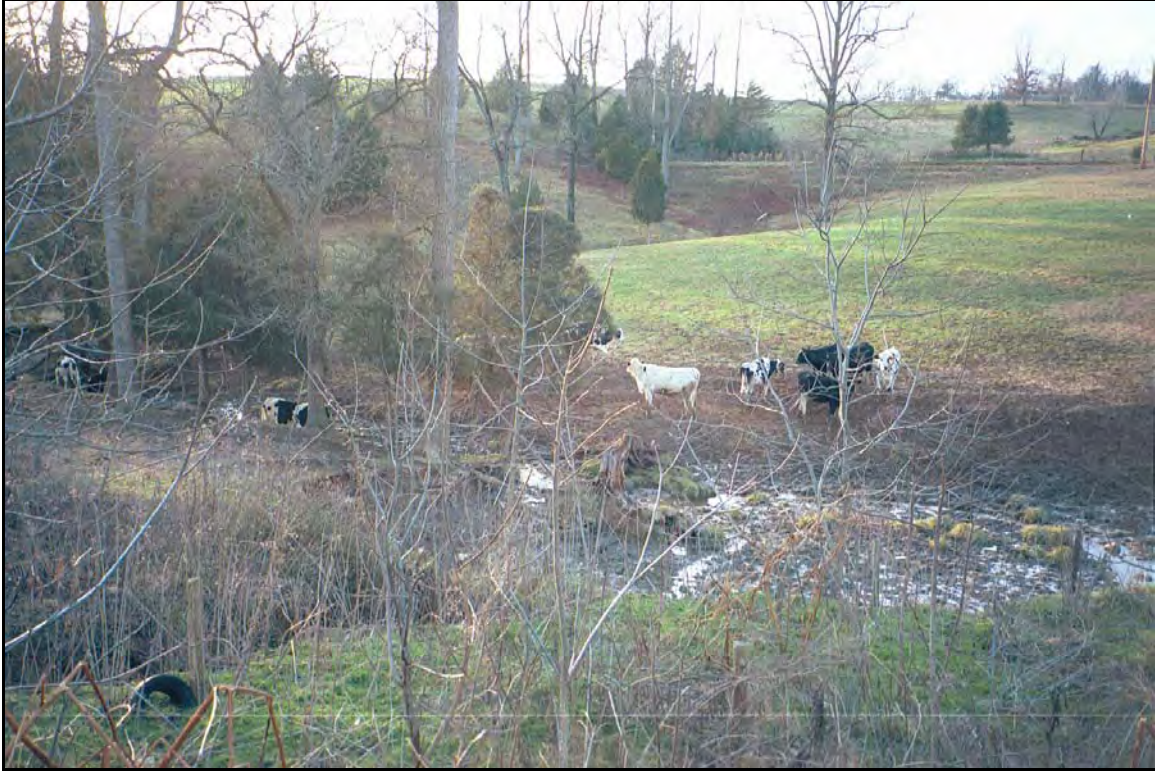
UTLHC exhibits characteristics of two separate stages in the CEM. Below the fence line near Station 10+40, cattle have access to the stream resulting in severe bank erosion and bed degradation. It appears the degradation in this reach has caused some bed instability upstream, as UTLHC is head cutting to the grade control point. The stream is transitioning from Stage III to Stage IV through this section as degradation is occurring above the fence line and degradation and widening are occurring in the area where the cattle are not fenced out.

Photograph 1 – Cattle access the stream below Station 10+40. Stream is highly unstable below “fenced out” area.

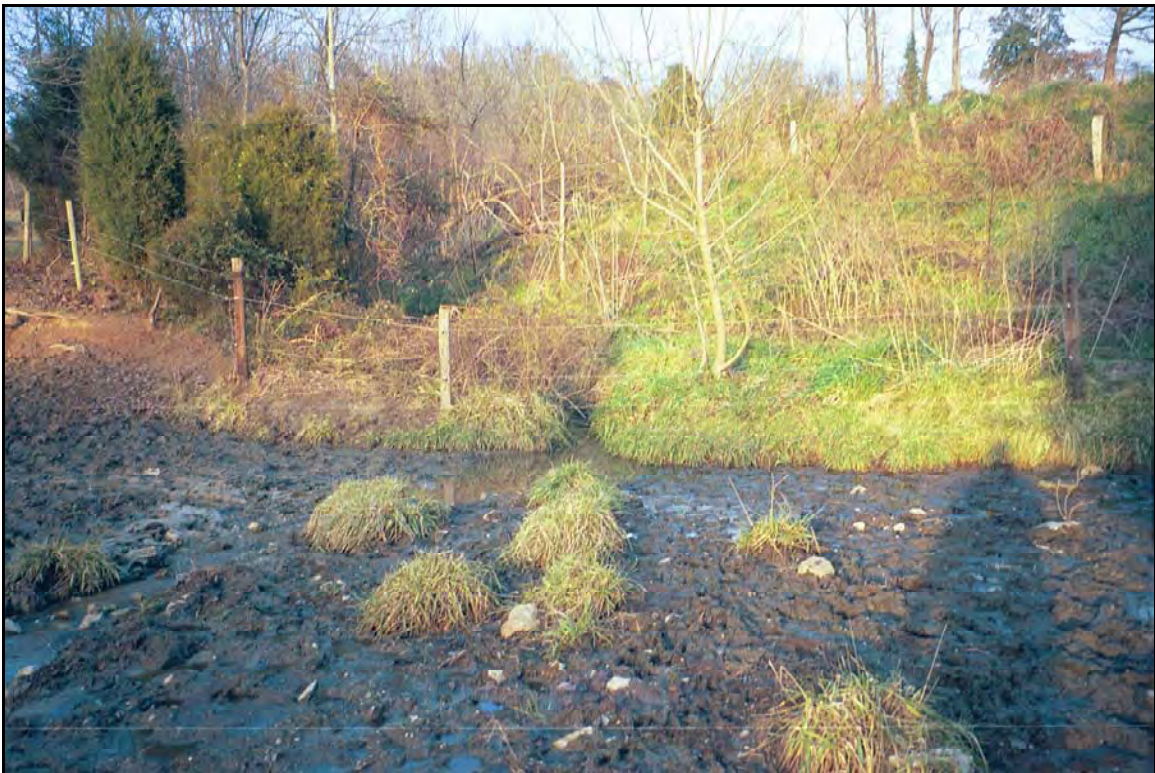
Photograph 2 – Looking upstream at Station 10+40 (fence line). Proposed stream restoration activities would begin at this location.

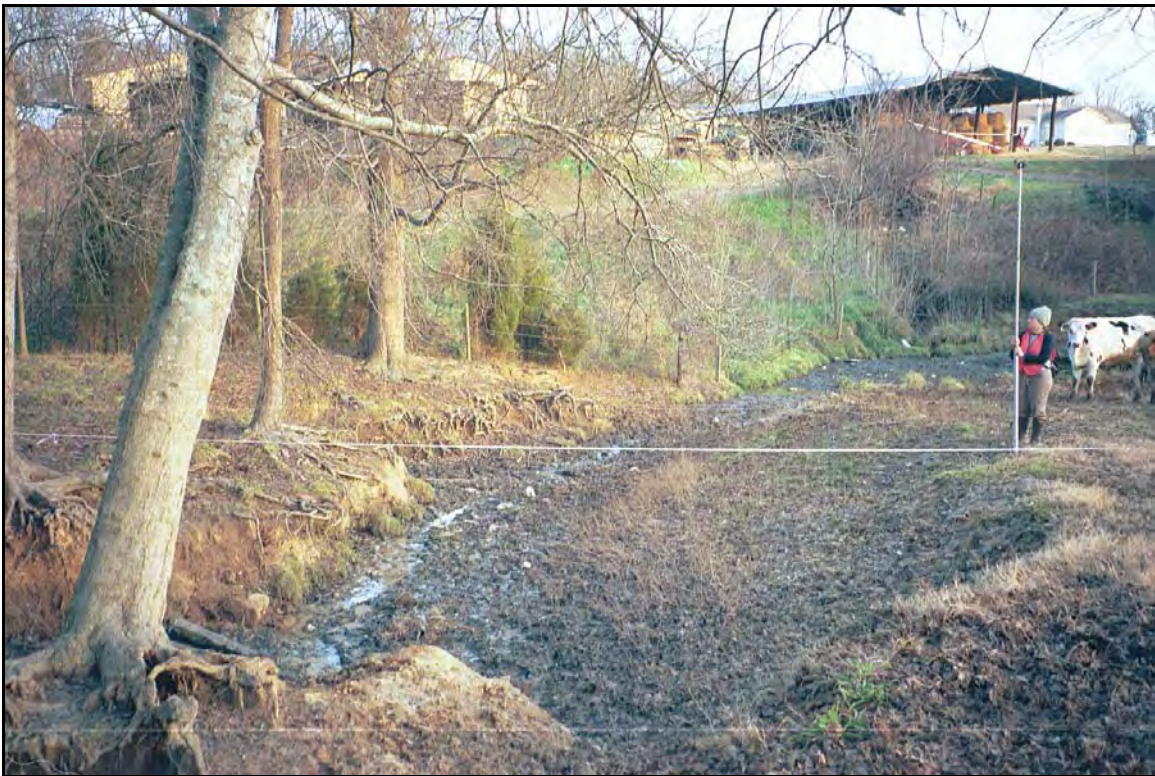
Photograph 4 – Cross section UT1-1, looking downstream. Cattle have access to each of the tributaries on the west side of UTLHC.

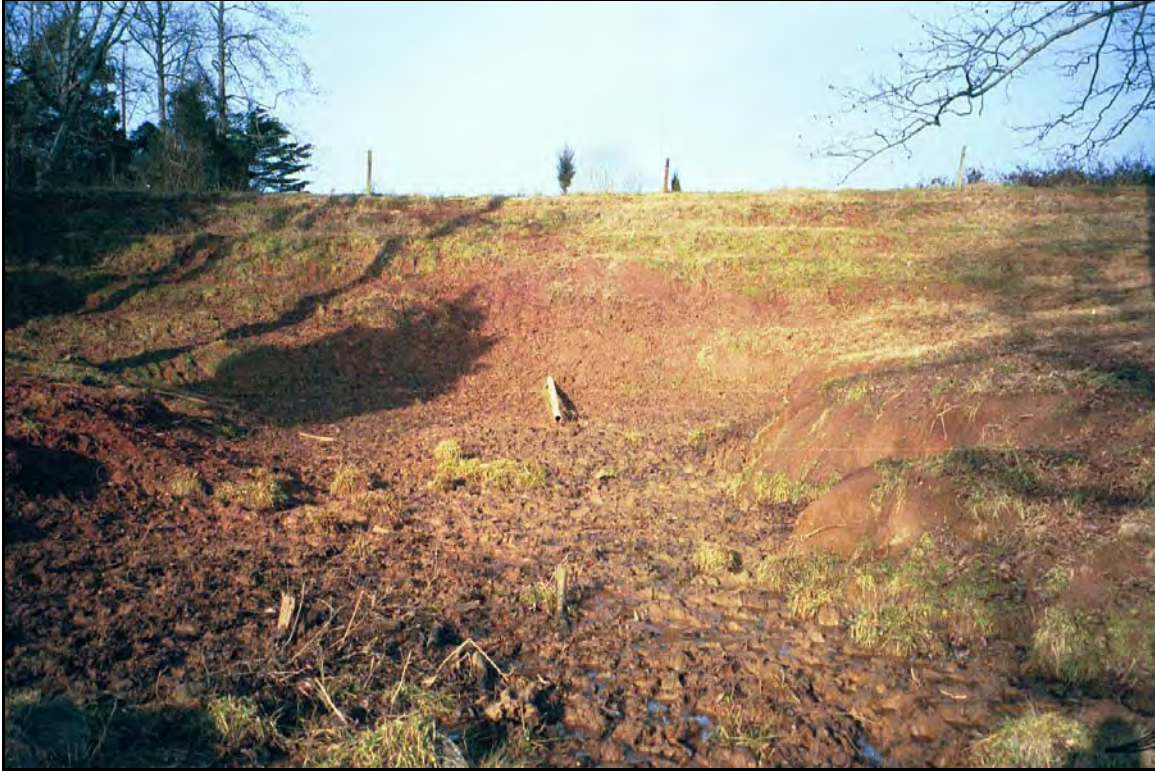
Photograph 7 – Four-inch PVC pipe drains water from pond into UT2.

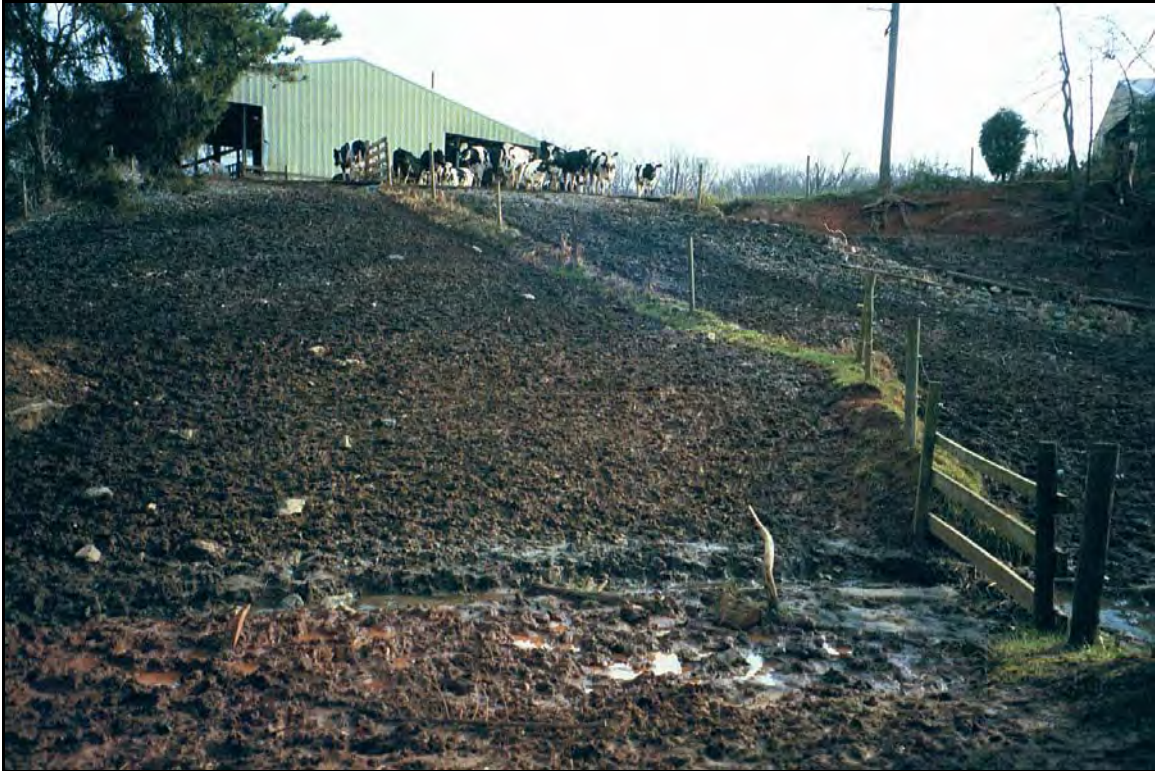
Photograph 9 – Fence line at Station 13+40. This fence divides the cattle groups. The group on the south side of the fence will be redirected as part of the management strategies.

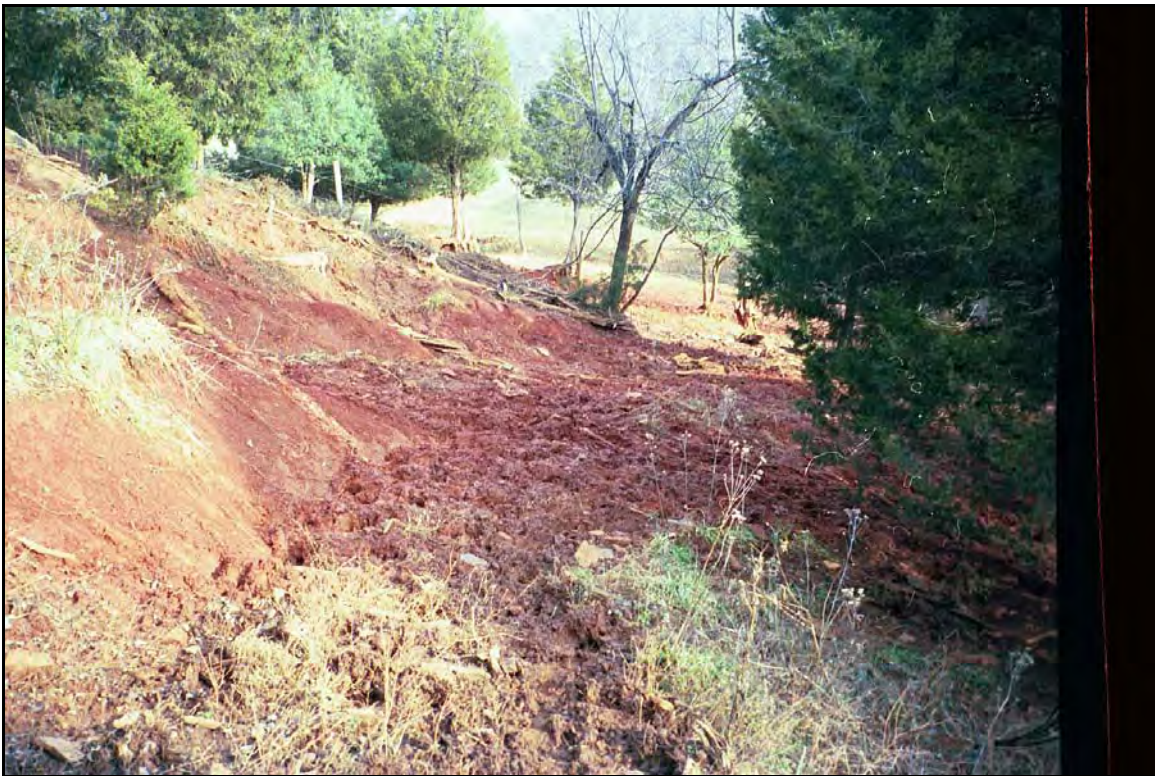
Photograph 10 – Cattle access/damage to the hill slope from Station 13+40. This disturbance provides high sediment supply to the system.

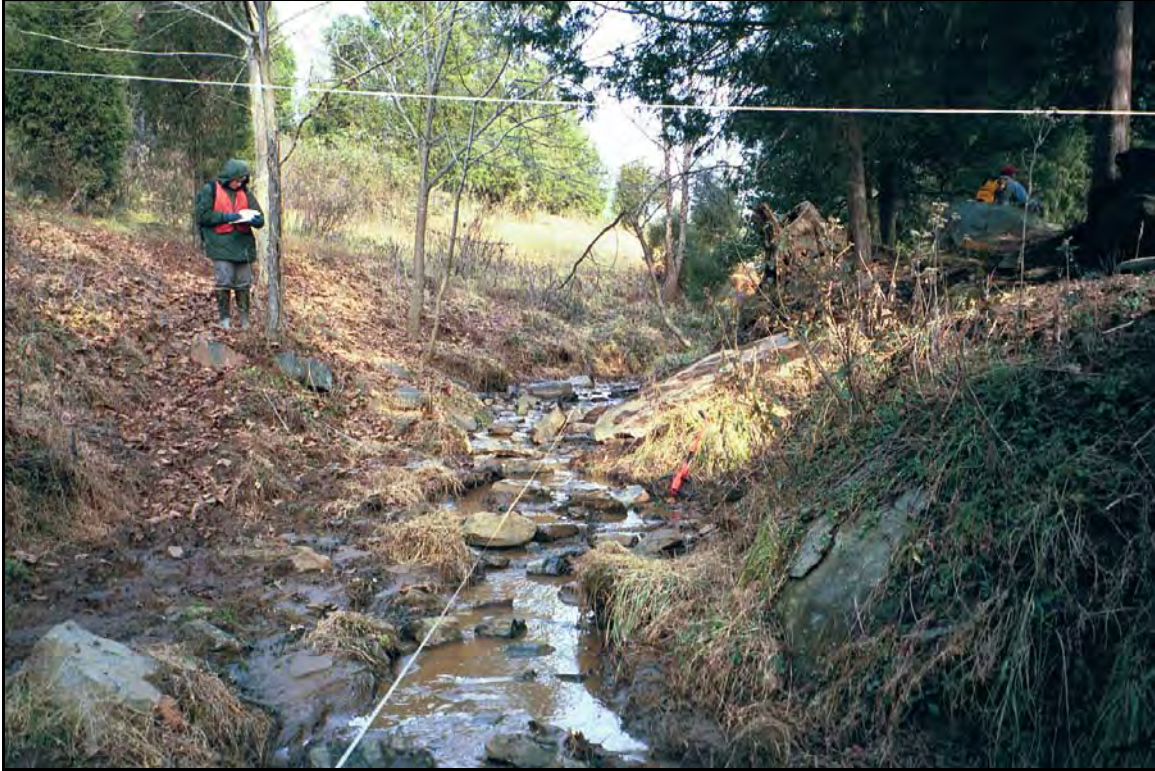
Photograph 13 – Bedrock outcrops and rock step sequence below cross section 2 (looking upstream).

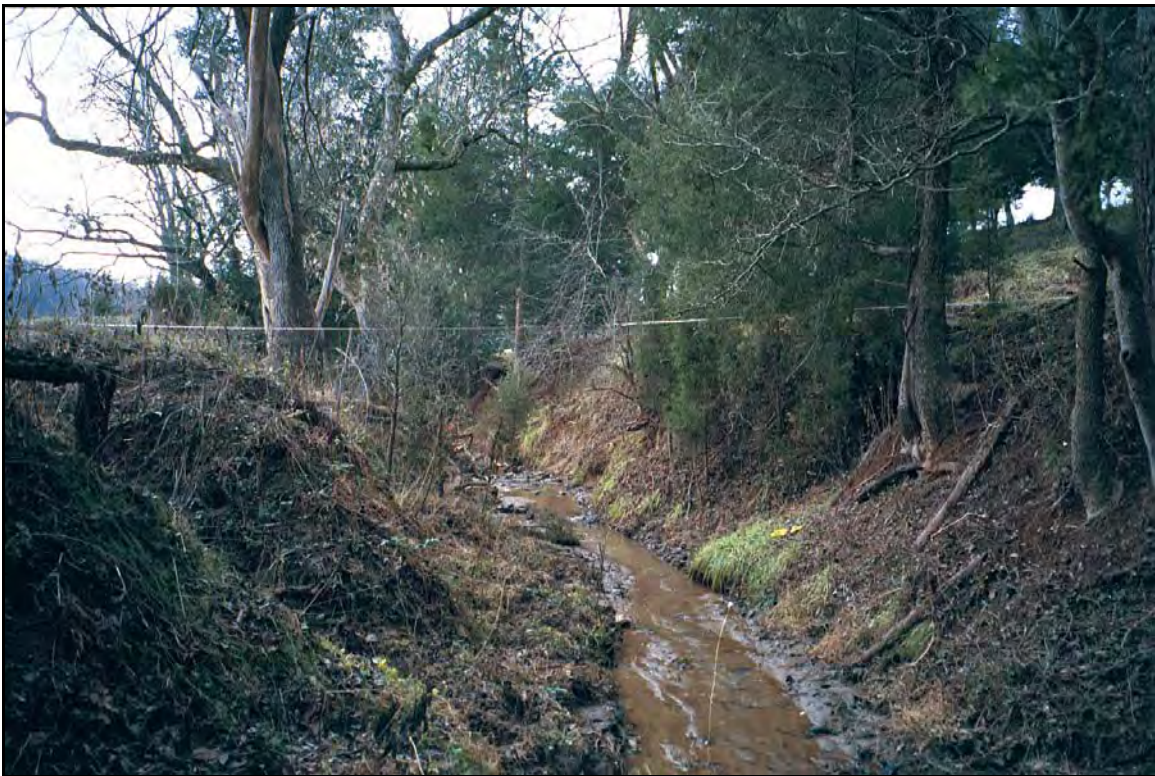
Photograph 14 – Cross section 3 (Station 19+15). Banks are high and nearly vertical throughout this reach.

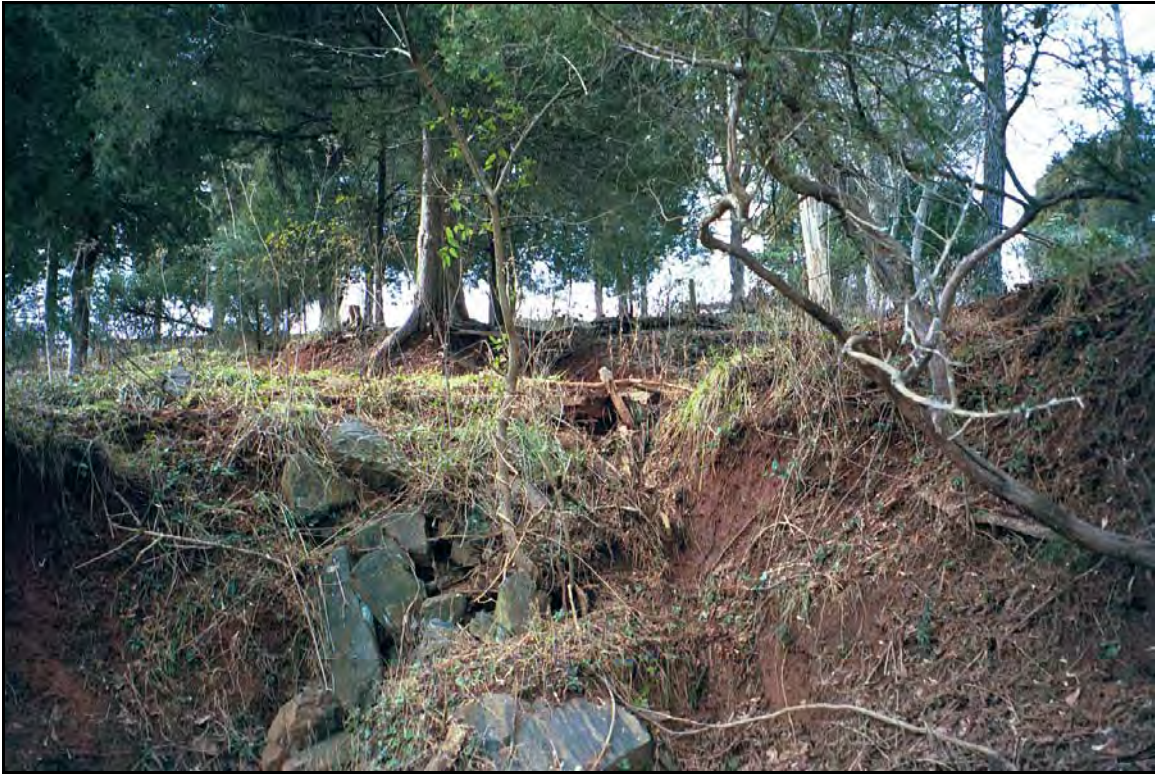
Photograph 15 – Formation of gully (gully erosion).

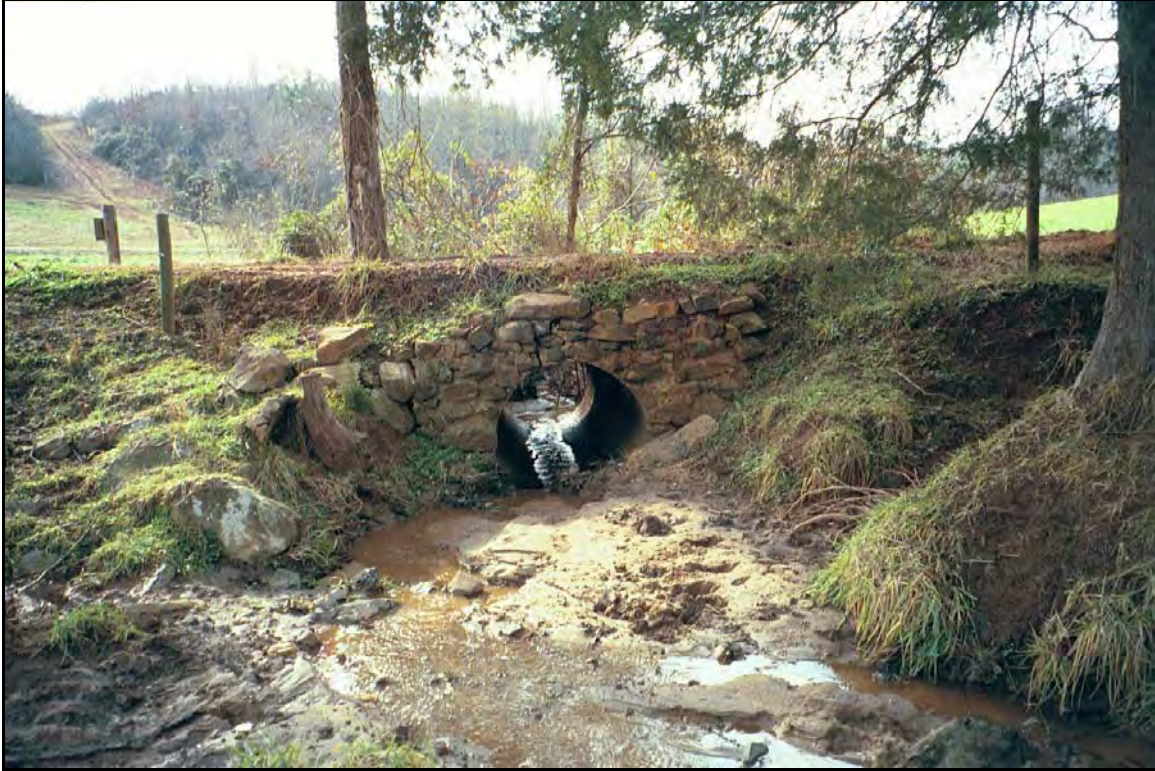
Photograph 17 – Forty-eight inch CMP conveys stream flow under dirt road leading to the northwest portion of the Johnson property.

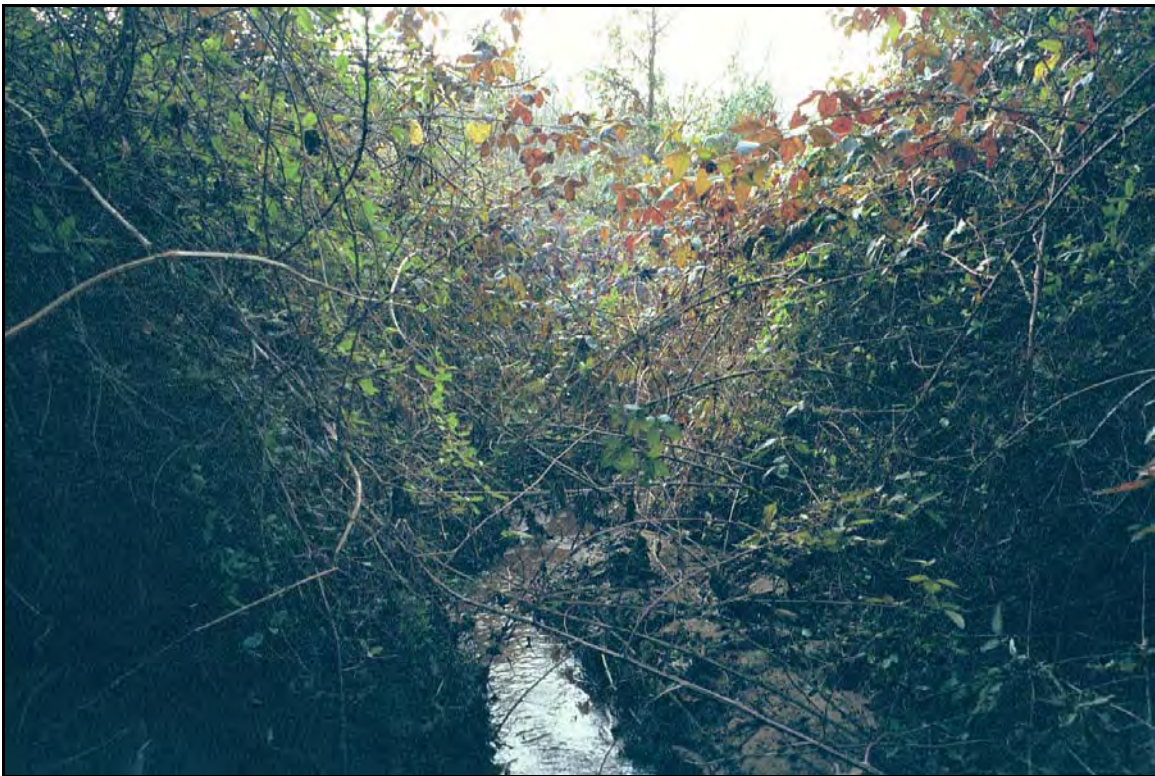
Photograph 18 – Typical view downstream of the pipe (approximately Station 24+00). Banks are greater than six feet high.

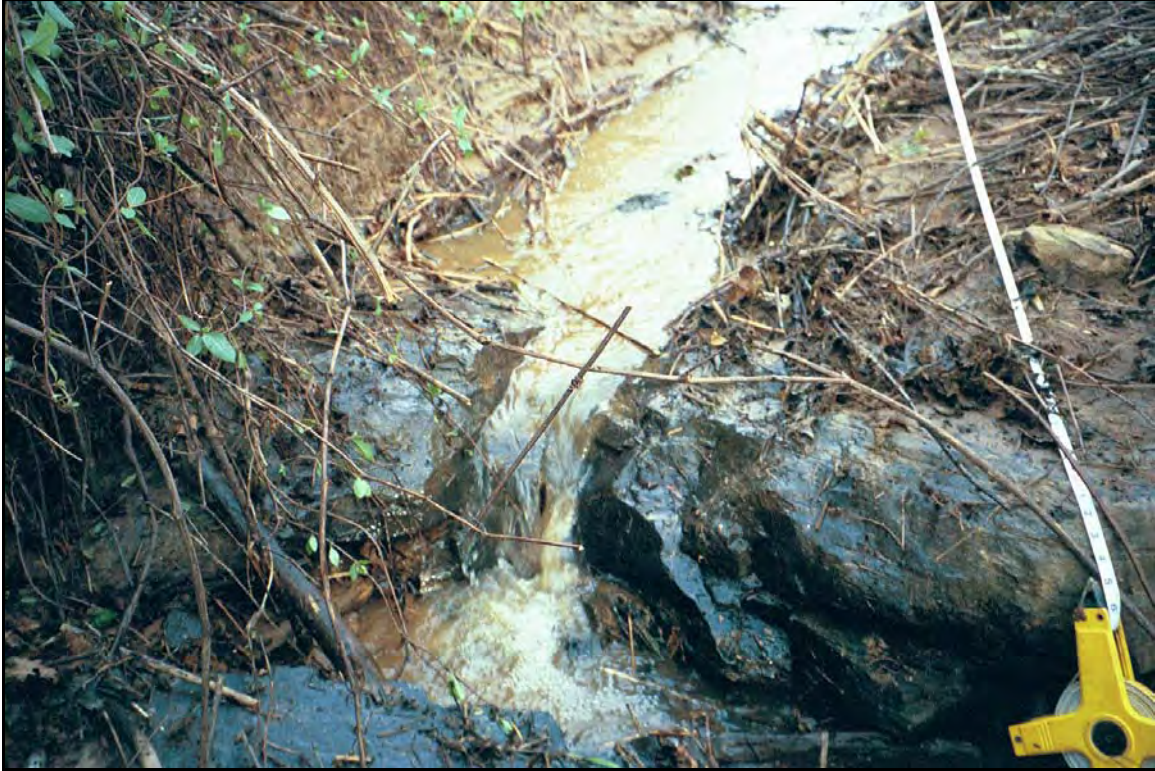
Photograph 21 – Natural bedrock feature directs flow to the center of the channel (Station 26+50).

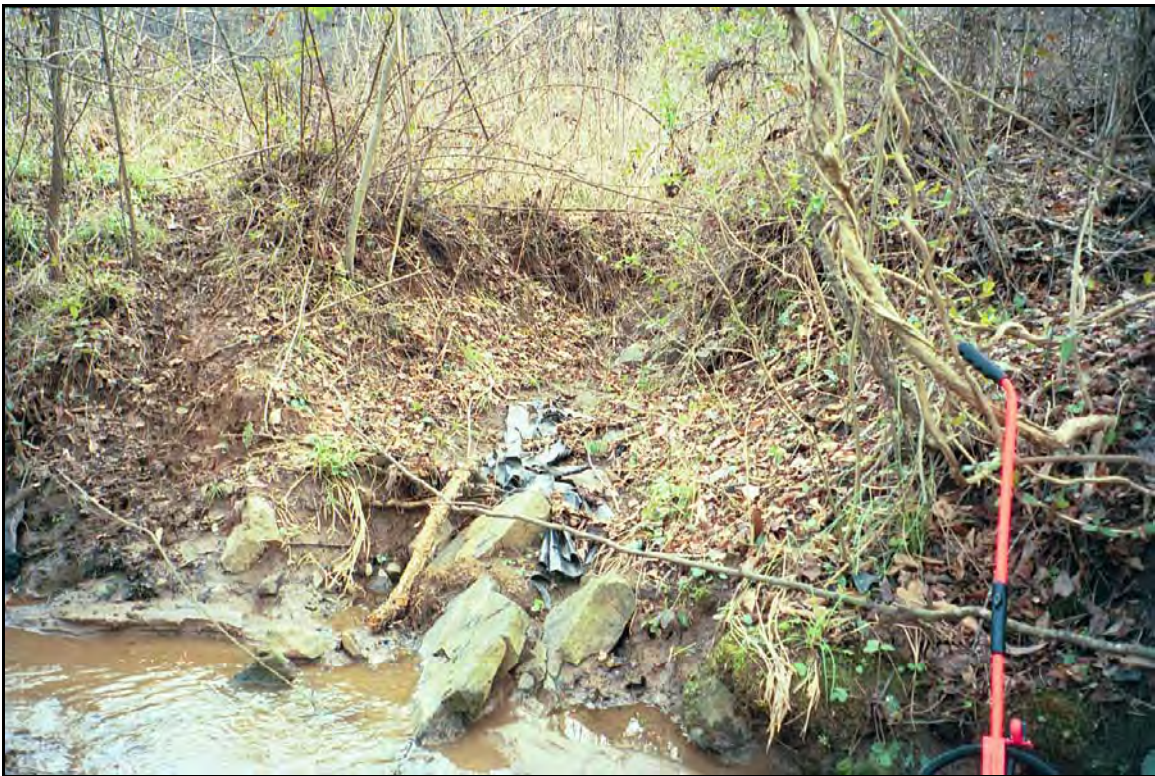
Photograph 22 – Roadside drainage from Hunting Creek Road drains to UTLHC via rock lined channel.

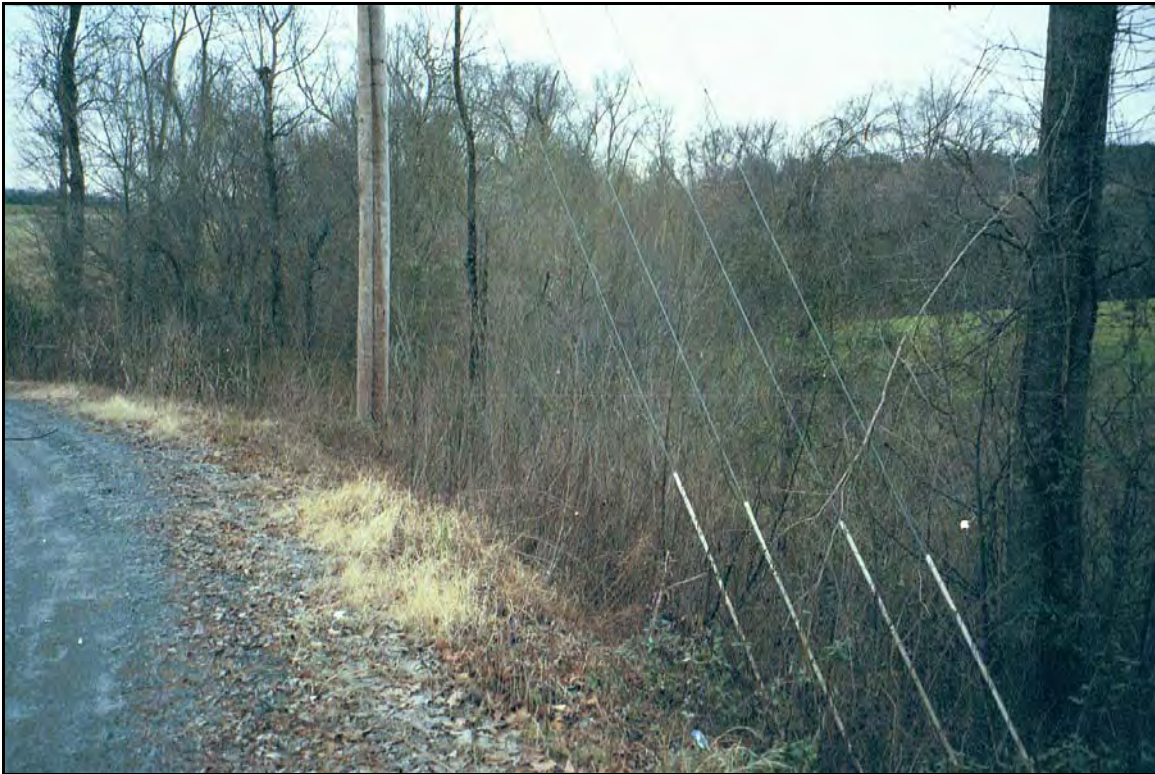
Photograph 26 – Power poles and guy wires adjacent to the south bank of UTLHC. Locations are approximated on Figure 5 – Existing Conditions.
