AS-BUILT MITIGATION PLAN
LLOYD STREAM AND WETLAND RESTORATION SITE
ONSLOW COUNTY, NORTH CAROLINA

(CONTRACT #16-D06003-1)
FULL DELIVERY PROJECT
CAPE FEAR/WHITE OAK RIVER BASIN
CATALOGING UNIT 03030001

May 2007
Amended July 2007

**LLOYD STREAM AND WETLAND RESTORATION SITE
AS-BUILT MITIGATION PLAN
ONslow COUNTY**

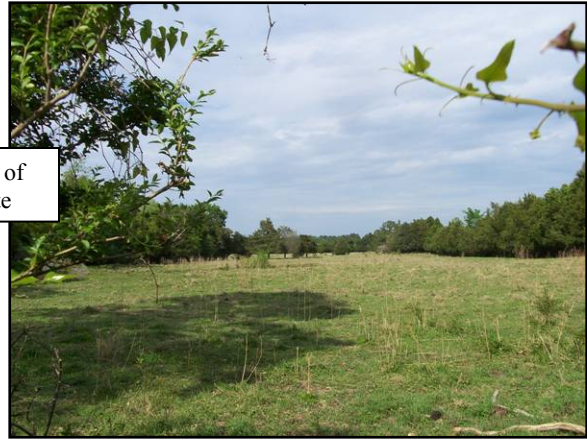
Bottom of
the Site

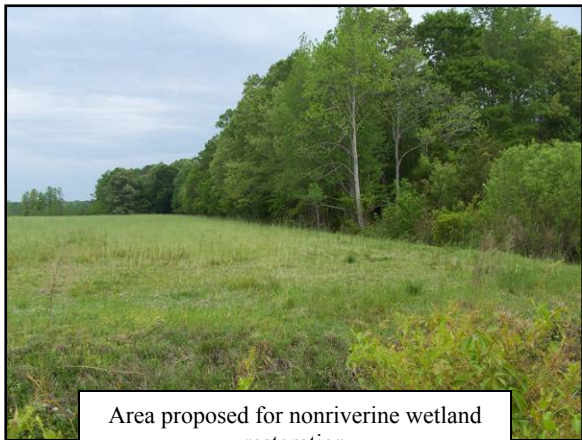
Area proposed for nonriverine wetland
restoration

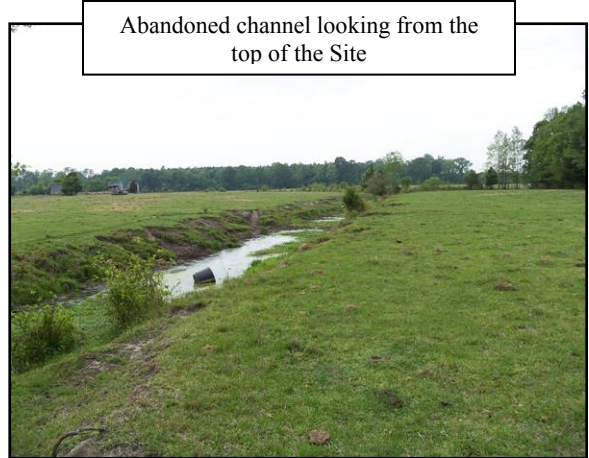
Abandoned channel looking from the
top of the Site

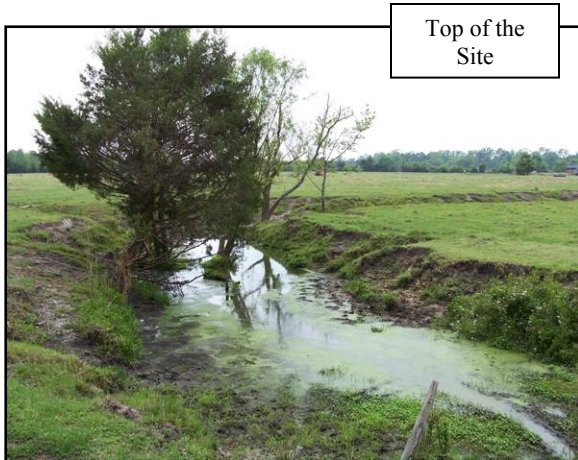
Top of the
Site

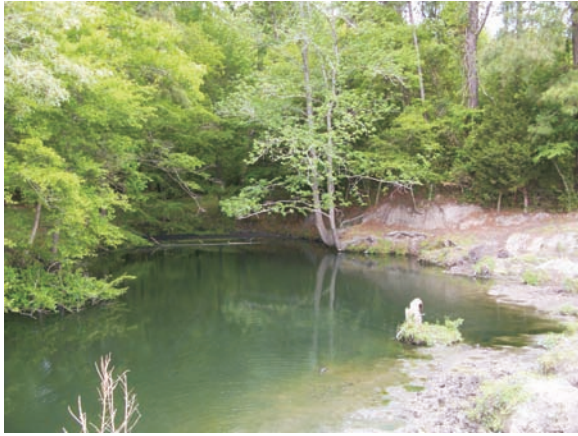
Looking upstream on abandoned channel at Site infall.

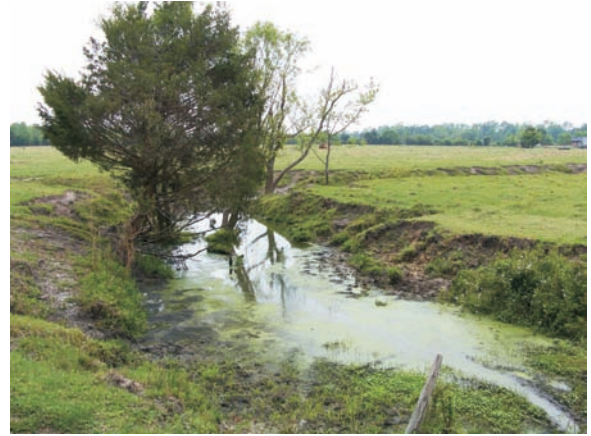
Looking downstream on abandoned channel from Site infall.

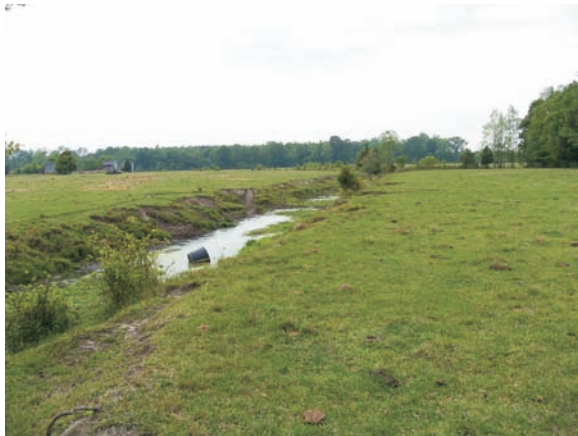
Looking downstream on abandoned channel.

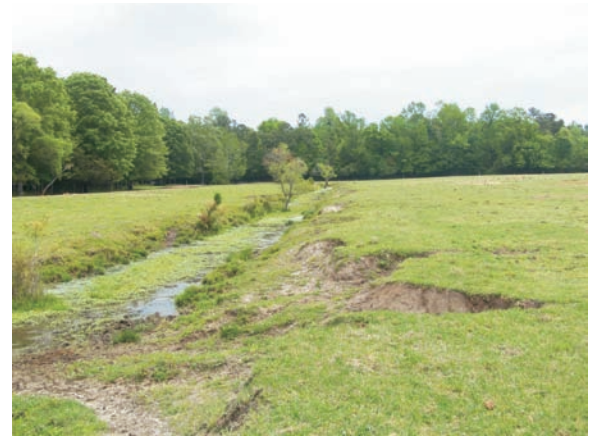
Looking upstream on abandoned channel.

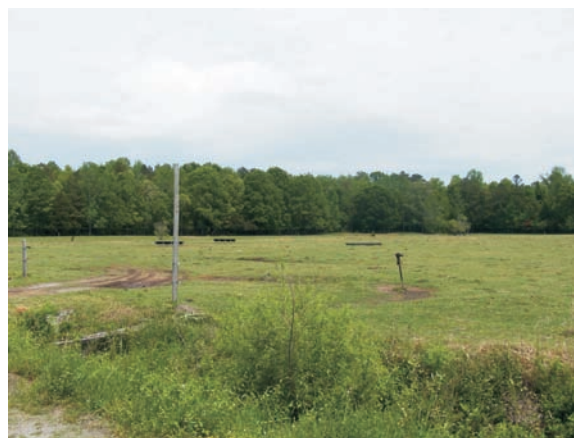
Looking across the abandoned channel toward the main tributary adjacent to the tree line.

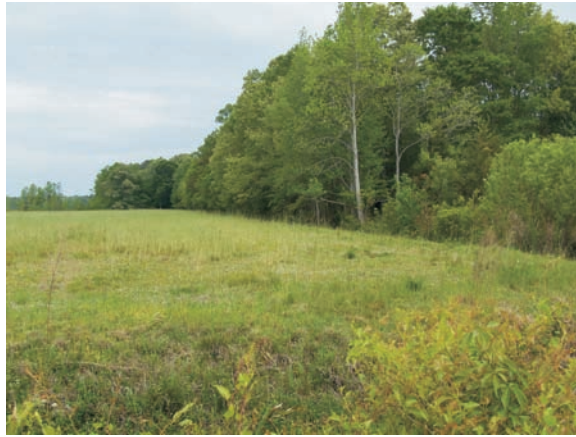
Looking across the abandoned channel toward the area of Rains soils proposed for nonriverine wetland restoration.

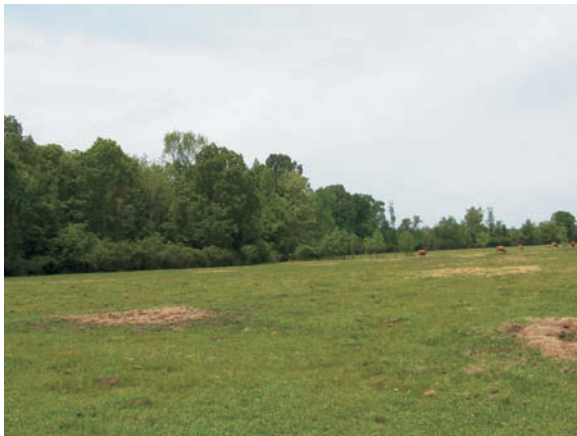
Looking upstream at the main channel adjacent to the tree line.

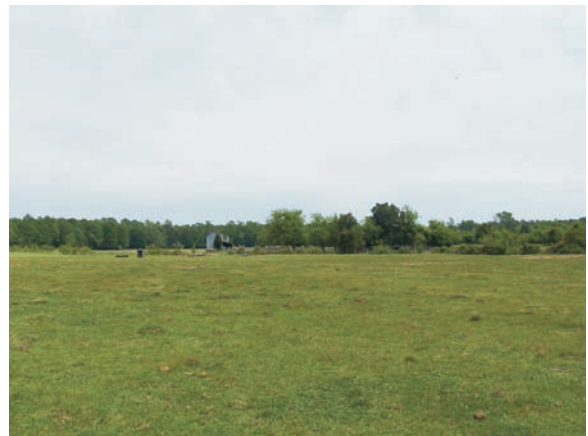
Looking towards the abandoned channel near the location of the culverted crossing that will bisect the easement.

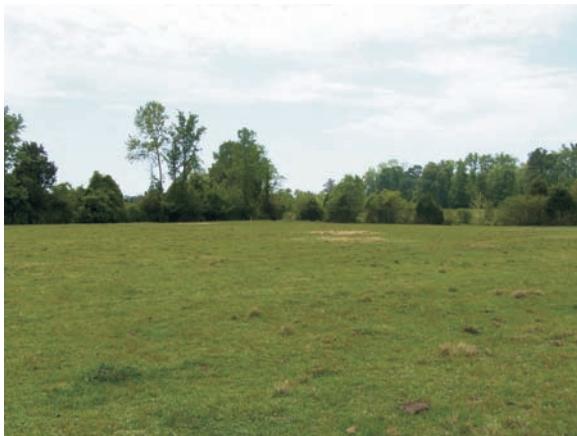
Looking downstream at the confluence of the main channel and the abandoned channel.

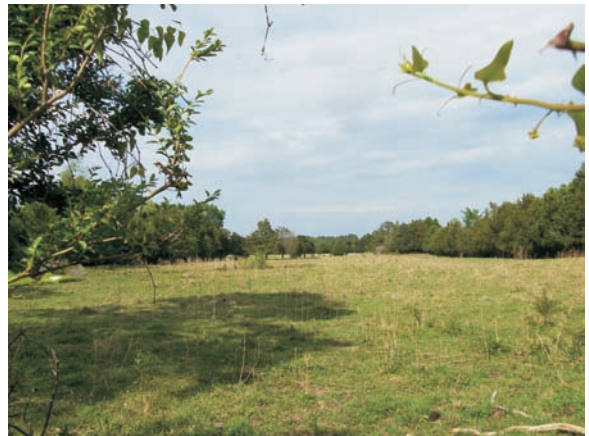
Looking upstream towards the confluence of the main channel and the existing eastern channel/roadside ditch.

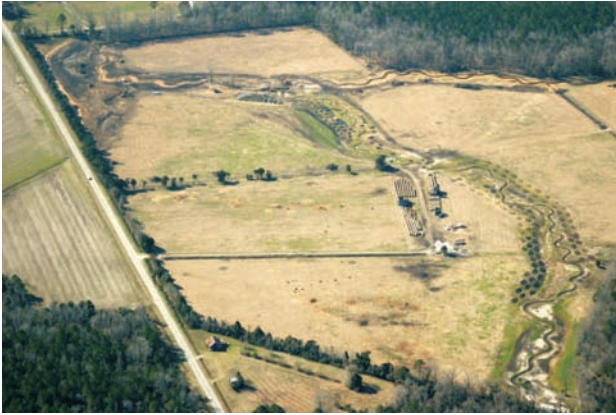
Overview of the Site looking from east to west.

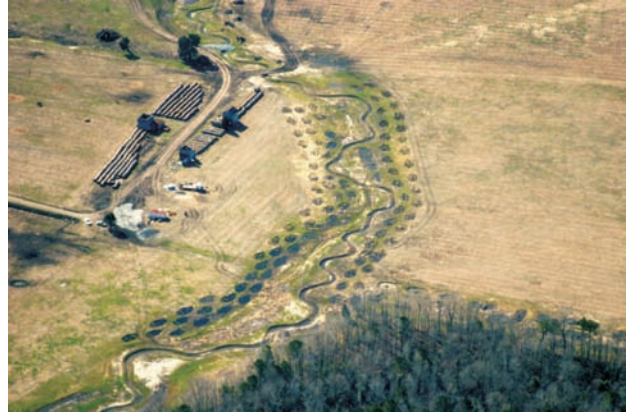
Looking from the top of the Site, downstream at the Main Channel (previously abandoned).

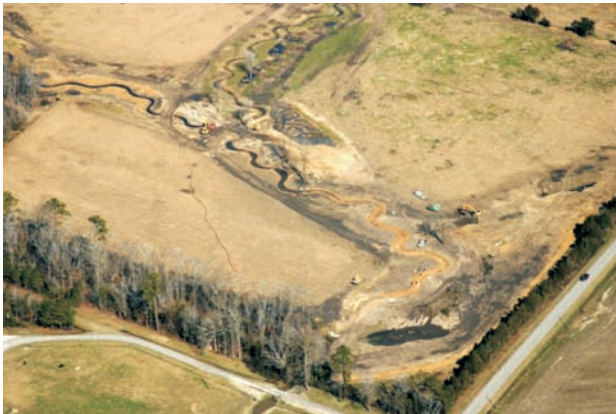
Looking from the bottom of the Site, upstream.

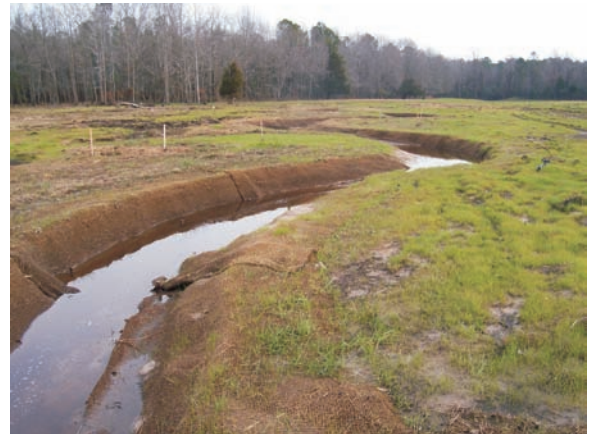
Looking upstream at the Main Channel (previously abandoned).

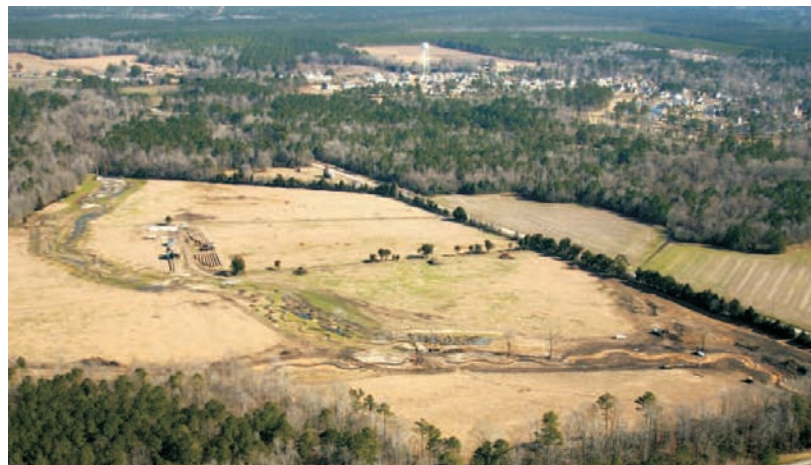
Overview of the Site looking from the northwest toward the southeast.

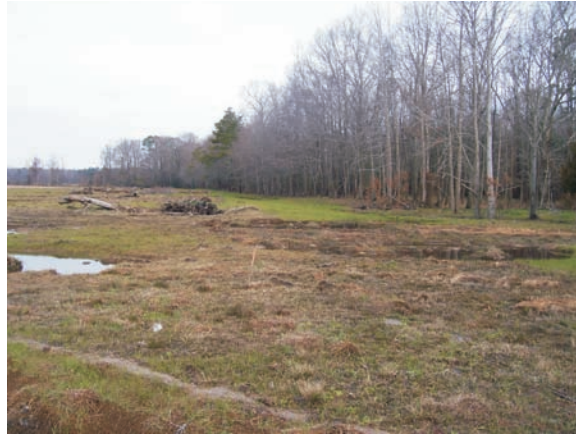
Looking across the filled abandoned channel toward the area of Rains soils/nonriverine wetland restoration.

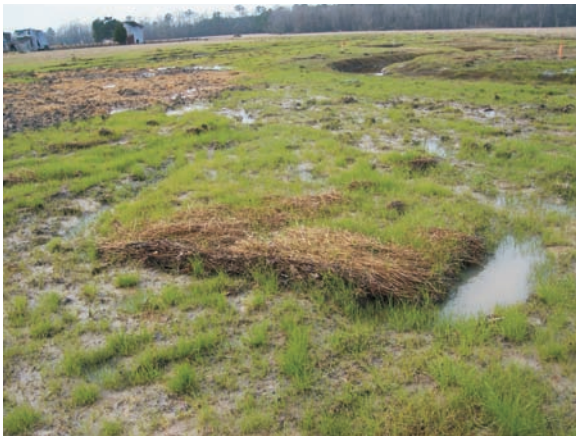
Wrack adjacent to the Main Channel from an overbank event that occurred during construction.

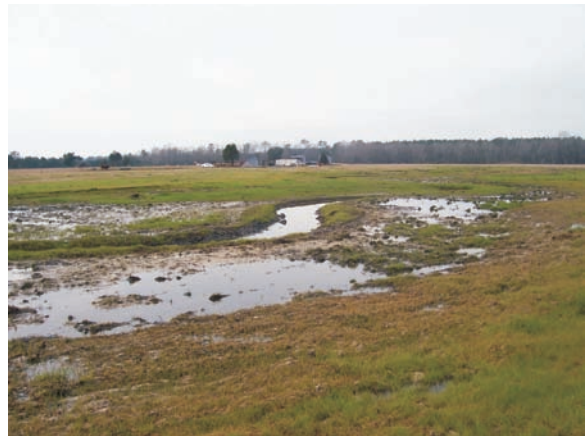
Looking at the Main Channel from the top of the Site. Adjacent Muckalee soils/riverine wetland restoration areas are beginning to rehydrate.

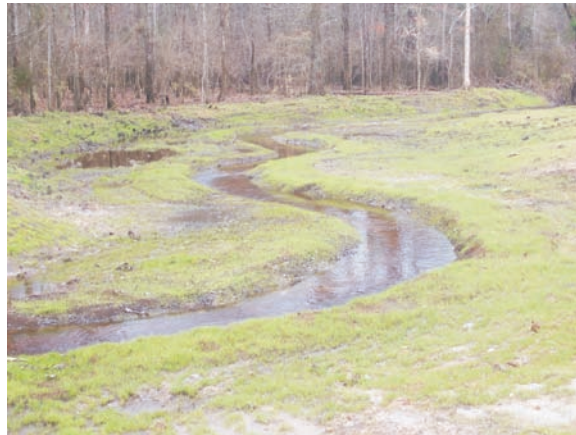
Looking upstream at upper reach of the Eastern Tributary where a floodplain bench was excavated to encourage overbank flooding.
