ANNUAL REPORT FOR 1999

Mallard Creek Mitigation Site
Mecklenburg County
Project # 8.U670123
TIP # R-211

Prepared By:
Natural Systems Unit &
Roadside Environmental Unit
North Carolina Department of Transportation
December 1999

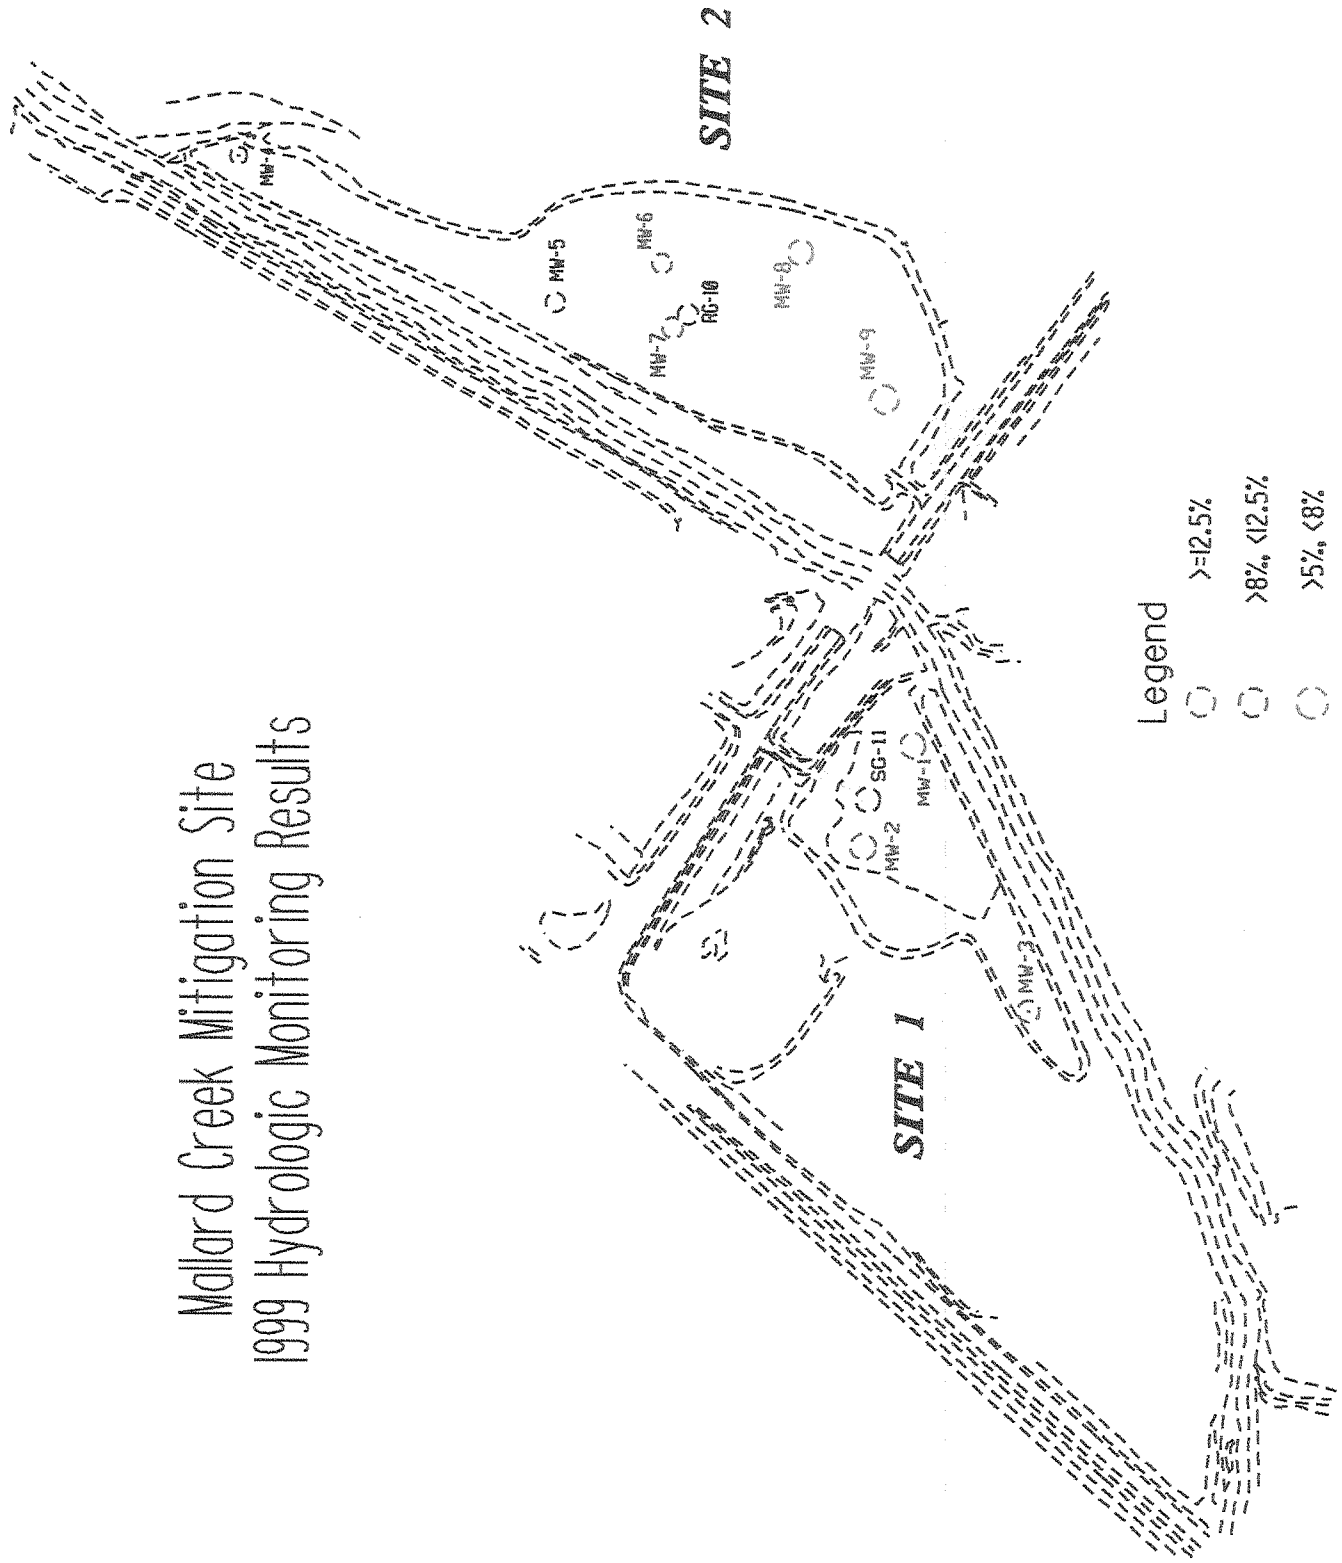
FIGURE 3
1999 HYDROLOGIC RESULTS

Figure 3 is a graphical representation of the hydrologic monitoring results.

Site 1 continues to meet jurisdictional hydrologic success by showing saturation for more than a consecutive 12.5% of the growing season. The surface gauge, which is located on this section, has shown consistent surface water throughout the growing season.

Site 2 has not shown the same success. Wells 6 and 7 showed saturation for over 30 days only after large rainfall events in early October saturated the Charlotte area. All of the wells on this site indicate that the groundwater levels drop quickly after rainfall.

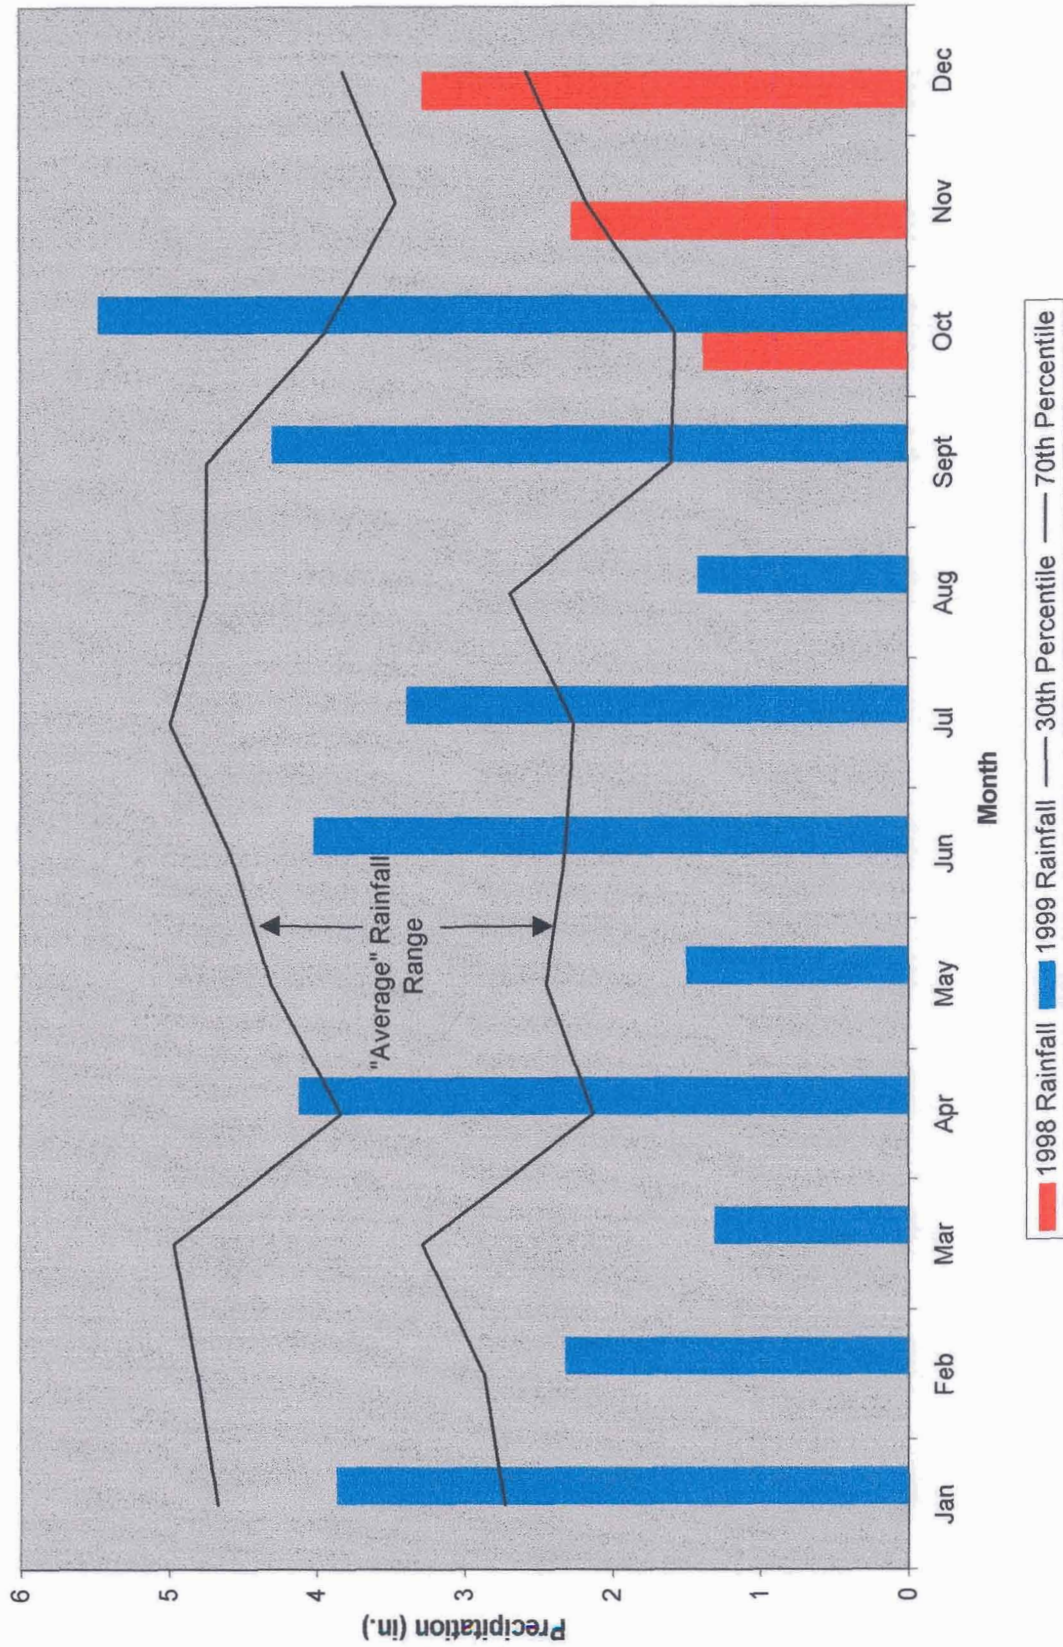
**FIGURE 4
30-70 PERCENTILE GRAPH**

climate conditions. The figure compares the rainfall from 1998 and 1999 with that of historical rainfall (data collected between 1948 and 1996). All rainfall data was collected from the NC State Climate Office. The graph shows 1999 rainfall totals through October 1999. Rainfall data for November and December 1999 will be presented in the 2000 Annual Monitoring Report.

Charlotte was not adversely affected by Hurricanes Floyd and Dennis, which hit the state in September 1999. Rainfall for September was within average limits for that month. However, a large storm (4.3 inches in two days) in October pushed that month's total rainfall well above average. February, March, May, and August were especially dry months.

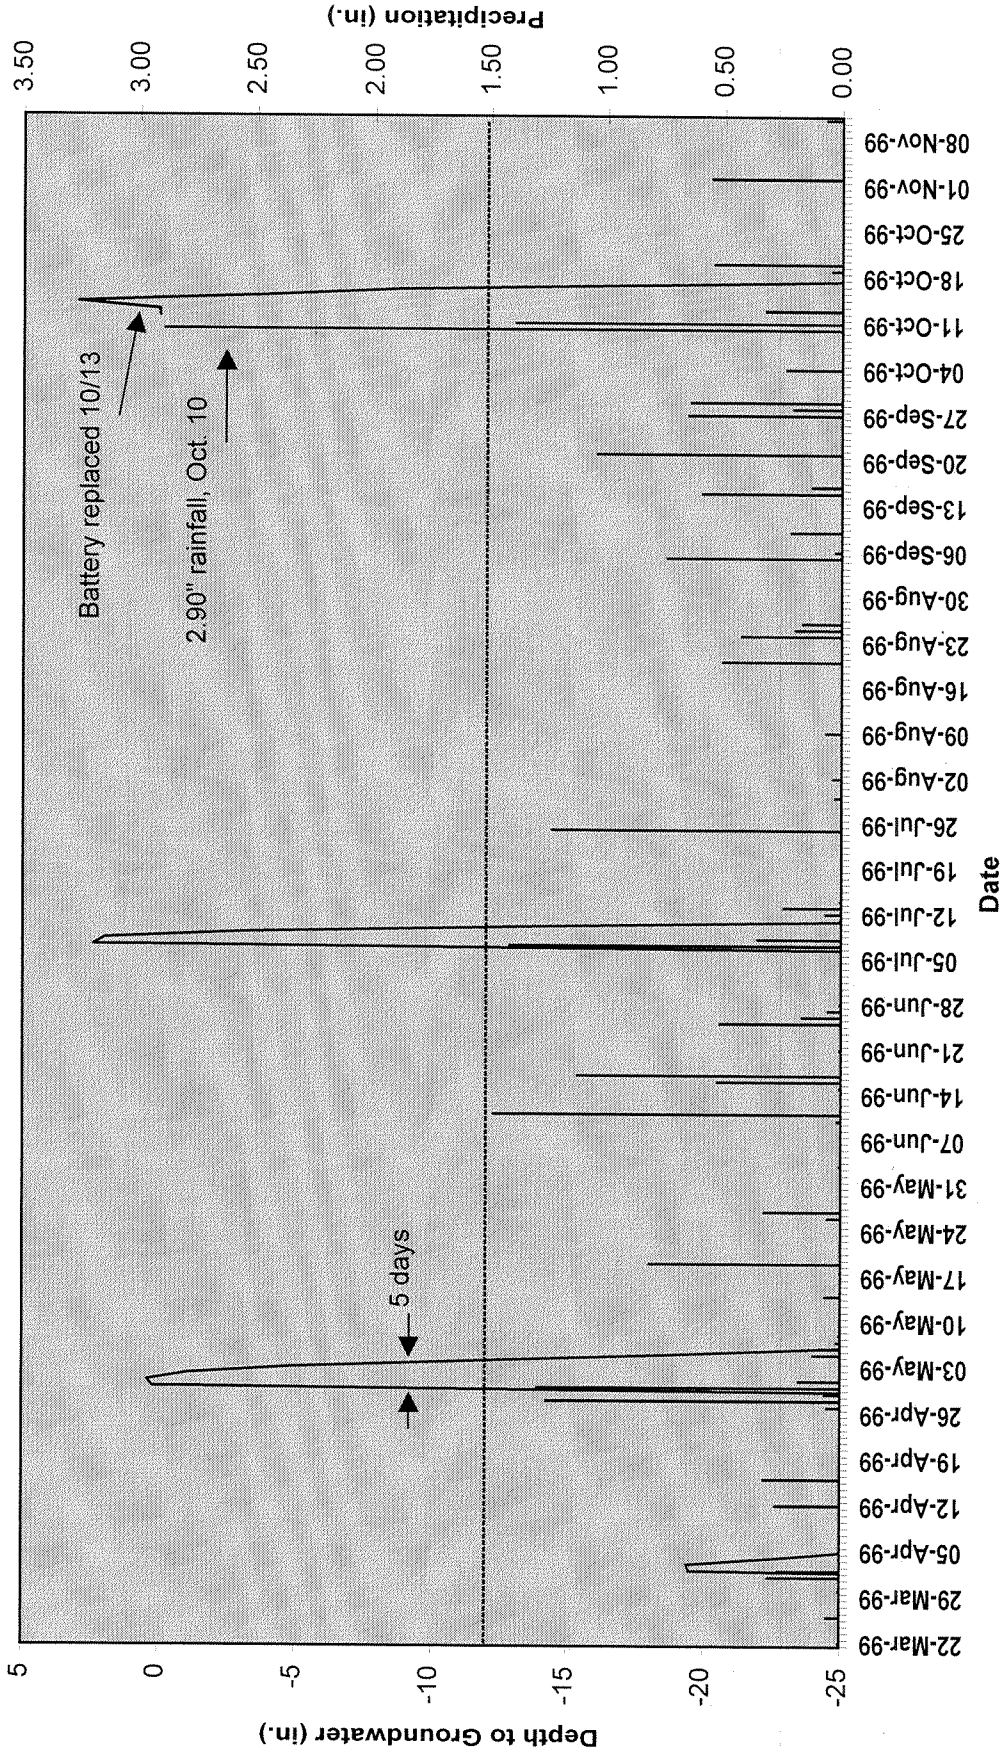
Mallard Creek MW-4

| Monitoring Well | < 5% | 5% - 8% | 8% - 12.5% | > 12.5% | Actual % | Success Dates |
|---|---|---|---|---|---|---|
| MW-4 | ✓ | | | | 2.1 | Apr. 30- May 4 |

Specific problems: The battery in monitoring well 4 had problems in the latter part of the growing season; this battery replaced in October of 1999, but not before one month's data for that location was lost. The battery in well 5 was replaced at the end of the growing season due to consistent problems.

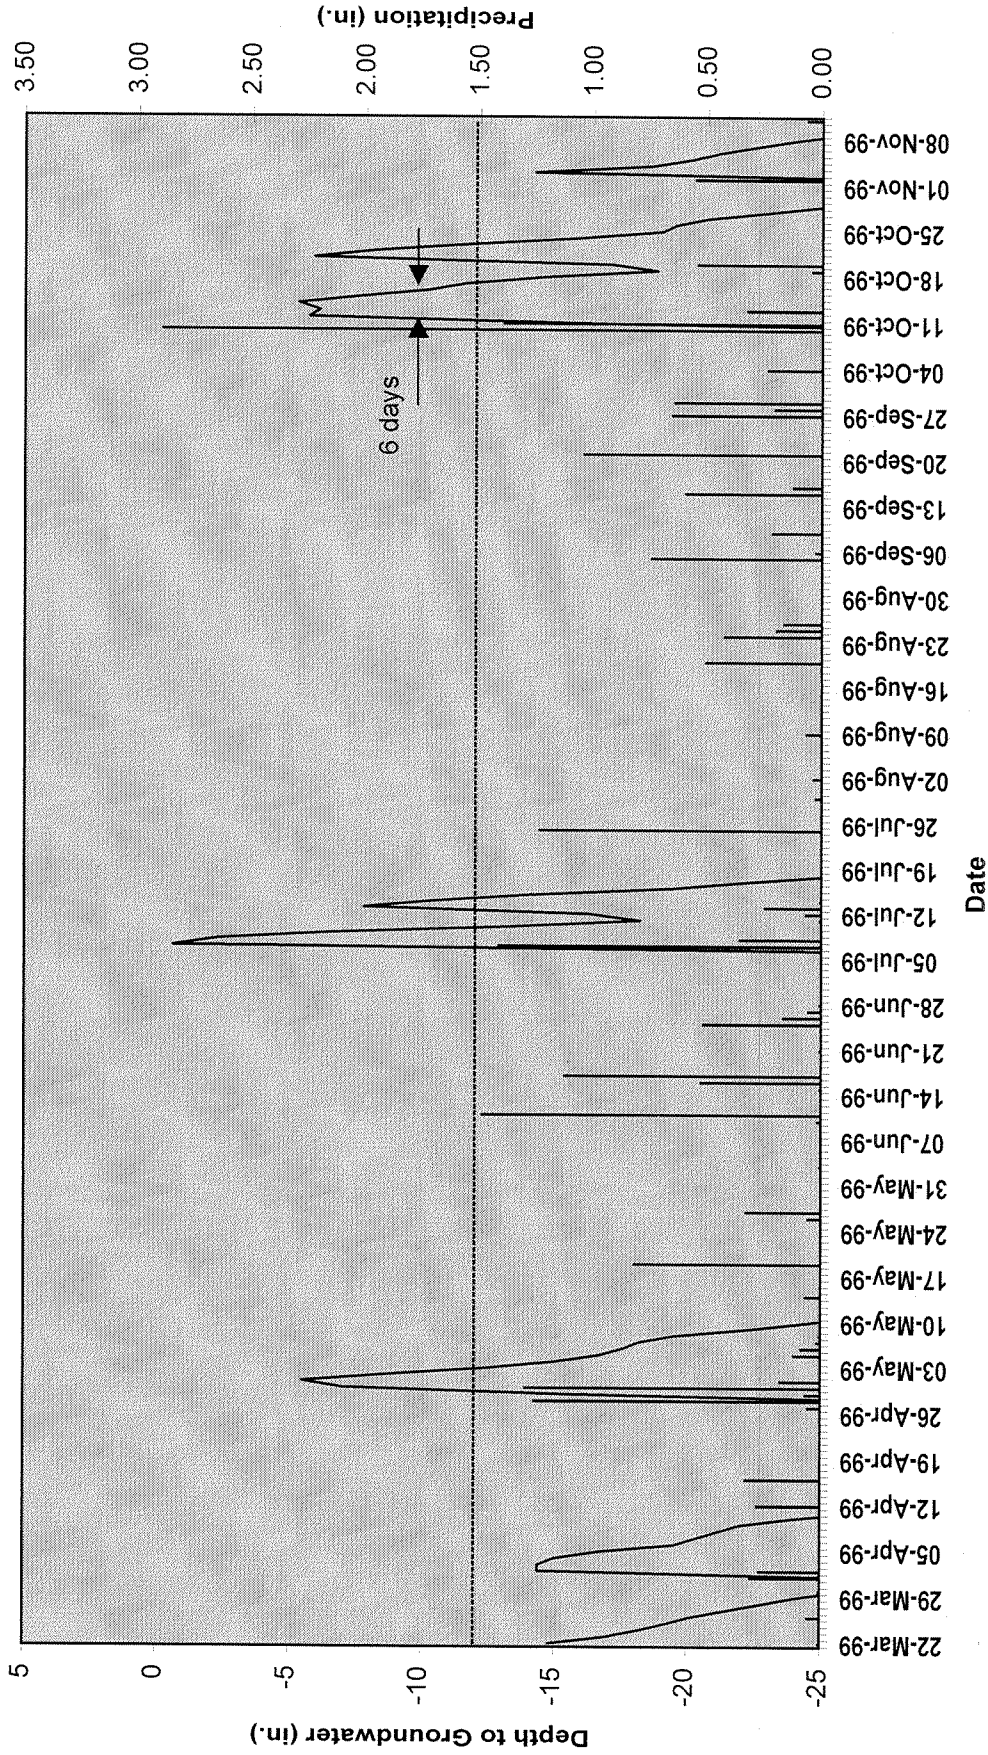
Mallard Creek MW-5

| Monitoring Well | < 5% | 5% - 8% | 8% - 12.5% | > 12.5% | Actual % | Success Dates |
|---|---|---|---|---|---|---|
| MW-5 | ✓ | | | | 2.6 | Oct. 12- Oct. 17 |

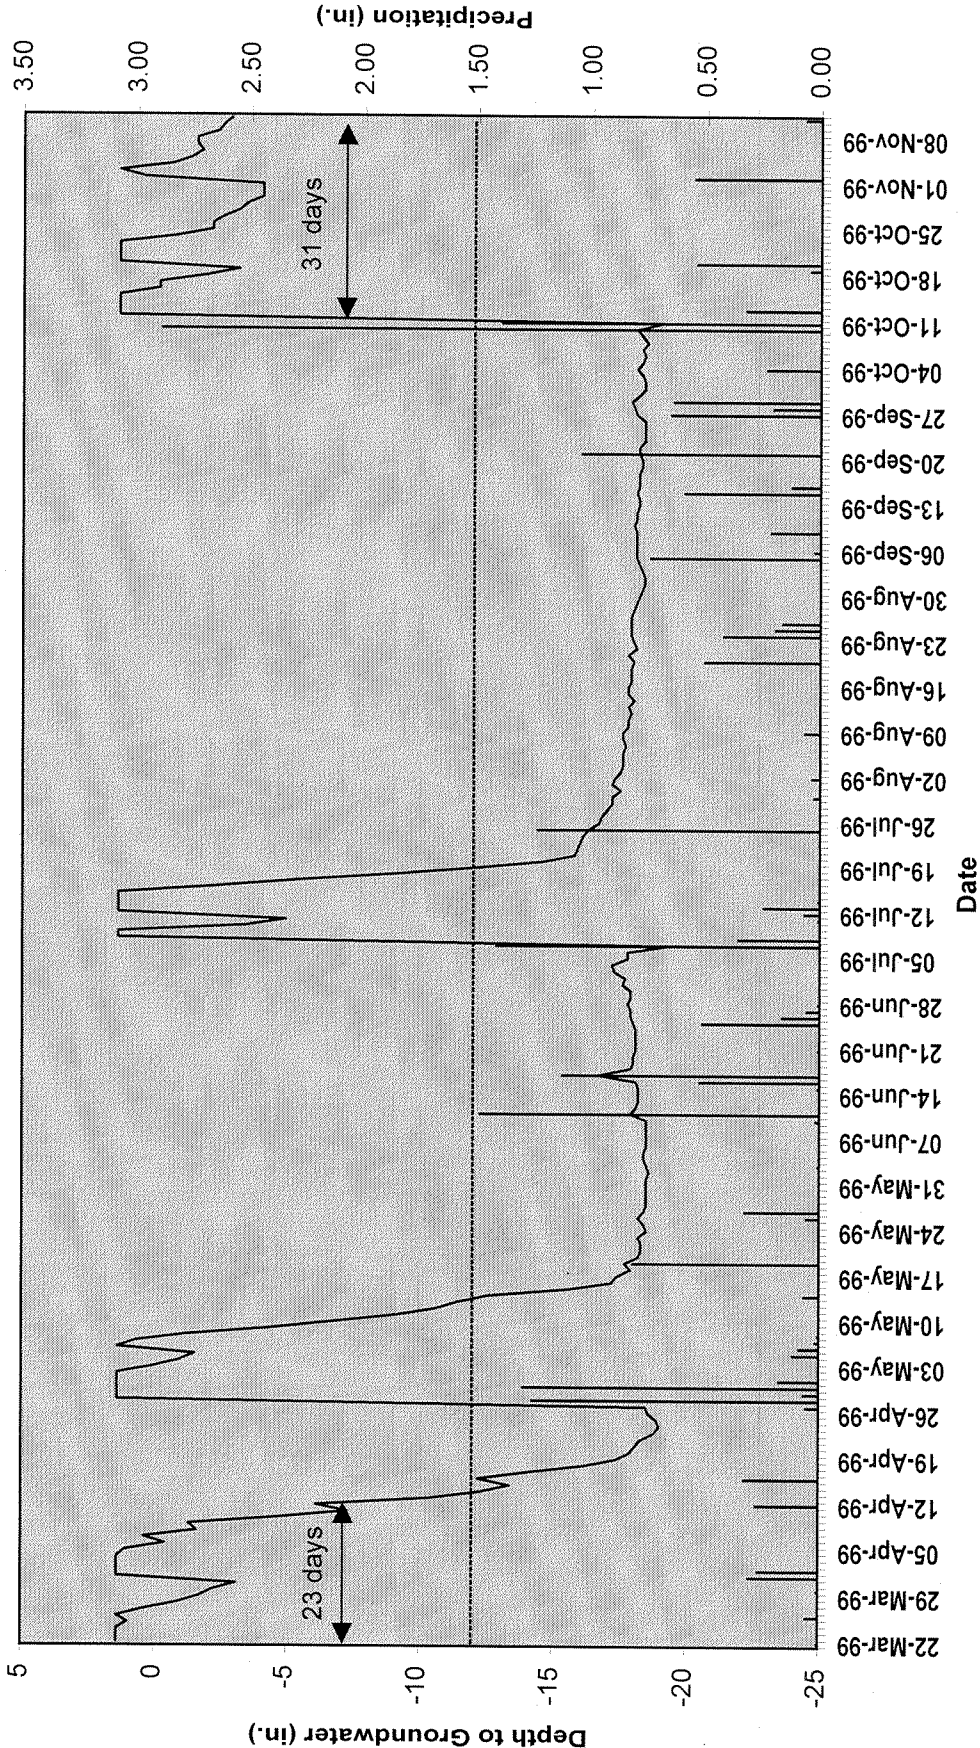
Mallard Creek MW-6

| Monitoring Well | < 5% | 5% - 8% | 8% - 12.5% | > 12.5% | Actual % | Success Dates |
|---|---|---|---|---|---|---|
| MW-6 | | | | ✓ | 13.3 | Oct. 12- Nov. 11 |

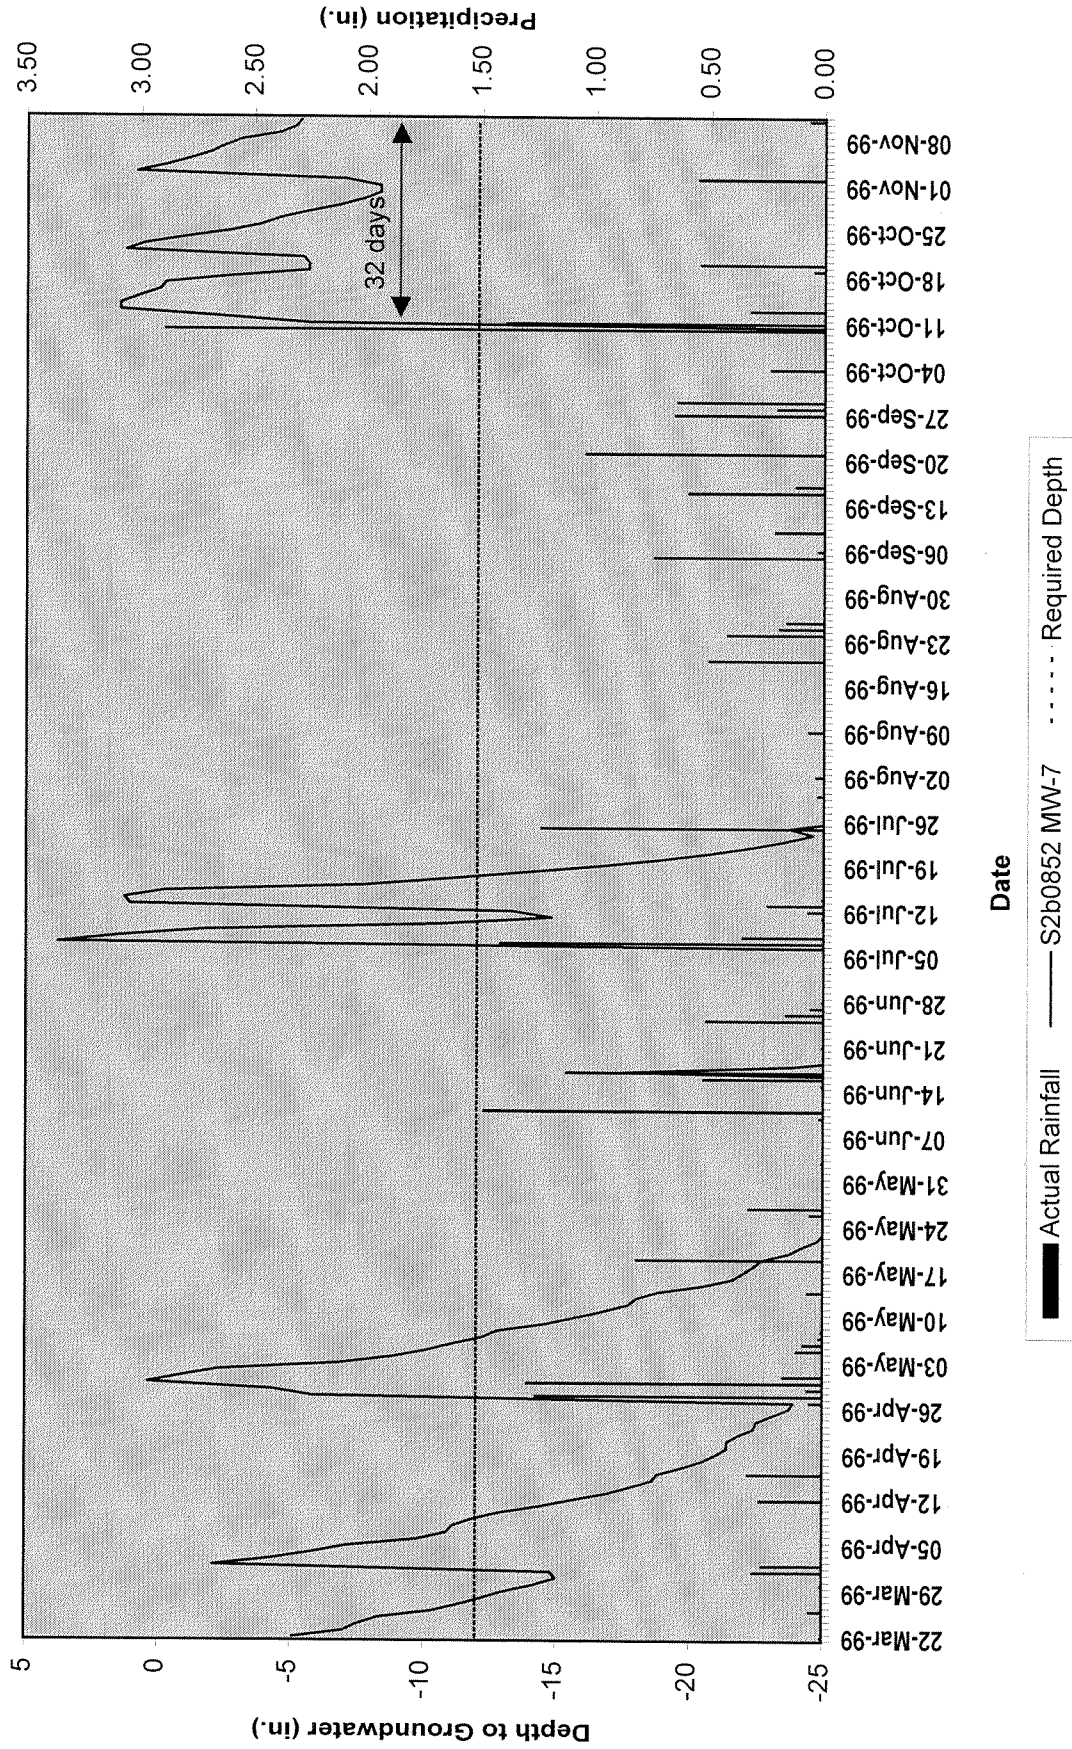
Mallard Creek MW-7

| Monitoring Well | < 5% | 5% - 8% | 8% - 12.5% | > 12.5% | Actual % | Success Dates |
|---|---|---|---|---|---|---|
| MW-7 | | | | ✓ | 13.7 | Oct. 11- Nov. 11 |

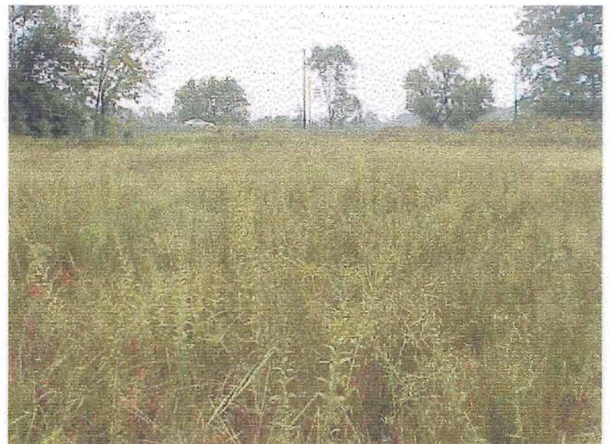
Photo 6: At P6 looking Northeast

| Plot # (Type) | Green Ash | Blackgum | Overcup Oak | Water Oak | Total (2 year) | Total (at planting) | Density (Tree/Acre) |
|---|---|---|---|---|---|---|---|
| 6(BLH) | 13 | 0 | 2 | 0 | 15 | 36 | 283 |

Approximately 10 acres of this site was re-graded in Fall, 1997. The total site is made up of two wetland mitigation areas. Wetland Mitigation Area #1 is a 2.80 acre site located in the southwest quadrant of the intersection of SR 2833 and Mallard Creek, while the remaining 7.20 acres is located directly across SR 2833 in the northwest quadrant. Six vegetation monitoring plots were established throughout the planting areas: 2 plots in mitigation area #1 and 4 plots in mitigation area #2. Based on the results of the stem counts for the two year monitoring period, we obtained an average tree density of 469 trees per acre. This average for the site as a whole is above the minimum success criteria of 320 trees/ acre; however, plot six yielded a density of only 283 trees per acre.
