Mason Property Wetland Mitigation Project

**2013 Supplemental Monitoring Report – Post Closeout
Year 6**

NCEEP Project Number D06001
Tar-Pamlico River Basin CU: 03020105

Date: December, 2013

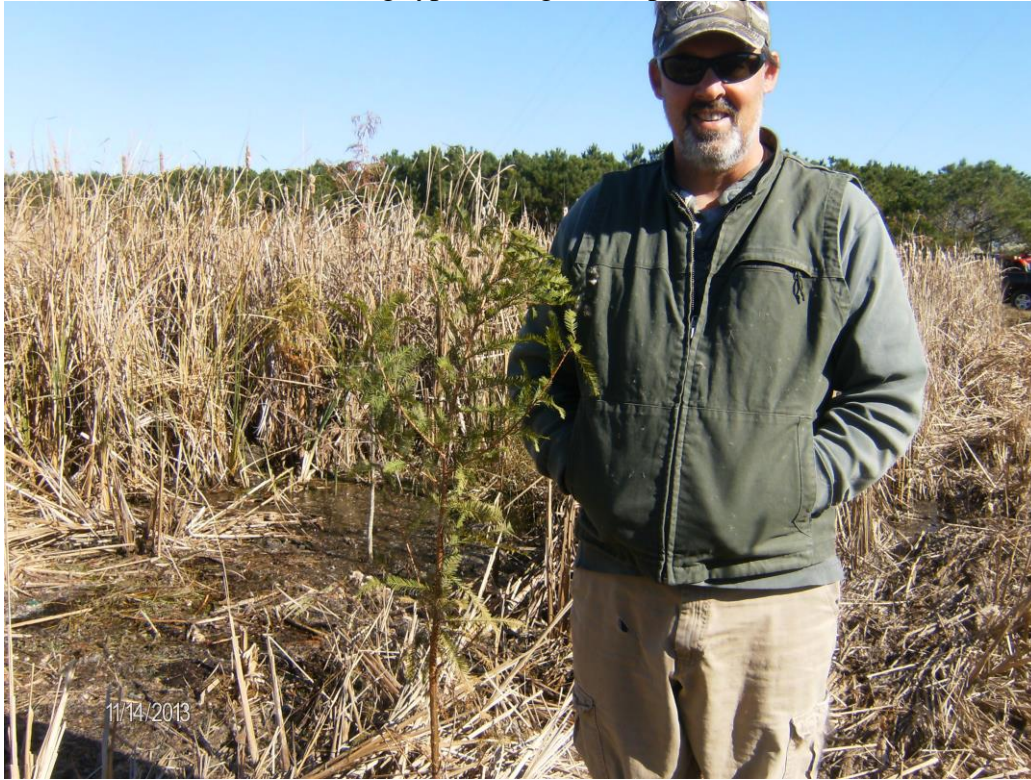
Photo showing typical height of replanting stock.

In September of 2013 portions of the site were disked to reduce the heavy cattail cover and facilitate planting. In November of 2013 6,000 containerized bald cypress (*T. distichum*) were planted. Bald cypress was chosen as it has proven to be the best suited species for the site given the frequency and duration of high water and the possibility of future salt water intrusion. On average, the trees range in height from three to six feet and stocking levels across the site have been brought up to average 412 stems per acre. This should be more than enough to allow for expected mortality and still provide the necessary 260 stems required for success.

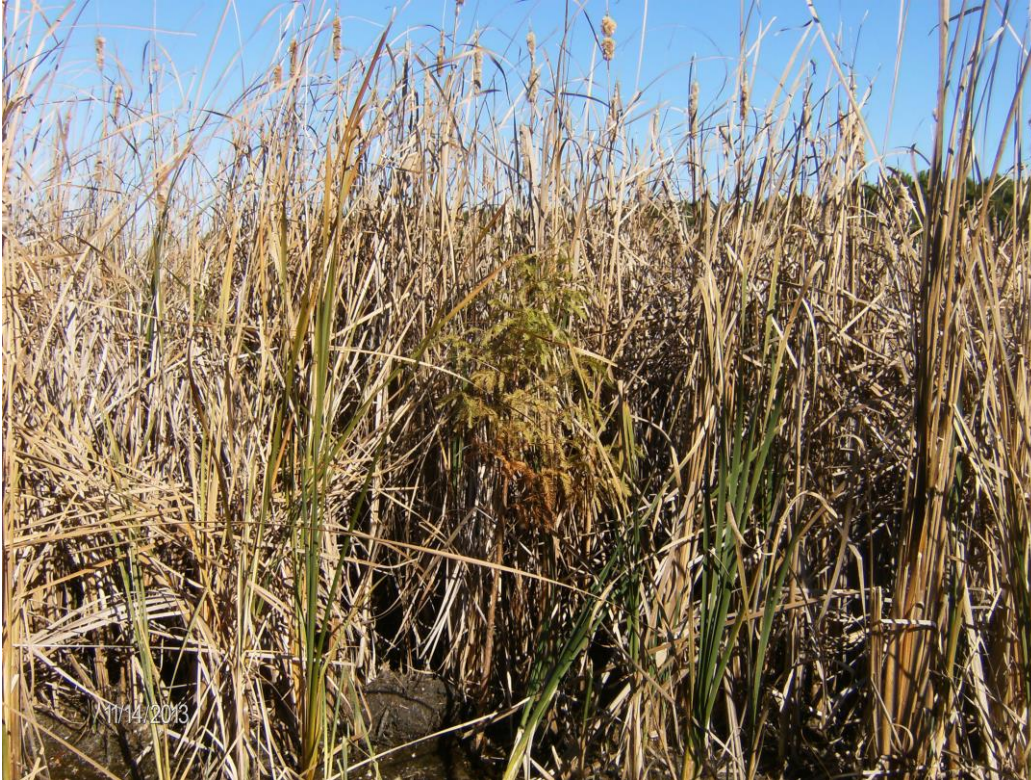
Another photo of typical replanting stock and heavy cattails.

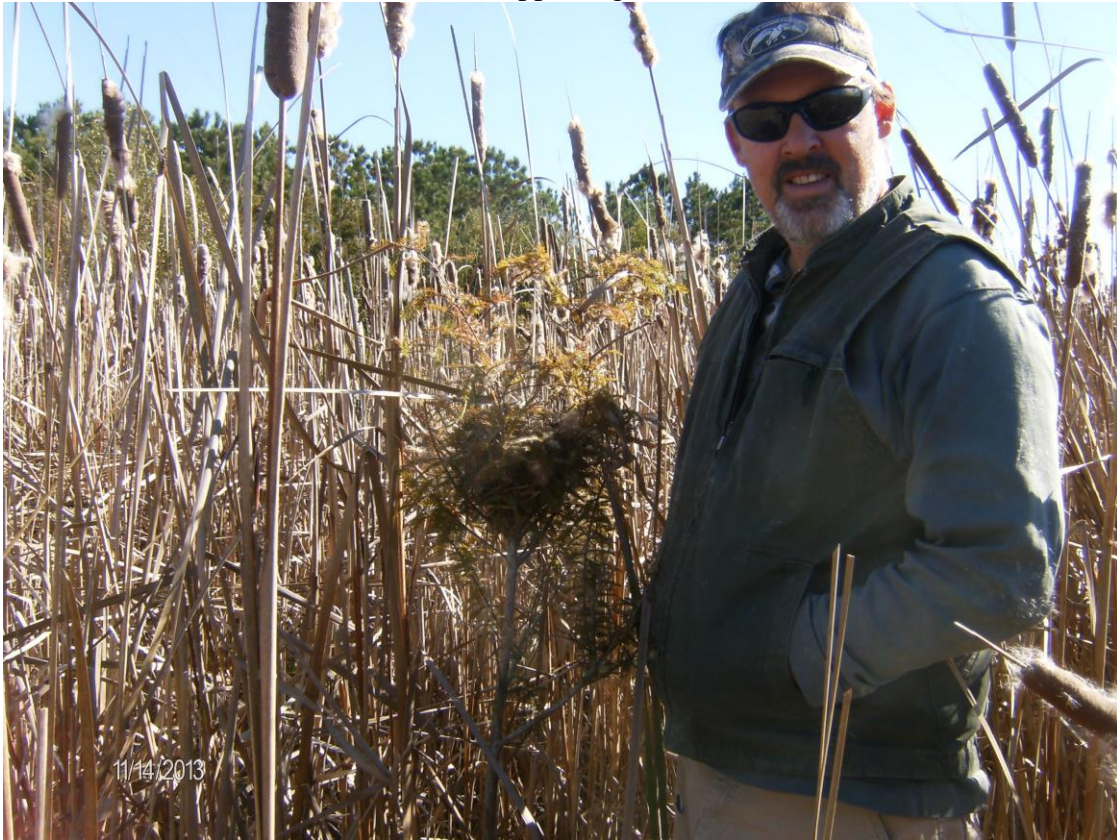
This stem was very close to those shown in the previous two photos and is a survivor of Hurricane Irene. It is similar in size and is supporting a bird nest from 2013.
