**McCain Site
Randolph County, North Carolina**

Stream Restoration Plan

Contract No. EW-02040S

North Carolina Ecosystem Enhancement Program

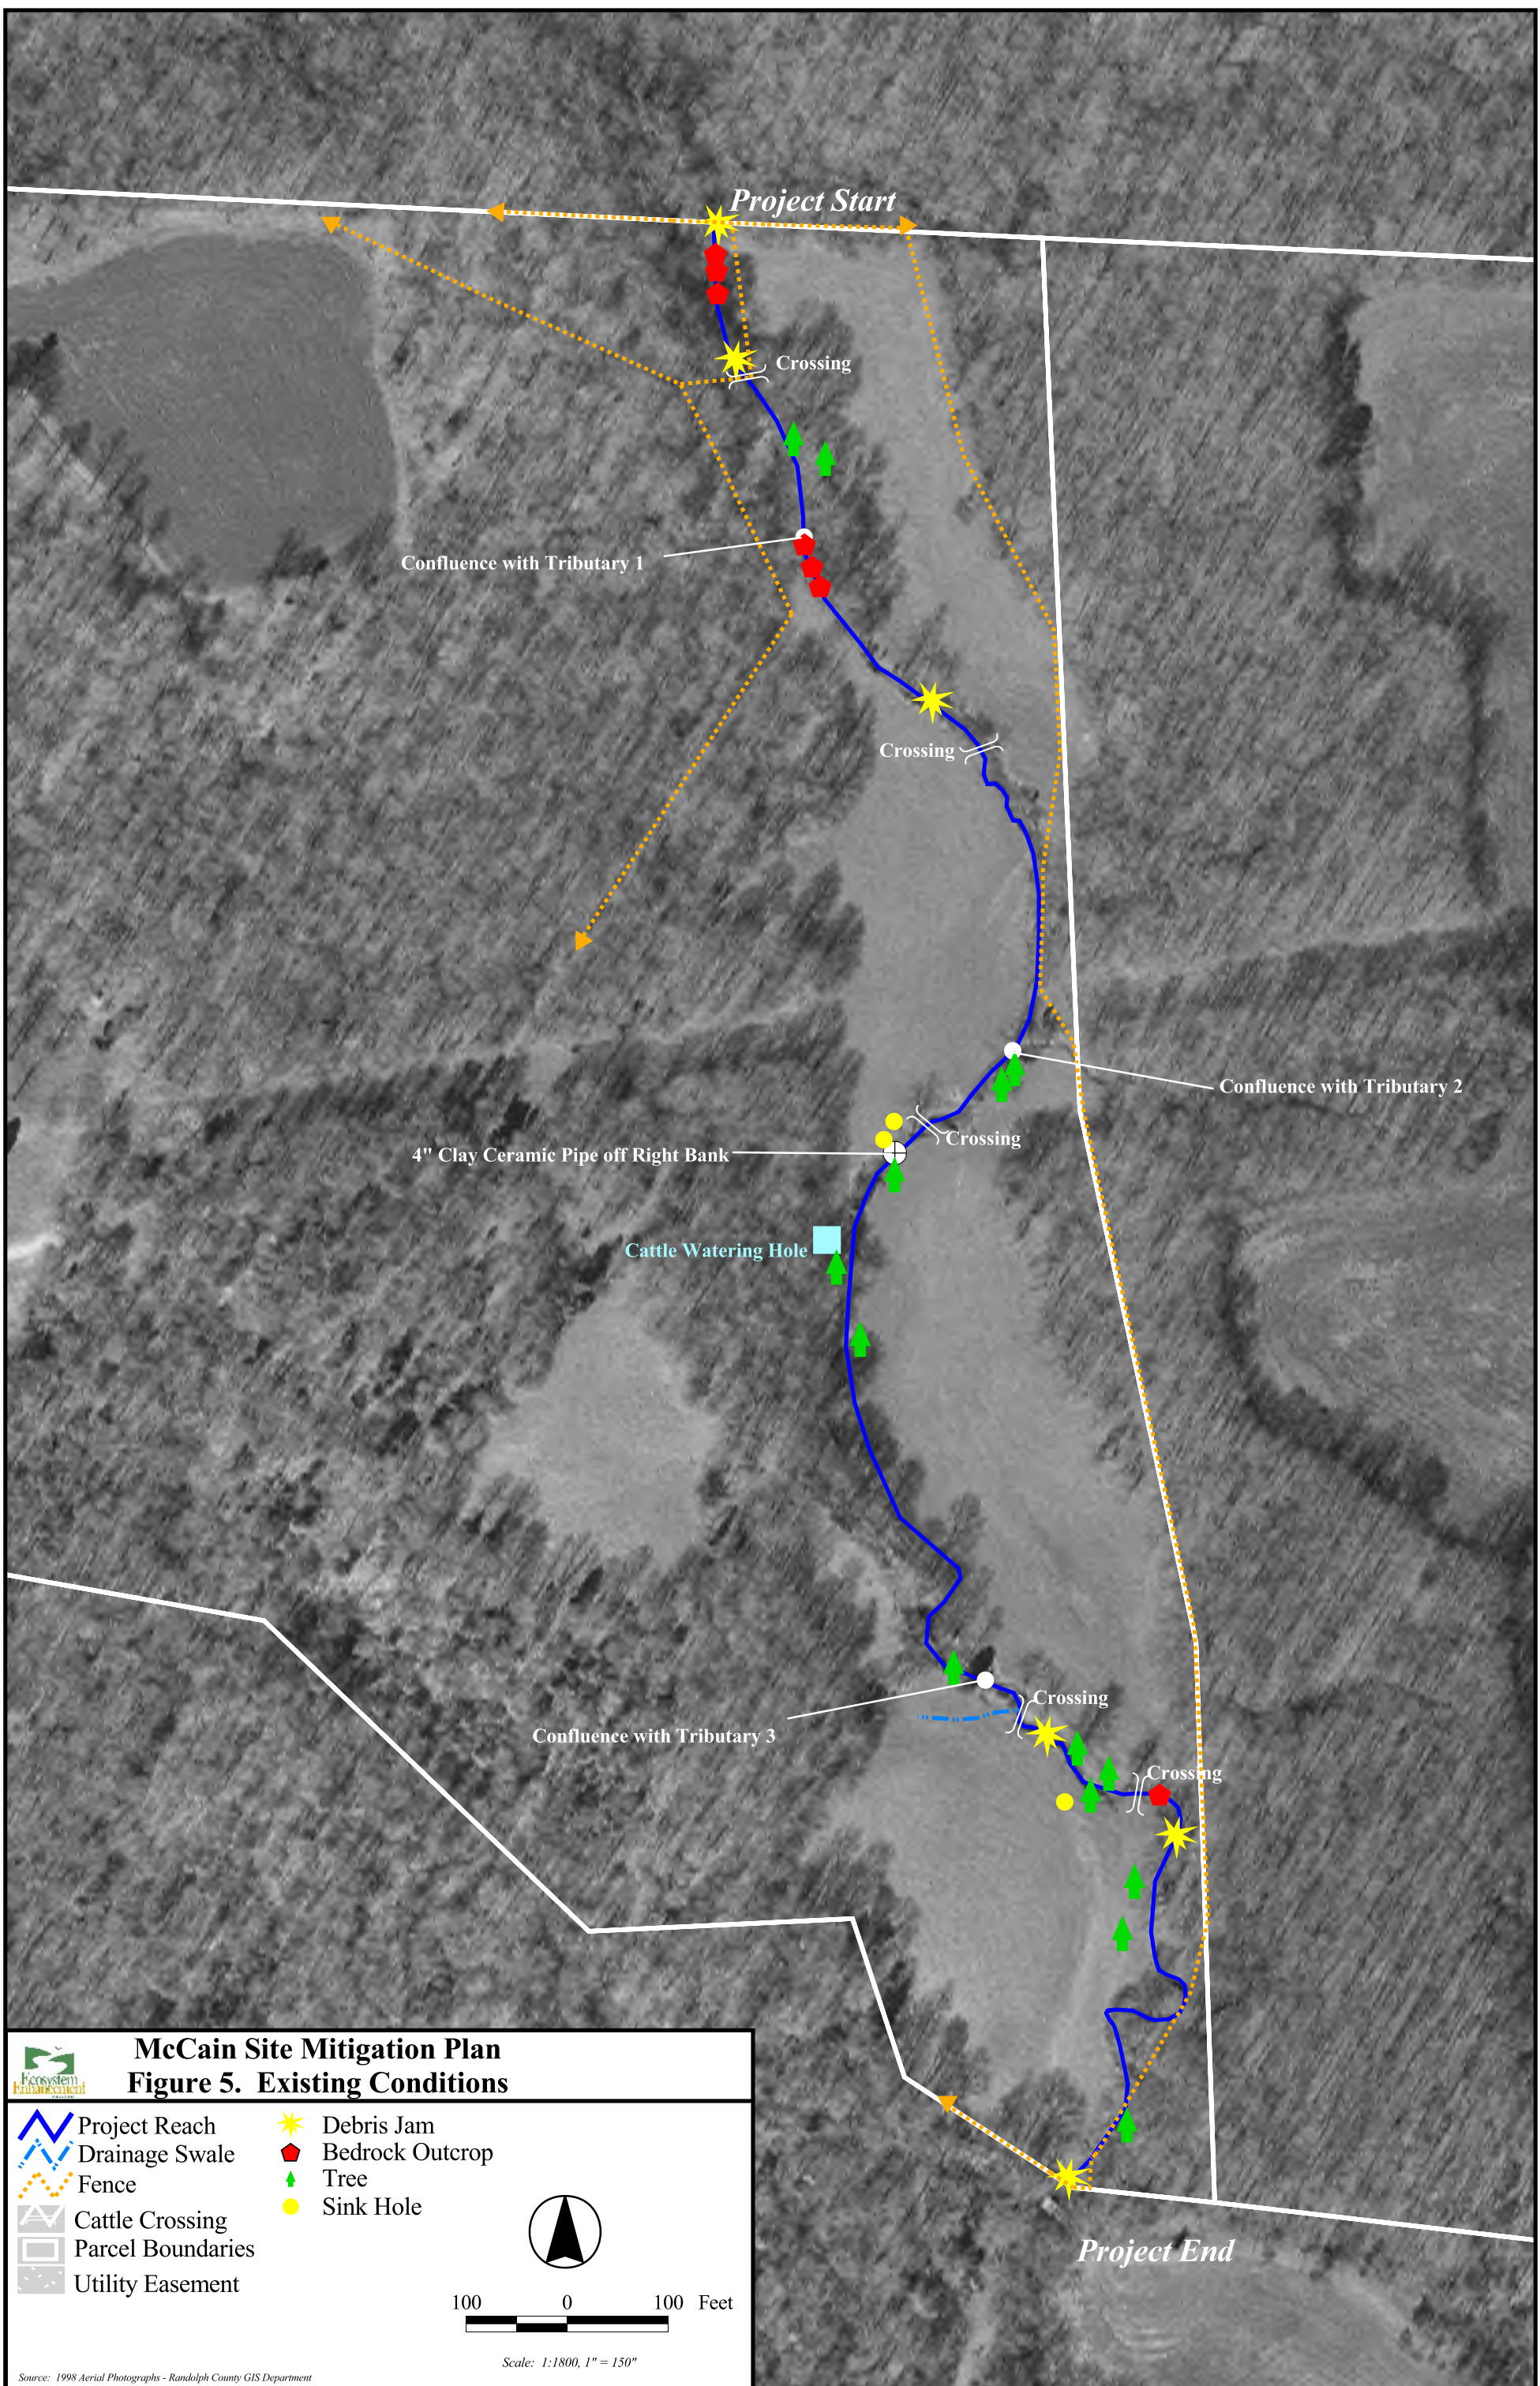
McCain Site Mitigation Plan
Figure 5. Existing Conditions

As the project location can be seen on the Figure 5; the valley has four natural bends, in which the stream channel flows near the low spot in the valley. It appears that in the two western bends of the valley that the stream may have been relocated hard against the valley wall to allow the valley bottom to be actively farmed, then pastured. Such an active relocation was undisputedly found on the upstream adjacent property.

In the two western valley bends, the channel is incised, with this incision extending through the *Dogue* loamy soil and into soils and sediment deposits, which are over 300 years old and predate the *Dogue's* depositional event. The upstream western bend in the valley appears to have eroded through a channery deposit and eroded down to bedrock in places. The downstream western bend in the valley is adjacent to some severe gully erosion caused by cattle taking short cuts to the stream channel. The two eastern bends of the valley are in better condition partly due to fences on the east bank preventing the cattle from climbing the far banks. In the upstream eastern valley bend, the stream does not strike the valley wall but, is never the less, heavily impacted by cattle movement because its low banks allow easy access. The lower eastern valley bend has the only true meandering stretch of stream channel that has exposed some bedrock. This meandering has caused some outer bends to consist of severely eroded valley wall cuts.

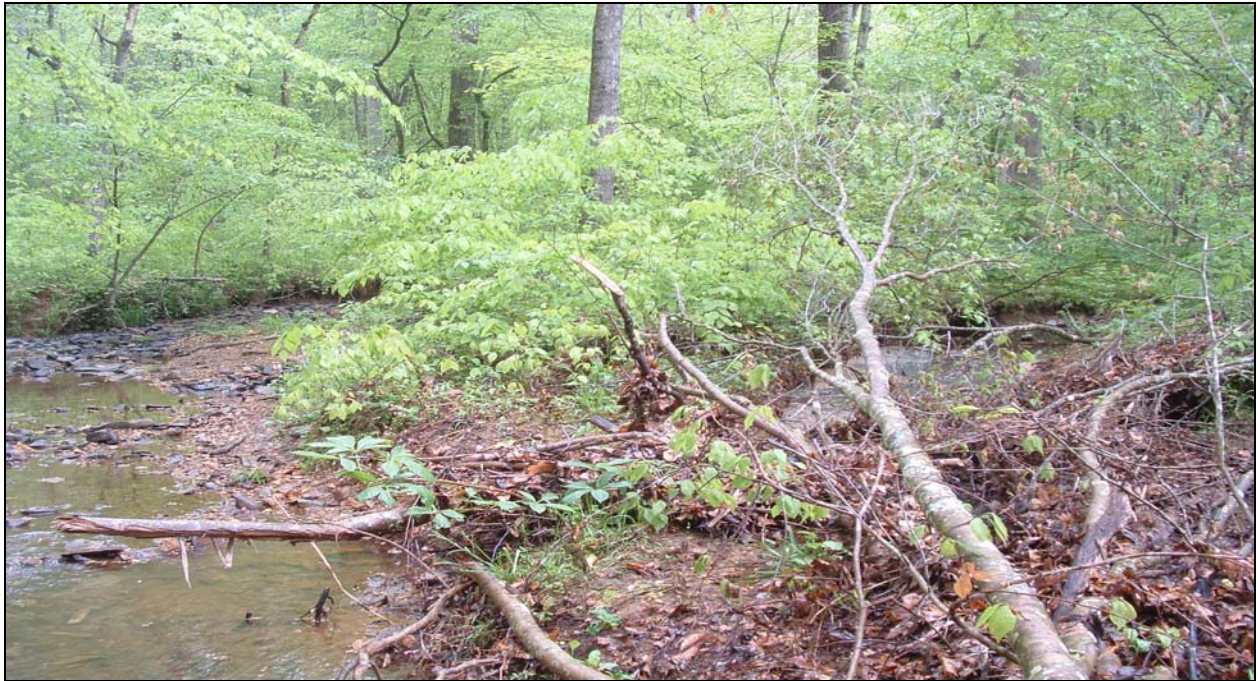
Photograph 1 – View of UTBC prior to entering project site, looking upstream from Station 10+00 across the McCain property boundary.

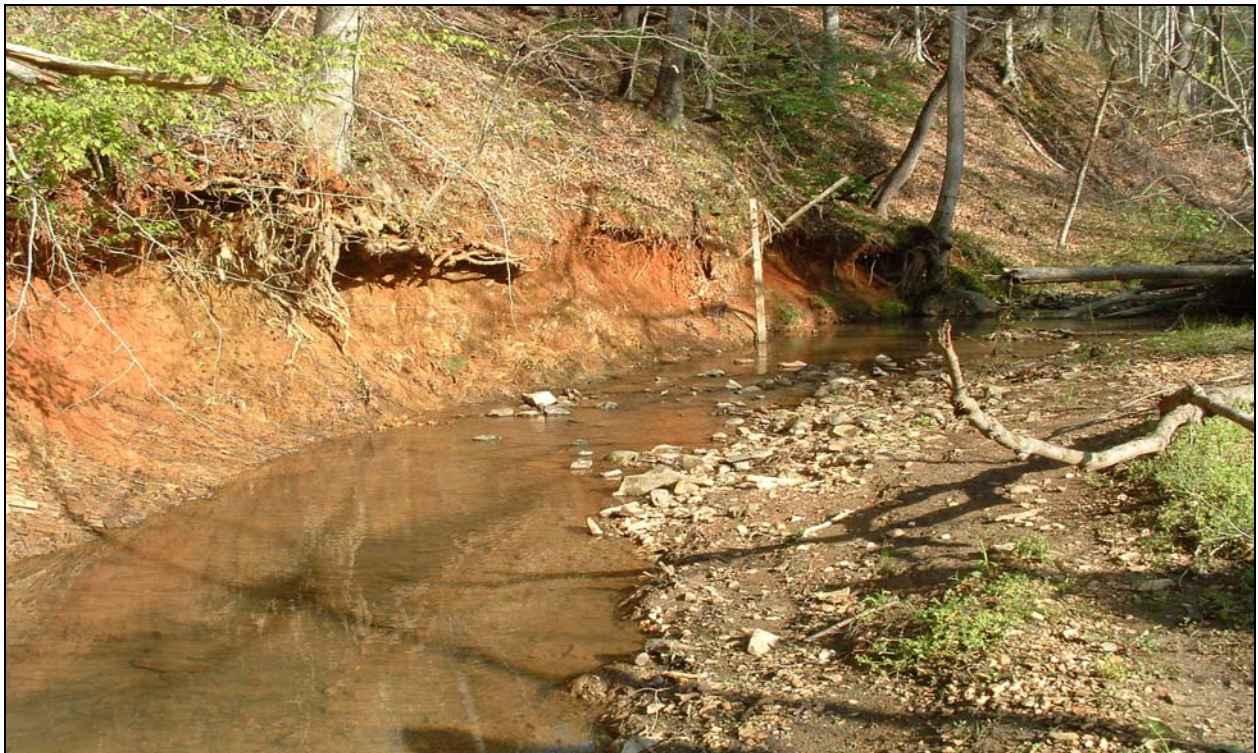
Photograph 2 – View looking upstream at top of project site. Logs in stream in upper right of photo mark station 10+00. Scour along the right bank is predominantly into weathered bedrock.

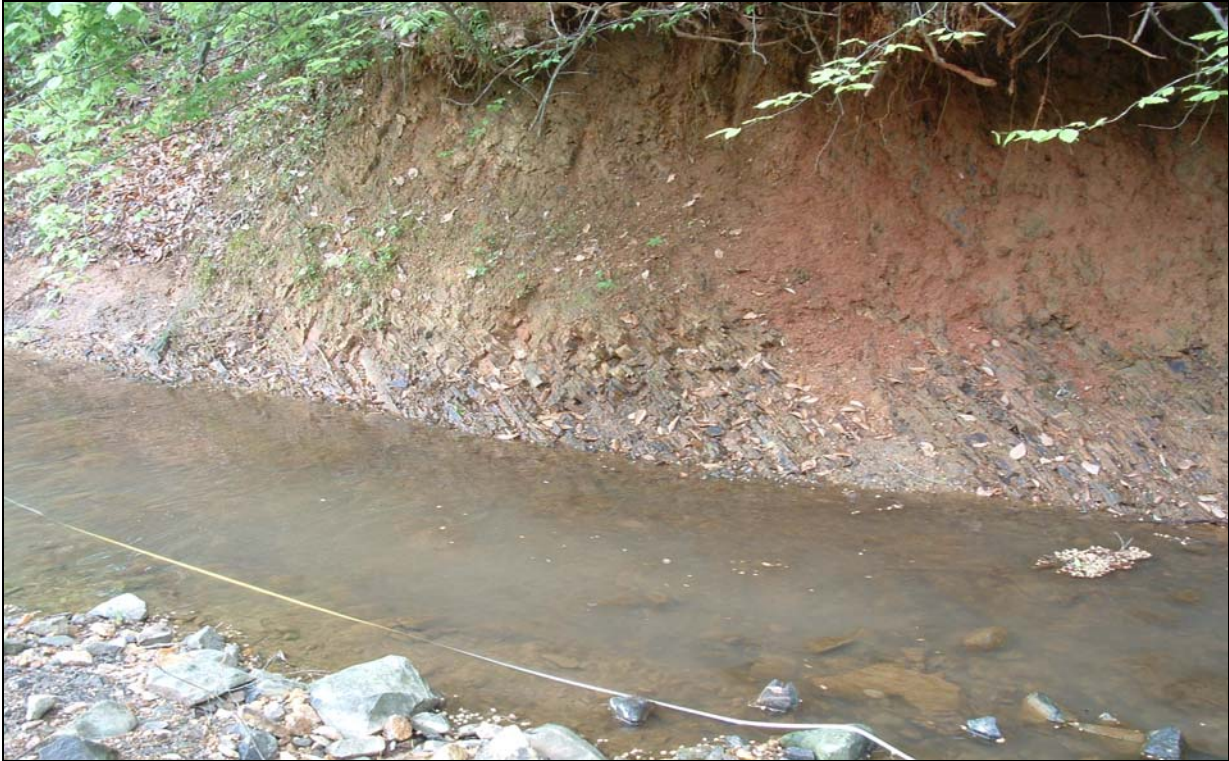
Photograph 3 – Weathered bedrock along right bank and in UTBC streambed (Station 10+20 to 10+35).

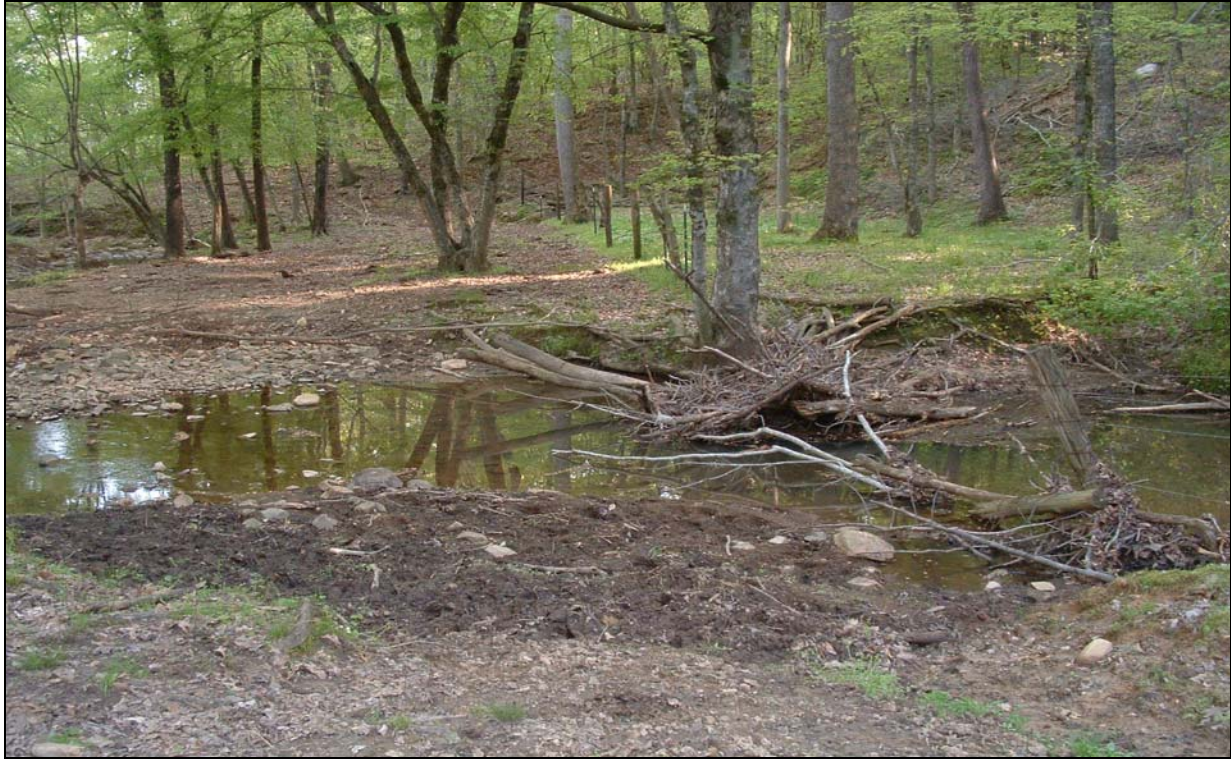
Photograph 5 - Barbed wire fence crossing stream that has caused a debris jam.

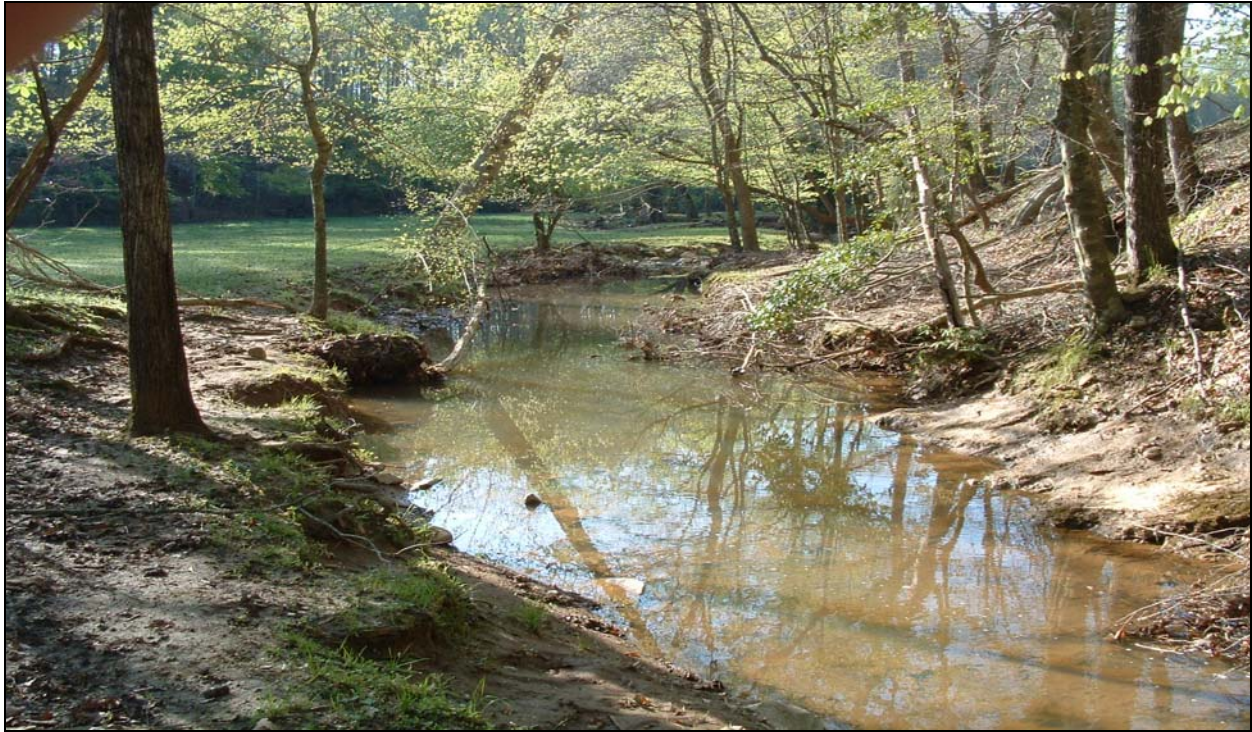
Photograph 9 – View looking downstream below confluence of tributary with UTBC. Bedrock along right bank and in stream, steep bank above bedrock on right bank (Station 13+50 to 14+00).

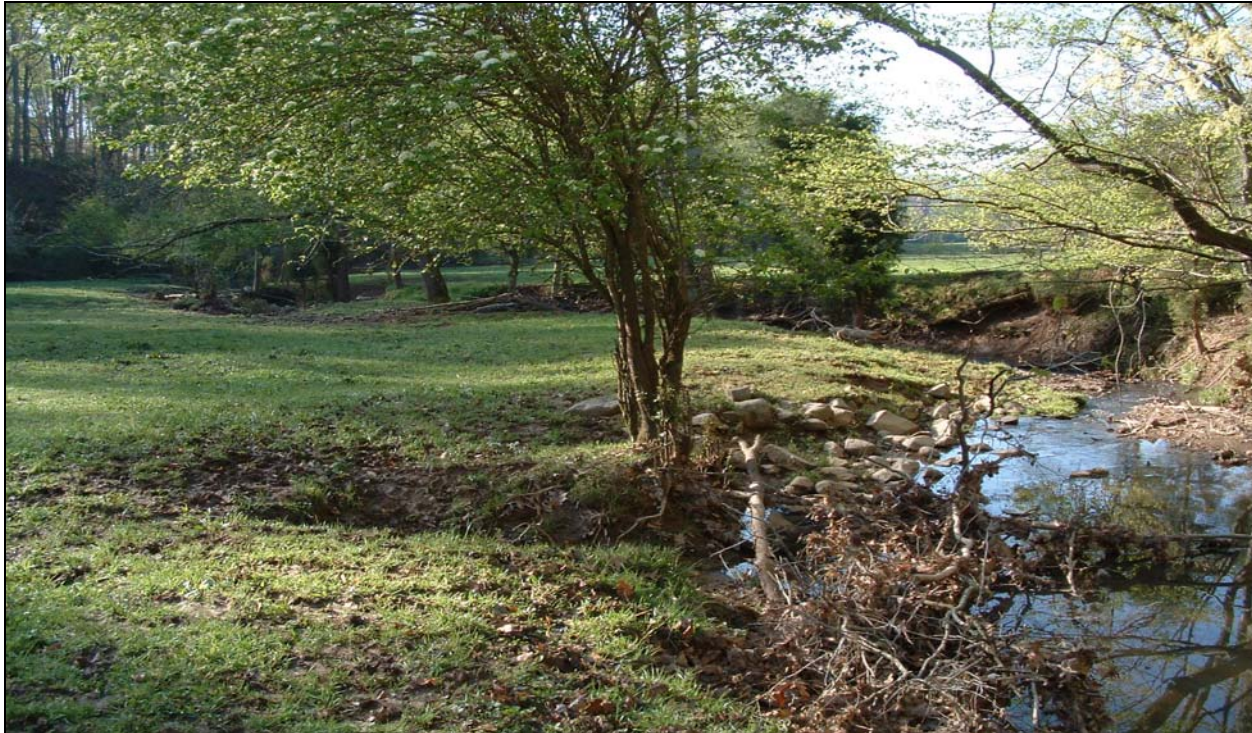
Photograph 10 – View looking downstream, meander pattern of UTBC is visible in the lower right of the photo, moving to the left. Steep, eroding banks occur on the outside meander bank with bar formation on the inside bank.

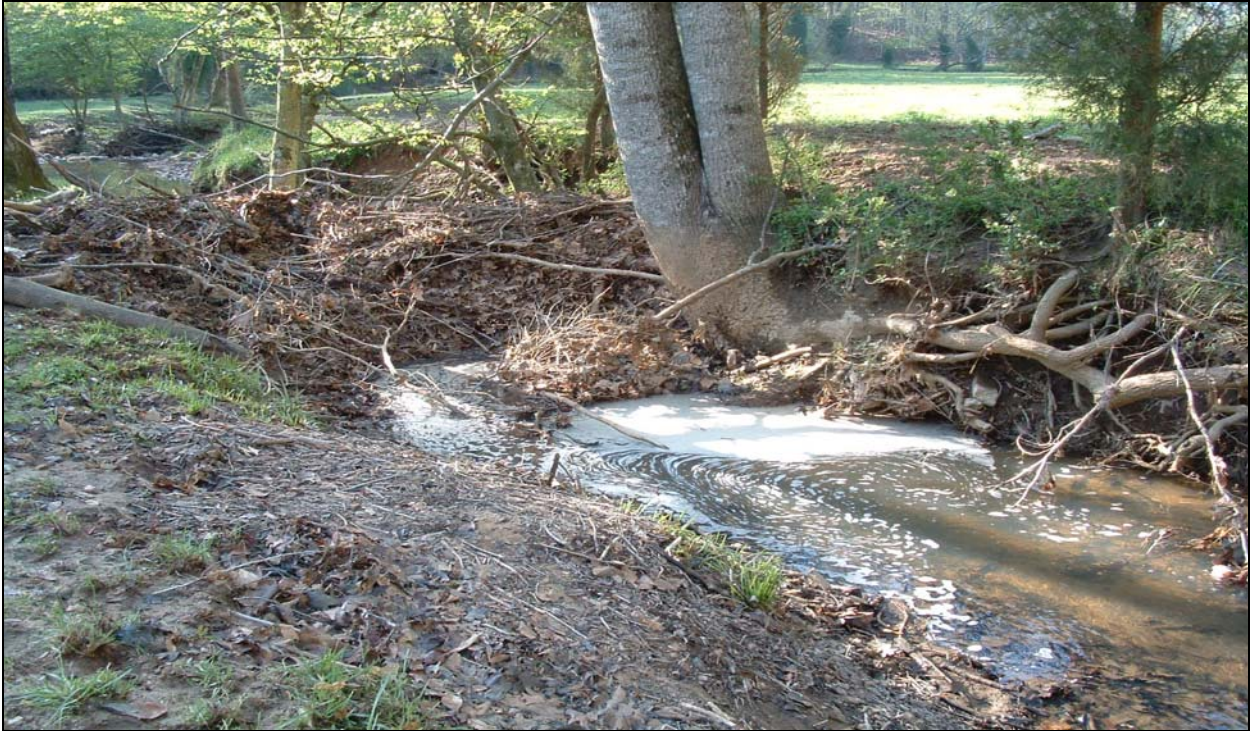
Photograph 11 – Looking downstream at debris jam across UTBC channel, right bank undercut with exposed roots upstream of jam (Station ~15+50).

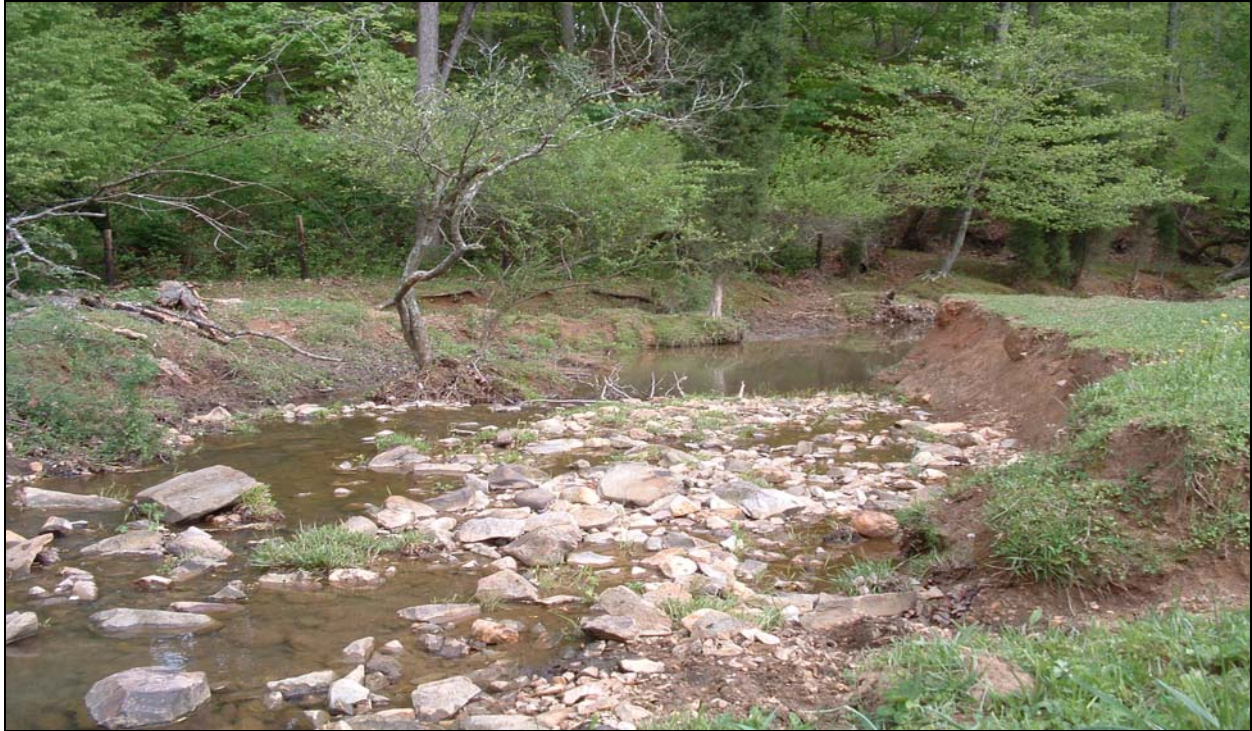
Photograph 13 – Boulder/cobble bar along steep right bank, cattle access in right foreground; small sod island with two small trees near left bank.

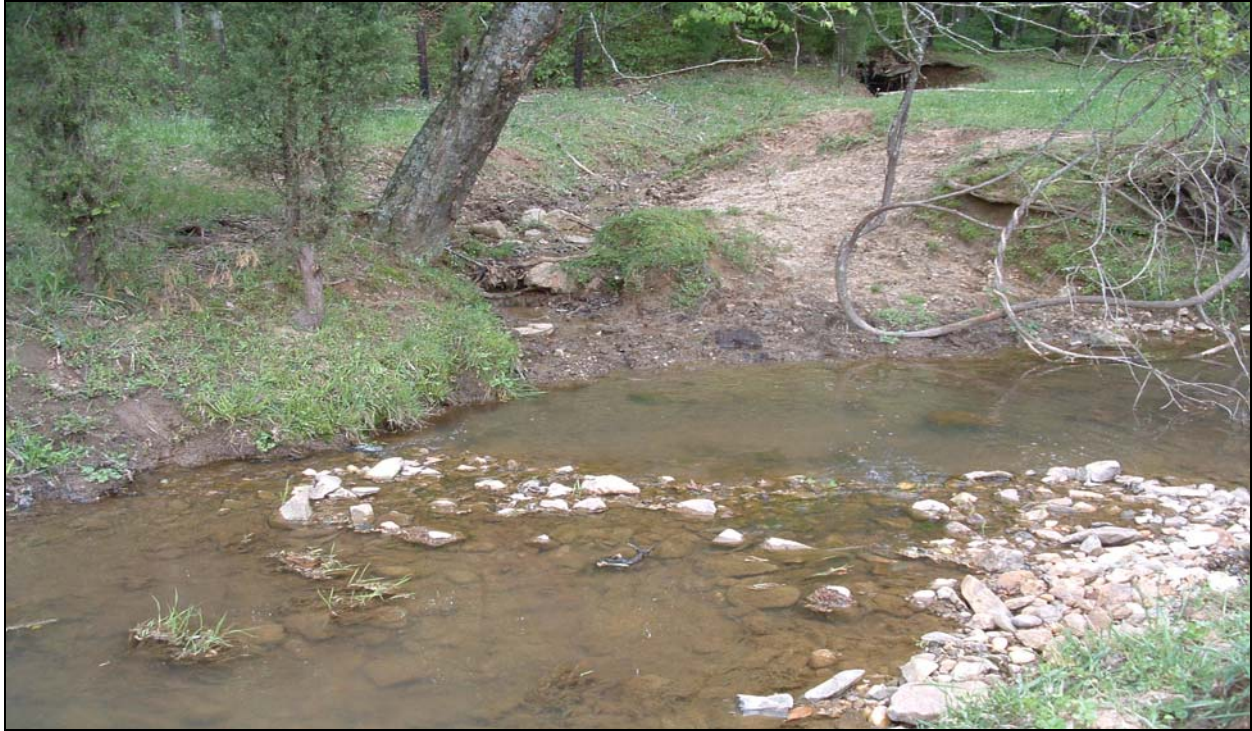
Photograph 15 – Confluence of UT2 with UTBC along left bank (Station ~19+50). Note transverse boulder/cobble bar extending across channel upstream of confluence. Fence marking property boundary is visible along top of photo.

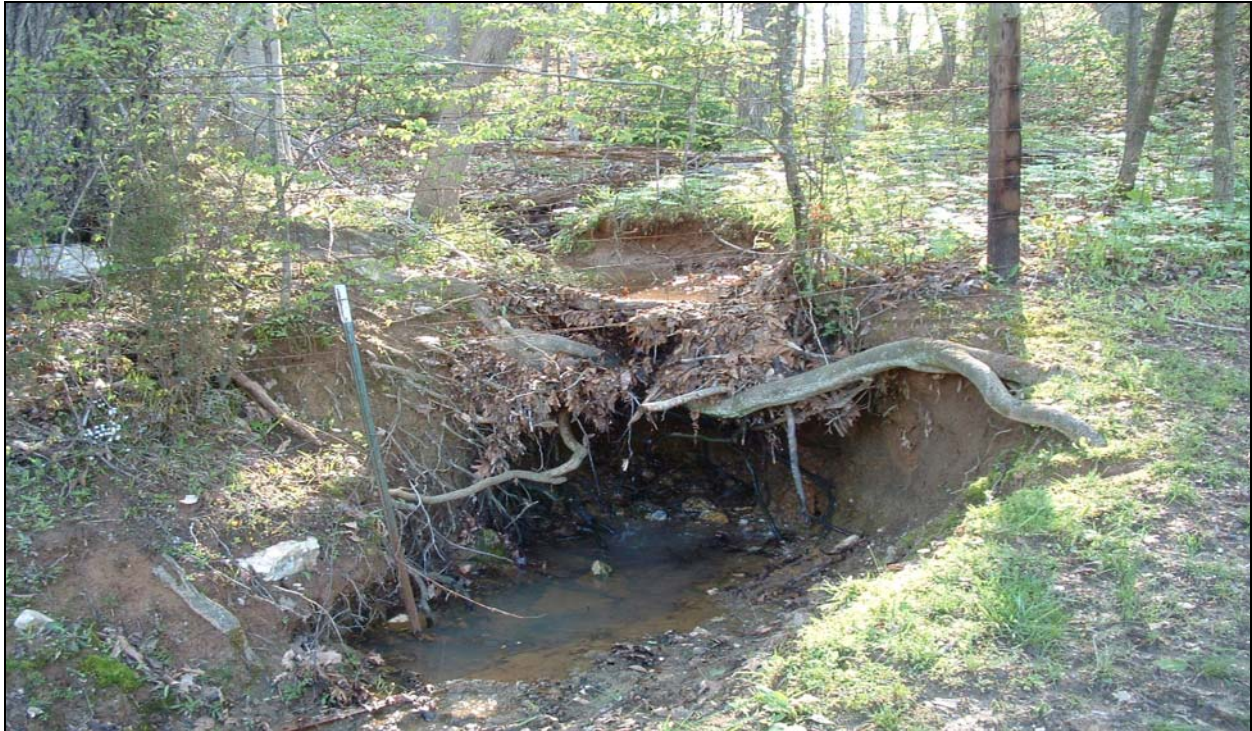
Photograph 16 – Headcut along Trib 2 at property boundary, approximately 50 feet upstream from confluence with UTBC.

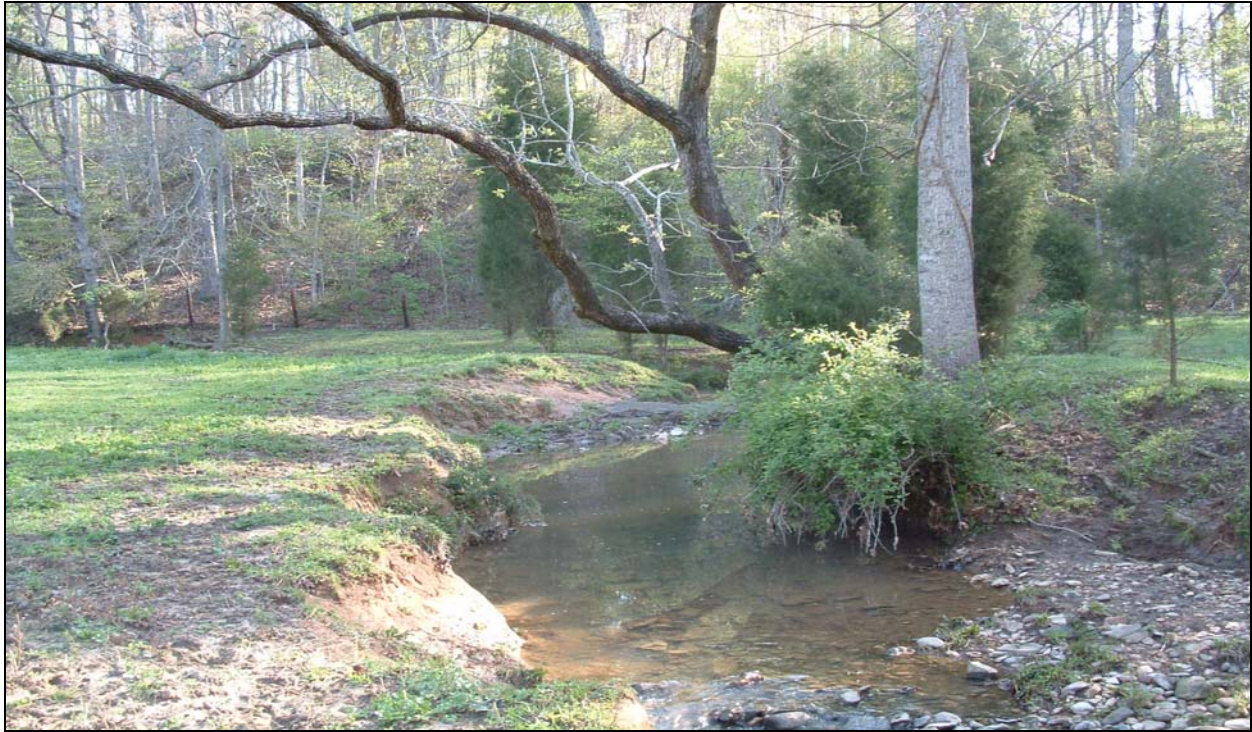
Photograph 17 – View upstream from Station 20+25. Note large gravel and cobble bar along left bank. Steep right bank in foreground; further upstream right bank has been worn down from cattle access.

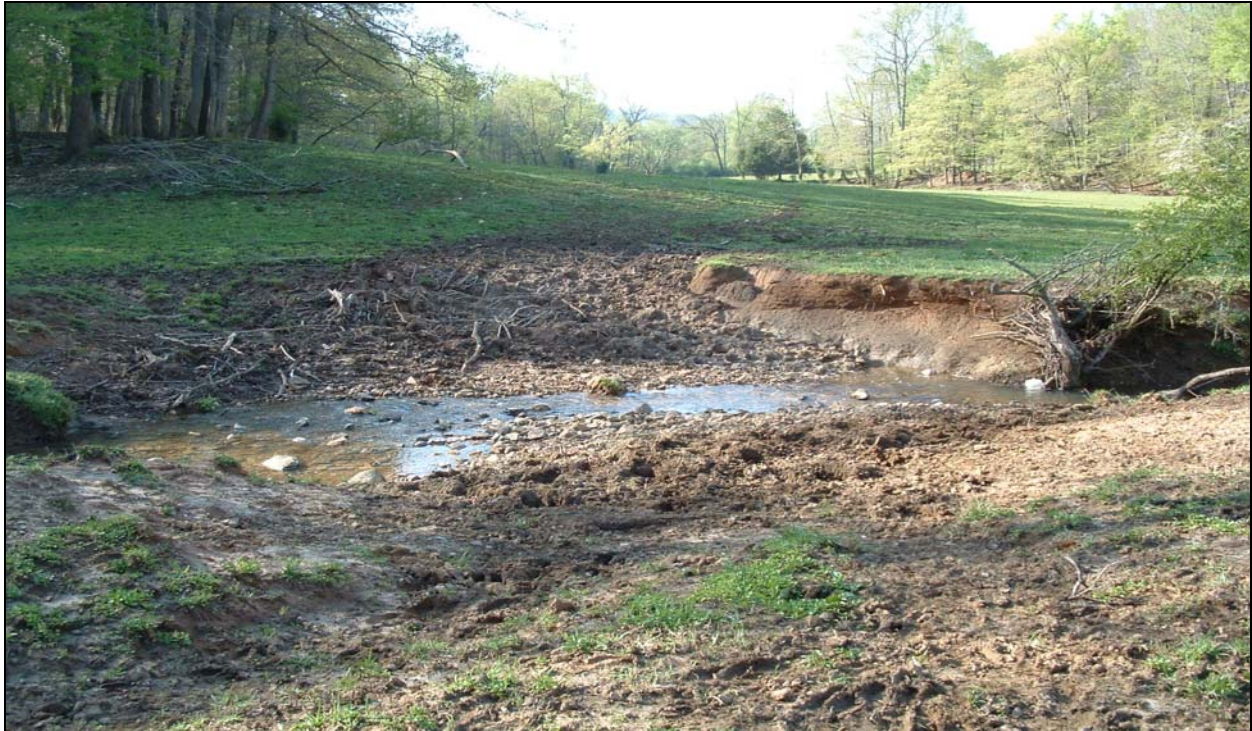
Photograph 18 – Cattle crossing at near Station 20+50. Cobbles and boulders in stream channel, possibly placed to help stabilize crossing. Banks flattened from cattle access, increasing channel width/depth ratio.

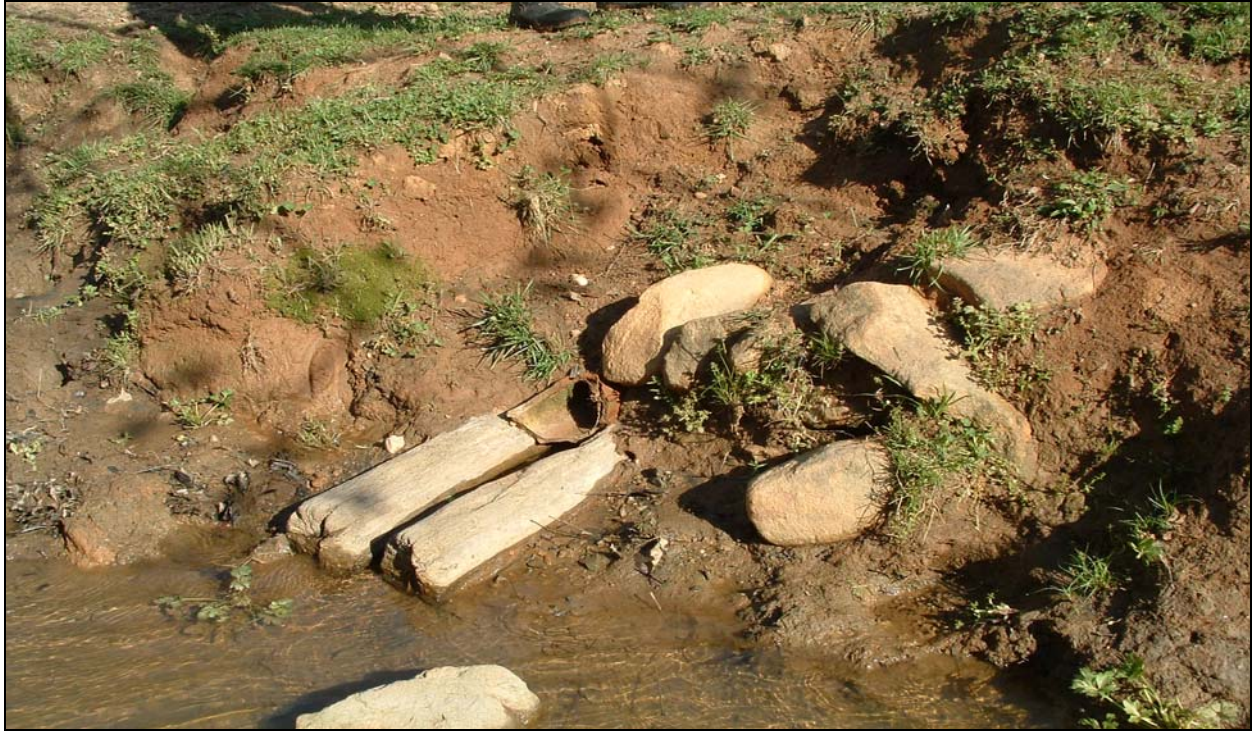
Photograph 19 – Ceramic drainage tile about four inches in diameter at base of right bank (Station ~21+00).

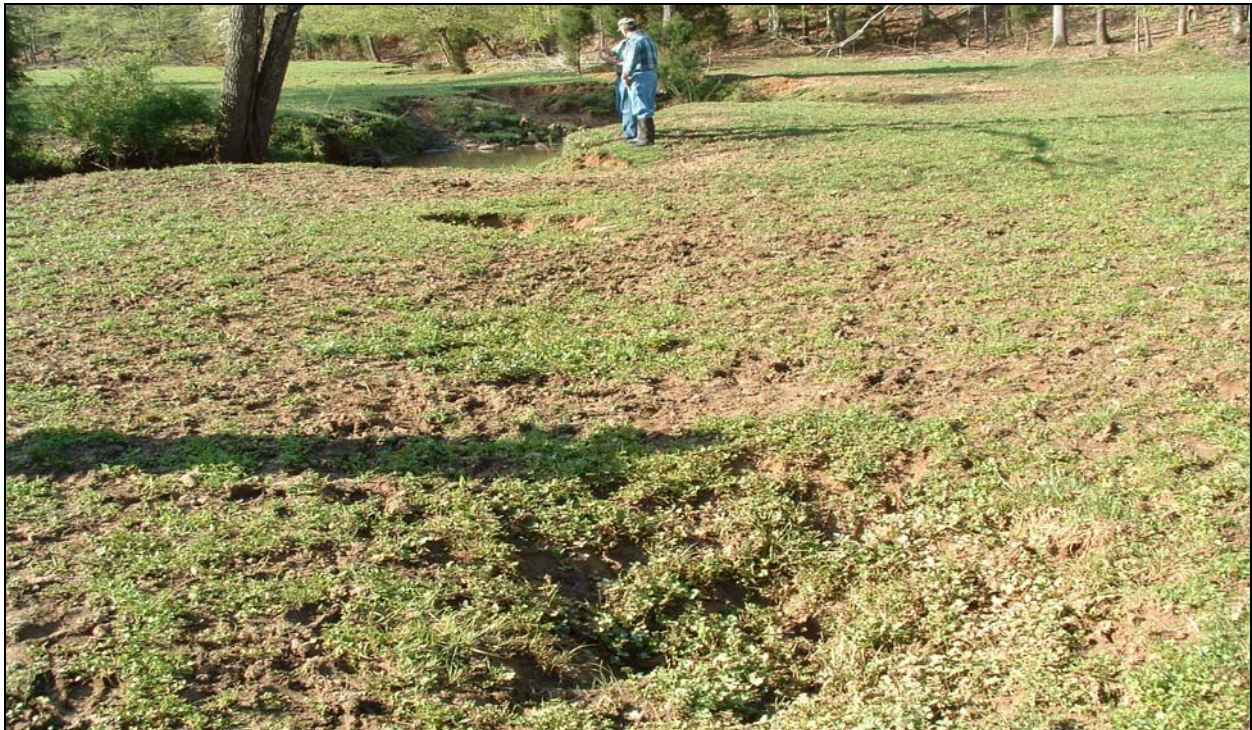
Photograph 20 – Sinkholes in right bank extending approximately 30 feet from top of bank, possibly associated with drainage tile (Station ~21+00).

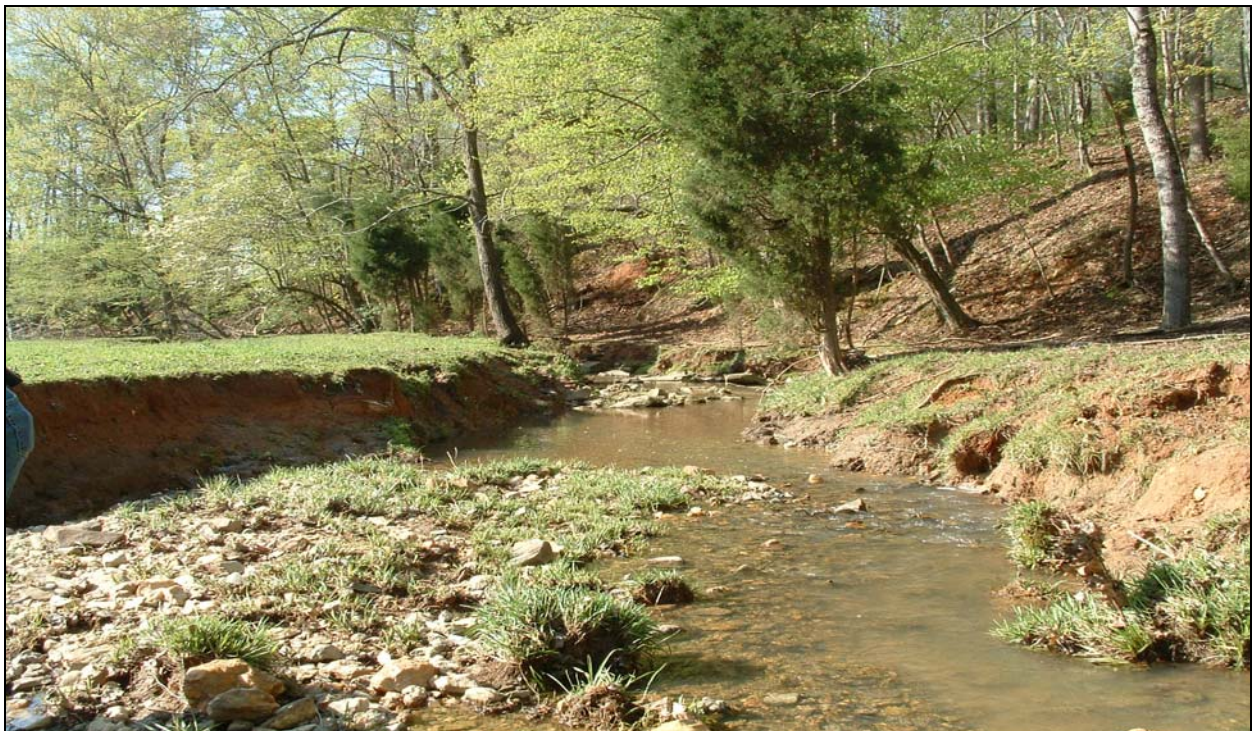
Photograph 22 – View downstream, gravel and cobble bar with grass along left bank. Both banks are relatively steep, though the right bank has more hoof shear. Right floodplain extends approximately 20 feet back from the top of right bank to the toe of slope.

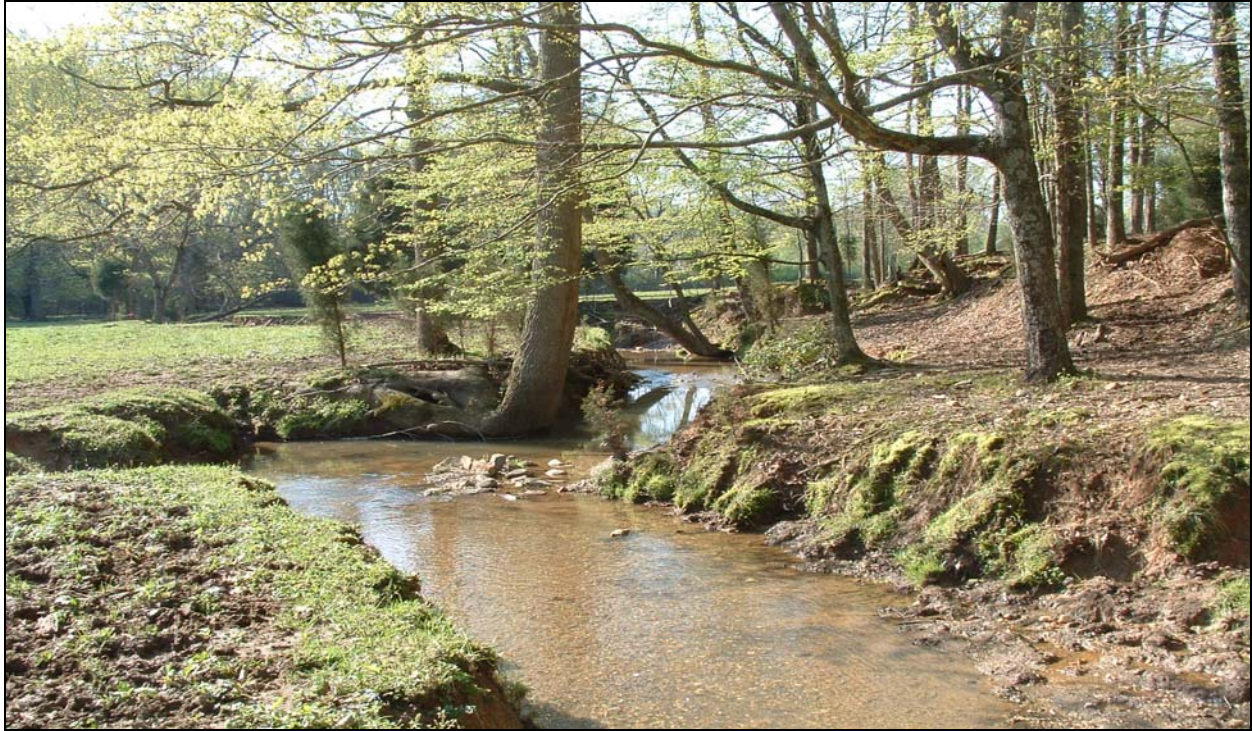
Photograph 23 – View downstream; right bank has significant erosion from cattle access. Large overhanging tree on left bank with roots exposed from undercutting.

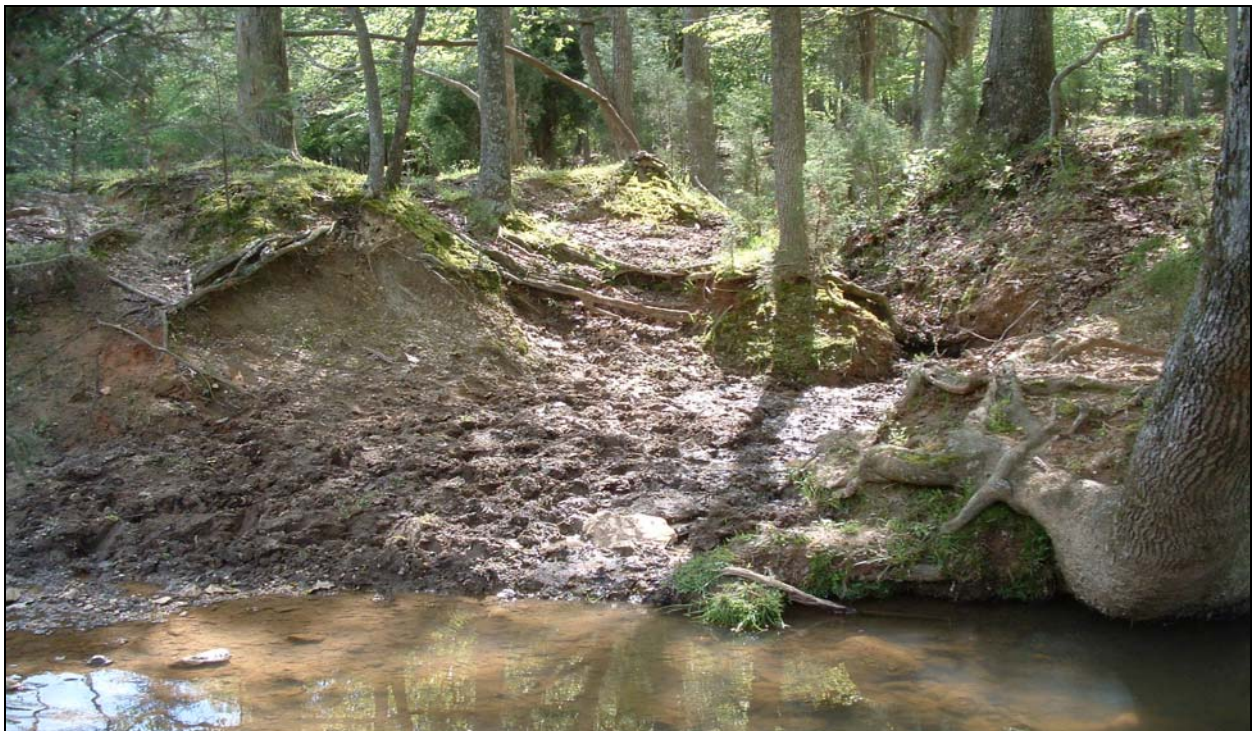
Photograph 24 – Confluence of UT3 with UTBC along right bank, significant erosion due to cattle access.

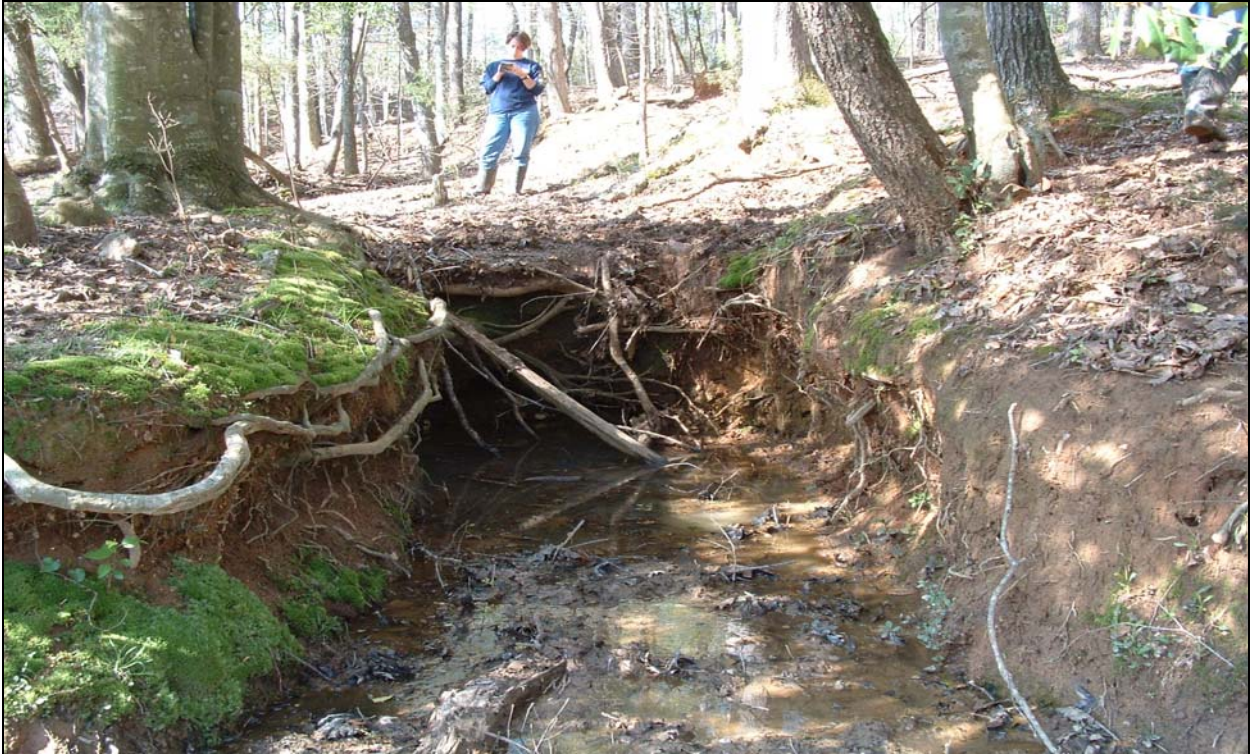
Photograph 25 – Headcut along UT3, approximately 50 feet upstream of confluence with UTBC.

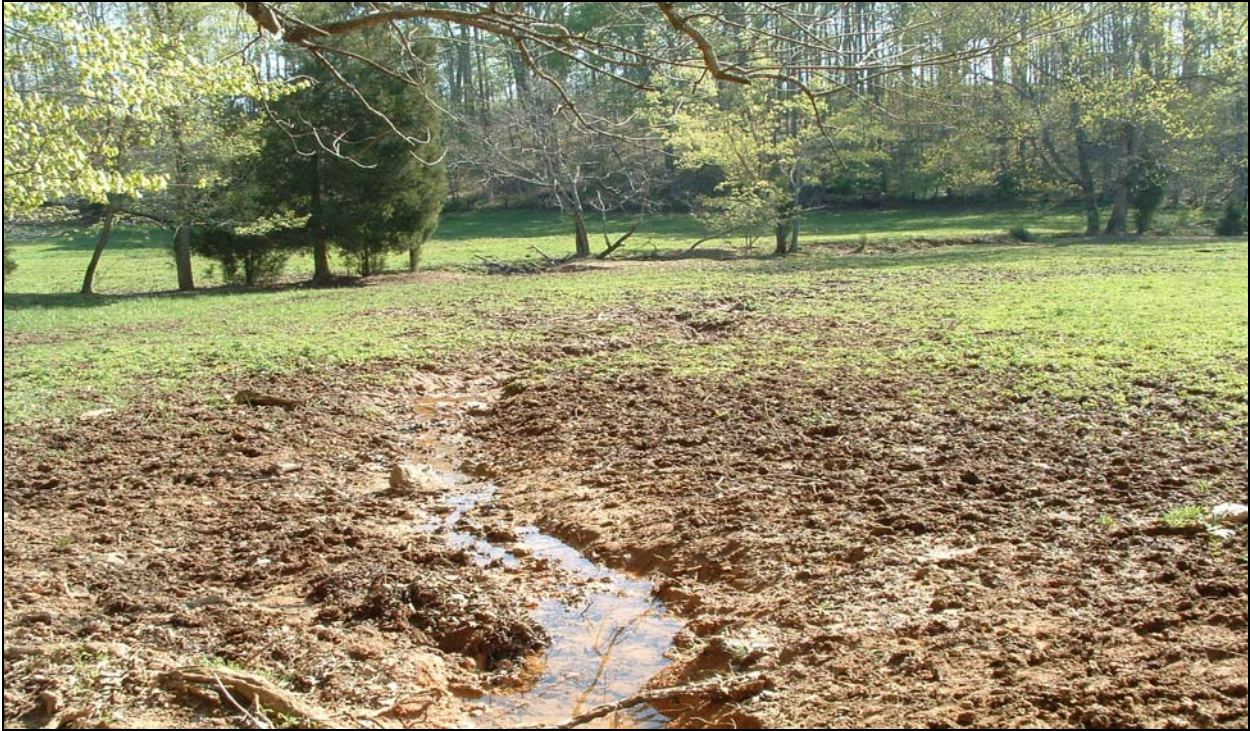
Photograph 27 – A portion of the flow in UT3 crosses a field towards the right bank of UTBC. The channel appears to be newly formed, either due to overbank flow or was excavated to redirect flow.
