**McCain Site
Randolph County, North Carolina**

Stream Restoration Plan

Contract No. EW-02040S

North Carolina Ecosystem Enhancement Program

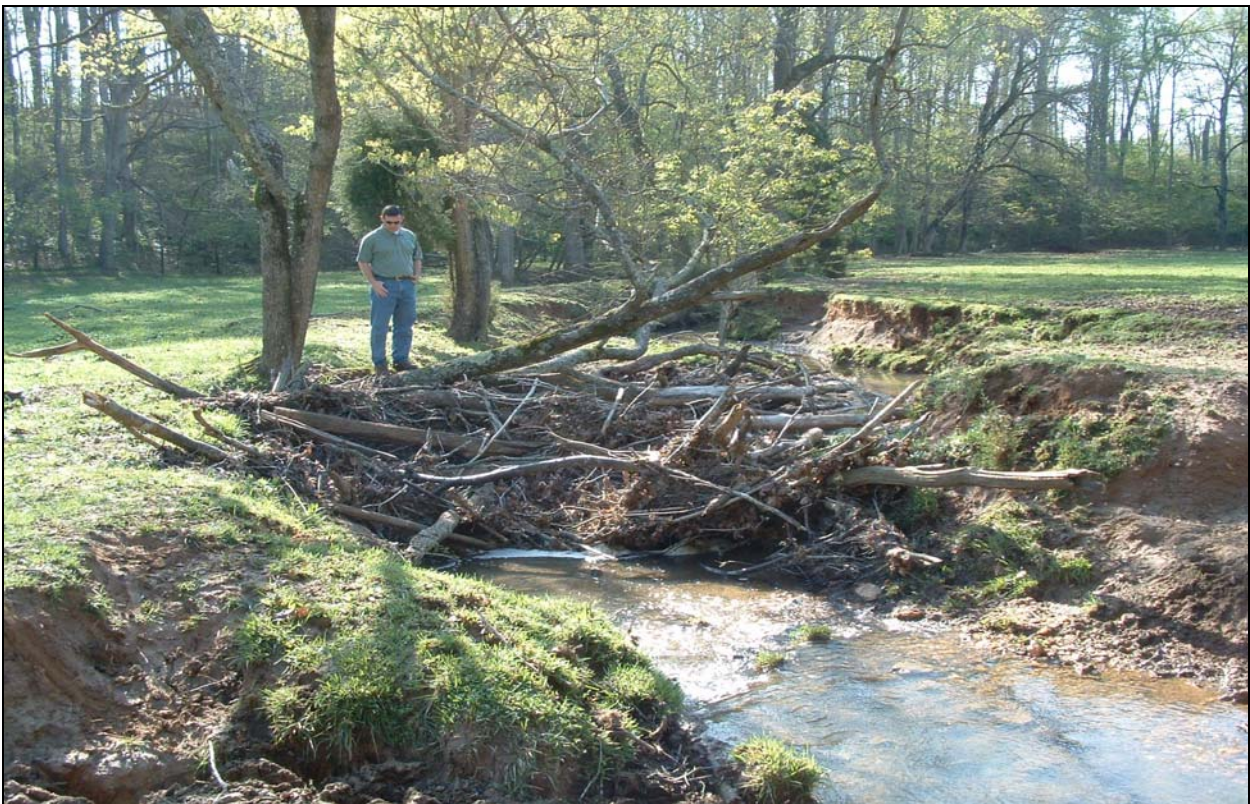
Photograph 28 – View downstream of fallen tree and large debris jam across UTBC.

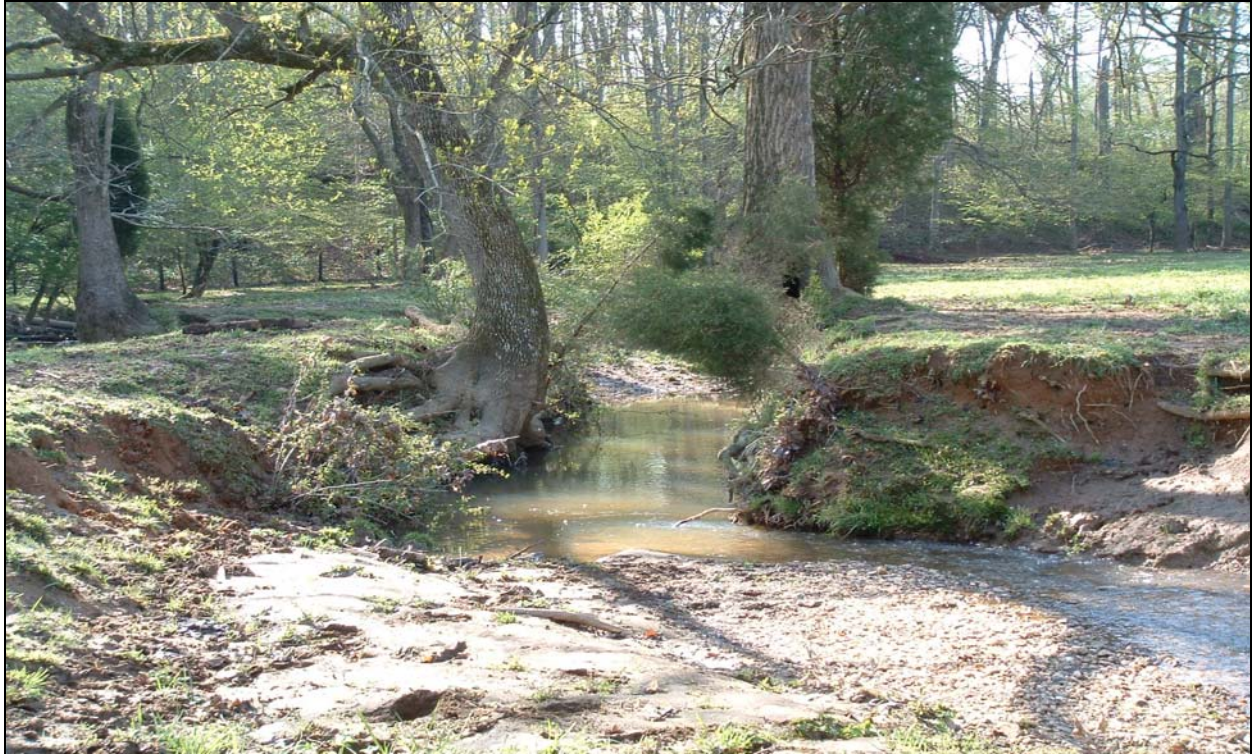
Photograph 29 – View downstream of left bank bench and gravel bar, erosion of right bank from cattle access.

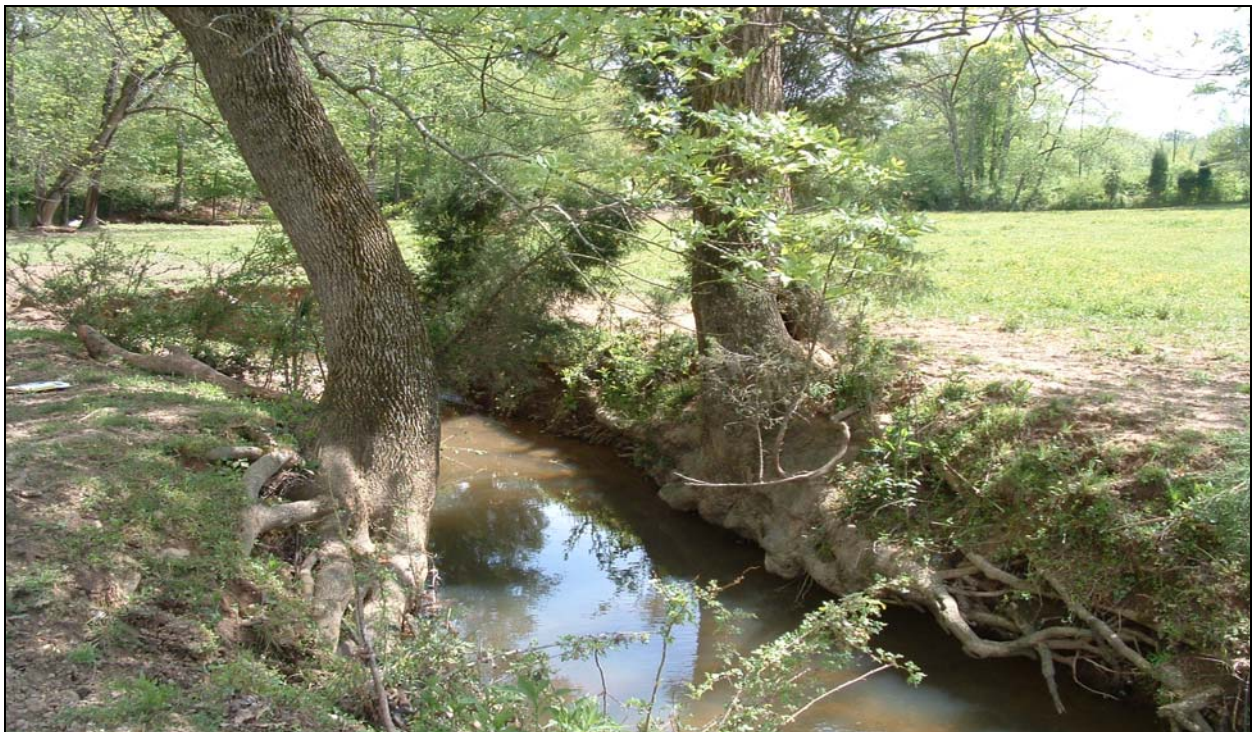
Photograph 30 – View downstream of channel constricted between large trees on each bank. Bank undercutting has left roots exposed.

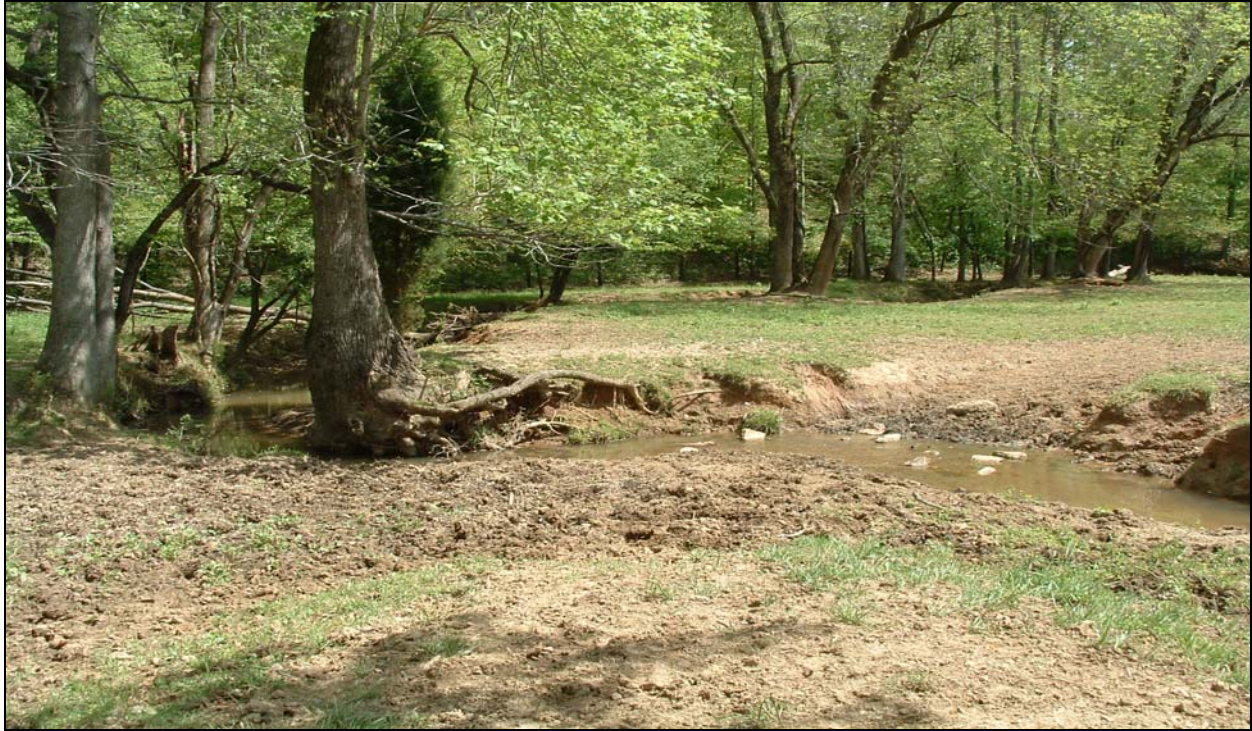
Photograph 31 – High-traffic cattle crossing. Note meander bend downstream of cattle crossing, with large tree on each bank.

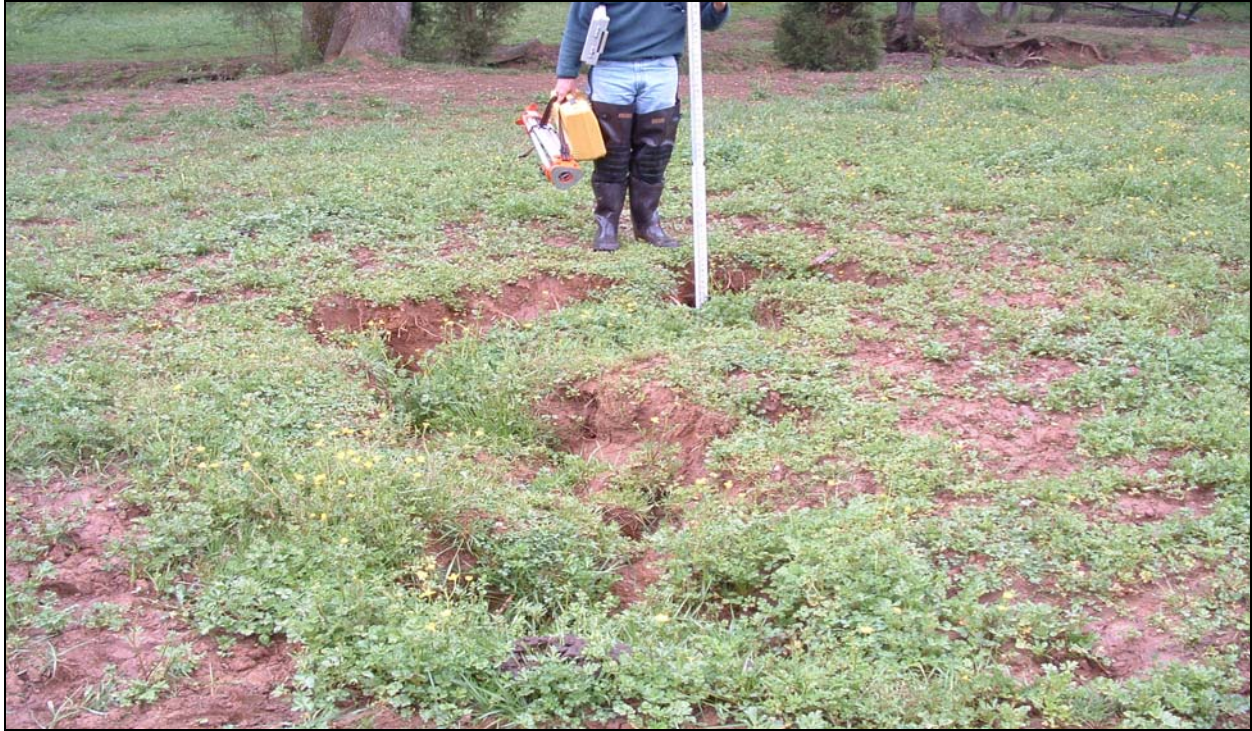
Photograph 33 – Sinkholes in riparian area approximately 30 feet from right bank of UTBC. Maximum depth is approximately two feet.

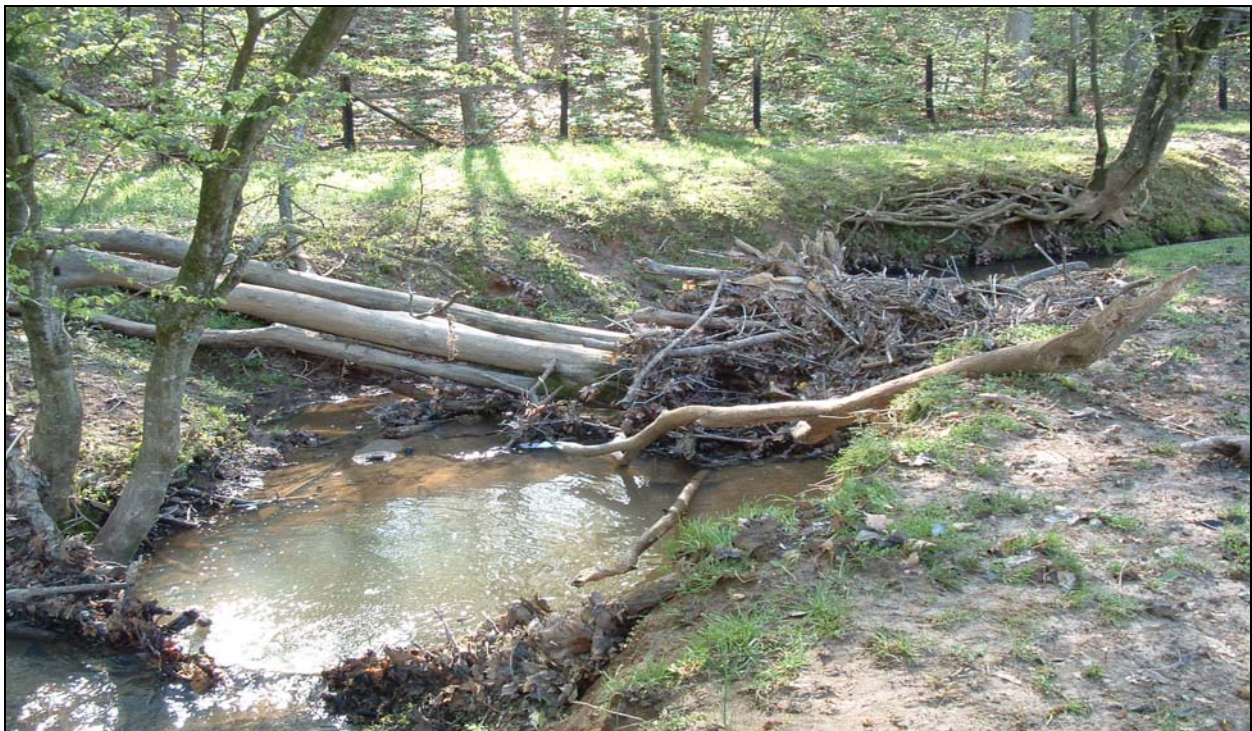
Photograph 34 – View downstream of series of debris jams. The disruption of flow has caused localized bank erosion and the formation of plunge pools. Fence line approximately 20 feet from left top of bank marks property boundary.

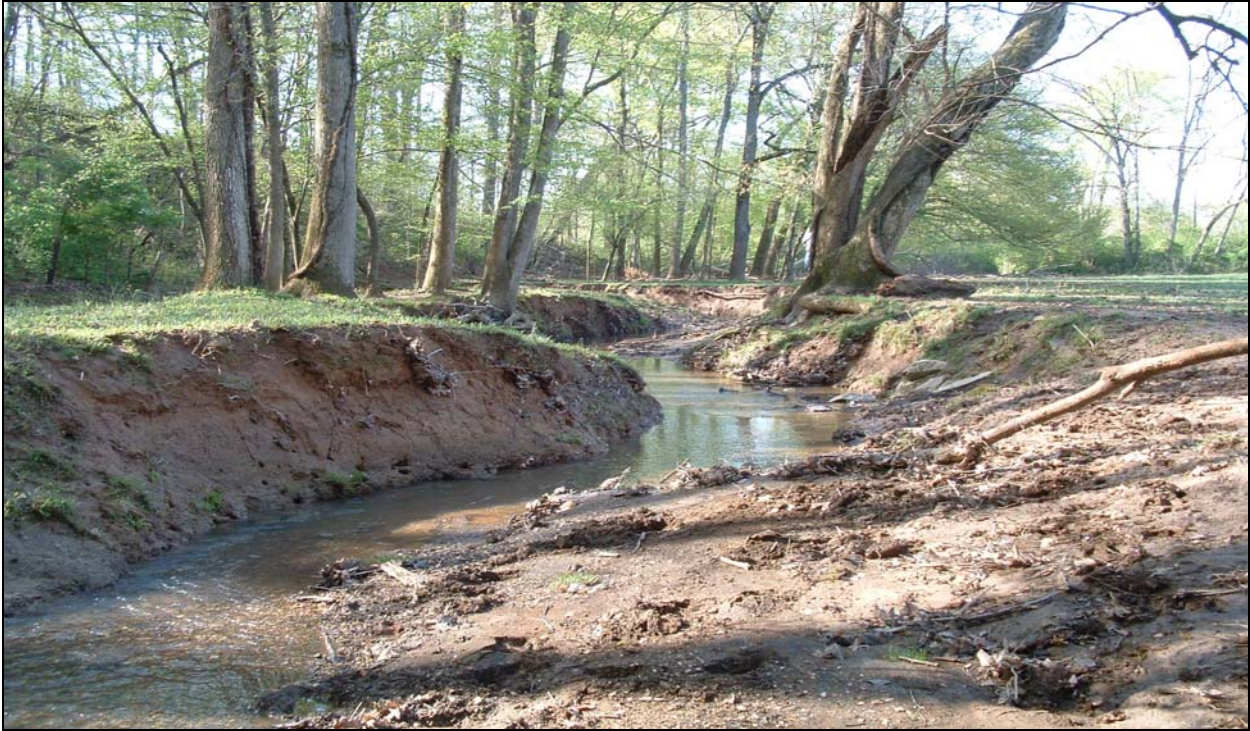
Photograph 35 – Downstream view. Left bank is nearly vertical; right bank is sloped back due to cattle access.

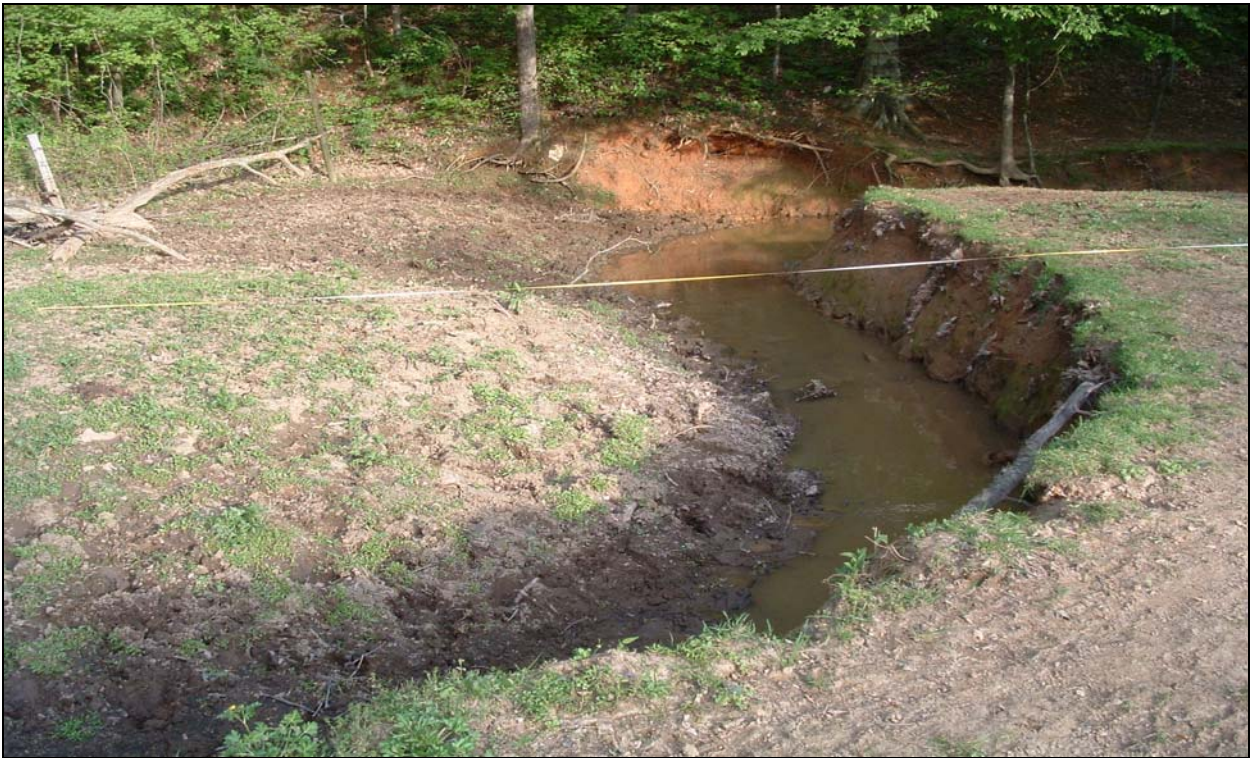
Cross sections 3 and 4 were classified as Type E5 and Type C5, respectively. This section may have been a stable Type E5 that is undergoing moderate bank failure and will stabilize as a Type C5 stream. At the present time, Section 3 seems to be undergoing the least amount of erosion and change in dimension, plan and profile of all the sections of the project stream.

Photograph 36 – Downstream view at Cross-section 3, located at crossover point between two sharp meander bends. Near-vertical right bank and sloping left bank are an indication of down-valley meander migration.

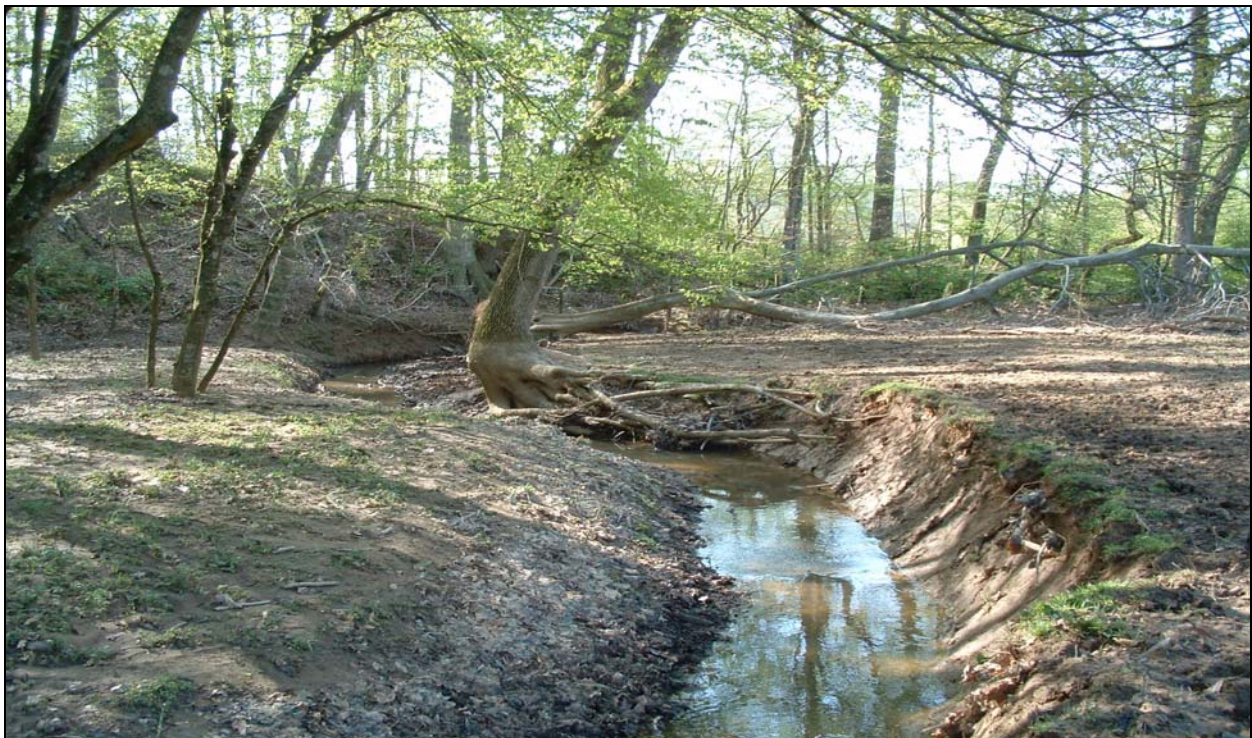
Photograph 38 – Downstream view of UTBC. Unstable banks, undercutting around large tree on right bank has left roots exposed. Further downstream, a large uprooted tree on the right bank has fallen away from stream into riparian area.

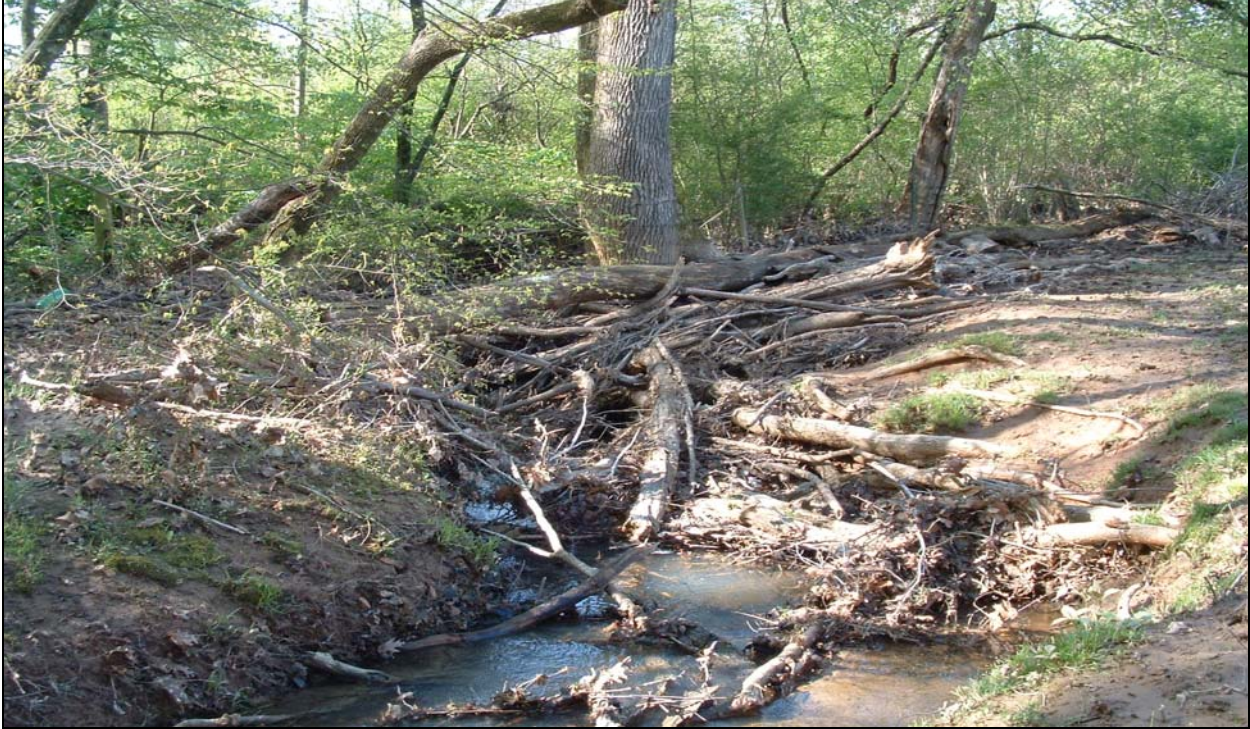
Photograph 39 – Debris jam at downstream end of project, caused by barbed wire fence crossing stream at the property boundary.
