# *Stream Restoration Plan*

**McIntyre Creek in Hornets Nest Park  
Mecklenburg County, North Carolina**

**N.C. Wetlands Restoration Program**  
NCDENR

**December 2002**

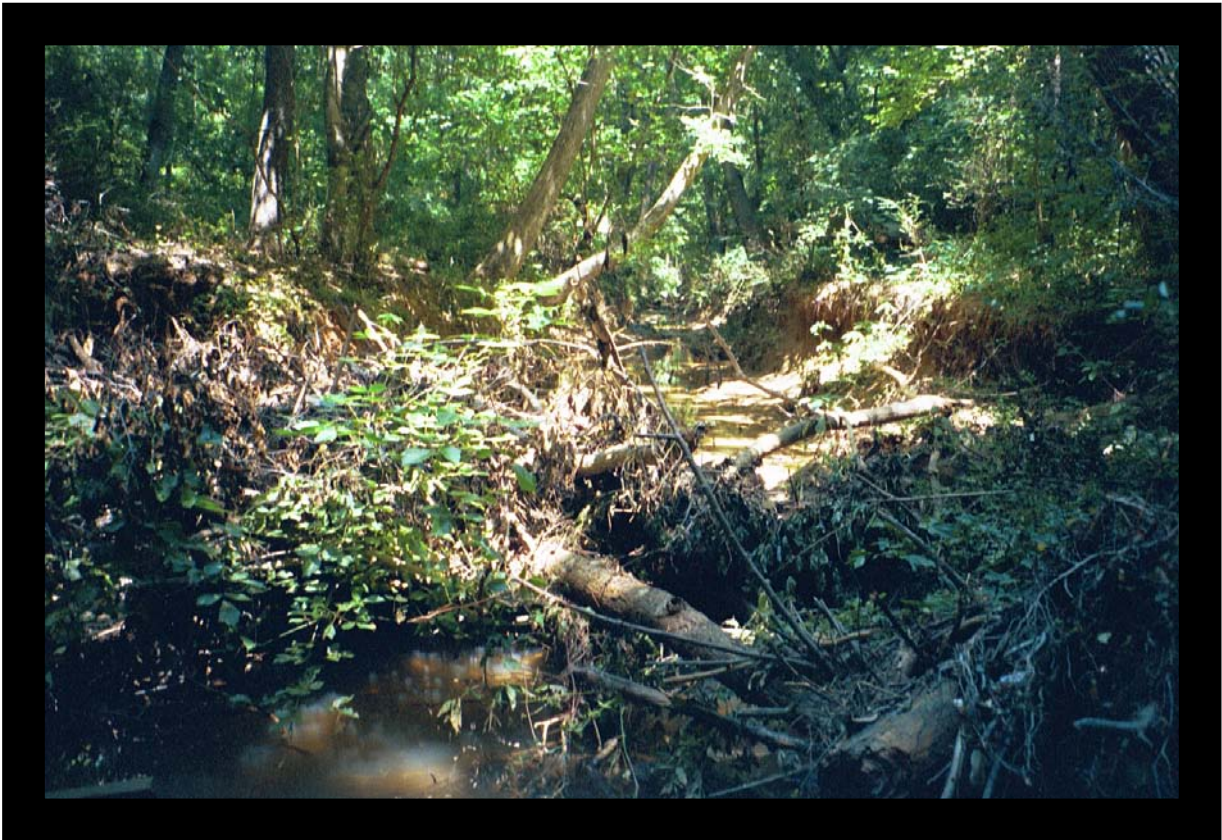
**Photo 3: View of debris jam, near Station 14+75. Numerous debris jams exist throughout the project reach, as a result of fallen trees caused by bank erosion.**

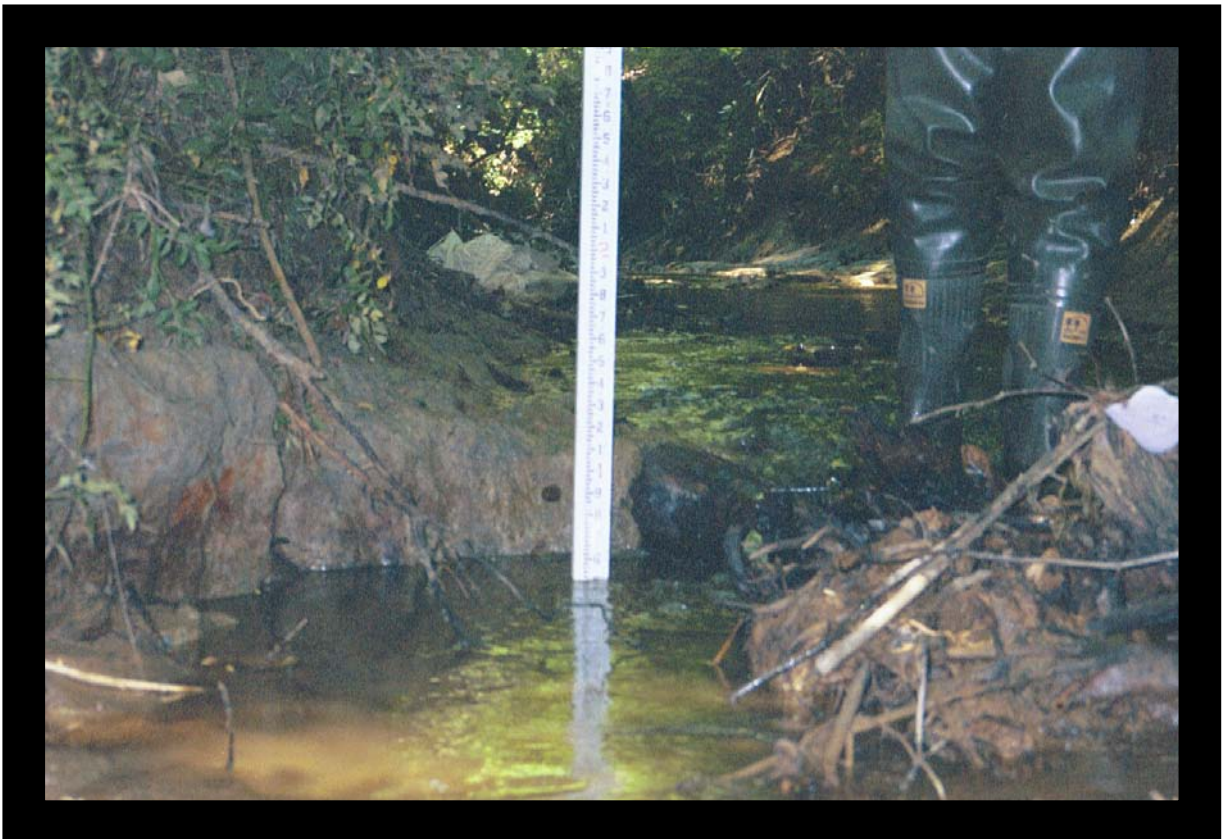
**Photo 4: Small knickpoint (approximately 14" high) indicating limit of headward erosion in this reach. (Approximate location = Station 14+00.)**

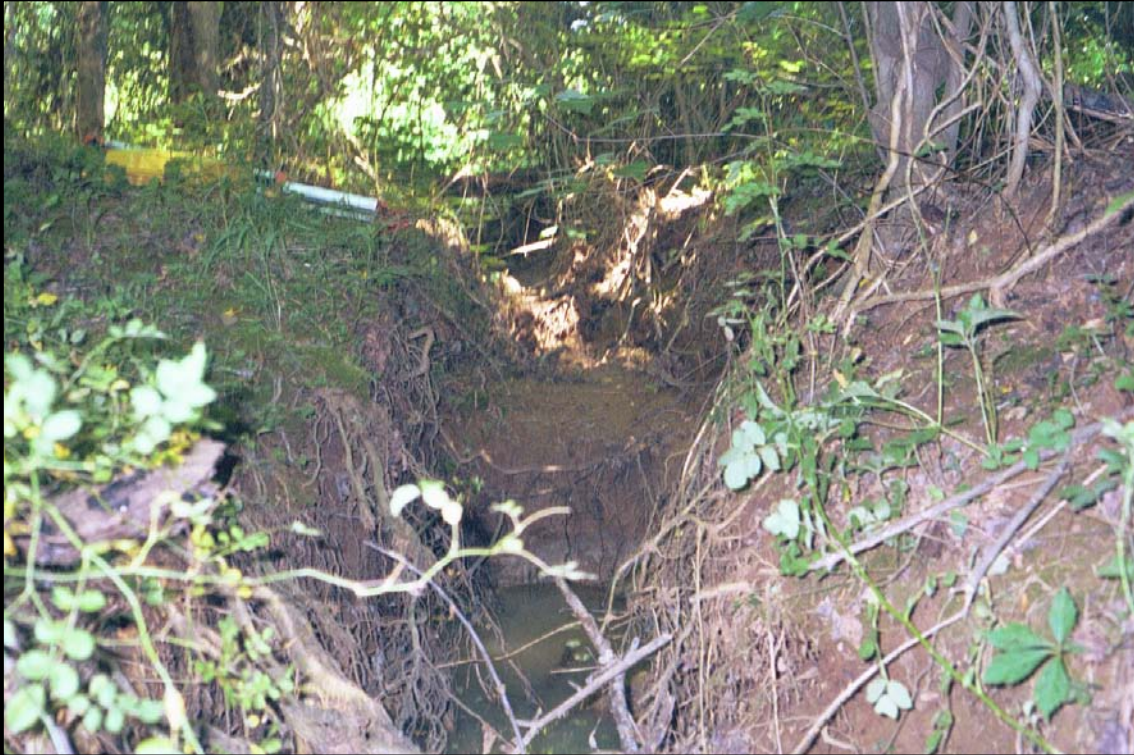
**Photo 5: Small tributary entering McIntyre Creek from the south. Note: The baselevel of the tributary is lowering with headward migration up the valley.**

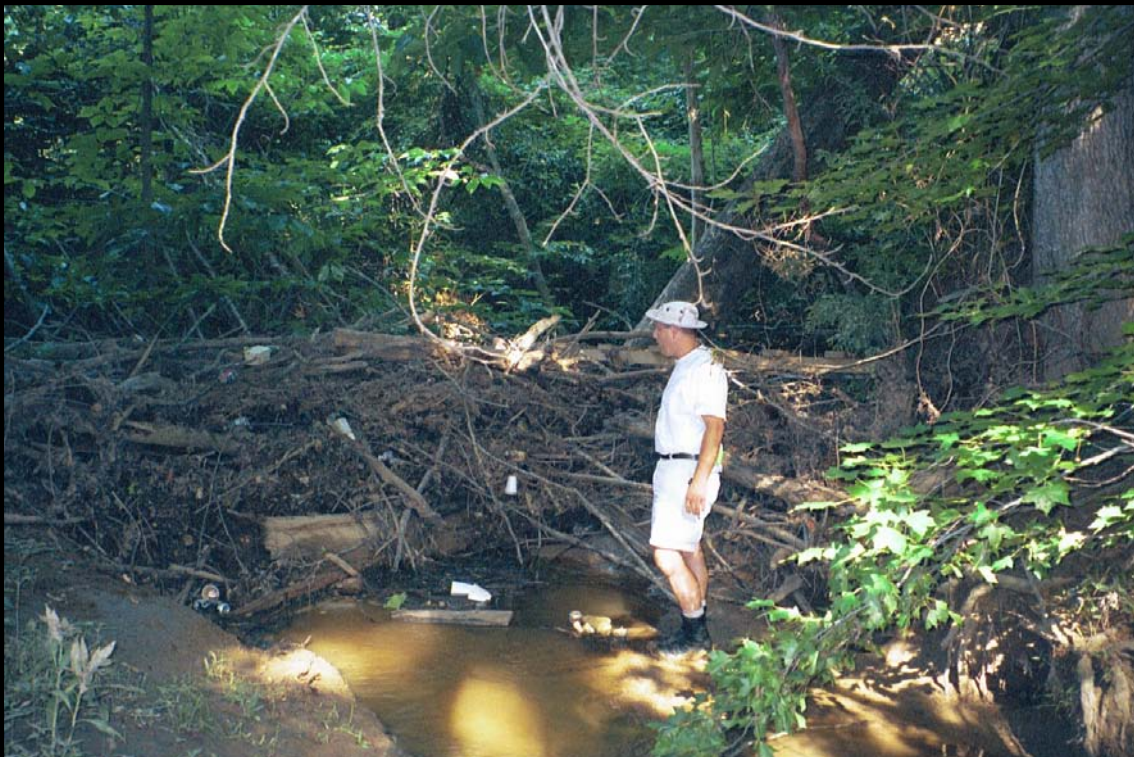
**Photo 6: Large debris jam, near station 38+00, disrupts flow in McIntyre Creek at this location.**

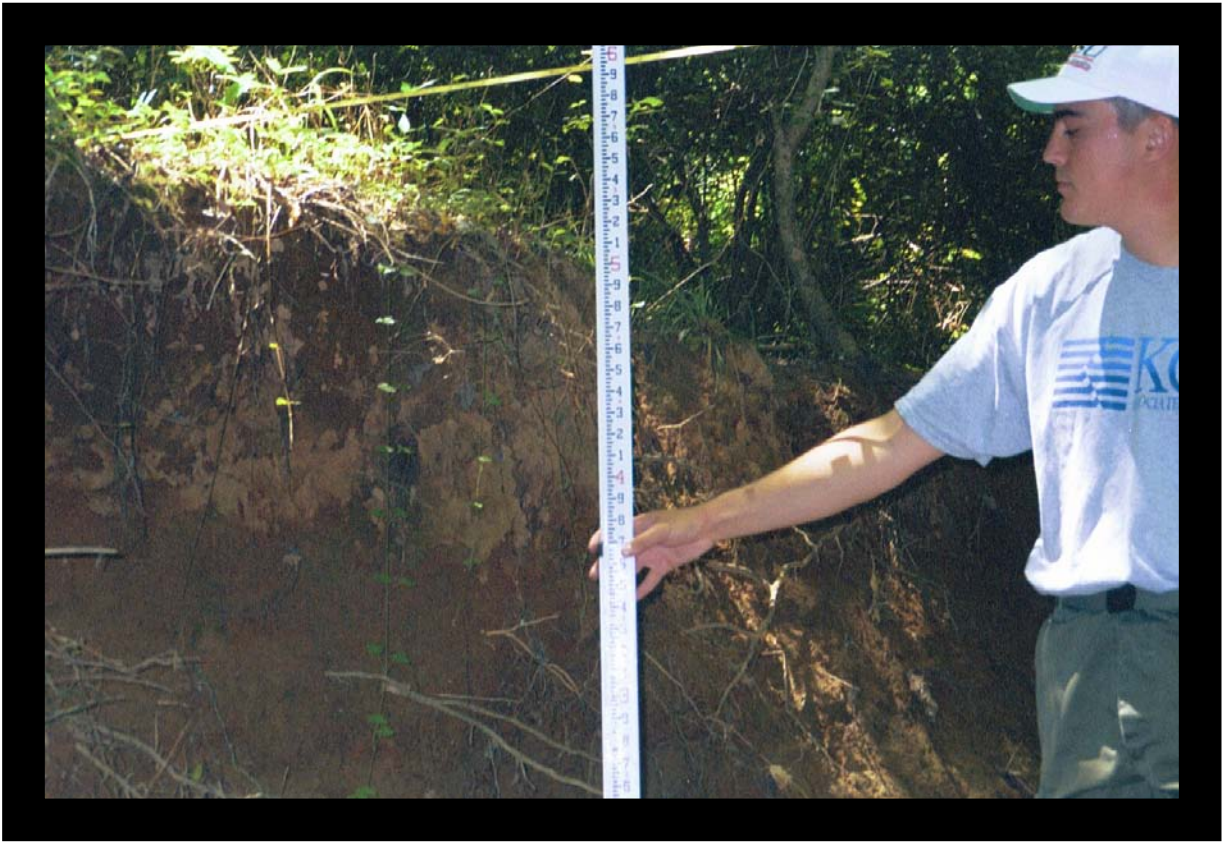
Bank Erosion Hazard Index (BEHI) scores ranged from 34 to 39 indicating a high potential for bank erosion and widening in the upper project reach. Sediment supply is high and sources include eroding banks and tributary inflows carrying fine materials from local construction sites. A potential stream evolutionary cycle in the upper portion of the project site indicates a change from an “E” to a “G,” which will eventually transition to an “F” before re-stabilizing as a “C” then an “E.” It is the intent of the restoration to create a stable “E5” channel type that accesses its floodplain on the adjacent terrace to the north.

**Photo 7: High BEHI scores are common in the upper portion of the project reach.**

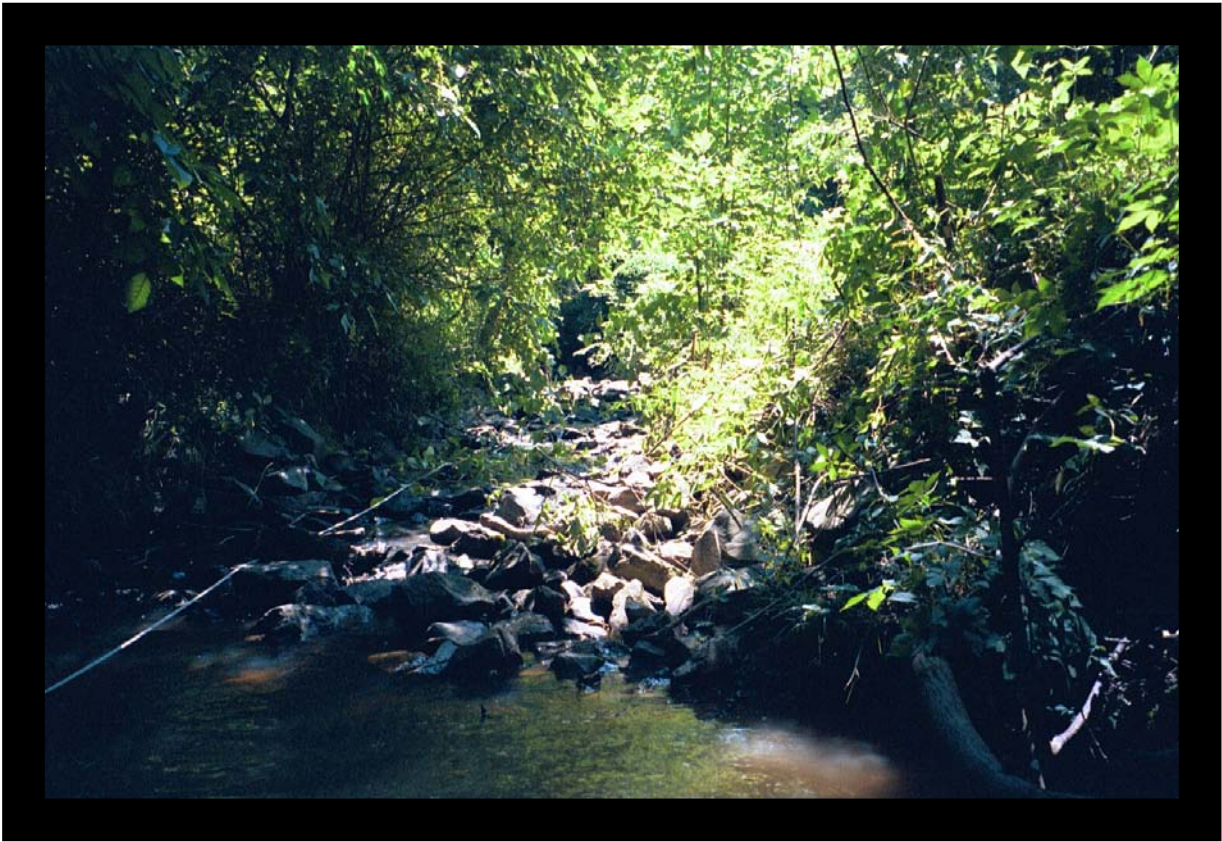
**Photo 9: Rip rap channel extending downstream from gas pipeline crossing. This point divides the project reach into upper/lower portions.**

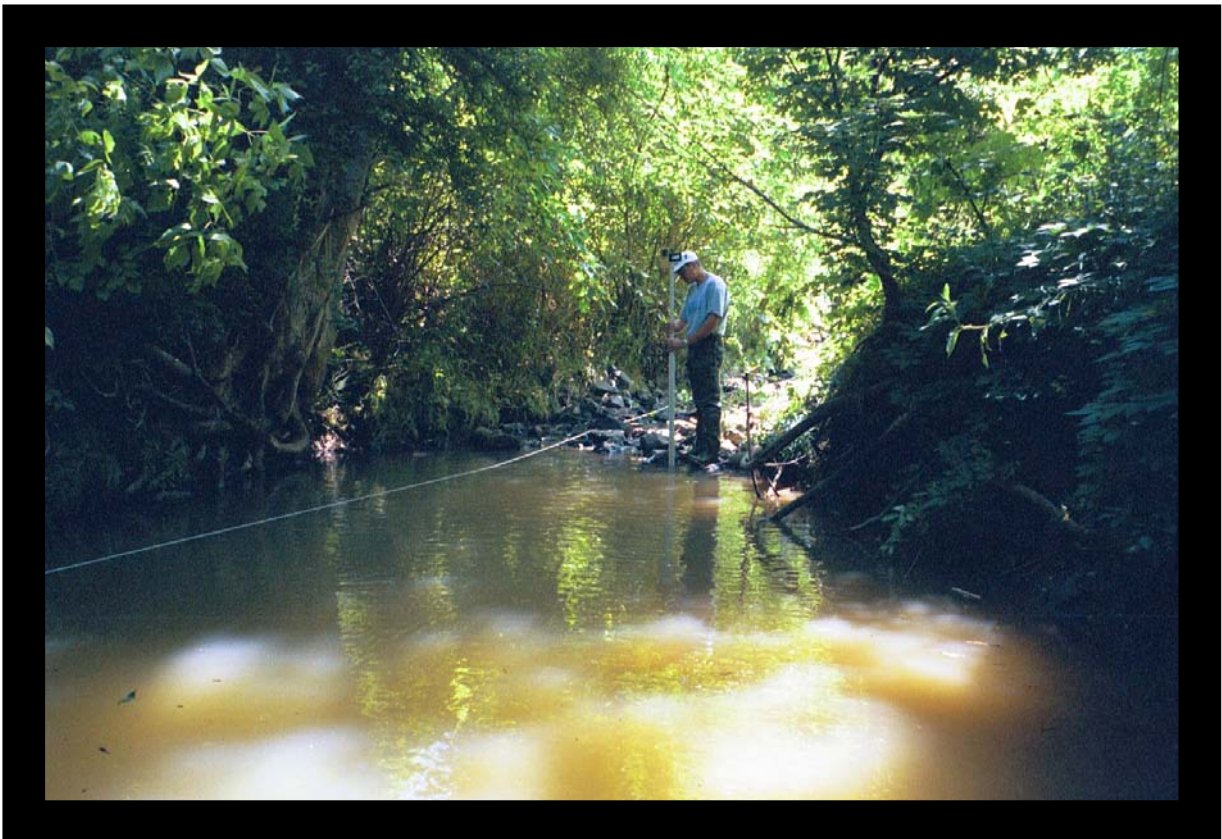
**Photo 10: Large scour hole at the confluence of McIntyre Creek with tributary #2.**

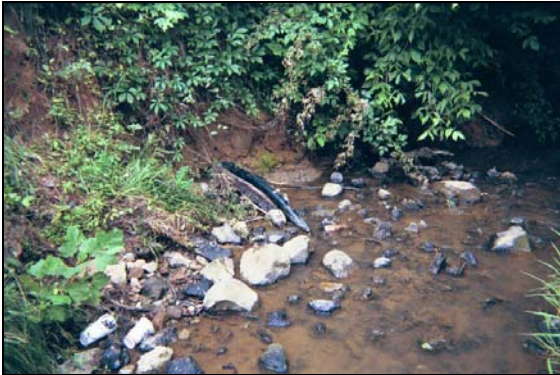
Photo 1. Exposed ABS conduit near the upstream project limits.

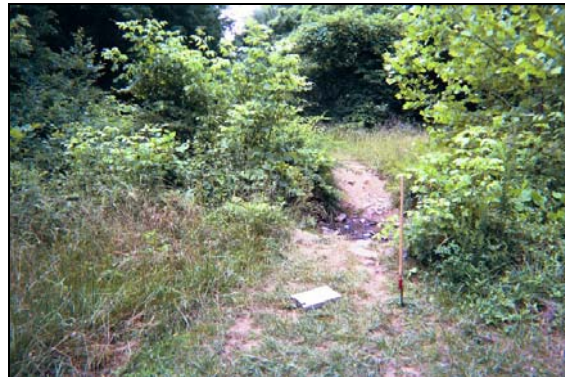
Photo 6. Gas pipeline crossing near existing Station 42+30 in the downstream portion of the project site.
