Stream Restoration Plan

Miller Site
Meat Camp Creek, Watauga County

North Carolina Wildlife resources Commission
Habitat Conservation Program

June 2001

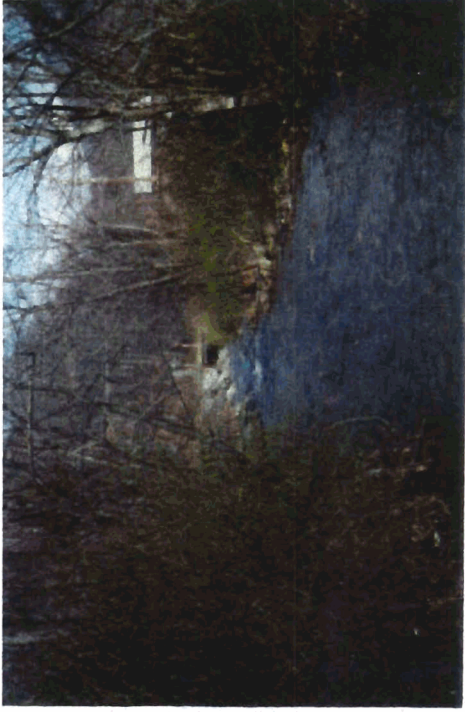
Looking upstream to SR1339 bridge

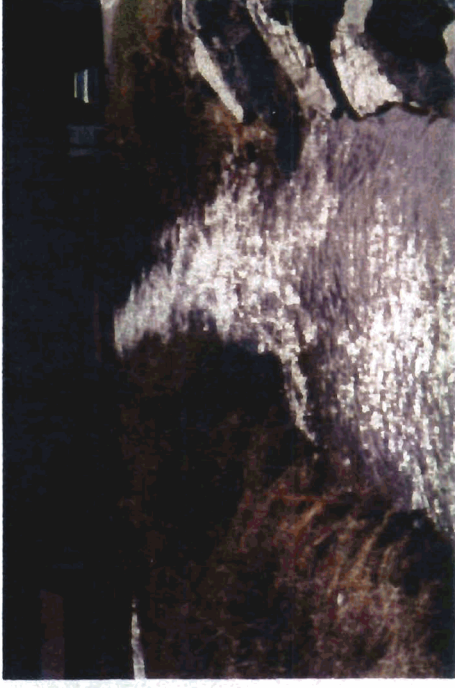
Looking downstream from the SR1339 bridge (upper end of project site) to eroding bank at station 3+33.

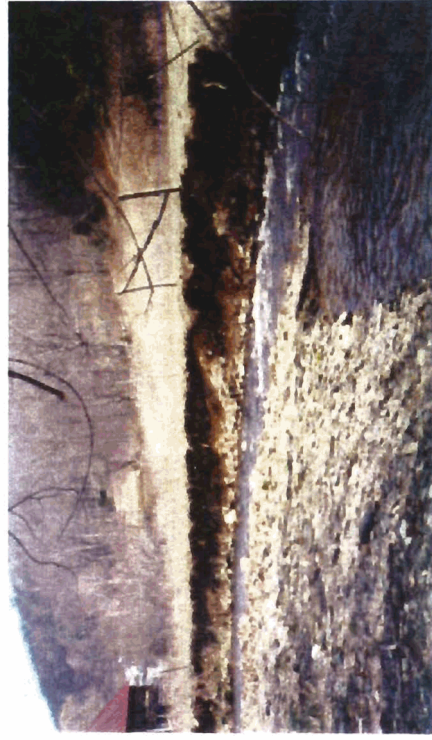
Major bank erosion site, approximately 110' in length at station 3+33.

1. Increase fish habitat by constructing three rock cross weirs between stations 1+00 to 3+00.
2. Stabilize, slope and vegetate the banks along the 110 foot section of eroding bank up and downstream from station 3+33 to reestablish a bankfull bench, create pool habitat in place of a riffle, and to make the banks more resistant to erosion and flooding. Root wads and rock vanes will be used at this location for long term bank stability

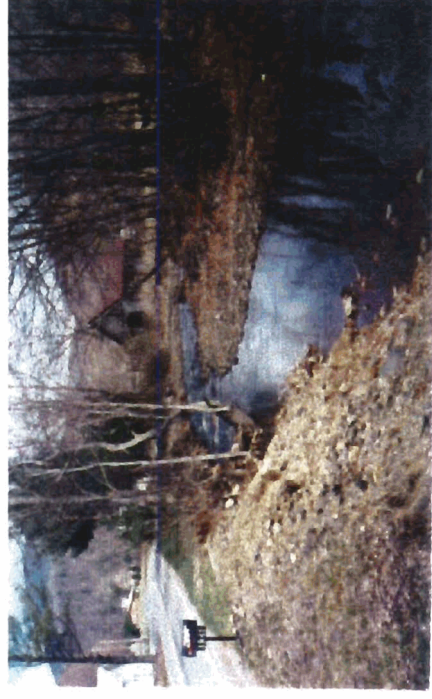
Looking upstream from station 5+31. This area will have structures installed to confine the thalweg towards the center to prevent any further bank erosion and to protect the road shoulder.

3. Where appropriate, install rootwads, rock vanes or rock weirs from stations 4+00 to 5+40 to provide long term bank stability, fish habitat, narrow and deepen the stream channel, and protect the SR 1335 road shoulder.

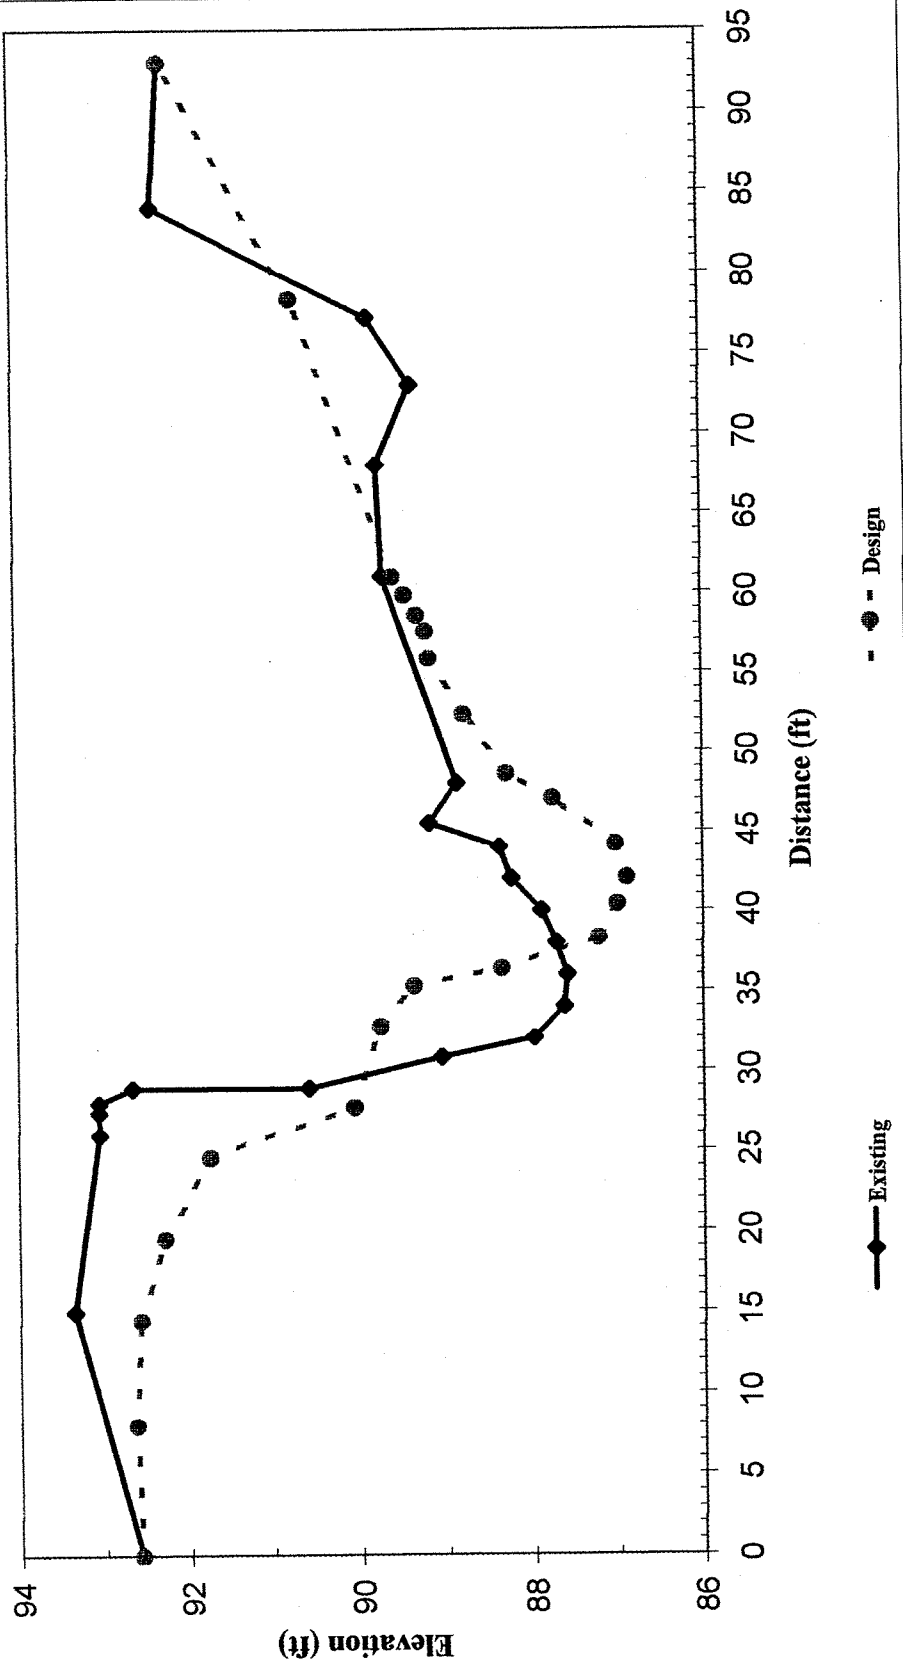
Cross Section STN 3+33, Riffle
Meat Camp Creek

3+33	Feature	Type	Wfpa	LBKF	RBKF	ELEVbkf	Wbkf	Dbkf	W/D	Abkf	Dmax	ER
Existing	Riffle	C3	100	28.9	77.2	90.59	48.30	1.56	30.91	75.47	3.00	2.07
Design	Run	C3	100	32.8	61	89.76	28.20	1.44	19.57	40.64	2.87	3.55

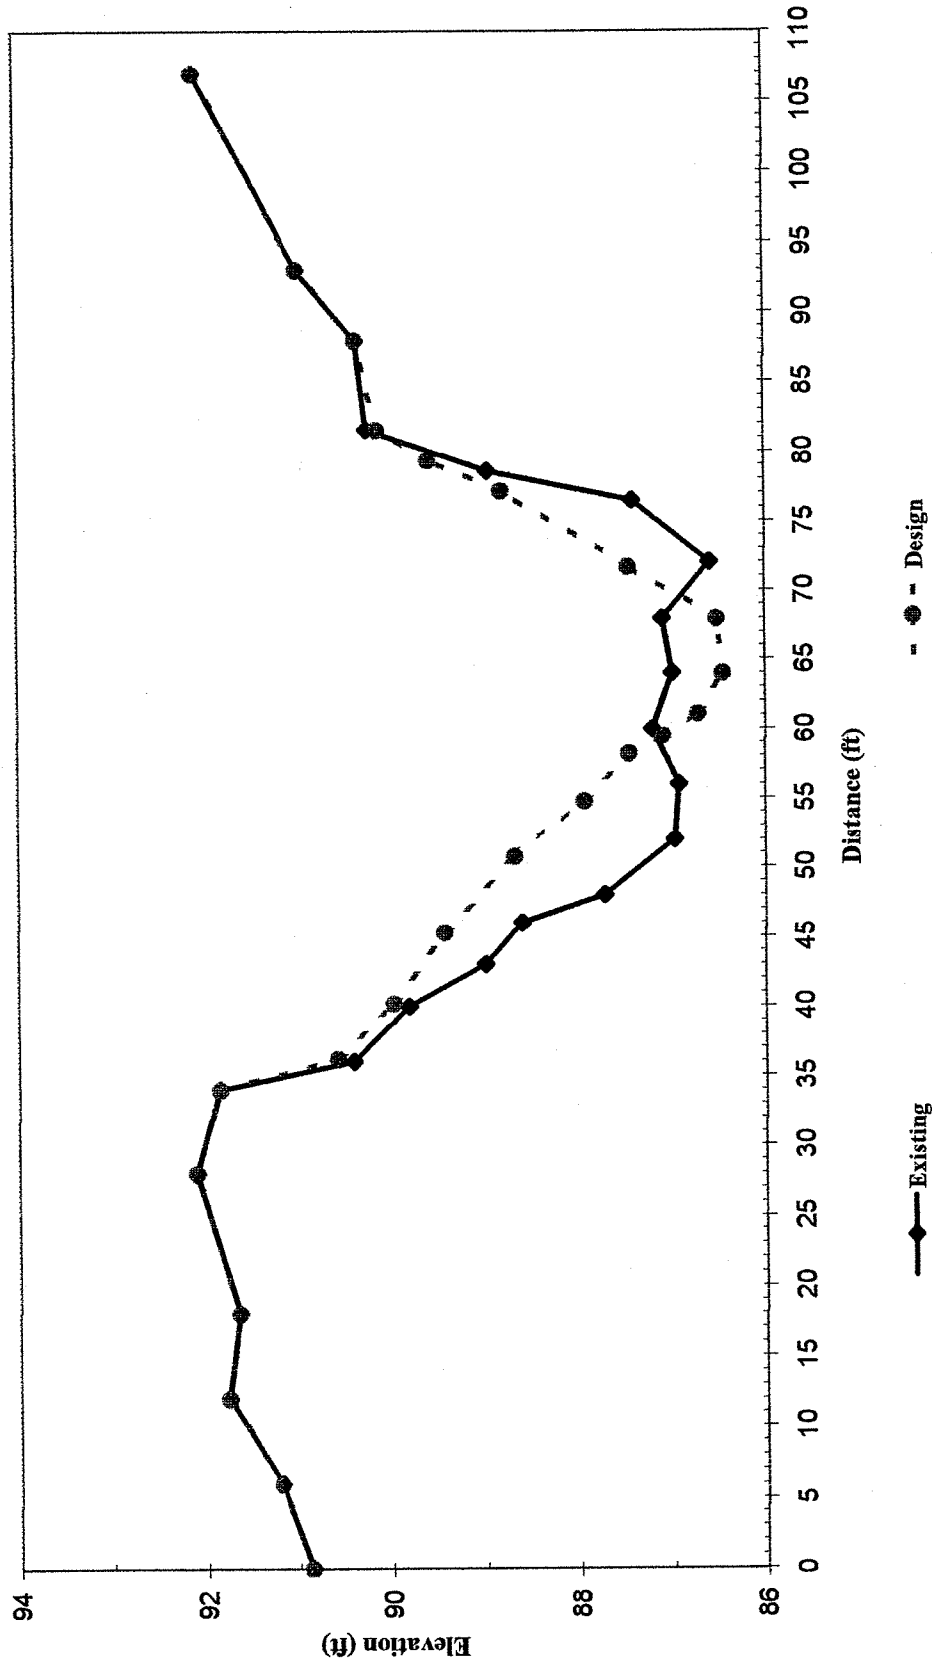
Cross Section STN 4+16, Riffle
Meat Camp Creek

4+16	Feature	Type	Wfpa	LBKF	RBKF	ELEV/bkf	Wbkf	Dbkf	W/D	Abkf	Dmax	ER
Existing	Riffle	B3	70	43	78.6	89	35.6	1.67	21.33	59.40	2.41	1.97
Design	Riffle	E3c	100	45.3	79.4	89.43	34.1	1.29	26.46	43.94	2.98	2.93
