Ellerbe Creek (Northgate Park) Stream Restoration Project

City of Durham
Durham County, North Carolina
SCO Project Number 040742501

Final Restoration Plan

June 29, 2006

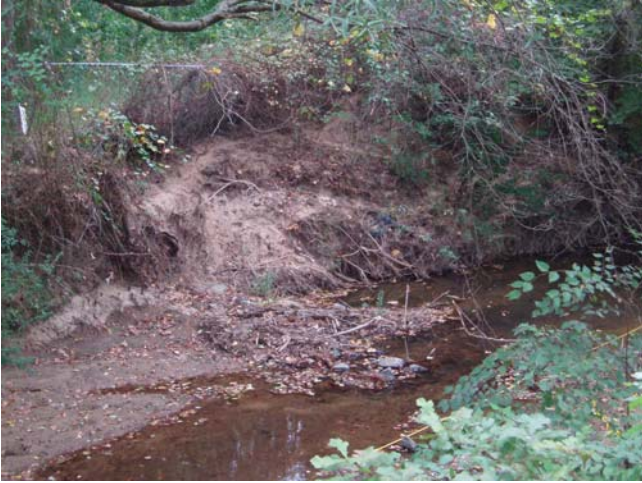
Photo 3. Eroding, sloughing banks in the upstream portion of the Project Reach

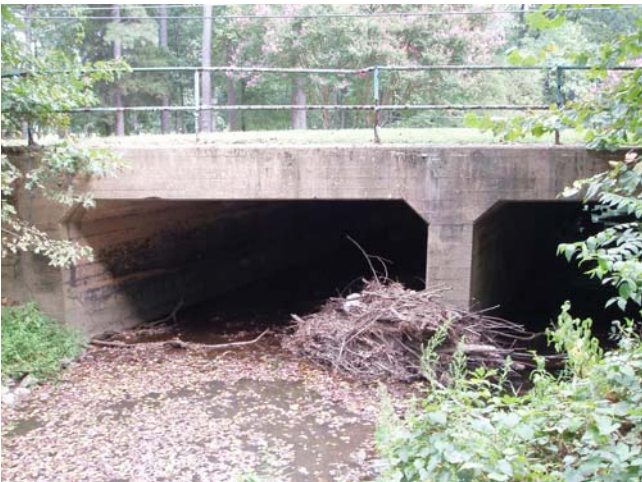
Photo 5. Culverts under Lavender Ave. Debris is gathering against the bridge

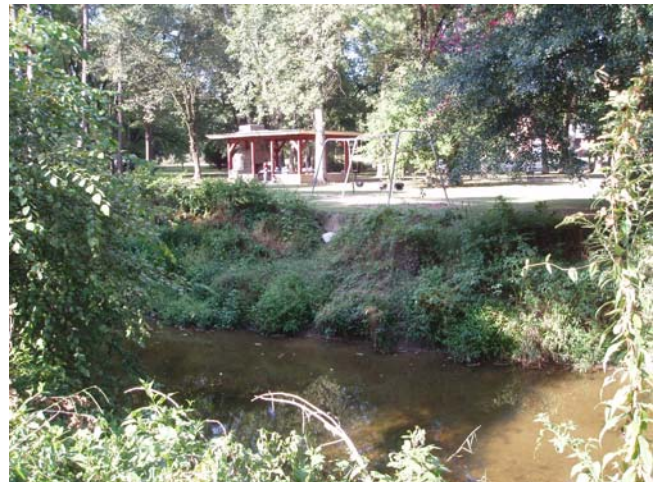
Photo 6. Eroding banks adjacent to park equipment

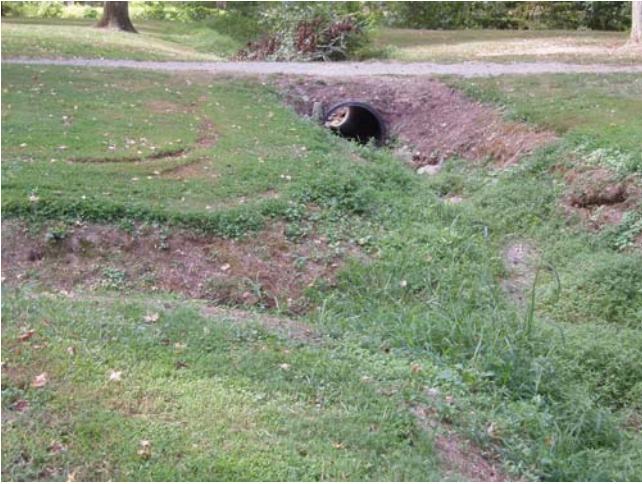
Photo 7. UT-3 has no buffering vegetation

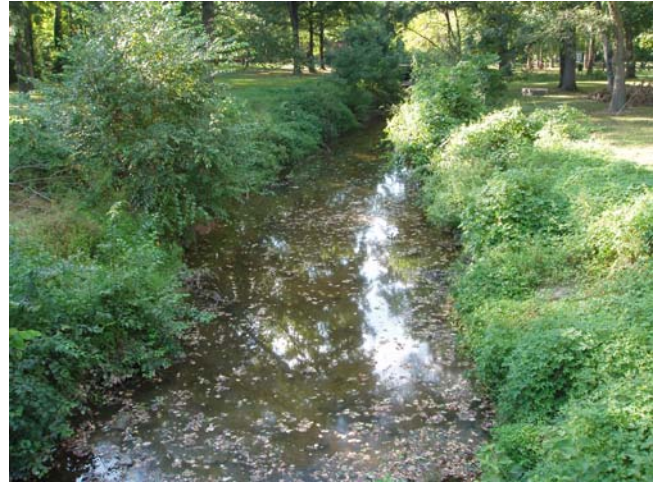
Photo 8. Limited herbaceous buffer along the downstream Project Reach

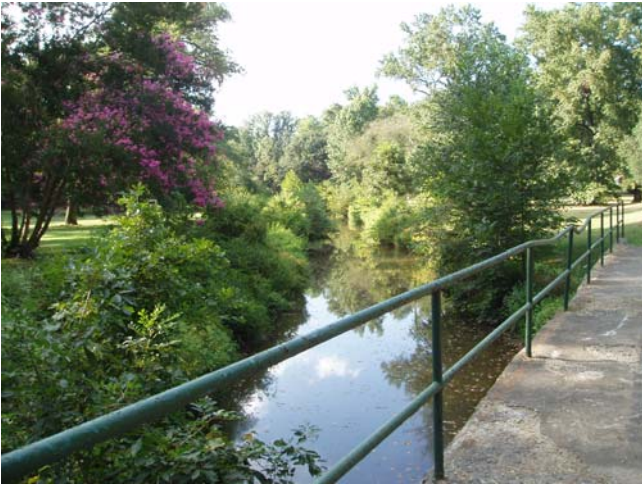
Photo 9. Limited buffer at the downstream portion of the Project Reach

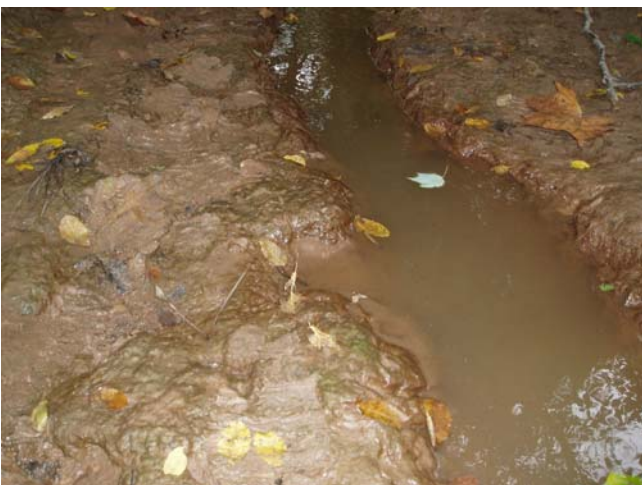
Photo 5. Hard-packed clay lining low flow channel
