Annual Monitoring Report

Monitoring Year 4 of 7

Pee Dee Stream Restoration Project

NCDMS Project No.: 95350

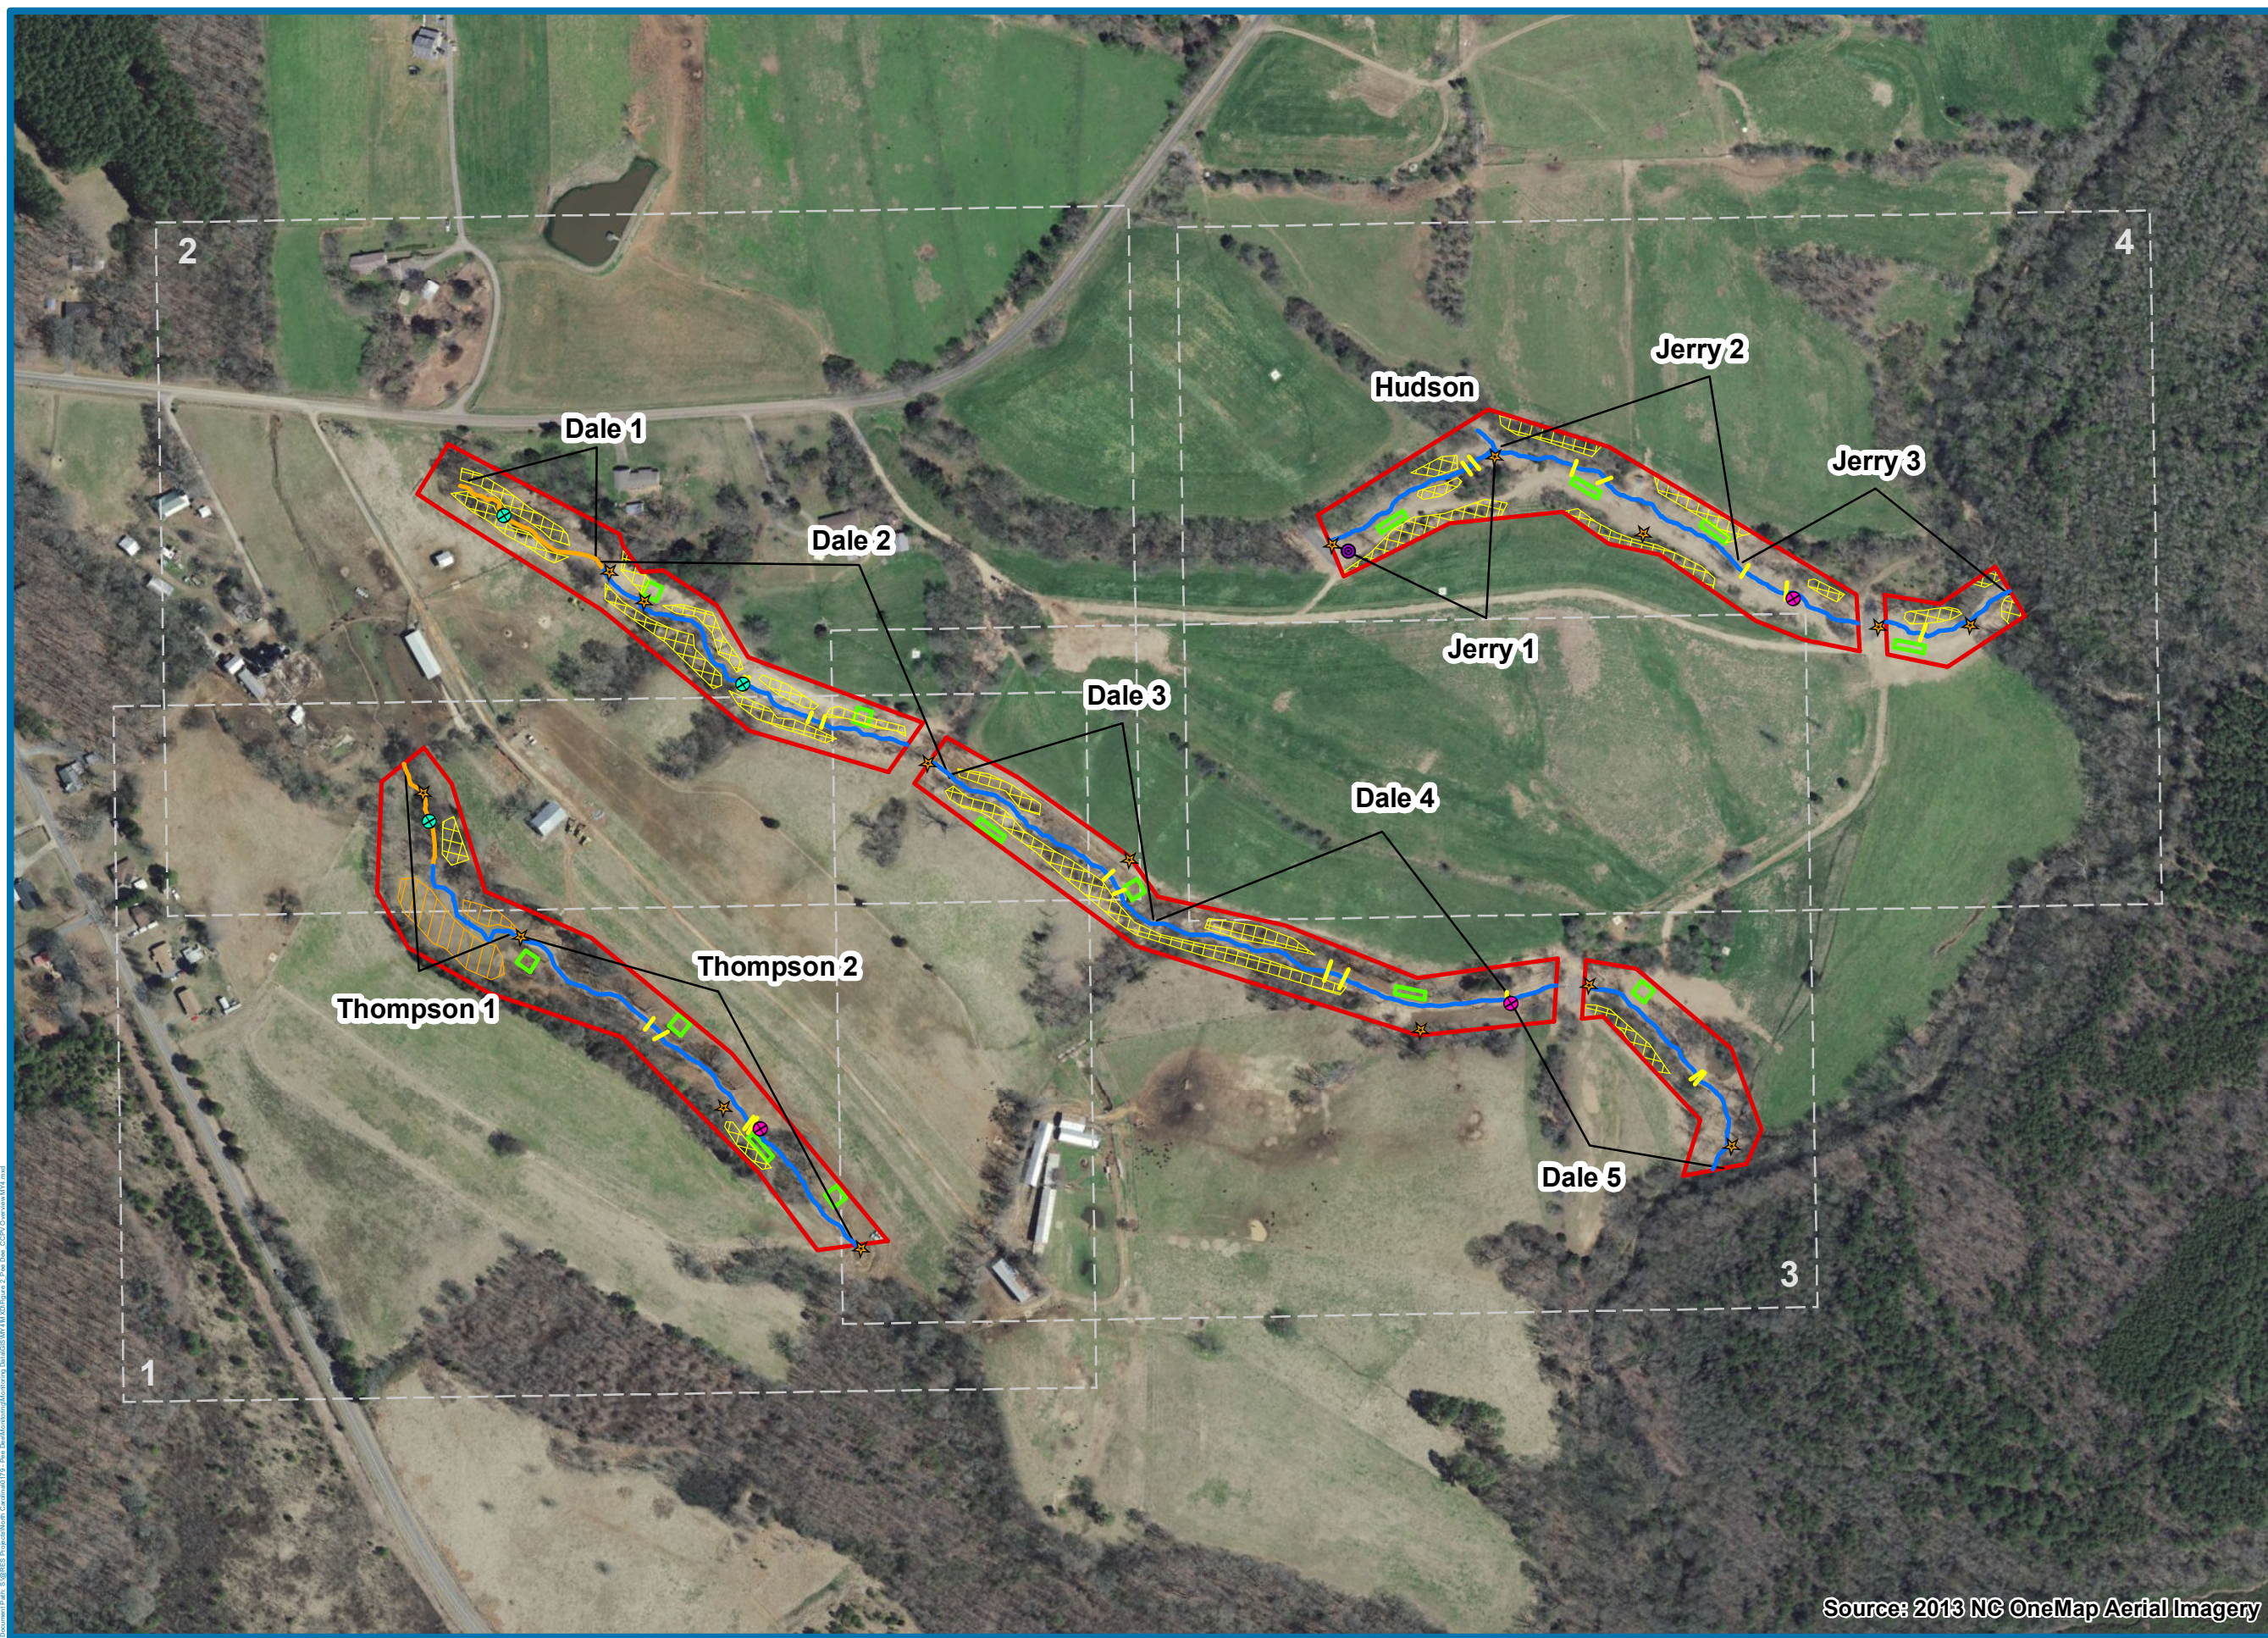
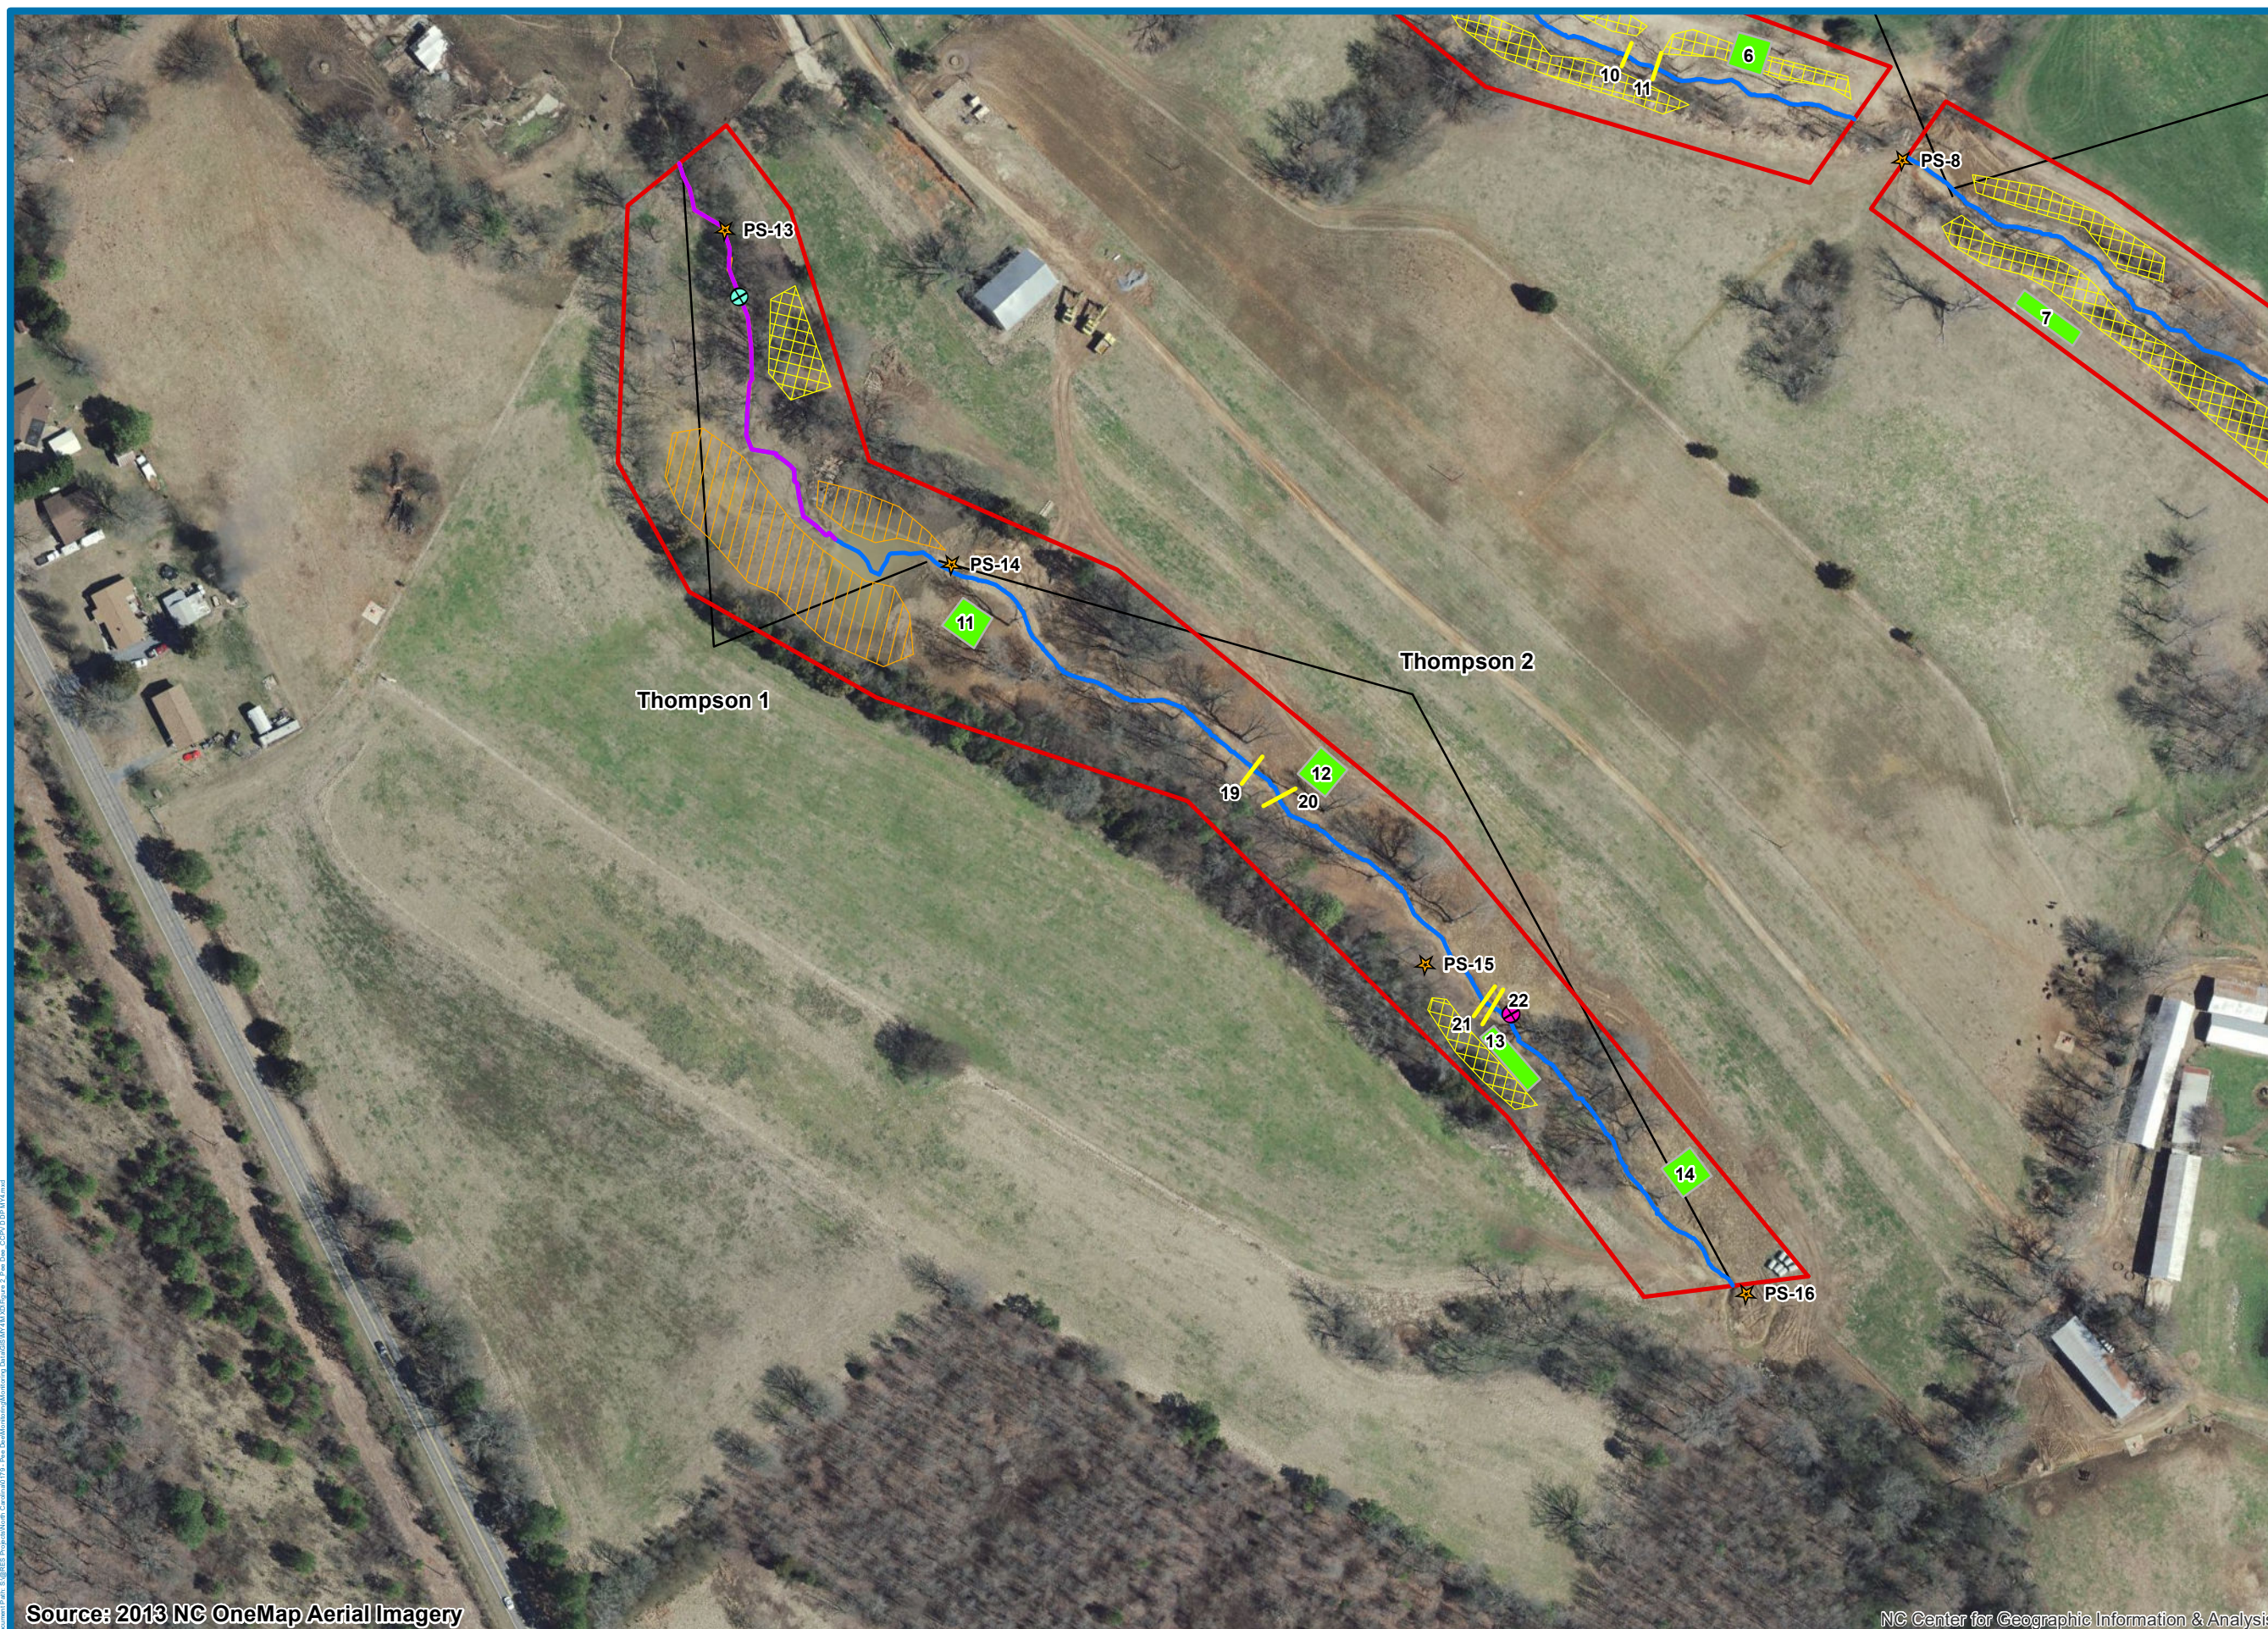
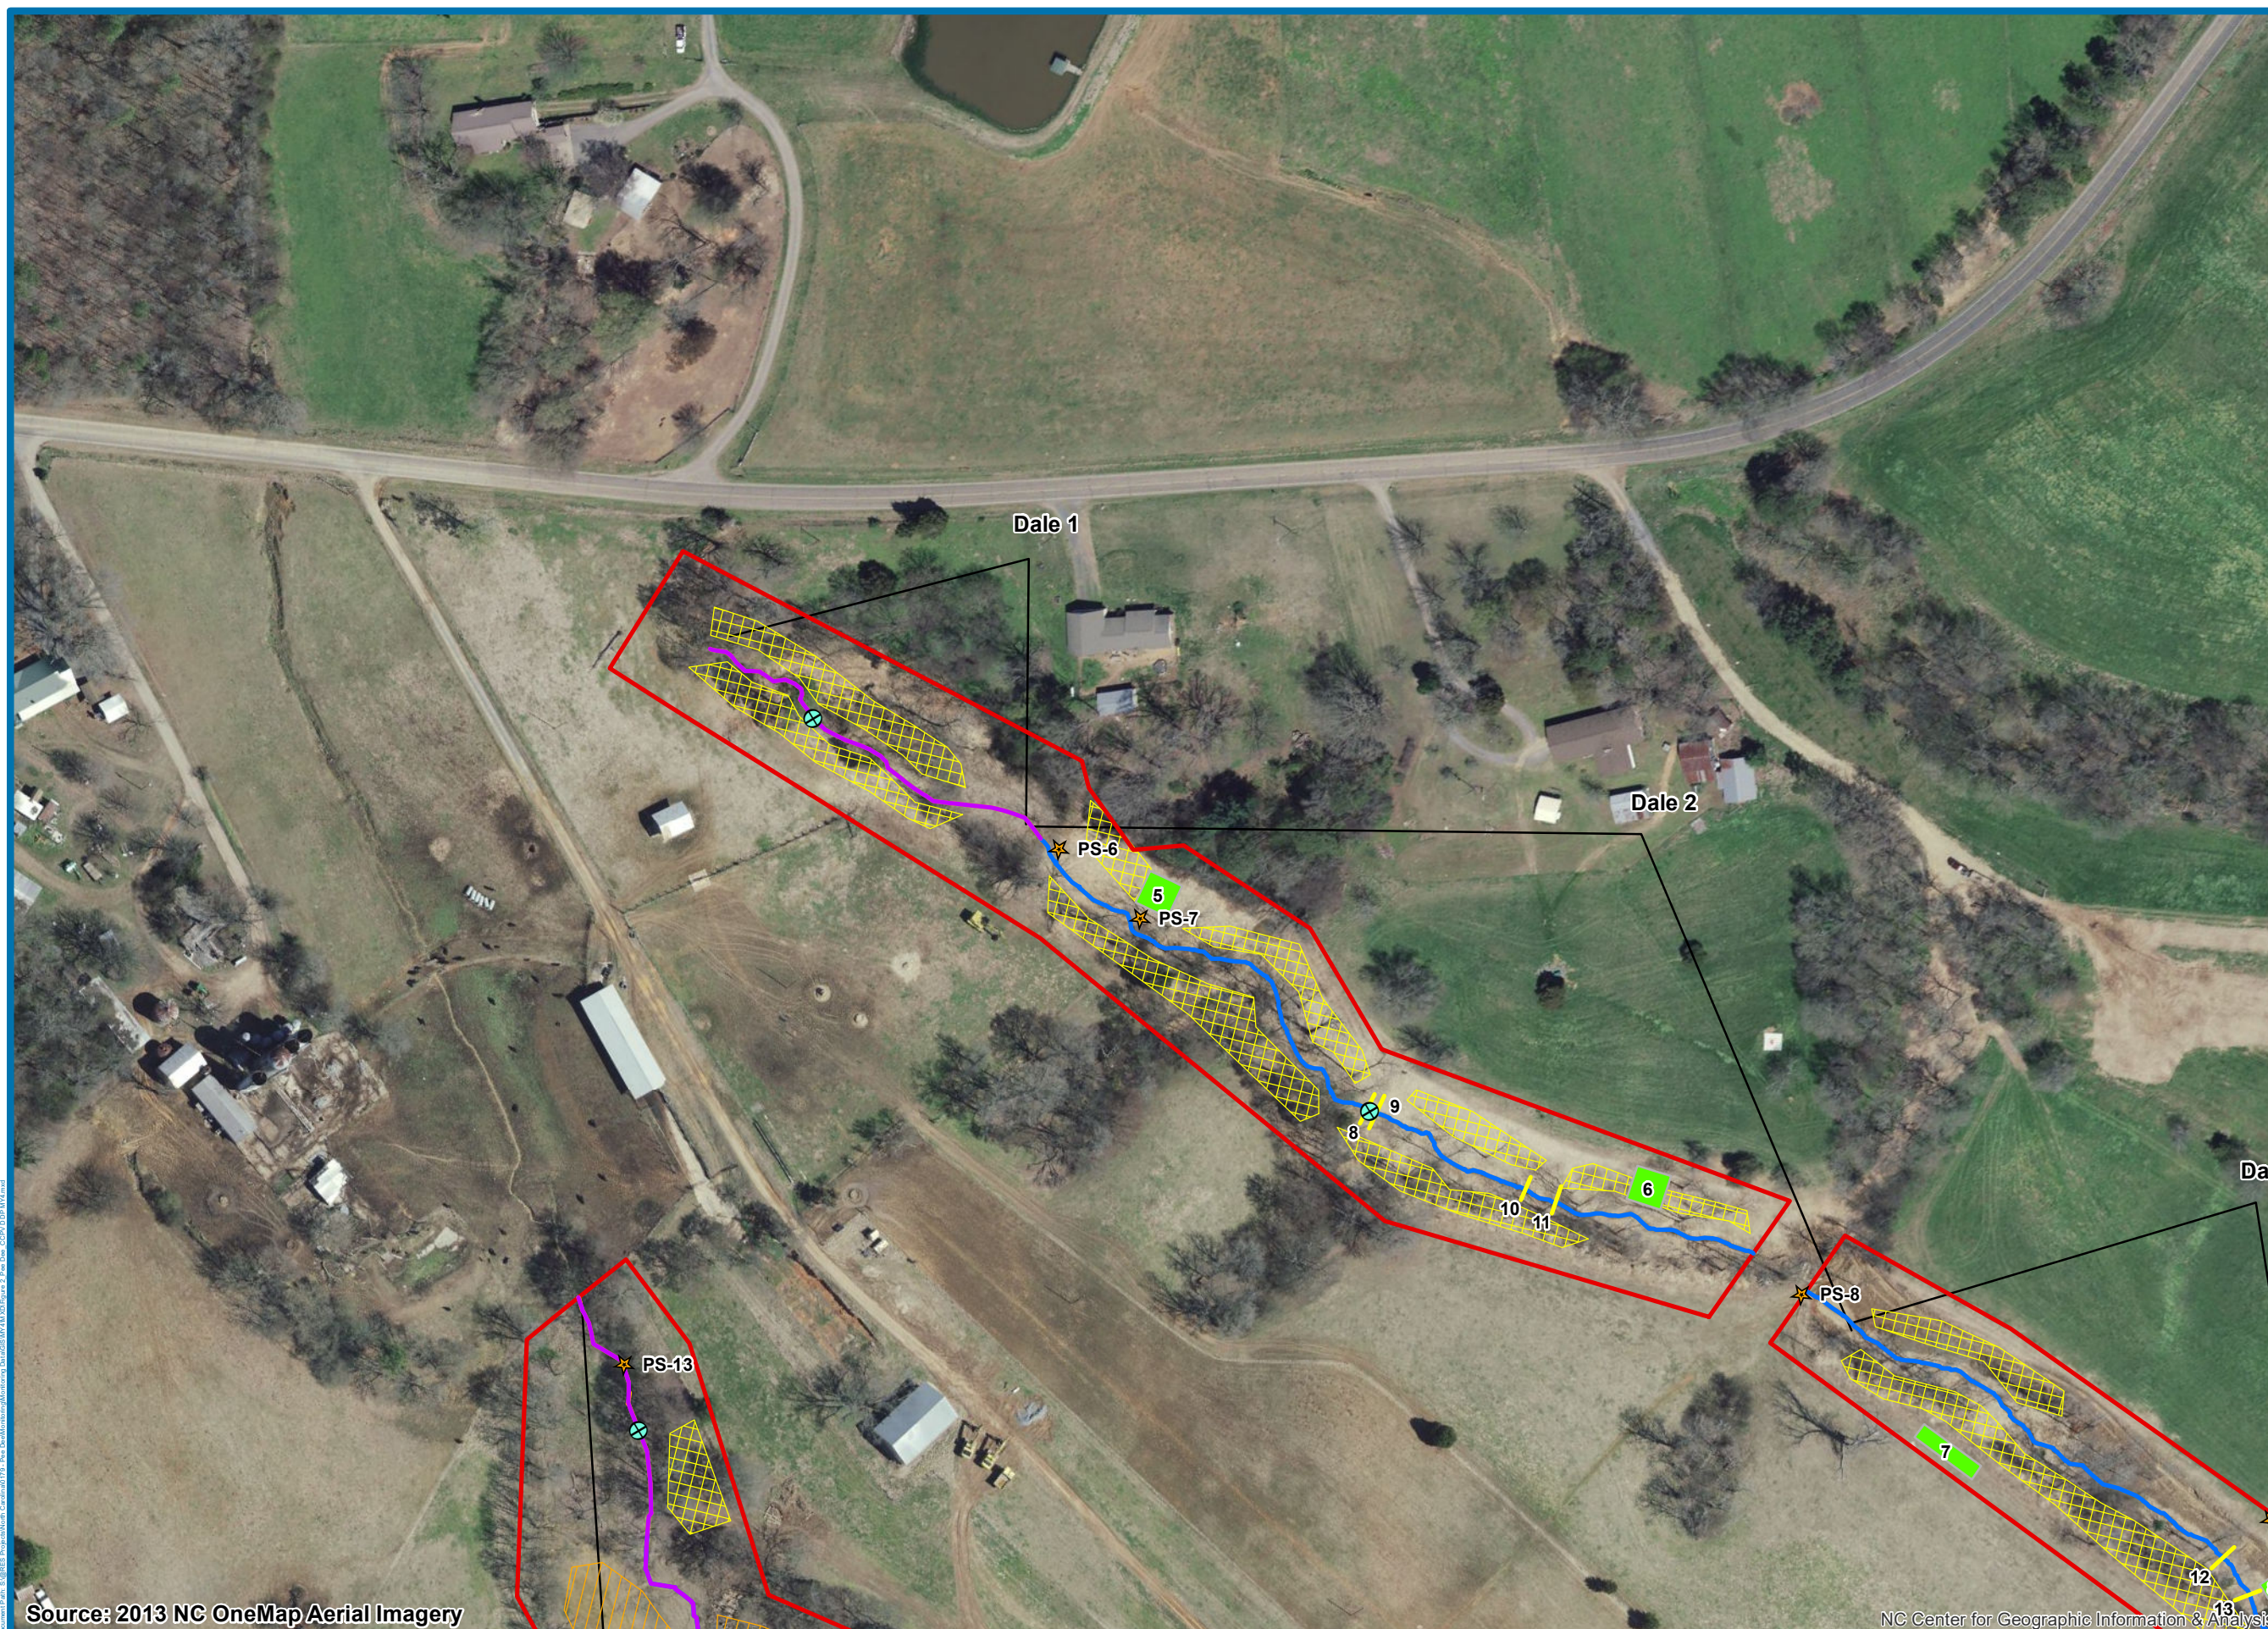
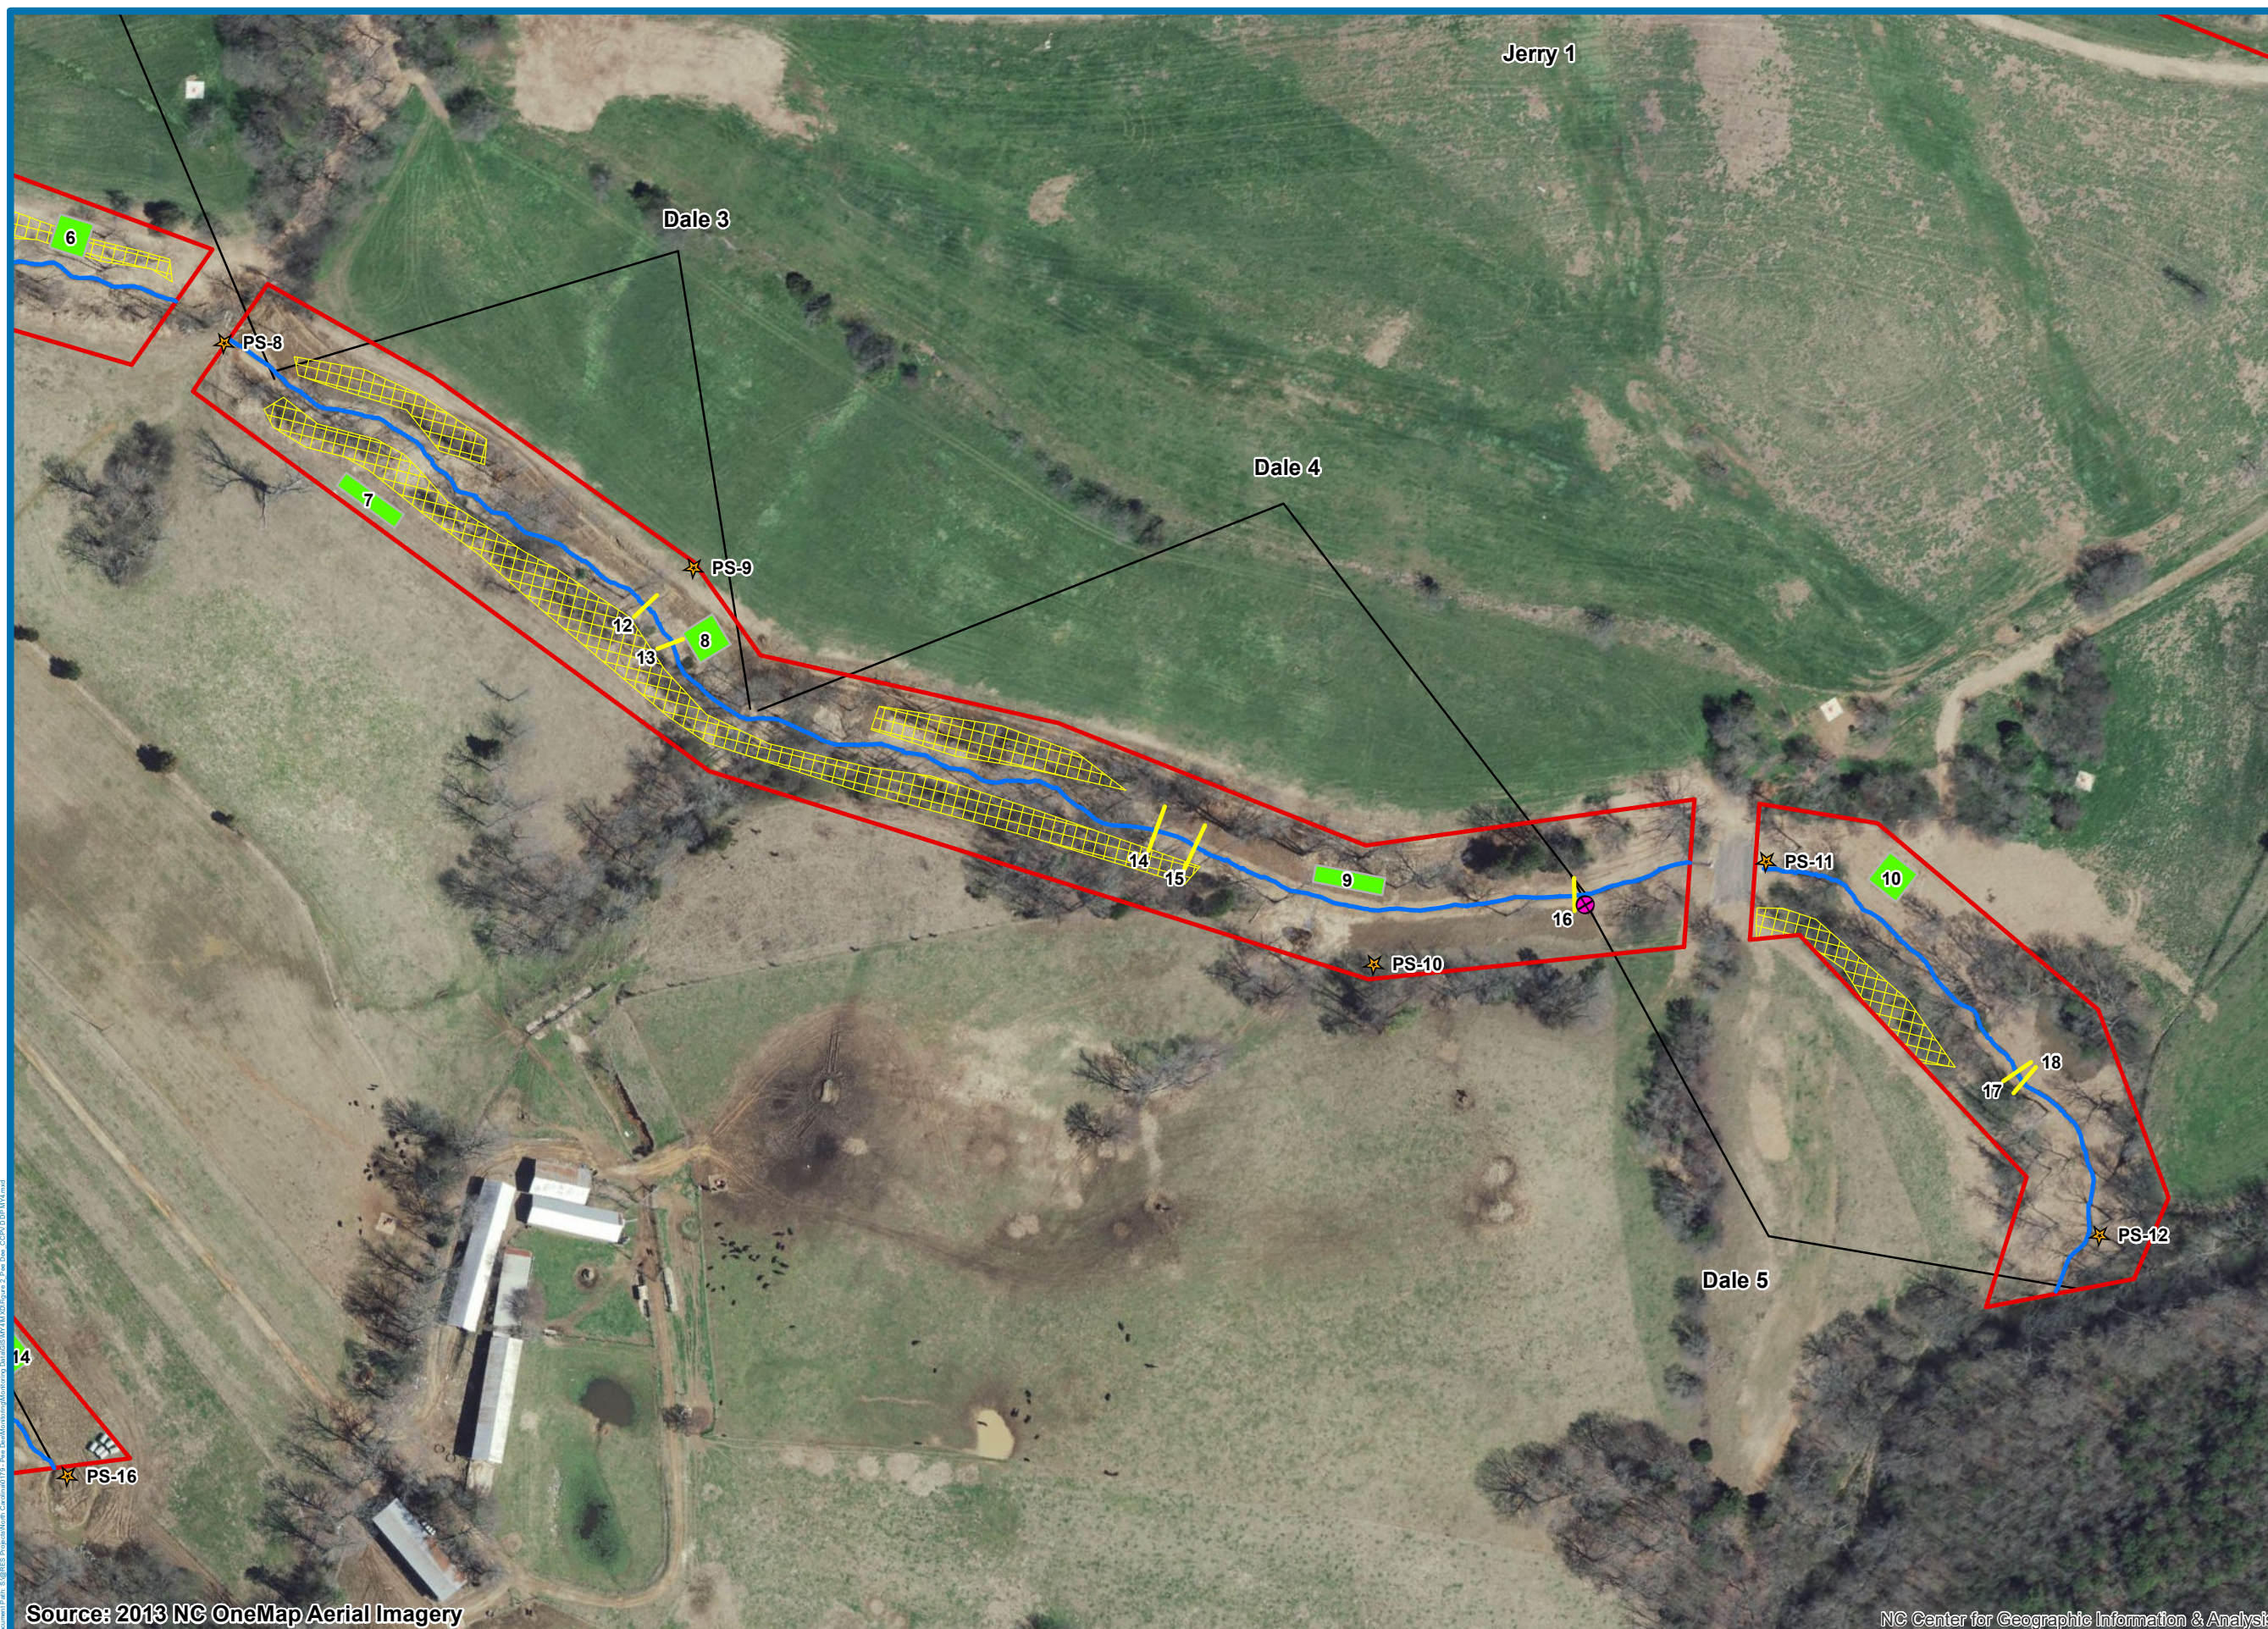
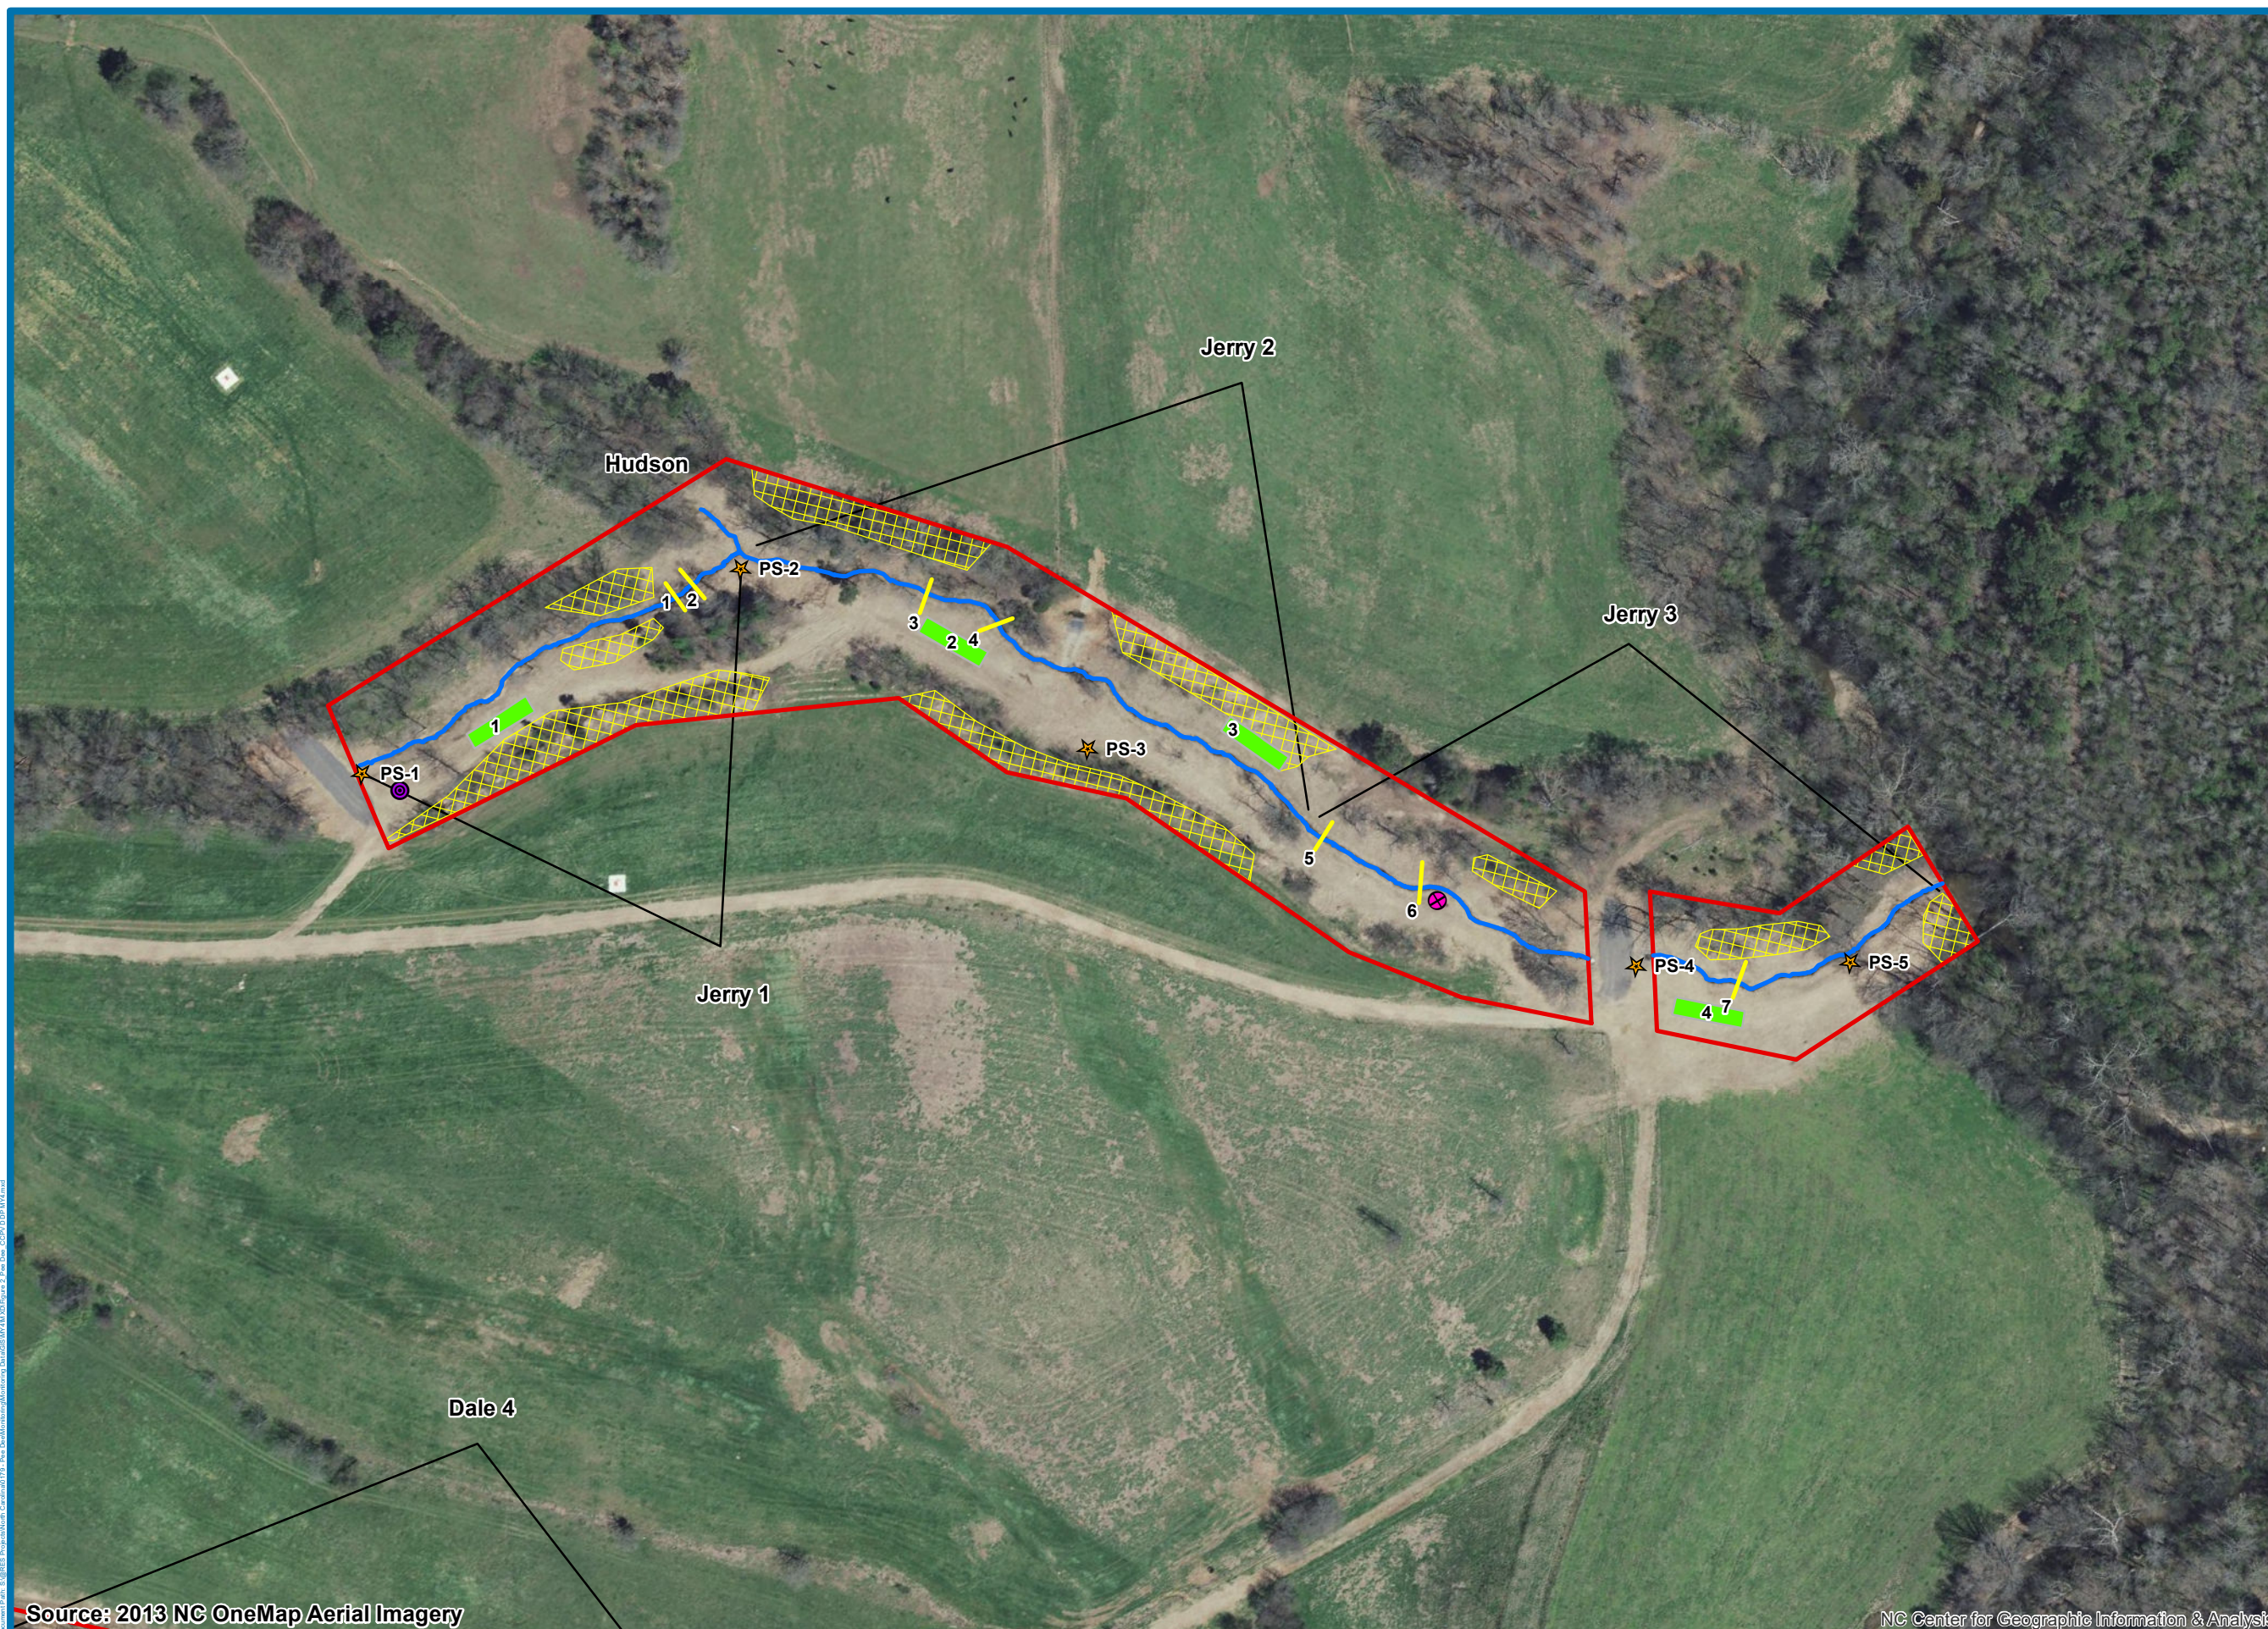
Figure 2

Invasive vegetation (mostly privet) is still significant (3.12 acres, 15% of easement).

Visual assessment of the easement (**Appendix B - Table 6, Figure 2**) indicates that herbaceous vegetation is well established throughout the project. Invasive exotic vegetation has been identified throughout the Site as Chinese privet (*Lingustrum sinense*). Invasive species treatments were administered in February and June of MY4. Treatments will continue throughout the monitoring period. RES plans to cut and spray the privet again in the spring, summer, and fall of 2019. RES remapped the invasive areas in MY4 and approximate size and locations of the invasive species areas are in **Table 6** and on **Figure 2**.

[RES will treat the invasive vegetation by cutting and spraying it. Due to the steep slopes in the easement, mulching is not an option. RES plans for the treatments to take place once in the spring, summer, and fall of 2019. This detail has been added to the report.](#)

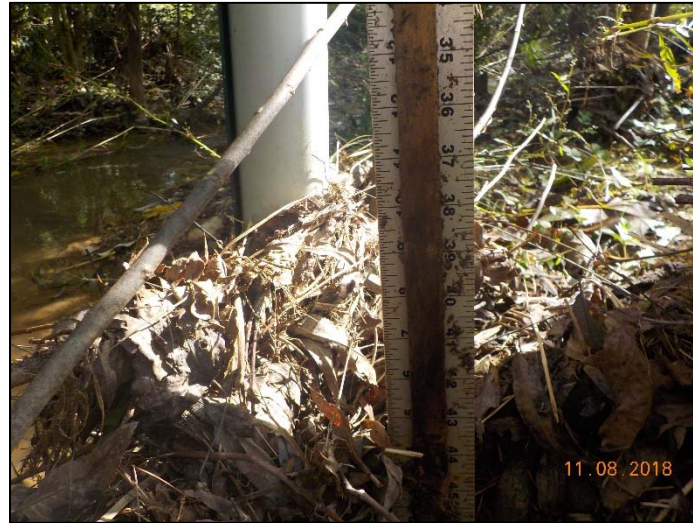
Wrack line @ Crest Gauge Jerry Branch – 0.88 ft. (Est. Date of Occurrence: 9/17/2018)

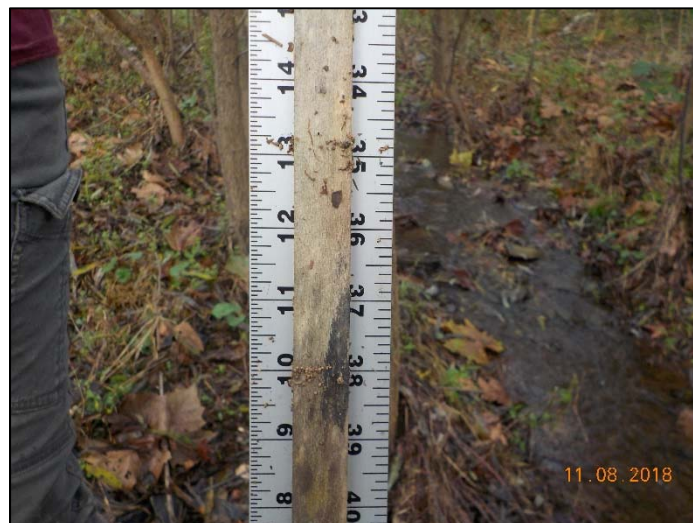
Crest Gauge @ Dale Branch – 1.08 ft. (Est. Date of Occurrence: 9/17/2018)

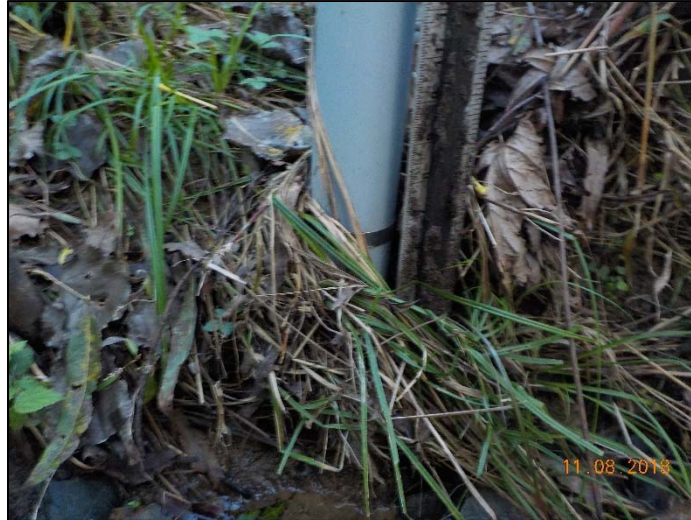
Wrack line @ Crest Gauge Thompson Branch – 0.67 ft. (Est. Date of Occurrence: 9/17/2018)
