STREAM RESTORATION PLAN

HATCHET'S GROVE

TRIBUTARY

WAKE COUNTY, NC
NOVEMBER 2002

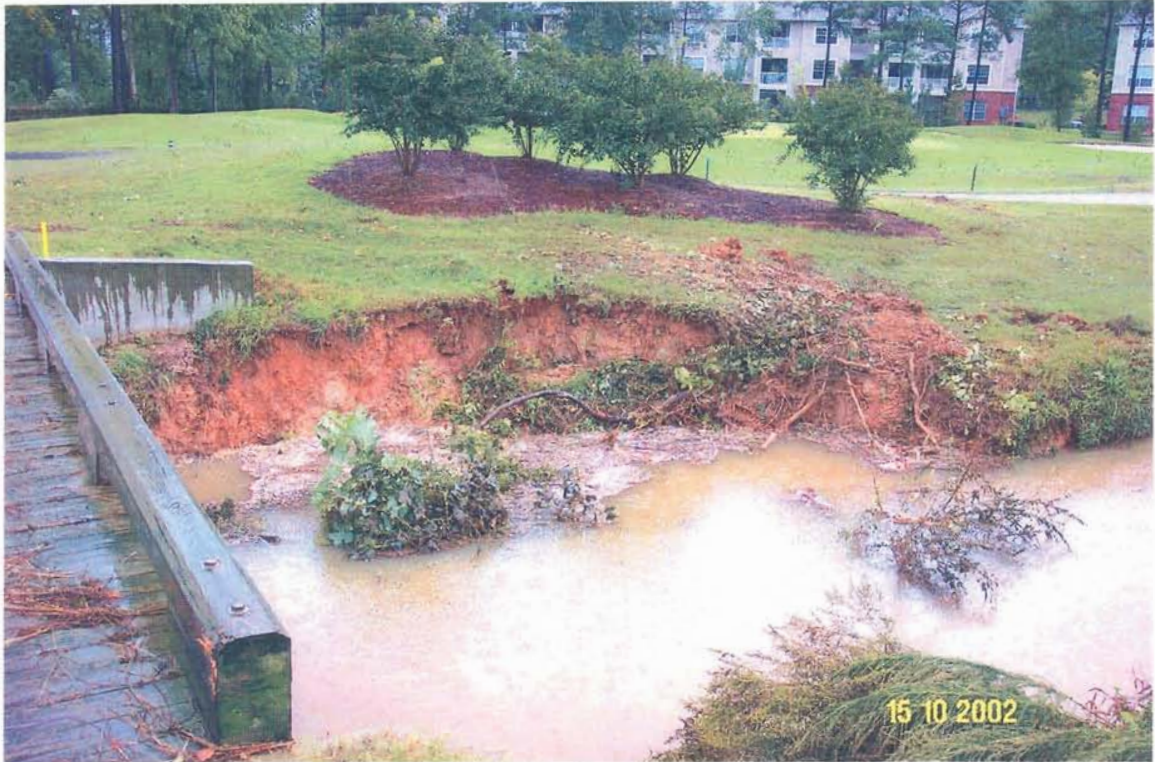
Ongoing bank erosion above bridge #3 after high flow (note collapsed vegetation)

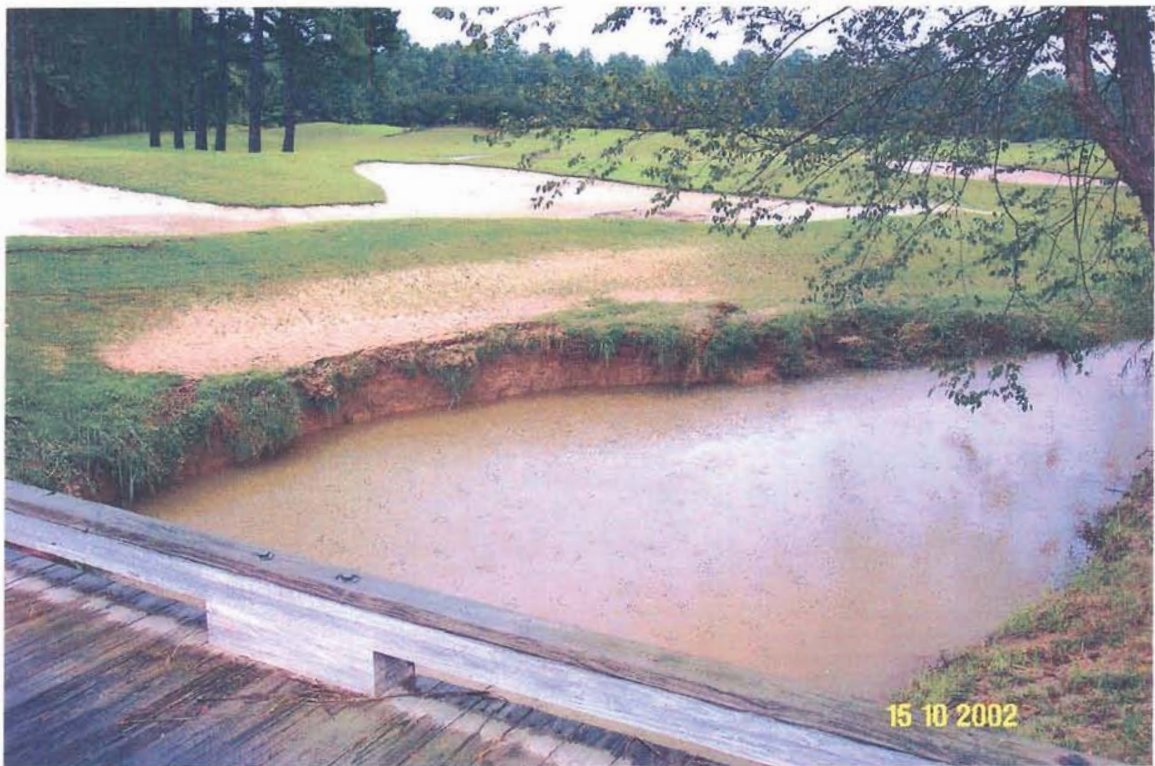
Bare, vertical bank with high erosion potential at high flow

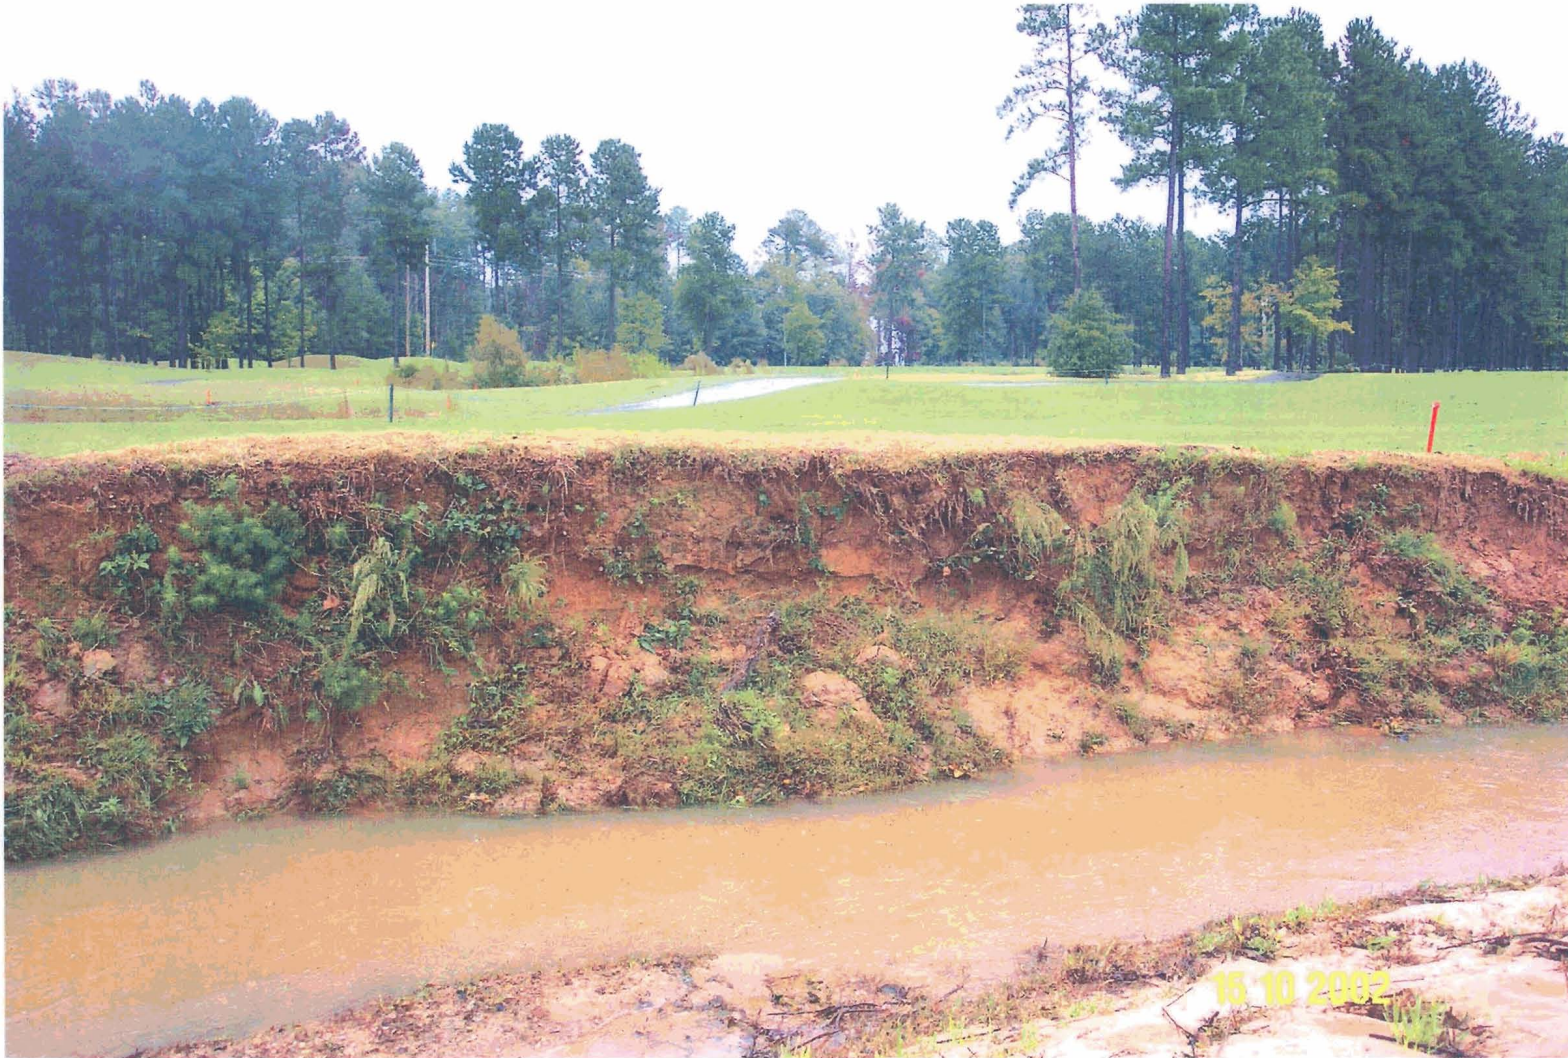
Location of BEHI #1 near cross-section L

Bank Erosion Potential: **VERY HIGH**
