# Conceptual Restoration Plan

Racey Site  
Laxon Creek, Watauga County

by  
Joe Mickey and Madelyn Martinez  
Stream Mitigation Program  
NCWRC

March 2000

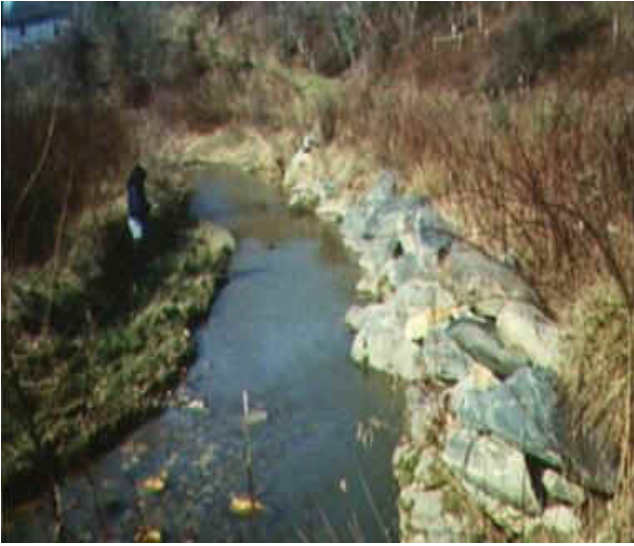
Existing riprap at stations 2+49 – 3+43 to be used to construct proposed rock vanes and cross vanes.

Also, we propose to use some of the large riprap from stations 2+49 to 3+43 for our project (located above the ford). This riprap was placed in this area by the previous owners to stabilize the bank. We will remove some of these large rocks for construction of proposed rock vanes/weirs at other locations. Once some of the riprap is removed from this bank, it will be resloped and vegetated.

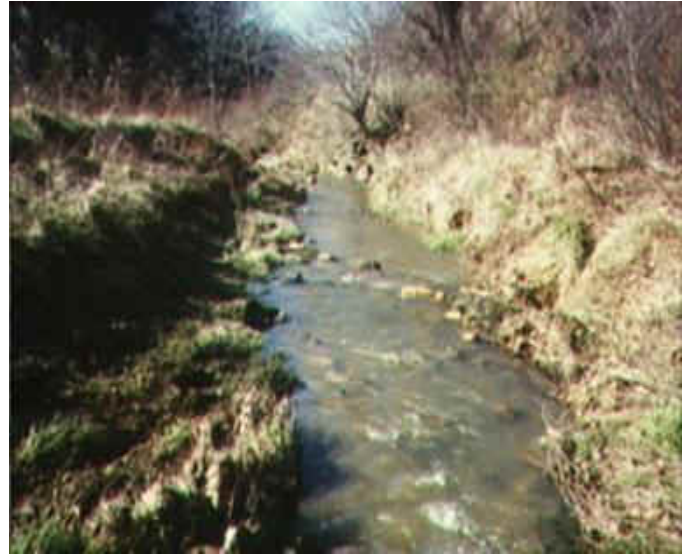
Typical riffle section in need of bank sloping.

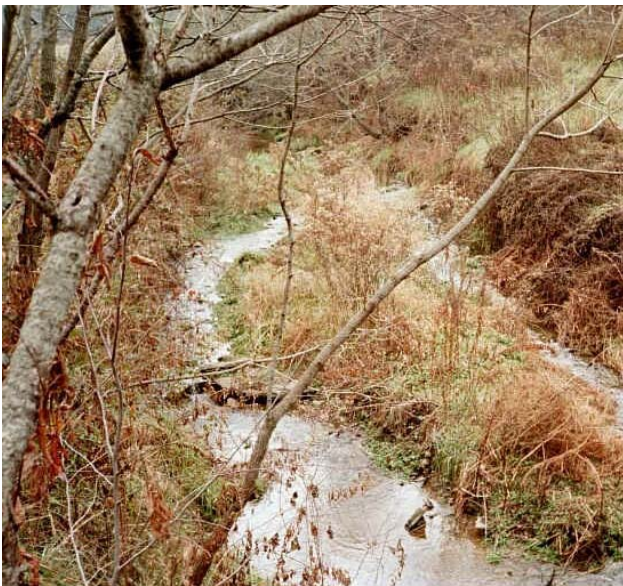
Braided and eroding channel section from stations 6+30 – 7+33

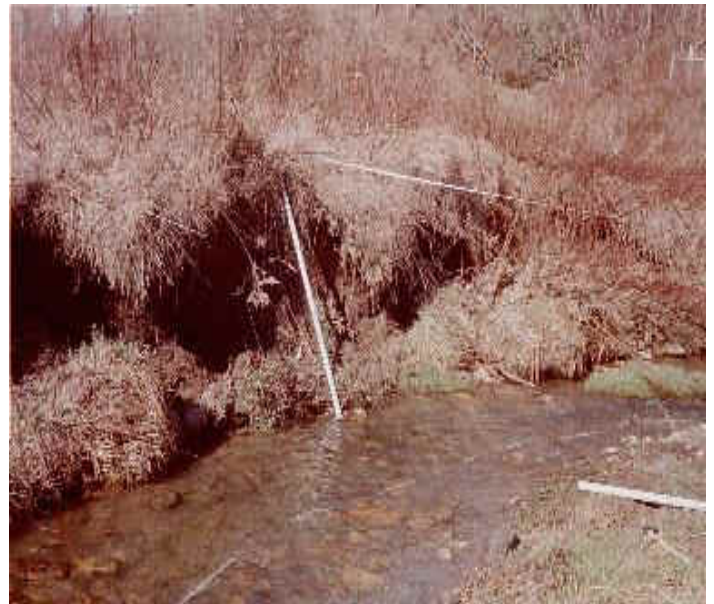
Eroding bank at station 1+86.
