**REEDY BRANCH
2007 FINAL MONTORING REPORT
YEAR 3 OF 5
2007**

EEP Project # 301
Alamance County, North Carolina

**REEDY BRANCH STREAM RESTORATION
YEAR 3 MONITORING REPORT**

CONDUCTED FOR:
NCDENR ECOSYSTEM ENHANCEMENT PROGRAM

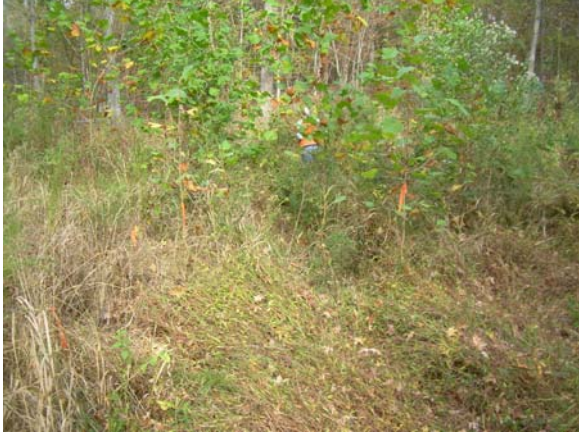
Table VI. Vegetative Problem Areas			
Feature/Issue	Station # / Range	Probable Cause	Photo #
Invasive/Exotic Populations	entire stream reach	Japanese stilt grass (<i>Microstegium vimineum</i>); likely remnant from pre-construction	1

Photo 1. Representative Japanese grass (*Microstegium viminium*) infestation (Vegetation Plot 9). Japanese grass is growing in the lower right-hand quadrant of the picture. Note how other vegetation has been suppressed where the Japanese grass has taken over.

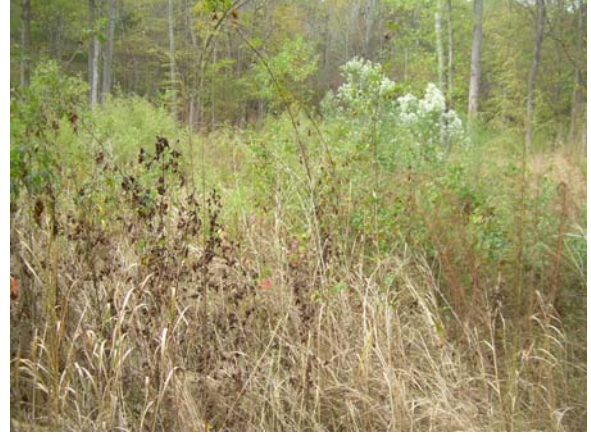
Photo 8: Vegetation Plot 8.

At the end of Monitoring Year 3, it may be concluded that bare root tree growth may be inhibited in some areas by the heavy prevalence of Japanese stilt grass (e.g. Vegetation Plots #7 and 8) with areas of concern at Vegetation Plots #9 and 10. These stem densities represent the ‘identified planted material’ as the inclusion of ‘volunteer’ species would result in an increase in the stem densities for these plots. Overall the average seedling density across the entire project is well above the Monitoring Year 5 goal of 260 stems per acre.

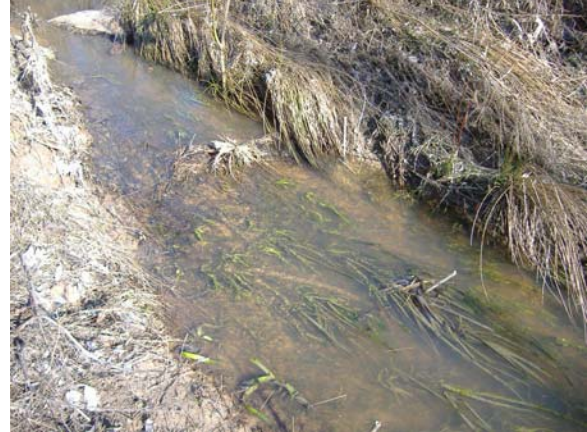
Photo 2: Representative grass and pickerelweed aggradation problem area (Station 26+98 along plan view).

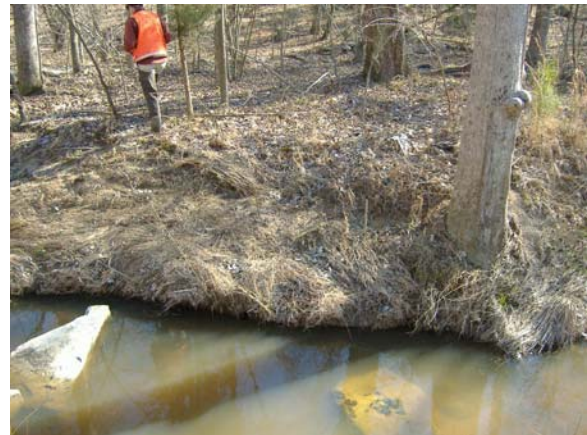
Photo 4: Representative undercut problem area (Station 30+82 along plan view).

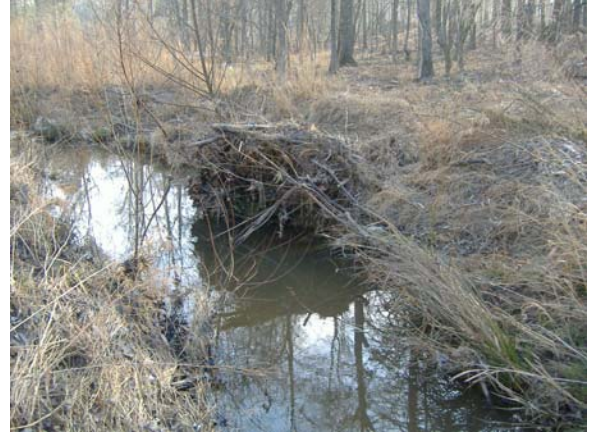
Photo 6: Representative problem rootwad (Station 11+62 along plan view).

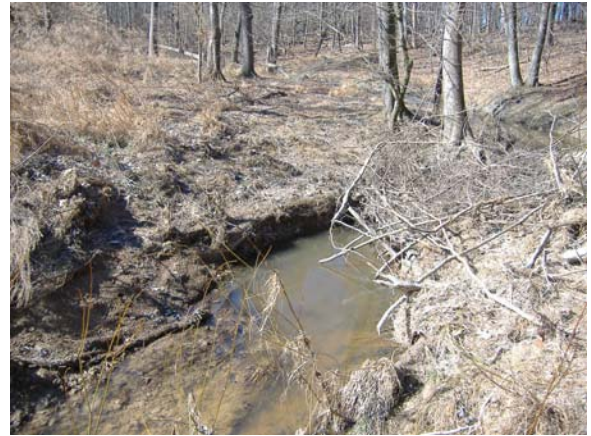
Photo 8: Representative debris jam (35+88 along plan view), scour caused by debris jam (Station 35+98), and resultant aggradation from scour-associated sediment deposition (Station 35+98).

Debris Jam	35+88	Tree in channel and vines remaining attached to cause jam.	8
Bank Erosion (left)	35+98	Piping around debris jam caused bank scour on outside of meander.	8
	36+09		
Aggradation (grass)	35+98	Resultant sediment deposition from adjacent bank erosion.	8
	36+15		
Aggradation (cattails/ pickerelweed)	37+53	Fine sediment aggradation observed with pickerelweed in channel.	
	37+75		
Aggradation (grass/ pickerelweed)	38+81	Fine sediment aggradation observed with grass and pickerelweed in channel.	
	39+03		
Crossvane	39+75	Angle or placement location is possible cause of erosion of both banks just downstream.	
Bank Erosion (right)	40+07	Minor scour; healing over.	
	40+30		
Bank Erosion (left)	40+11	Minor scour; healing over.	
	40+28		
Bank Erosion (left)	40+97	Past bank sloughing. Appears to be good vegetative protection. Perhaps the erosion was a post-construction adjustment now healing over.	
	41+20
