**Rowel Branch Tract:
Year Five Monitoring Report**

Brunswick County, NC

Prepared by:
Land Management Group, Inc.
Wilmington, NC

January 2006

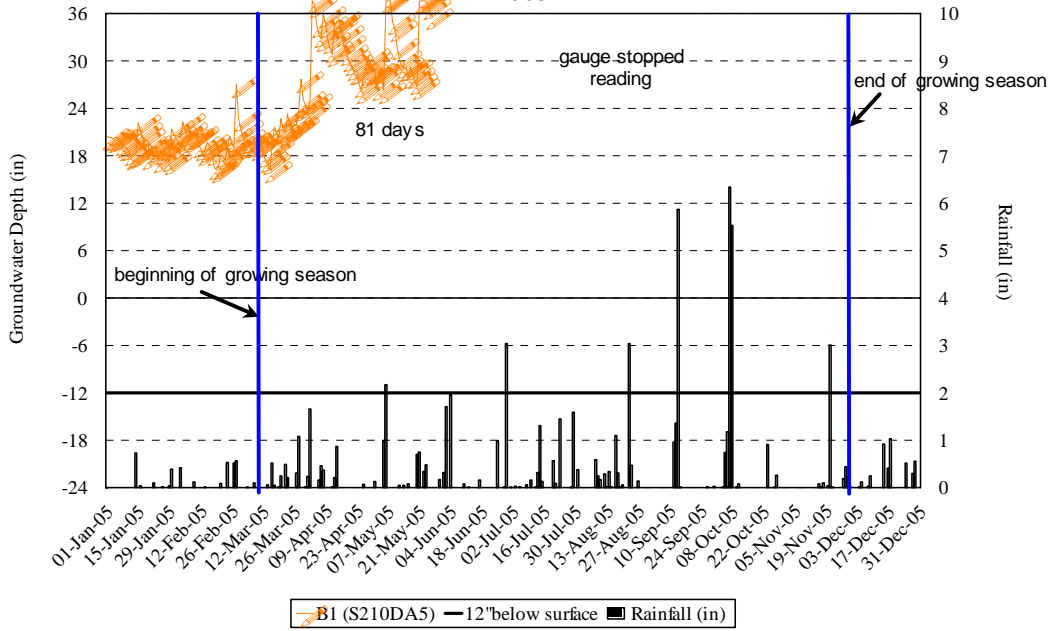
Figure 3. Hydrology Monitoring, Gauge B1
Rowel Branch Tract; Restoration
2005

* Gauge stopped reading during the monitoring period.

* Gauge malfunctioned during a majority of the monitoring period.

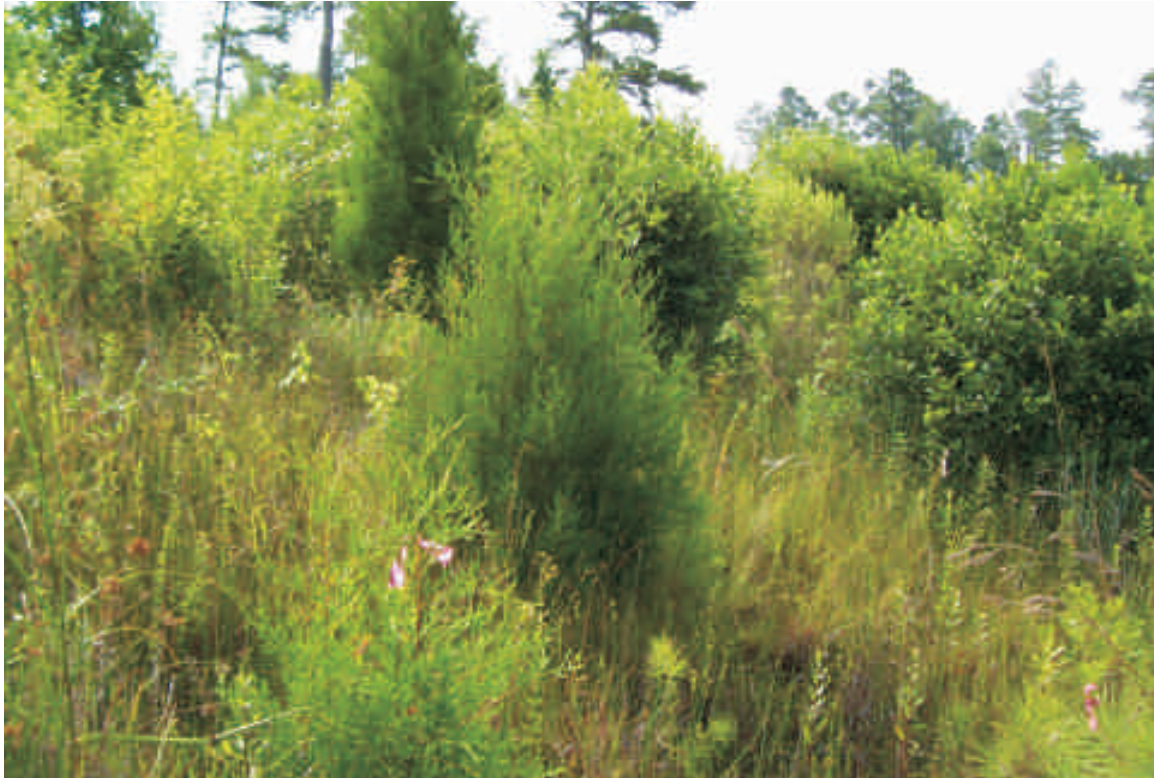
↓ Atlantic white cedar within Transect 1.

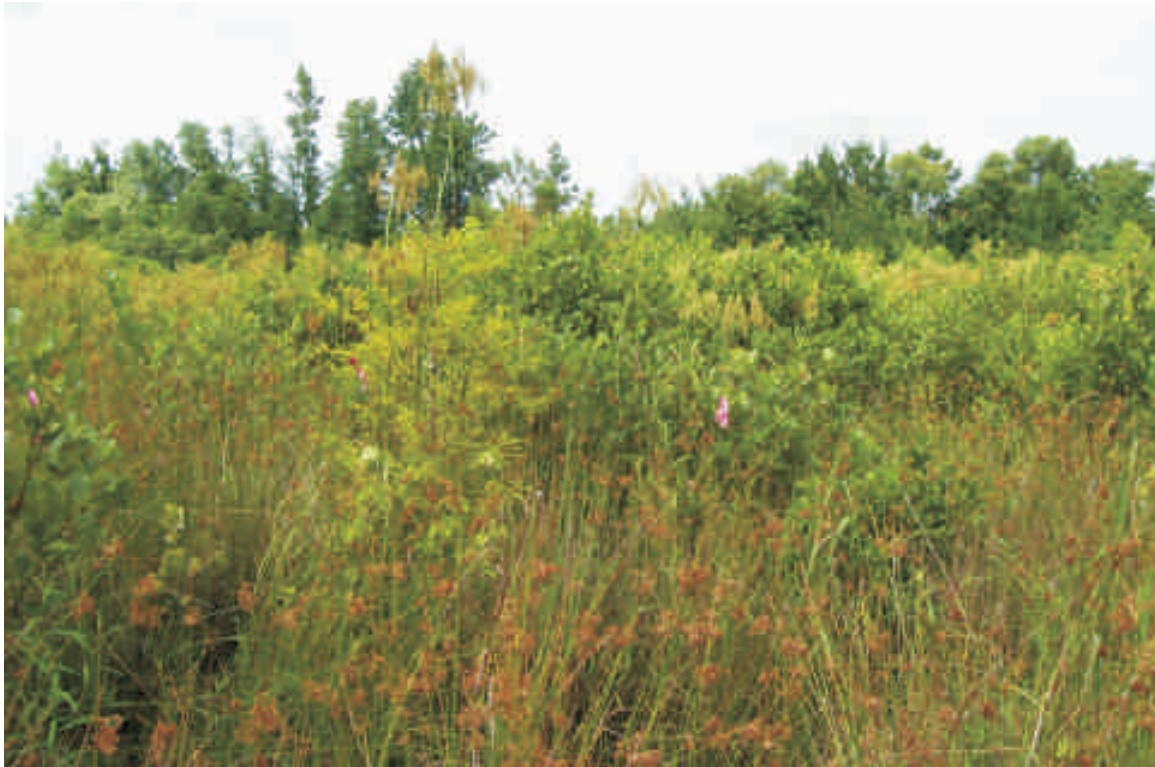
↓ Bald cypress within Transect 2.
