# Monitoring Report MY02

**Sandy Bridge Restoration Site  
DMS Contract 6400  
DMS Project Number 96920**

**DWR #: 15-0414  
USACE Action ID: 201500827  
Rutherford County, North Carolina**

**Monitoring Data Collected: September 2018  
Date Submitted: December 2018**

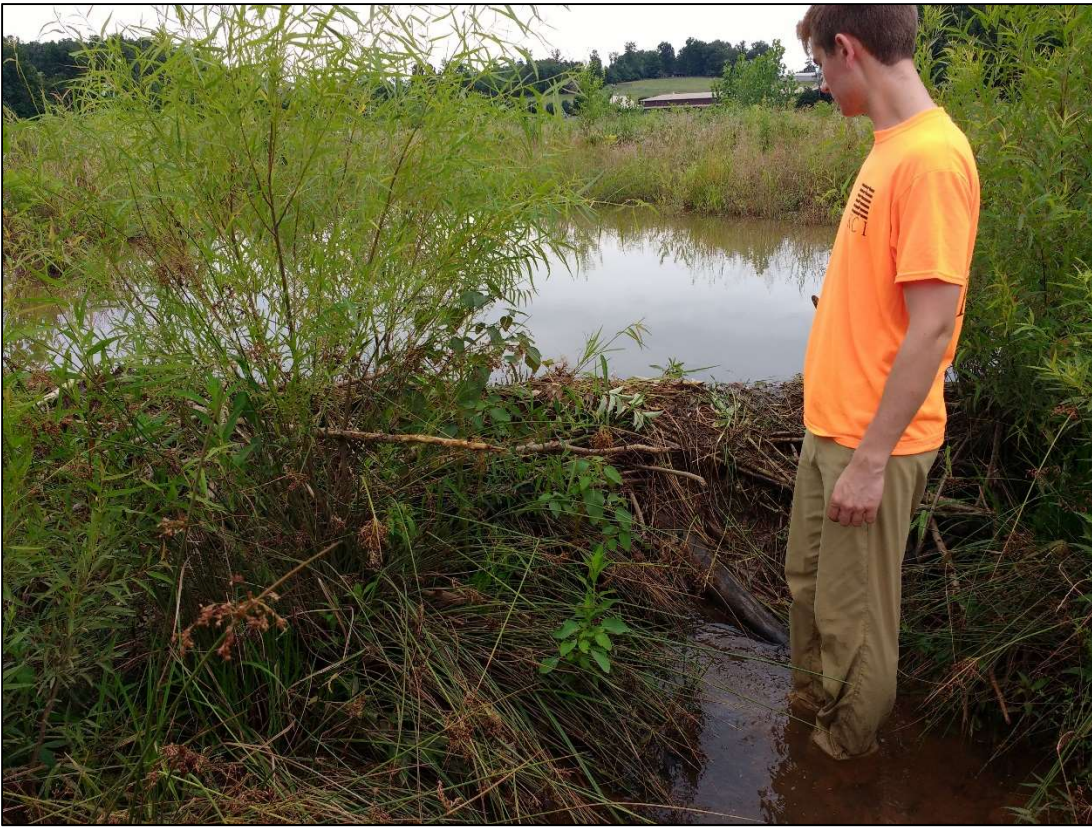
Photo 1. One of the beaver dams onsite (has been removed), 6/28/18

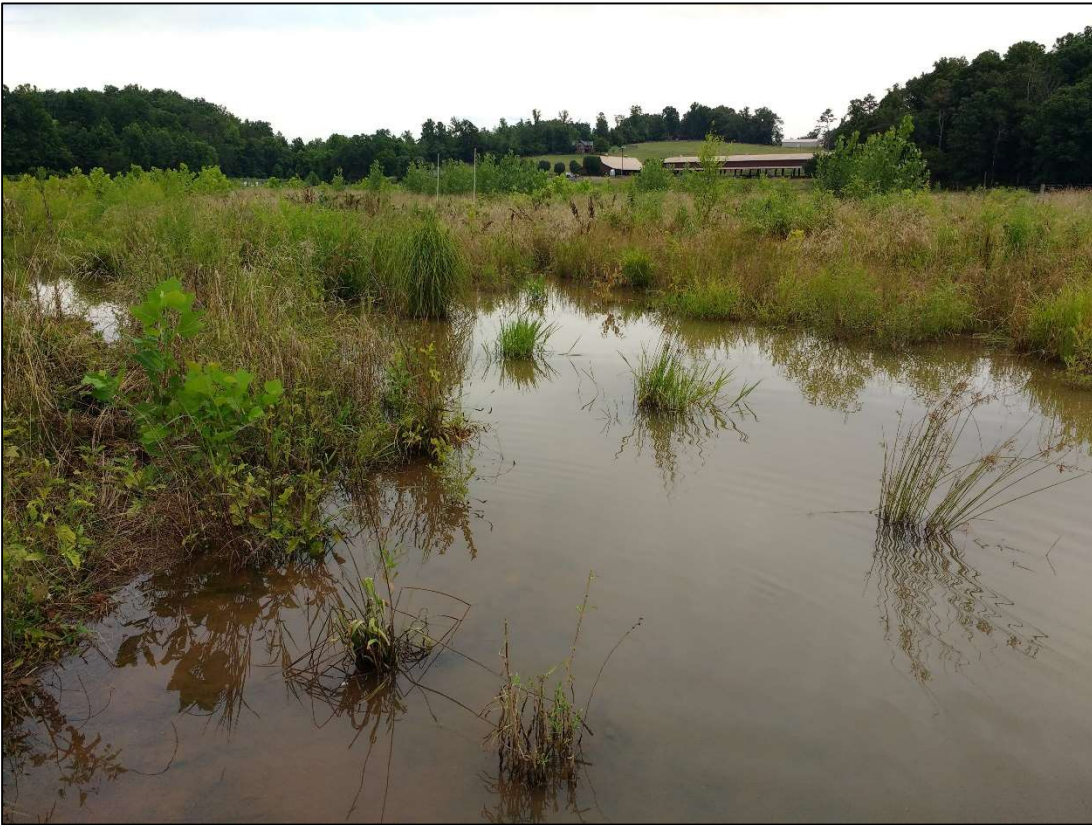
stream flows. In June 2018, several large beaver dams were discovered towards the lower half of the stream. These dams were removed in early August 2018. A second set of dams was discovered in October 2018 and were removed in early November 2018. KCI is actively trapping beavers on-site and monitoring for further signs of beaver activity. See Appendix B and Appendix E for more information.

Photo 2. Floodplain flooding due to beaver dams, 6/28/18

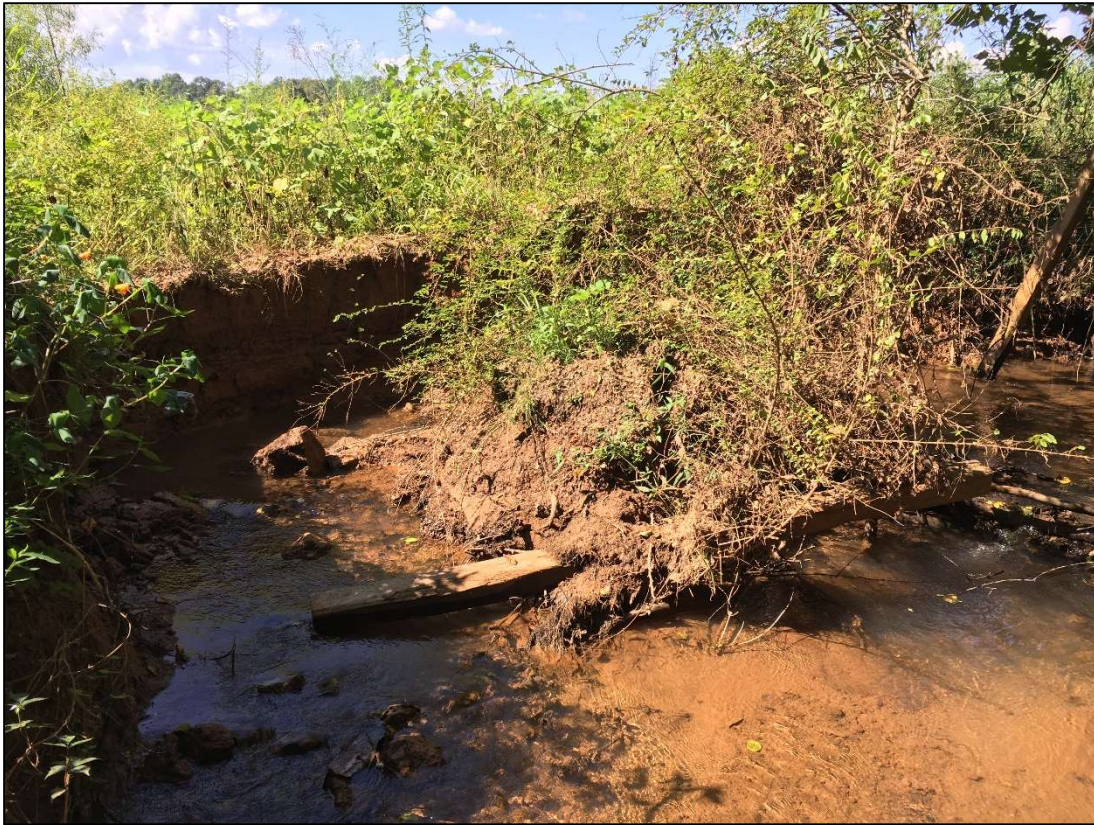
The right bank of the stream that flows along the easement's southern boundary has been experiencing significant erosion due to several areas of obstruction in the center of this channel that are diverting water into the banks. Although this stream is not part of the project, and is located outside of the easement bounds, the erosion on the right bank has encroached into the easement. KCI is planning to repair and stabilize this area within the next year. This will involve removing the mid-channel obstructions and sloping back the eroding bank. See Appendix B for photos of this area.

Photo 3. Eroding stream bank that is encroaching into easement, 8/29/2018

3. Please note the location of the eroding stream on the CCPV (Problem Area photos 3 and 4).  
*KCI Response: This has been added to the CCPV.*

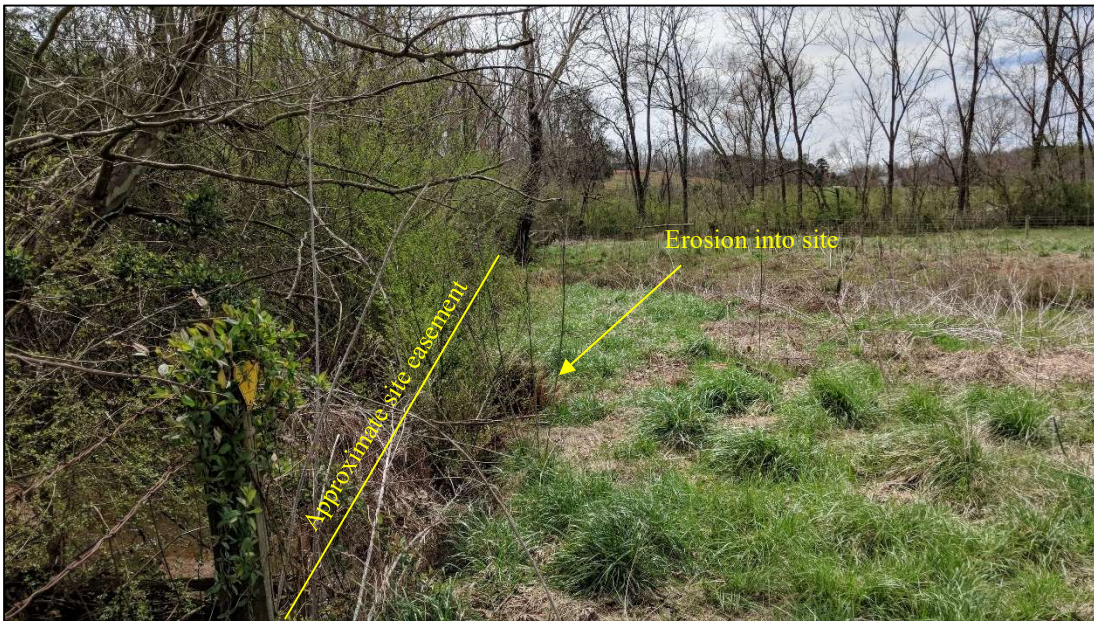
Photo 4. View along easement boundary where stream bank is eroding, 8/29/2018

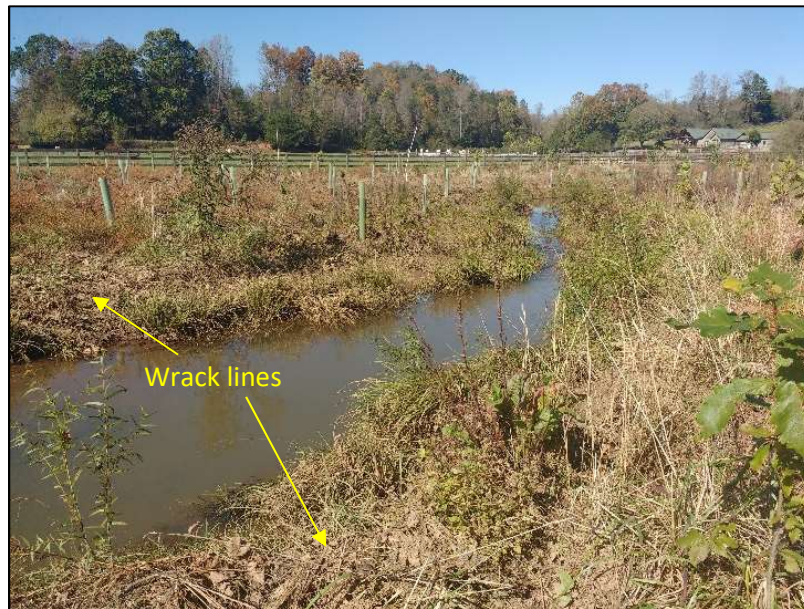
Photo 1. Sediment on plants and wrack lines above bankfull, 10/26/2017

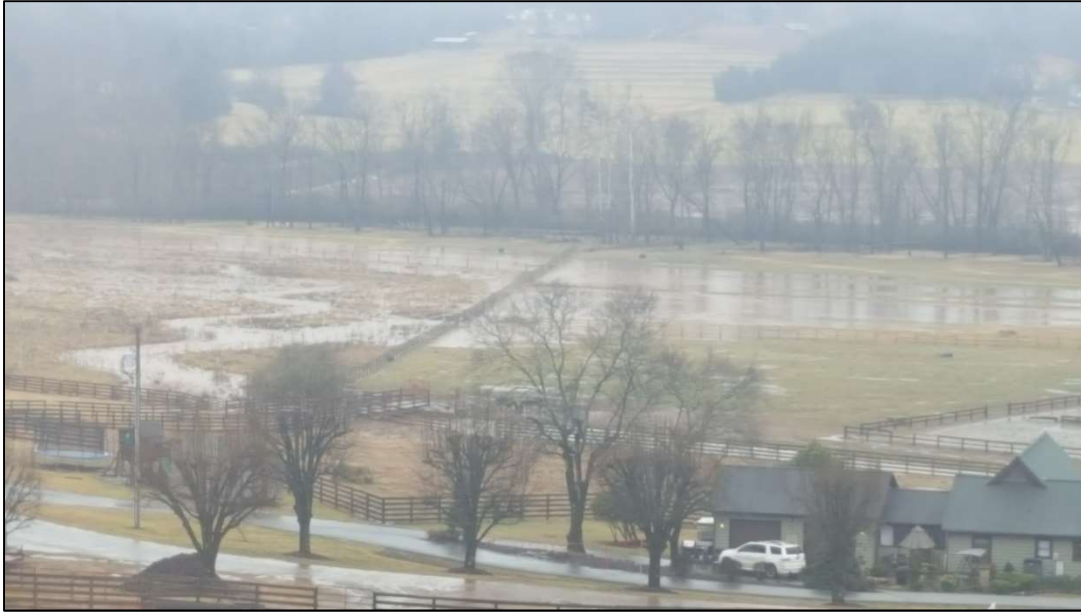
Photo 2. Bankfull event on site, 2/7/2018

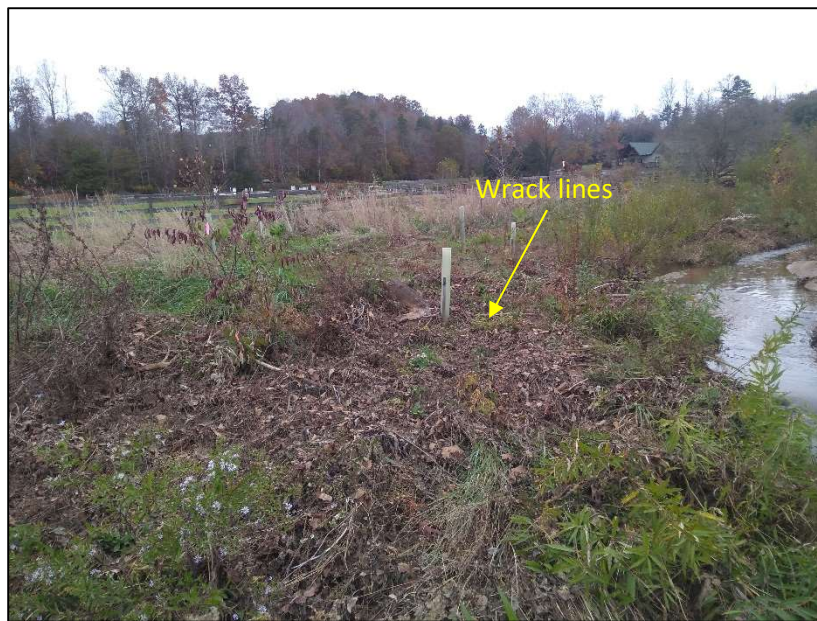
Photo 3. Wreck lines above bankfull, 11/7/2018
