Silas Creek Stream Restoration Project Winston-Salem, North Carolina

North Carolina Department of Environment and Natural Resources
Wetlands Restoration Program

November 2002

Design Report Prepared By Buck Engineering PC

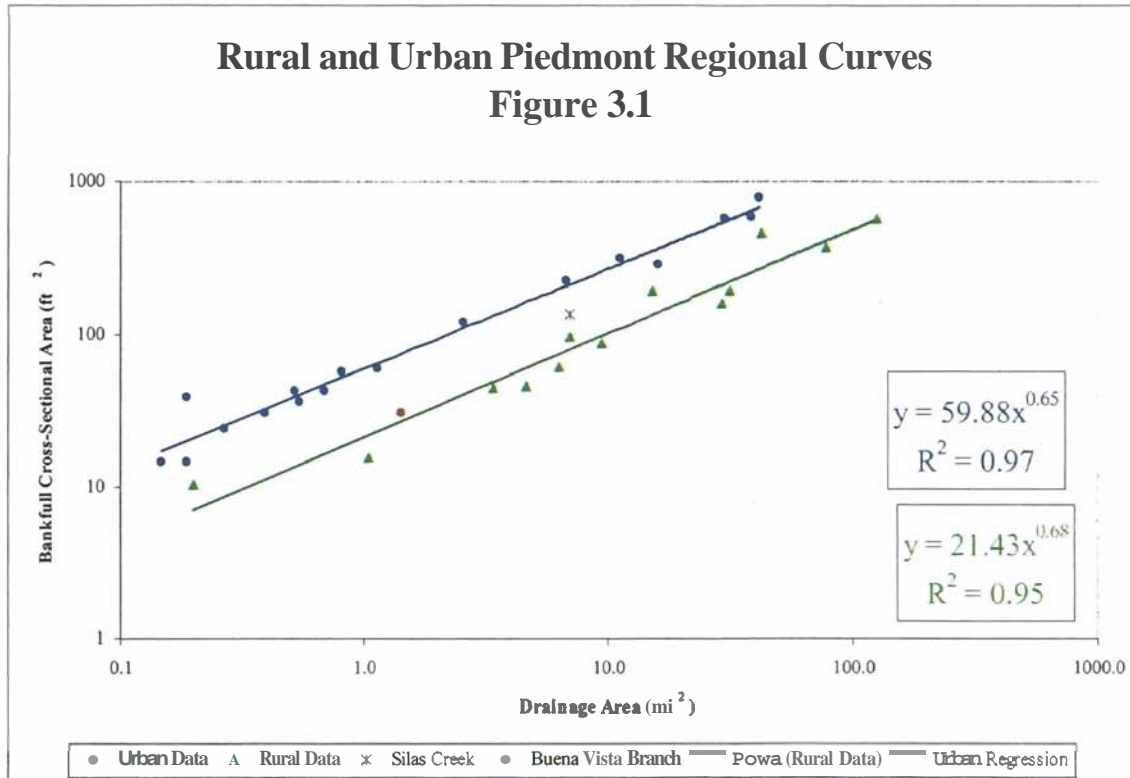
Figure 3.1. Rural and Urban Piedmont Regional Curves with Surveyed **Bankfull** Cross-Section Areas for Project Reaches. (Project data points were not used in determining the regression line.)

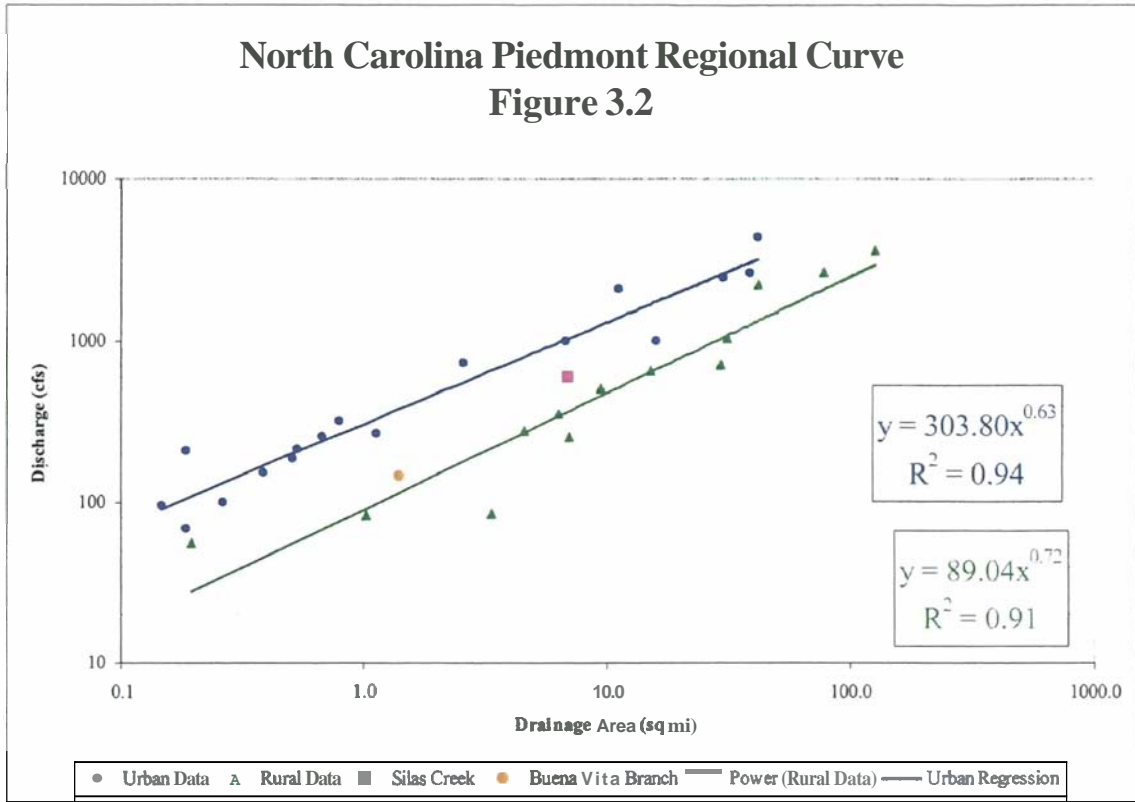
Figure 3.2 Rural and Urban Piedmont Regional Curves showing **bankfull** discharge versus drainage area. The **bankfull** discharge predicted using HEC RAS is overlaid with the regional curve for comparison.

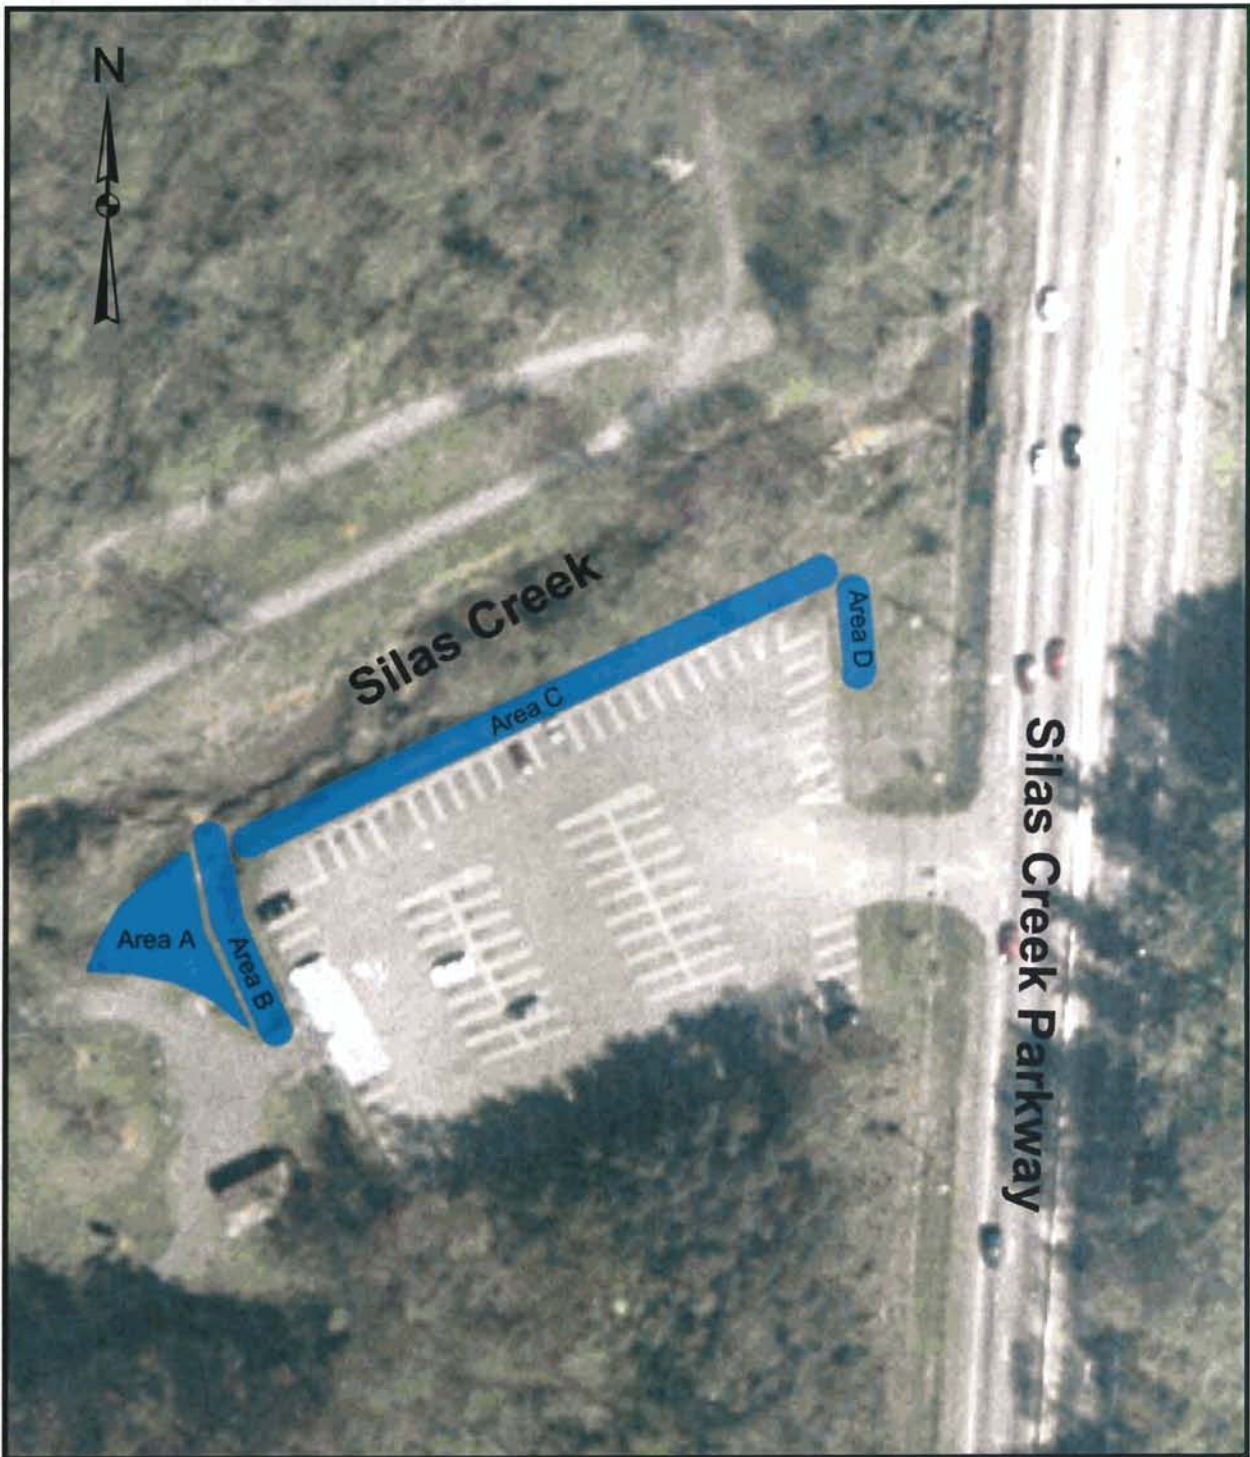
Figure 5.1: Silas Creek BMP Design
Winston Salem, NC
Forsyth County

This area is shown in Figure 5.1 and allows for a small detention/infiltration basin (900 ft²) to be placed along the existing tributary to treat storm flows before entering Silas Creek. The treatment mechanisms would include particle settling, infiltration, and

This area is shown in Figure 5.1 and allows for in channel improvements limited to channel stabilization and vegetation enhancements. Existing invasive vegetation (primarily Kudzu) would be replaced by native vegetation along the banks and the channel would be regraded to allow for the construction of a step-pool system. This alternative directly effects water quality by limiting erosion and by encouraging aeration through a series of steps pools. Energy dissipation from the step pools would also discourage erosion in Silas Creek on the opposite channel bank. This location would be highly visible for public education as it is located adjacent to the bridge crossing to the park.

This area is shown in Figure 5.1 and could be enhanced by creating a 5 foot wide filter strip along the Northern boundary of the parking lot. The filter strip would allow settling of particulates from the parking lot, catch trash, and encourage infiltration. The strip would also act as a level spreader, so concentrated runoff from the parking lot would not affect bank stability as it runs into Silas Creek. This area could be constructed in conjunction with the bank construction of Silas Creek. Vegetation would be selected to aesthetically fit within the park setting and still provide a native vegetated buffer to Silas Creek. This area is not as visible a location as Areas A and B but could still provide an educational opportunity.

This area is shown in Figure 5.1 and would be used to create a small infiltration basin (800 SF) to treat parking lot runoff before entering Silas Creek. This area could be graded to receive water from area C, allowing additional settlement, infiltration, and nutrient removal before flows enter Silas Creek. The outflow from this area could be controlled so as not to disturb the Silas Creek streambank. Area D's size is limited by the location of a large water line. This area is not a visible location for public education because it is located between the parking lot and Silas Creek Parkway.

Considering the site constraints, treatment potential, costs, and educational benefits, Buck Engineering recommends the improvements discussed above for areas B and C. The Area B BMP is consistent with the water quality goals of the Silas Creek restoration and also would be an aesthetic enhancement to the entrance of Shaffner Park. This is a key public viewing and awareness area. Area C is a cost effective location since it is part of the regrading efforts of Silas Creek and offers an opportunity to treat parking lot runoff before it enters Silas Creek. Area C also demonstrates how an existing parking lot can be retrofitted to improve water quality and still be an attractive amenity to a landscaped area, which is a valuable public awareness goal.

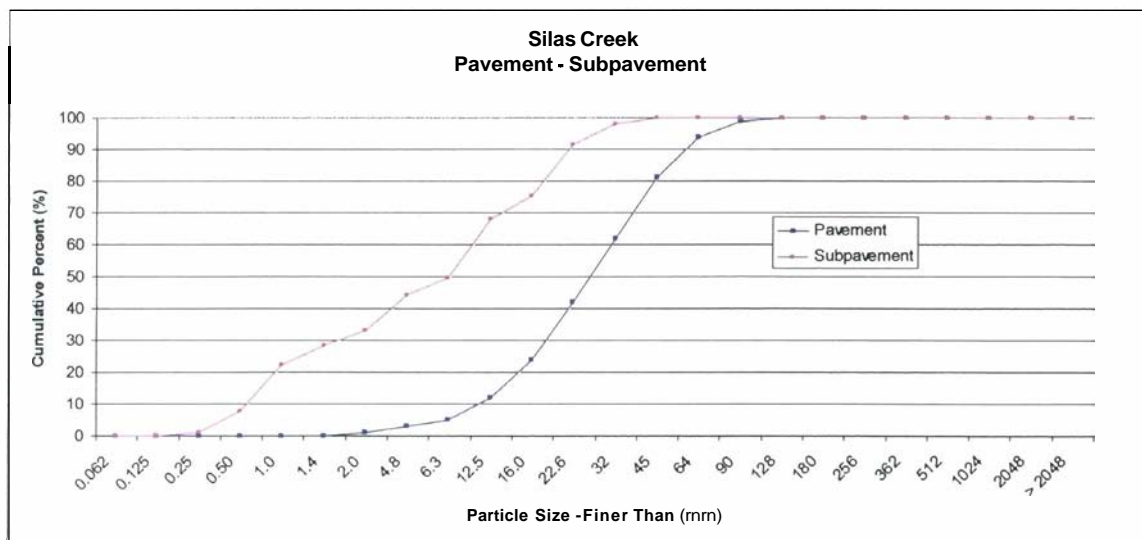
Data presented in Figure 6.1 were used to determine particle sizes for the various calculations. The D_{50}/D^{50} ratio is 4.1, so Equation 1 is valid. Critical dimensionless shear stress was calculated using Equation 1 as $\tau_{ci}^* = 0.024$. This value of dimensionless shear stress is used in the aggradation analysis presented below.

Figure 6.1. Silas Creek Pavement / Subpavement Analysis

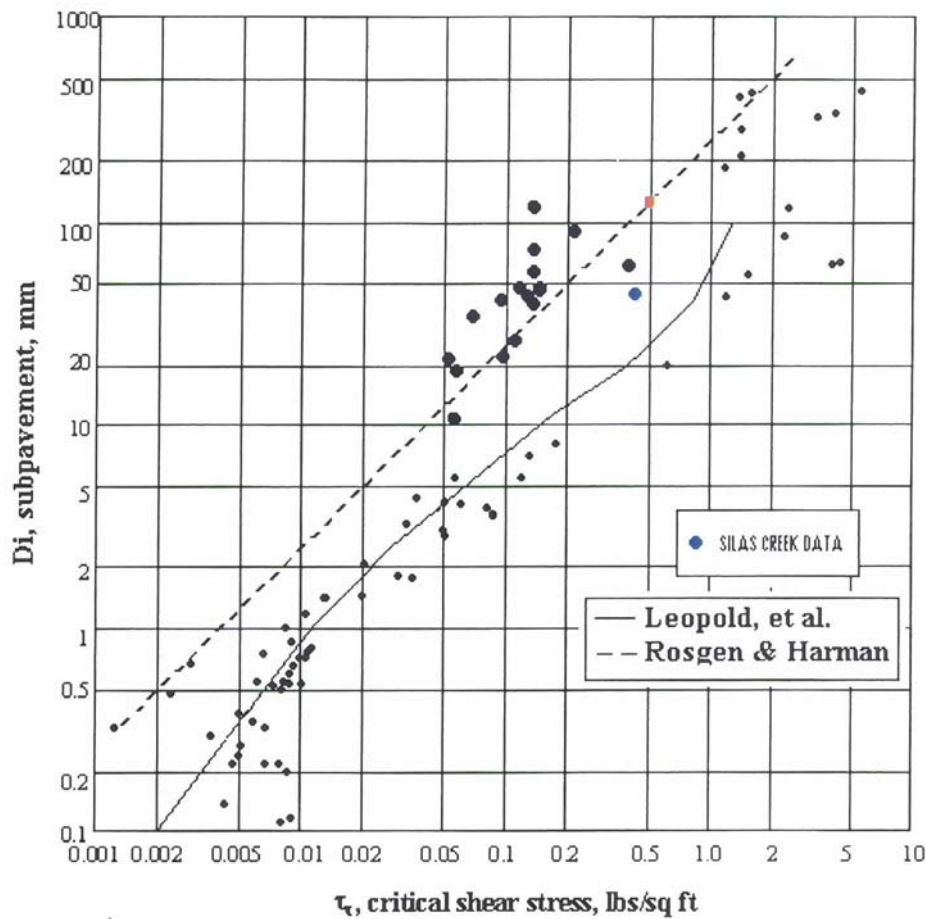
The boundary shear stress estimated for the design cross-section is 0.46 lb/ft². The measured D_i of the subpavement was 45 mm. As shown on the Modified Shield's Curve (Figure 6.2), this value of shear stress and D_i are just slightly below the range of values used to calculate the regression equation. The Shield's Curve analysis supports the critical depth based conclusion that the design-cross sections can move sediment competently and prevent aggradation.

Figure 6.2. Modified Shield's Curve for Grain Diameter of Transported Particle in Relation to Critical Shear Stress.

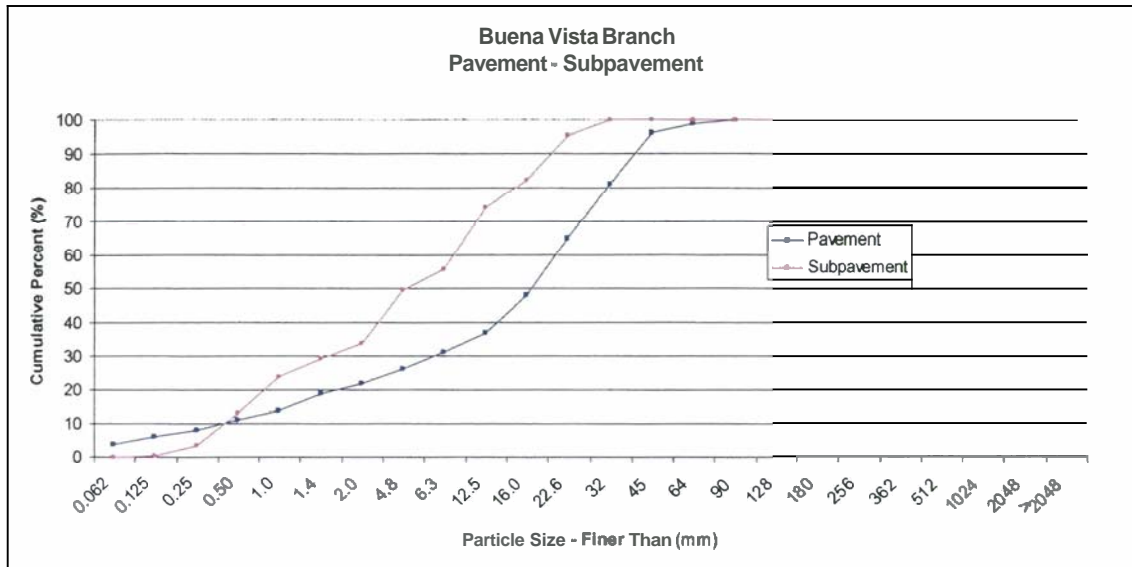
Data presented in Figure 6.3 was used to determine particle sizes for the various calculations. The D_{50}/D^{*}_{50} ratio is 3.4, so Equation 1 is valid. Critical dimensionless shear stress was calculated using Equation 1 as $\tau^*_{ci} = 0.0285$. This value of dimensionless shear stress is used in the aggradation analysis presented below.

Figure 6.3. Buena Vista Branch Pavement / Subpavement Analysis.

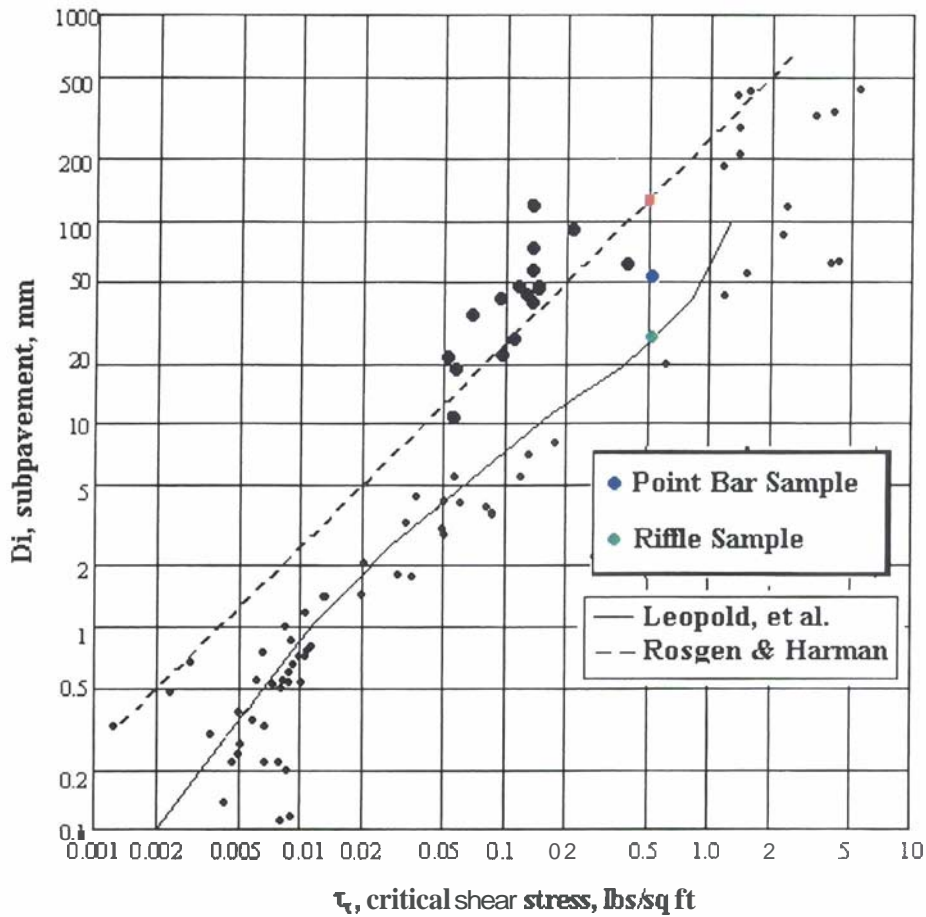
The boundary shear stress estimated for the design cross-section on Buena Vista Branch is 0.51 lb/ft². The measured D_i of the subpavement was 55 mm from the bar sample and 36 mm from the riffle sample. As shown on the Modified Shield's Curve (Figure 6.4), this value of shear stress and both D_i values fall below the range of values used to calculate the regression equation. The Shield's Curve analysis supports the critical depth based conclusion that the design-cross sections can move sediment competently and prevent aggradation. The issue of potential degradation is discussed below.

Figure 6.4. Modified Shield's Curve for Grain Diameter of Transported Particle in Relation to Critical Shear Stress.

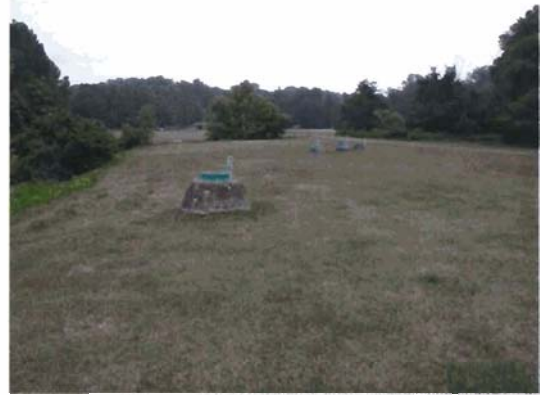
H. Sewer Lines on Left flank of Reach 2

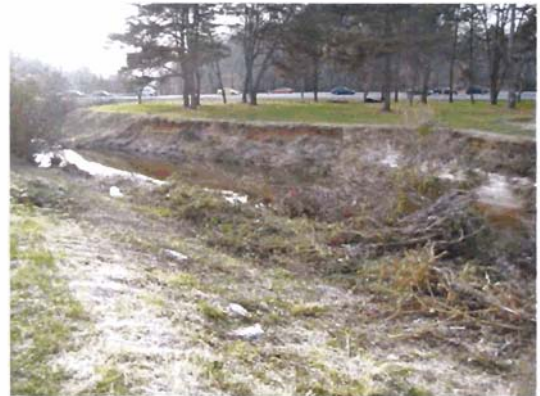
J. Bank Erosion on Silas Creek

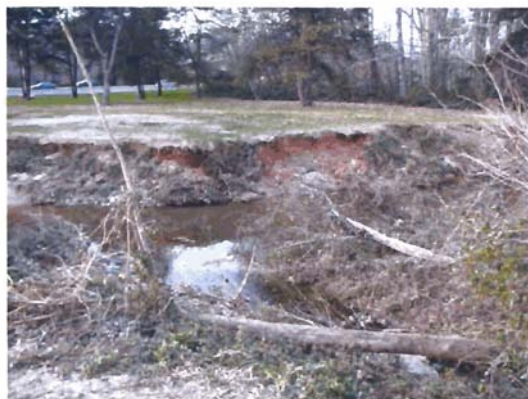
K. Bank Erosion on Silas Creek

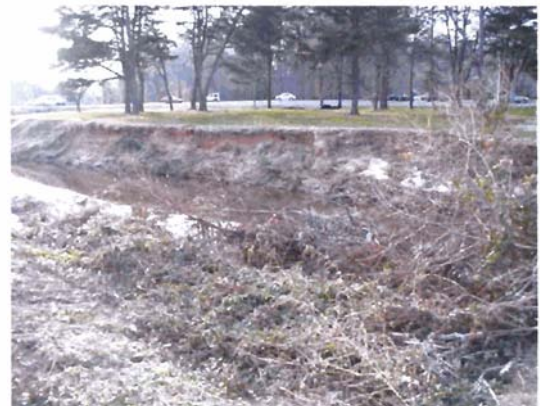
L. Bank Erosion on Silas Creek

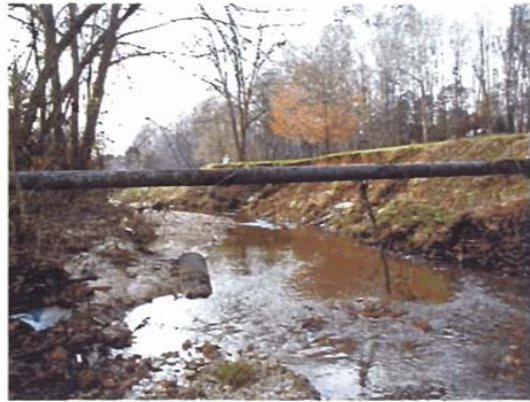
I. Bank Erosion on Silas Creek

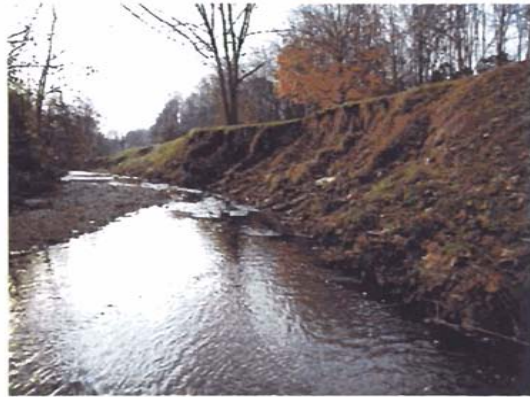
K. Bank Erosion on Silas Creek
