# Mitigation Plan for Stream Mitigation of Silver Creek and Unnamed Tributary

Silver Creek and Unnamed Tributary  
Burke County, NC  
SCO # D05016-1

**Submitted:** September 11, 2007

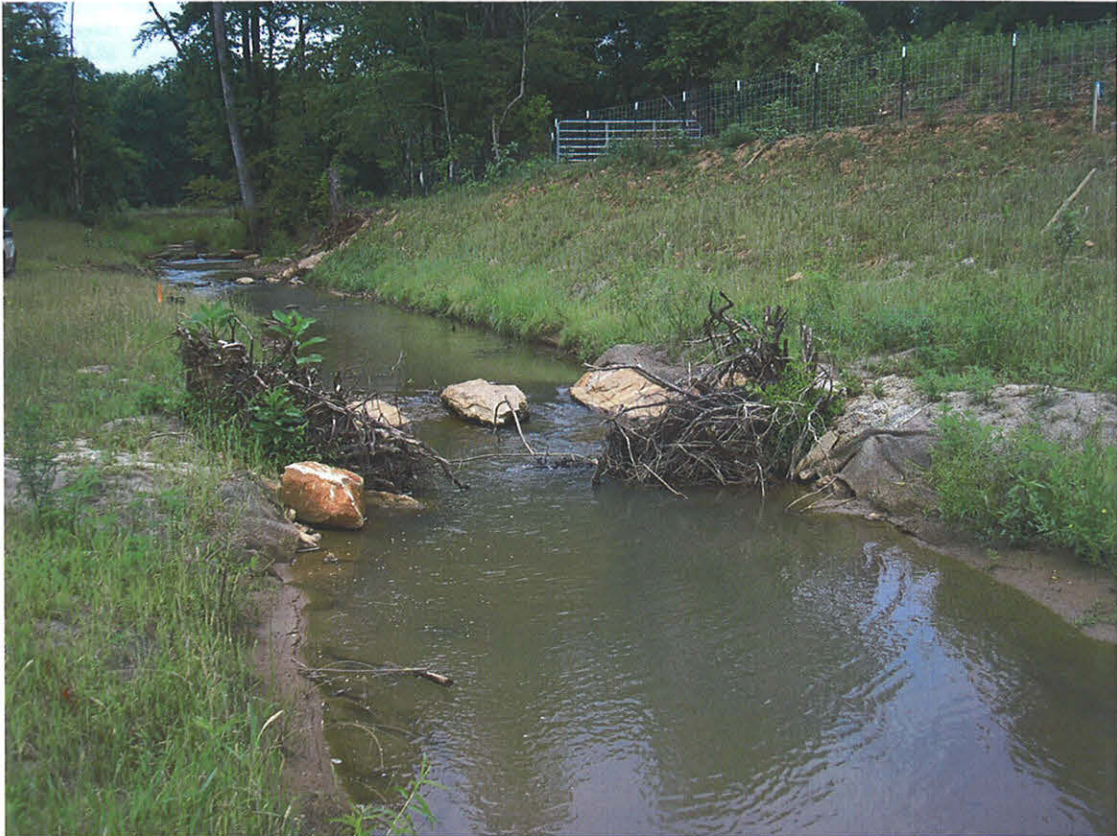
Mainstem Reach – Cross-Vane No.1 - Post Revetment – Looking Upstream

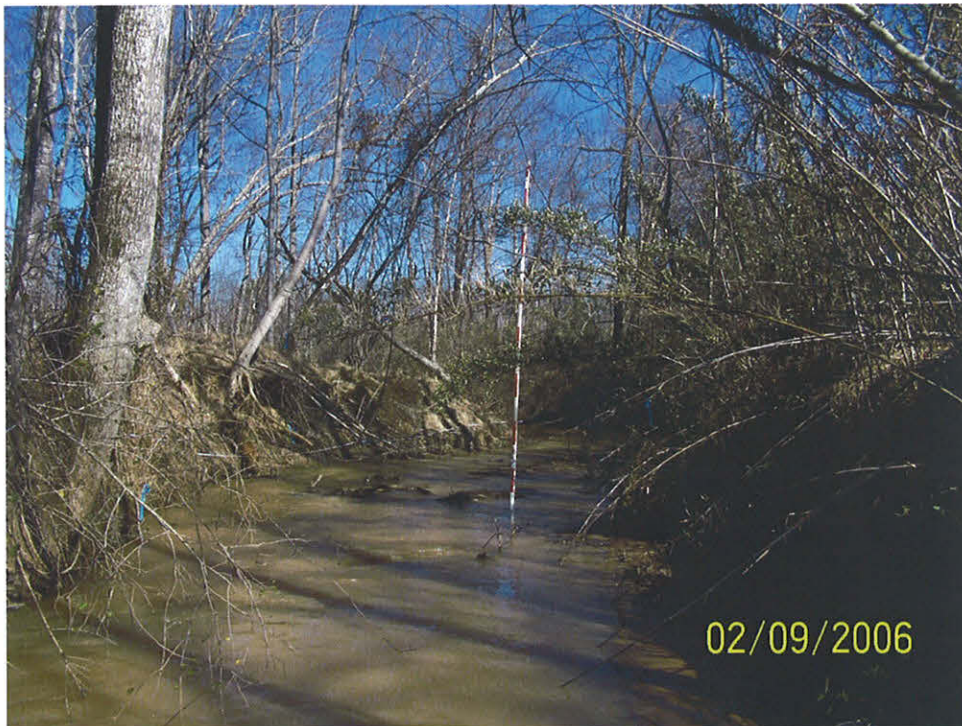
General Vicinity of Cross-Vane No. 2 – Pre-Restoration – Looking Upstream

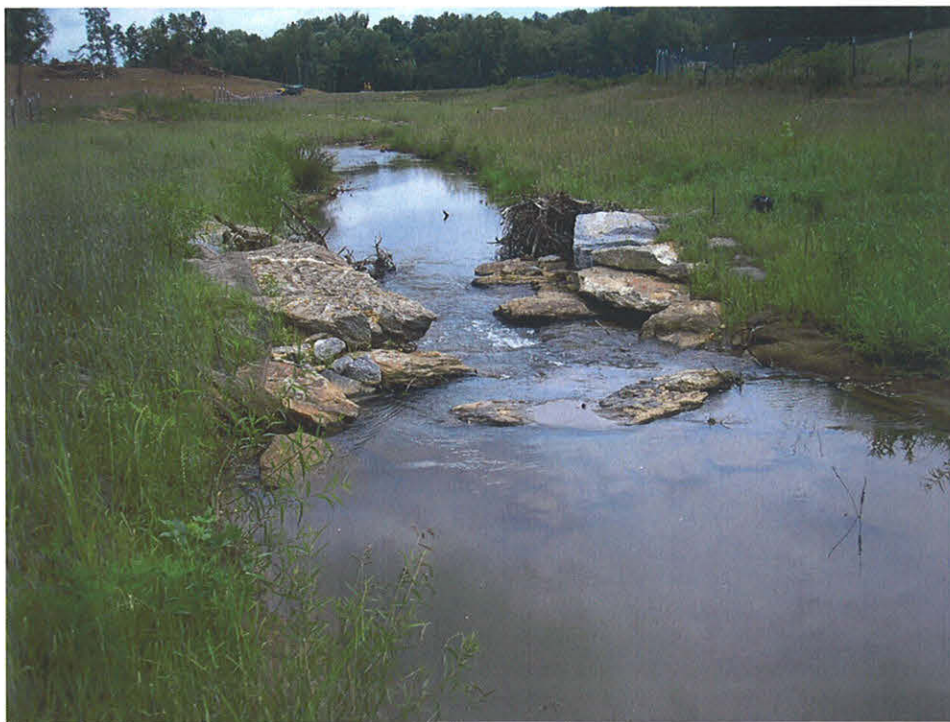
Mainstem Reach – Cross-Vane No. 2 – Post Restoration – Looking Downstream

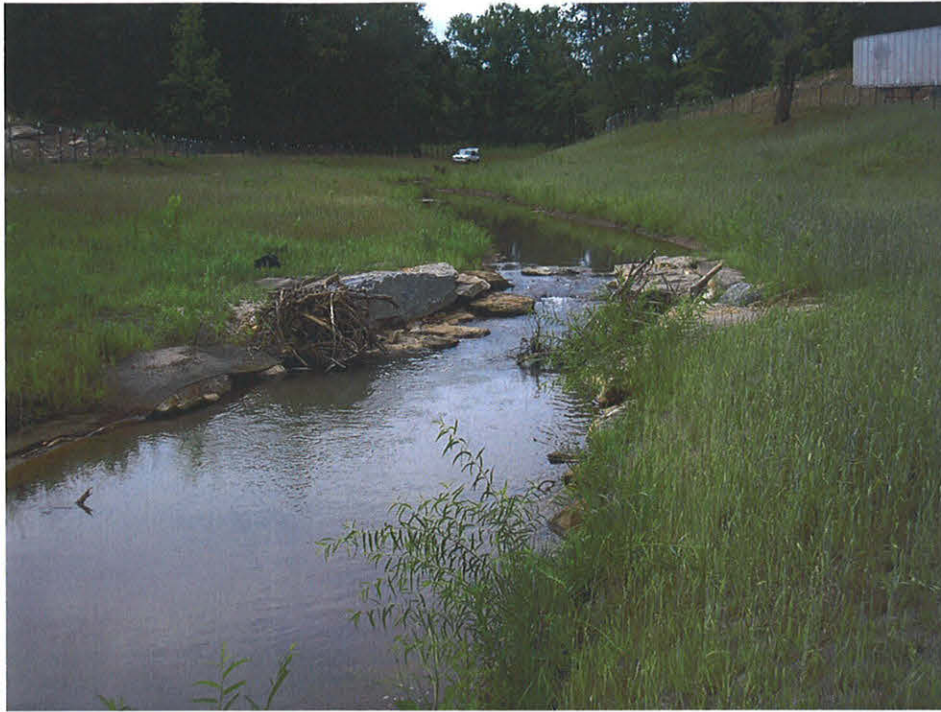
Mainstem Reach – Cross-Vane No. 2 – Post Restoration – Looking Upstream

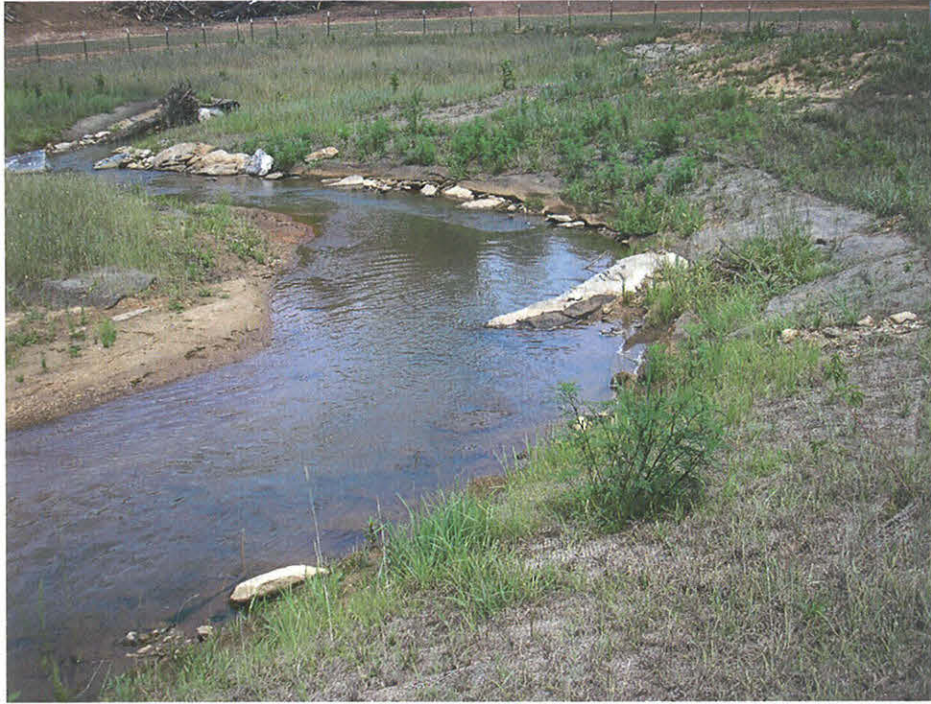
Mainstem Reach – Over Tightened Meander – Post-Restoration - Rock Vane – Boulder Toe Bank Reinforcement – Upstream Bend – Looking Downstream

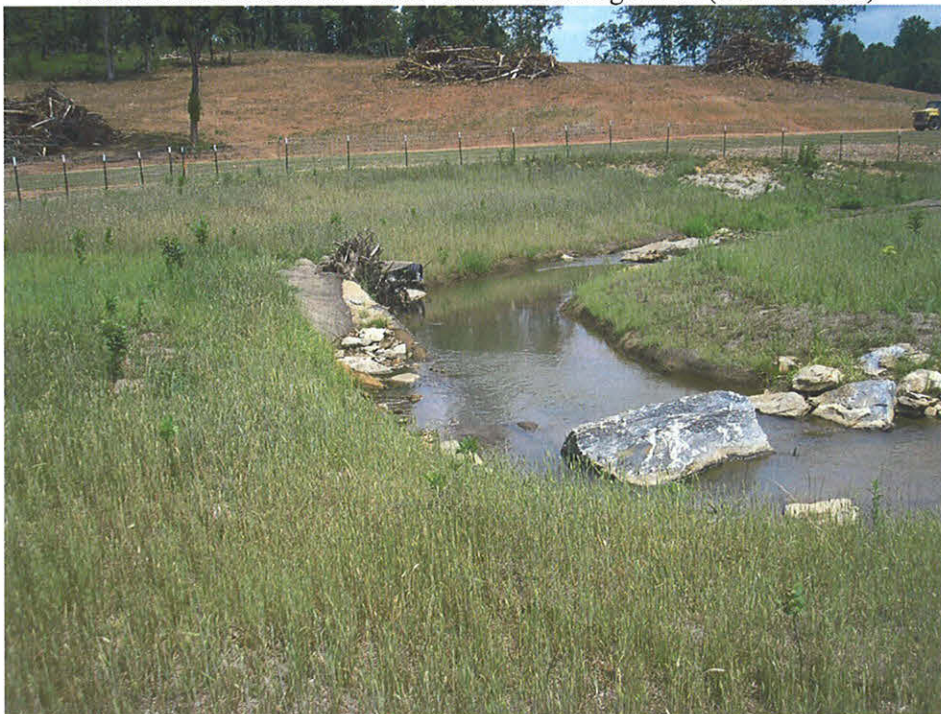
Mainstem Reach – Over Tightened Meander – Post-Restoration - Log Vane - J-Hook – Root Wad Combination Structure – Mid-Bend – Looking North (Downstream)

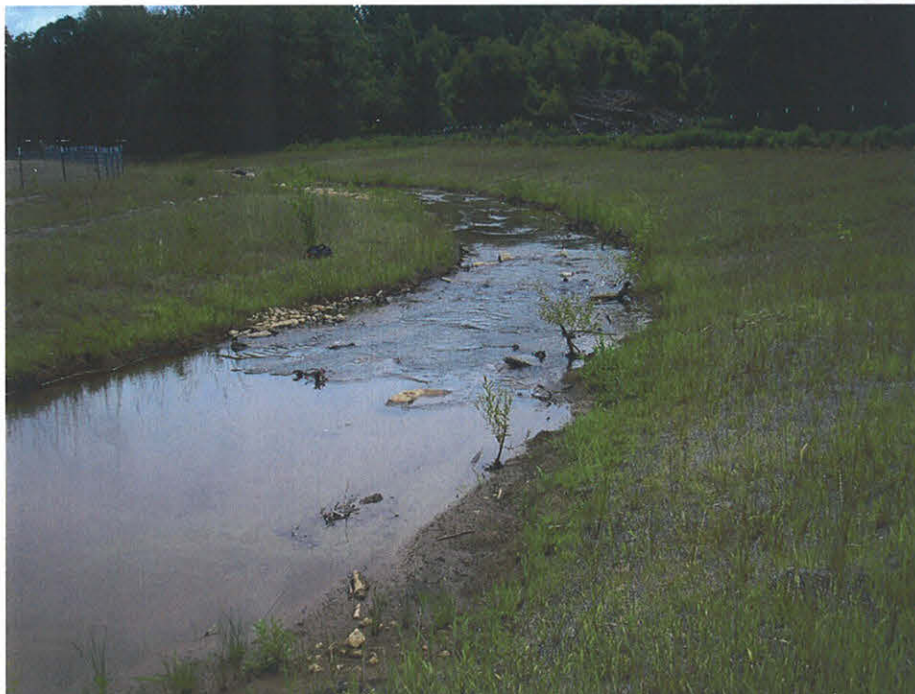
Mainstem Reach – Constructed Riffle – Downstream End – Over Tightened Meander

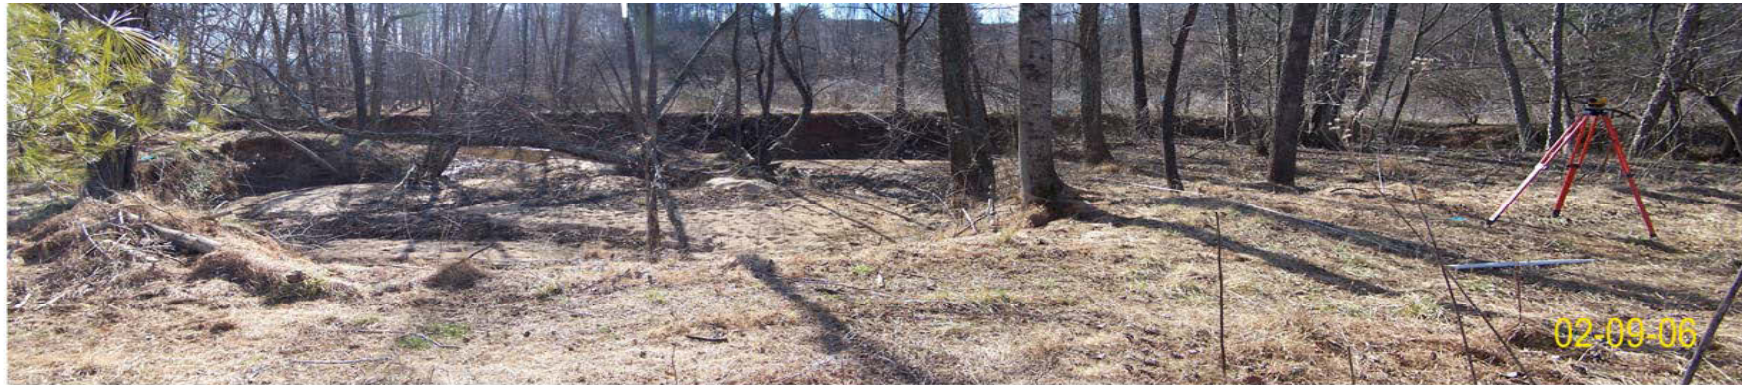
Mainstem Reach - Abandoned Oxbow – Pre-Restoration

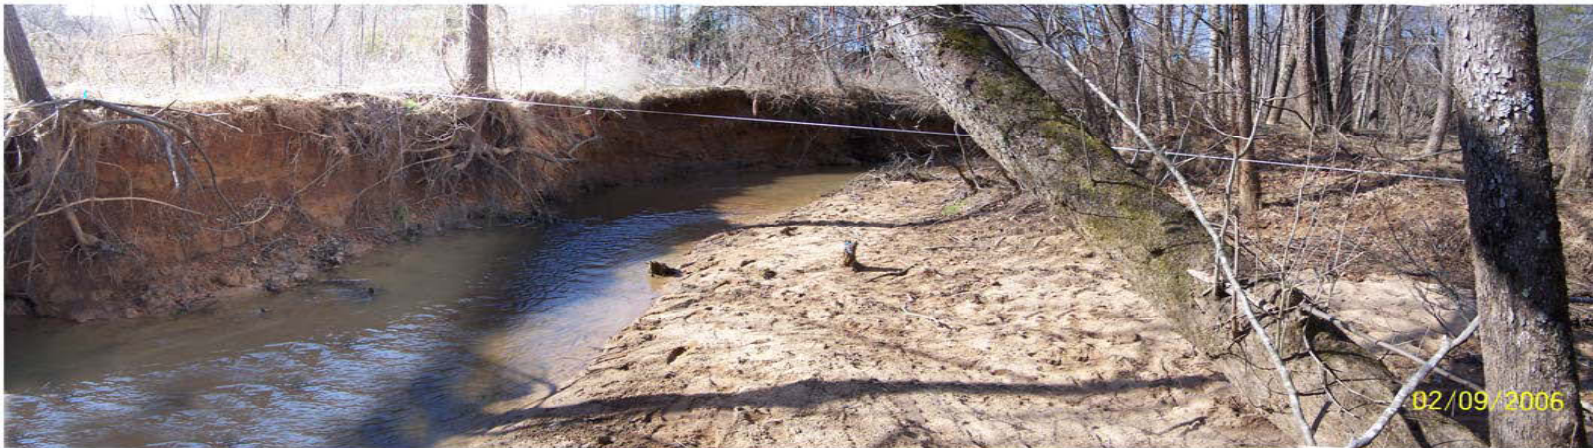
Mainstem Reach – Abandoned Oxbow – Riffle Cross-Section – Looking Upstream – Pre-Restoration

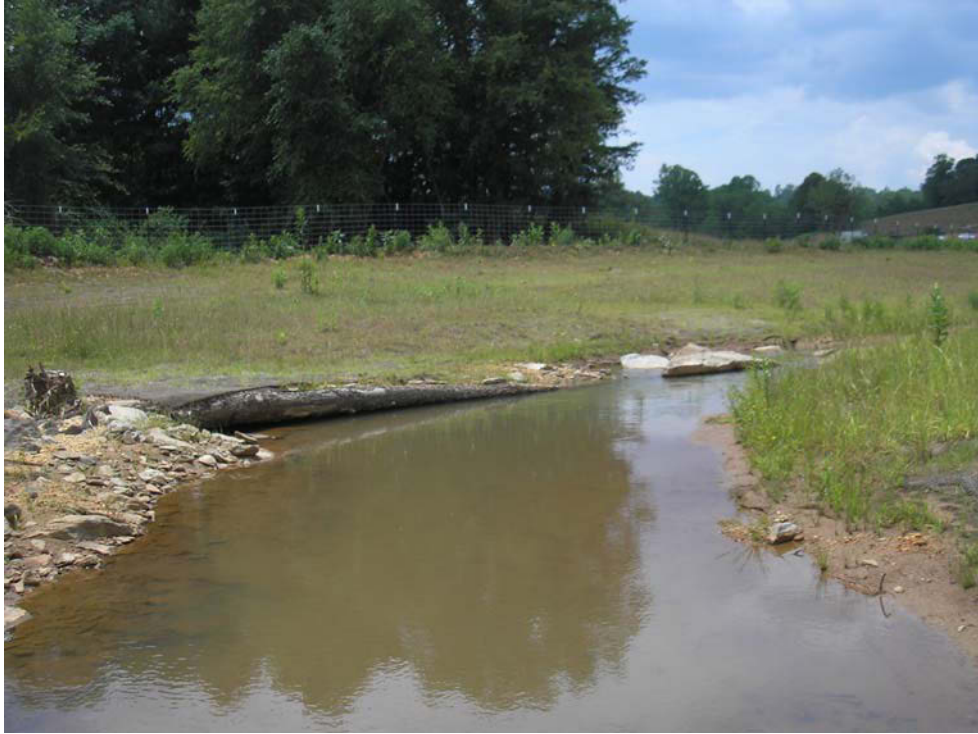
Log-Vane J-Hook Structure – Upstream from former Abandoned Oxbow – Post-Restoration -  
Looking Upstream

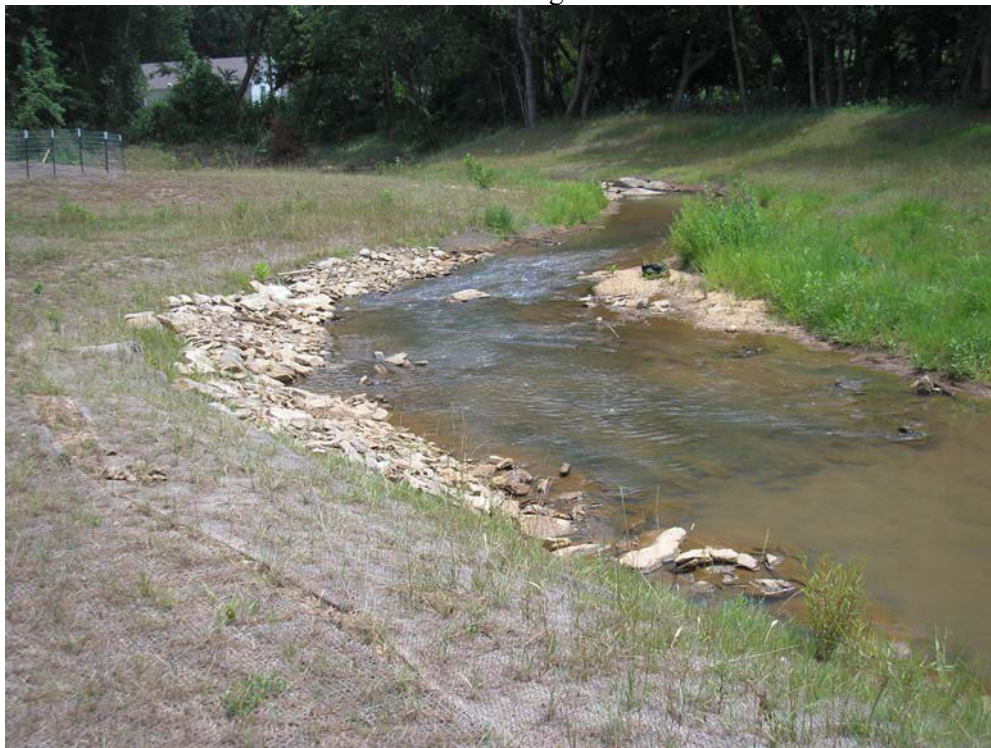
Constructed Riffle with Rock Toe Bank Reinforcement - Location of former Abandoned Oxbow Post  
Remediation – Looking Downstream

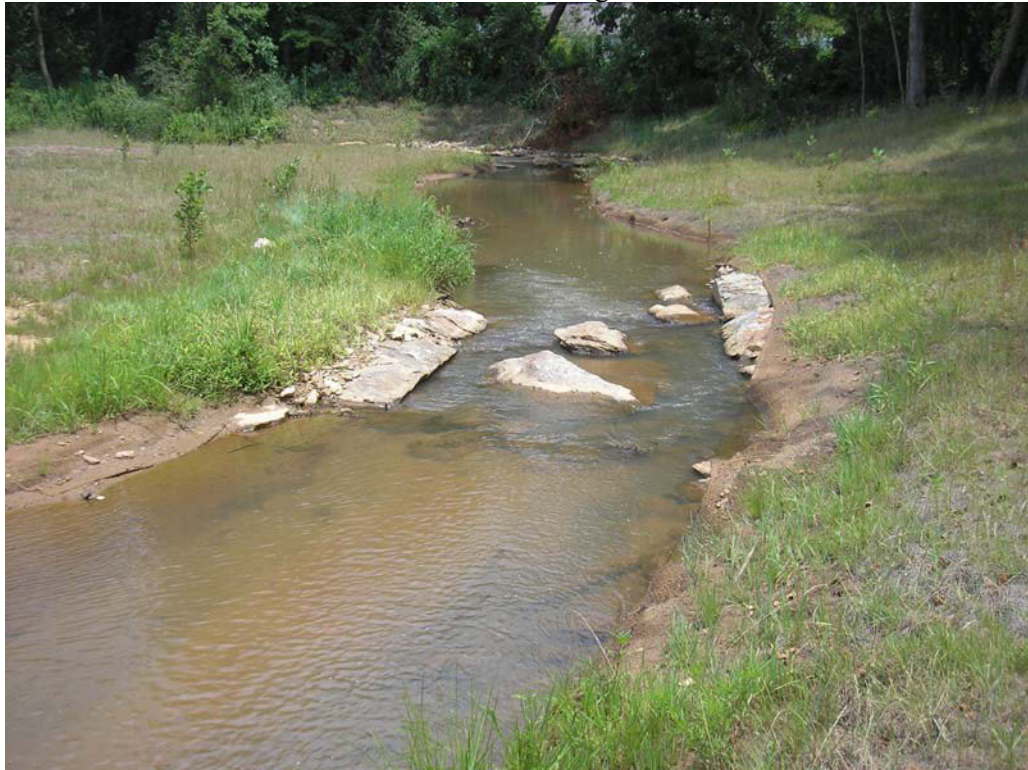
Dual-Winged Jetty Riffle with Random Boulder Cluster - Location of former Abandoned Oxbow –  
Post Remediation – Looking Downstream

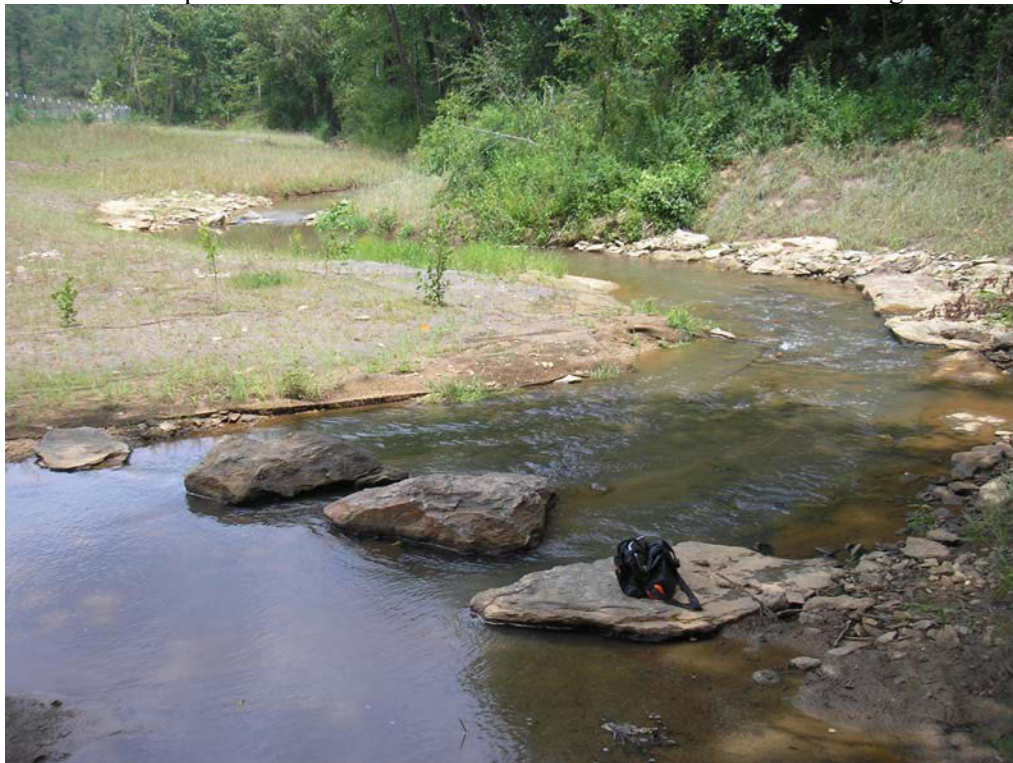
Rock Vane with Upstream Boulder Cluster – At confluence of UT-D – Looking Downstream

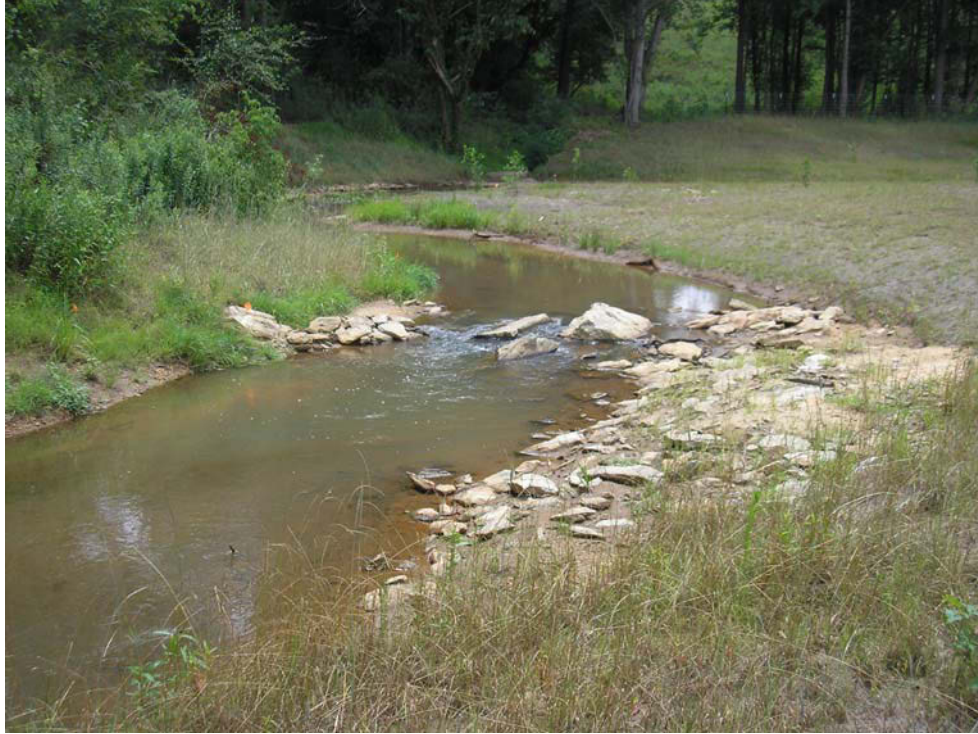
J-Hook Rock Vane – Looking Upstream at the confluence of UT-D – Post Restoration

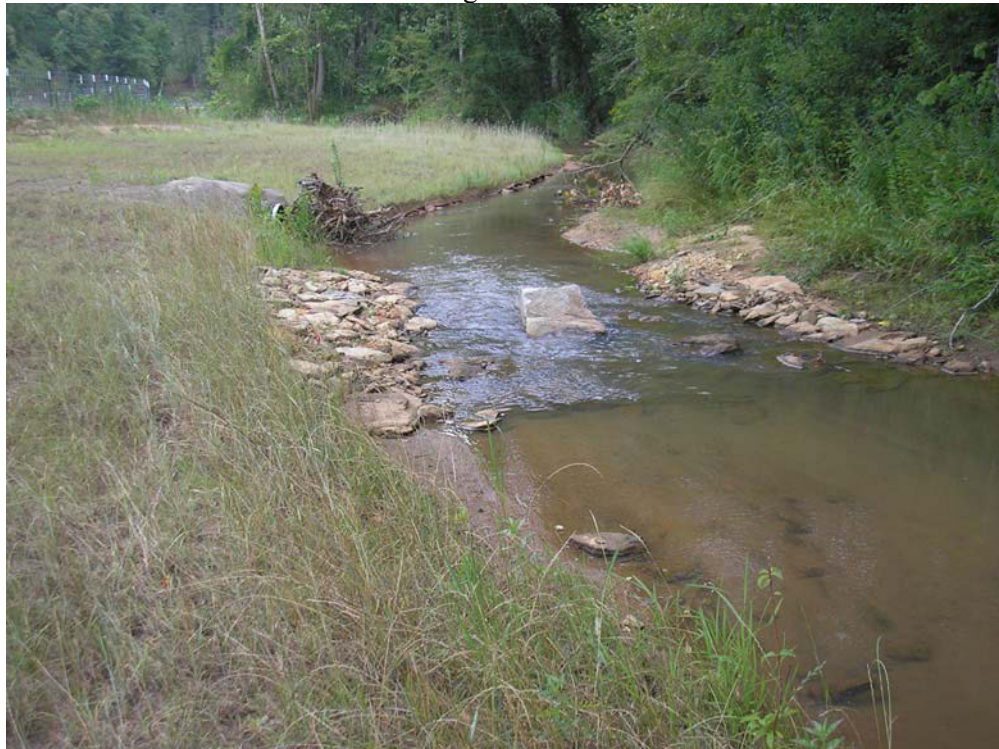
Dual Winged Jetty Riffle with Random Boulder Cluster – Downstream from confluence of UT-D – Looking Downstream

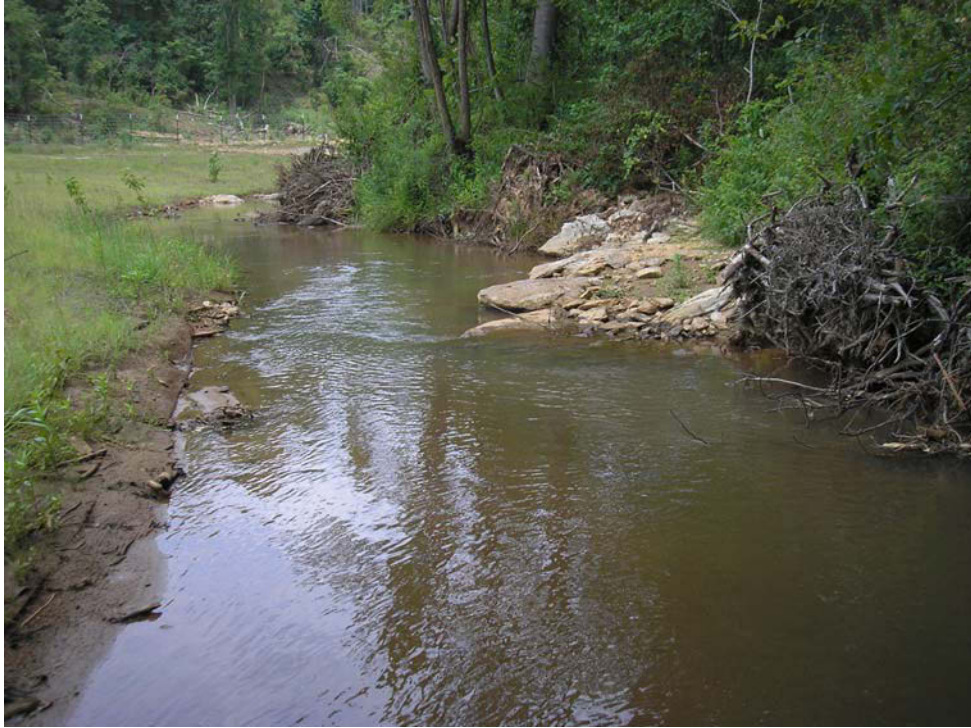
Single Arm Rock Vane with Root Wad Bank Stabilization at approximate mid-point between confluences of UT-C and UT-D with Silver Creek – Looking Downstream

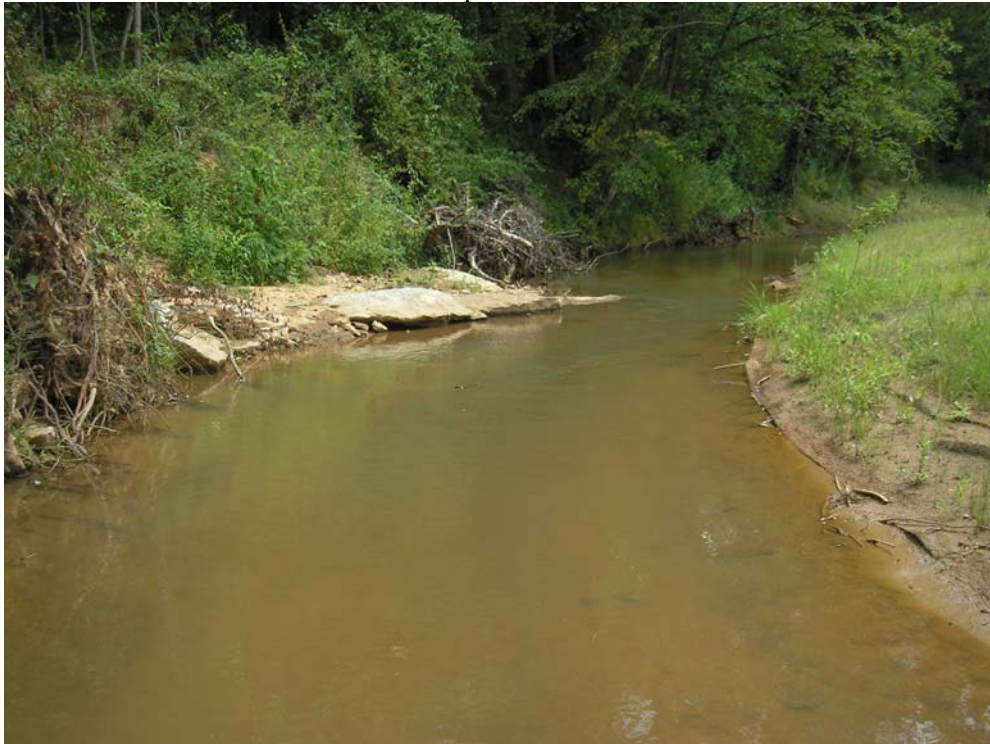
Single Arm Rock Vane with Root Wad Bank Stabilization (shown above) – Post-Restoration Looking Upstream

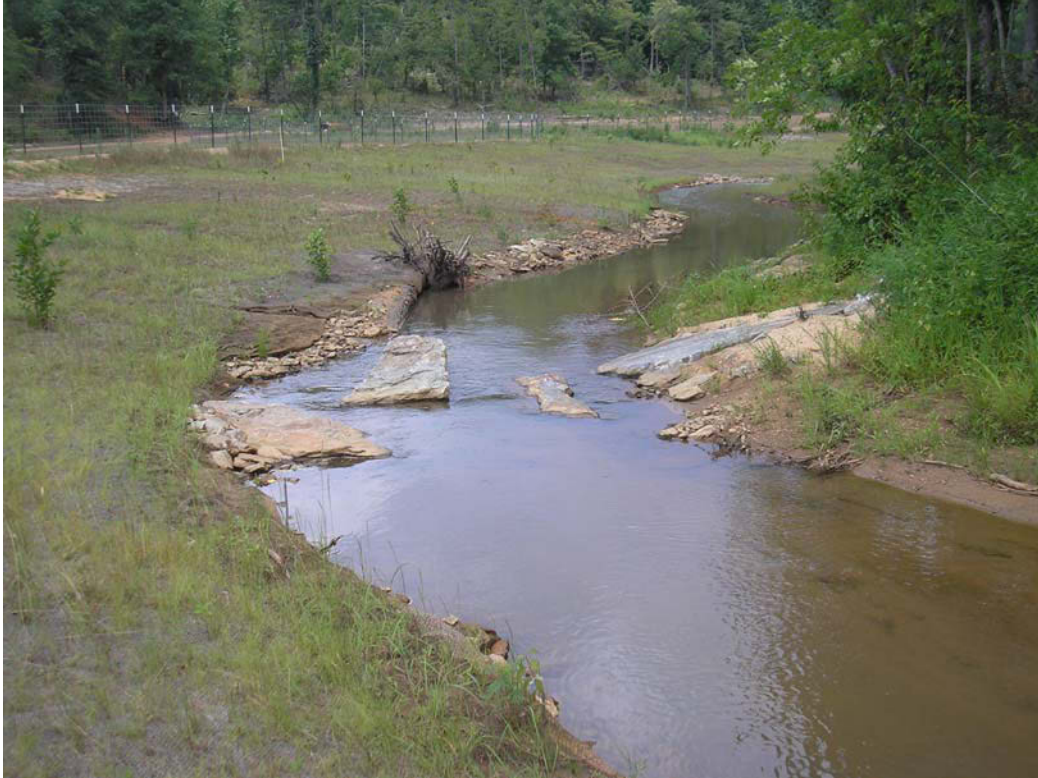
Log Vane J-hook Combination Structure – Upstream from Confluence of UT-C – Post Remediation

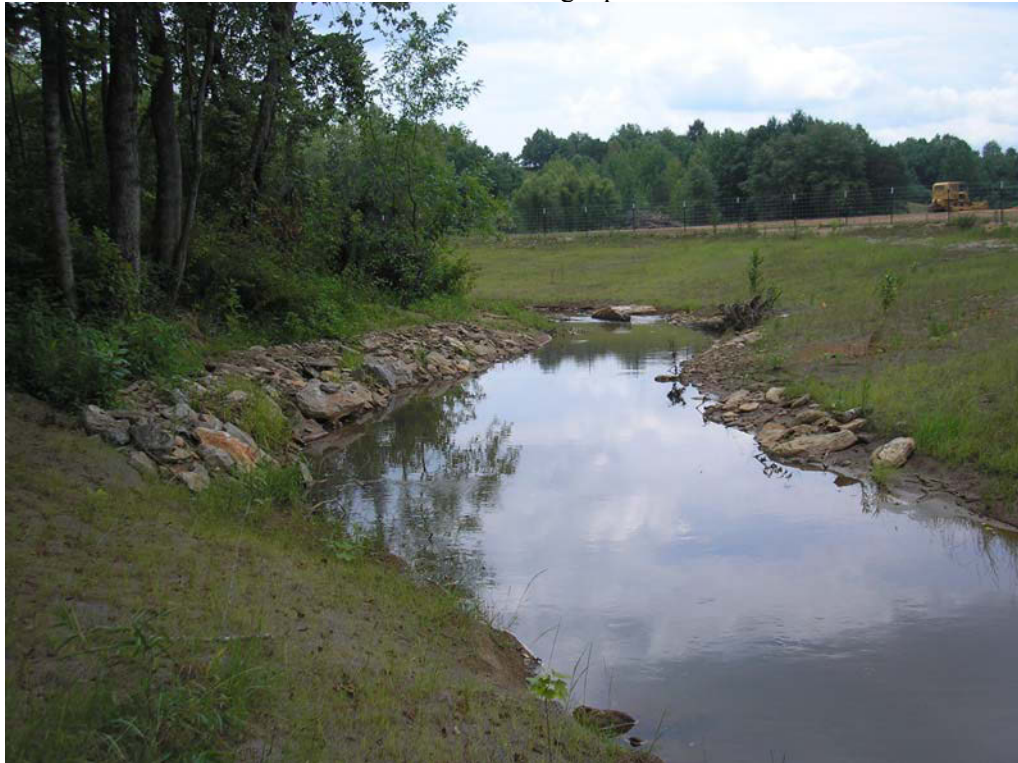
Rock Toe Channel Reinforcement upstream from confluence of UT-C with Mainstem – Post-Restoration Looking Upstream

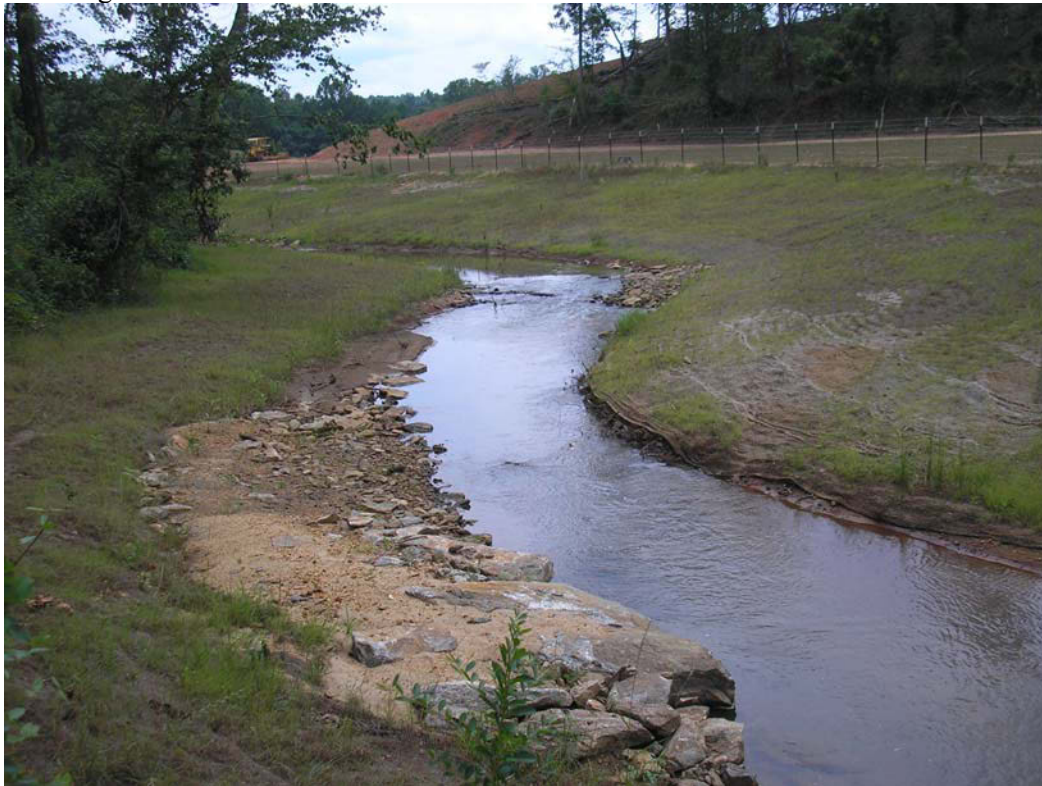
Single Arm Rock Vane above confluence of UT-C with Silver Creek Mainstem

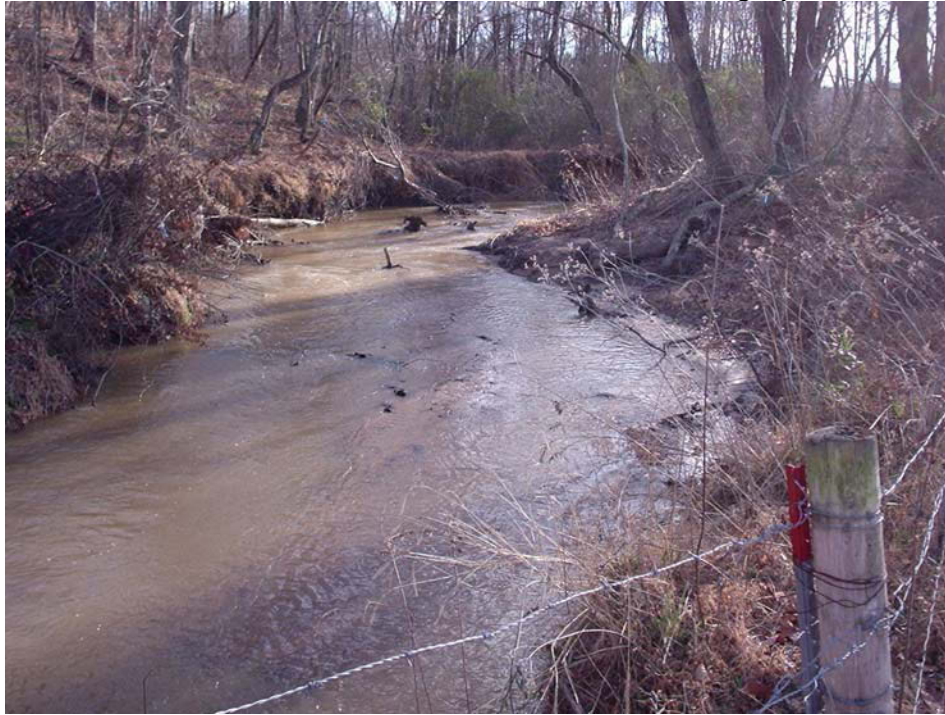
Bottom of Mainstem Reach – Pre-Restoration – Looking Upstream

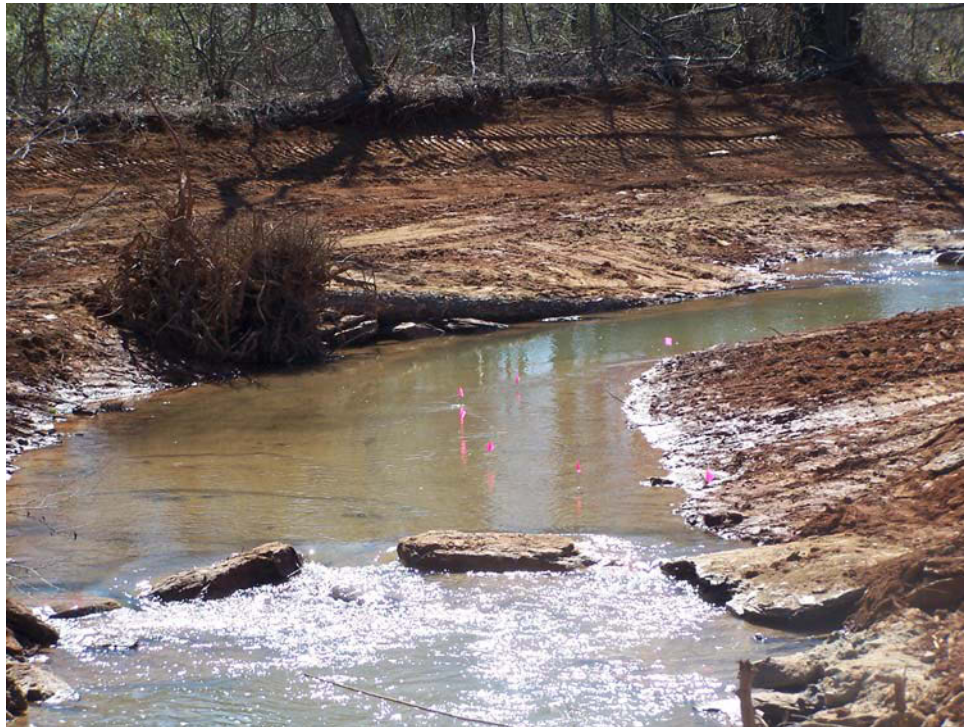
Bottom of Mainstem Reach – Log-Vane, J-Hook, Root Wad Combination Structure followed by Cross-Vane No. 4 – During Construction - End of Mainstem Project

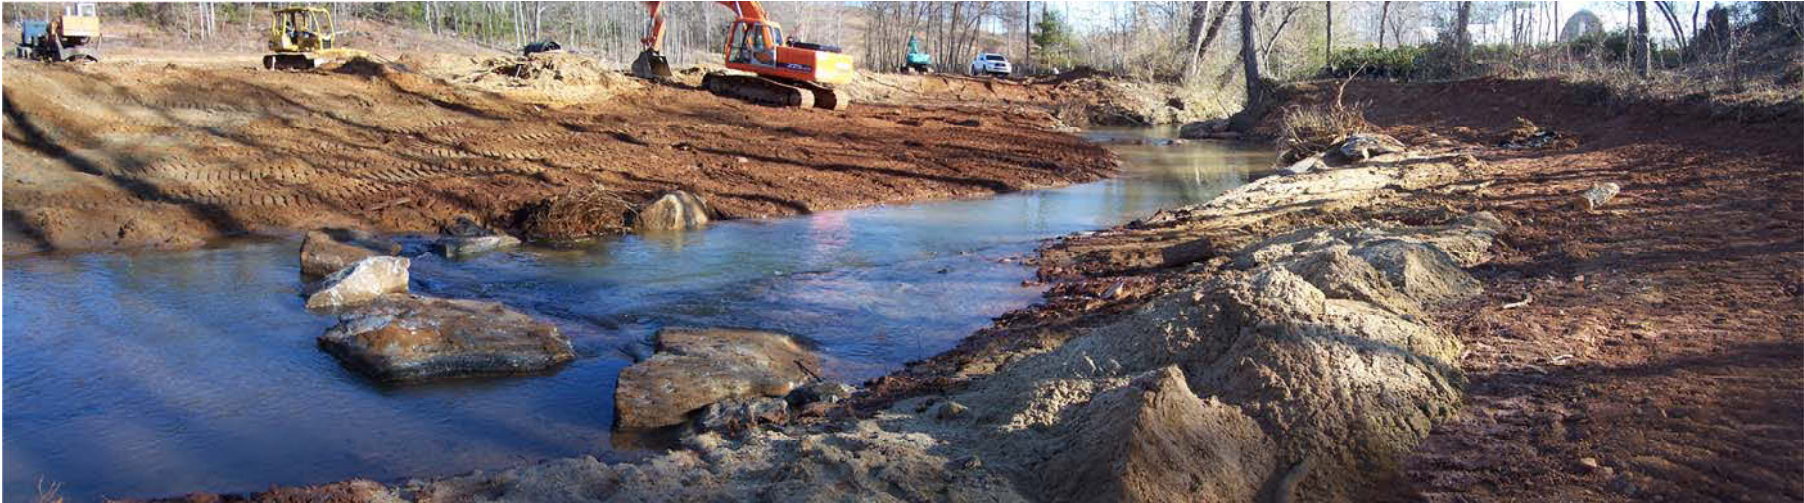
Mainstem Reach – Log-Vane, J-Hook, Root Wad Combination Structure – During Construction – February 2007

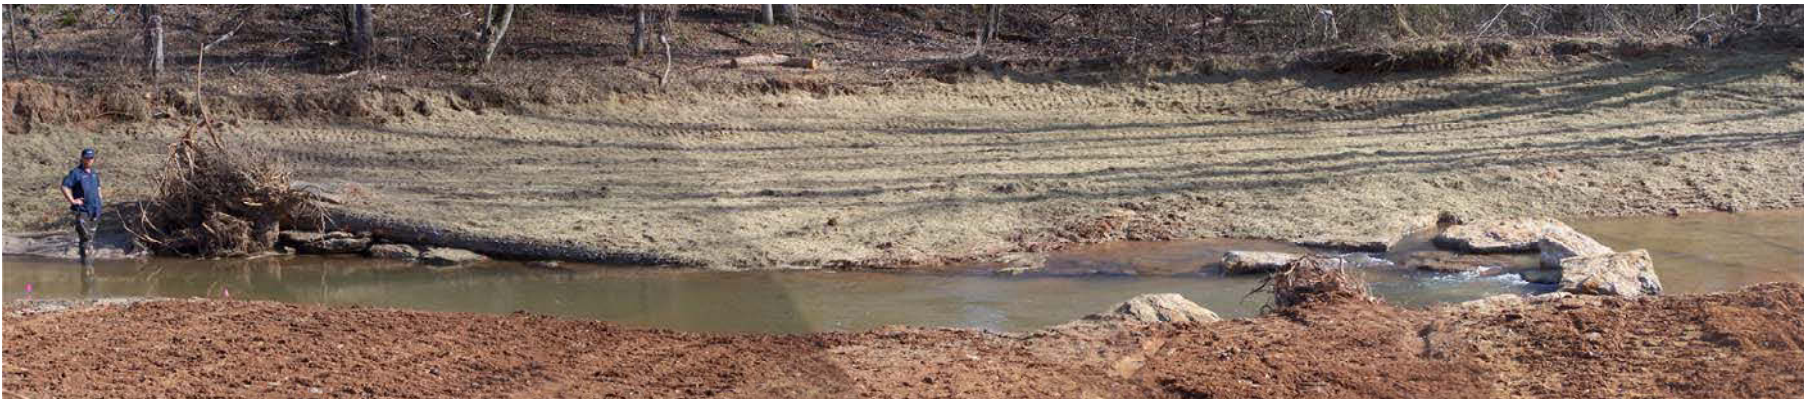
Mainstem Reach – Log-Vane, J-Hook, Root Wad Combination Structure – After Seeding, Mulching and Jute Matting Right Bank – February 2007

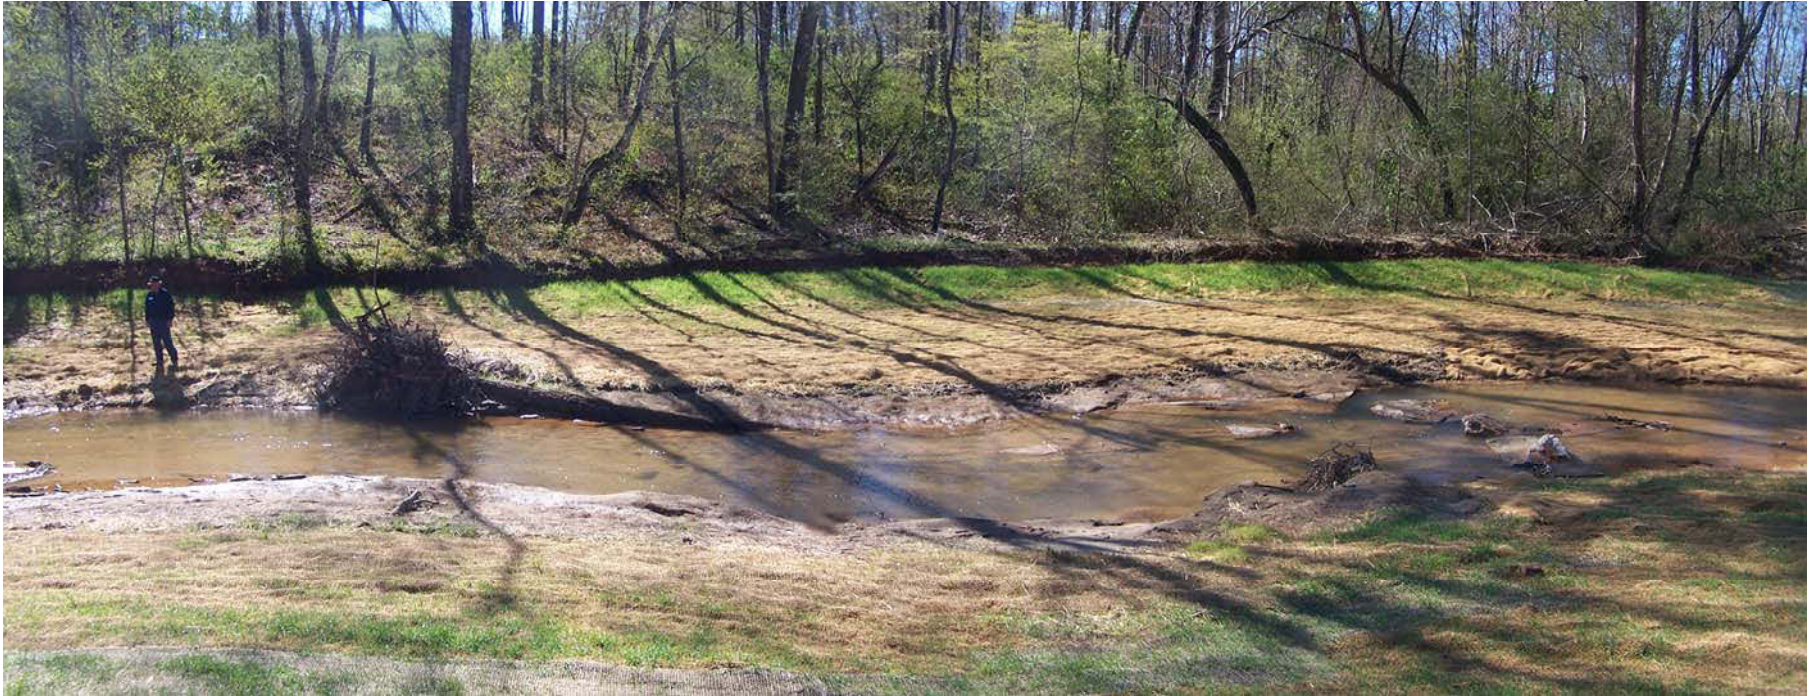
Mainstem Reach – Log-Vane, J-Hook, Root Wad Combination Structure – After Herbaceous Ground Cover Established – April 2007
