STREAM RESTORATION PLAN

UNNAMED TRIBUTARY TO CANE CREEK

Alamance County, NC

APRIL 2003

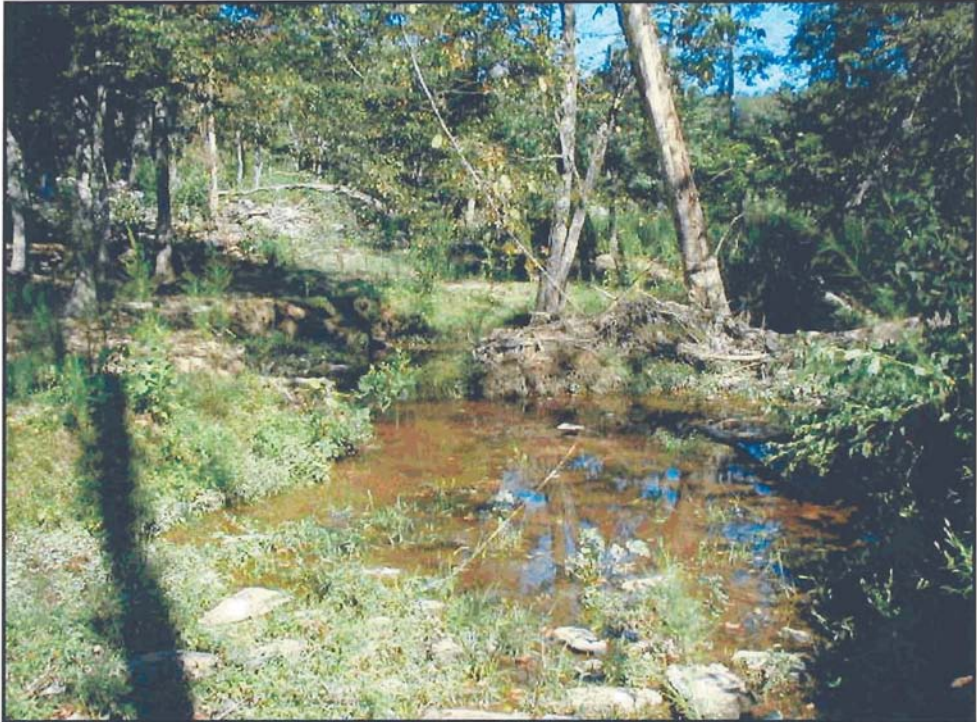
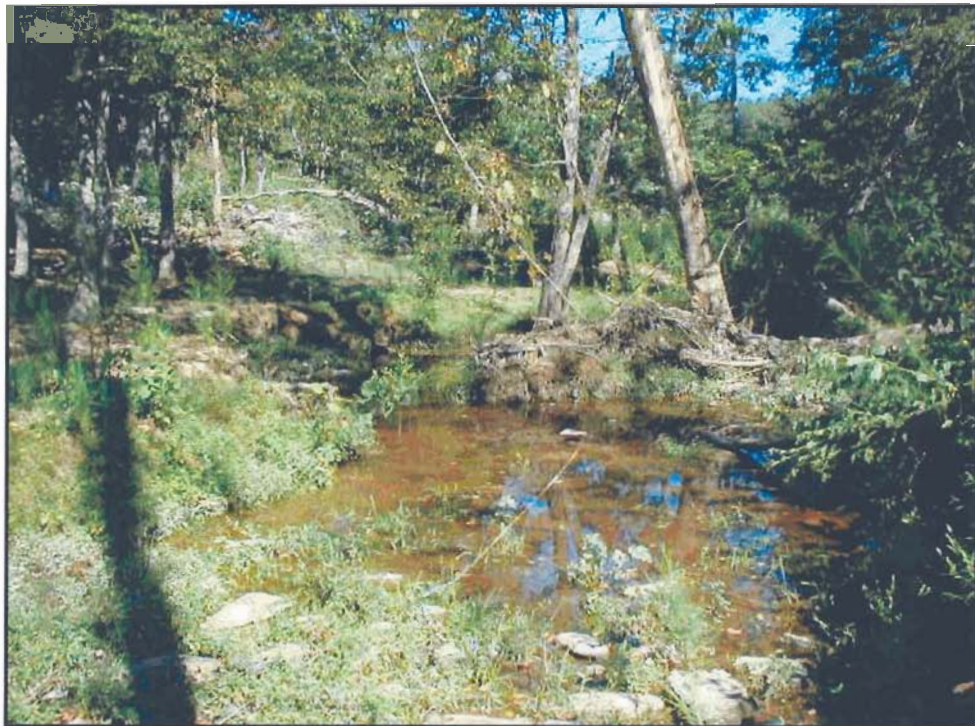
Exhibit 2.2.1b Site Photographs

Bank erosion is prevalent in the upper and middle reach due to the highly erosive soils and lack of vegetation that helps to stabilize an area. The lower reach of the restoration site has been straightened in the past and is dominated by straight, shallow pools.

Vegetation growing in channel from dry summer conditions

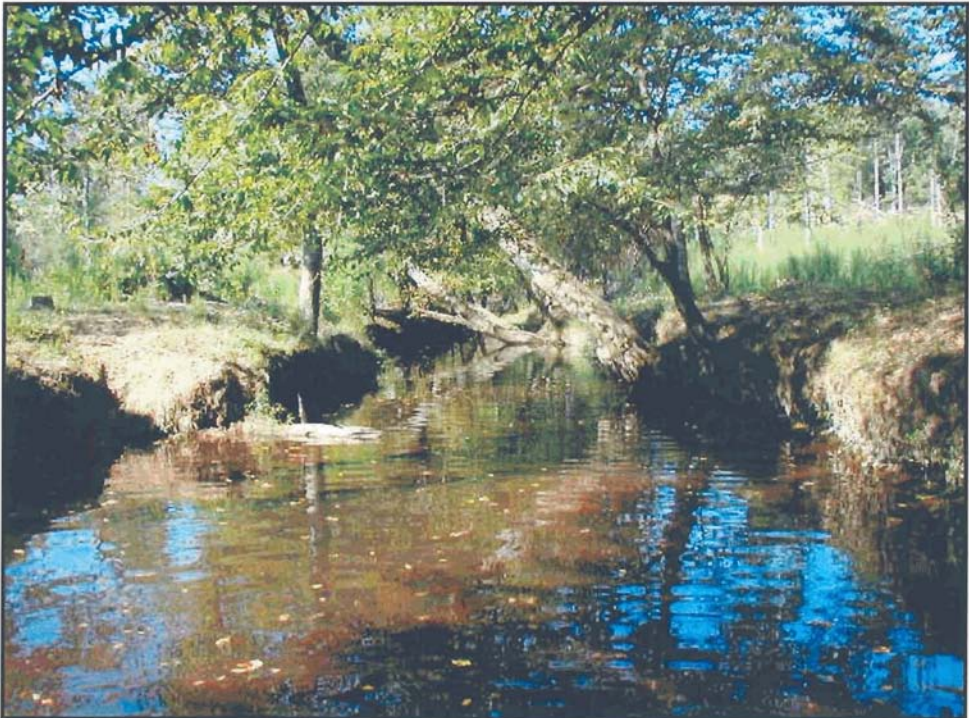
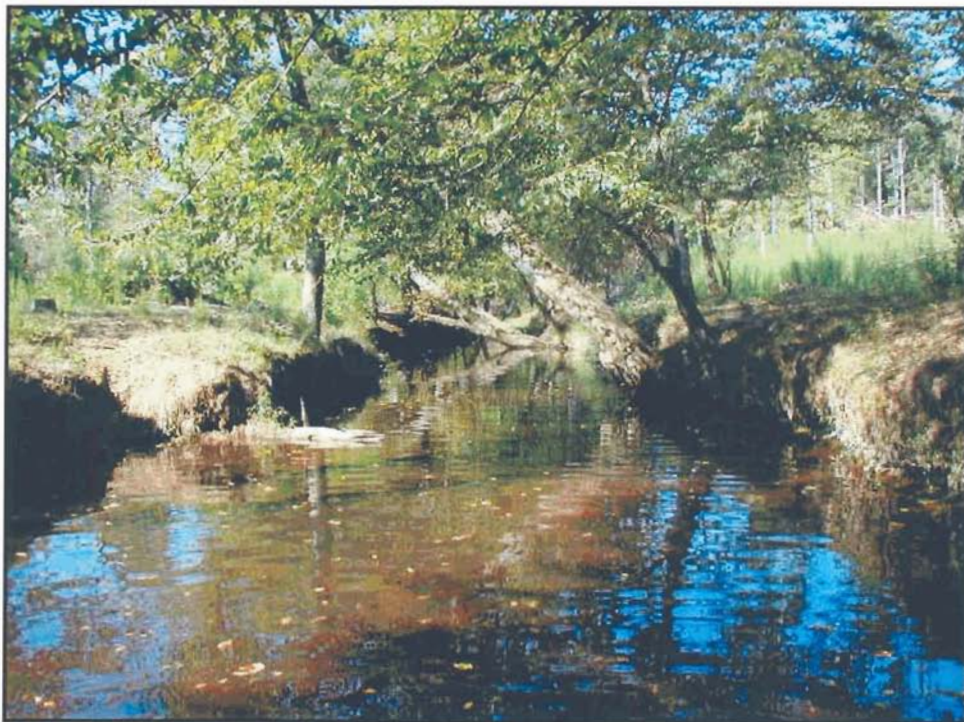
Long straight, shallow pool feature common throughout site

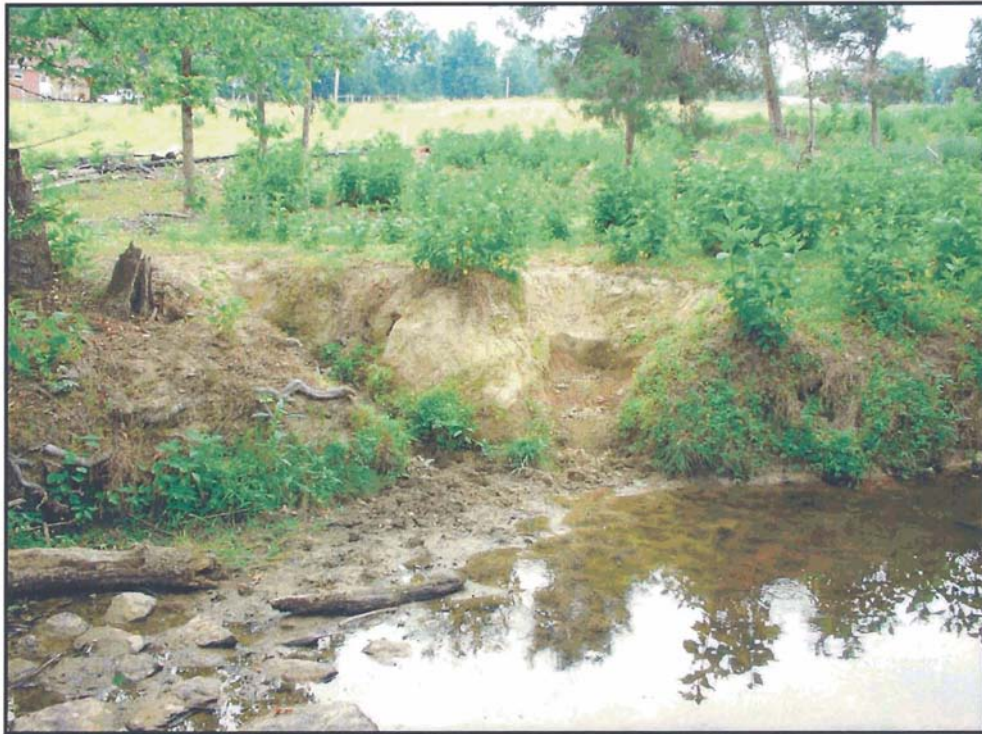
Exhibit 2.2.2 Cattle Impacts to the UT to Cane Creek

Bank degradation at this site can be attributed to the unlimited access that the cattle have to the channel and to the lack of a vegetated riparian buffer. During reach surveys, many cattle trails were observed entering the UT. The cattle have repeatedly trod through these areas, destroying the vegetation and causing gullies and ruts to form on the banks (Exhibit 2.2.2). These conditions have created highly erosive areas where sediment can enter the channel and cover the natural substrate. Additionally, the cattle are utilizing the channel as a wading pool. These areas are low, mucky depressions that host seasonal vegetation during summer droughts. Further, cattle have urinated and defecated in the stream channel adding to the mucky conditions, increasing nutrient levels and creating conditions for bacteria to flourish.

Ruts created by cattle moving through the area

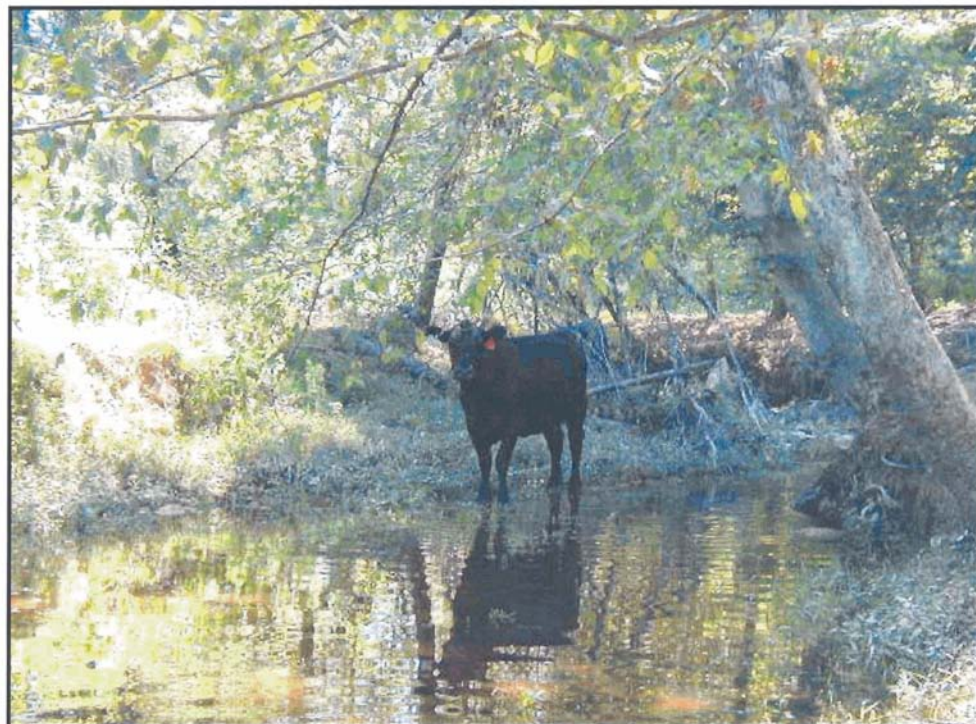
One of many cattle that have access to the stream

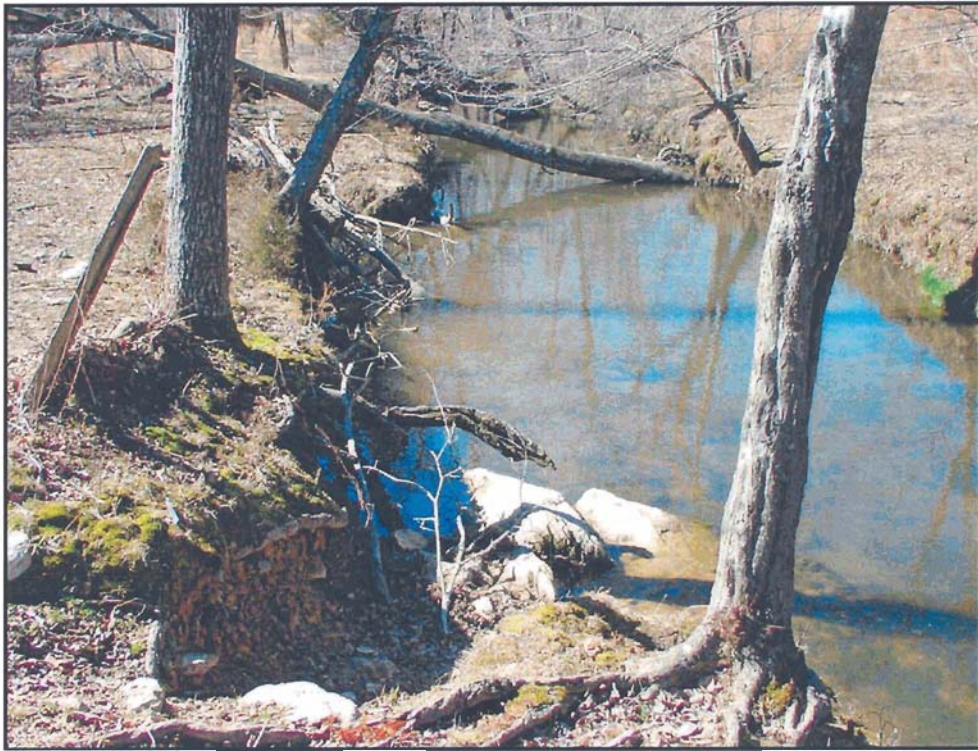
Exhibit 3.2.1a Existing Stream Conditions

Eroded banks with trees falling in channel

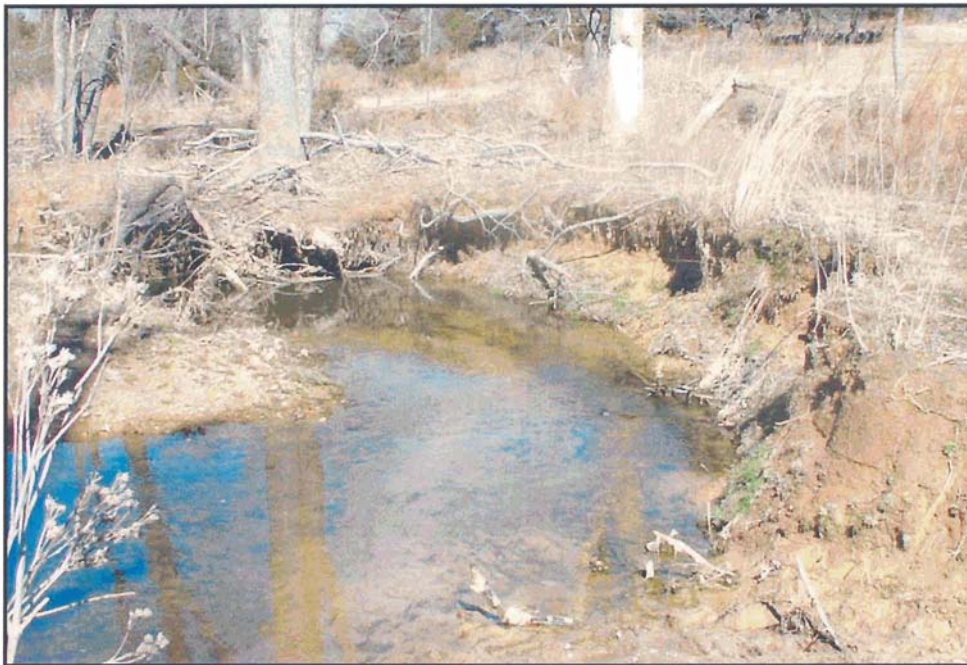
Eroded banks
