**Stream Restoration Plan**

**UNNAMED TRIBUTARY TO  
MARYS CREEK  
Alamance County, NC**

**APRIL 2003**

Stantec Consulting Services Inc.  
801 Jones Franklin Road, Suite 300  
Raleigh, NC 27606

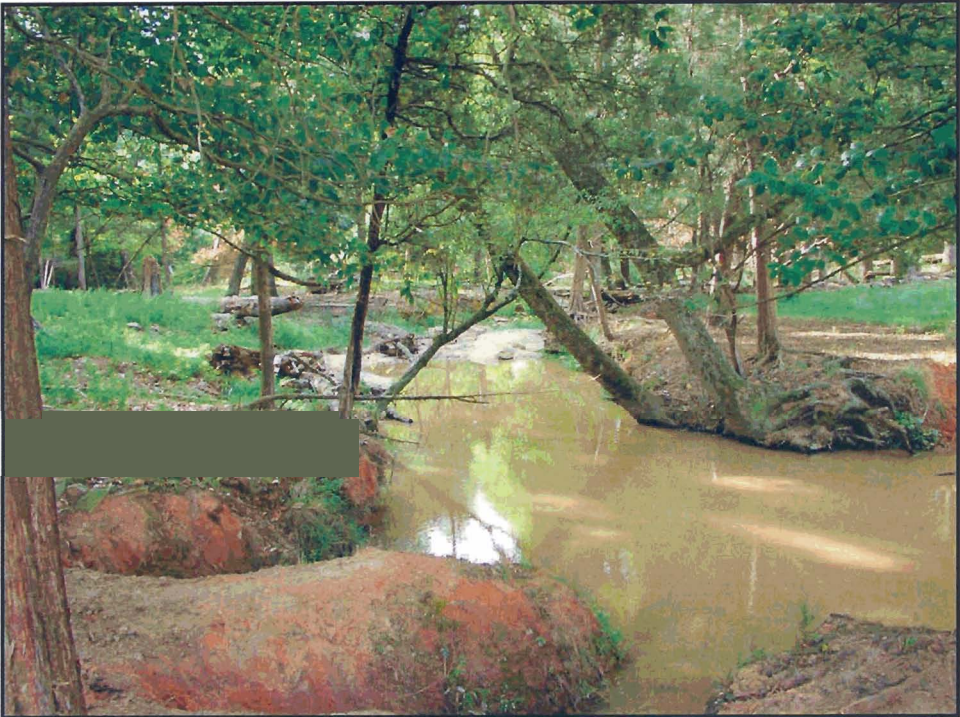
Cattle paths, undercut banks, and sedimentation in the channel.

Severe bank degradation is evident on both the MC and SC. Bank degradation at this site can be attributed to the unlimited access that the cattle have to the channel and to the lack of a vegetated riparian buffer. During reach surveys, 30 cattle trails were observed crossing the UTs. The cattle have repeatedly trod through these areas, destroying the vegetation and causing gullies and ruts to form on the banks (Exhibit 2.2.2). These conditions have created highly erosive areas where sediment can enter the channel and cover the natural substrate. Additionally, numerous wading pools for cattle were also observed. These areas are low, mucky depressions that host seasonal vegetation during summer droughts. Further, cattle have urinated and defecated in the stream channel adding to the mucky conditions, increasing nutrient levels and creating conditions for bacteria to flourish.

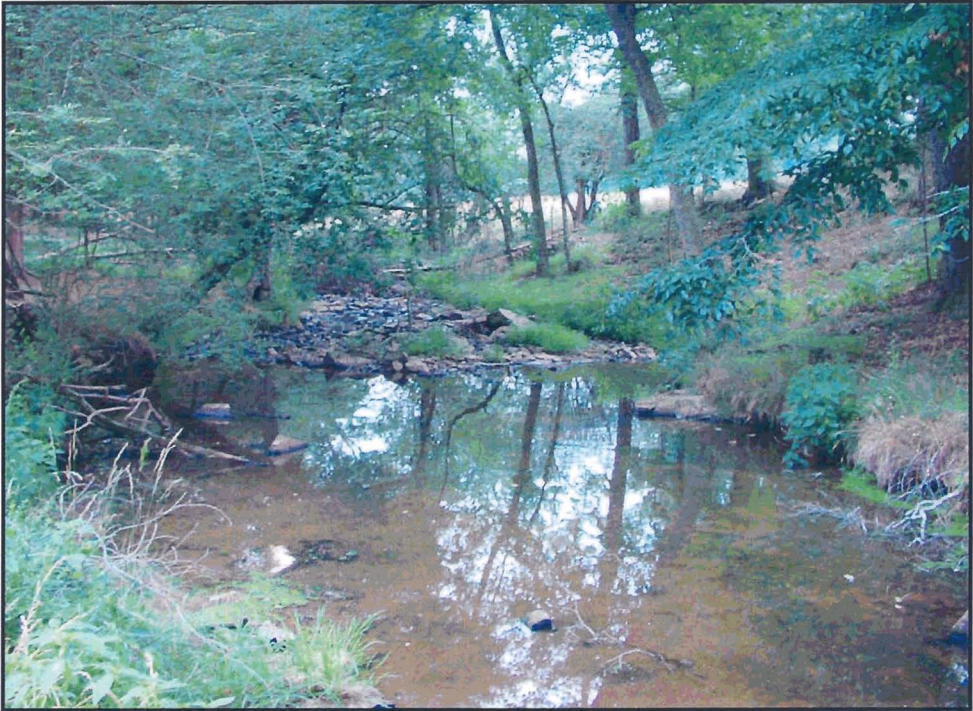
Widened section of stream with undercut banks.

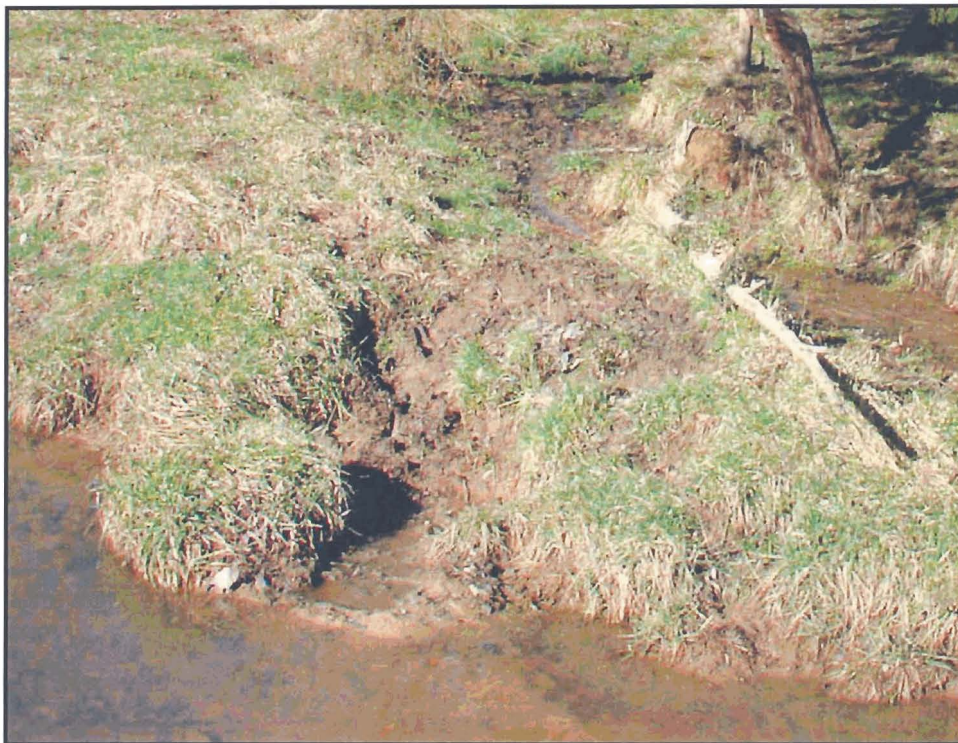
Rut created by cattle with sediment deposition in channel.

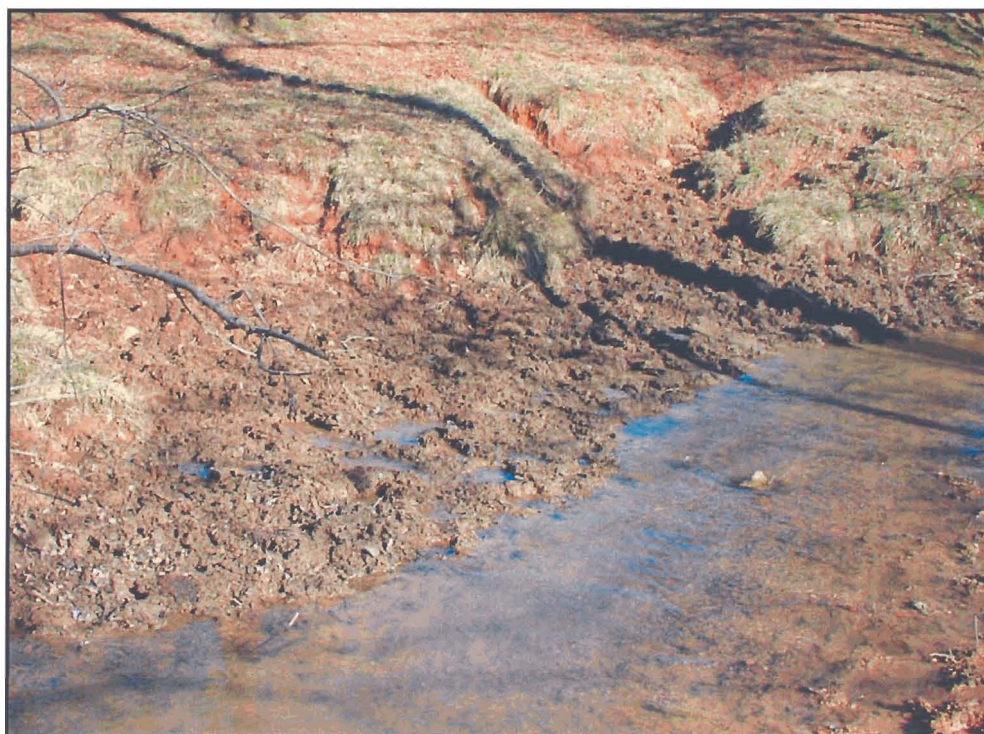
Ruts created by cattle in and evidence of increased sedimentation.

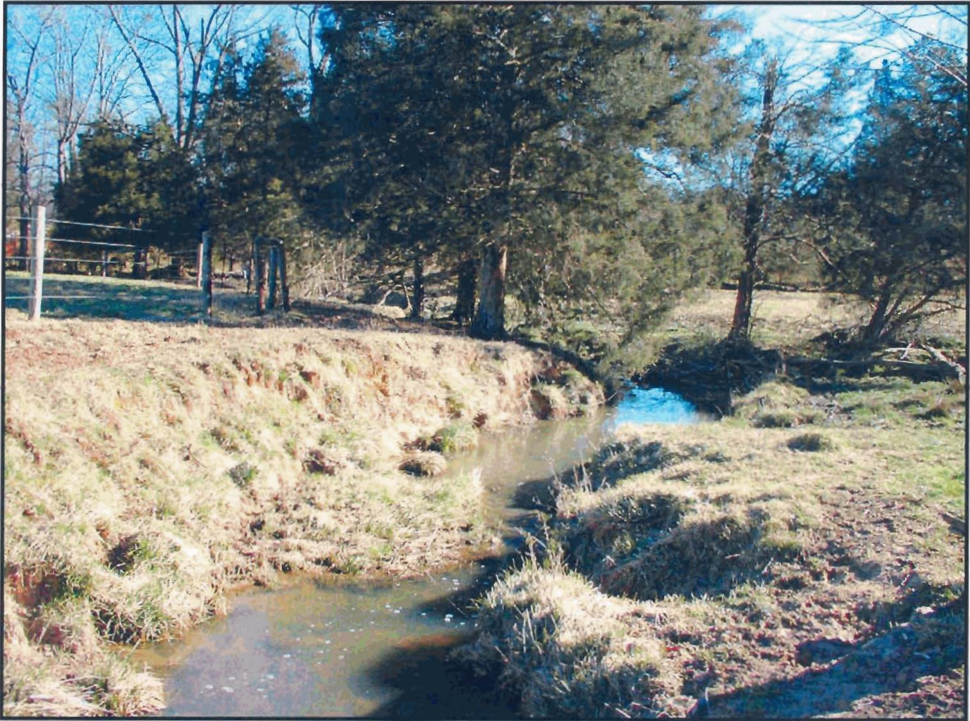
Although the channels classify as a C channel, both systems are experiencing adjustments, which are indicative of unstable conditions. Erosion has down cut the channel and created unstable, sloughing, and bare banks. Additionally, the channels' alternating point bars have been eroded which has straightened the channels. This straightened pattern is not normally found in stable streams. These deteriorating processes are expected to continue unless restoration practices are implemented.

View of Upstream MC looking north (downstream).

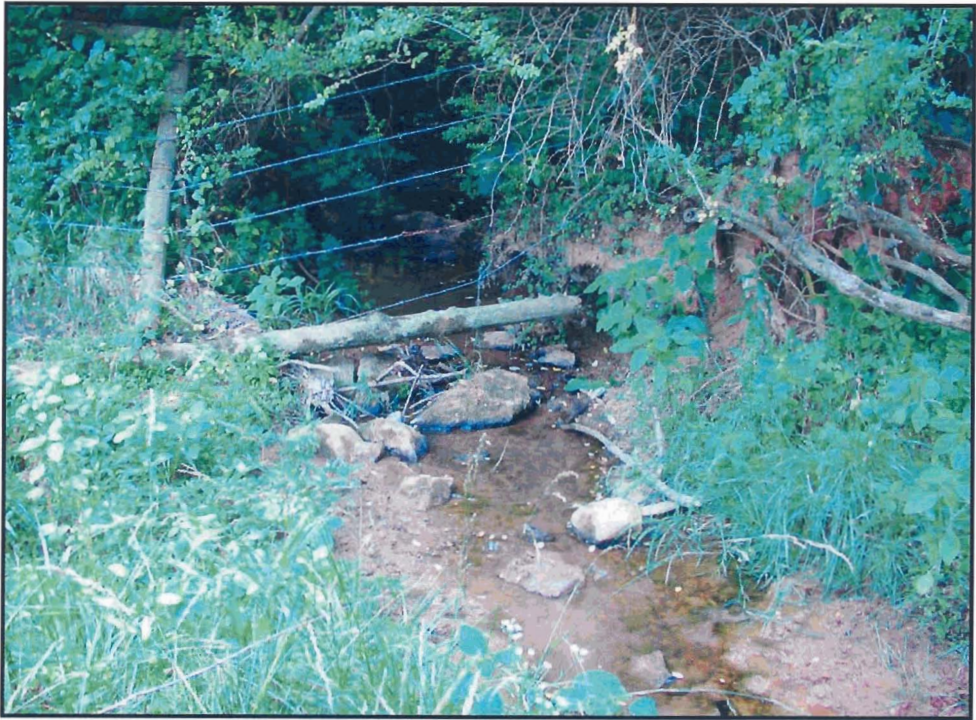
View of SC looking south (upstream).

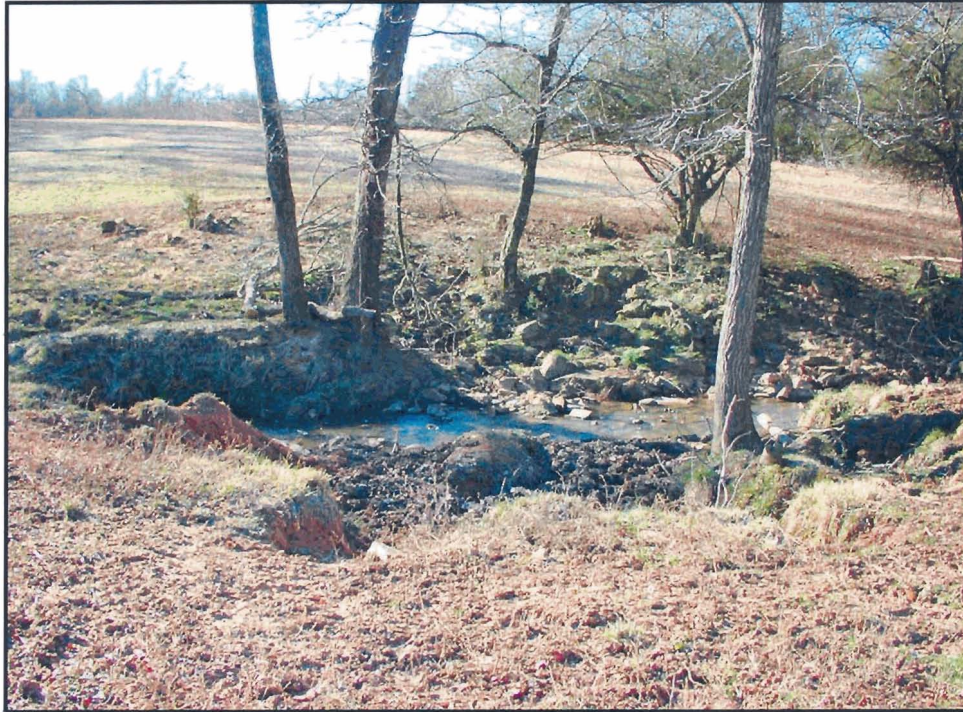
View of MC.

The survey of the upstream section of the MC determined that the average bankfull width is 15.7 feet with a mean depth of 1.4 feet. Based on these numbers, the width-to-depth ratio is 10.9. The bankfull cross-sectional area is 22.7 square feet (ft<sup>2</sup>). Bankfull mean velocity is 4.6 feet per second (ft/s) and the bankfull discharge is 104 cubic feet per second (cfs). The bankfull maximum depth is 2.1 feet and the width of the flood-prone area is 47 feet.
