Stream Stabilization and Enhancement Plan

Wild Site
Obids Creek, Ashe County

NCDOT/NCWRC Stream Mitigation Program

Prepared by
North Carolina Wildlife Resources Commission
Habitat Conservation Program

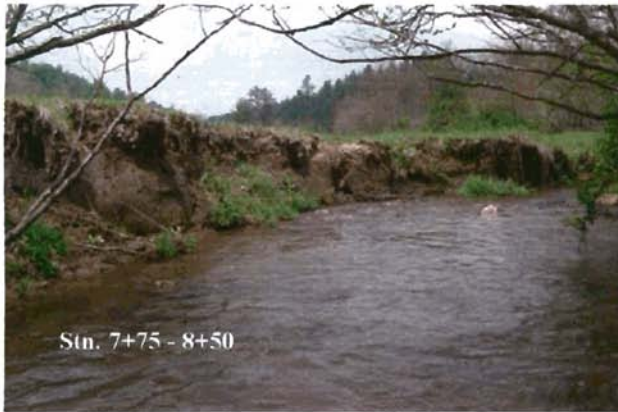
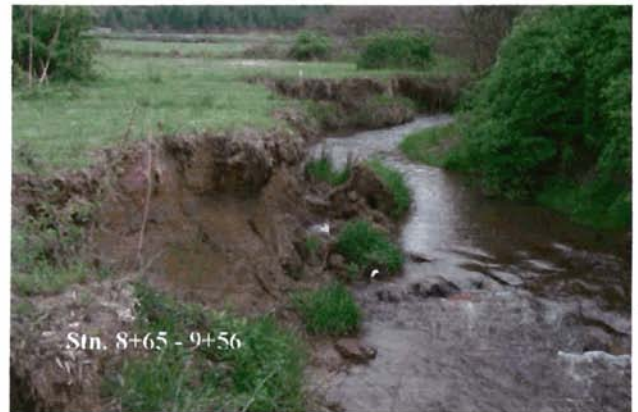
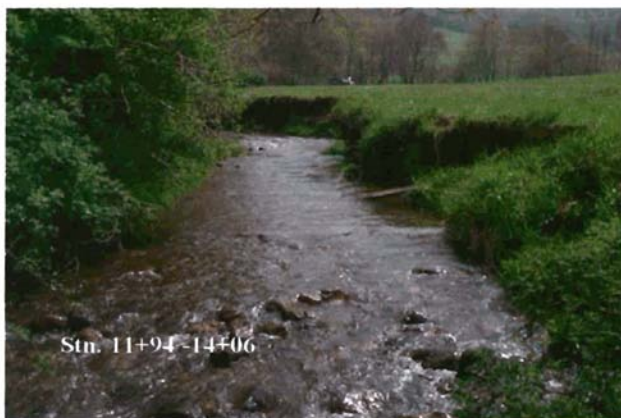
FIGURE 2: Pictures of Obids Creek on the Wild site, Ashe County, May 3, 2000.

Eroding stream banks are in need of bank stabilization/enhancement work to restore the stream corridor to a more state condition. The following major bank erosion areas were noted during the survey:

The first three **pictures are** areas of the stream that **are** priority bank **stabilization** sections. **These are** major sites of sedimentation resulting in poor habitat and loss of riparian vegetation. Rock vanes, rock weirs, and root wads will be installed at these locations to prevent **further** bank erosion. Banks will be sloped and revegetated. Livestock will be **fenced** from the riparian zone for long **term protection**.

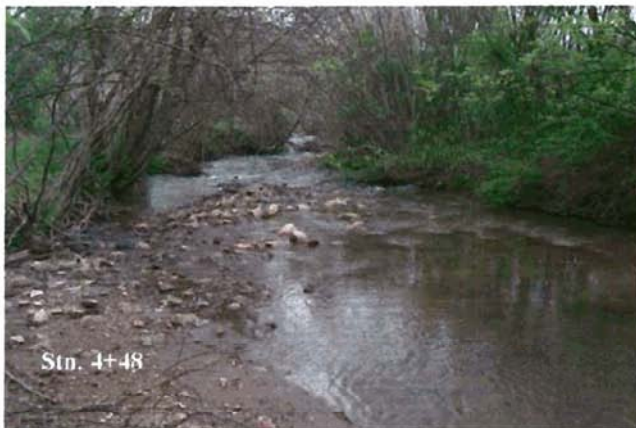
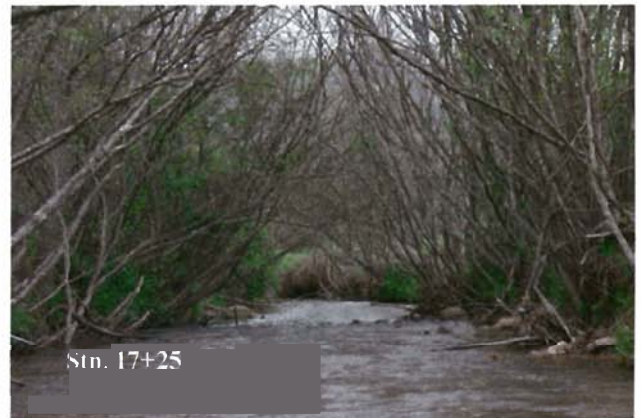
These two pictures show examples of a stable stream section. The **banks are** vegetated with alders and other **trees** which help prevent bank erosion, provide for stream shading and nutrient input..

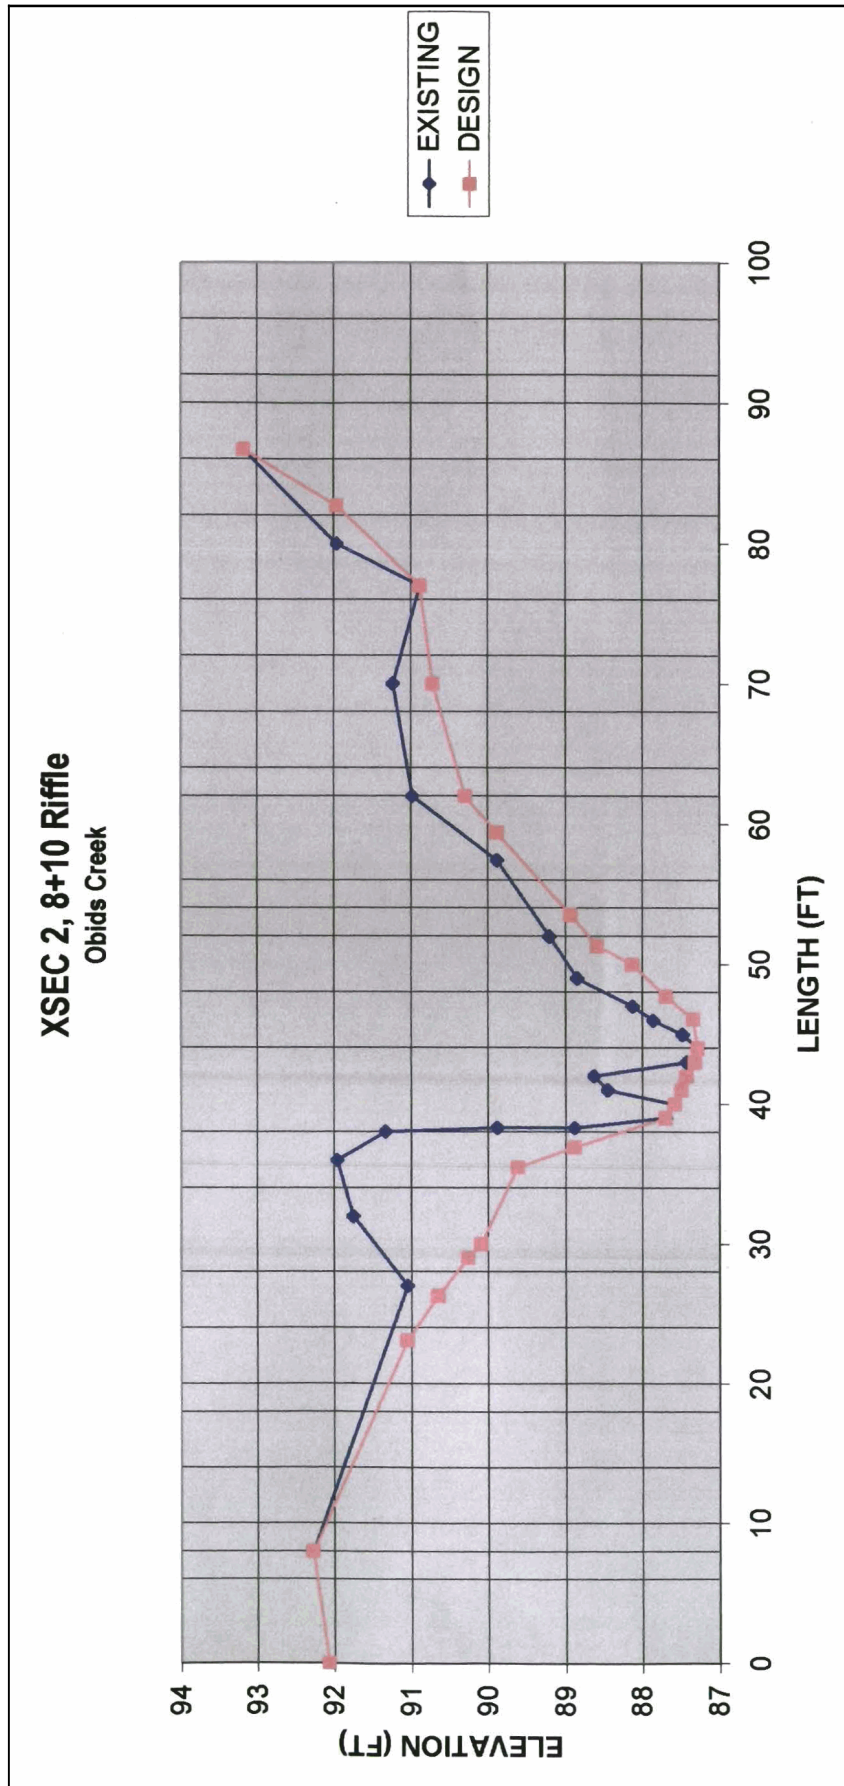
FIGURE 21. Cross-section 8+10 existing condition and design comparisons, Obids Creek, Wild site, Ashe County.

8+10	Feature	Type	Wfpa	LBKF	RBKF	Elev bkf	Wbkf	Dbkf	W/D	Abkf	Dmax	ER
Existing	Riffle	C4	150			90.98	26.2	1.8	14.2	48.4	3.7	5.7
Design	Riffle	C4	150	30	62	90.29	32.0	1.6	20.6	49.6	3.01	4.7

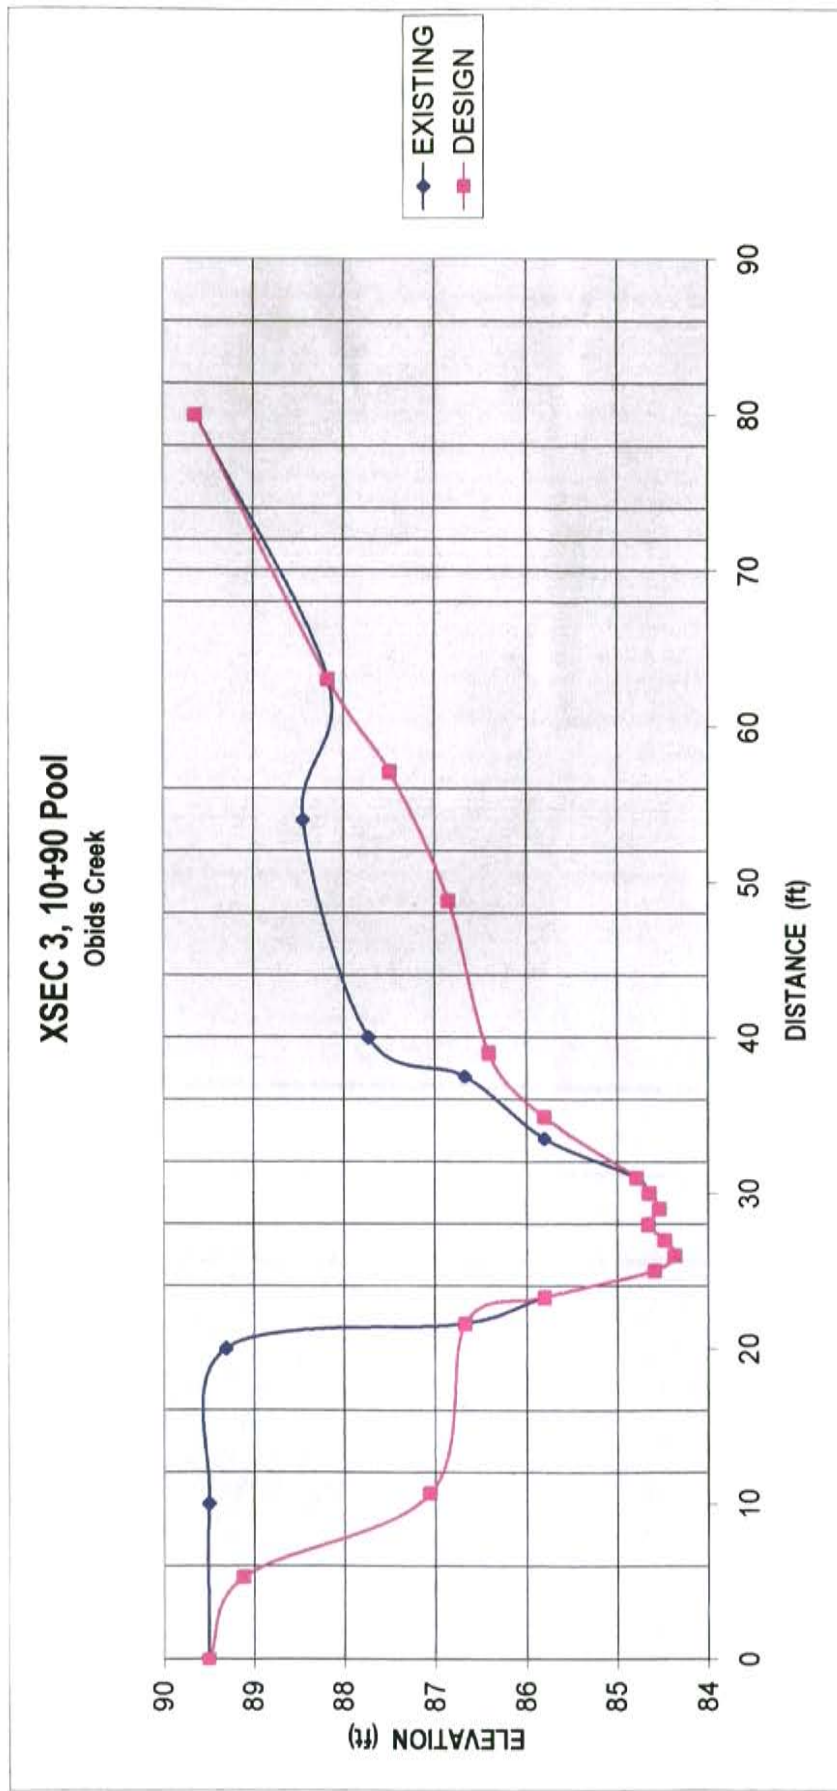
FIGURE 22. Cross-section 10+90 existing and design comparisons, Obids Creek, Wild site, Ashe County.

10+90	Feature	Type	Wfpa	LBKF	RBKF	Elev bkf	Wbkf	Dbkf	W/D	Abkf	Dmax	ER
Existing	Pool	C4		10.7	57.1	88.45	45.7	1.3		60.2	4.1	
Design	Pool	C4				87.49	46.4	1.2	39.7	54.2	3.12	0.0

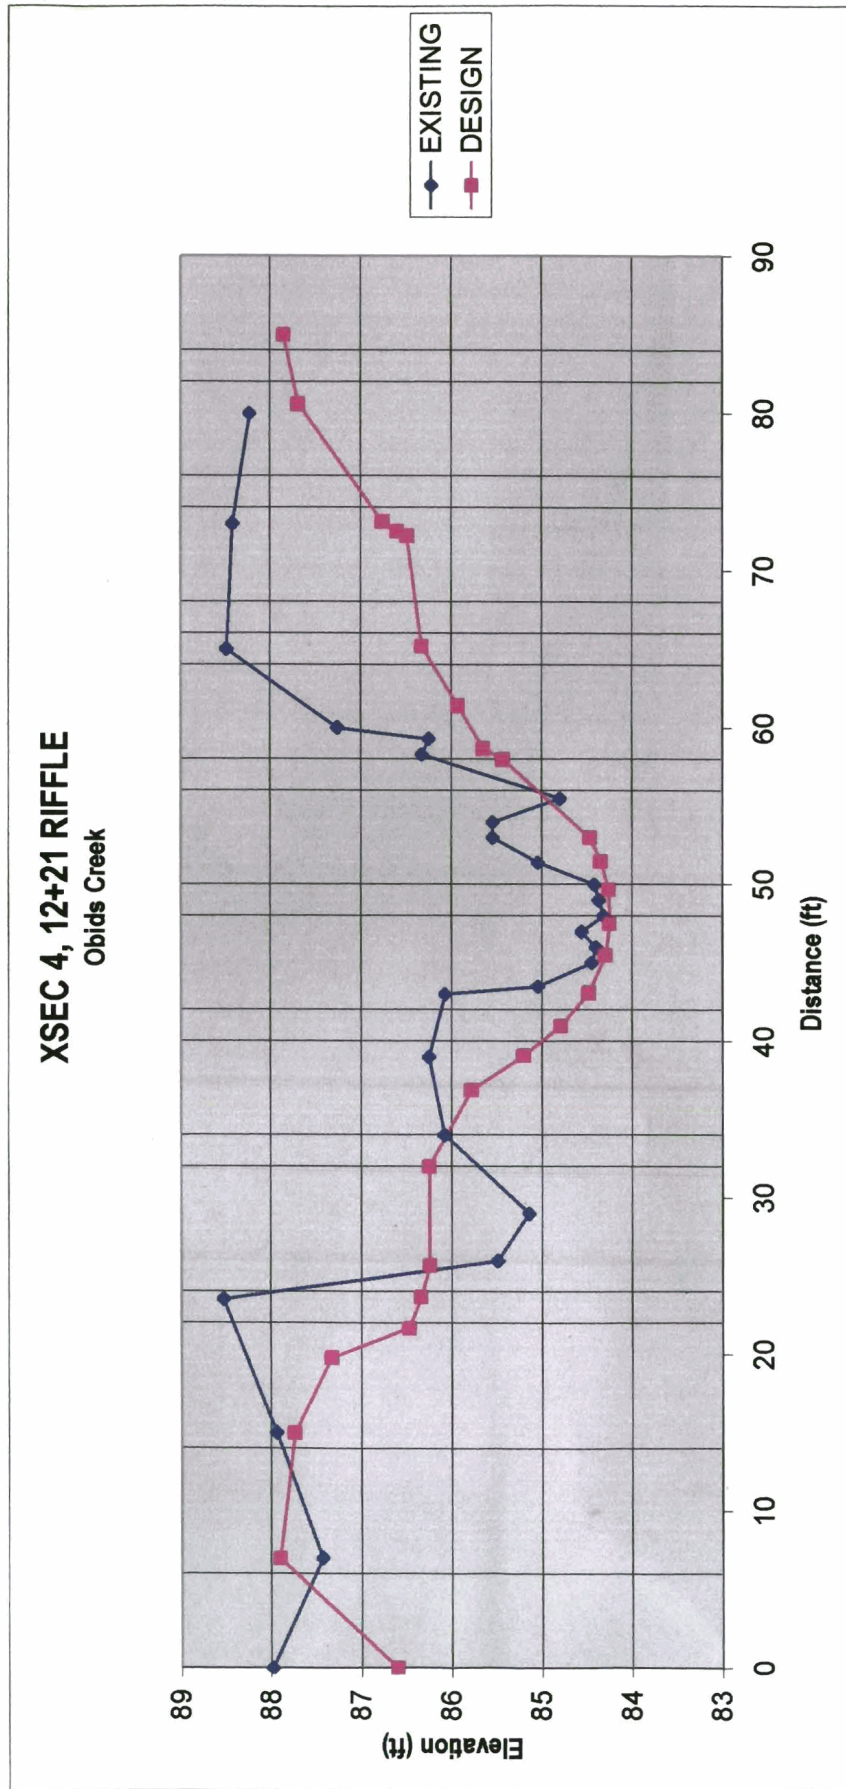
FIGURE 23. Cross-section 12+21 existing and design comparisons, Obids Creek, Wild site, Ashe County.

12+21	Feature	Type	Wfpa	LBKF	RBKF	Elev bkf	Wbkf	Dbkf	W/D	Abkf	Dmax	ER
Existing	RIFFLE	C4	150			87.26	34.9	1.4	25.2	48.3	2.6	4.3
Design	RIFFLE	C4	150	19.8	72.5	86.6	52.7	1.0	52.7	52.7	2.35	2.8
