ORE KNOB MINE

Water Quality Issues & Restoration Efforts

2011 NEW RIVER BASIN PLAN: ORE KNOB MINE (SOUTH FORK NEW RIVER WATERSHED)

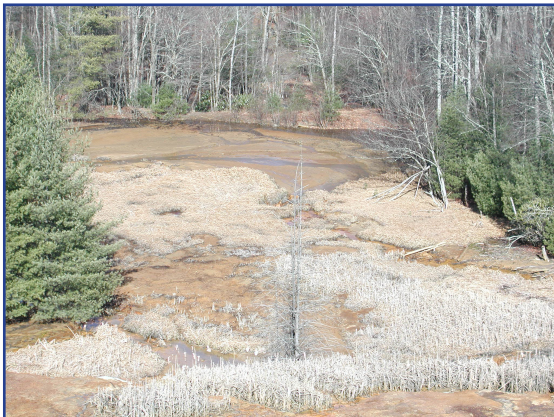
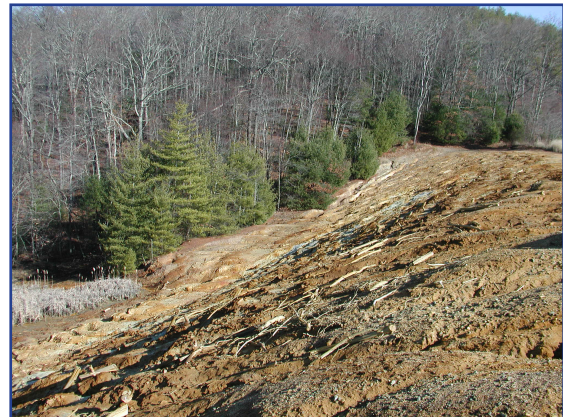
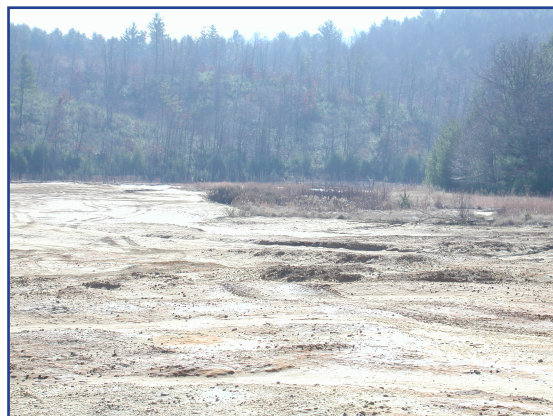
The waste tailings from this process were mostly pumped into a large tailings impoundment located on Ore Knob Branch. A smaller portion of the tailings were dumped in a small hollow adjacent to the processing facility. The drainage from the processing facility and associated waste piles is an acidic toxic mix that has contaminated the surface and ground water in the drainage area.

FIGURE 4-1: PHOTOS TAKEN OF THE WASTE/TAILINGS PILES DURING A SITE VISIT IN DECEMBER 2006 BY DWQ. (TOP LEFT: TOP OF IMPOUNDMENT FACING THE SETTLING POND; TOP RIGHT: LOOKING NORTH EAST ACROSS THE IMPOUNDMENT; BOTTOM: ON IMPOUNDMENT LOOKING BACK ACROSS TAILINGS PILE.)

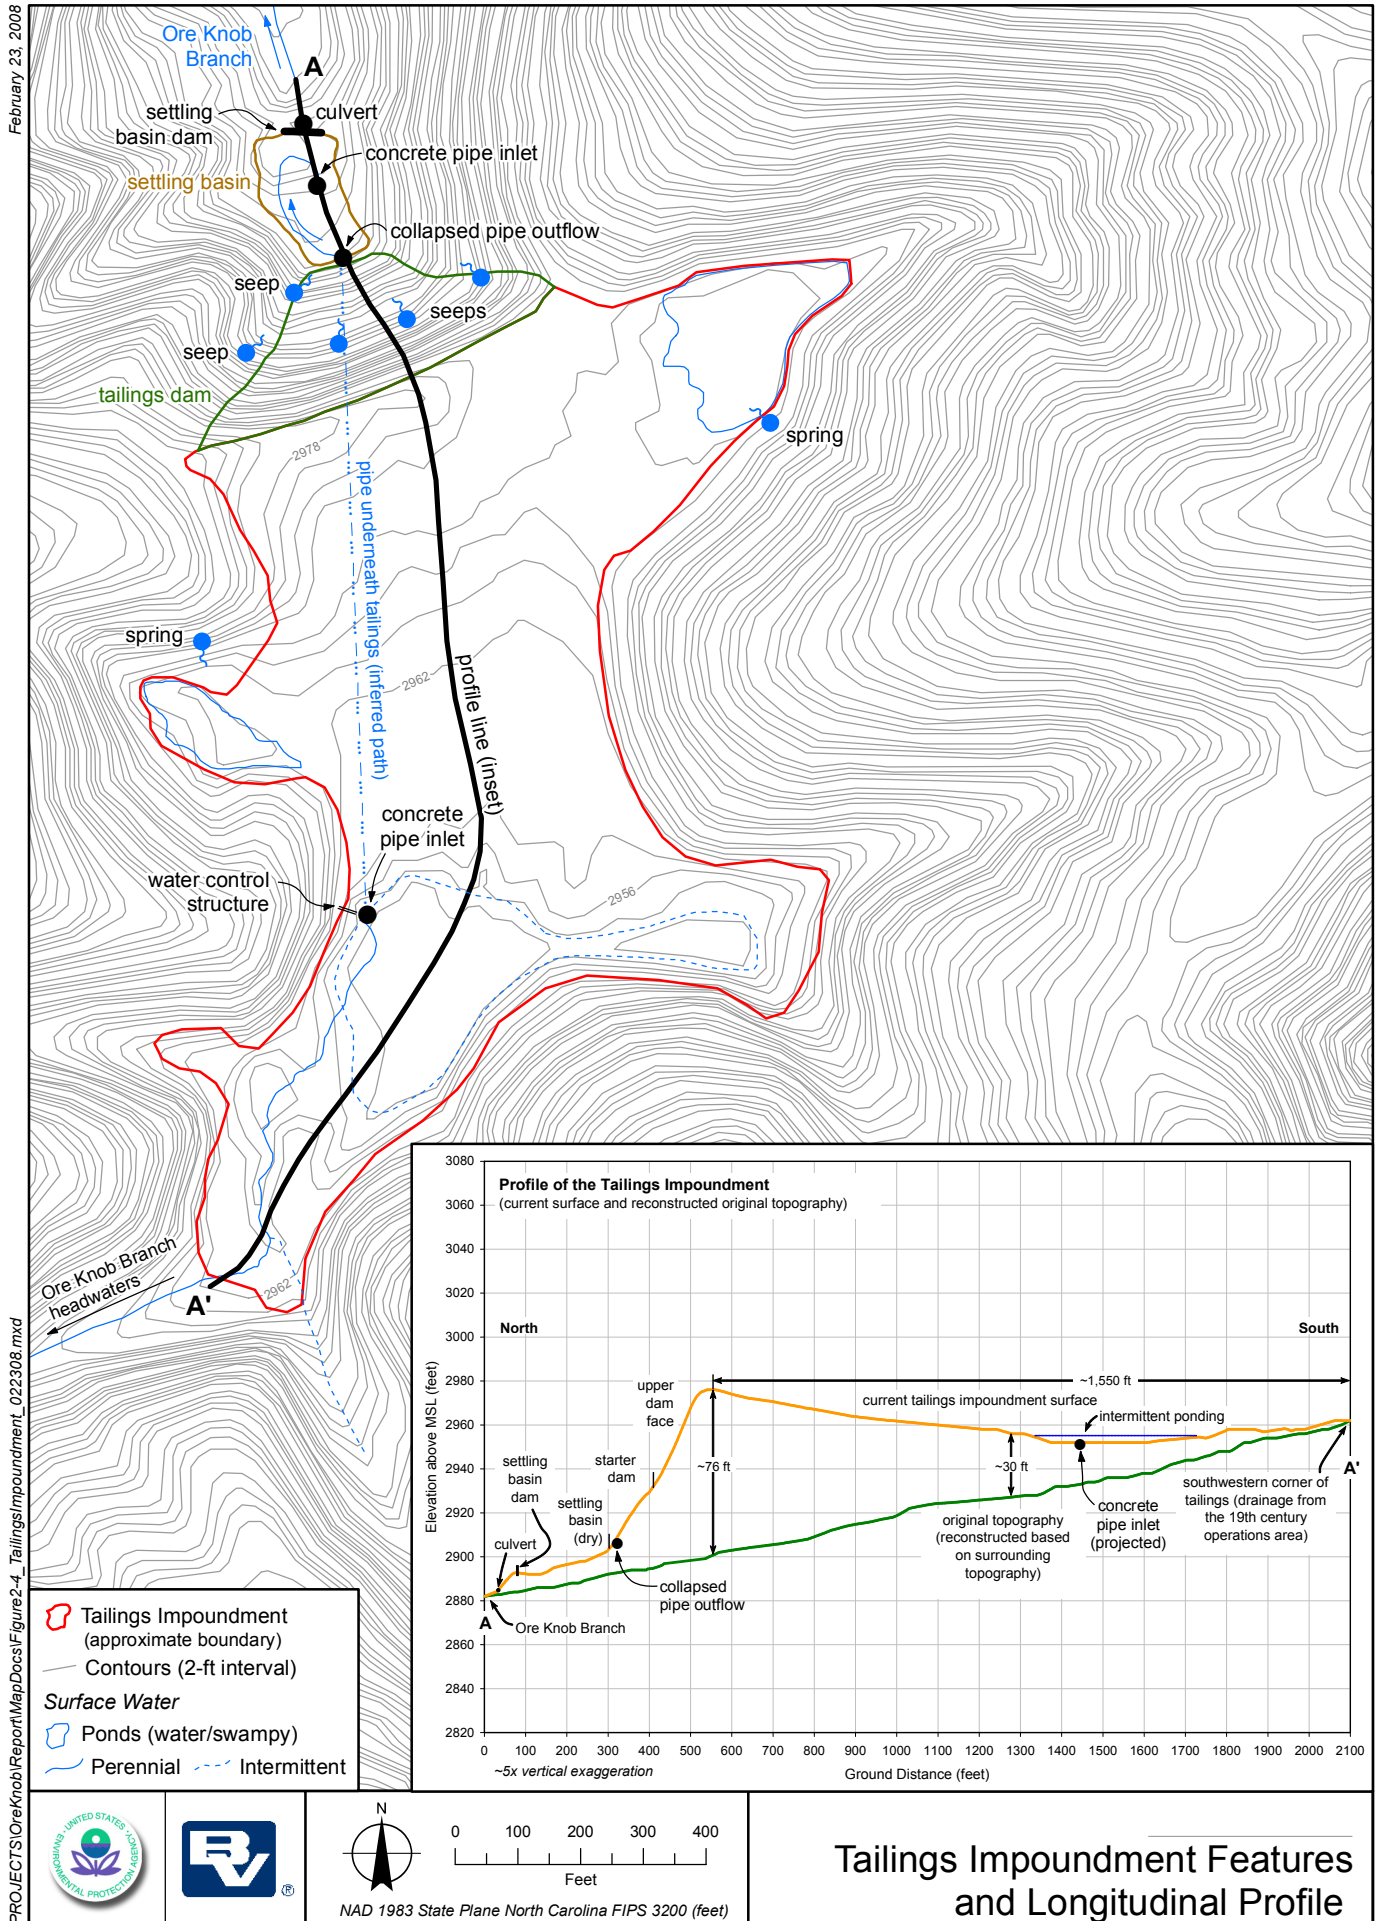
Tailings Impoundment Features and Longitudinal Profile

FIGURE 4-2: TAILINGS IMPOUNDMENT AND PONDS FEATURES AND LONGITUDINAL PROFILE (BLACK & VEATCH, 2008).

The main area of the Ore Knob Mine that is impacting surface and ground water is the tailings pile which is a little over 20 acres and holds most of the waste tailings from the mining operations. This is seen in Figure 4-2 as the area outlined in red. The tailings pile, estimated at 720,000 cubic yards, is held behind a 60 foot dam. Behind the large dam is a settling basin held back by a smaller 20 foot dam. This smaller dam has a culvert which drains directly to Ore Knob Branch.

Two small streams flow into the southern portion of the pile where it intermittently ponds (two blue lines at the bottom left corner of Figure 4-2). A concrete pipe inlet drains the intermittent pond, bypassing majority of the tailings pile and the larger dam, discharging into the settling basin. Two spring fed ponds, located on either side of the northern portion of the pile, filter through the tailings and seeps through the larger dam where it then collects in the settling basin.

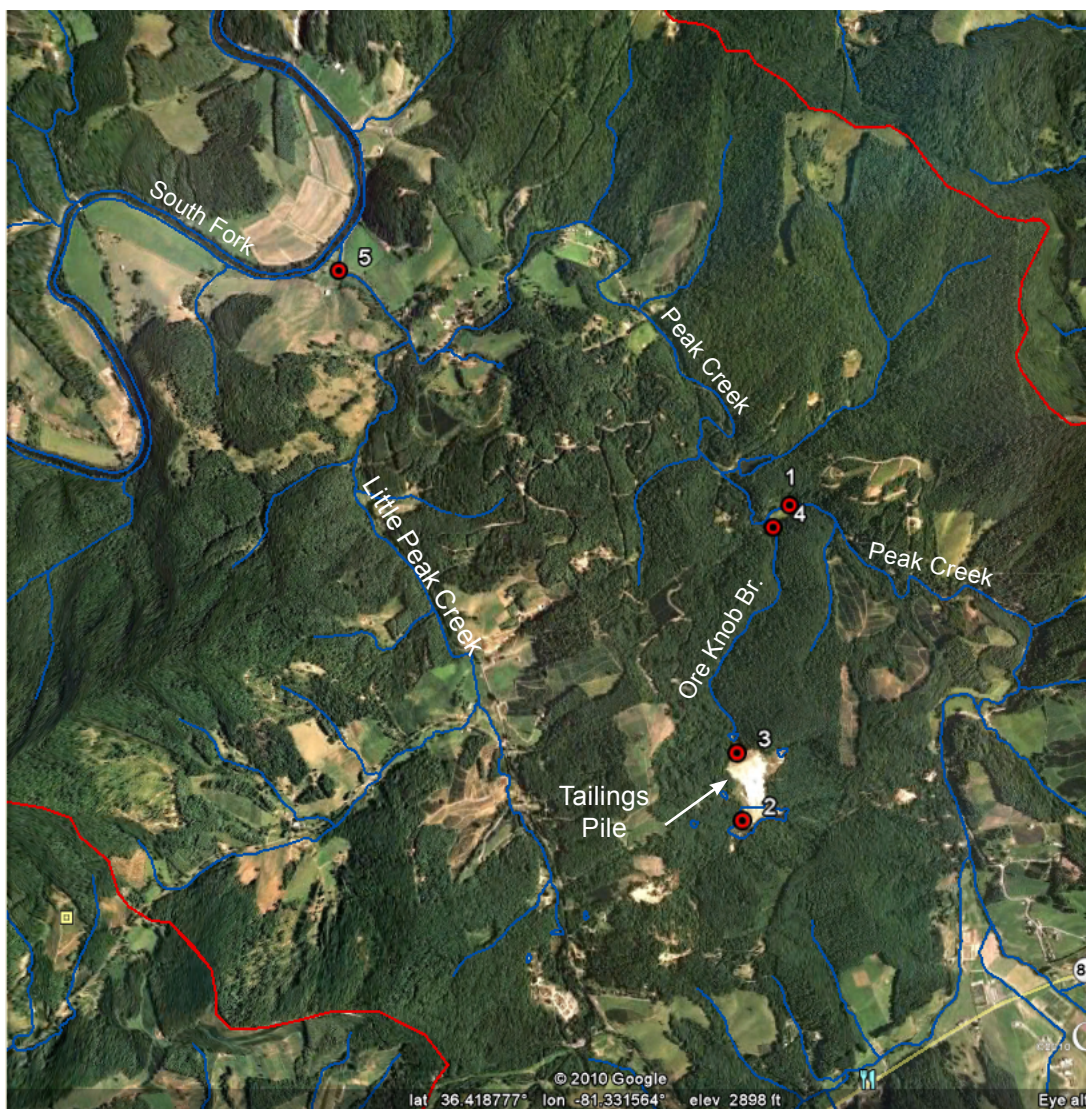
Site 4 (Figure 4-3), which is located on Ore Knob Branch just before its confluence with Peak Creek, results showed that much of the contaminates were reaching Peak Creek. And Site 5, on Peak Creek just before its confluence with the South Fork, results also showed evidence of the contaminates, but to a lesser degree.

FIGURE 4-3: SAMPLE LOCATIONS FOR THE 319 WATERSHED RESTORATION PLAN PROJECT FUNDED BY THE 319 GRANT*

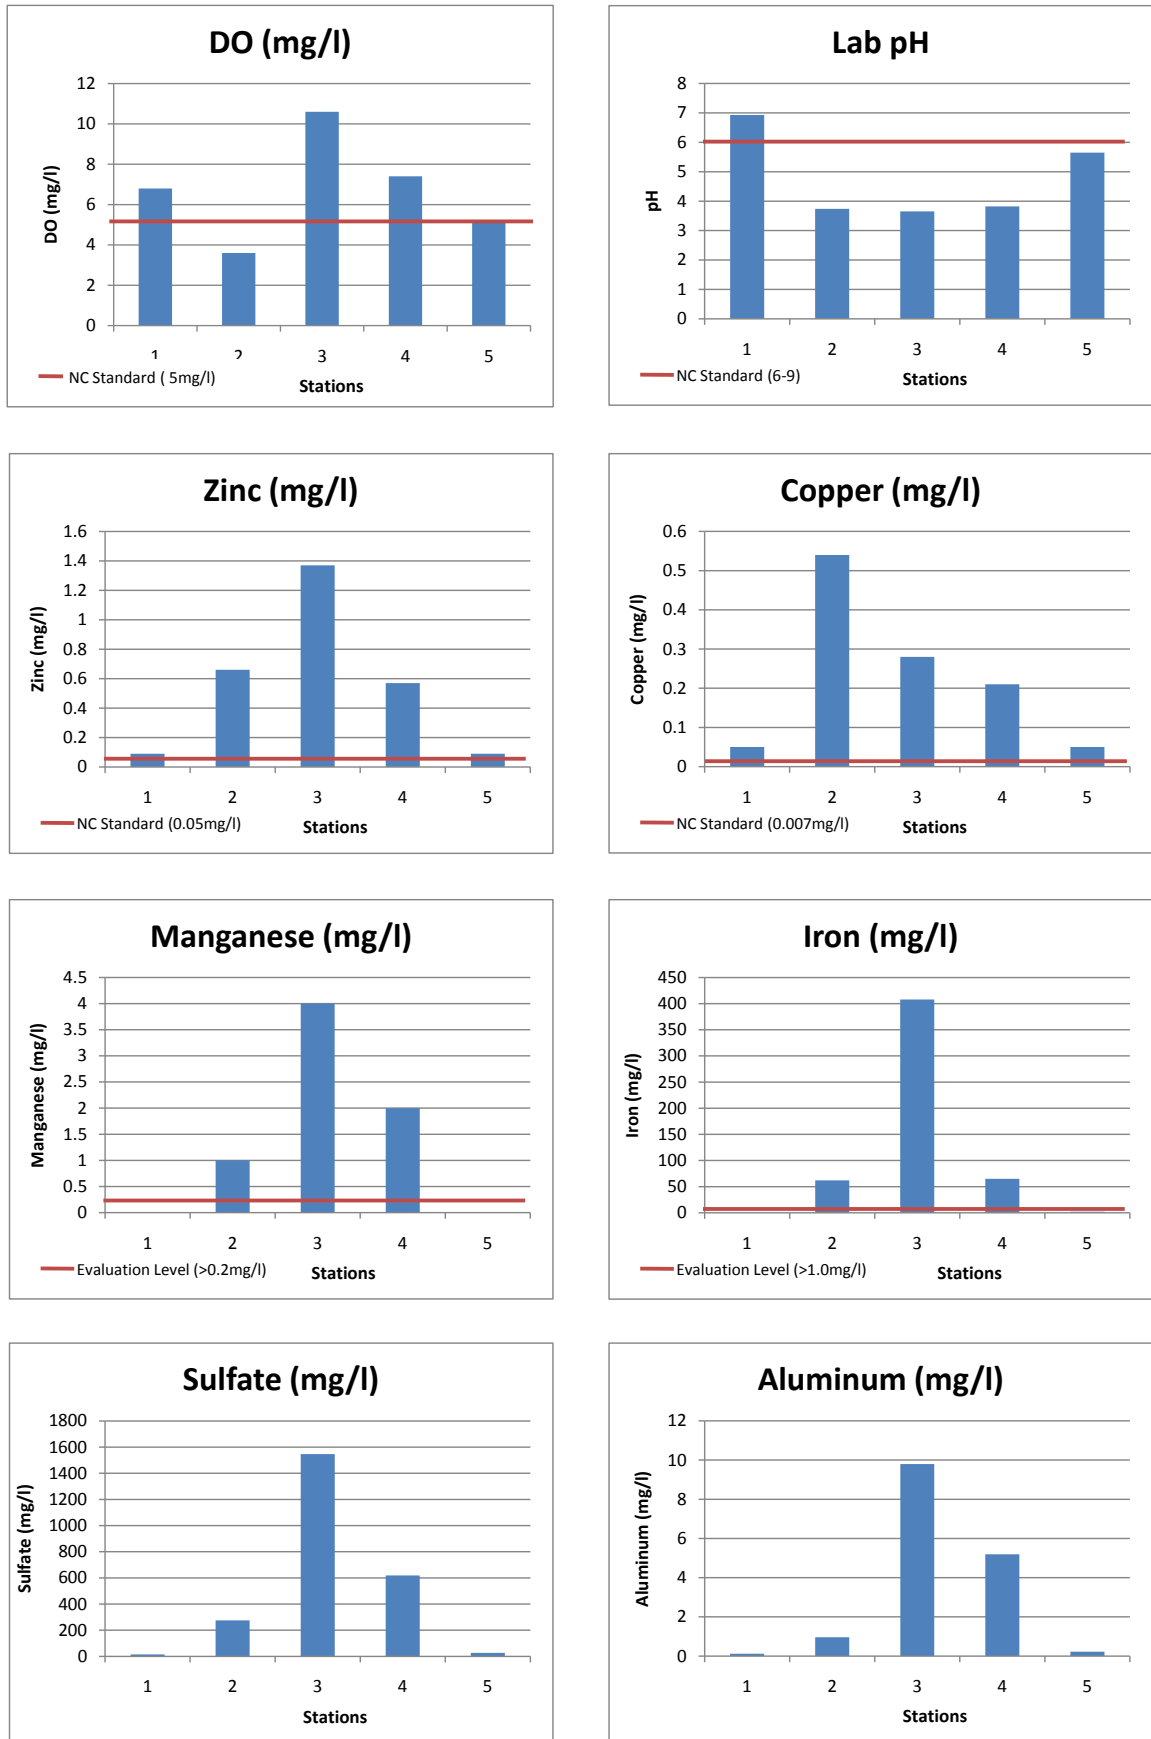
Results of the sampling indicated pH levels at all stations except one were significantly lower than the states surface water quality standard of 6. The one station that was not below the standard was Site 1 which is the only site upstream of the mines impacted area. Acidity levels were highest were the concrete pipe discharges the tailings into the settling basin (Site 3). Copper was the only metal, sampled during this study, that showed higher levels at Site 2 (located at the intermittent pond) than Site 3. Site 2 represents runoff from the watershed area upstream (south) of the tailings pile as well as runoff that flows through the adits (a slightly sloped passage into the mine) before it enters the intermittent pond at the south end of the tailings pile. Higher copper levels at this site indicate signs of filtration of the metal as the water from the intermittent pond travels through the tailings pile. All other metals shown in Figure 4-4 had a much higher value once discharged from the tailings pile into the settling basin.

FIGURE 4-4: AVERAGES FOR FIVE MONITORING SITES SAMPLED FOR THE ORE KNOB 319 PROJECT

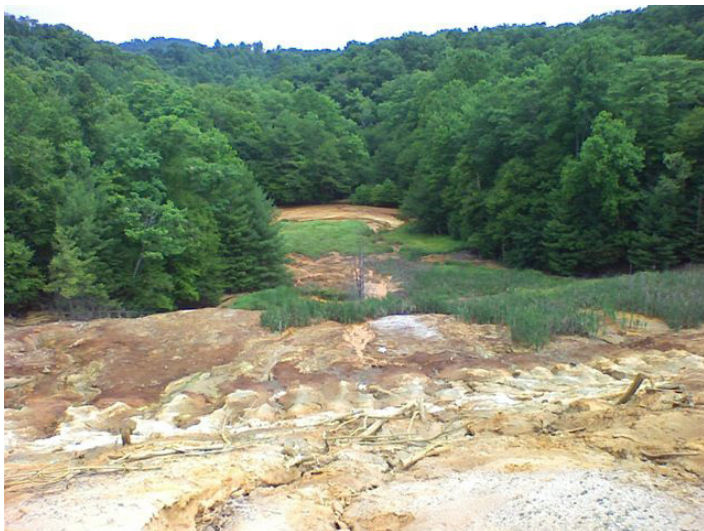
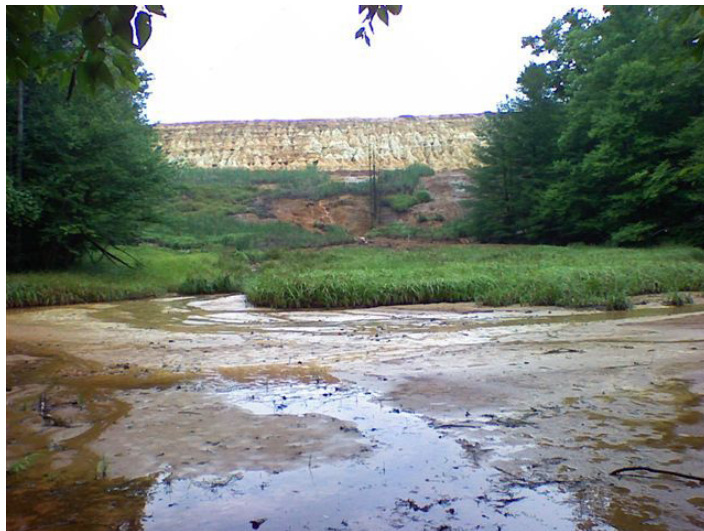
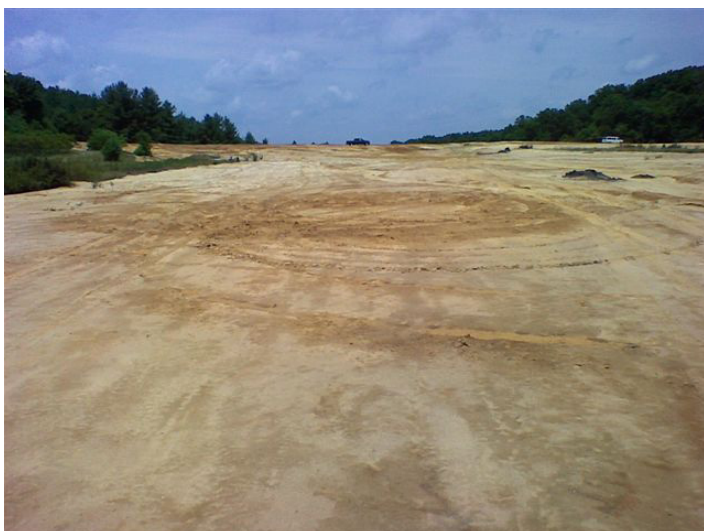
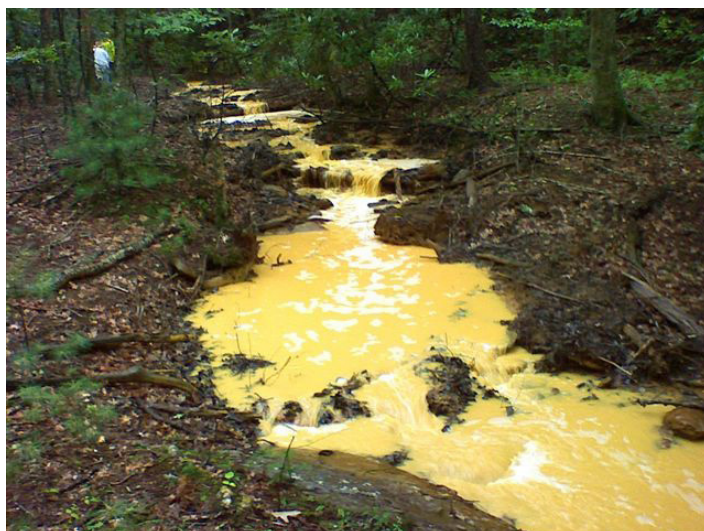
DWQ and EPA Region 4 conducted site visits in 2007 to check on the degradation status of the embankment and tailings. During the February 2007 visit, the concrete pipe used to divert stream flow under the tailings pile to the settling pond was blocked at both inlet and outlets causing the flow to filter through the tailings. The 60 foot dam (Figure 4-5: top right) exhibited rills up to three feet deep along with numerous seeps. Storm runoff and water seeping from the dam face would be collected in the settling pond before reaching Ore Knob Branch; however, the settling pond had been completely filled with sediment which likely eroded from the face of the dam. This surface and groundwater was monitored in 2007 and 2008 as part of a 319 grant project.

FIGURE 4-5: PHOTOS OF TAILINGS PILE AND DOWNSTREAM TAKEN DURING A SITE VISIT IN JULY 2007 BY DWQ. (TOP LEFT: TOP OF LARGER DAM FACING THE SETTLING BASIN; TOP RIGHT: SETTLING BASIN LOOKING BACK TOWARDS LARGER DAM; BOTTOM LEFT: TOP OF LARGER DAM LOOKING BACK ACROSS TAILINGS PILE; BOTTOM RIGHT: ORE KNOB BRANCH DOWNSTREAM OF SETTLING BASIN CULVERT.)

- 💧 20,000 of 720,000 cubic yards of tailings and sediment excavated from the settling pond;
- 💧 Restored a freeboard in the settling pond so it now acts as a clarifier as water empties into Ore Knob Branch;
- 💧 Completed the diversion channel designed to reroute 200 gallons per minute of surface water around the tailings dam;
- 💧 Recycled soil and sediment excavated from the site to re-use throughout the rest of the site; and
- 💧 Completed a geotechnical stability analysis and a slope stability analysis for the tailings dam face.

In July of 2010, EPA Region 4 requested additional funding to complete the remaining restoration of the site. This will cover the capping of the tailings impoundment and add vegetation throughout the site, excavate tailings from Ore Knob Branch and excavate and stabilize the 1950's mine and mill site. Federal sediment and erosion controls will be put in place during the restoration efforts. However, federal measures are not as preventive as state measures; therefore, elevated turbidity levels are expected to occur in Ore Knob Branch, Peak Creek and possibly the South Fork until restoration is completed.
