BEAVERDAM CREEK WATERSHED PLAN

Funded by: North Carolina 319 Program
Grant Applicant: Watauga River Partners

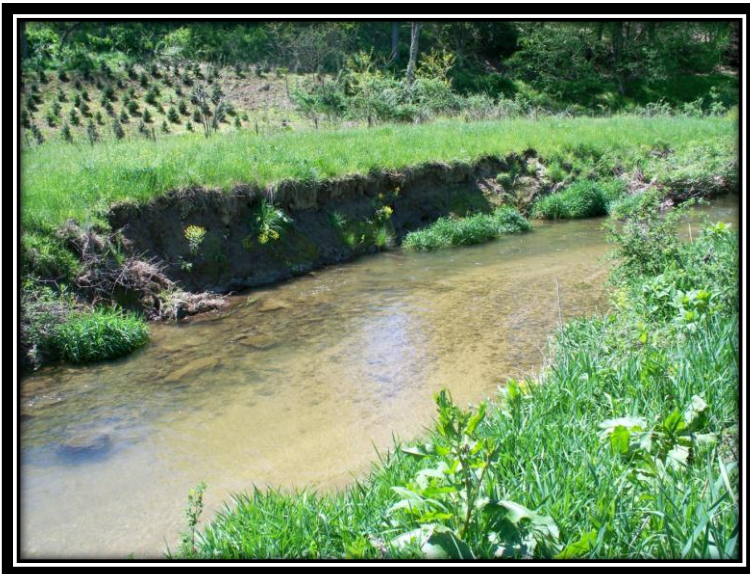
If land is mowed to the stream, the lack of buffer causes erosion.

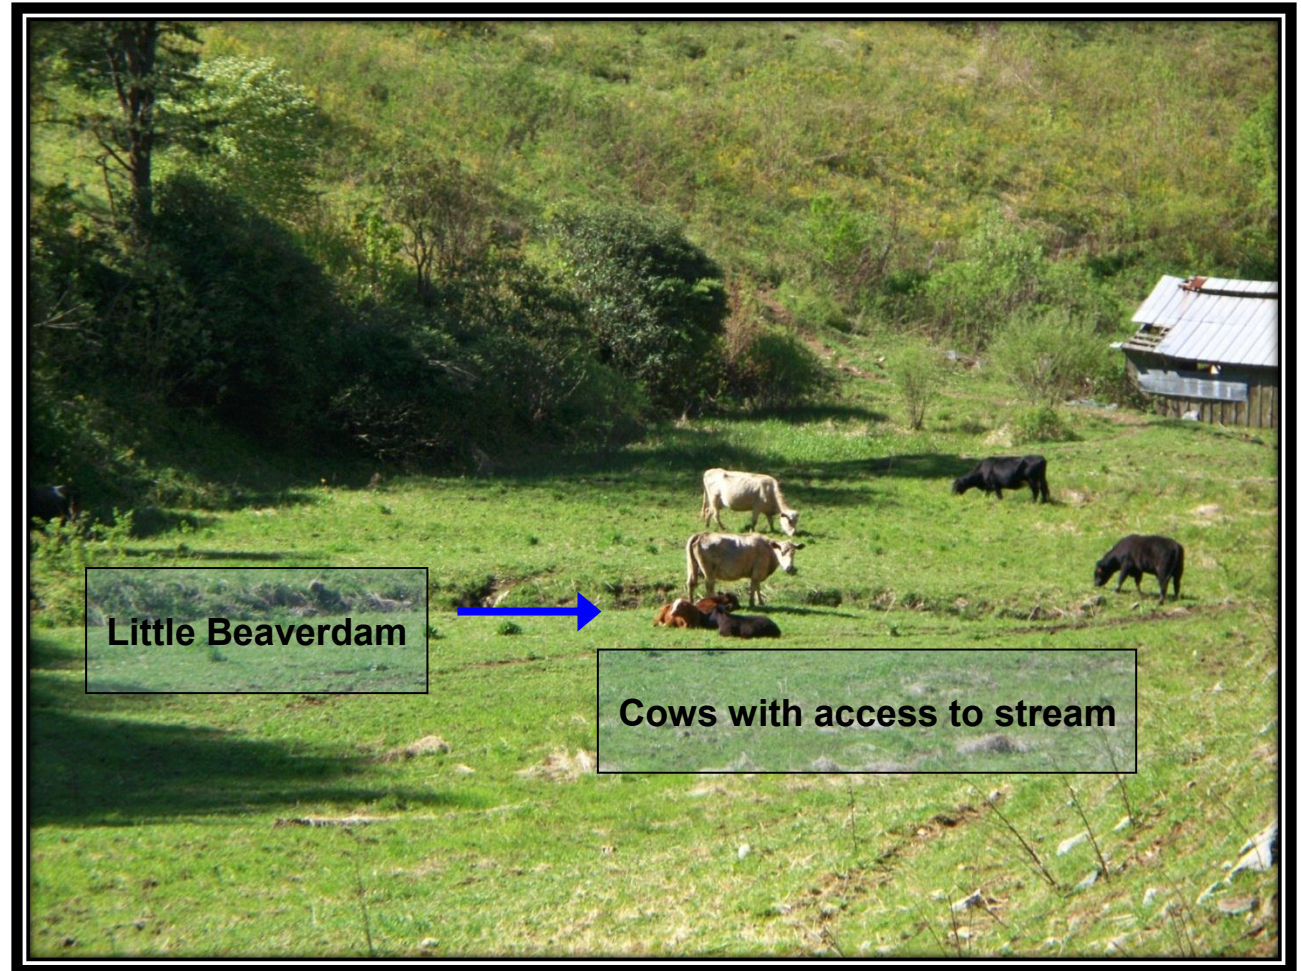
SITE 7

Length of Degraded Portion of Stream: ~450 linear feet

Recommendations:

- Streambank stabilization
- Alternate watering source
- Native plants along banks

Priority Ranking: High

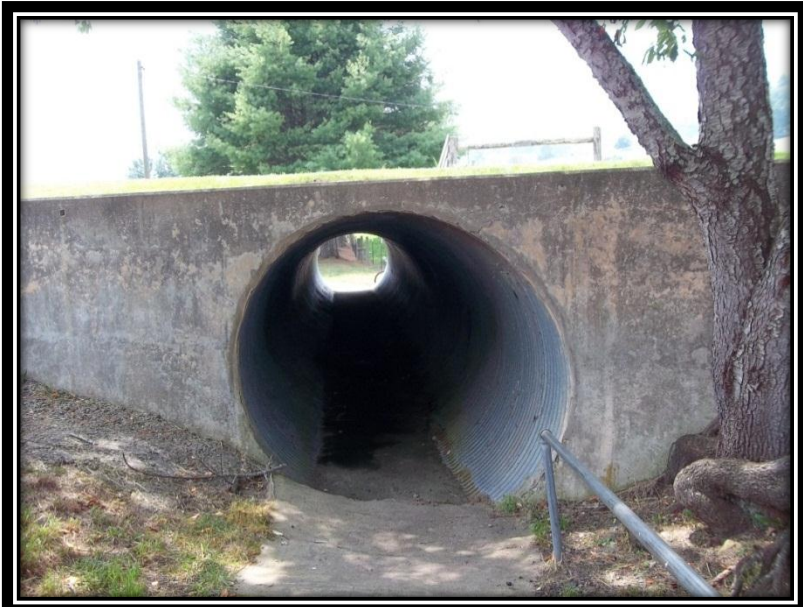
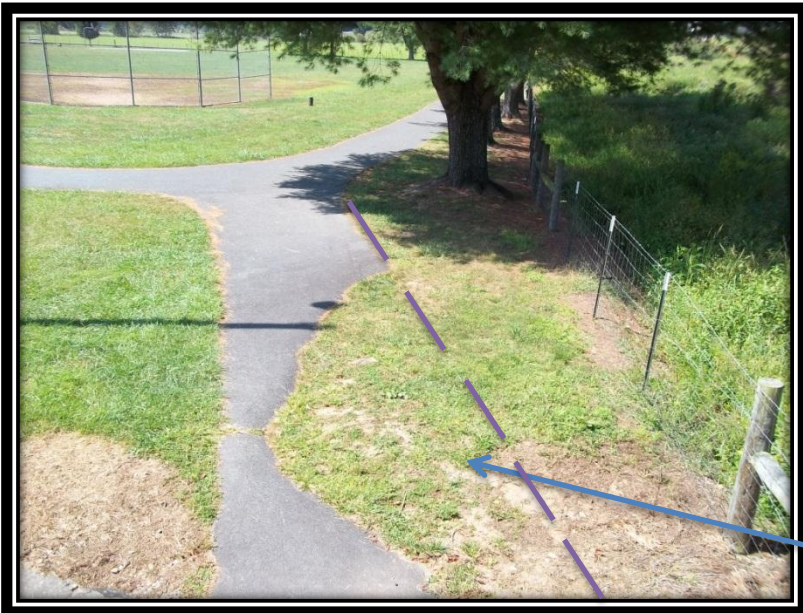
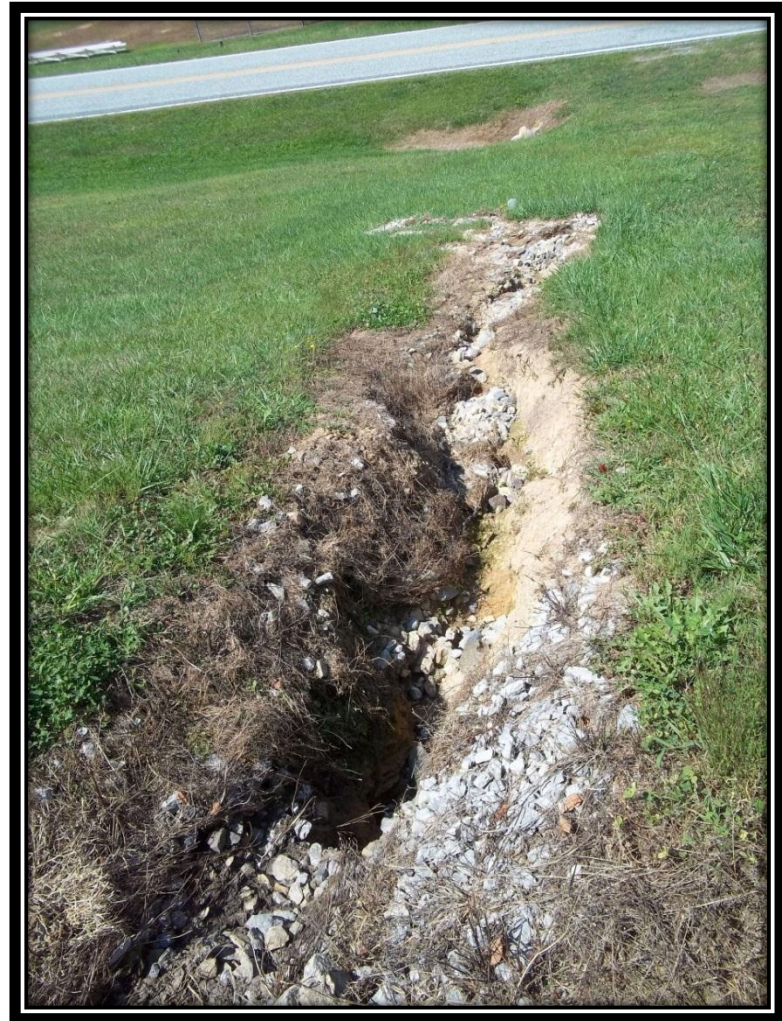
Upper Left: large storm drain connects school property to playground across Rush Branch Rd. During rainstorms this could present a hazard with rushing water.

Lower Left: Significant deposition is covering sidewalk used to access playground.

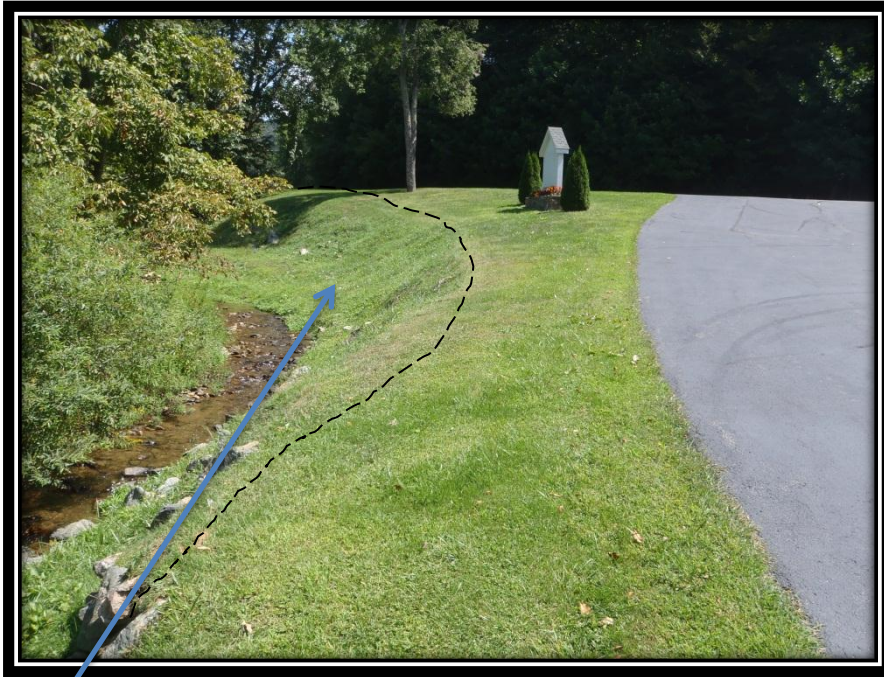
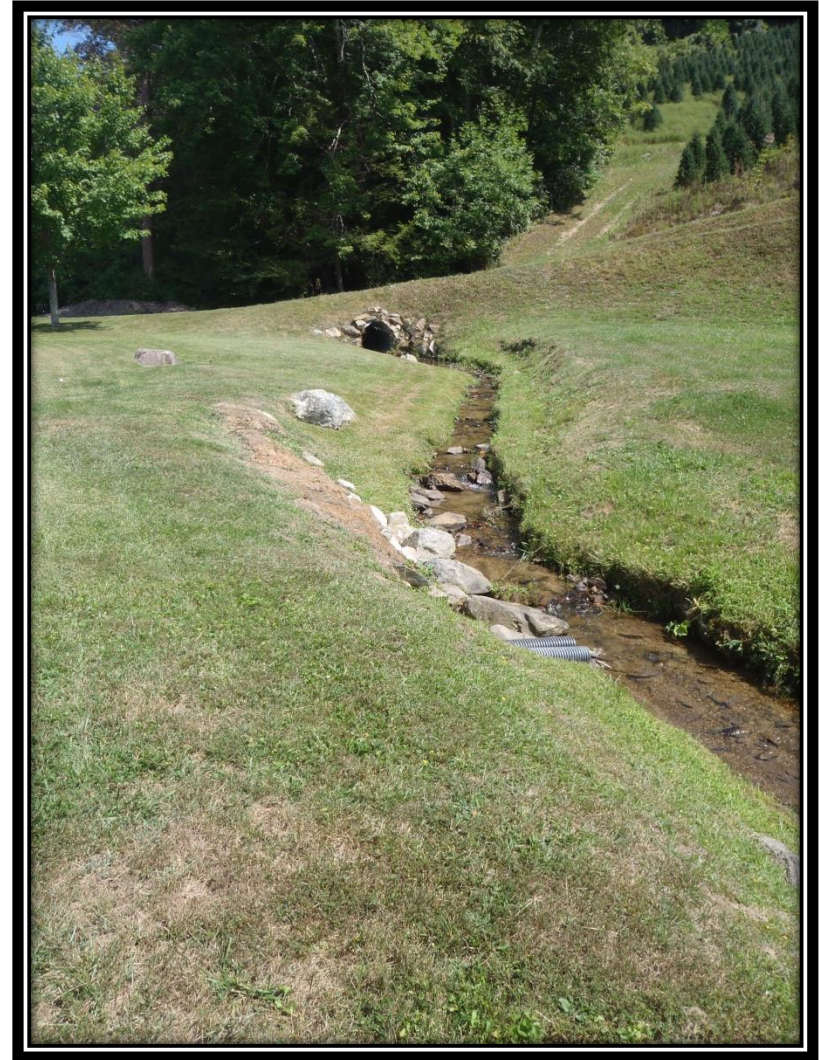
Upper Left: Opportunity to re-establish a streamside forest at Beaverdam Baptist Church. Photo shows a comparison of one side of the streambank with native plants and the other mowed to edge.

Right: Another opportunity (at Mountain Dale Baptist Church) to re-establish native plants along the river bank to create habitat and prevent erosion.
