Hurricane Helene Effects on Benthic Macroinvertebrates of 11 North Carolina Streams, a Preliminary Analysis

Nov. 19 – Dec. 6, 2024

North Carolina Department of Environmental Quality
Division of Water Resources
Water Sciences Section

Biological Assessment Branch SUMMARY

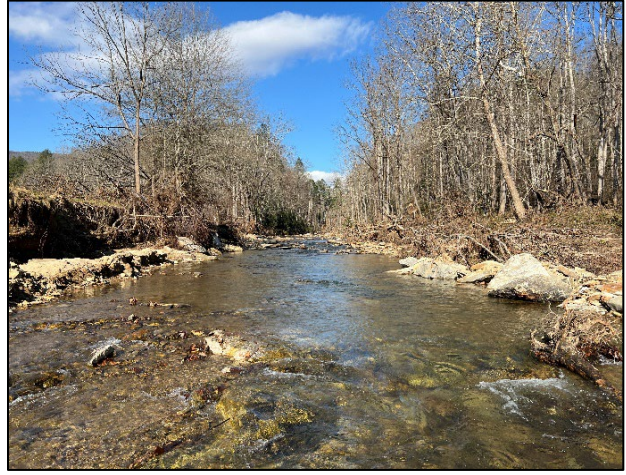
Broad River at SR 2802 post-Helene, December 2024.

Macroinvertebrate habitat scored moderate (70/100), which was significantly less than when the site was previously assessed in August 2015 (85/100). Facing upstream, riparian vegetation on the right bank appeared intact. However, left bank vegetation was sparser with deeply incised, nearly vertical straight banks. Physical-chemical parameters measured were within normal ranges for this river (Table 3). Water was clear with a turbidity of 2.01.

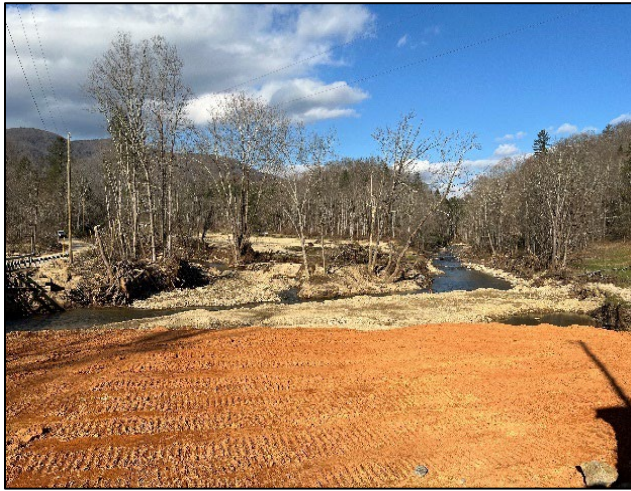
Confluence of Flat Creek and Broad River post-Hurricane Helene.

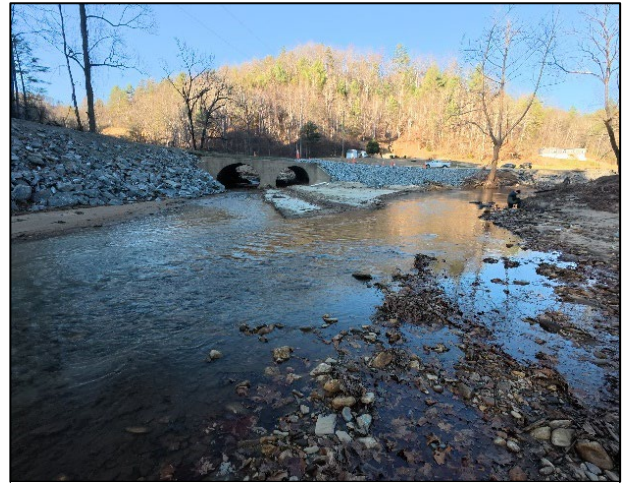
Hungry River off SR 1799 post-Helene, December 2024.

Macroinvertebrate habitat scored low (52/100), but was similar to the site's previous assessment in June 2021 (57/100). However, DWR biologists noted significant new sand deposits in the channel, with 8-12-inch-high sand wrack lines in the mainstream channel. Although this site has had historical issues with sand and fine sediment

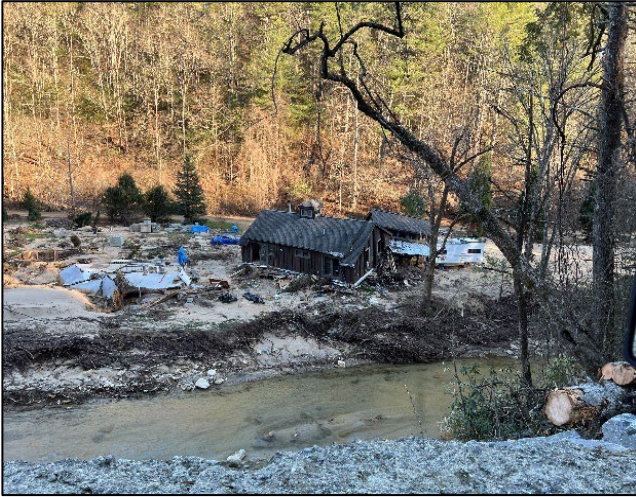
Home swept off foundation, Hungry River downstream of SR 1799.

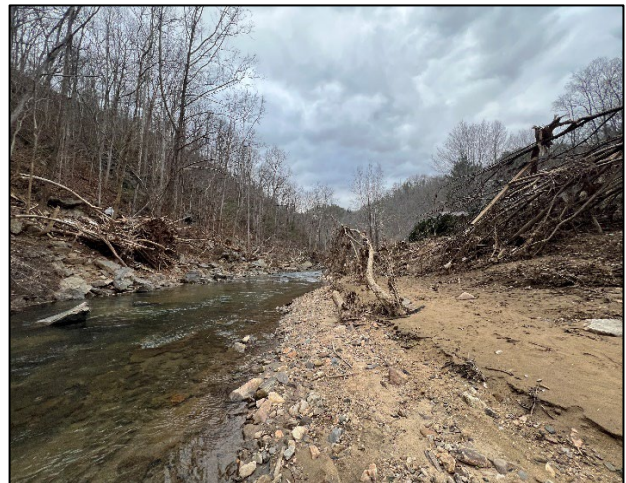
Ivy Creek at US25-70 BUS facing downstream post-Hurricane Helene, December 2024.

Macroinvertebrate habitat scored low (56/100), which was significantly less than when the site was previously assessed in September 2022 (73/100). Facing upstream, left bank riparian vegetation was completely removed by the extreme flows. Physical-chemical parameters measured were within normal ranges for a healthy river of this size in this ecoregion (Appendix Table 1). Water was clear, but turbidity was 8.28 NTU, indicating that active erosion and suspension of alluvial deposits of sand and fine sediments are still ongoing more than two months post-Hurricane Helene.

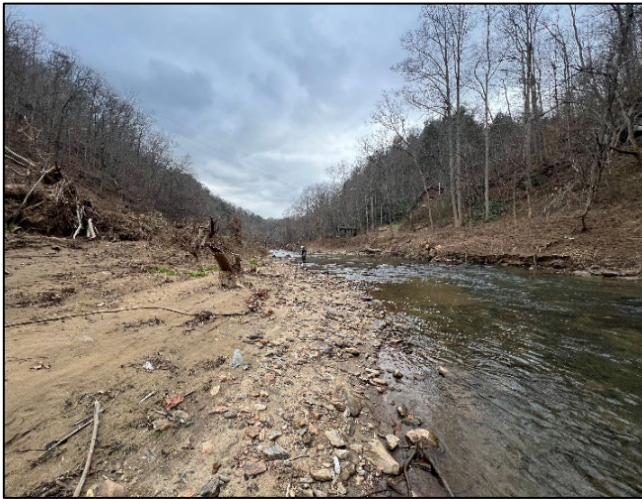
Ivy Creek at US25-70 BUS facing upstream post-Helene showing riparian damage and downed transmission lines.

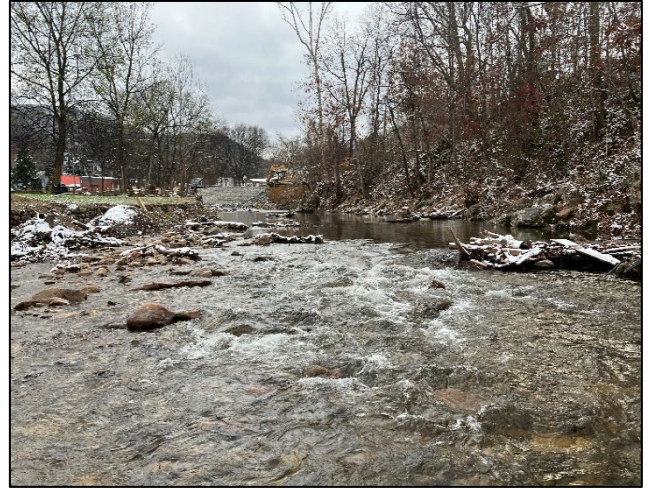
Spring Creek well downstream of NC 209 facing upstream post-Hurricane Helene, December 2024.

Macroinvertebrate habitat scored low (57/100), which was significantly less than when the site was previously assessed in September 2022 (77/100). Facing upstream, left bank riparian vegetation was completely removed due to scour during major flood stage. Physical-chemical parameters measured were within normal ranges for a healthy river of this size in this ecoregion (Appendix Table 1). Water was clear and turbidity was 0.71 NTU despite ongoing in-stream habitat modification work continuing in the watershed.

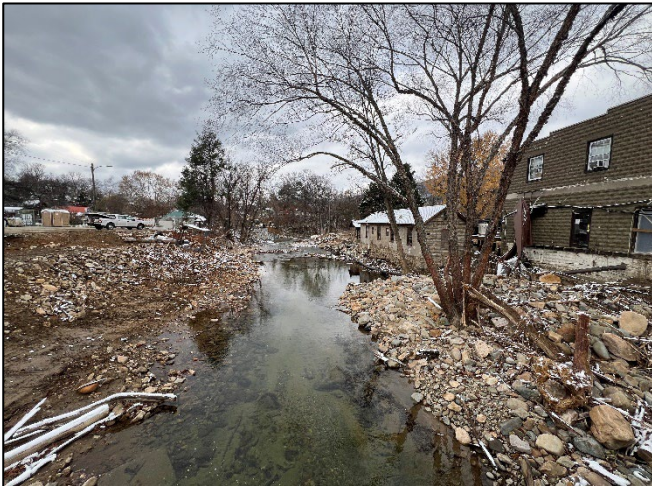
Spring Creek facing downstream from NC 209 bridge in Hot Springs, December 2024. Note Spring Creek Tavern to the right.

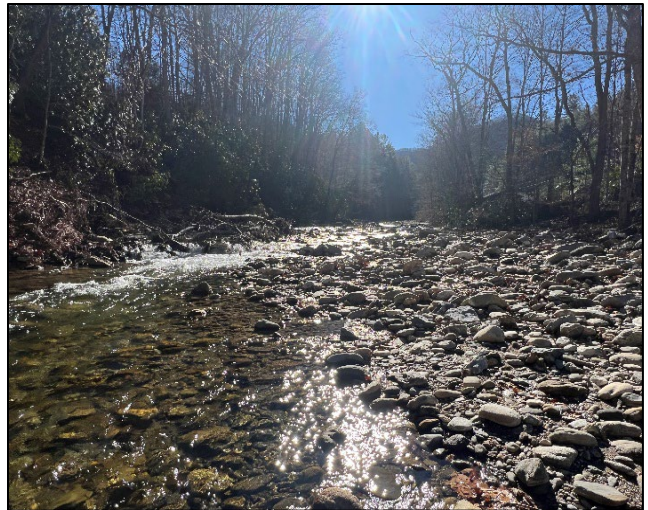
West Fork Pigeon River at SR 1216 facing upstream post-Hurricane Helene, December 2024.

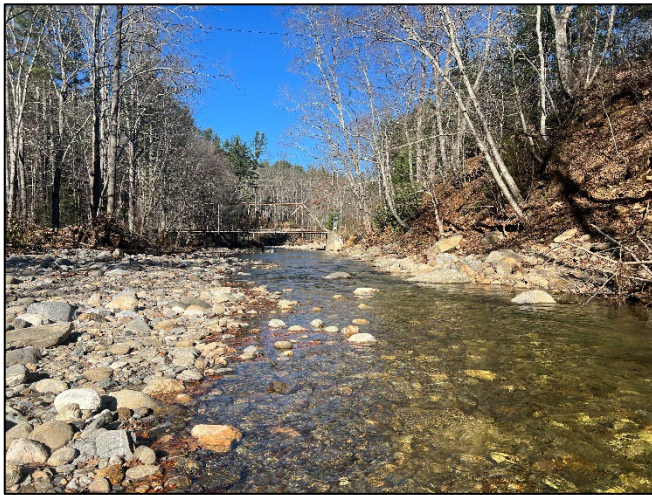
West Fork Pigeon River at SR 1216 facing downstream post-Hurricane Helene, December 2024.

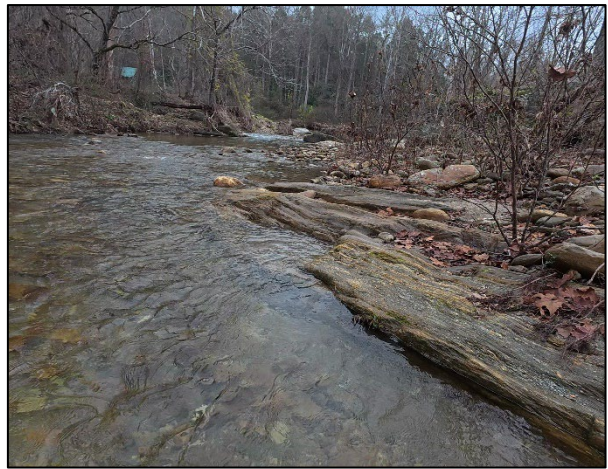
Gragg Prong post-Helene, 20 November 2024.

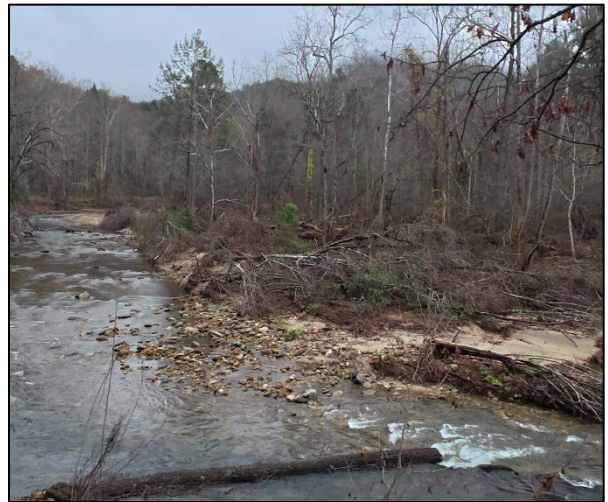
Wilson Creek post-Helene, 20 November 2024.

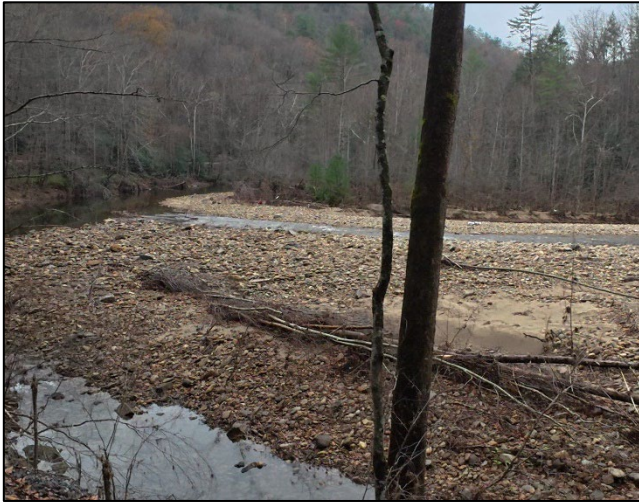
Wilson Creek with new stream channels post-Helene (foreground).

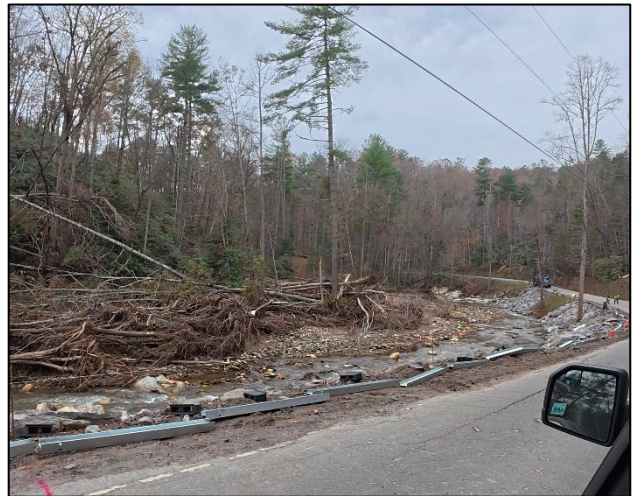
Buck Creek, same reach, post-Helene, 19 November 2024.

Macroinvertebrate habitat was severely affected (75/100) by the flooding and scour, with the edge habitat almost completely gone. Periphyton was notably absent, and the channel was scoured down to bedrock in places. In some areas the stream was a small, wetted channel amidst a large, dry boulder and cobble field. While physical-chemical parameters measured were within normal ranges, the water was only relatively clear, with a turbidity measure of 3.0 NTU, likely due to ongoing in-stream construction work occurring in the upstream catchment. Buck Creek has historically rated Excellent or Good based on the macroinvertebrate fauna present. If rated for this study, Buck Creek would have received a Fair rating, or three bioclassifications below Excellent.

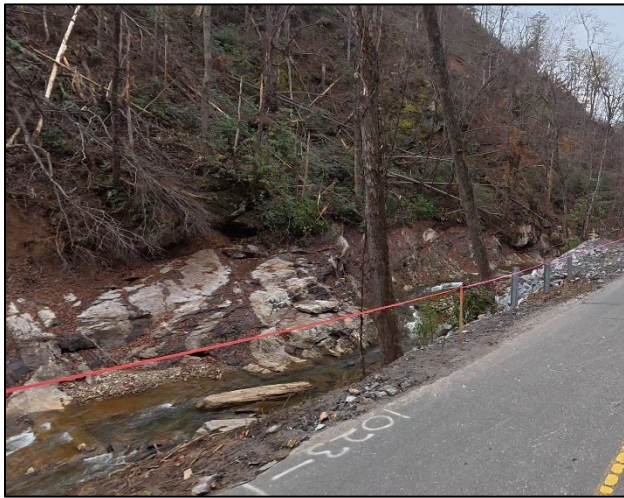
Buck Creek denuded banks, post-Helene, 19 November 2024.

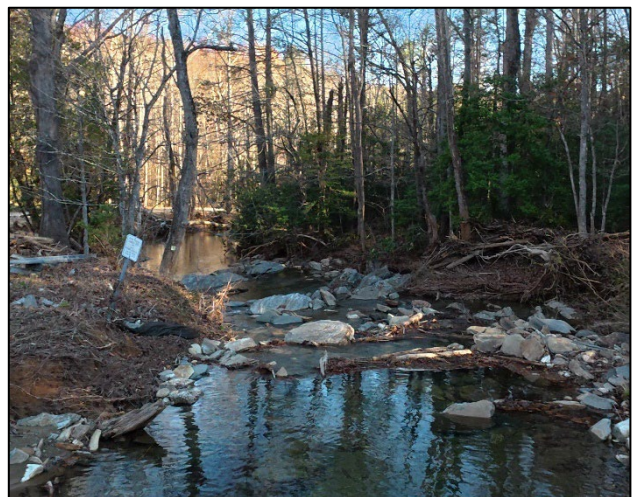
Catawba River, same reach post-Helene, 21 November 2024.

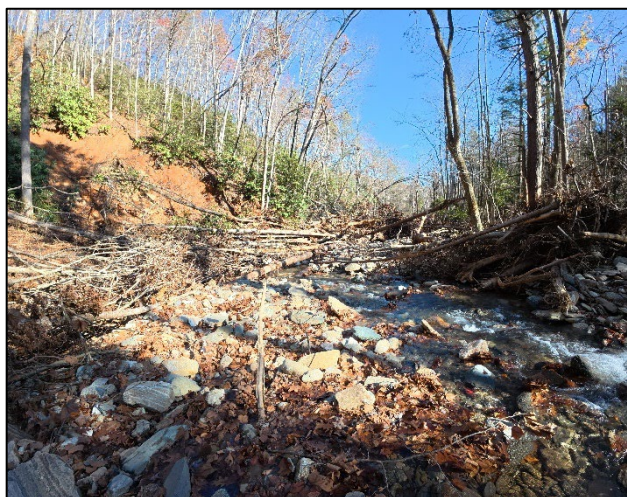
A small landslide and debris dam just upstream of the sampling site.

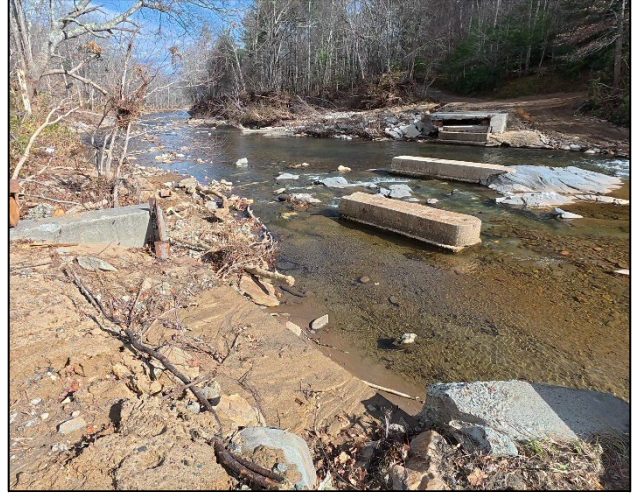
South Toe River, post-Helene, 21 November 2024.

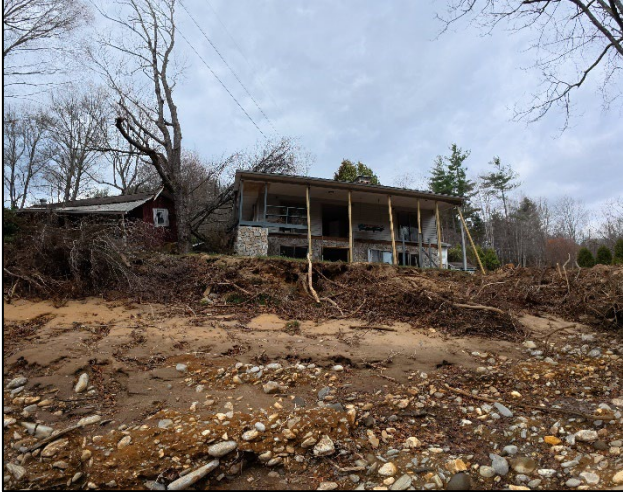
South Toe River bank, 21 Nov. 2024. The red house on the left was moved off its foundation, but stopped from hitting the white house only by a large tree.
