# 2022 DWR Submerged Aquatic Vegetation (SAV) Survey Report Lake Reidsville and Lake Hunt

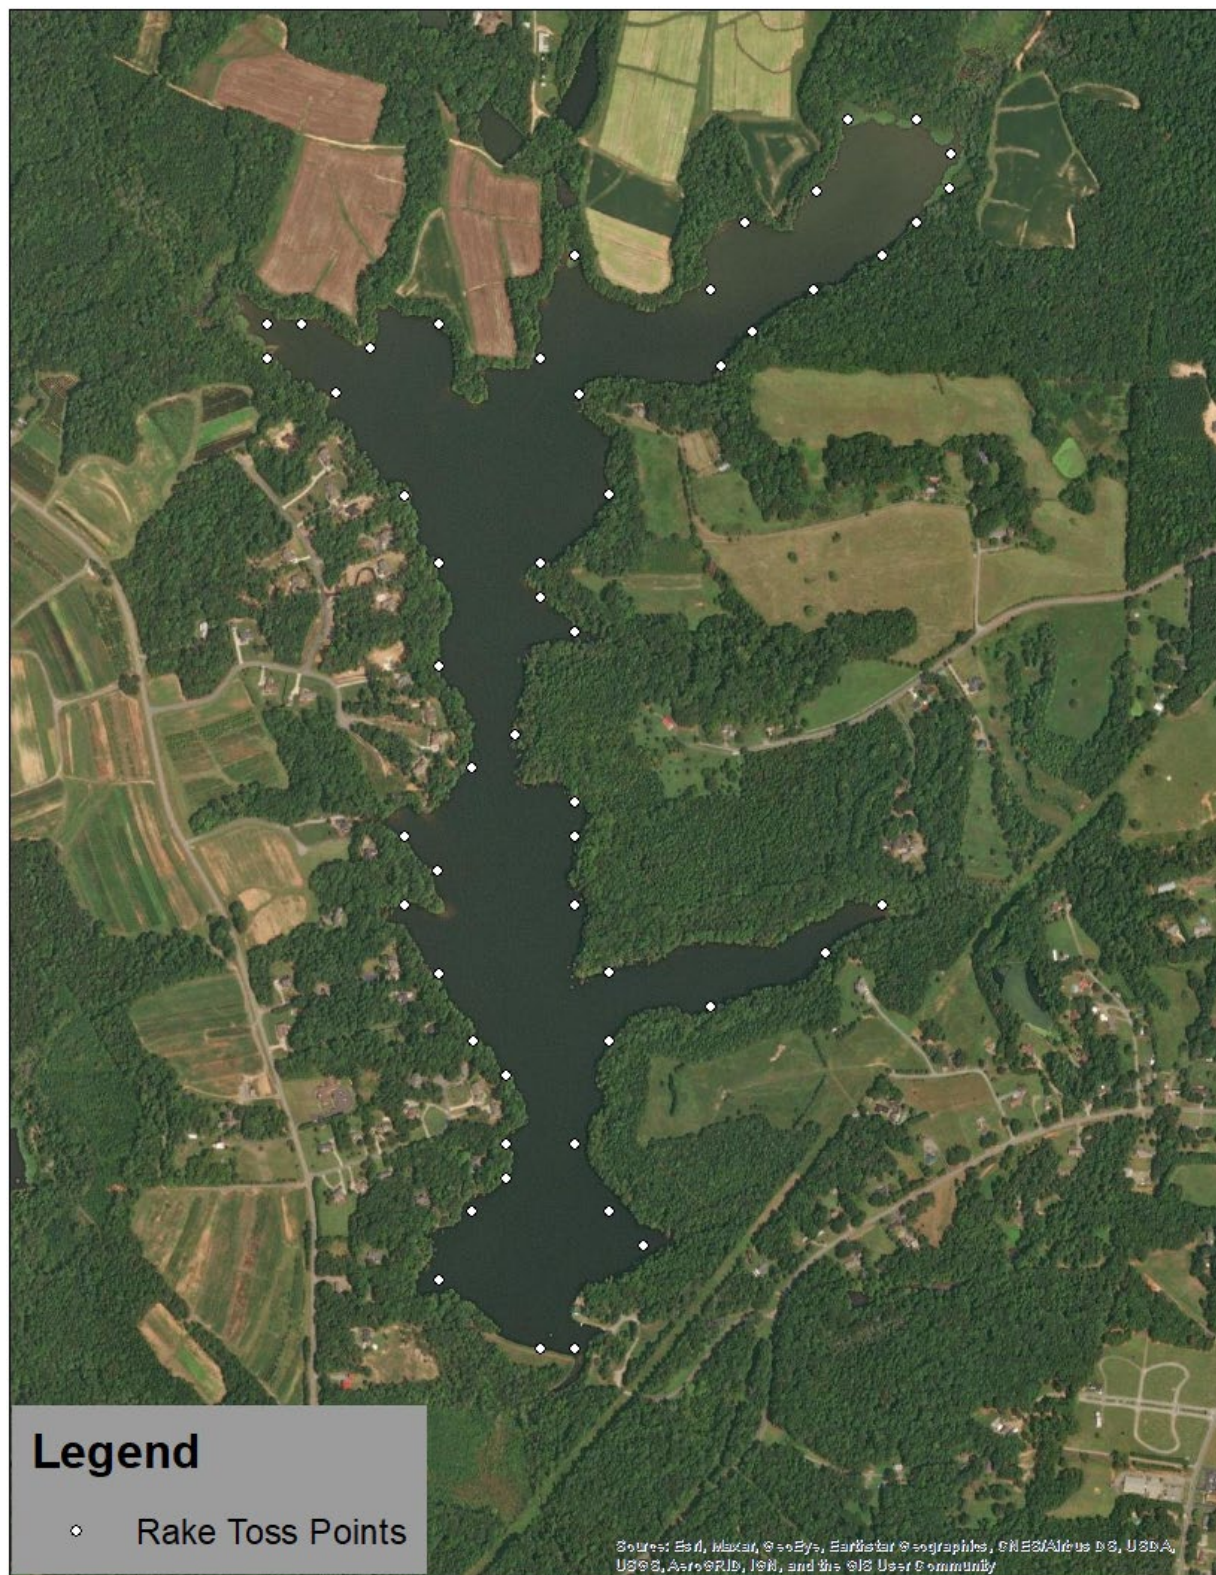
Figure 1. Map showing pre-determined rake toss points at Lake Hunt.

The AWCP conducted a full-lake survey at Lake Hunt on September 27<sup>th</sup> and a full-lake survey on Lake Reidsville October 18<sup>th</sup> – October 19<sup>th</sup>. Using a point-intercept method, a total of 53 points were sampled at Lake Hunt (Figure 1) and a total of 126 points were sampled at Lake Reidsville (Figure 2). Three rake tosses were conducted at each point along the shoreline to determine presence/absence of SAV as well as quantify rake coverage. Rake coverage was quantified using a scale from 0 to 4 (0 = no vegetation; 1 (Trace) = <25%; 2 (Sparse)= 25% - 50%; 3 (Moderate)= 50% - 75%; 4 (Dense) = 75% - 100%). Additionally, a recording fathometer (SONAR) was used to map and record the bottom. Roughly 28 miles of SONAR were logged. The SONAR data was uploaded to a third-party company, Biobase, to quantify the depth and biovolume data. Biovolume is a percentage of the water column taken up by vegetation when vegetation is present. All of this was then combined with the rake-toss data using GIS software to estimate coverage.

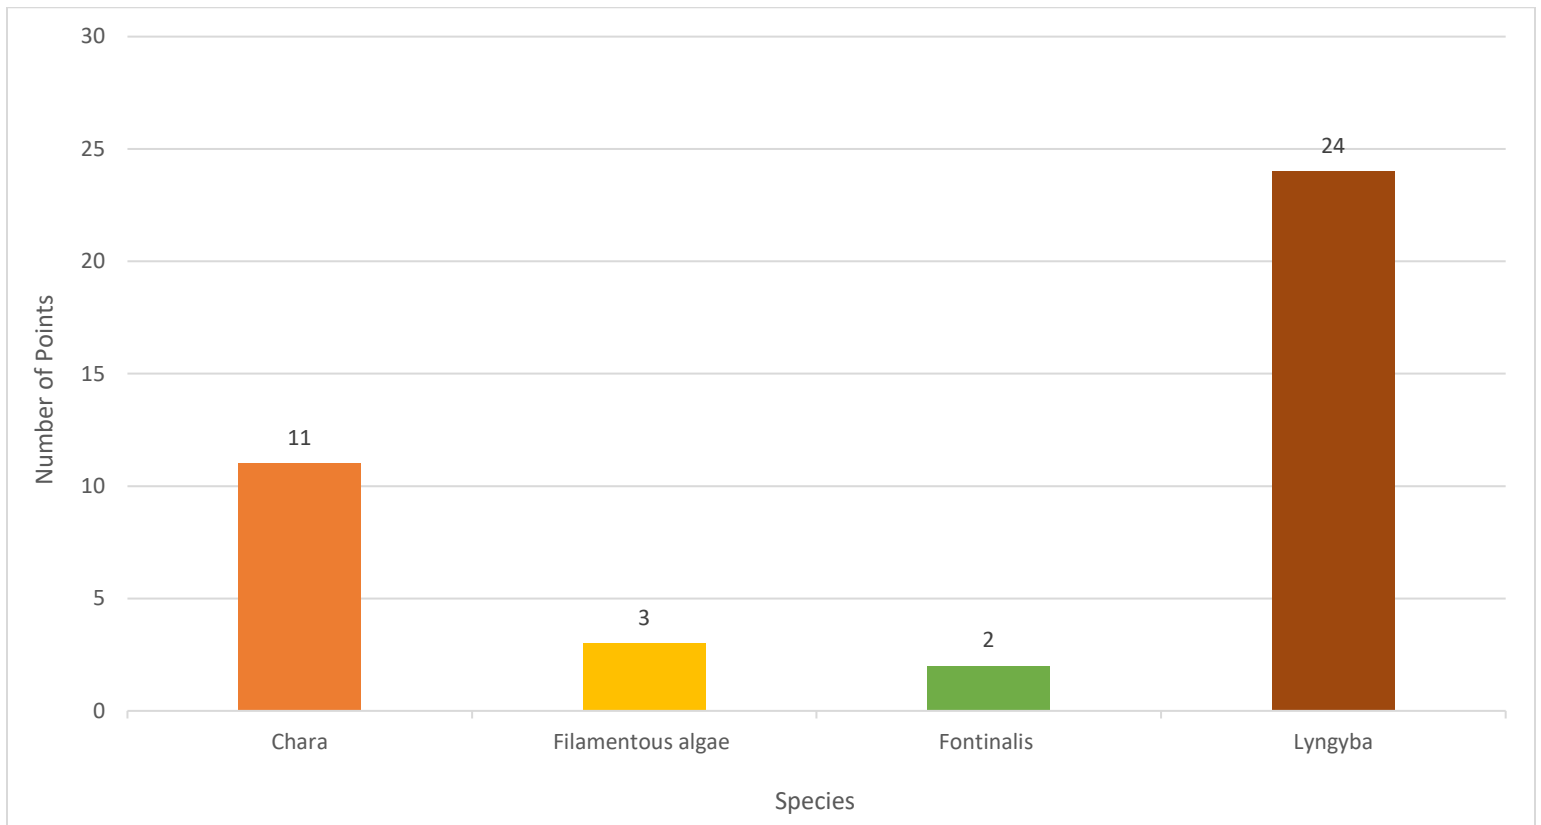
Figure 3. Relative abundance during the 2022 Lake Hunt survey.

SAV was found at 29, or 55%, of the rake toss points (Figure 5). Species found during the survey include the aquatic moss *Fontinalis* (*Fontinalis spp.*), the macroalgae *Chara* (*Chara spp.*), Filamentous algae (*Spirogyra spp.*) and the blue-green algae *Lyngbya* (*Microseira wollei*) (Table 1; Figures 3, 6 – 9). All these species have been found during previous surveys except for *Fontinalis*. The estimated coverage of *Lyngbya* was 7 acres (Figure 10).

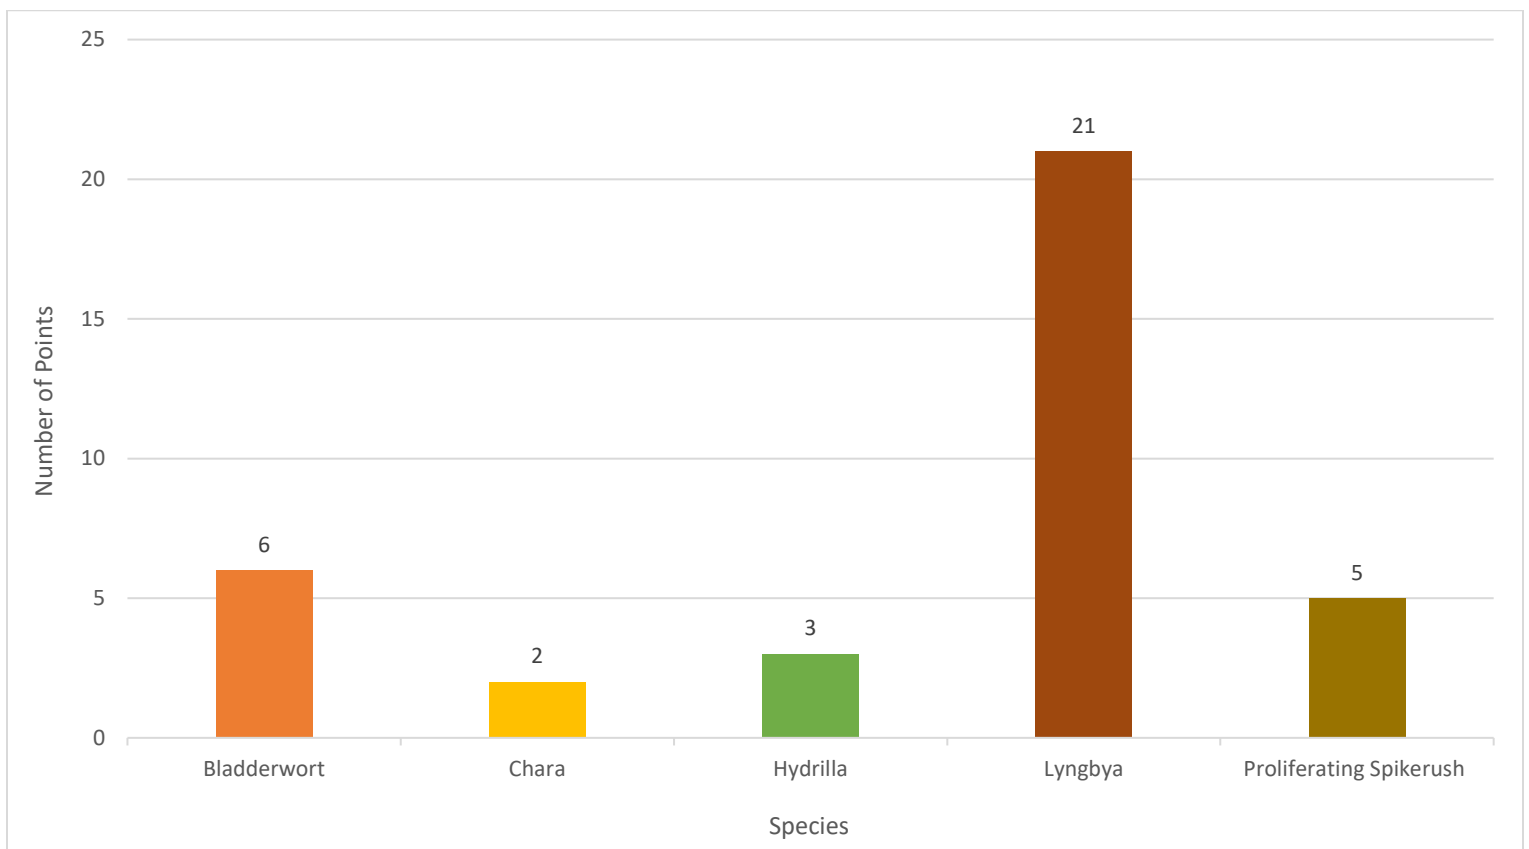
Figure 4. Relative abundance during the 2022 Lake Reidsville survey.

SAV was found at 33, or 26%, of the rake toss points (Figure 11). Species found during the survey include Bladderwort (*Utricularia spp.*), Chara (*Chara spp.*), Hydrilla (*Hydrilla verticillata*), Proliferating Spikerush (*Eleocharis baldwinii*), and Lyngbya (*Microseira wollei*) (Table 2; Figures 4, 12 – 16). All these species have been found during previous surveys.

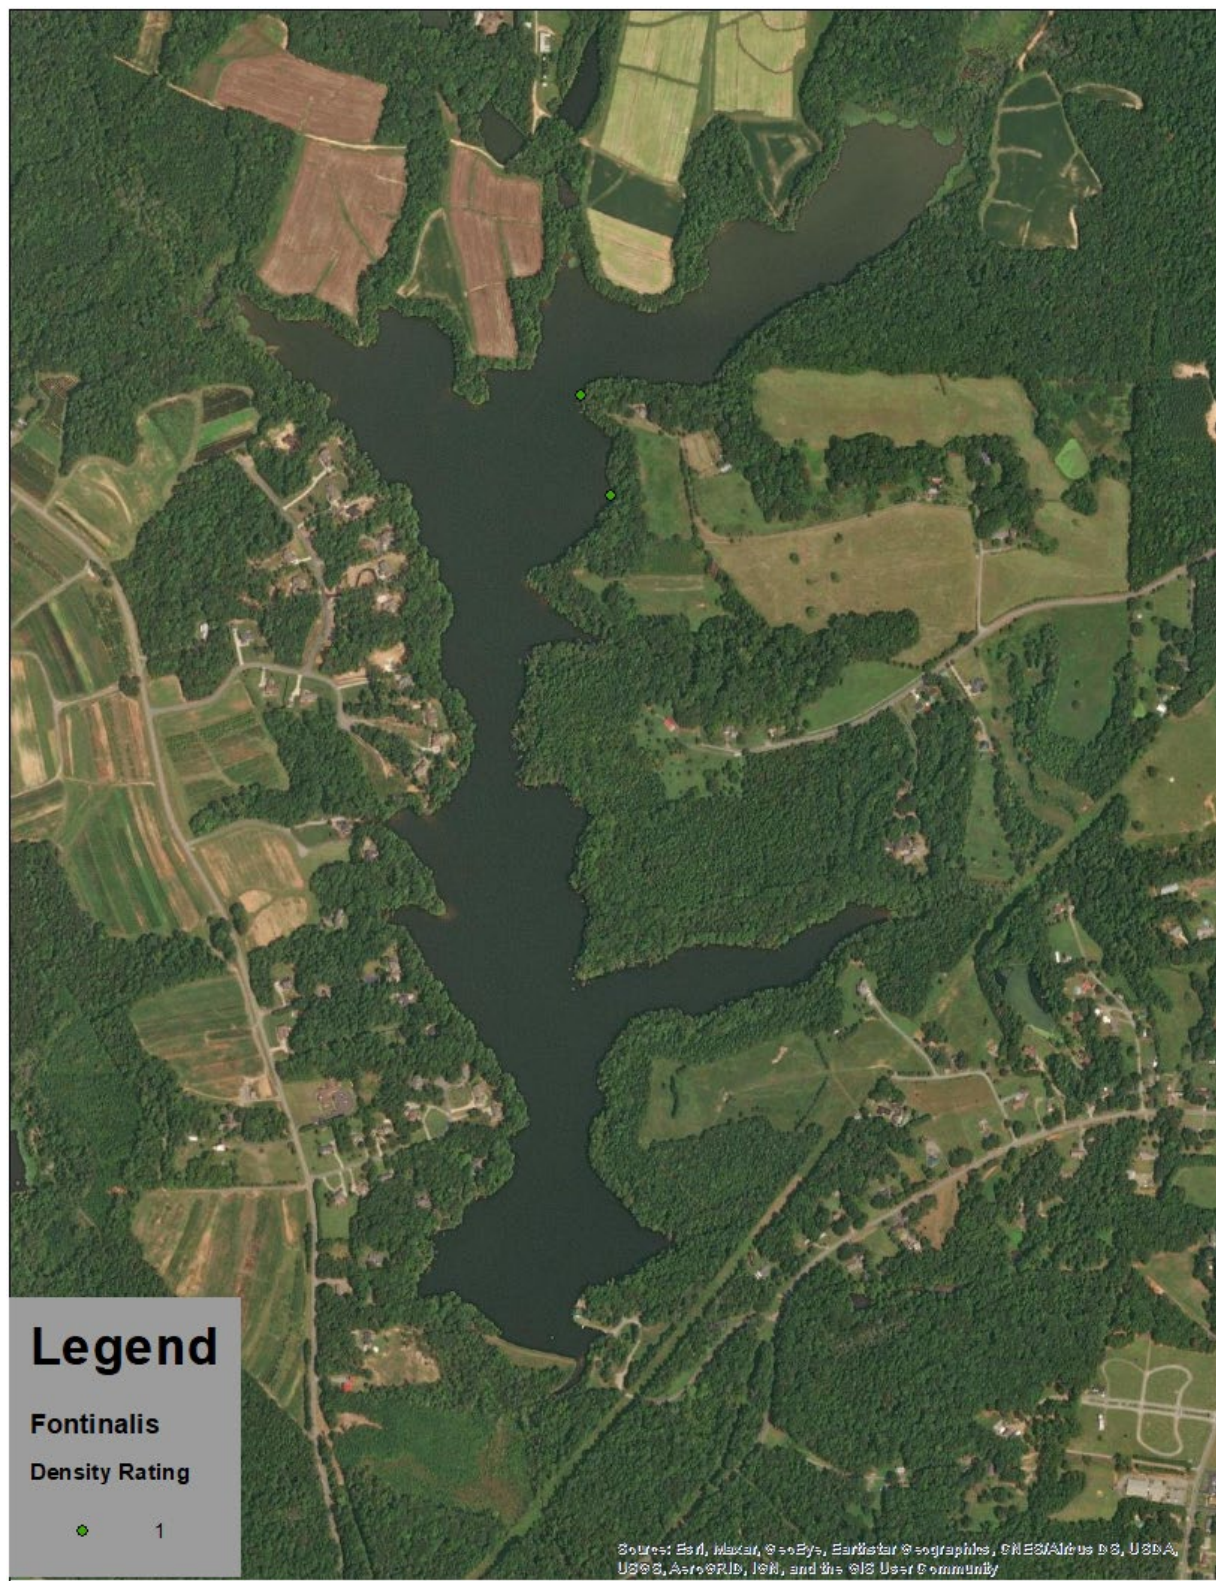
Figure 6. Map showing density rating and location of the aquatic moss Fontinalis at Lake Hunt.

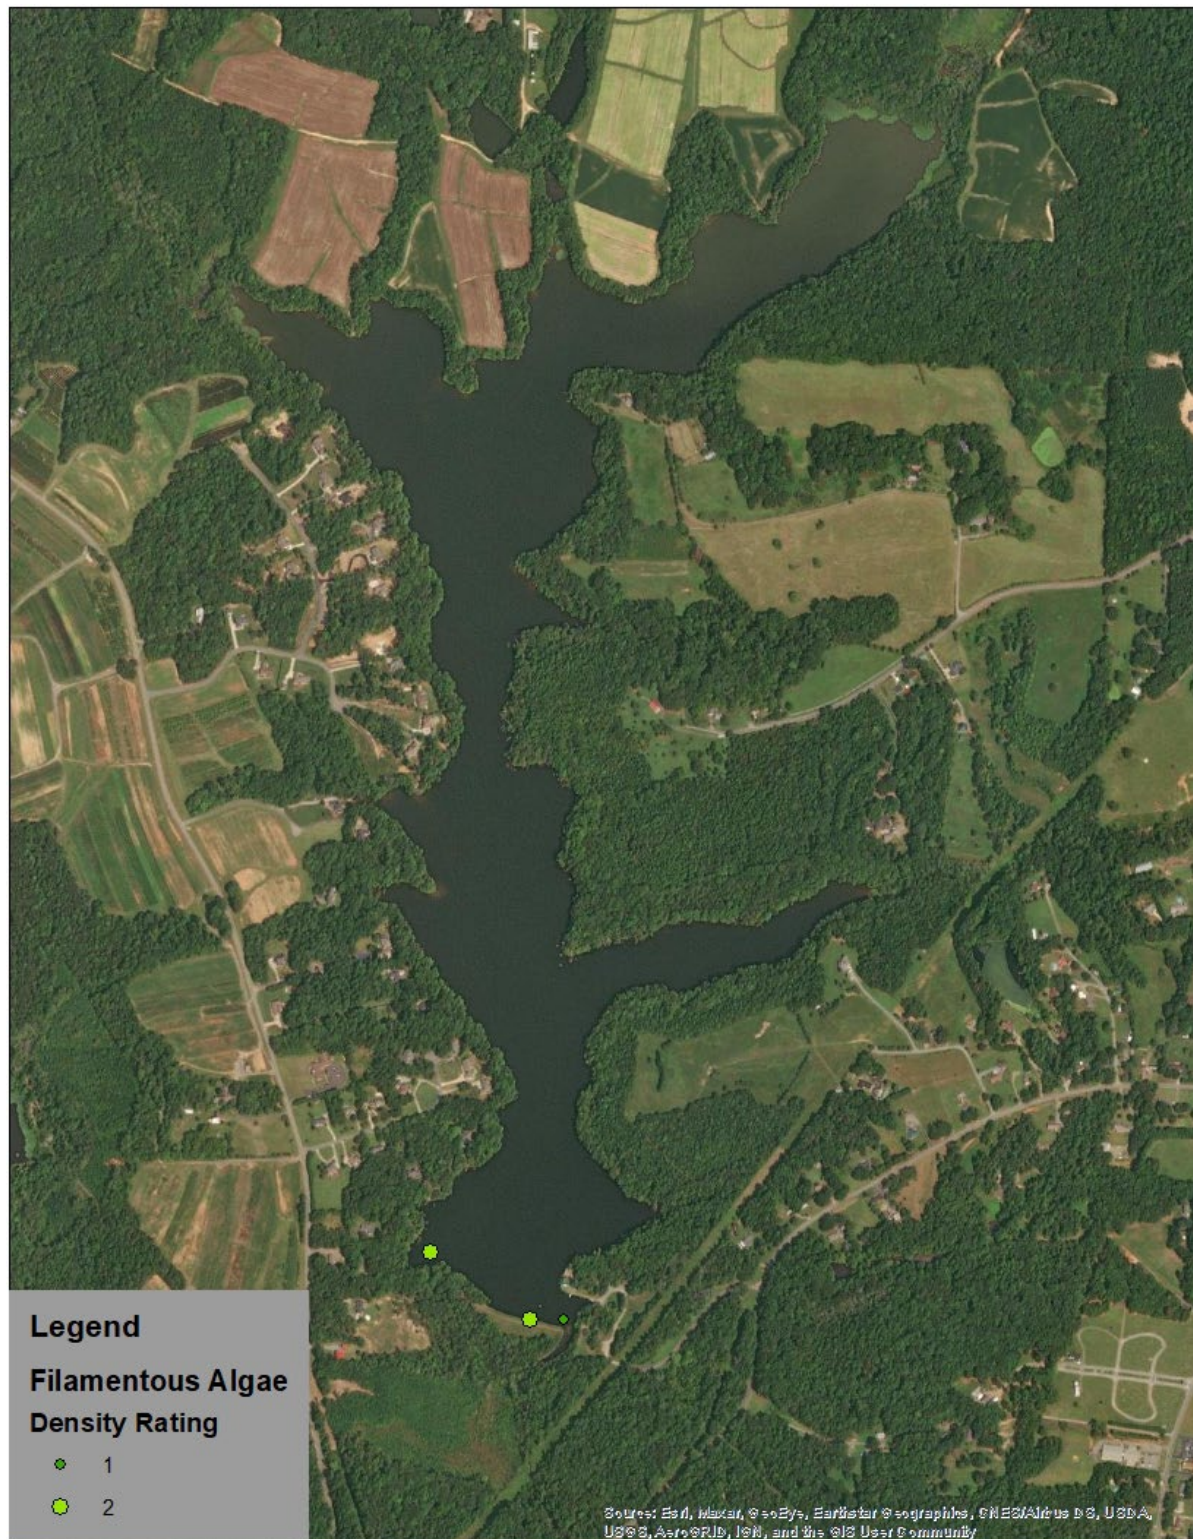
Figure 8. Map showing density rating and location of the filamentous algae (*Spirogyra spp.*) at Lake Hunt.

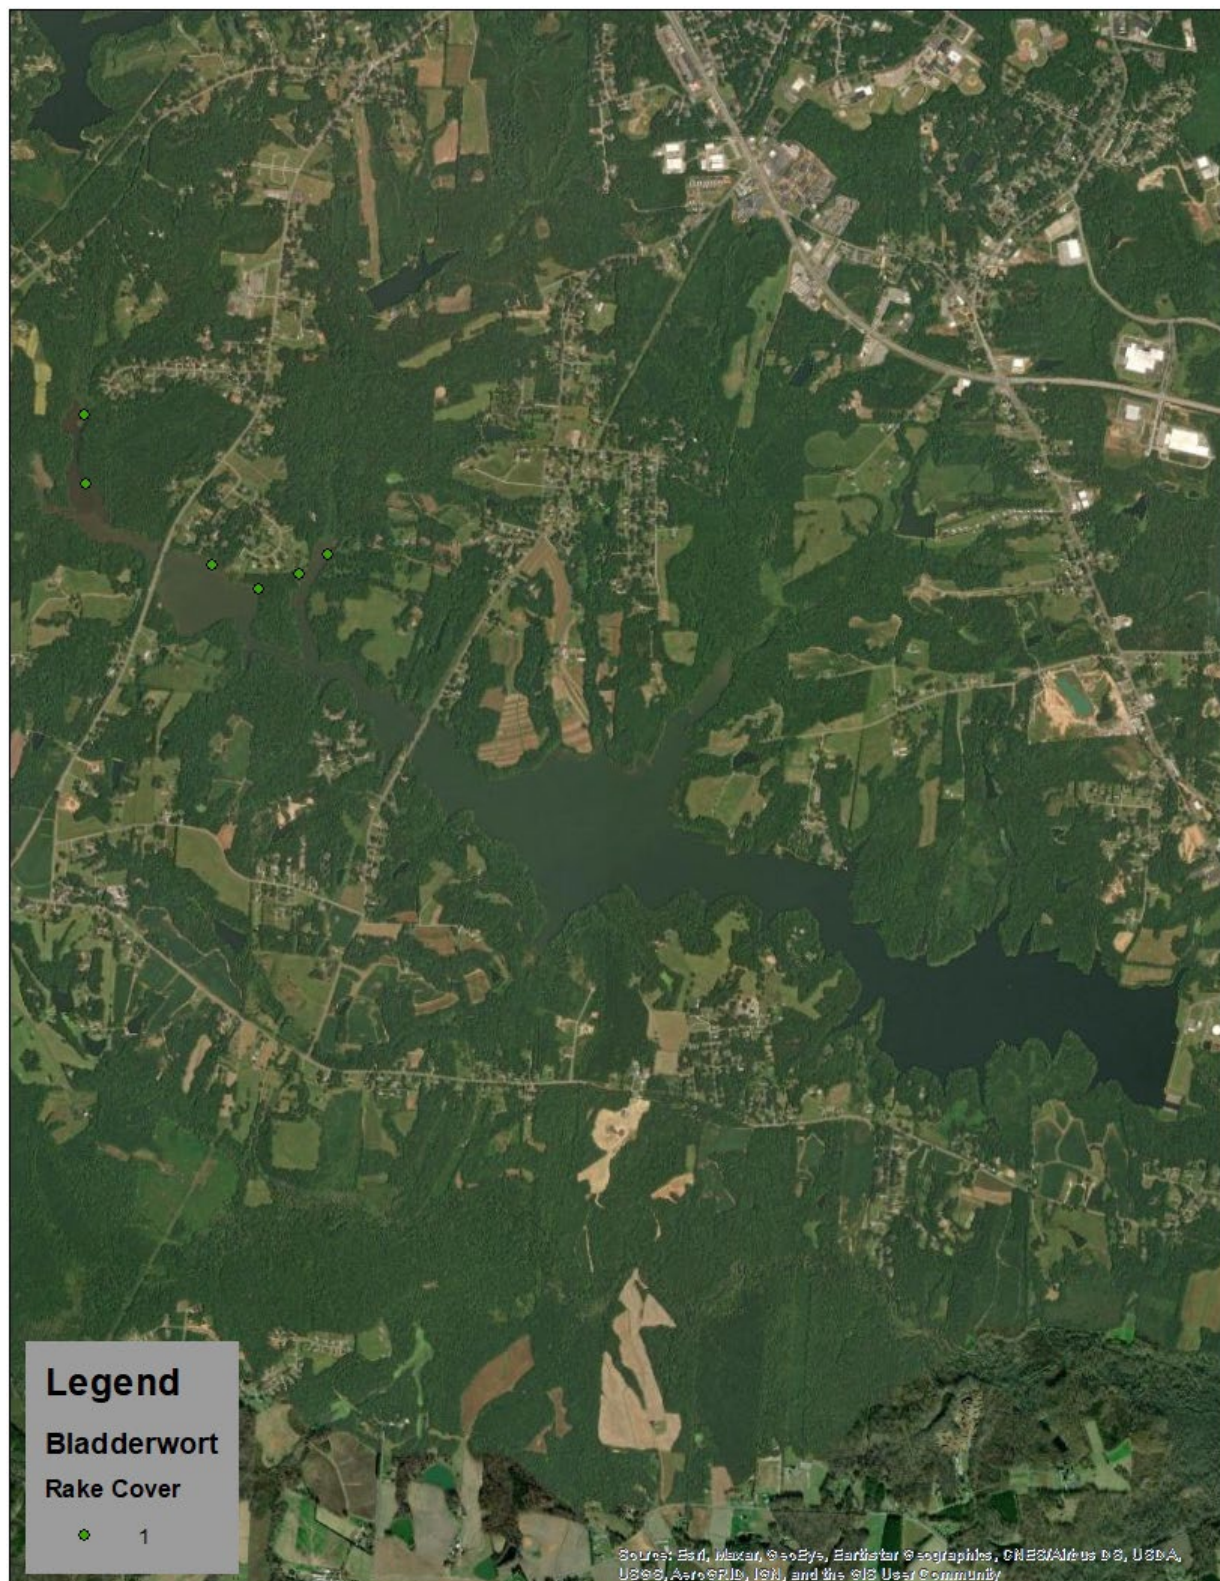
Figure 12. Map showing density rating and location of Bladderwort in Lake Reidsville.

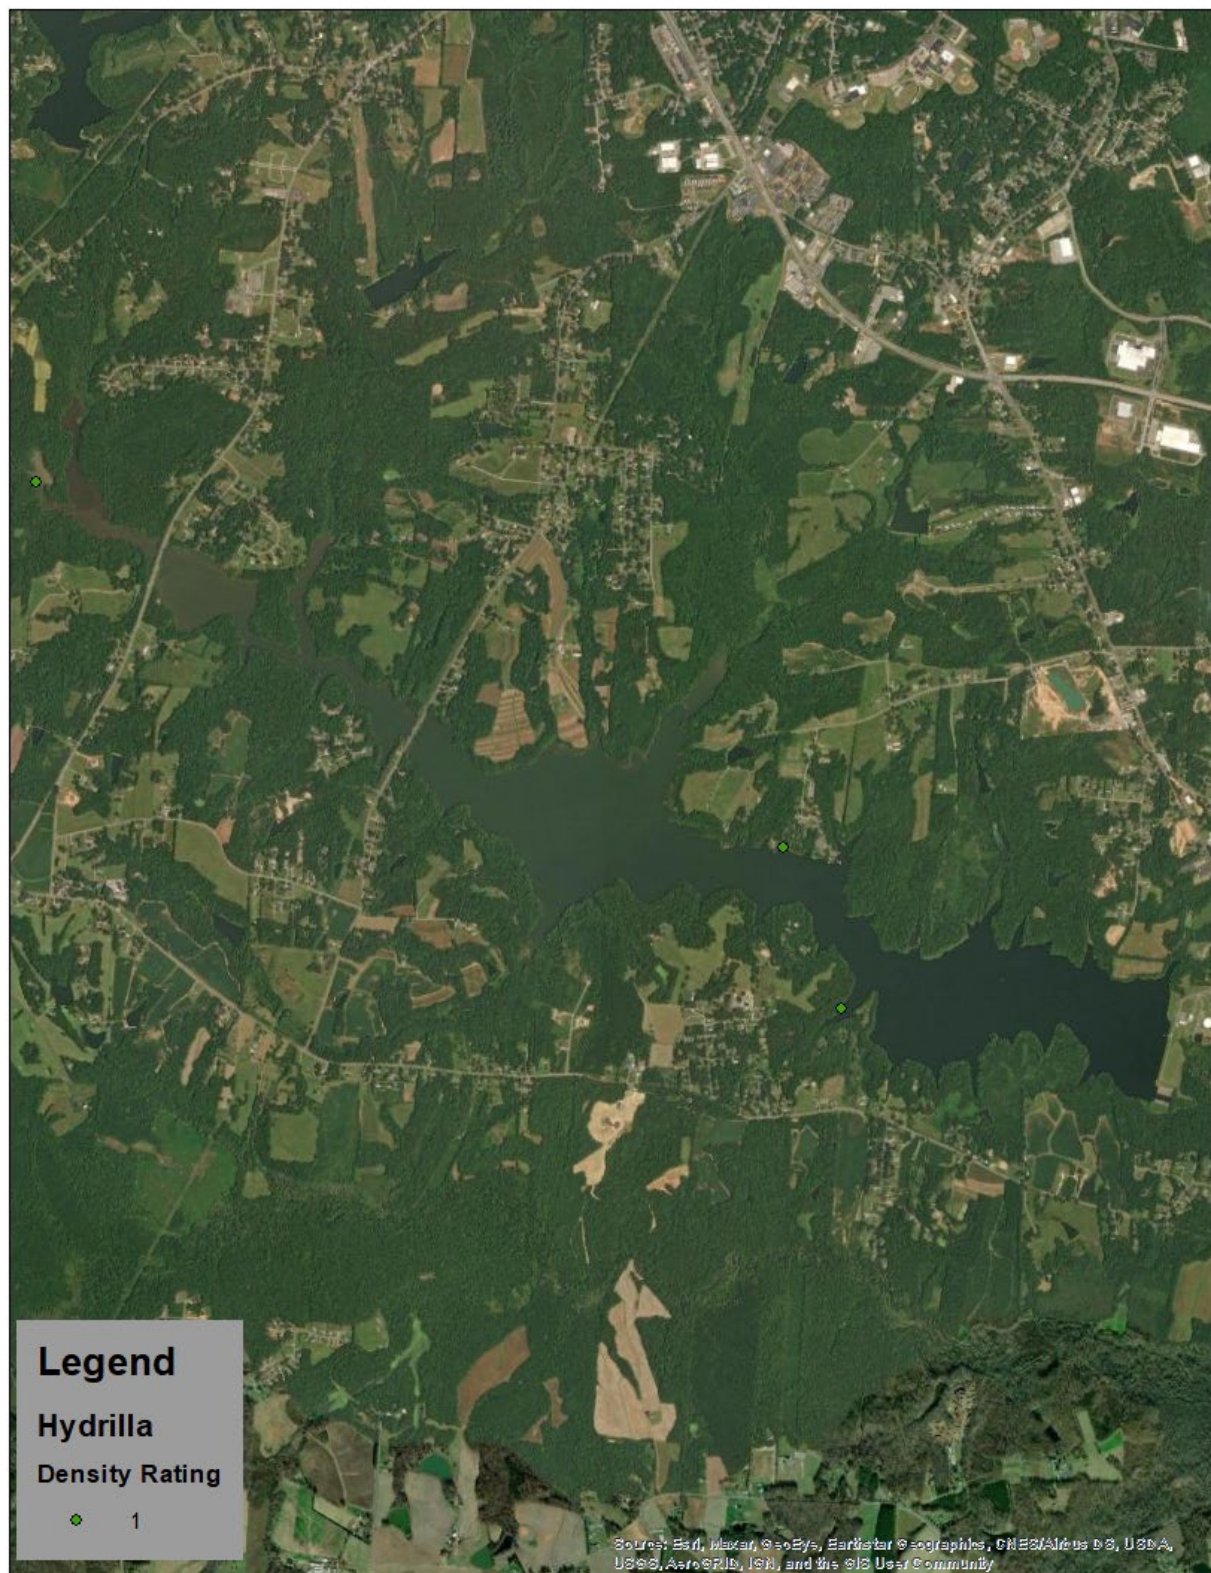
Figure 14. Map showing density rating and location of Hydrilla in Lake Reidsville.

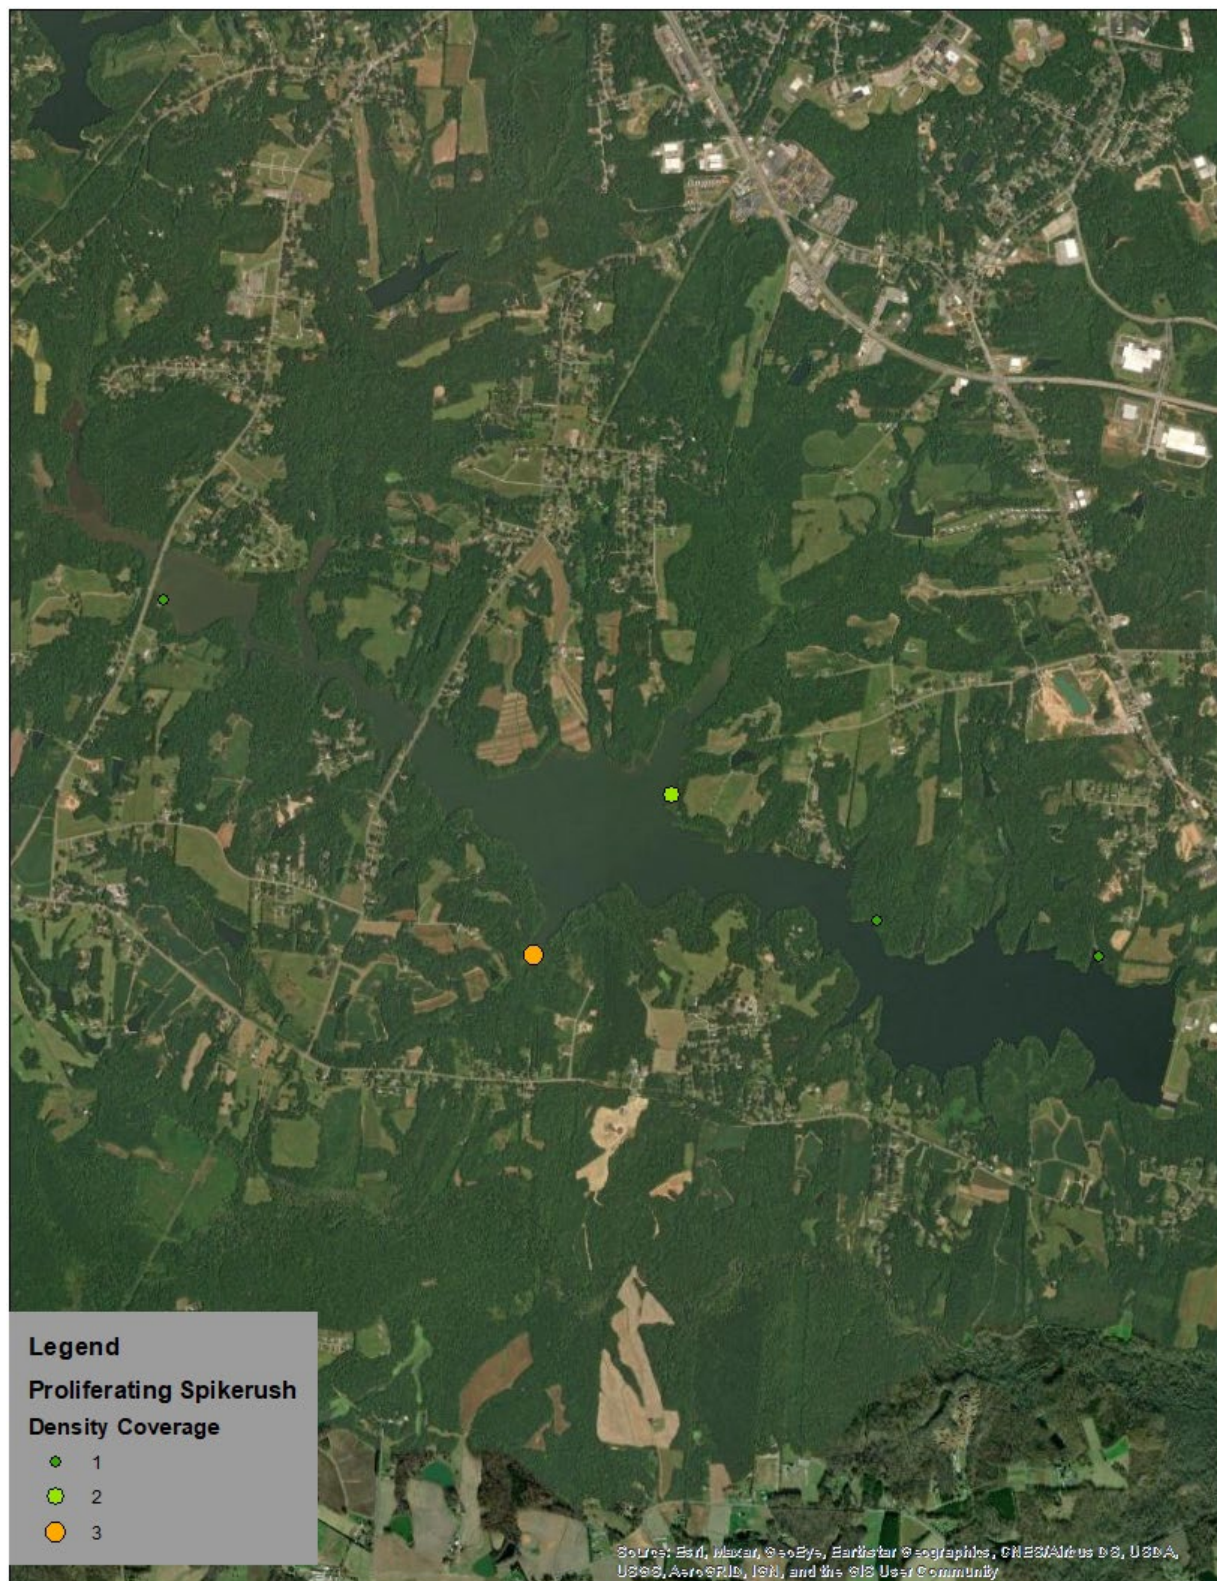
Figure 15. Map showing density rating and location of Proliferating Spikerush in Lake Reidsville.
