Living shorelines research: erosion control and hurricane resilience

Brandon Puckett (on behalf of an army of colleagues and collaborators)

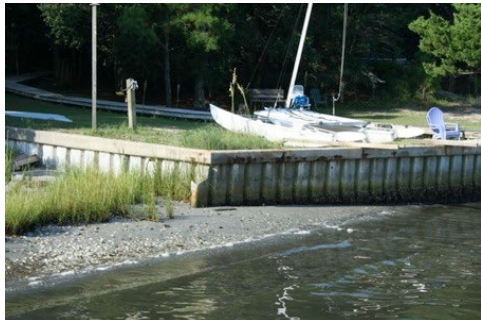
Before

Hurricane Irene (2011)

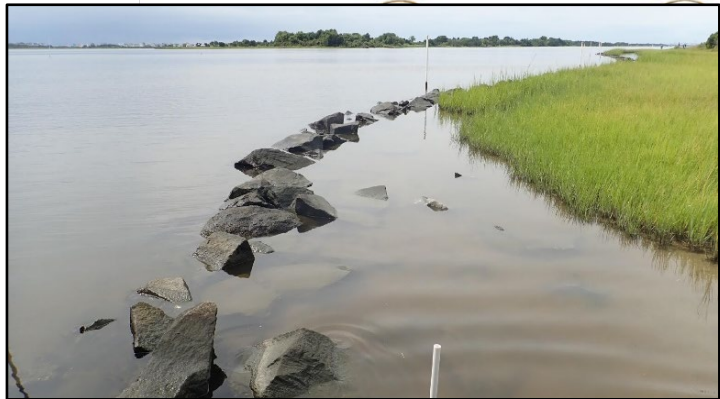
Before

Average marsh edge horizontal erosion 11.8 in (0.3m)

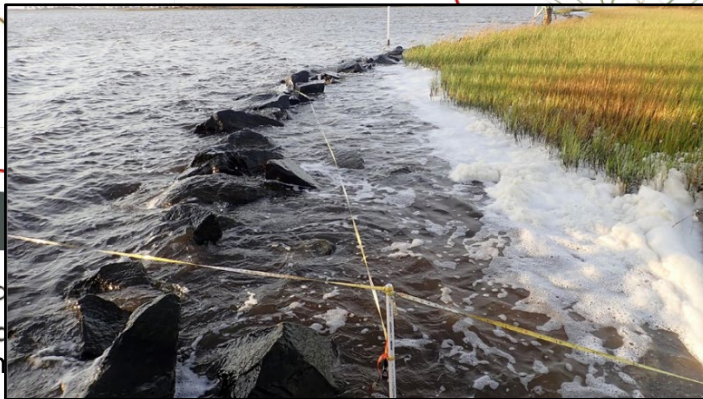
After

Average loss of 14% of marsh vegetation coverage

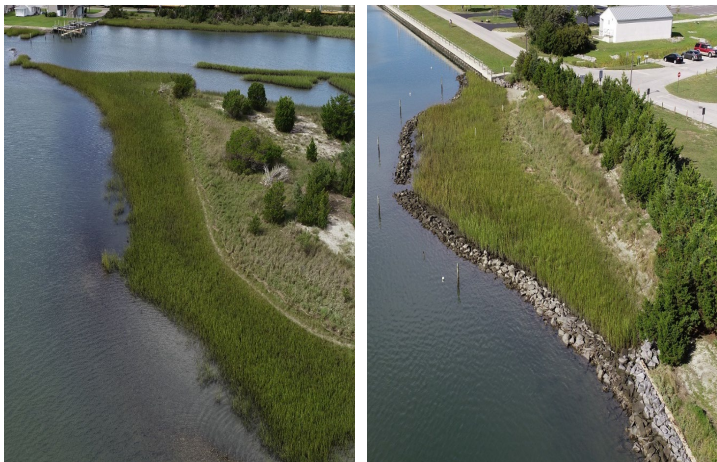
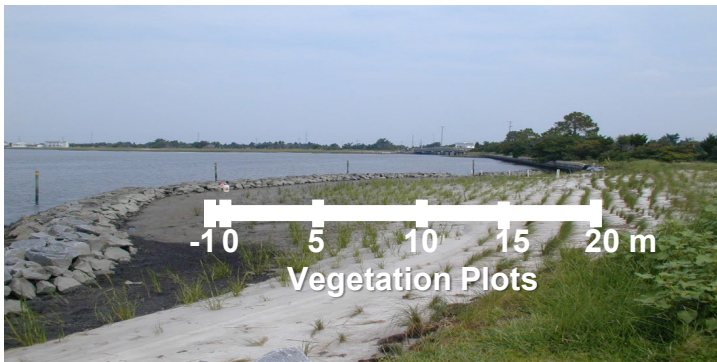
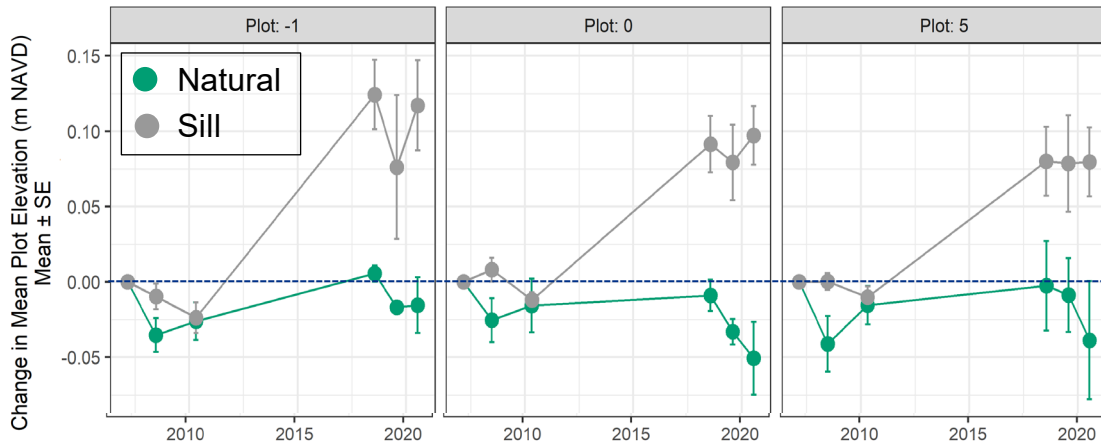
Elevation change: sills vs natural

Currin et al. in prep

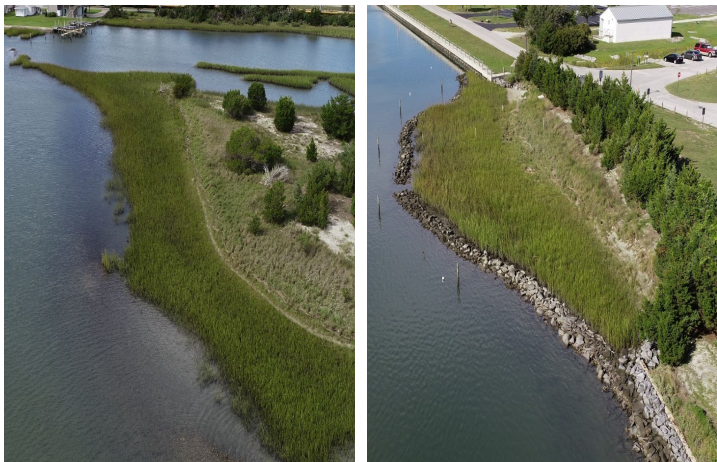
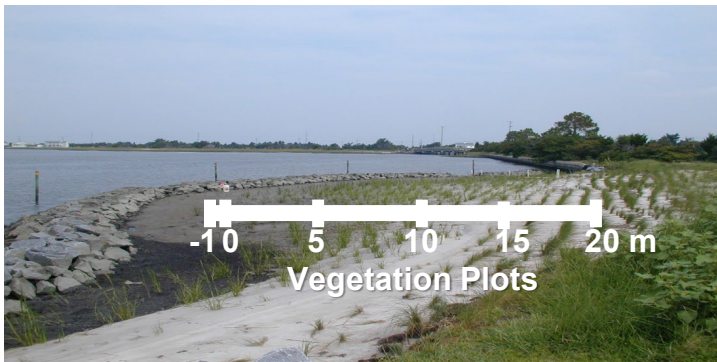
Vegetation cover: sills vs natural

Currin et al. in prep
