**RESTORATION AND MANAGEMENT PLAN FOR THE  
EMILY AND RICHARDSON PREYER BUCKRIDGE  
COASTAL RESERVE, TYRRELL COUNTY,  
NORTH CAROLINA**

**A CONCEPTUAL APPROACH**

**PREPARED BY J. DAVID FUSS**

**FOR THE NORTH CAROLINA COASTAL RESERVE PROGRAM,  
DIVISION OF COASTAL MANAGEMENT, DEPARTMENT OF  
ENVIRONMENT AND NATURAL RESOURCES**

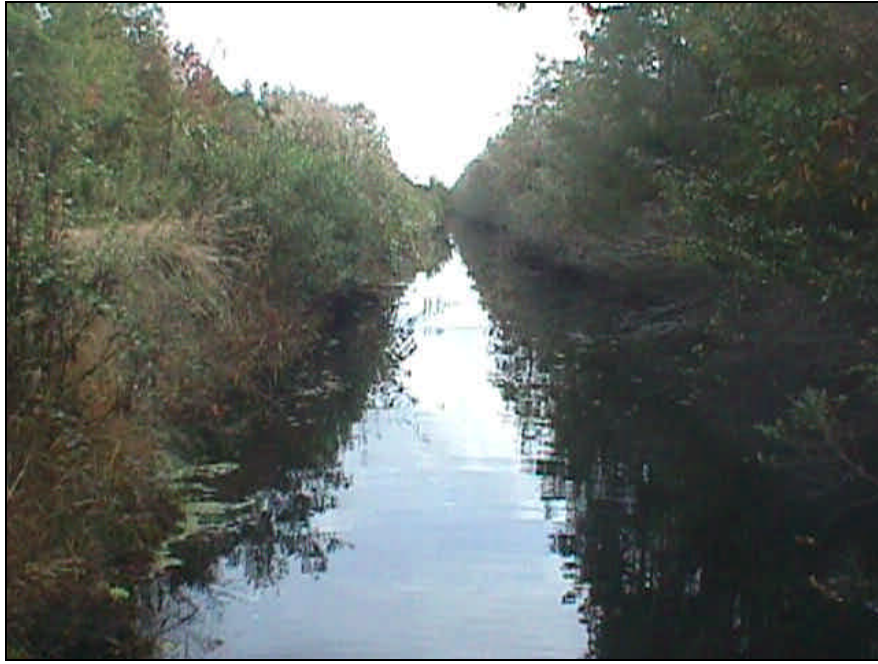
*Figure 6. A typical drainage ditch at the Preyer Buckridge Reserve.*

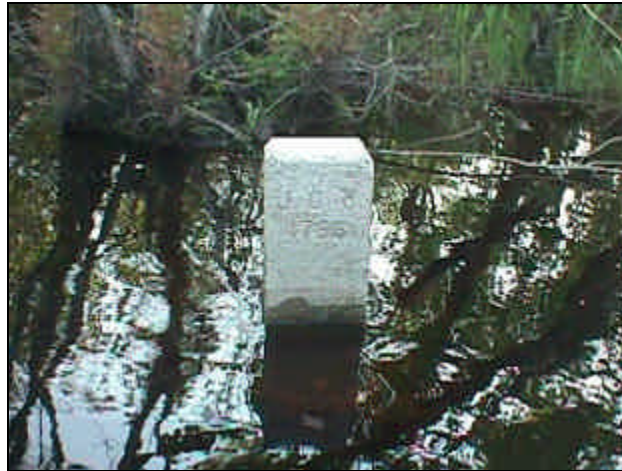
swampy areas during that time. Around the turn of the century, a major land dispute erupted between Richmond Cedar Works and the John L. Roper Company that ultimately led both companies to erect concrete markers to define their boundaries. Some of these markers can still be found at the Reserve (*Figure 16*).

*Figure 16. Concrete marker in Gum Neck Creek erected by Richmond Cedar Works.*

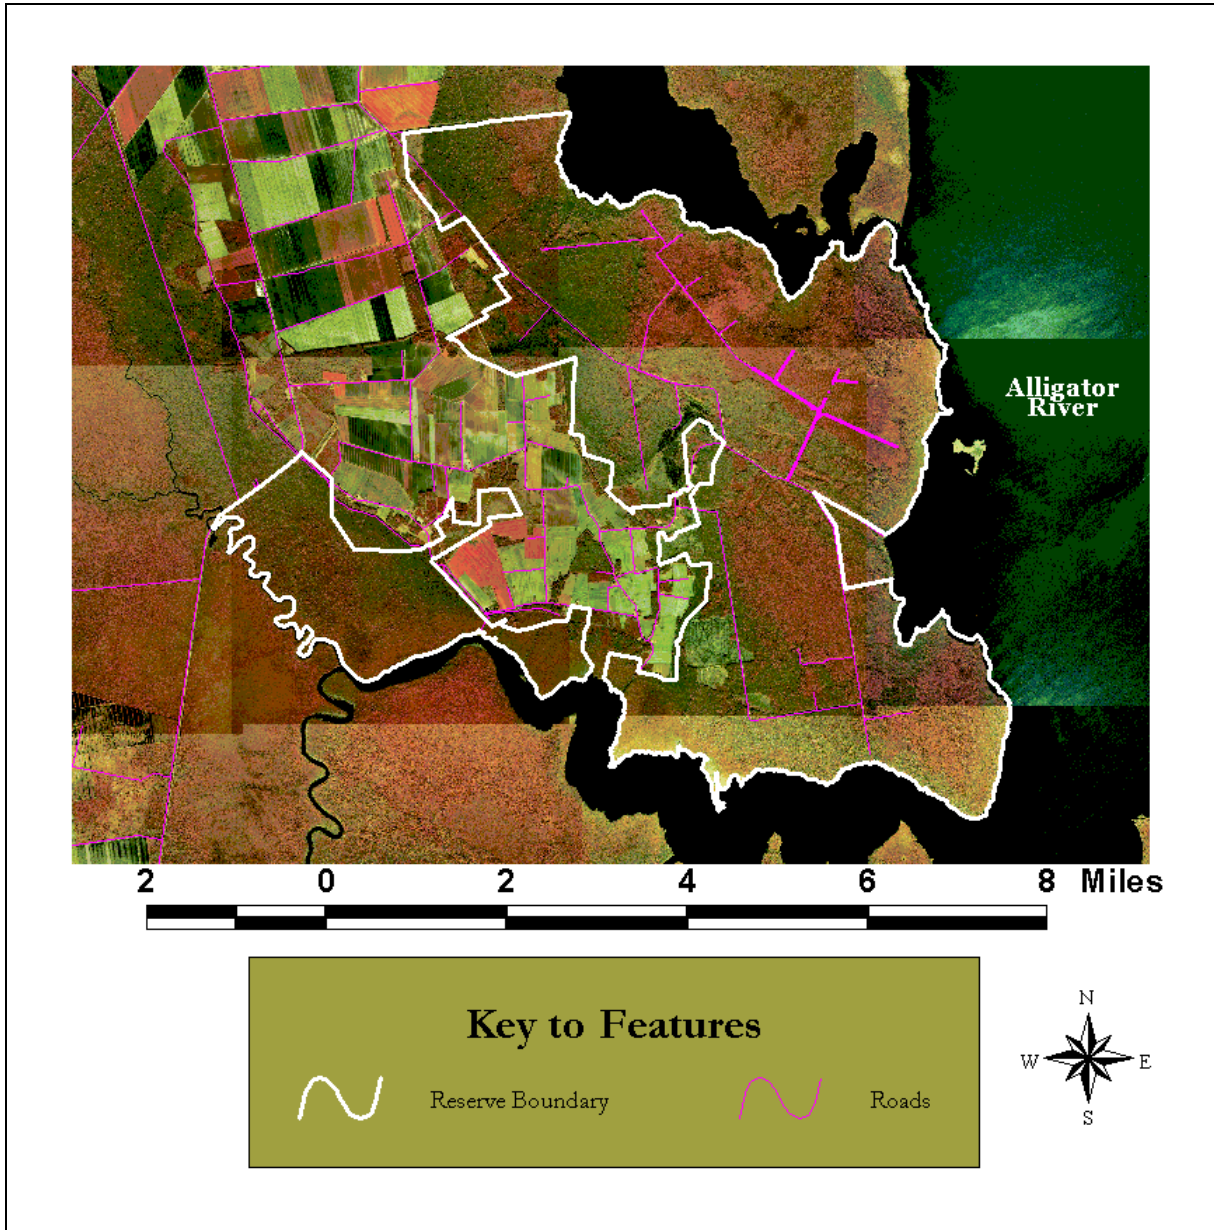
*Figure 18. 1998 color infrared aerial photography of the Preyer Buckridge Reserve.*

Aerial photography has been acquired for Buckridge for 1998 (*Figure 18*), 1993, 1974, and 1951. Available vegetation type maps date from 1955 and 1960 (Westvaco) and 1948 (Richmond Cedar Works). Finally, a Richmond Cedar Works land ownership map for Tyrrell County was made in 1921.

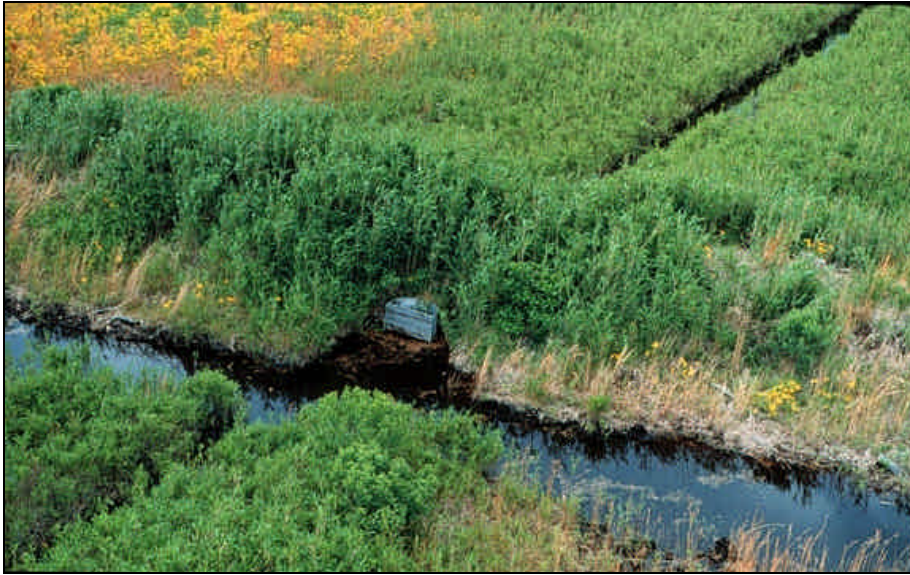
Second, water control structures may be installed at strategic locations in the ditches in order to approximate a natural hydrologic regime. These structures (*Figure 25*), most likely culverts with combinations of flashboard risers and fish passage structures (if needed), are appropriate if hydrology data show that water levels are lower nearer to

*Figure 25. Example of a water control structure along a drainage ditch.*

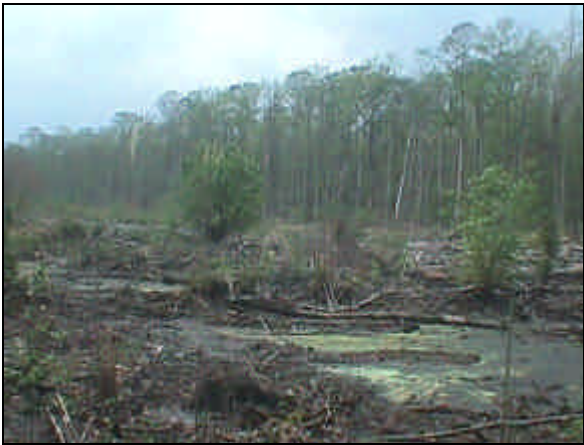
Figure 27. Proposed planting area showing lack of competitive growth.

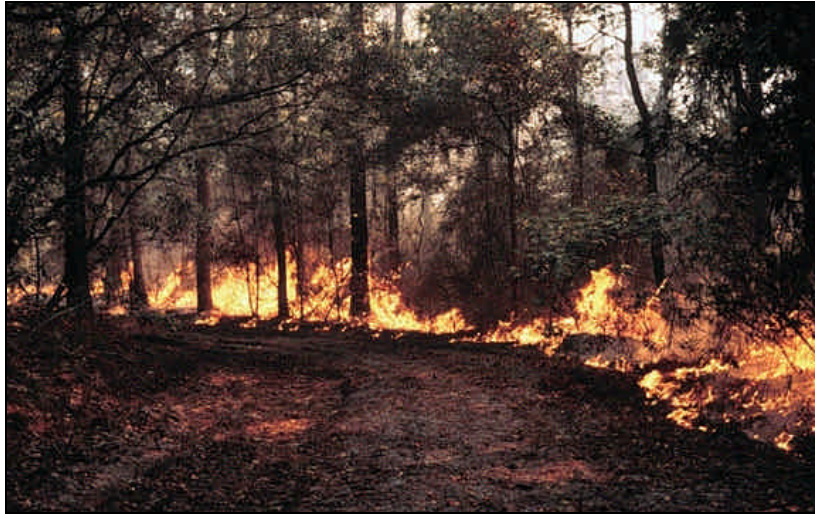
*Figure 28. Example of prescribed burning in a peatland environment.*

Another strategy is fire management, which may include prescribed burning (*Figure 28*). Fire is a natural component of peatland swamp forests and pocosins and affects the distribution and structure of many wetland plant communities (Frost, 1995; Christensen et al., 1981; Wells, 1946). Plant communities tend to regenerate quickly and diversity usually increases after fire (Christensen et al., 1981). Some species, such as pond pine, are dependent on fire for their long-term survival because fire stimulates seed germination. Likewise, some animals, such as the endangered red-cockaded woodpecker, are tied to a cycle of periodic fire to maintain their habitat.

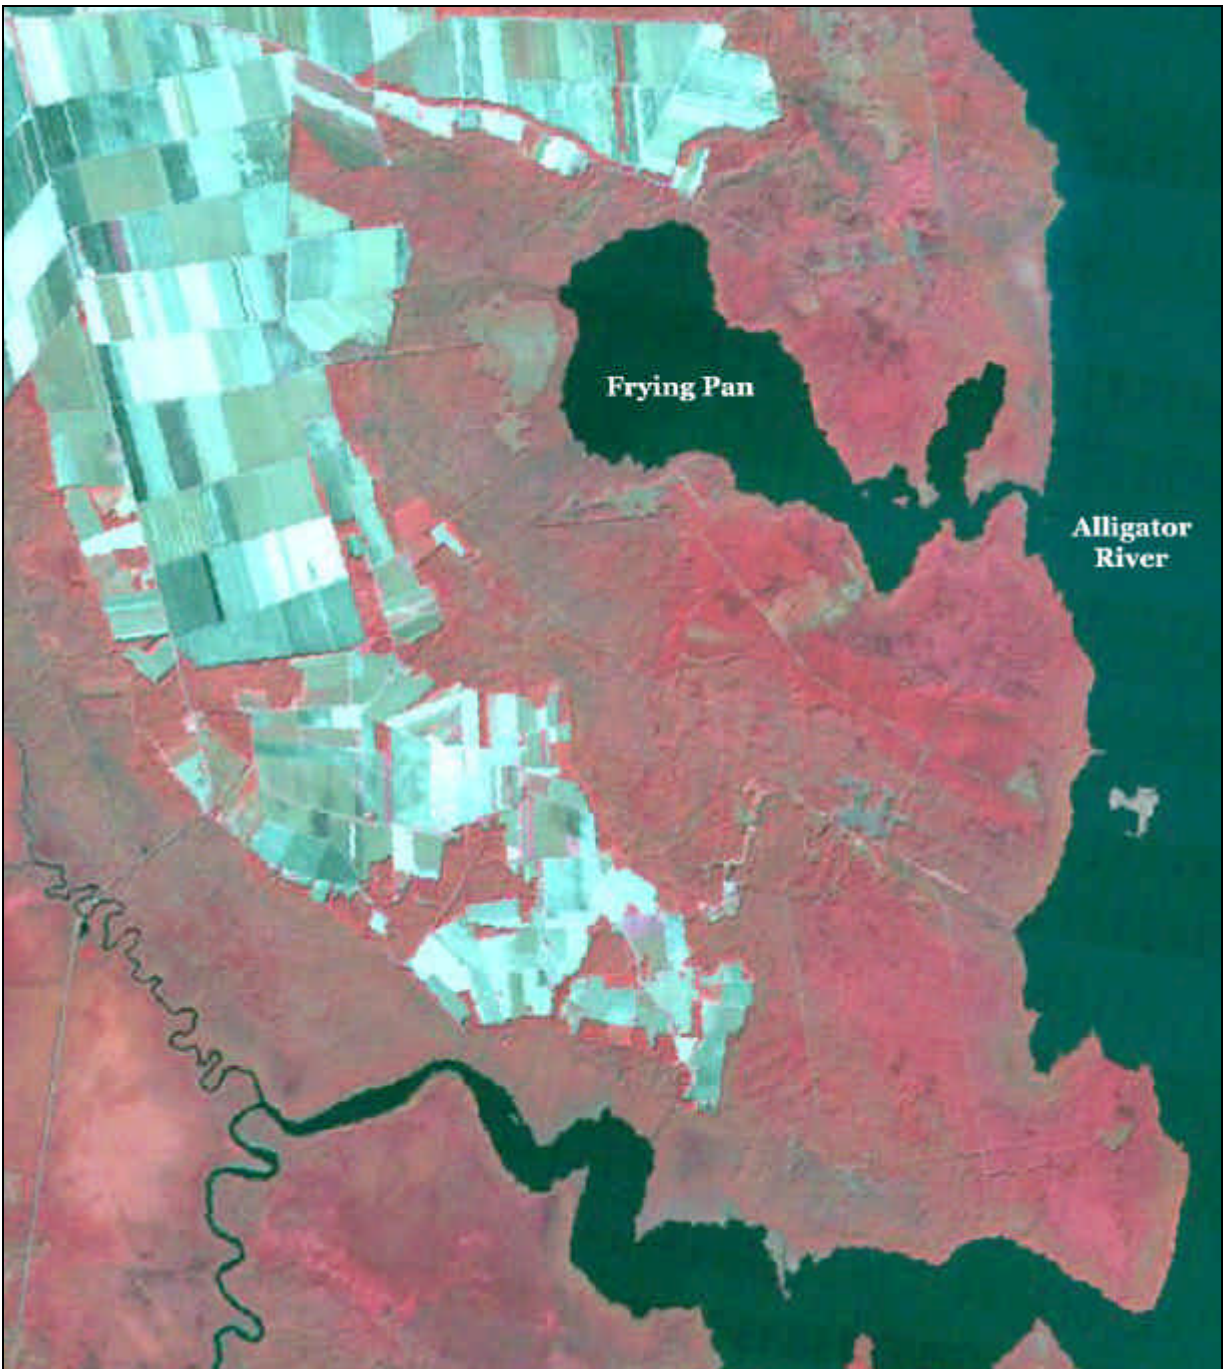
*Figure 32. Landsat TM satellite image of the Preyer Buckridge Reserve from 1988.*
