CRC-24-04

April 9, 2024

TO: Coastal Resources Commission
FROM: Heather Coats, Beach & Inlet Management Project Coordinator
SUBJECT: Addition of Rule Language to Allow the Installation and Maintenance of Straw Bales

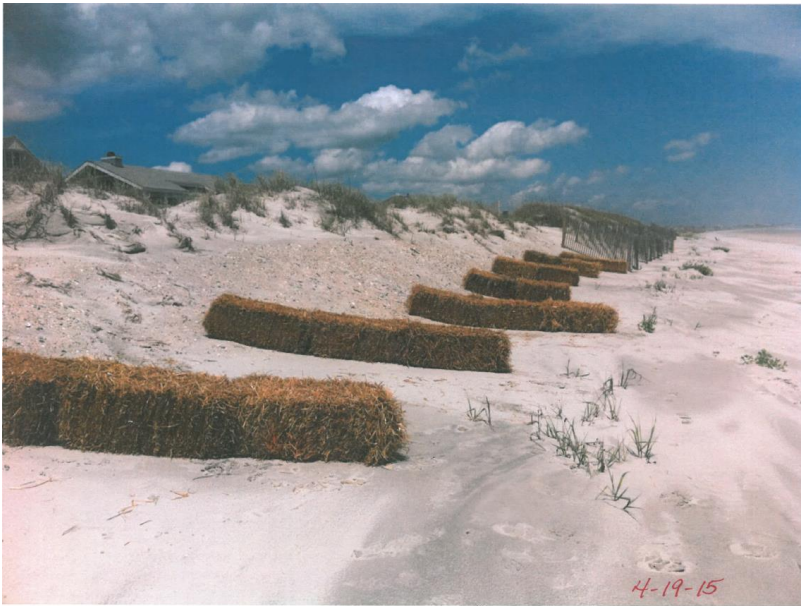
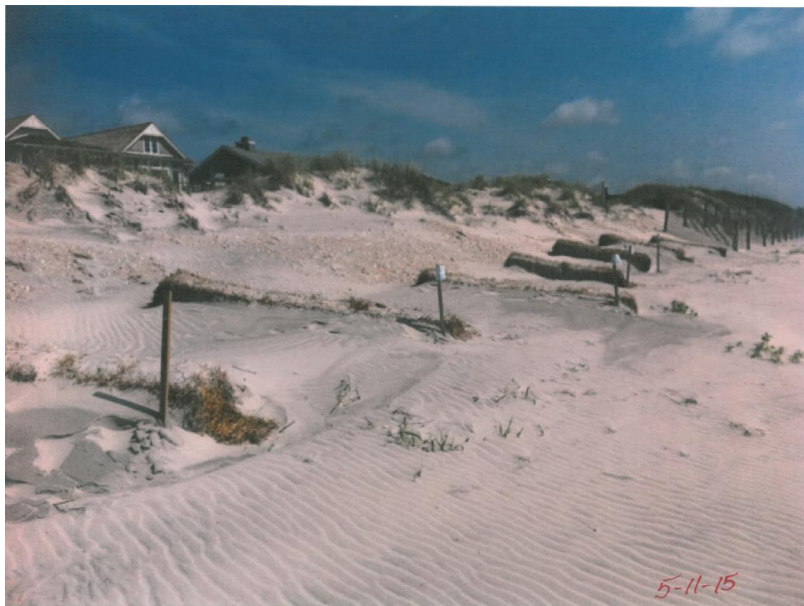
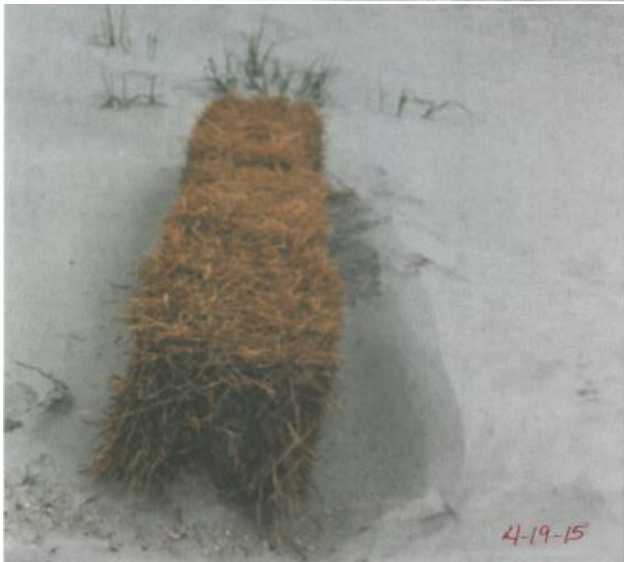
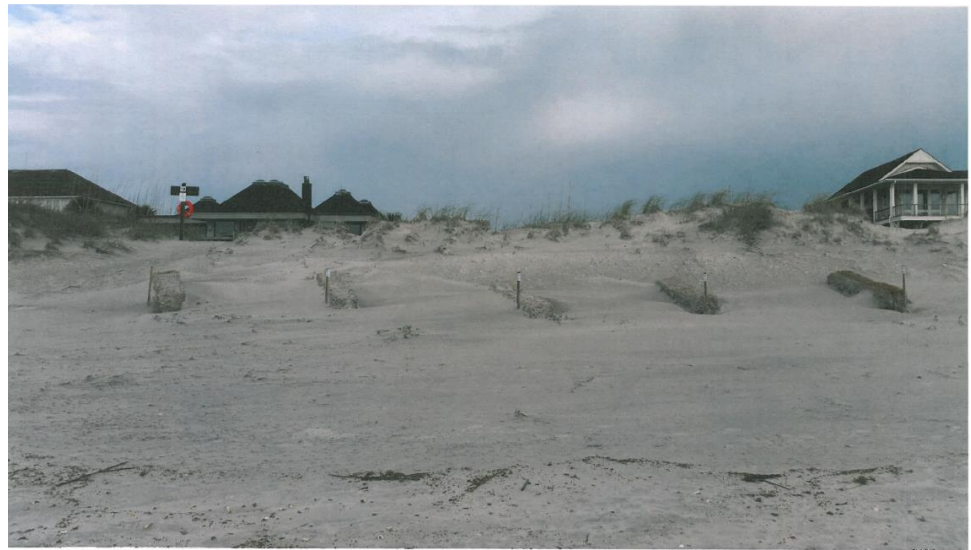
5-11-15

The experimental Minor Permit issued on Figure 8 Island followed the same criteria listed above, however the permit conditions limited the vertical extent to the height of one bale as per the request of the NC WRC. Recommendations from resource agencies also included removal of all bindings or ties on the bales to prevent entanglement with threatened or endangered species.

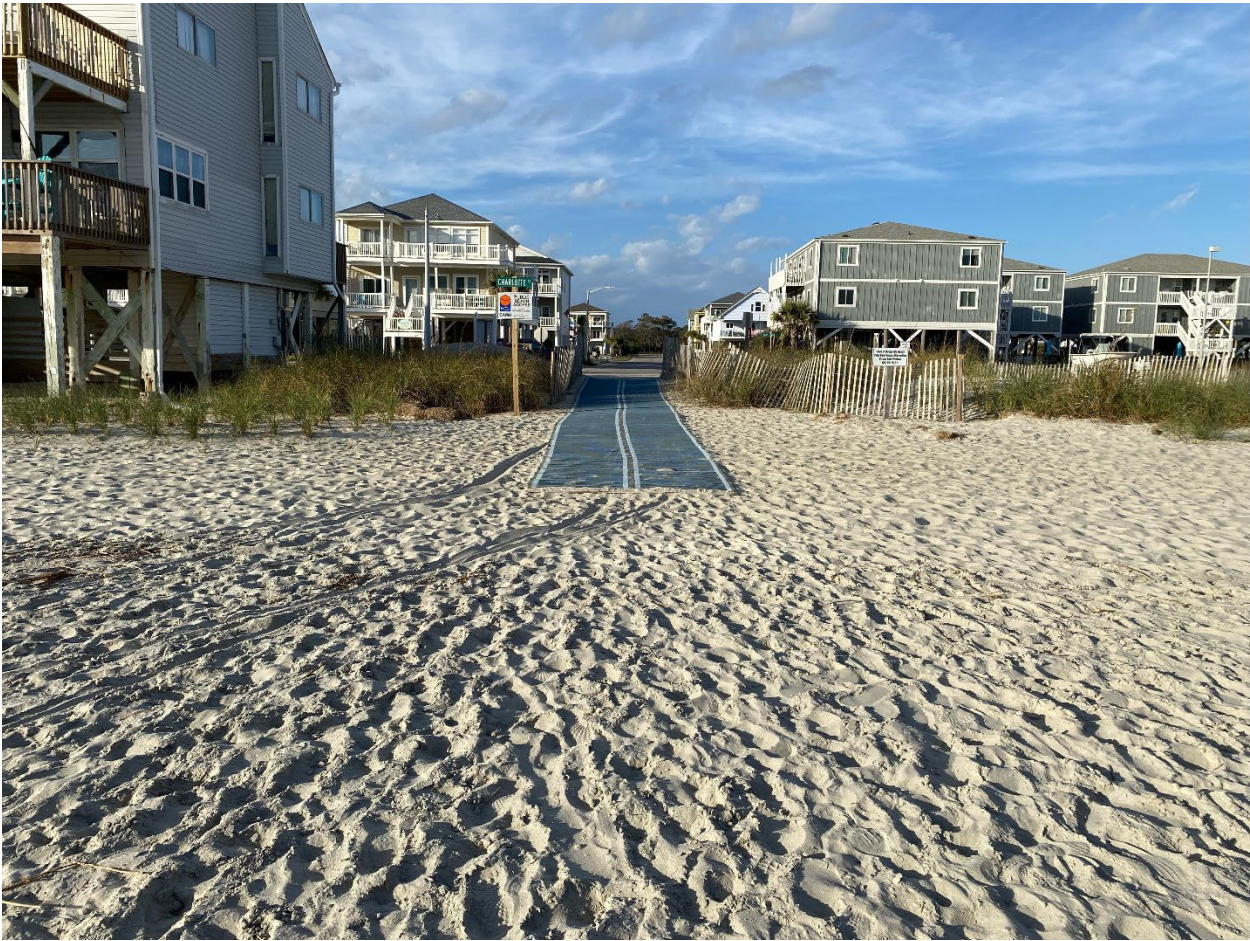
Charlotte St.

Attached is the monthly straw bale photos for November 2023. The photos were taken November 20, 2023. The temperature was 64 degrees and partly cloudy. The bales are all fully intact and most are completely covered.

Thank you for the photos and report. I was onsite November 7, 2023 and have a slightly different interpretation of the bales. Several of the ones I saw had fallen apart somewhat. They were either depressed on the top or just fallen away with the installed wooden stakes more exposed than the bales. Stakes originally were at or below half bale height. This was especially true at Shallotte Street. A casual look may have them appear to be covered but looking at the height of the bale and surrounding conditions, it seems they deteriorated. The area with the best collection was East Third Street. The bales closest to the access really weren't covered at all, but those closer to the groin were – perhaps the difference was due to the groin influence or beach angle difference due to inlet proximity. However, it is hard to compare as those bales did not seem to appear in the May photos I took. There were also random bales placed landward the frontal dune at Charolotte Street. These were not part of the original proposal. We request their removal.

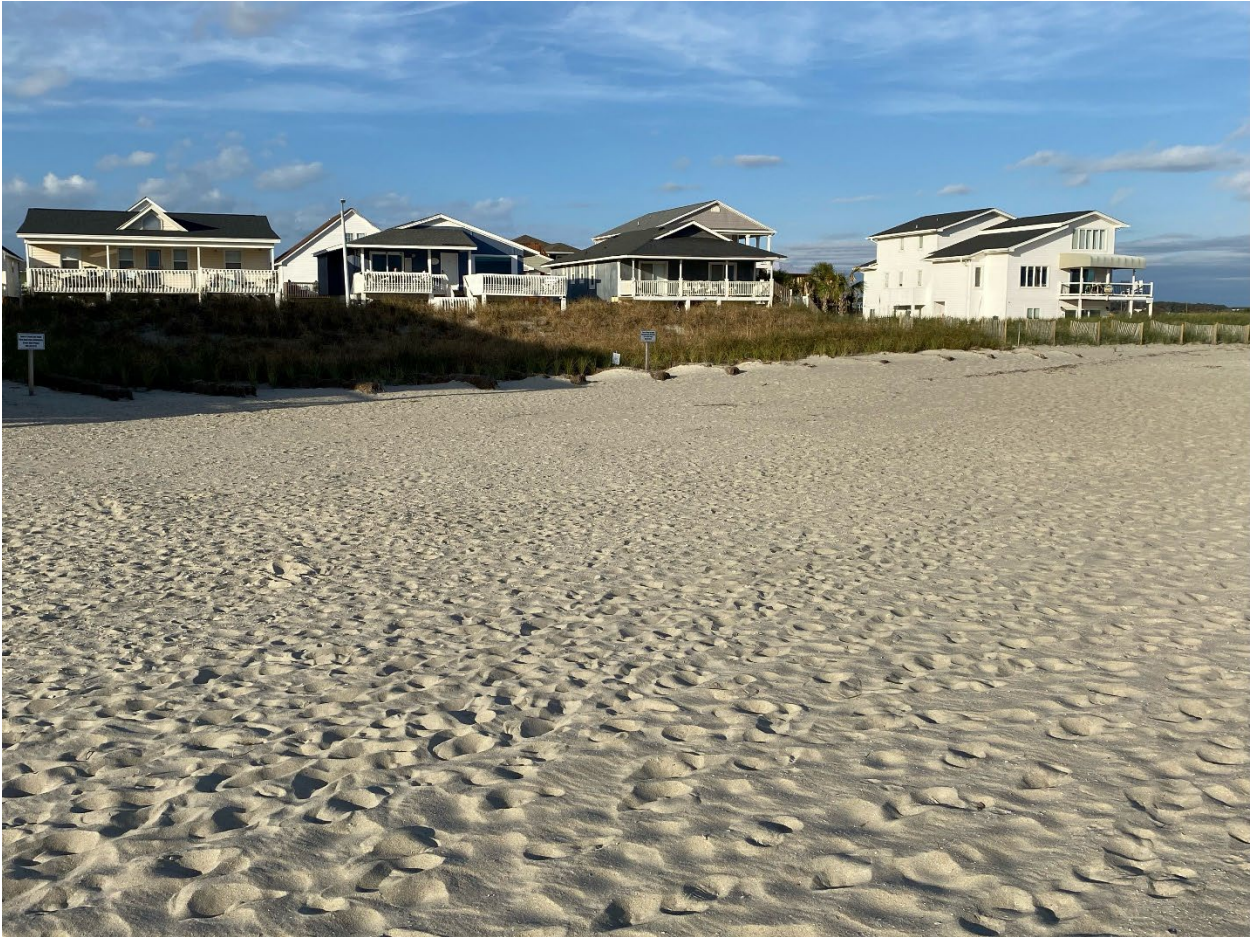
E. Third St.

We believe if the bales were allowed to be placed 2-high (similar height as sandfence), it would have reduced the chances of beachgoers walking over the bales once they became covered. The bales along E. Third Street are not adjacent to a public beach access and are not experiencing the same compression. This indicates that the bales aren't falling away. The bales along E. Third that aren't as covered are being blocked by a home adjacent to their location.

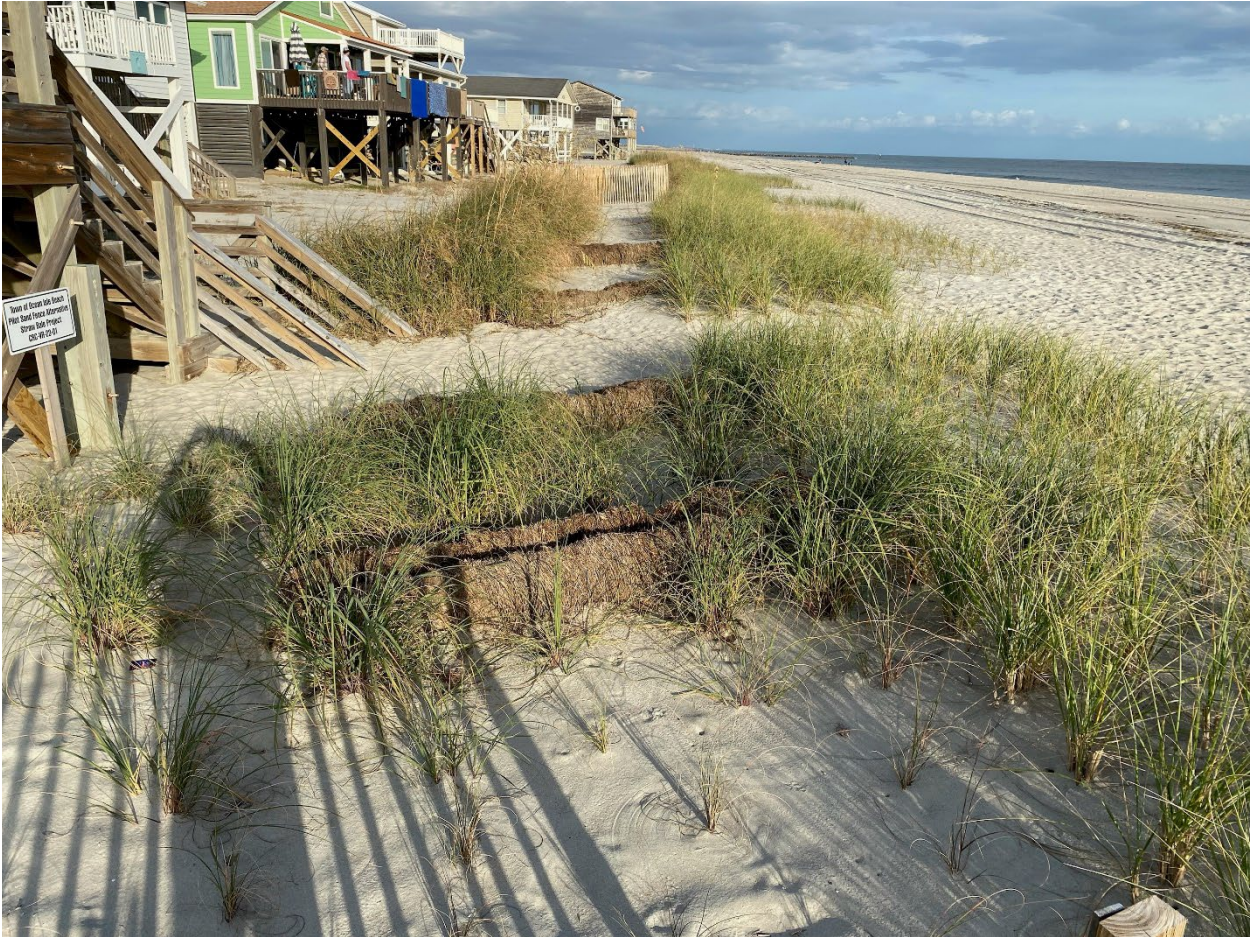
Lumberton St.

After further investigation the depressed bales near Lumberton Street appear to be because of people sitting on the bales since they have taken longer to cover due to their location landward of the vegetation. Those are ones we would like to relocate to the oceanward side of the vegetation so they can trap the blowing sand. The bales you mentioned at Shallotte Blvd. have not fallen away. We dug down and found the bale compressed. We believe that once the bales became covered that beachgoers would walk over the tops of the bales, compressing them into the sand. You can see all the footprints along and on top of the bales in the photos you submitted.

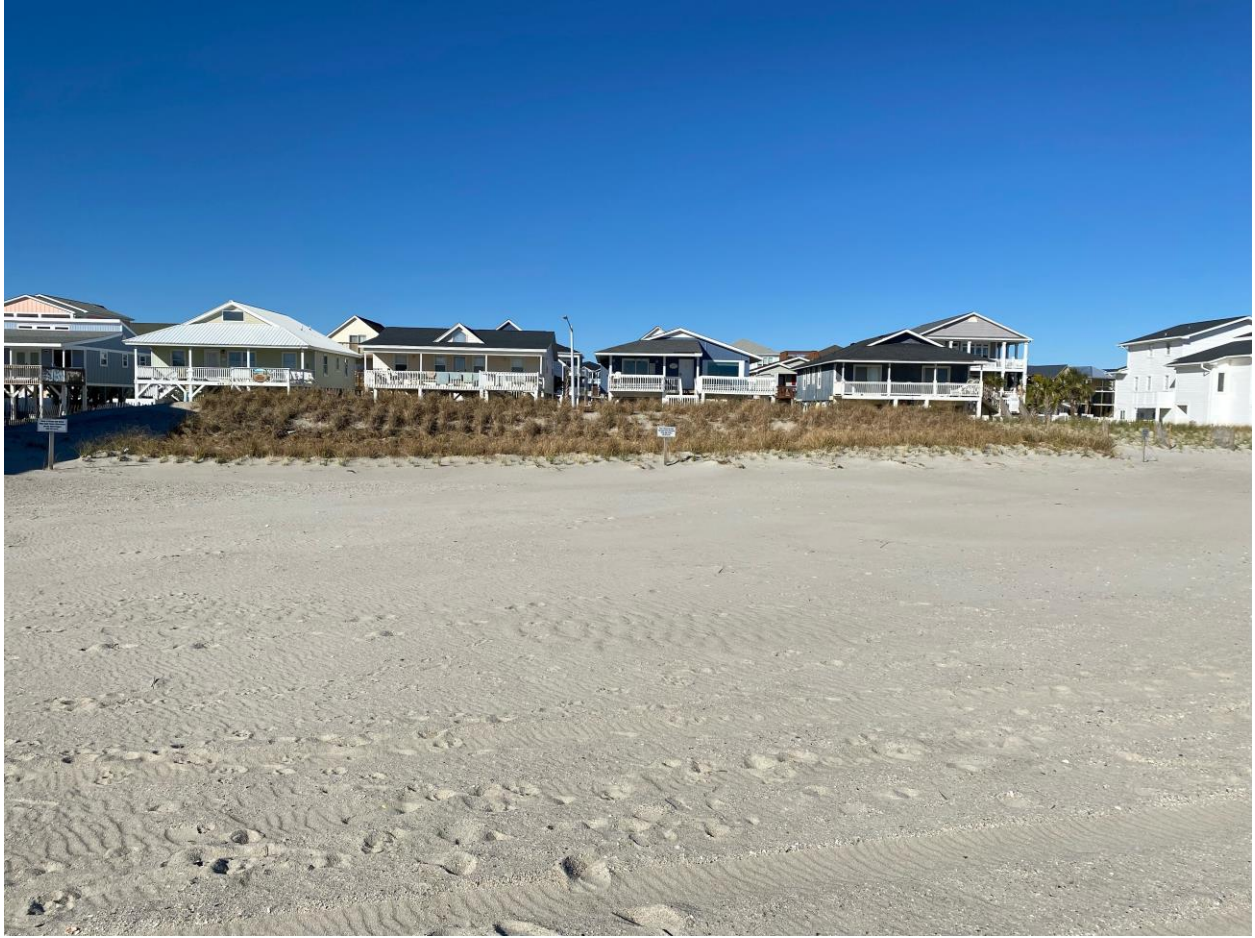
After back to back storm events in December we only have 1 remaining area of straw bales. The attached photo is from the E. Third St. location. The photo was taken January 16, 2024. The weather was clear and approximately 51 degrees.

We would like to have some discussion on replacing the bales. They were working and getting covered with sand prior to the storm events. Even though they washed away, they left no remains or debris on the beach strand.
