# MEMORANDUM

**Project:** One Hour Martinizing Site, DSCA ID 32-0013  
1103 W Club Blvd, Durham, NC

**Subject:** Monthly Update

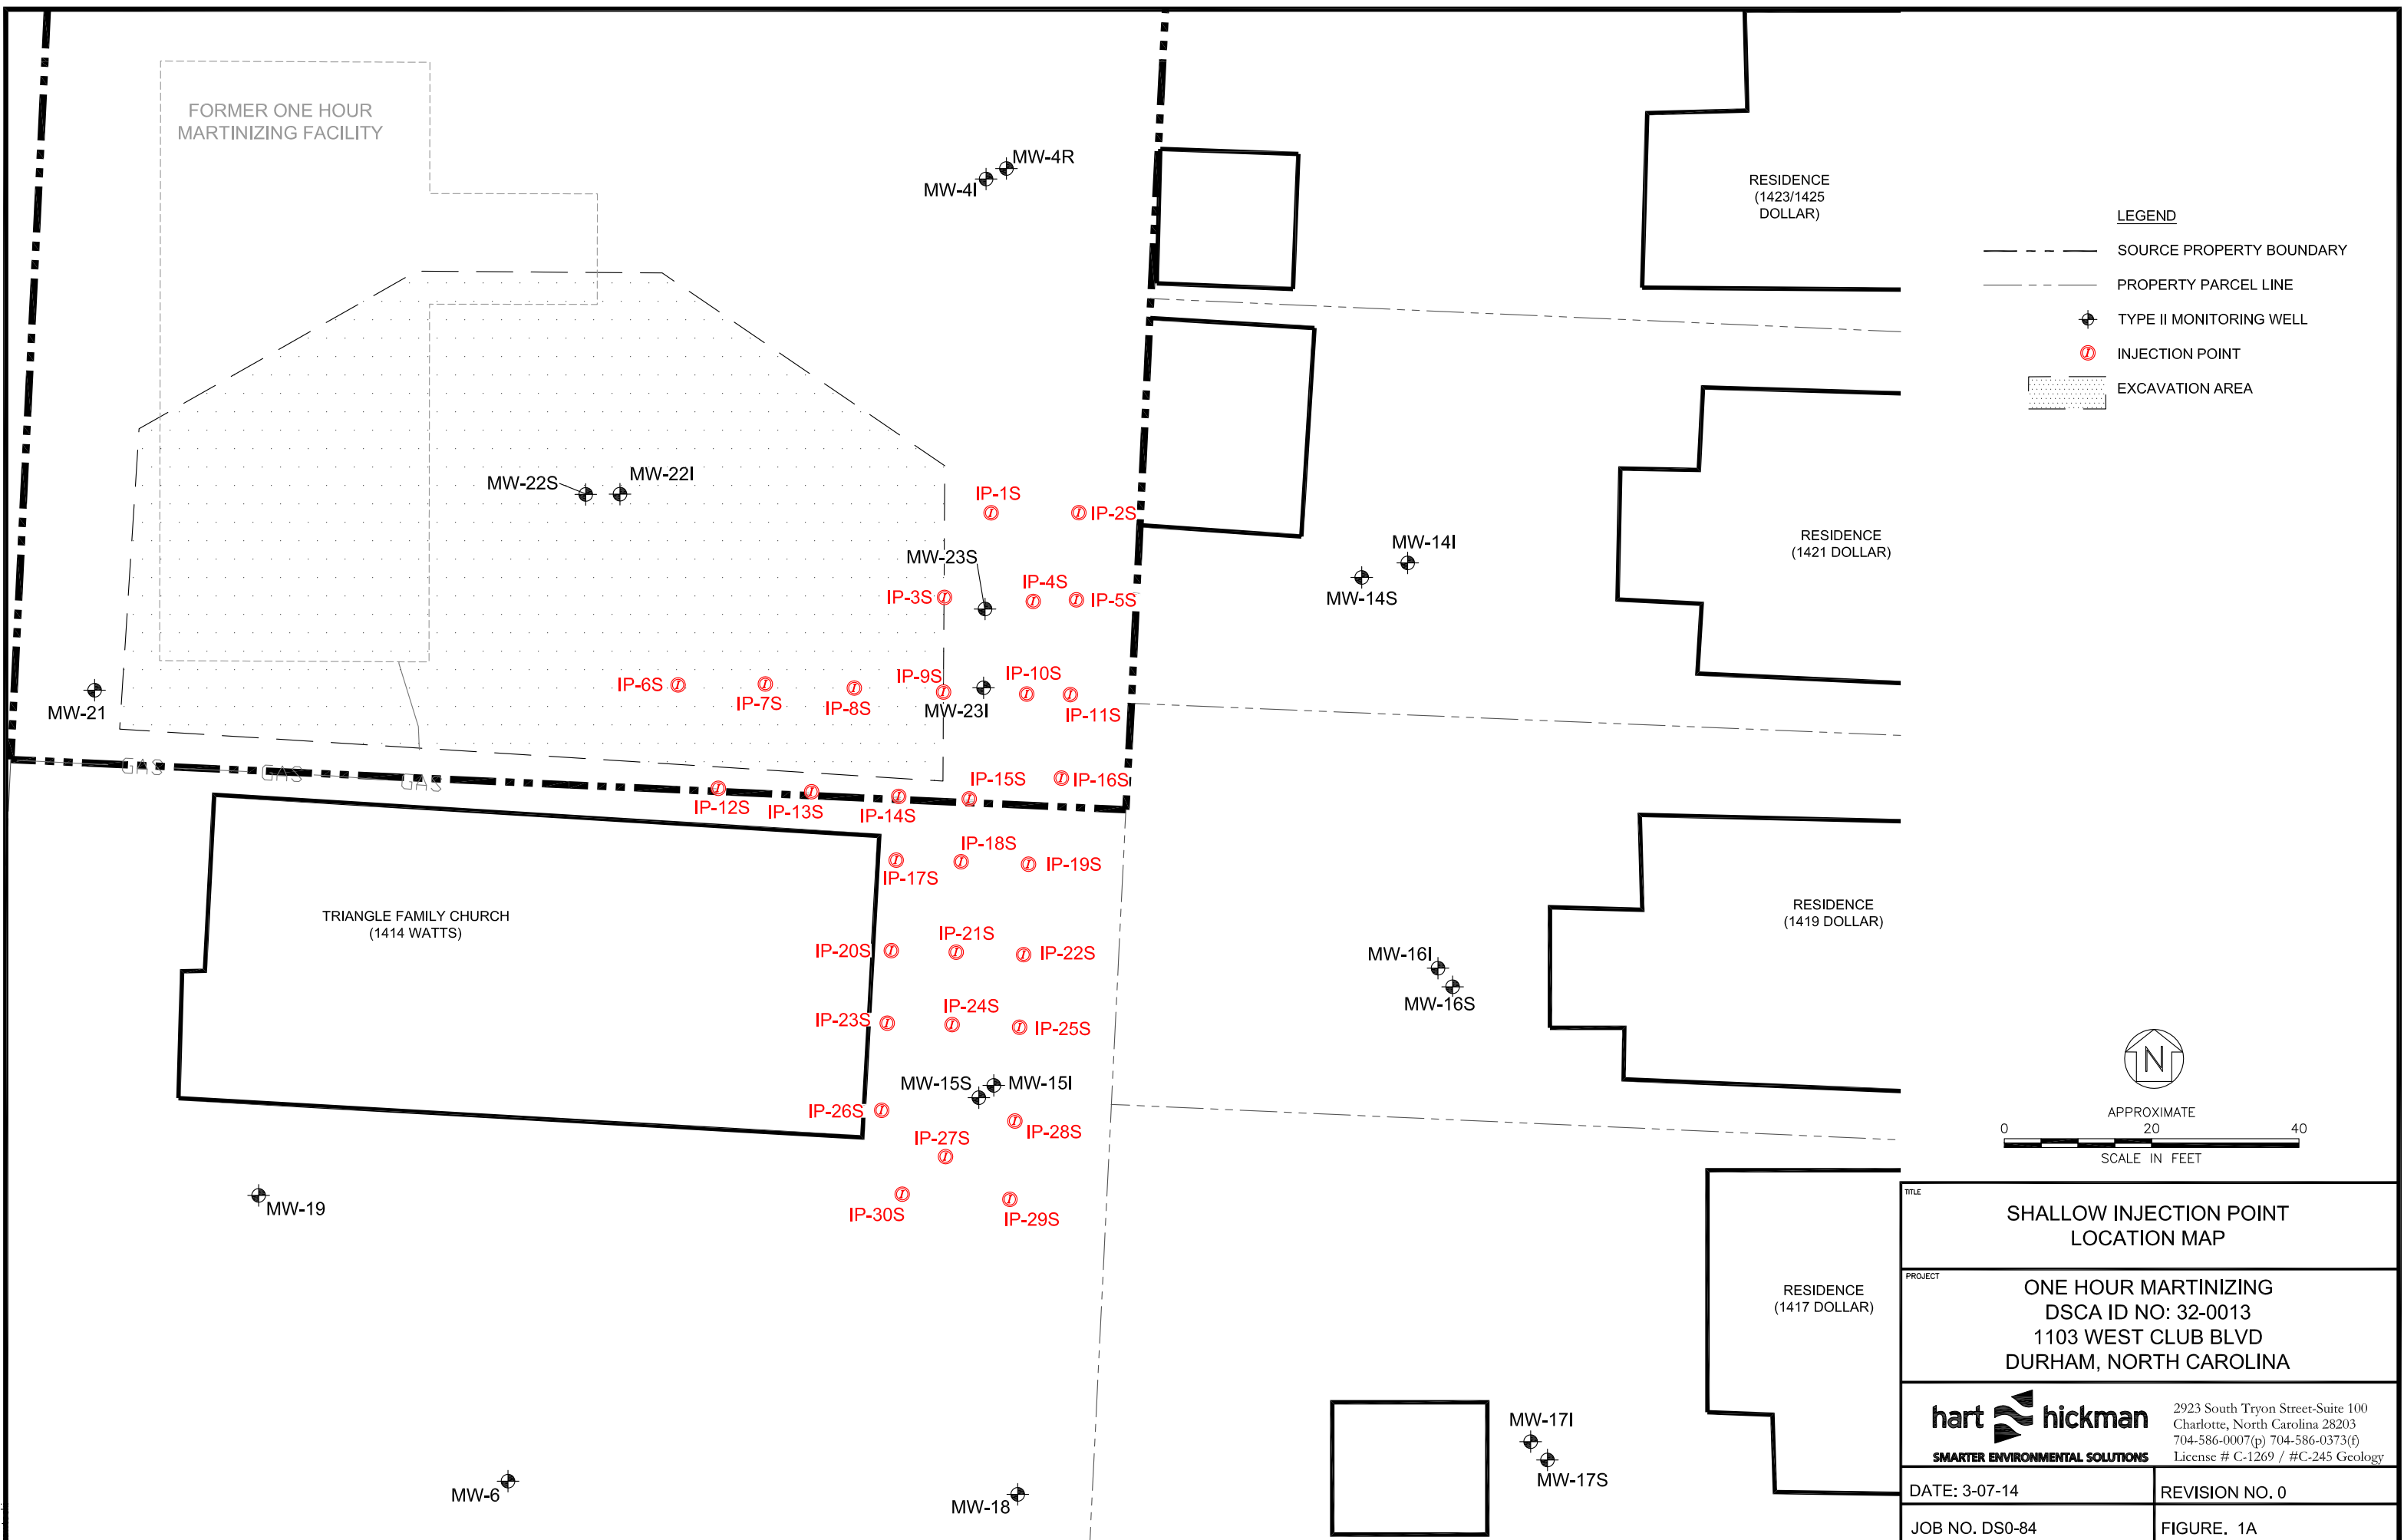
2923 South Tryon Street-Suite 100 Charlotte, North Carolina 28203 704-586-0007(p) 704-586-0373(f) License # C-1269 / #C-245 Geology	
DATE: 3-07-14	REVISION NO. 0
JOB NO. DS0-84	FIGURE. 1A

TITLE <b>SHALLOW INJECTION POINT LOCATION MAP</b>	
PROJECT <b>ONE HOUR MARTINIZING DSCA ID NO: 32-0013 1103 WEST CLUB BLVD DURHAM, NORTH CAROLINA</b>

The injection design included spacing the shallow and intermediate injection points on approximate 12-ft centers. The target injection interval for the shallow points was approximately 22 to 40 ft below ground surface (bgs). For the intermediate injection points, the design included injecting over a 10-ft vertical interval with the bottom of the injection interval at the refusal depth of the direct-push rig. The refusal depth was estimated to be between 45 and 50 ft bgs. Actual refusal depth for the intermediate points varied between 36 and 55 ft bgs. The injection point locations and injection intervals were slightly adjusted in the field due to access, difficult drilling conditions, and proximity to existing monitoring wells. The shallow and intermediate injection point locations are depicted on Figures 1A and 1B, respectively. The injection intervals and pounds of EHC injected into each injection point are summarized on Tables 1A and 1B for the shallow and intermediate points, respectively.

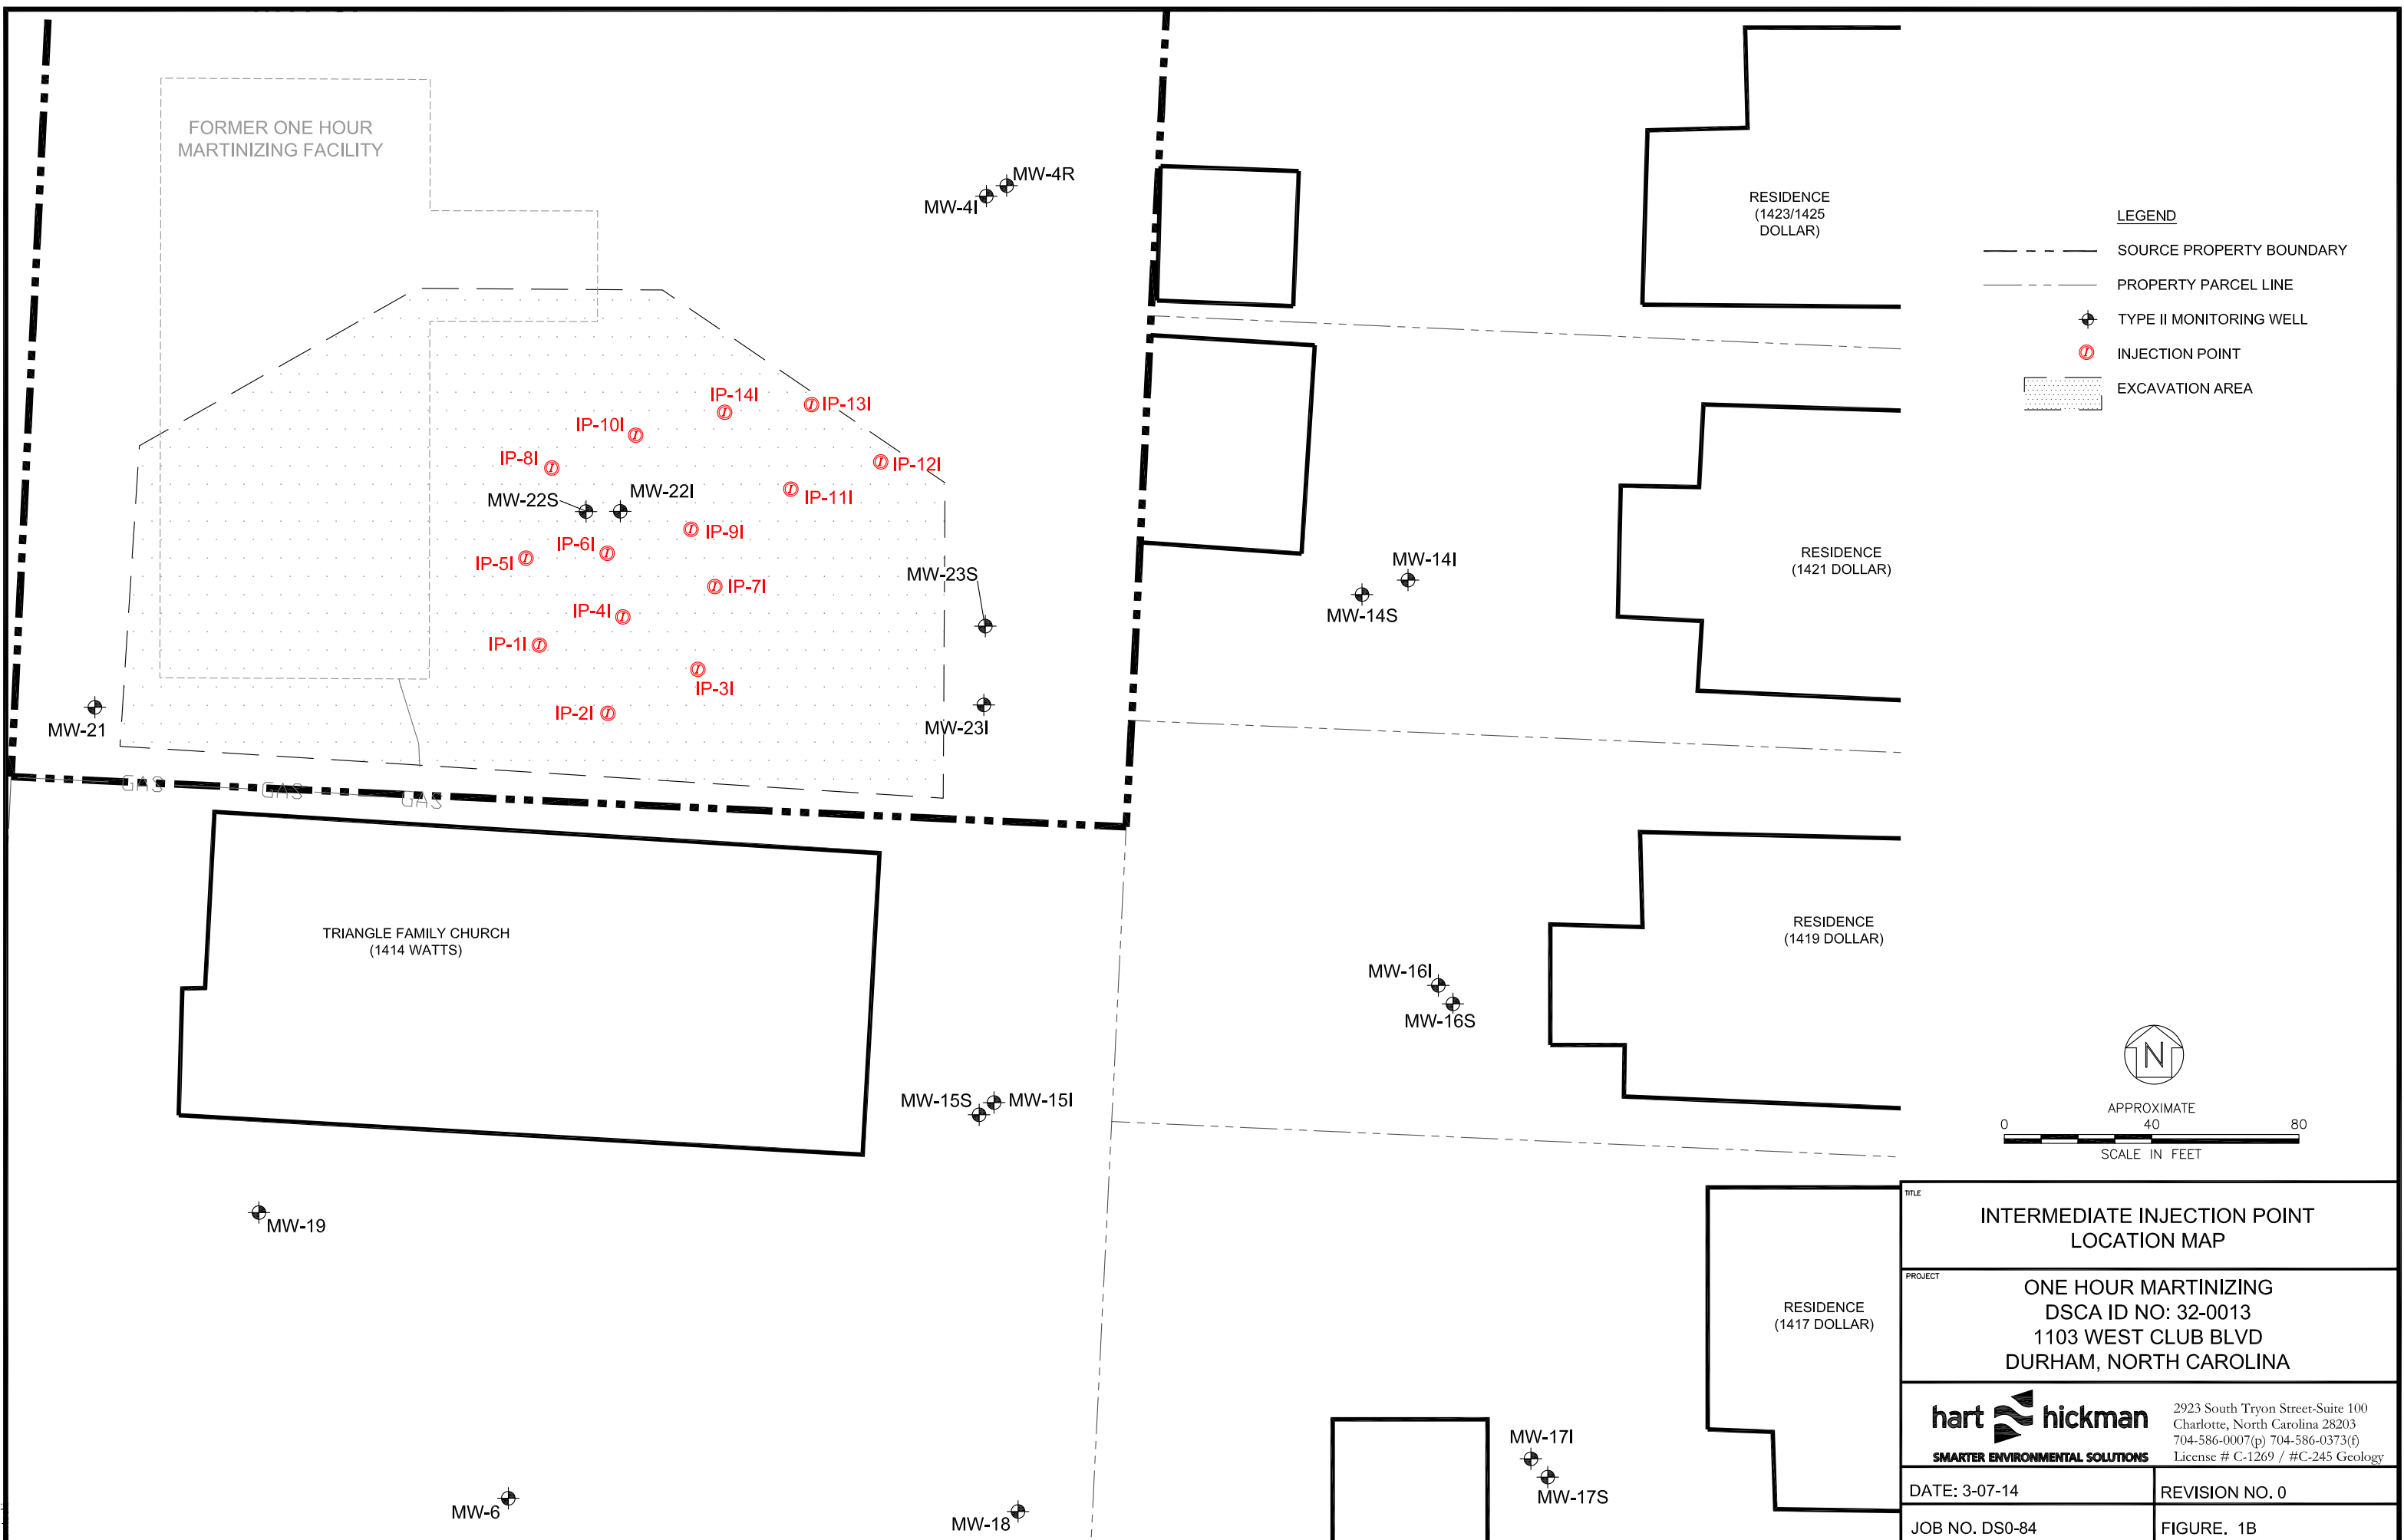
2923 South Tryon Street-Suite 100 Charlotte, North Carolina 28203 704-586-0007(p) 704-586-0373(f) License # C-1269 / #C-245 Geology	
DATE: 3-07-14	REVISION NO. 0
JOB NO. DS0-84	FIGURE. 1B

TITLE <b>INTERMEDIATE INJECTION POINT LOCATION MAP</b>	
PROJECT <b>ONE HOUR MARTINIZING DSCA ID NO: 32-0013 1103 WEST CLUB BLVD DURHAM, NORTH CAROLINA</b>
