SAND BAG REVETMENT EXTENSION
BALD HEAD ISLAND, NORTH CAROLINA

EXISTING CONDITIONS
(JUNE 2011)

PLAN OF IMPROVEMENT

**SAND BAG REVETMENT
 TYPICAL SECTIONS**

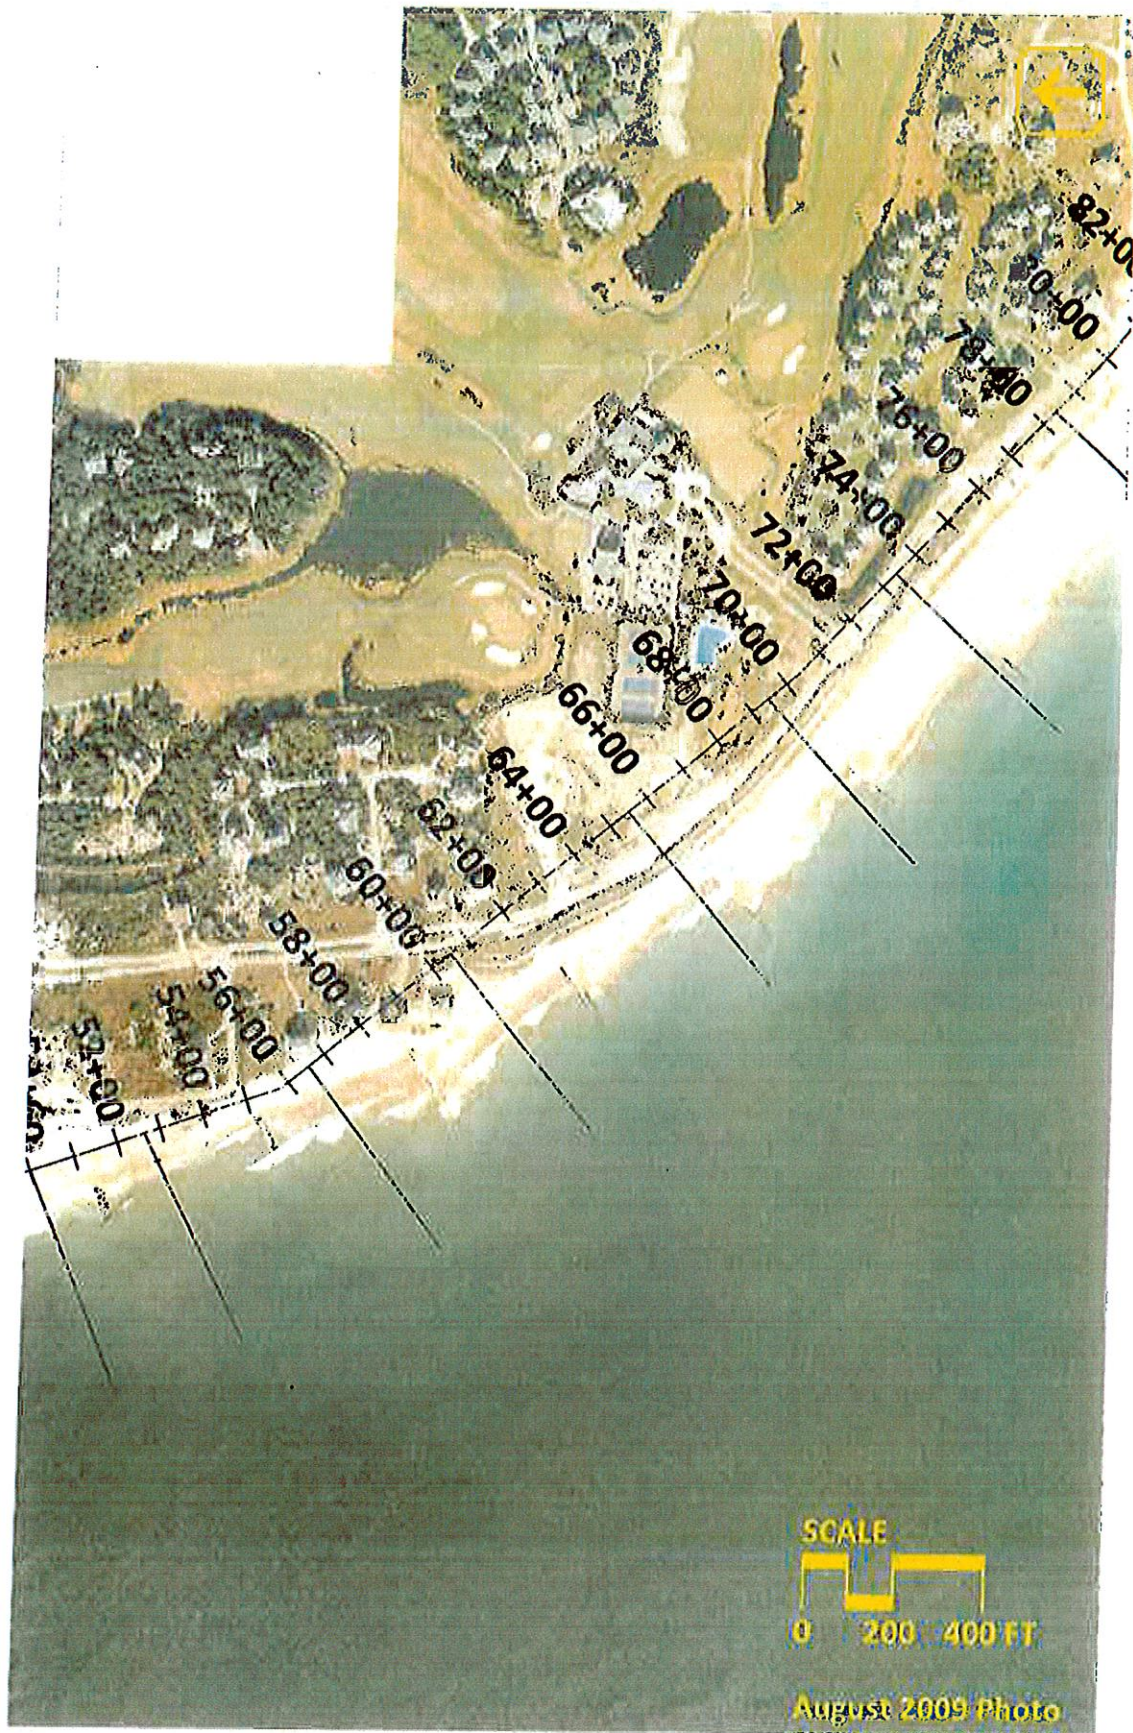
Figure C-5: Bald Head Island August 2009 aerial photography.

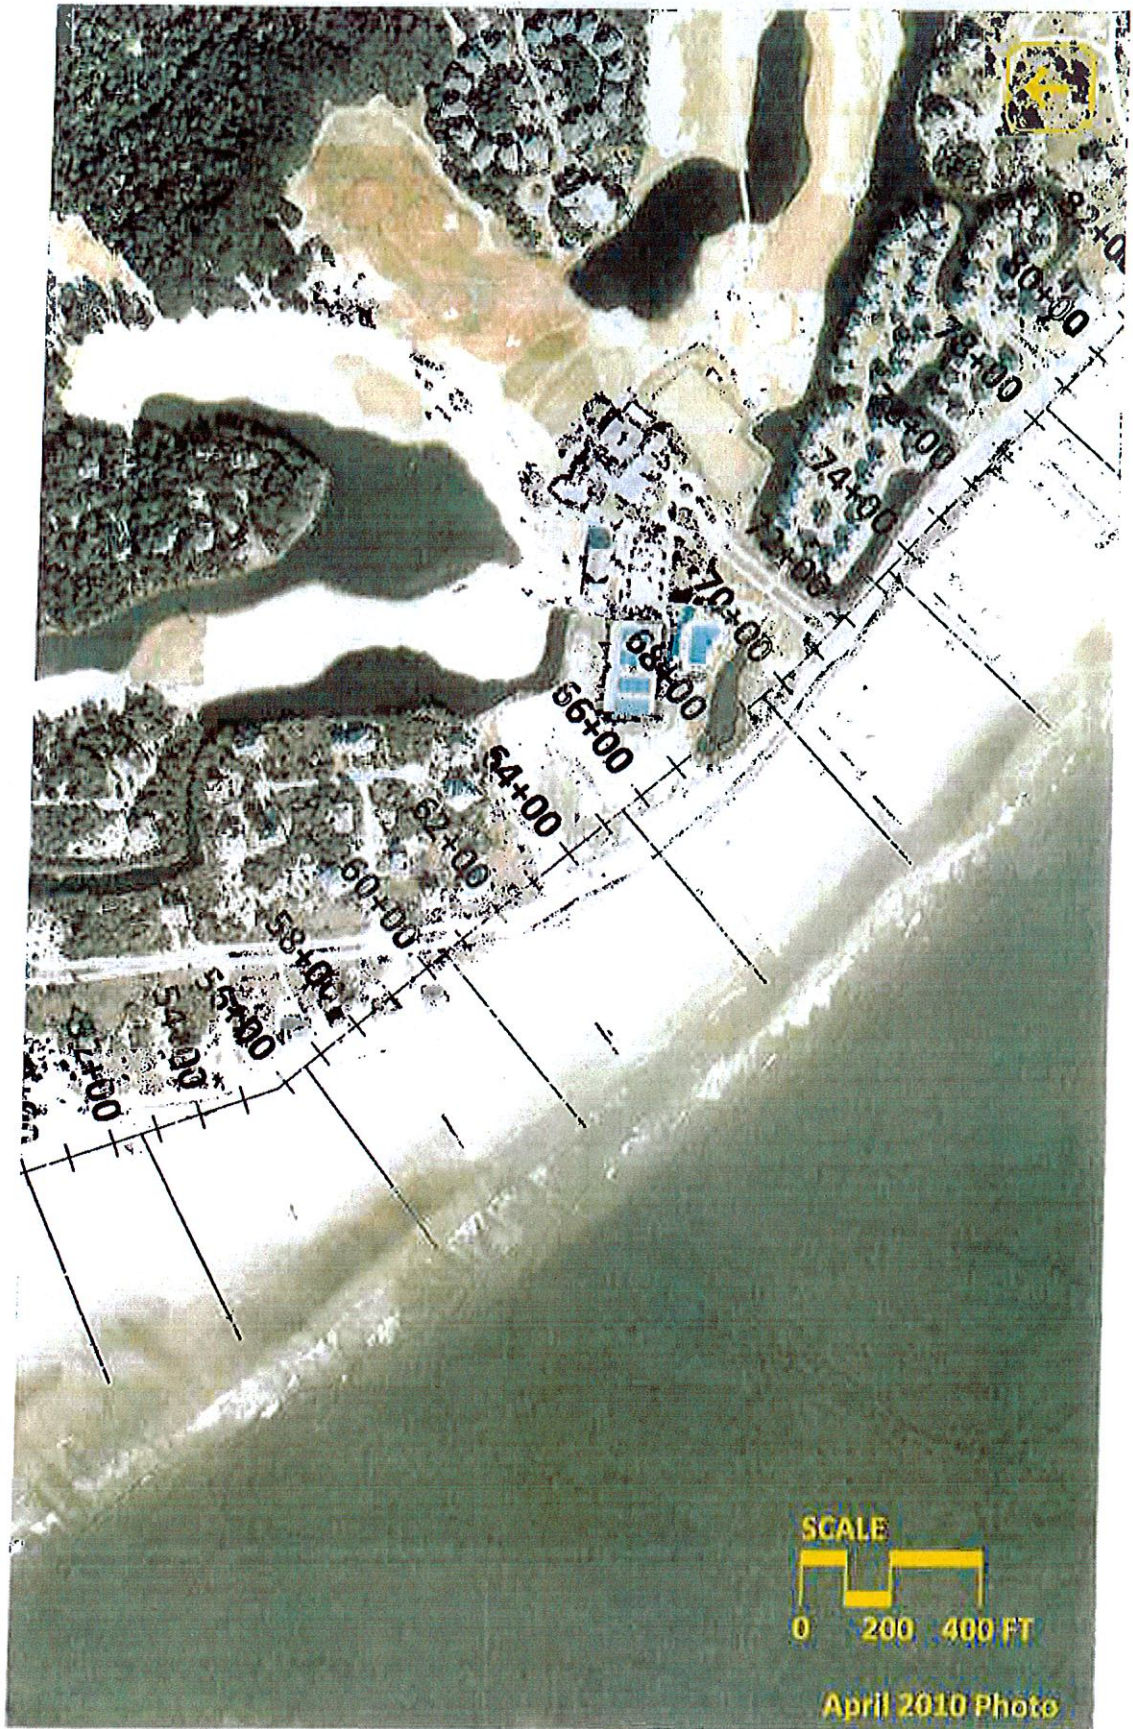
Figure D-5: Bald Head Island April 2010 aerial photography.
