NC COASTAL RESOURCES COMMISSION

N.C. Division of Coastal Management
Assessment of 27 Marsh Sills in North Carolina
Final Report

Prepared by: John Fear, Ph.D. and Bonnie Bendell

April 2011

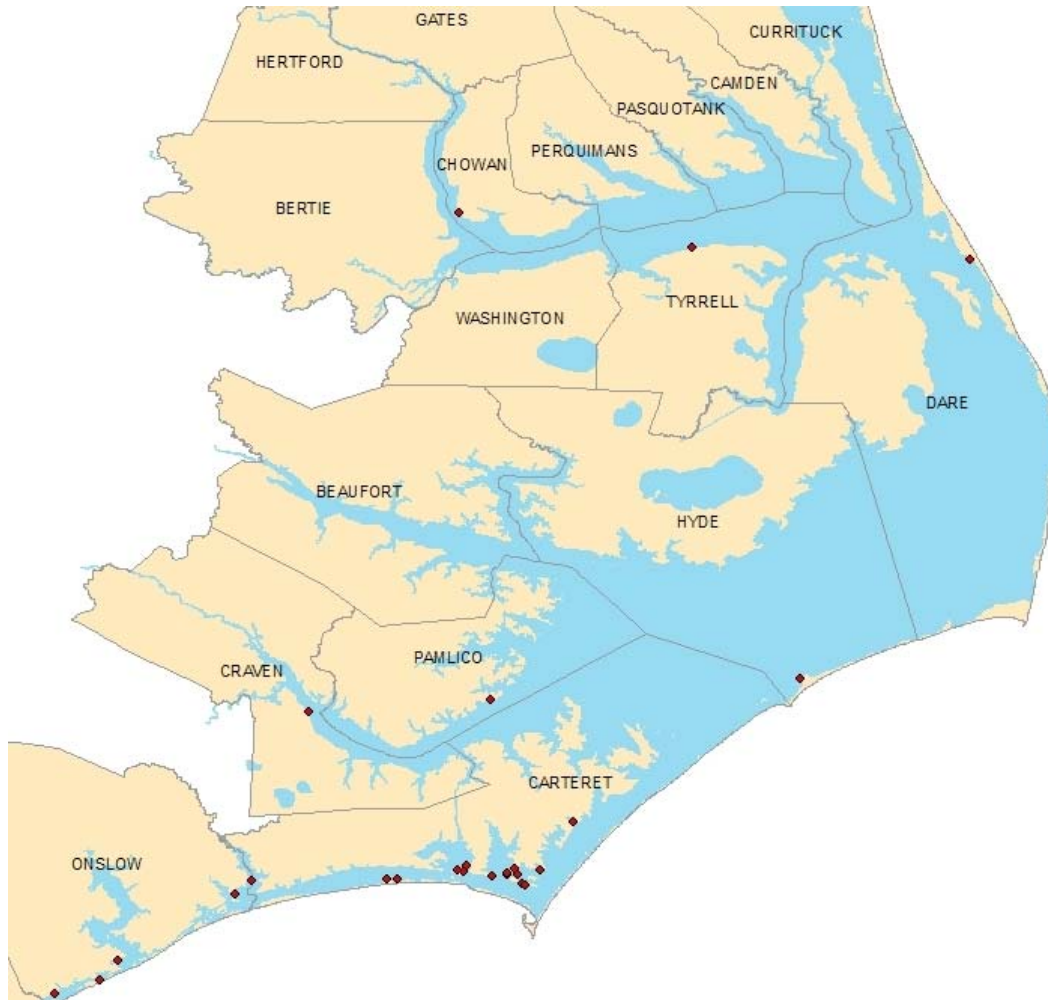
Figure 2: Locations of marsh sills visited during the study. Marsh sill locations are marked by red dots. Note that some points represent more than one marsh sill.

Questions associated with criterion one were assessed by visiting 27 marsh sills that have been installed in North Carolina through the CAMA major permit or marsh sill general permit process (Figure 2). These sites were identified by a review of the DCM permit database (Bendell 2010). A full description and photograph of each site is included in Appendix 8.1. Table 1 includes general characterizations for each visited marsh sill site.

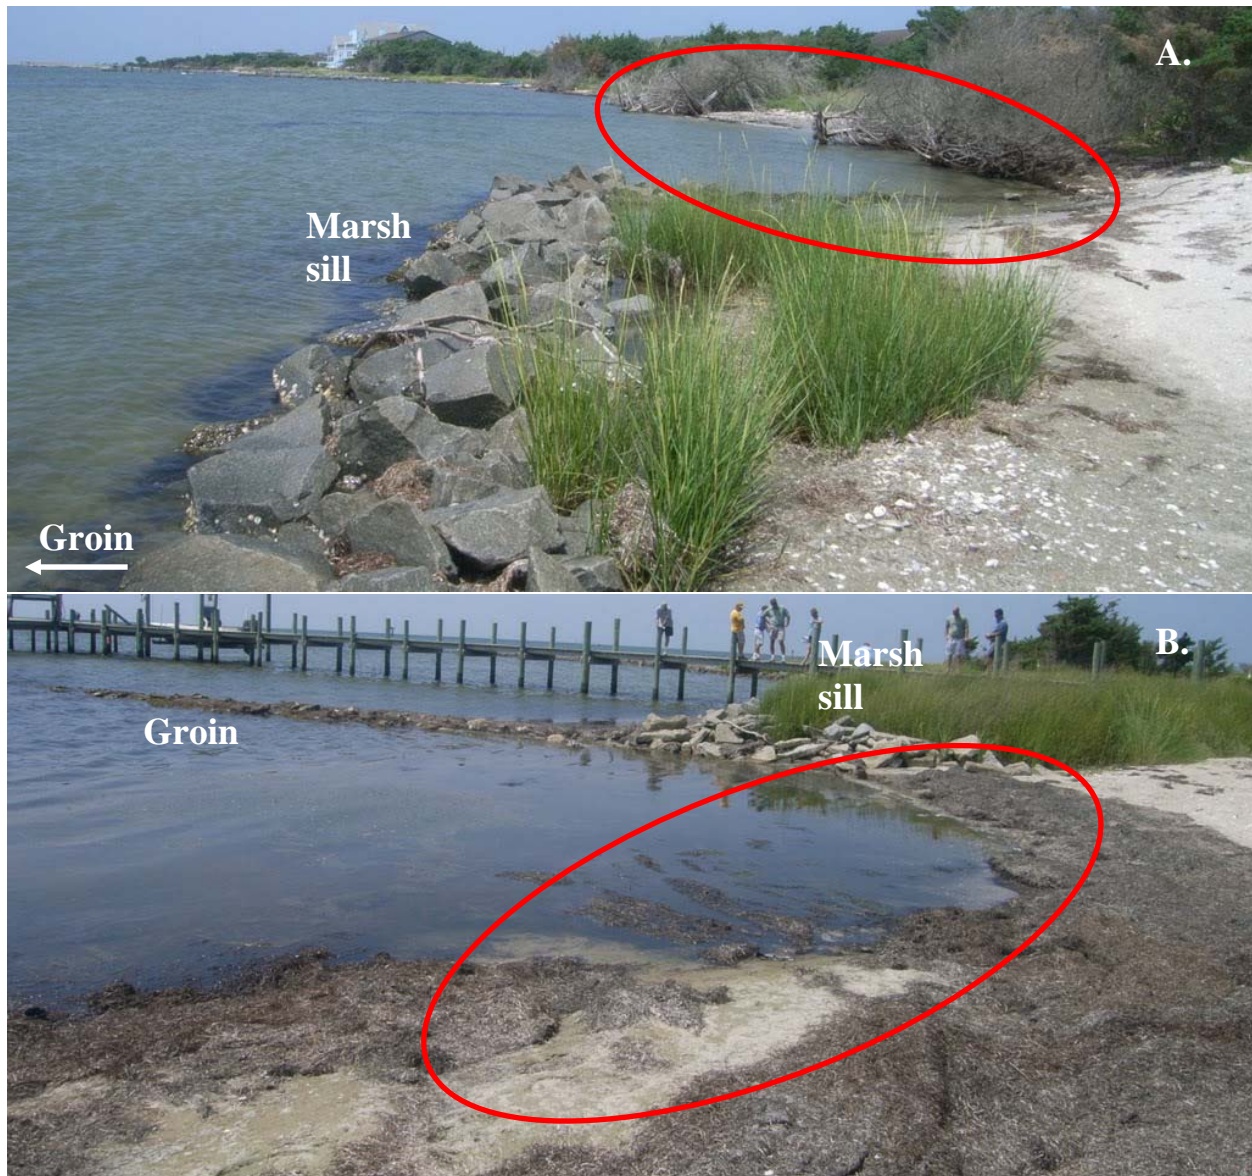
Several different areas of erosion on the adjacent properties were noted by the field team at site 46565B (Appendix 8.1, page 93, question 12). However, the field team was unsure if the erosion was being caused by the marsh sill or the two groins present at the site, as most of the erosion seemed to be occurring near where the marsh sill joined with the groins (Figure 6).

Figure 6: Erosion on adjacent properties of project 46565B. Panel A shows a picture of the adjacent property to the north taken from the junction of the marsh sill and one of the two groins. The groin extends off picture to the left as indicated by the arrow. Panel B is taken from the adjoining property to the south and shows where the other groin joins the marsh sill. The red circles on both panels show the areas of erosion.

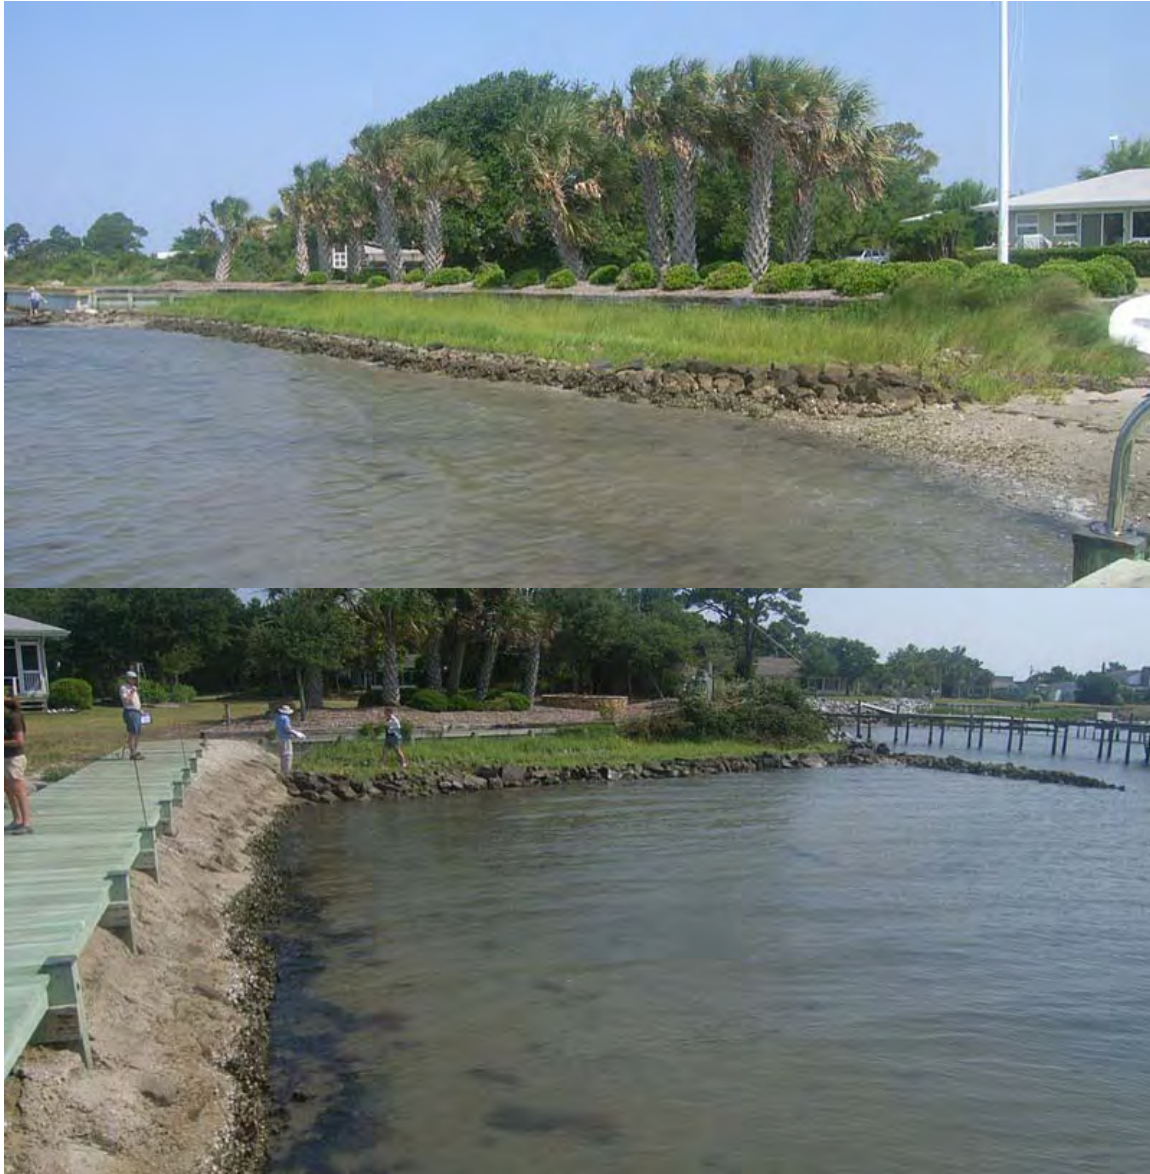
Major Permit No: 42-00-03

46	Overall, do you think the wetland creation portion of the project has been successful?	4	2	4		<ul style="list-style-type: none"> - Not sure; not really wetlands as one thinks of sills. - Not sure; limited direct access for fish.
47	Do you think this structure will continue to function into the future given expected sea level rise?	0	5	5		<ul style="list-style-type: none"> - Not sure; not for long. - No; bulkhead will not allow marsh migrate. - No; bulkhead. - No; bulkhead behind.
48	Please provide any additional concerns and/or comments in regards to this site location.					<ul style="list-style-type: none"> - Distance of sill from bulkhead provides zero space for marsh to retreat. I like the height of the sill ... just needs to be a little farther offshore. - Sill appears to have excess fill behind it. - Because they already have a bulkhead just planting and putting cultch down my have been sufficient.

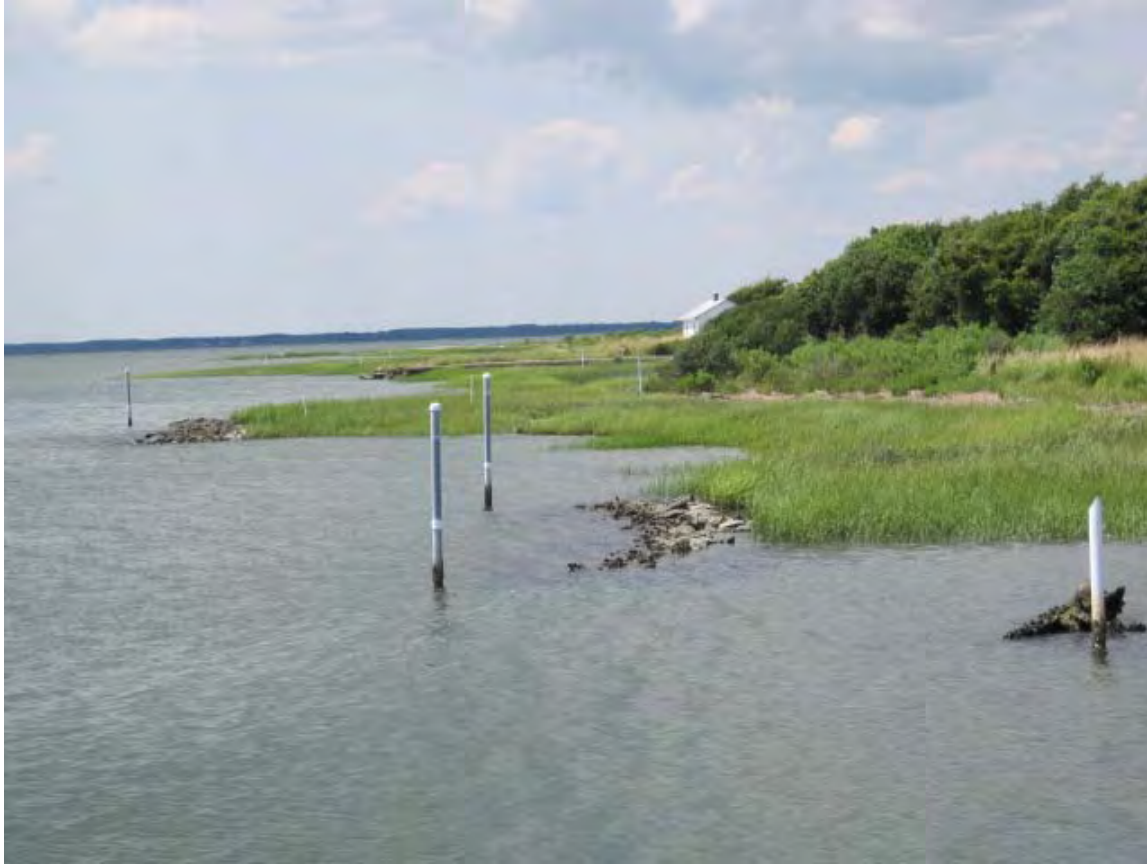
Major Permit No: 39-01

46	Overall, do you think the wetland creation portion of the project has been successful?	2	0	5		
47	Do you think this structure will continue to function into the future given expected sea level rise?	1	0	6		<ul style="list-style-type: none"> - Migrate landward. - Yes and no - In short term, yes, but at some point erosion will continue in embayment's and entire shoreline will move landward. Structure may allow marsh to keep pace for longer time and lack of other bulkhead/riprap will allow marsh migration.
48	Please provide any additional concerns and/or comments in regards to this site location.					<ul style="list-style-type: none"> - There was little information about the site before the riprap was put in place. The tide was coming in so some of the erosion that was mentioned could not be observed. - Oysters at base of marsh may have been an improved alternative at this site.

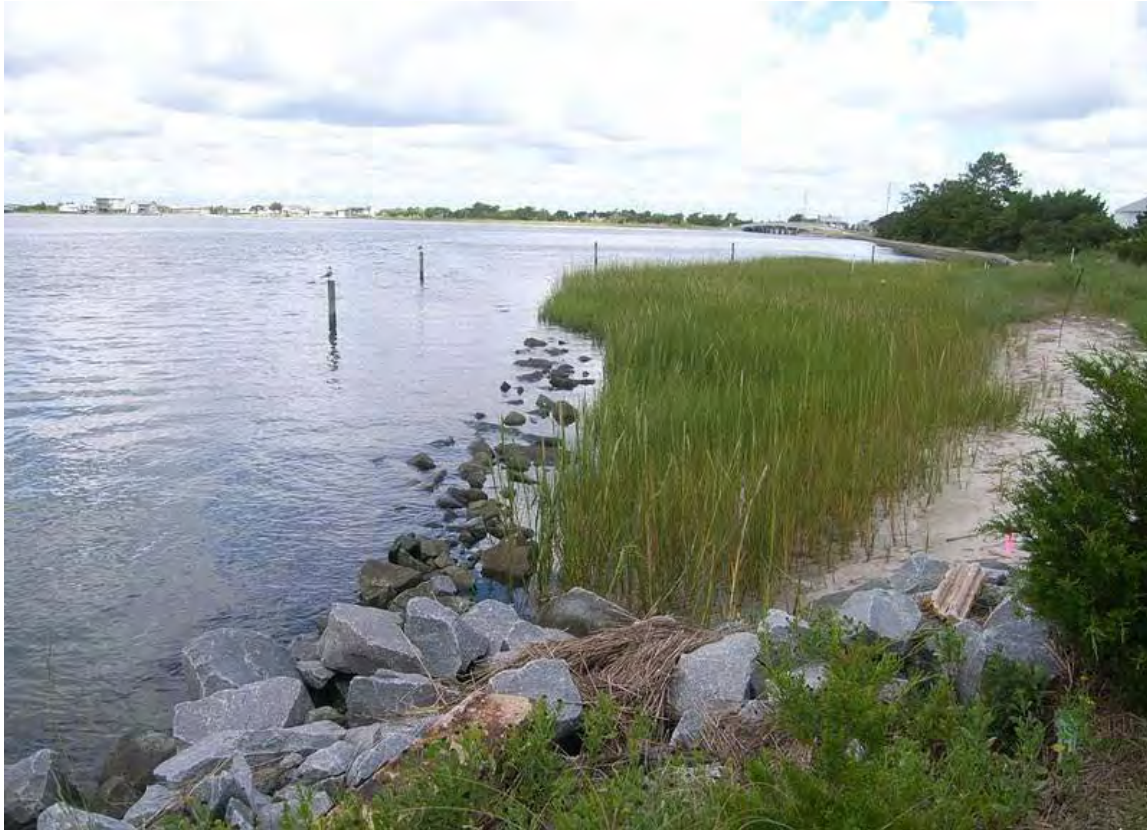
Major Permit No: 13-02

48	Please provide any additional concerns and/or comments in regards to this site location.					<ul style="list-style-type: none"> - Fish passage drop down could be better - use overlap with drop down to reduce scour. - There could be a change to an upland marsh or loss of an upland marsh if sea level rises considerably. I also have concerns about the maintenance of the sill gaps to allow nekton access. - This site is a trash and dead bird collector - needs more frequent maintenance. - Hopefully, marsh evolution and migration will keep pace with expected sea level rise scenarios. Will eventually impact upland berm areas and in longer term, ___?___ if allowed continued migration. Sill will be overtopped more after but should continue to provide adequate dissipation for many decades, or at least another 2 feet of rise in sea level , low marsh will be replaced by shallow subtidal, high marsh by low marsh, etc.

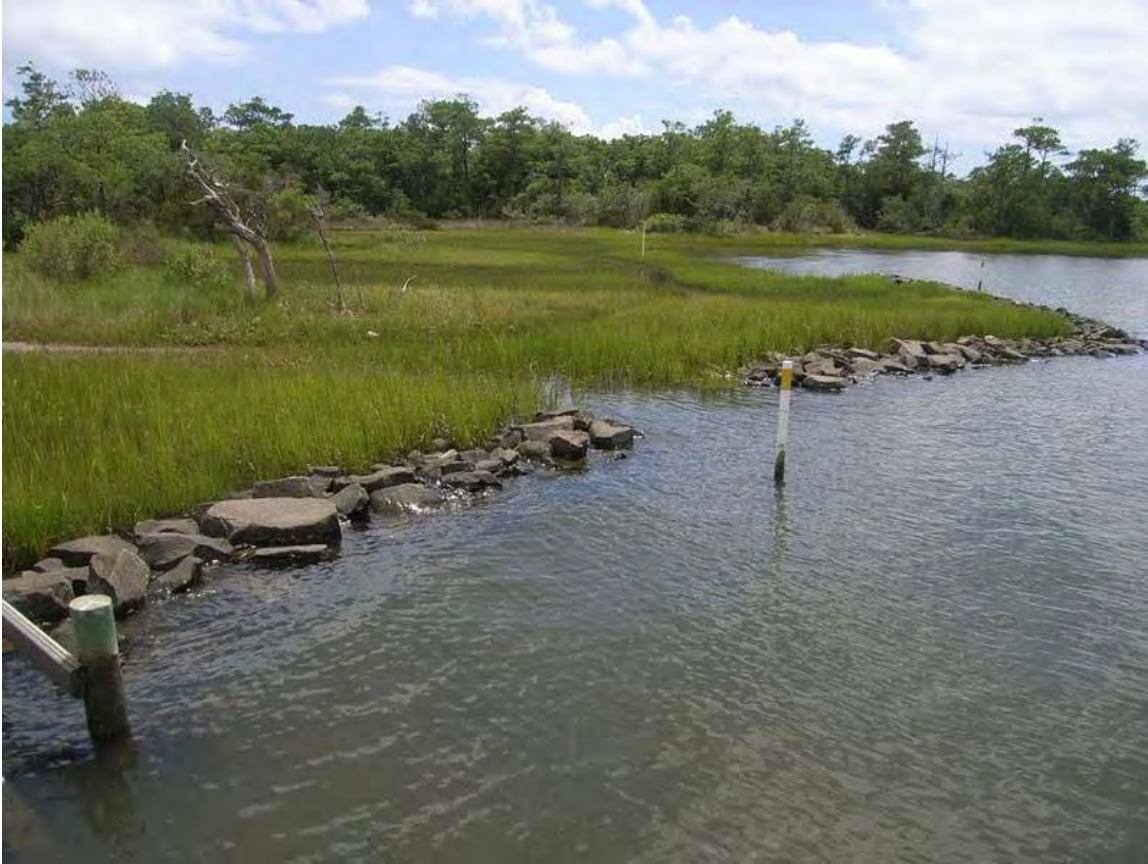
Major Permit No: 42-00-05

46	Overall, do you think the wetland creation portion of the project has been successful?	10	0	0		
47	Do you think this structure will continue to function into the future given expected sea level rise?	5	1	4		<ul style="list-style-type: none"> – Not sure - depends on timeline. – Not sure - structure may be less effective in providing the designed effect.
48	Please provide any additional concerns and/or comments in regards to this site location.	<ul style="list-style-type: none"> – Evaluated this location at high tide. – This sill is well established. I do have concerns about the low marsh being converted to upland marsh due to the high rate of sediment accumulation.

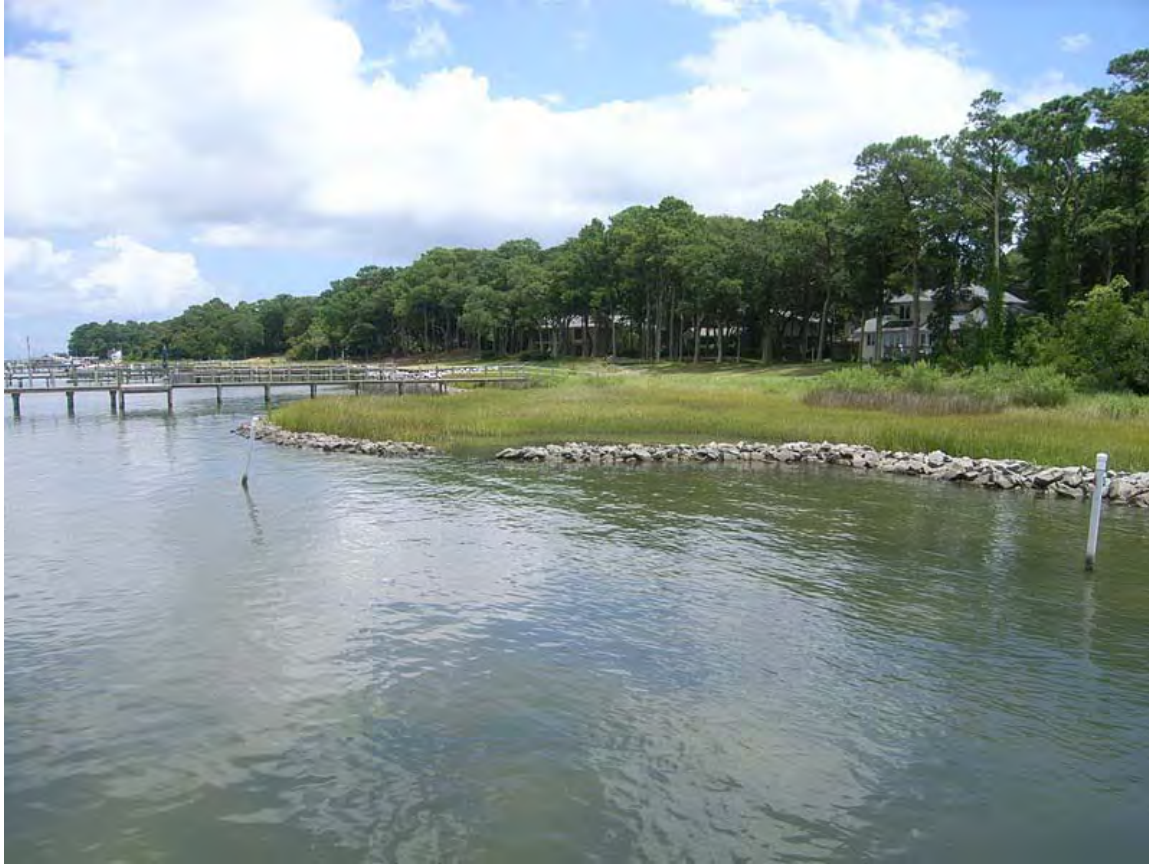
Major Permit No: 42-00-06

46	Overall, do you think the wetland creation portion of the project has been successful?	9	0	1		
47	Do you think this structure will continue to function into the future given expected sea level rise?	7	0	3		
48	Please provide any additional concerns and/or comments in regards to this site location.					<ul style="list-style-type: none"> - Erosion at this site created by construction of bulkhead of incident erosion forces, design effective but if I were to redesign - would decrease overall size of sill and decrease fill elevations overall and encourage open water landward of sill. Property owners might not agree with this especially during storms, which still brings water over marsh/sill and into yard. - Seems like a large structure and eventually may fill in with sediment that would change the wetland species to more higher ground species (patens etc) Would like to see drop downs lower. - Wall too high for site conditions. - This sill has had a lot of sediment accretion. More drop downs would provide better fish habitat.

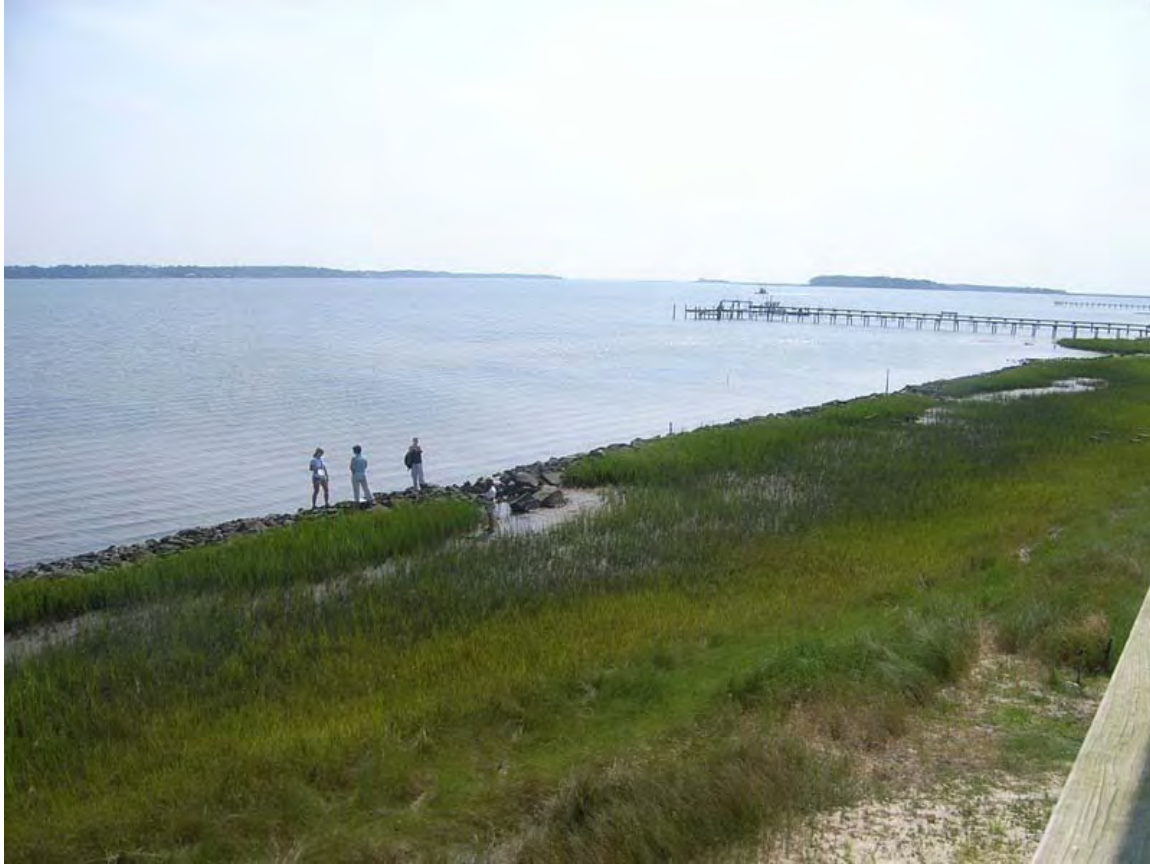
Major Permit No: 42-00-08

48	Please provide any additional concerns and/or comments in regards to this site location.	– Good demonstration site of functioning sill and habitat. – The sill and marsh seem to be functioning as intended. However the fill from the house has encroached on the marsh. – With vegetation growing to rock, I doubt there will be much of ingress/egress (fish), probably only at high tide. – East end of sill, appears to be erosional pocket forming on adjacent property.

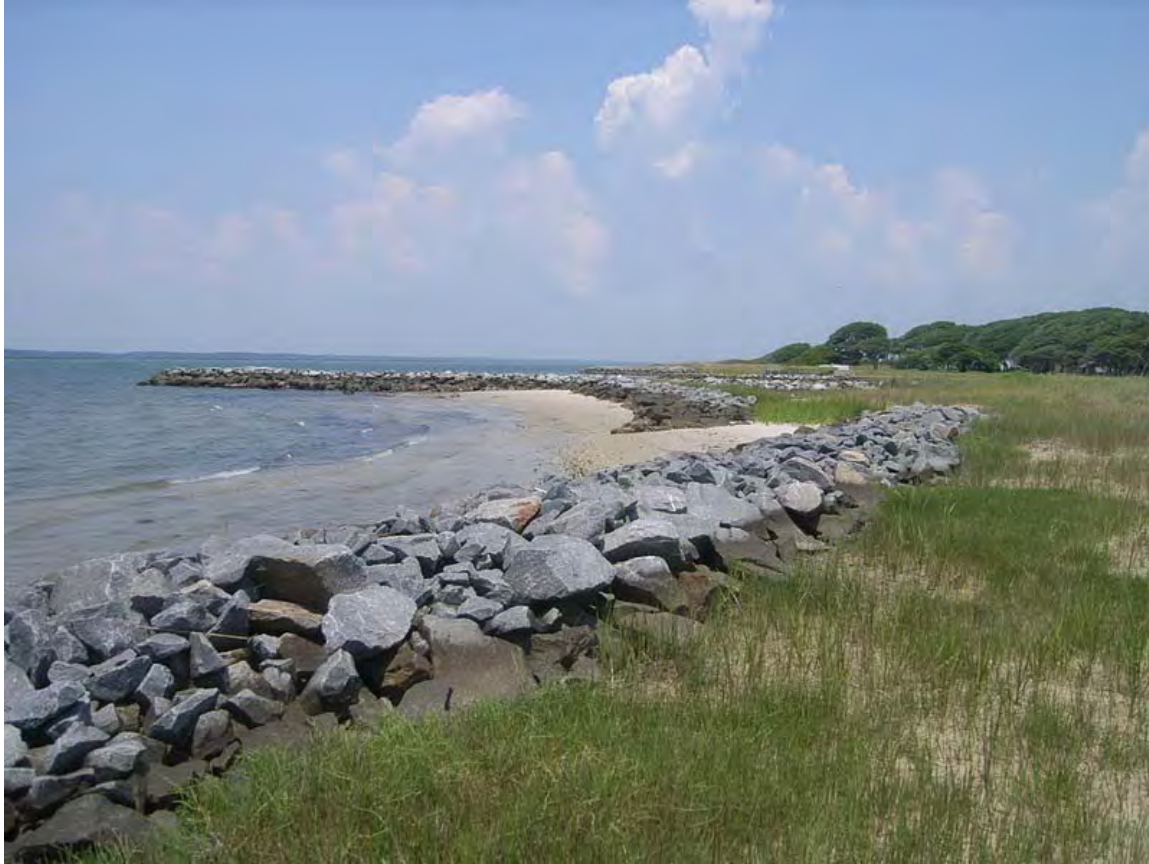
Major Permit No: 42-00-10

Other	# yes	# no	# not sure	# N/A	Field Team Comments
42	For this question, please refer back to the original permit packet. Were the comments/concerns your agency made during the permit process substantiated during and/or after construction? Please explain and/or respond to each comment/concern that was made by your agency for this permit.					
43	Do you think this sill is functioning as intended?	6	0	1		
44	Do you think a different structure would have performed/functioned better in this location?	1	4	2		
45	If so, which one (bulkhead, riprap revetment, marsh toe protection riprap, groin, planting only, sheetpile sill, or no structure at all) and Why?					
46	Overall, do you think the wetland creation portion of the project has been successful?	6	0	1		– Too dry.
47	Do you think this structure will continue to function into the future given expected sea level rise?	5	0	2		
48	Please provide any additional concerns and/or comments in regards to this site location.					<ul style="list-style-type: none"> – This sill could have been smaller with drop downs at more locations. It also could have been pushed seaward. – Some aspects are like a marsh sill others are higher almost like a revetment. The area especially near inlet is extremely high land relative to the water level. Mostly upland species and/or higher elevation species. – Dead bird present behind sill, big project, old bulkhead left in place at corner is serving as a small breakwater. In places high marsh has colonized entire area up to sill suggesting elevation is not correct.

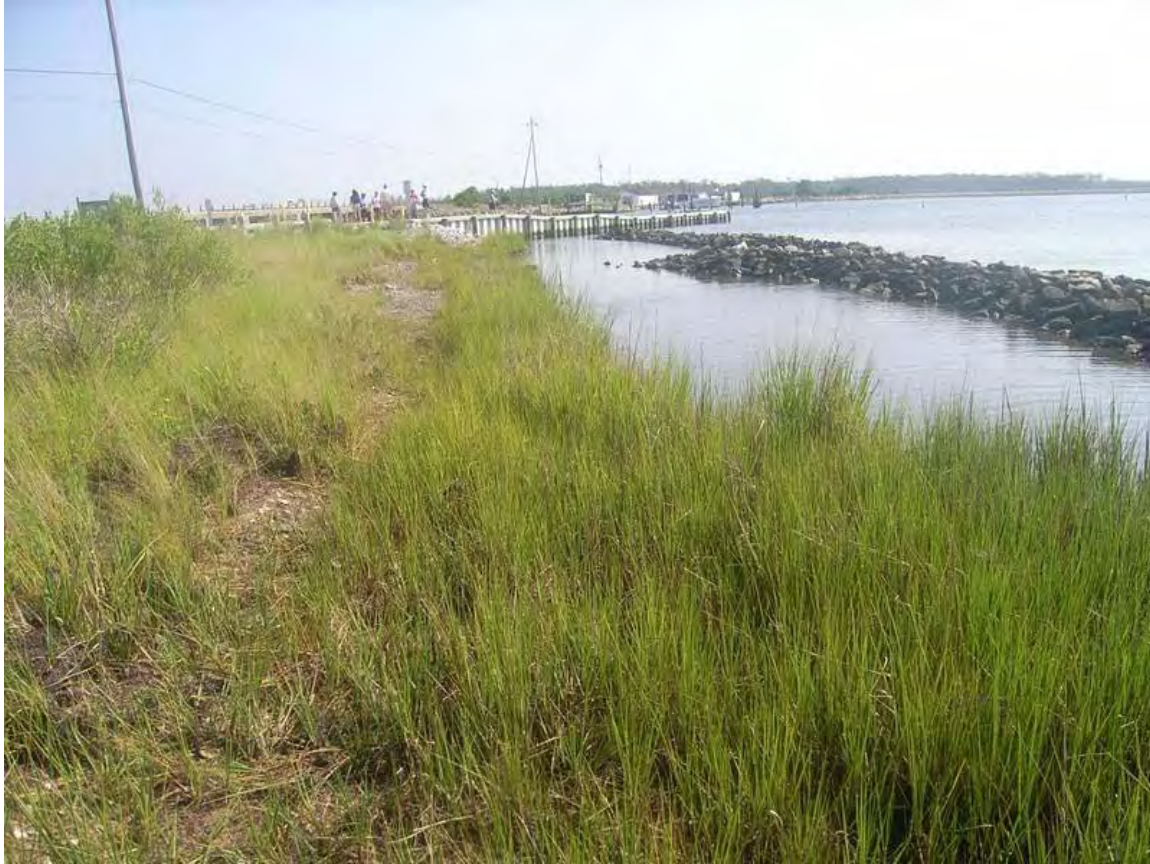
Major Permit No: 20-05

46	Overall, do you think the wetland creation portion of the project has been successful?	8	0	2		
47	Do you think this structure will continue to function into the future given expected sea level rise?	4	0	6		
48	Please provide any additional concerns and/or comments in regards to this site location.					<ul style="list-style-type: none"> - I really like this one. Has fish access while still providing protection. - Evaluated this site at mid tide. - This sill seems appropriate for the site. It seems to be well constructed and is providing accessible habitat. The gap between the two sills is larger than I have seen, but does not seem to be resulting in erosion. - Lots of pebble rock in marsh and behind the sill. - Overall sill height looks good. The overlap seems large. I think it will perform as designed. I like this project. - Good design concept and implementation. Good crest height. - Sill provides great protection of restored marsh.

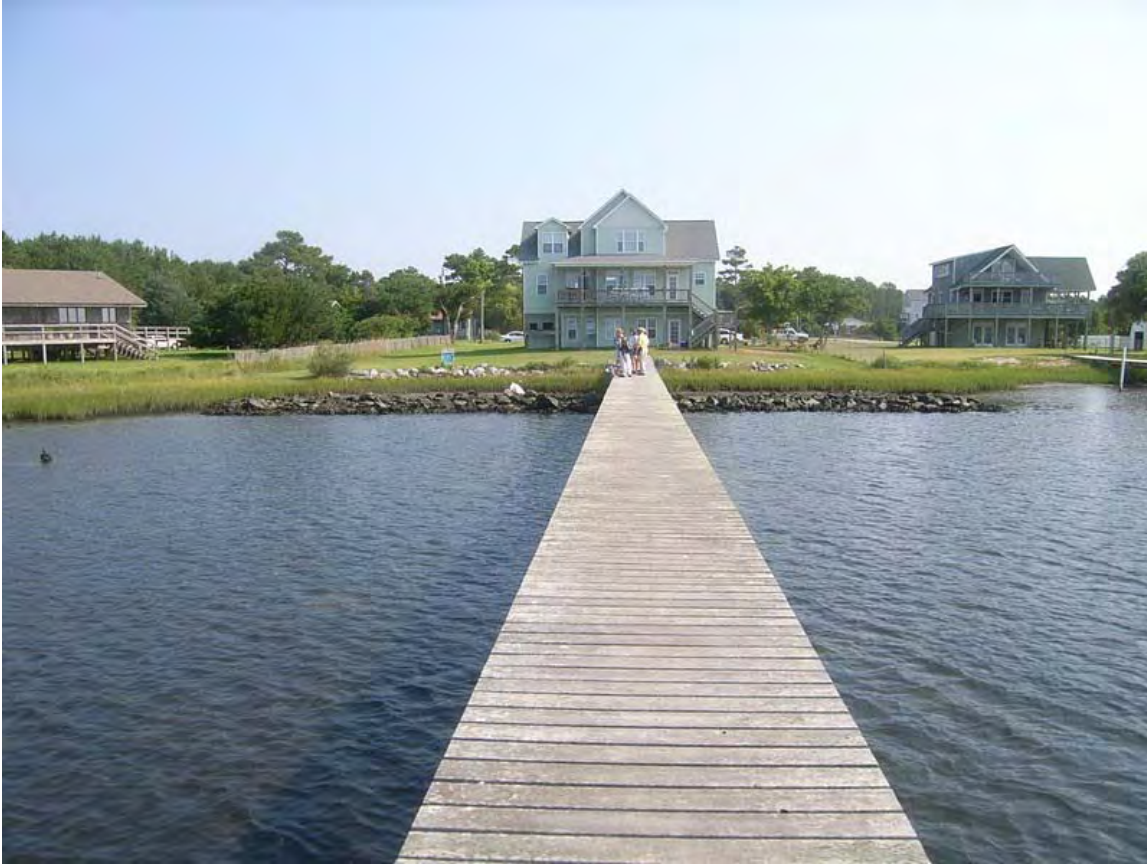
General Permit No: 45794C

46	Overall, do you think the wetland creation portion of the project has been successful?	2	1	4		<ul style="list-style-type: none"> - Not planted? - Not a lot of marsh created. - Already believe marsh was present.
47	Do you think this structure will continue to function into the future given expected sea level rise?	3	0	4		<ul style="list-style-type: none"> - In the immediate future, but not long-term as wetland cannot migrate due to upland riprap. - Depends on SLR rate.
48	Please provide any additional concerns and/or comments in regards to this site location.					<ul style="list-style-type: none"> - Sill may not have been necessary; no apparent erosion issues, oyster bag sill would have worked too, or just planting the shoreline. - No gaps in structure, ends open, but does it fit permitted design? Could not compare to GP drawing, not available, marsh already seemed present in construction photos. - This should not have been a general permit b/c additional review may have shown that less structure is needed to protect this shoreline.

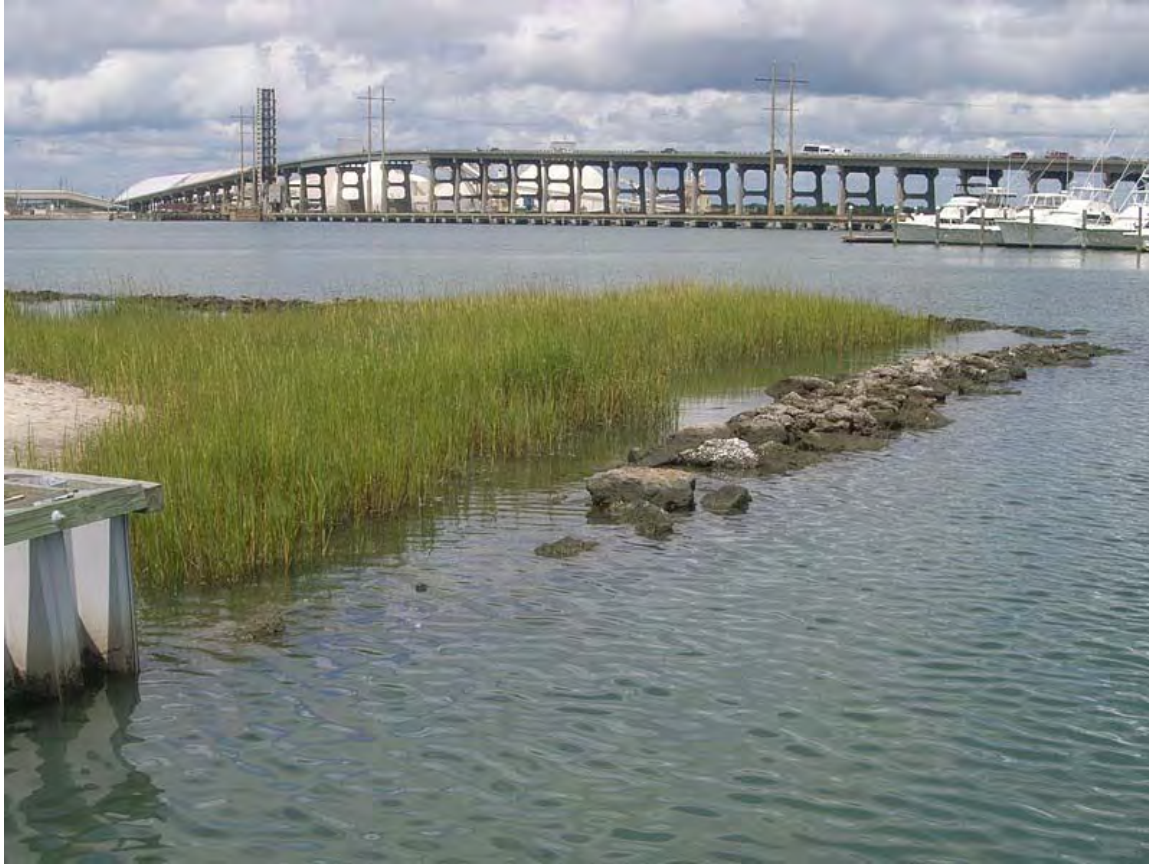
Major Permit 142-06

46	Overall, do you think the wetland creation portion of the project has been successful?	4	0	2		– Marsh was not created, was already present here. – Protection/enhancement...not creation.
47	Do you think this structure will continue to function into the future given expected sea level rise?	1	1	4		
48	Please provide any additional concerns and/or comments in regards to this site location.	– I think this sill is functioning as intended and creates viable fish habitat. The opening is deep and wall designed for tidal passage. – From aerial photo, it appears that marsh has changed configuration. Would be useful to compare before/after photos to see if total marsh acreage has changed. – This sill appears to be protecting the marsh. – Sill continues to function even with elevated sea level rise, but shoreline will not be able to migrate landward past bulkhead. Sill will dissipate energy with additional 1- 2 feet but low marsh will move up profile and more shallow subtidal will exist between sill and low marsh.

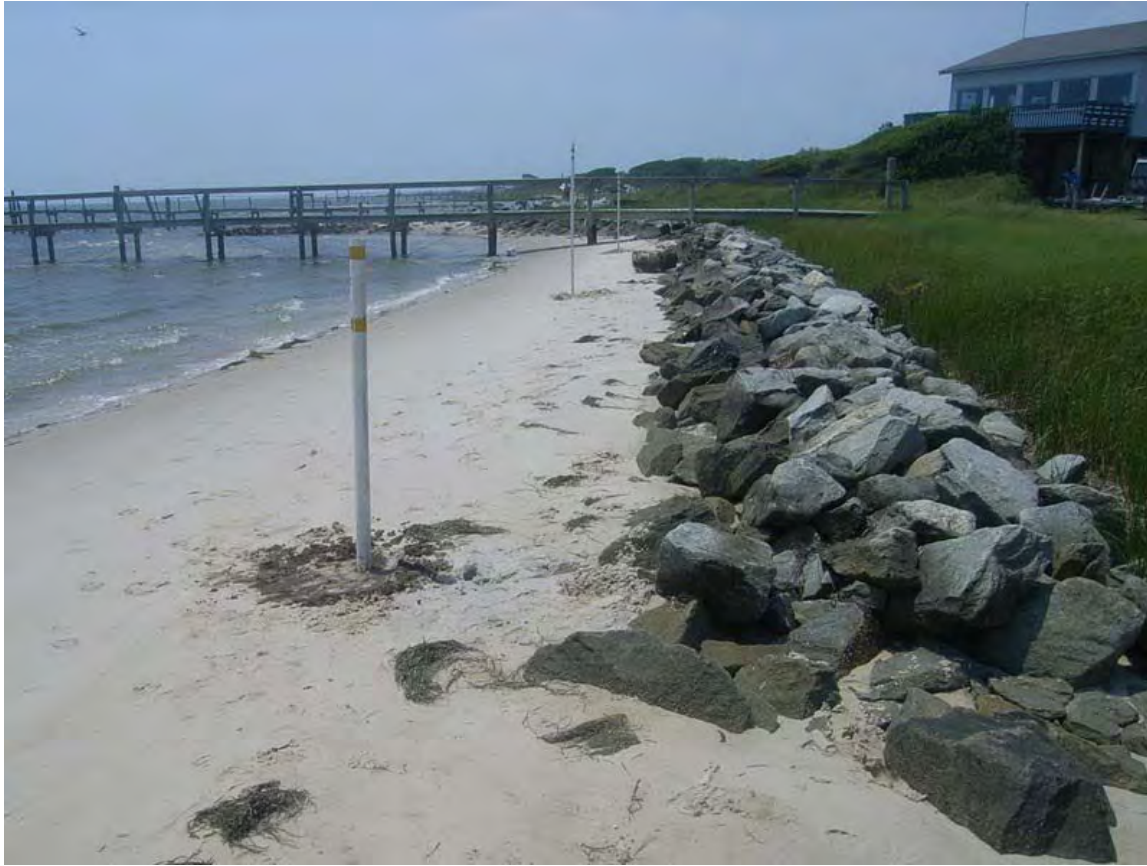
General Permits 48144C, 48145C, 50129C, 50168C, 50130C

48	Please provide any additional concerns and/or comments in regards to this site location.					– Drainage ditch between properties empties right adjacent to sill.

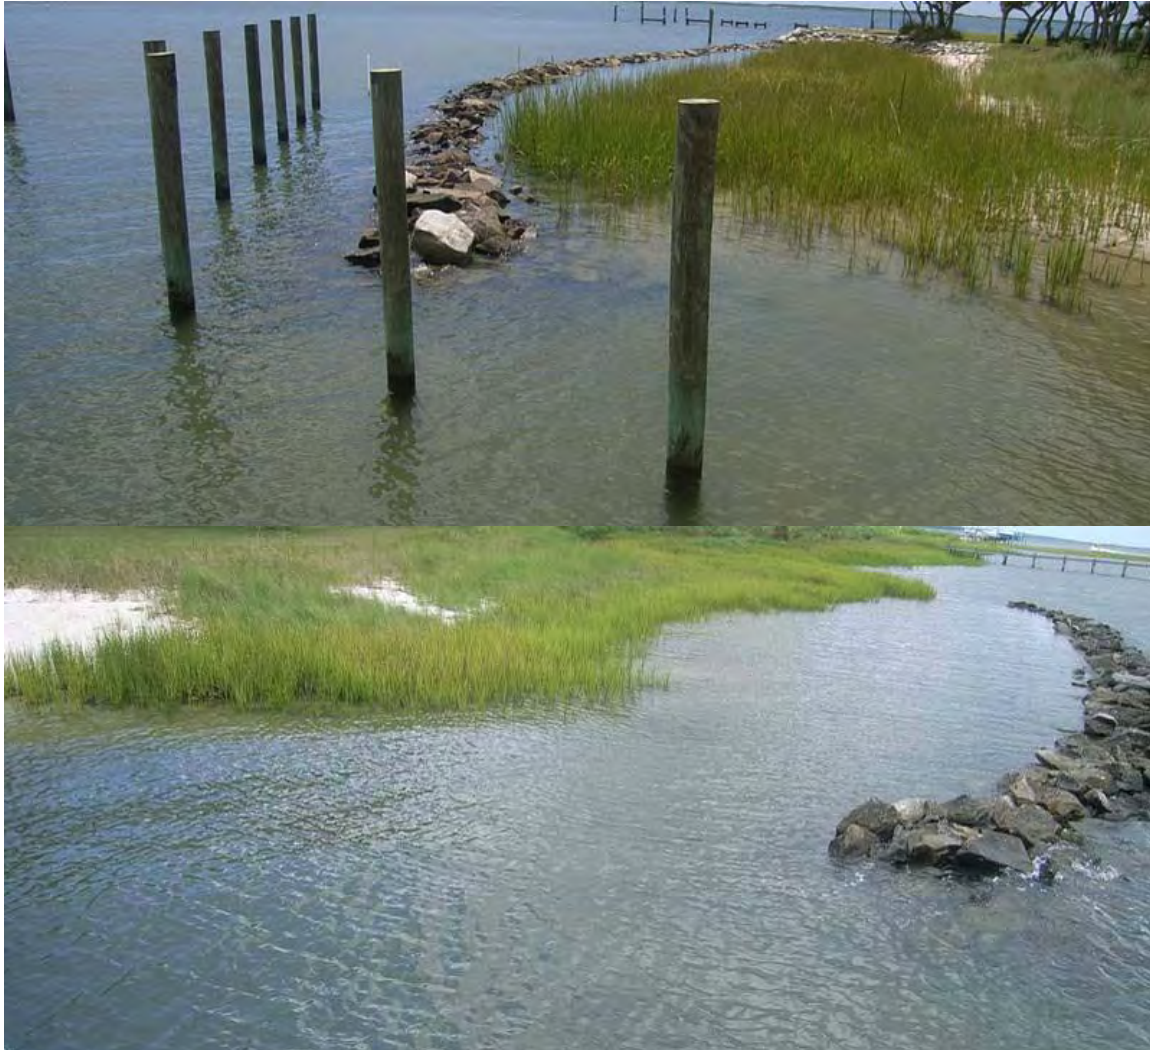
Major Permit No: 131-07

48	Please provide any additional concerns and/or comments in regards to this site location.	– Sill should allow energy dissipation even at higher water levels, low marsh will ->shallow subtidal->high marsh will not equal low marsh etc. Element profile will allow migration landward but location of house is already done to shoreline - at some point, increased water levels and anticipated increase in storm energy will compromise house regardless. How many yrs? Not certain - sill can function even with 1'-1.5' (?) increase in SLR – The project had excessive fill large amt. of bottom impacts due to structure; ends of sill should have been tapered around boat ramp; overall, though sill is doing what it was intended to do.

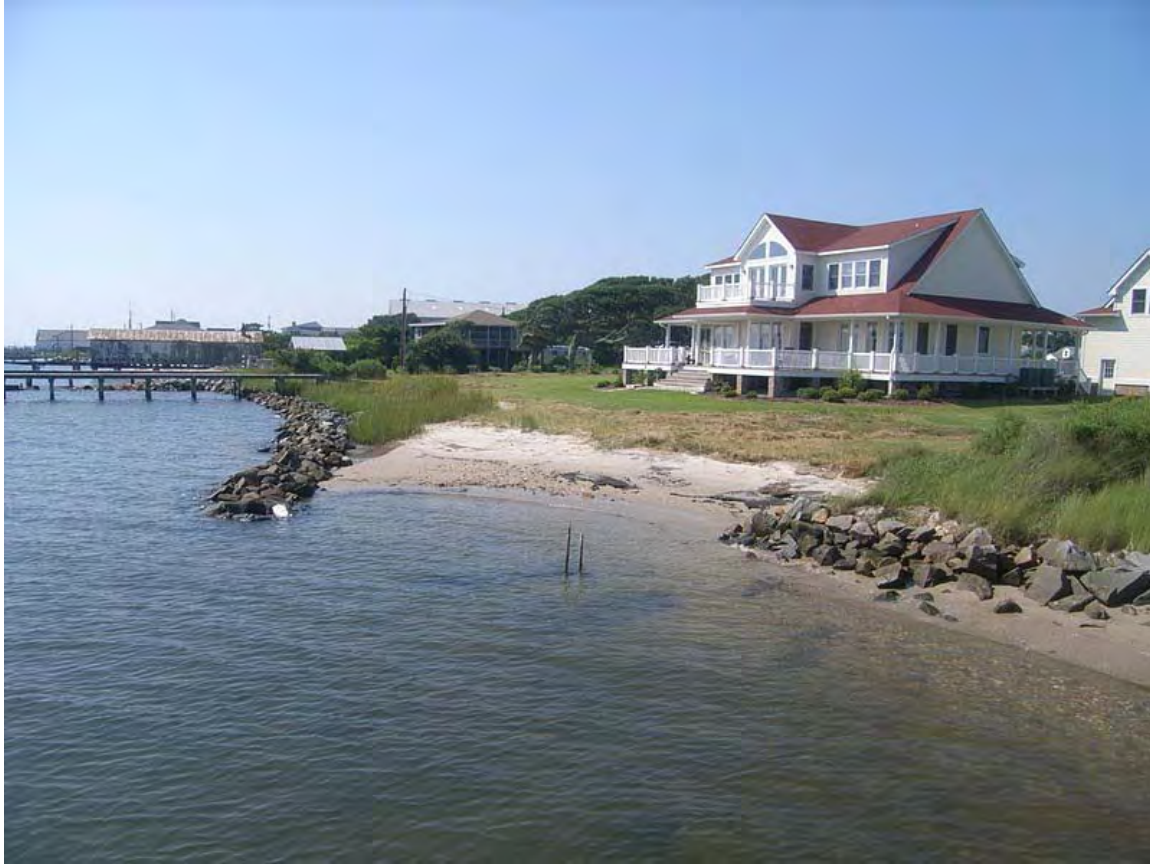
General Permit No: 49808C

48	Please provide any additional concerns and/or comments in regards to this site location.	– A smaller sill further seaward with more dropdowns may provide better fish habitat. – Reflectors are all broken.

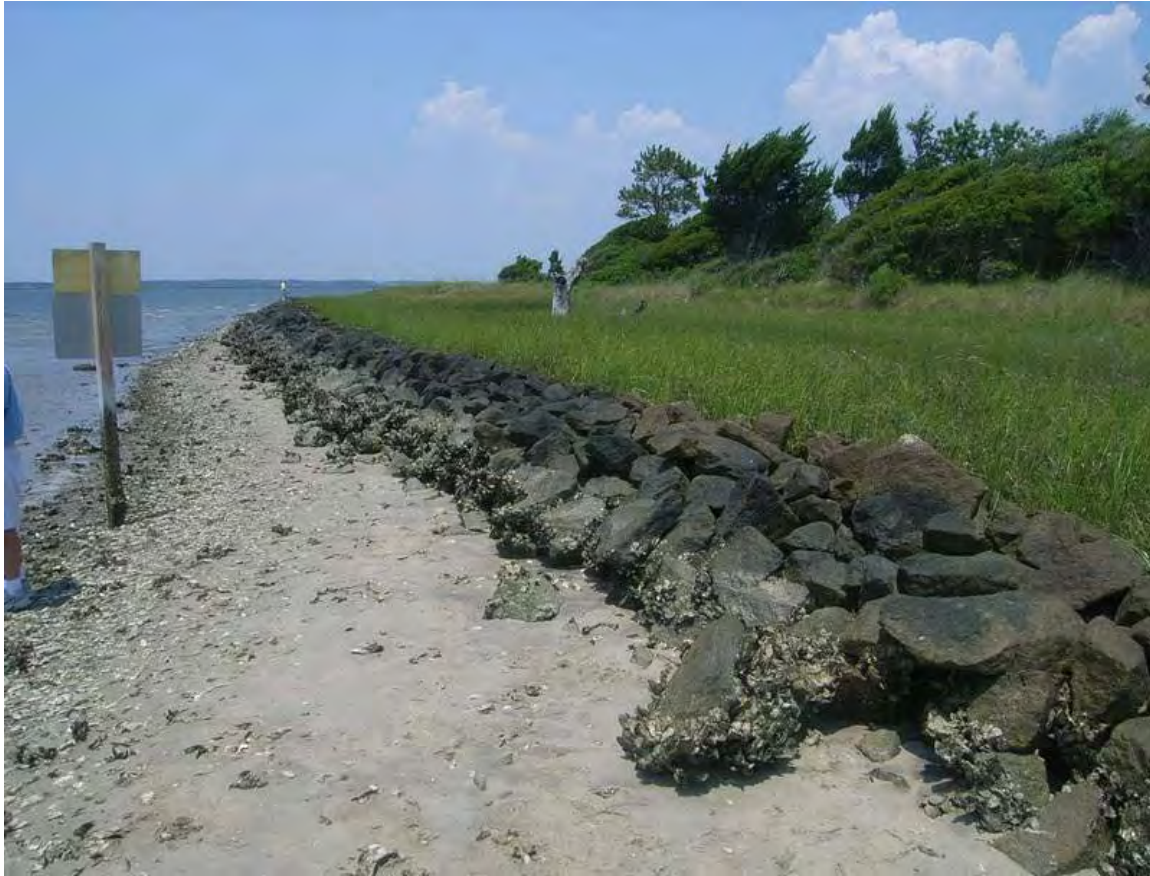
Major Permit No: 15-08

Other	# yes	# no	# not sure	# N/A	Field Team Comments
42	For this question, please refer back to the original permit packet. Were the comments/concerns your agency made during the permit process substantiated during and/or after construction? Please explain and/or respond to each comment/concern that was made by your agency for this permit.					– Yes, design was changed.
43	Do you think this sill is functioning as intended?	7	0	0		
44	Do you think a different structure would have performed/functioned better in this location?	0	4	3		
45	If so, which one (bulkhead, riprap revetment, marsh toe protection riprap, groin, planting only, sheetpile sill, or no structure at all) and WHY?					
46	Overall, do you think the wetland creation portion of the project has been successful?	7	0	0		
47	Do you think this structure will continue to function into the future given expected sea level rise?	5	0	2		
48	Please provide any additional concerns and/or comments in regards to this site location.					<ul style="list-style-type: none"> – Marsh is healthy and has established since it was planted, despite everyone else's comments saying its dying. I can send you all pre-planting pics taken in 2008. – High energy shoreline. – This is a huge sill. I think having more breaks with rock behind the drop downs would promote more fish utilization of the marsh. It is also too tall in some places. – Groins built into sill at end may be problematic, this is a big sill...may be too tall.

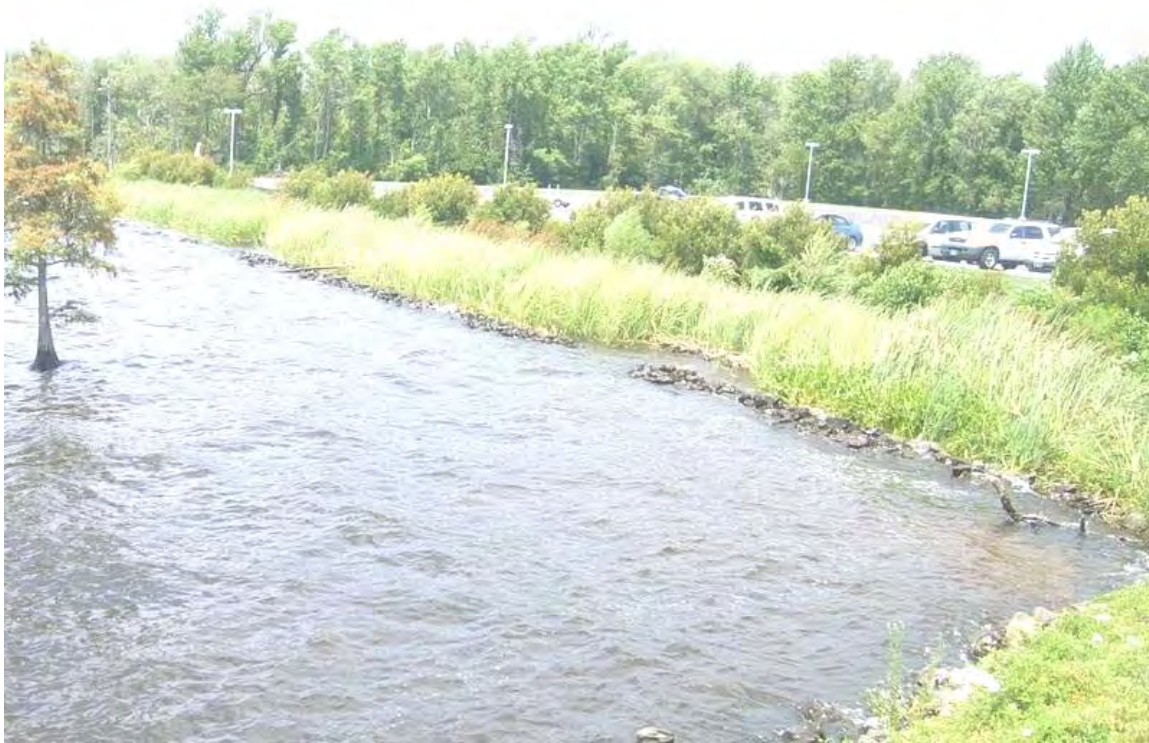
Major Permit No: 42-00-09

48	Please provide any additional concerns and/or comments in regards to this site location.	<ul style="list-style-type: none"> – Overall impression: Design needs to be done by someone with some engineering experience. Built from foot of old bridge landing, north. Living Cypress trees in front of sill. Parking lot gives little room for marsh retreat. – Like this project - with the gaps. Would like to have the structure further offshore.
