NC COASTAL RESOURCES COMMISSION

N.C. Division of Coastal Management
Assessment of 27 Marsh Sills in North Carolina
Final Report

Prepared by: John Fear, Ph.D. and Bonnie Bendell

April 2011

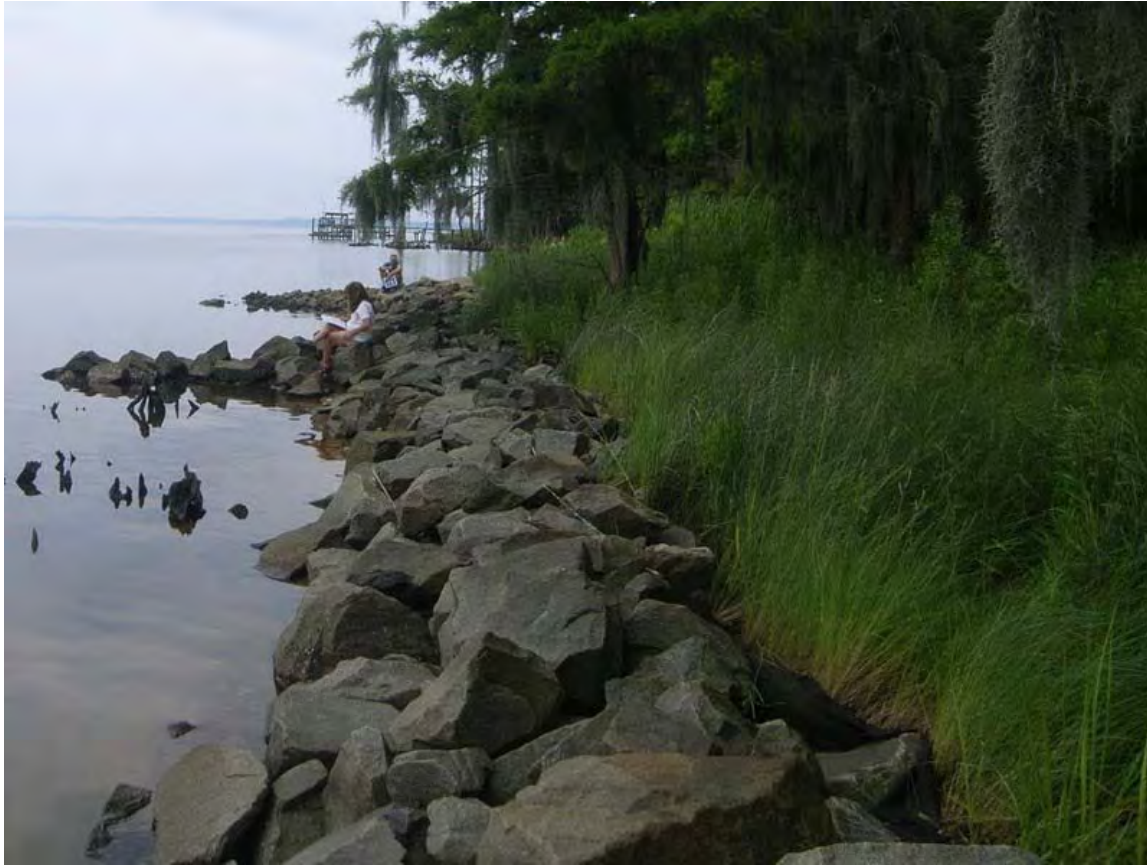
Major Permit No: 42-00-04

Other Continued		
48	Please provide any additional concerns and/or comments in regards to this site location.	<ul style="list-style-type: none"> - This is a fresh water site so the habitat considerations might be slightly different than the salt water sites. Perhaps a gentler slope and a sill further out would provide better fish habitat, but this may have put the existing bald cypress at risk from erosion, stagnant inundation. - Could have been placed further offshore? But functioning well. - Don't see this as a real marsh sill type of project. I think the habitat diversity is preferred verses adjacent sand beaches. Looks like a perched beach kind of set up. - Structure superior to revetments, bulkheads etc. at same location - but would modify design to allow better fish passage and reduce amt of stone. Project will accommodate shoreline migration with SLR projections for a while.

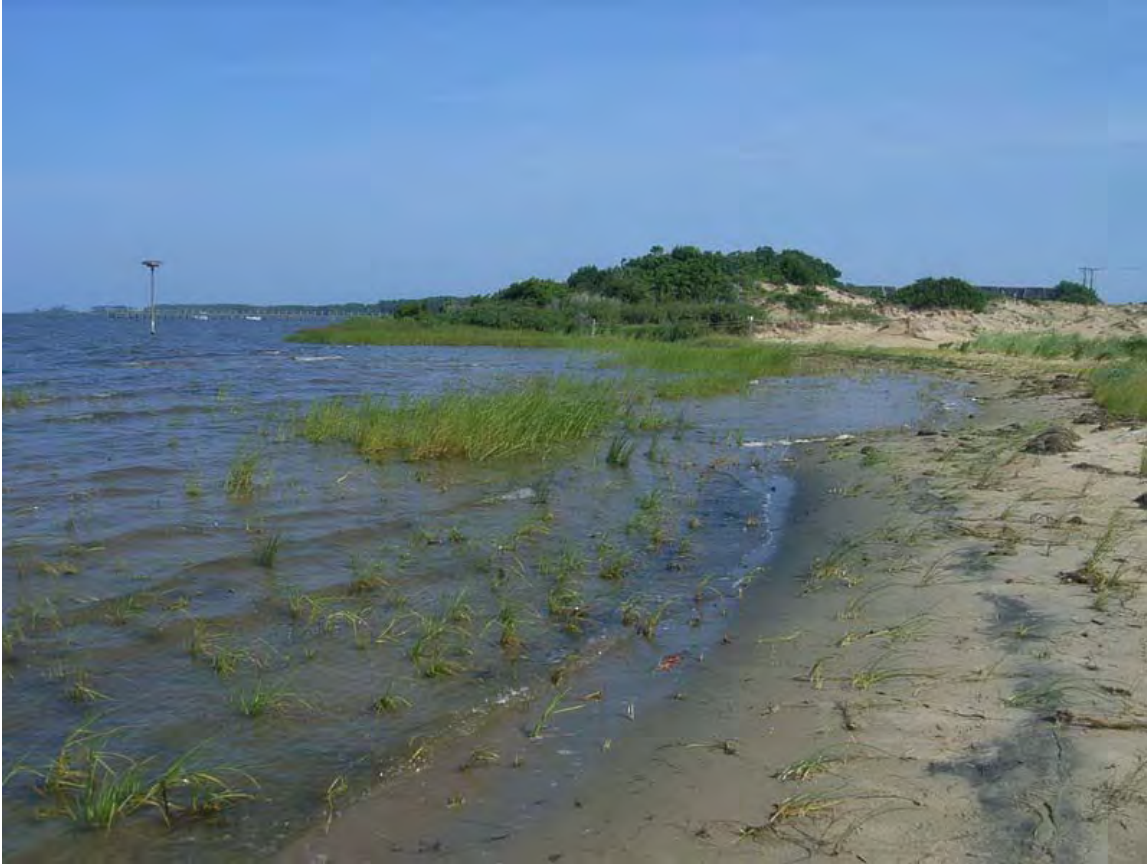
Major Permit No: 36-09
 Issue Date: March 26, 2009
 Nags Head, NC, 27959
 Waterbody: Roanoke Sound
 Dare County

Other Continued	# yes	# no	# not sure	# N/A	Field Team Comments
47	Do you think this structure will continue to function into the future given expected sea level rise?	2	3	3		<ul style="list-style-type: none"> - No - height modifications needed. - Only if the marsh establishes itself well. - Yes with maintenance will allow marsh to migrate with SLR.
48	Please provide any additional concerns and/or comments in regards to this site location.	<ul style="list-style-type: none"> - The sill could be higher to account for an average wind driven tide day. Today is an average wind day (minor wind) and the water level is 6 inches above normal water level. They constructed the site to 6 inches above normal water level and it was completely underwater today. - Need to increase the width and height of the sill. Large fetch to overcome. - Concern that no thought given to the fact that lots of sand is being moved from dune ridges toward sound. With bags present much of this sand might be caught making elevation behind sill too high (everything might get buried).

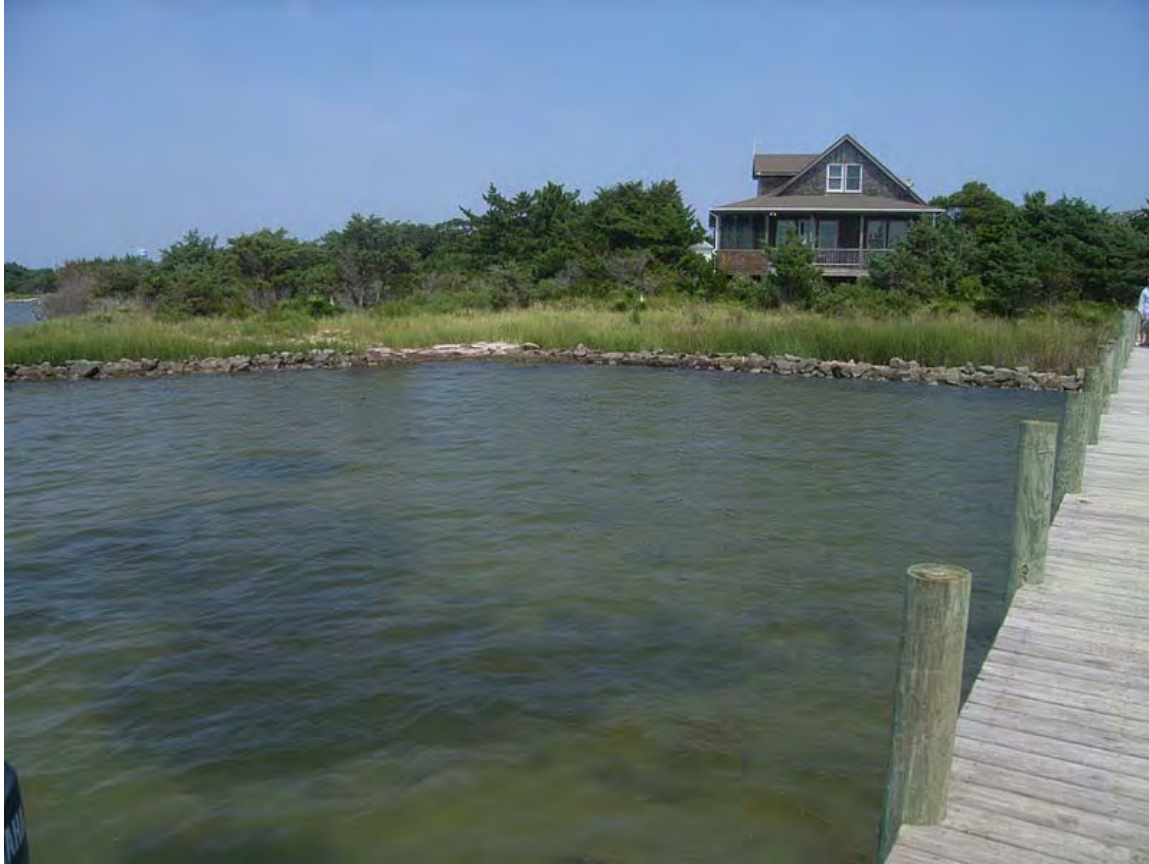
General Permit No: 46565B

Other	# yes	# no	# not sure	# N/A	Field Team Comments
42	For this question, please refer back to the original permit packet. Were the comments/concerns your agency made during the permit process substantiated during and/or after construction? Please explain and/or respond to each comment/concern that was made by your agency for this permit.					
43	Do you think this sill is functioning as intended?	4	0	2		
44	Do you think a different structure would have performed/functioned better in this location?	0	3	3		
45	If so, which one (bulkhead, riprap revetment, marsh toe protection riprap, groin, planting only, sheetpile sill, or no structure at all) and Why?					
46	Overall, do you think the wetland creation portion of the project has been successful?	6	0	0		
47	Do you think this structure will continue to function into the future given expected sea level rise?	4	1	1		
48	Please provide any additional concerns and/or comments in regards to this site location.					– Height of sand behind sill, location of rock relative to SAV, pier crosses sill.

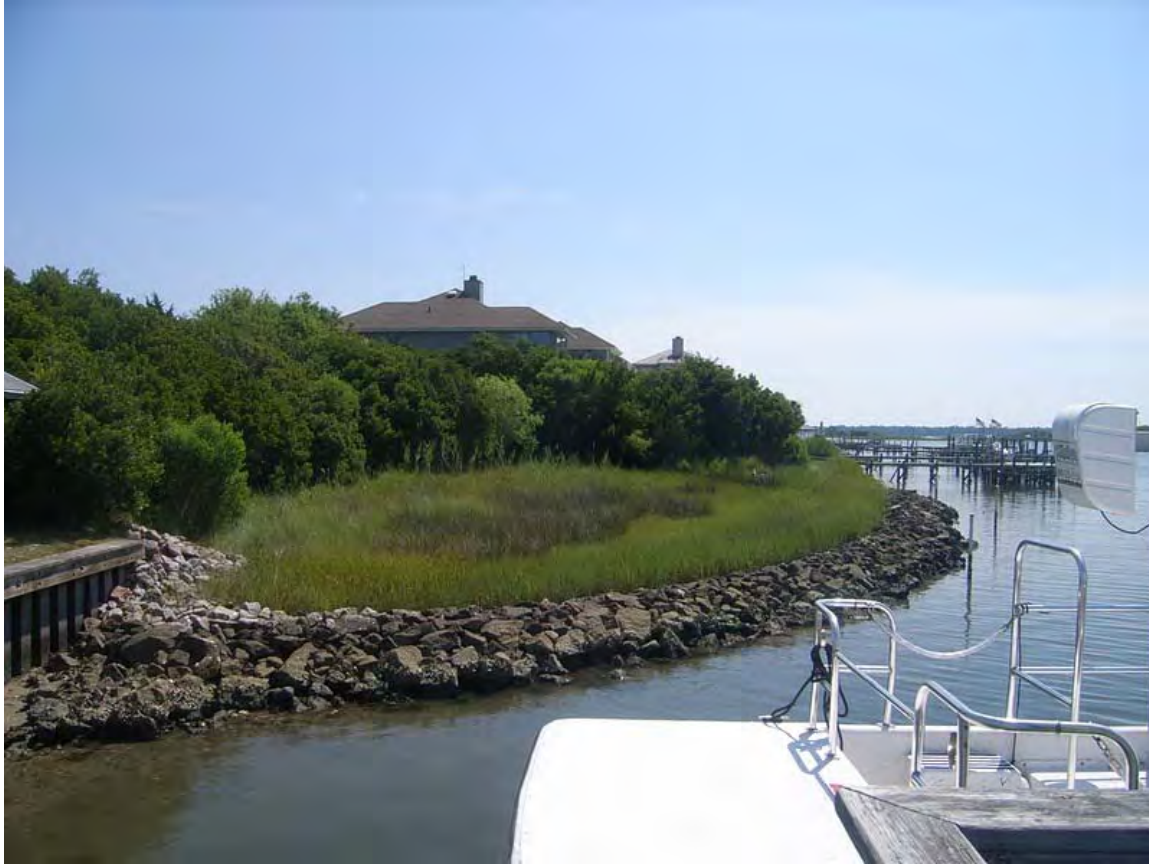
Major Permit No: 42-00-02

48	Please provide any additional concerns and/or comments in regards to this site location.					<ul style="list-style-type: none"> • Needs drop downs or openings. • Lots of oyster shell but little live oyster colonization. • Need greater access for fish. • This is a really nice structure/site regarding function and aestheticism. Combined with stormwater management at site, makes this a very desirable area for shoreline stabilization purposes and habitat creation and maintenance. • Great demonstration site, great habitat, reduces stormwater flow.

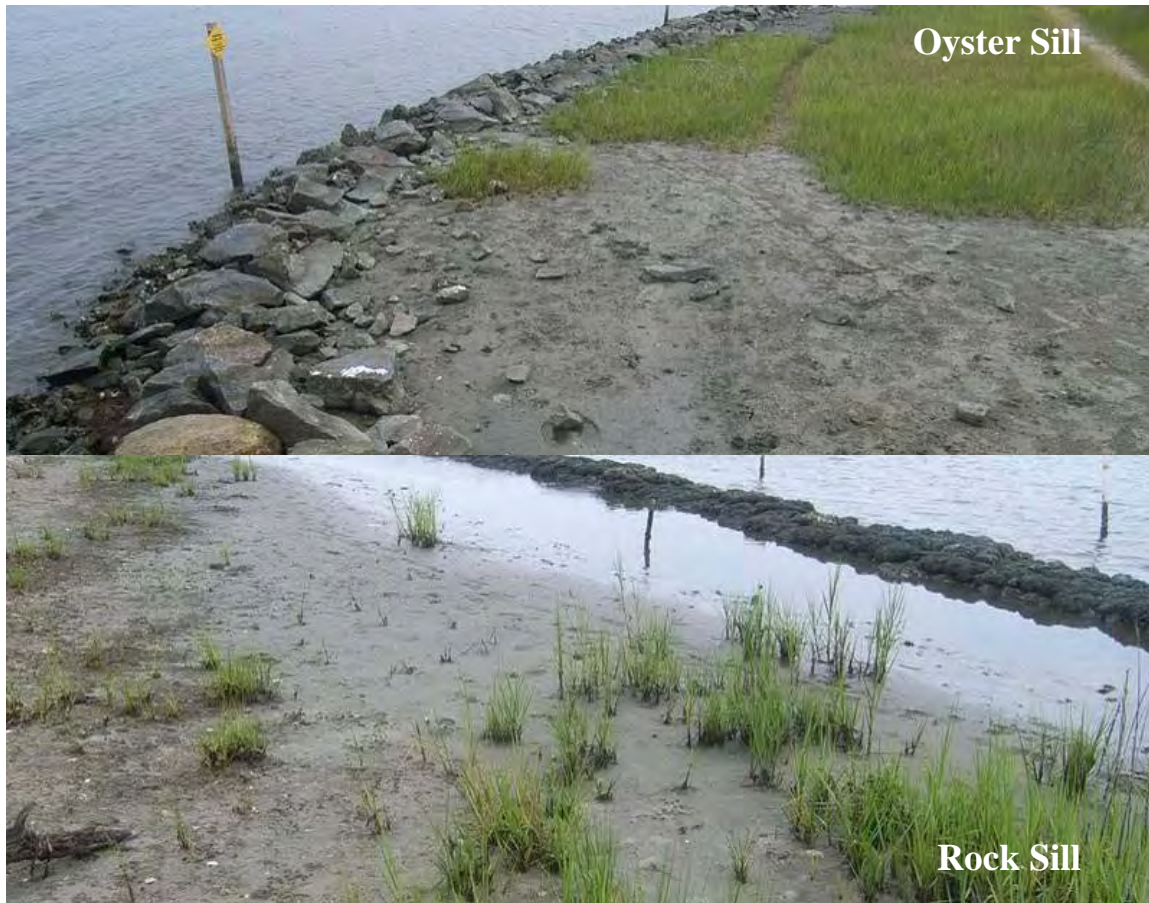
Major Permit No: 28-05

47	Do you think this structure will continue to function into the future given expected sea level rise?	3	1	4		
48	Please provide any additional concerns and/or comments in regards to this site location.					<ul style="list-style-type: none"> • Either too open/exposed or poor sediment source. Has resulted in no accretion and washing away of plantings. Very silty area. • A new modification to extend the sill northwards is currently in the works. Extending the sill should further buffer the high wake energy of the area. • This site may not be appropriate for an oyster bag sill. • <i>Spartina alterniflora</i> had to be replanted many times. • Very low and short structure. Would like to see it extended and more oyster bags stacked on top.

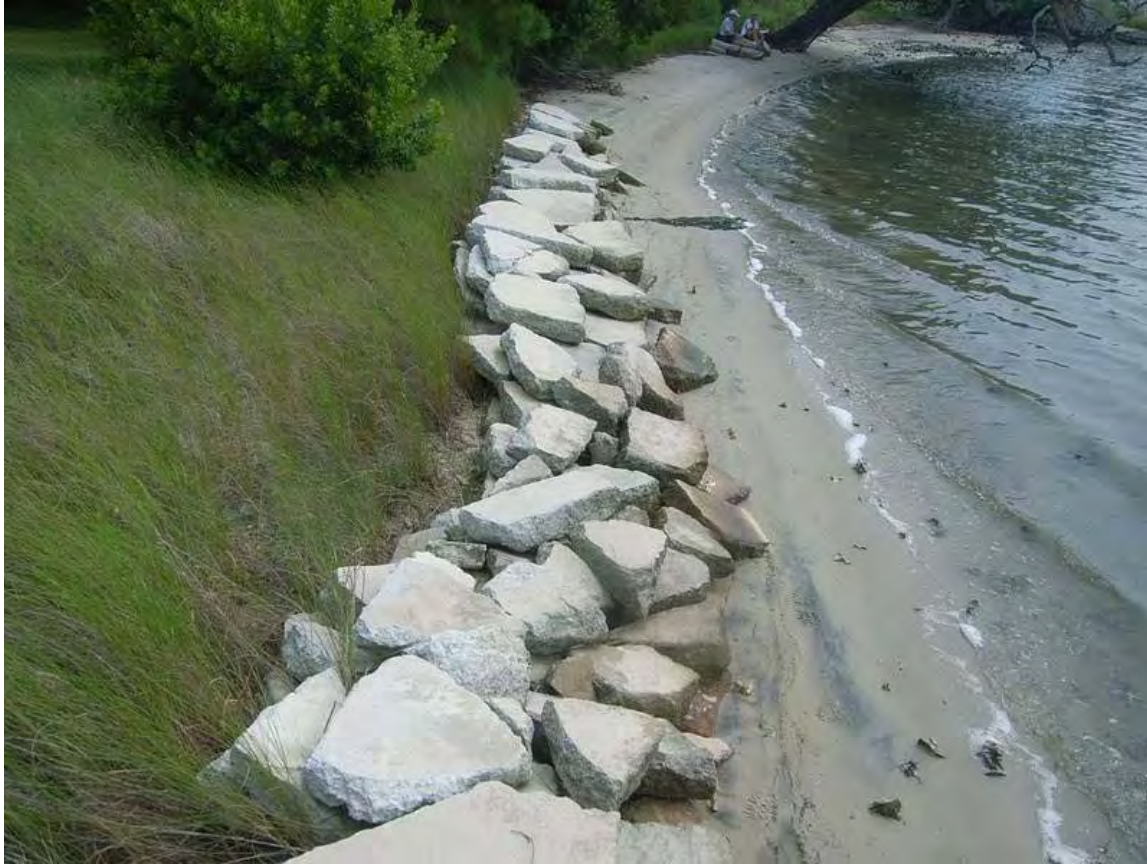
General Permit No: 47575D

46	Overall, do you think the wetland creation portion of the project has been successful?	4	3	1		<ul style="list-style-type: none"> • Yes, success in high marsh restoration. • No; none observed.
47	Do you think this structure will continue to function into the future given expected sea level rise?	4	1	3		
48	Please provide any additional concerns and/or comments in regards to this site location.					<ul style="list-style-type: none"> • This should not have been permitted as a sill. • Does not appear to have had wetland created. Question the pre construction site conditions in relation to what species grew here and the amount of erosion. Appears to be a rip rap revetment, not a sill. • Bad example of a project used for one GP. • Wall needs to be finished to fully protect property.

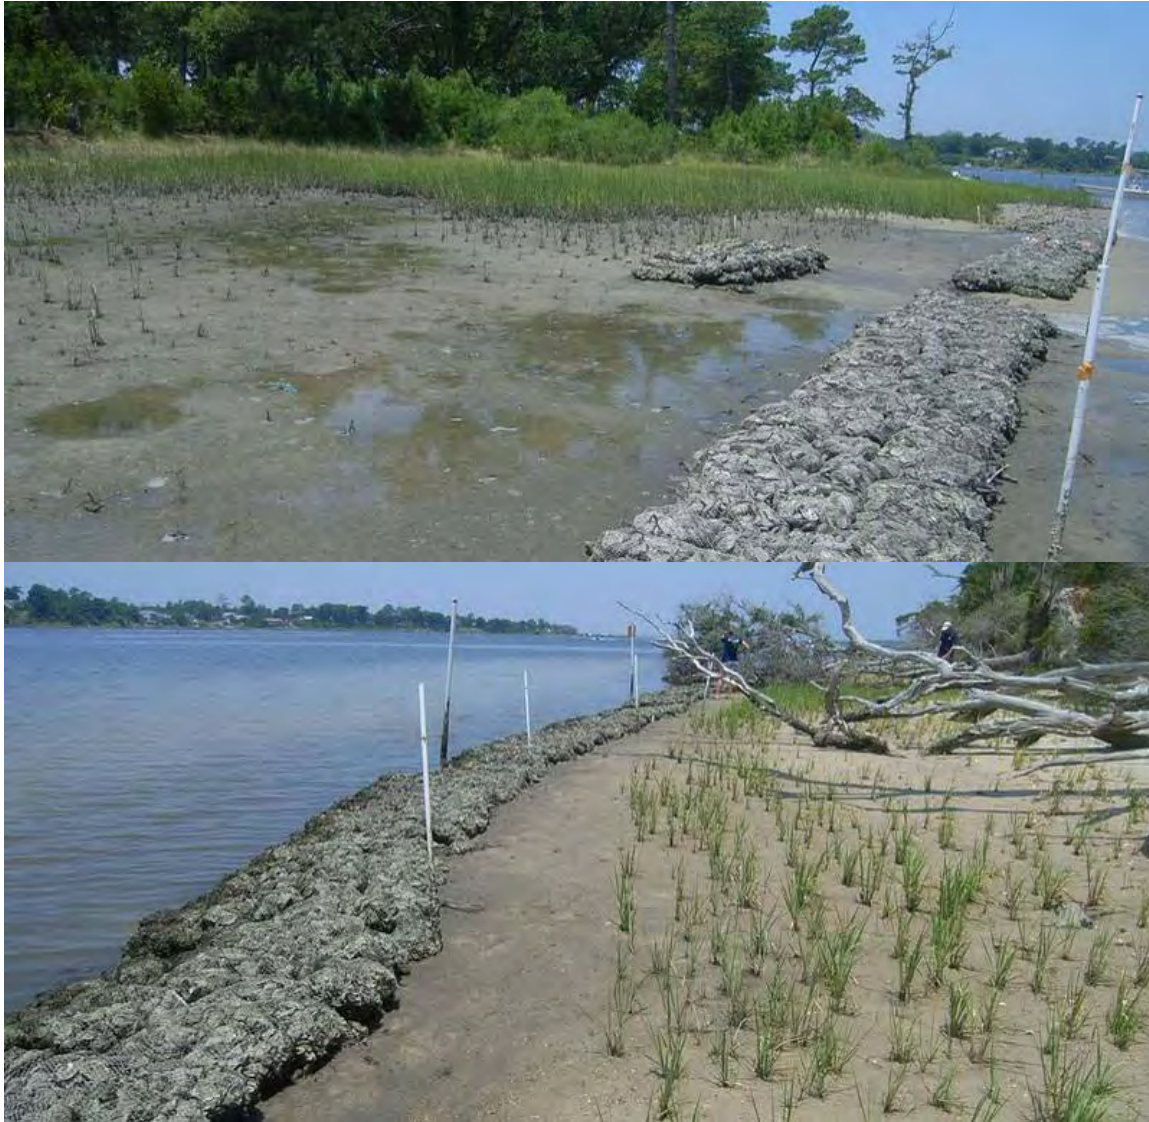
Major Permit No: 47-09

47	Do you think this structure will continue to function into the future given expected sea level rise?	4	0	3		<ul style="list-style-type: none"> • No/not sure - the low elevation may need to be altered. Especially with the significant escarpment on the south side. • Yes on North side, No on South side. • Not sure - hard to say due to elevation of the structure.
48	Please provide any additional concerns and/or comments in regards to this site location.					<ul style="list-style-type: none"> • Think sediment from bluff on south side will cover marsh. Also think gaps are too wide and will allow erosion behind sill to continue. • I like the gaps at the downed trees and that they remained in place. The sill is not great protection for the high bank, but it will create a buffer eventually to help with some of the wave energy.

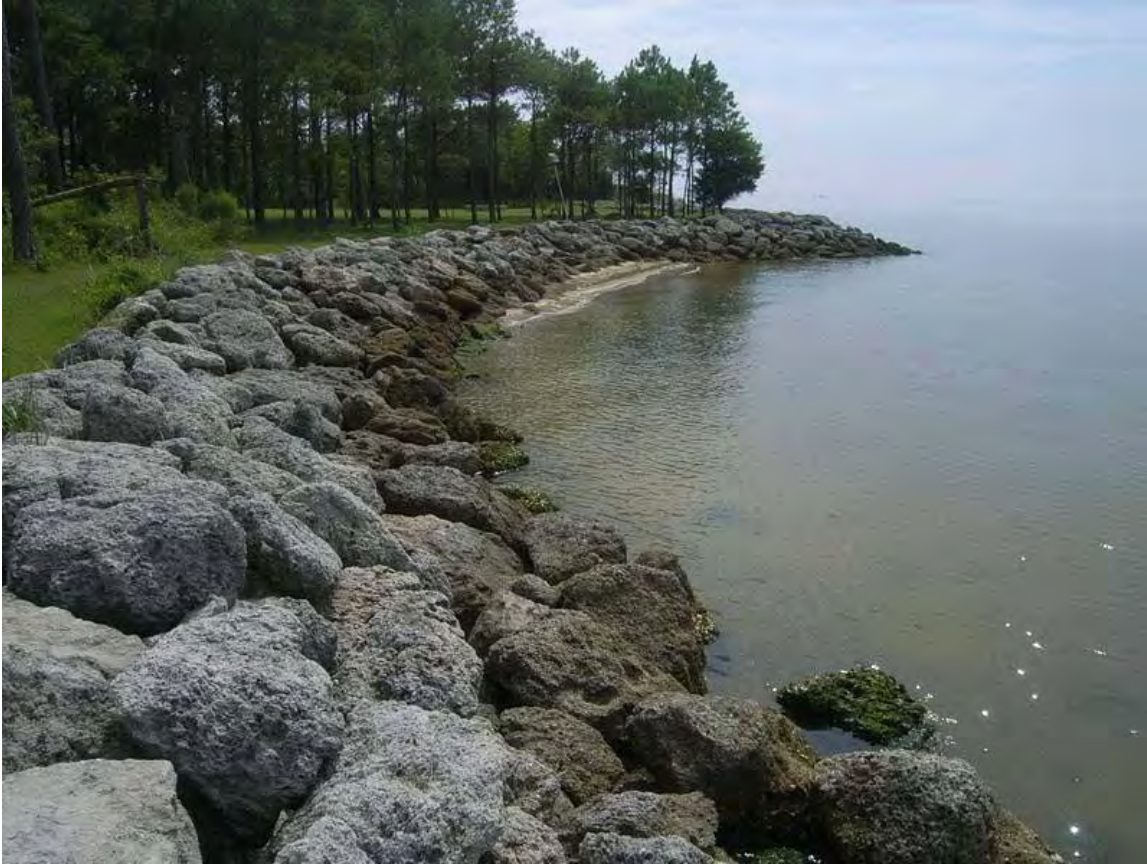
Major Permit No: 50-03

Other Continued	# yes	# no	# not sure	# N/A	Field Team Comments
46	Overall, do you think the wetland creation portion of the project has been successful?	9	0	0		
47	Do you think this structure will continue to function into the future given expected sea level rise?	5	0	4		<ul style="list-style-type: none"> • Depends on how much land sinks.
48	Please provide any additional concerns and/or comments in regards to this site location.	<ul style="list-style-type: none"> • Project will accommodate shoreline protection and migration with sea level rise projectors but will not provide protection for much increase in SLR for house for very long given low elevation of marsh landward of sill. • Nice site but our concerned about sediment deposits directly behind the sill almost will be a barrier to having more sand distribute itself behind the sill area. • Good demonstration site for comparison bw sill, revetment, rip rap. No marsh behind rip rap. • The fetch and elevation of the site seem to require shoreline protection. The sill seems appropriate.

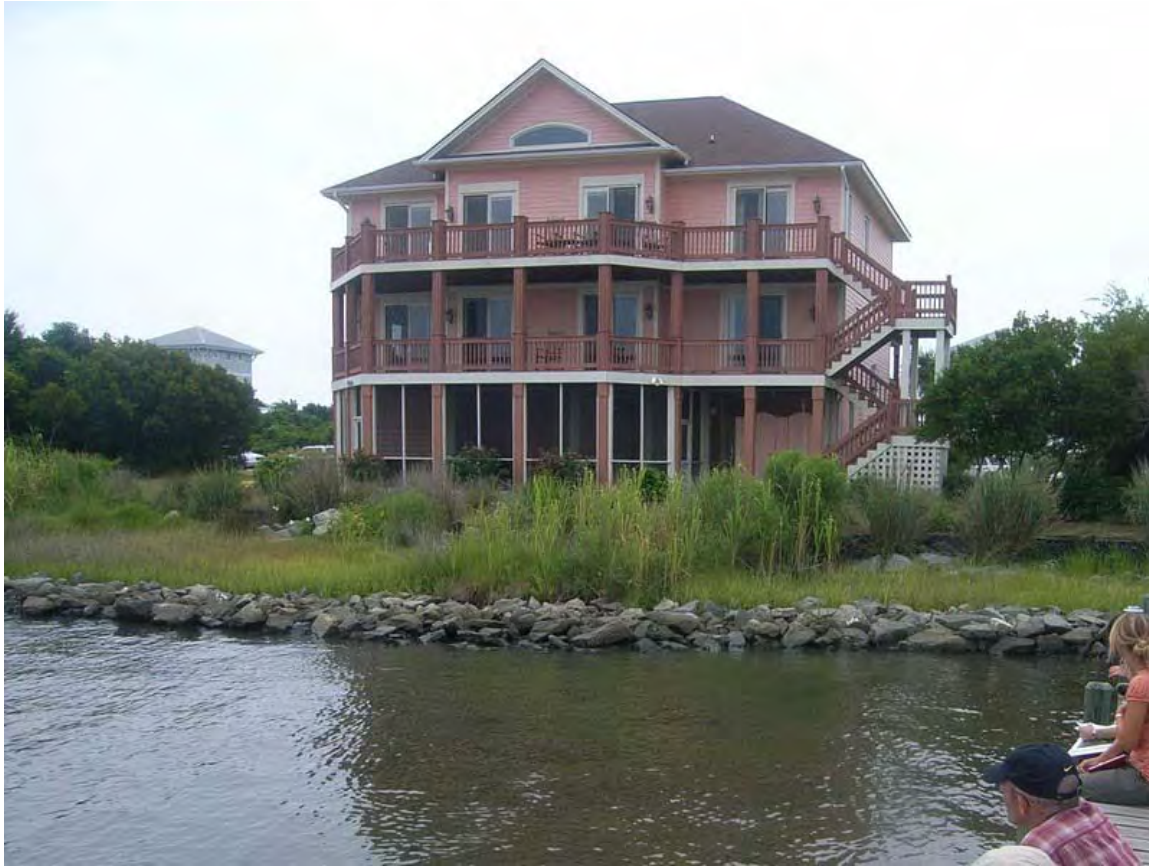
Major Permit No: 42-00-11

46	Overall, do you think the wetland creation portion of the project has been successful?	9	0	0		
47	Do you think this structure will continue to function into the future given expected sea level rise?	4	4	1		
48	Please provide any additional concerns and/or comments in regards to this site location.					<ul style="list-style-type: none"> • The rip rap revetment and the bulkhead seem to be unnecessary. • But not much marsh buffer between bulkhead and sill. • Could have been placed waterward a bit. Really lift sill height/size. • Existence of bulkhead behind sill leaves marsh as where to retreat to . Given performance of adjacent natural properties, I don't see why rocks were needed. • Bulkhead constructed in vicinity of MHW or slightly higher in elevation. Not needed for environmental control. • This sill has fairly high species diversity and active fish utilization. It seems appropriately constructed, but due to lack of erosion of surrounding properties, I don't think the sill was necessary.
