## II. Physical Assessment

### A. *Function of a Terminal Groin*

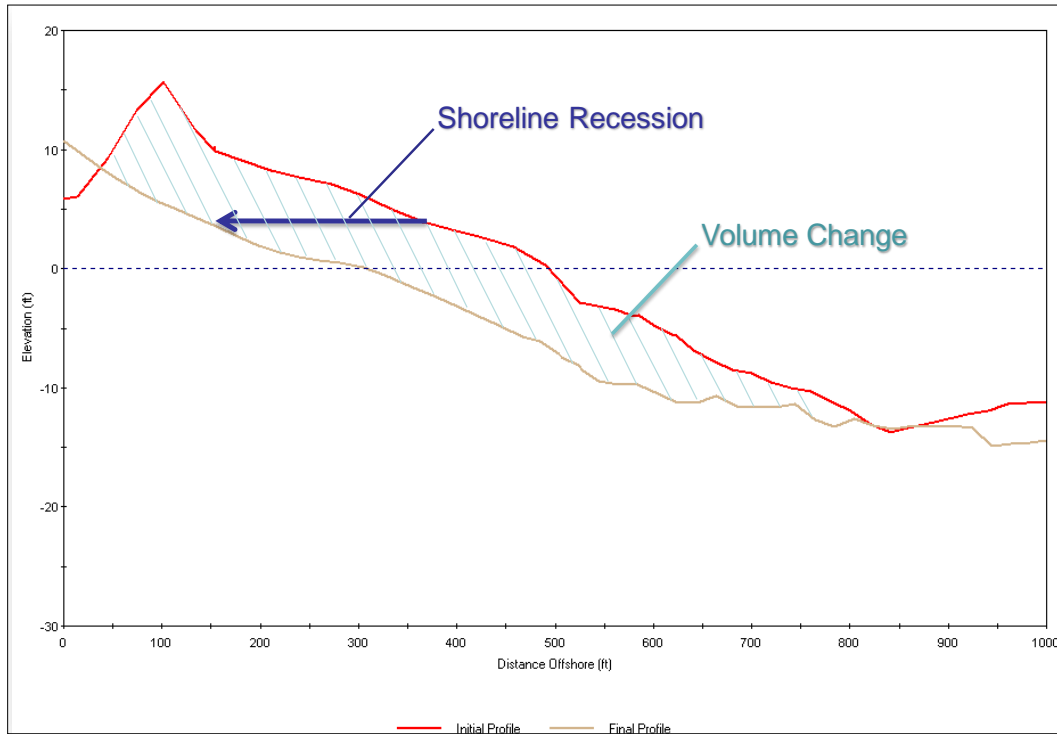
**Figure II-3. Shoreline to Beach Volume Change Relationship**

those profiles not surveyed near the time of storm or nourishment events. Profiles were taken out to near visual depth of closure where appropriate but were shortened in many instances to remove slight hydrographic errors along the seafloor which can result in large apparent changes if the profiles are extended to their fullest extents offshore.

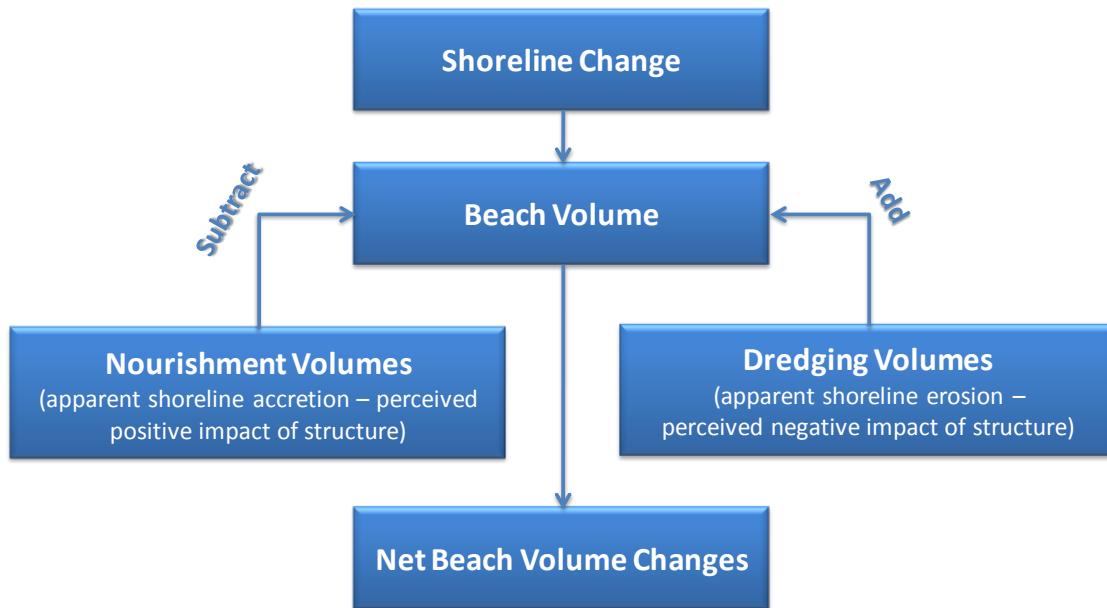
**Figure II-4. Analysis Procedure**

Interpreting the impact of the terminal groin requires understanding the influence of placing sand on the beach (nourishment) and potentially removing sand from the system (dredging) on the observed shoreline change (see Figure II-4). Beach nourishment contributes to volume gains that are not attributable to the presence of the terminal groin. Another human activity that can have large effects on inlet and neighboring beach behavior is dredging of a channel through the inlet for navigation purposes. The channel typically cuts through the bar formations at the inlet and alters the flow and sediment transport patterns. Thus, dredging of sand from near the inlet removes sand from the beach system and results in beach volume loss that is not attributable to the presence of the terminal groin.

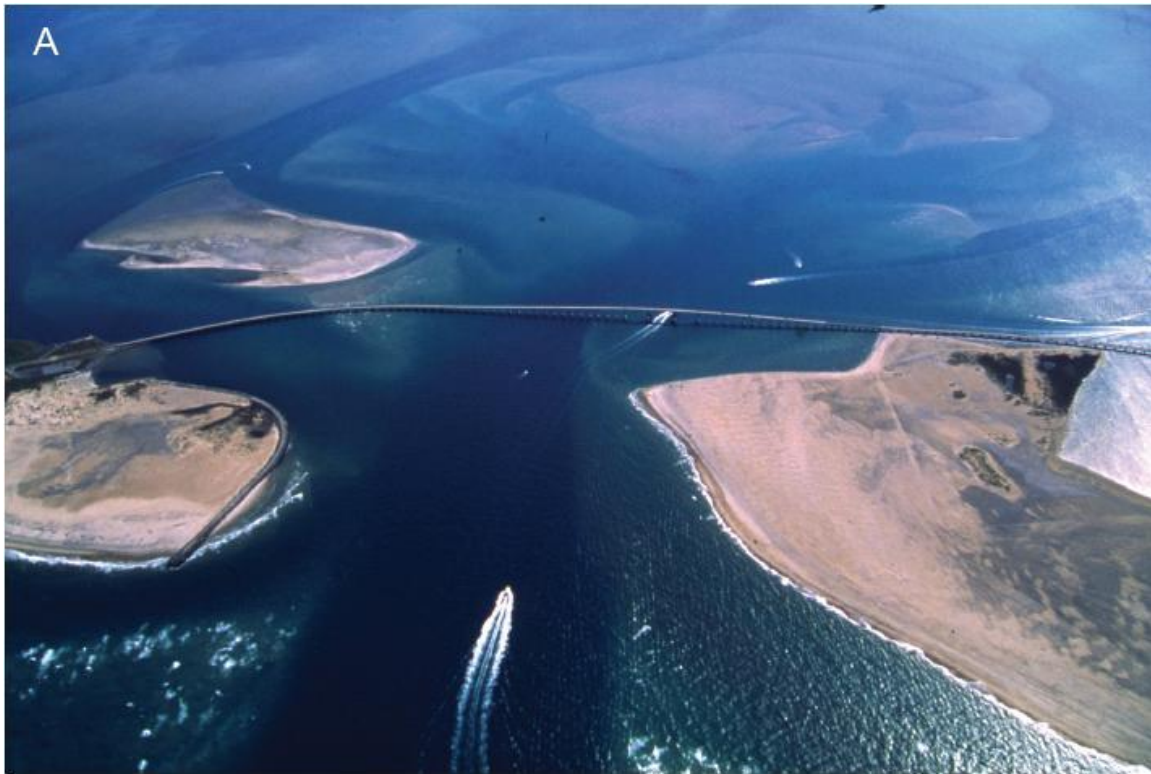
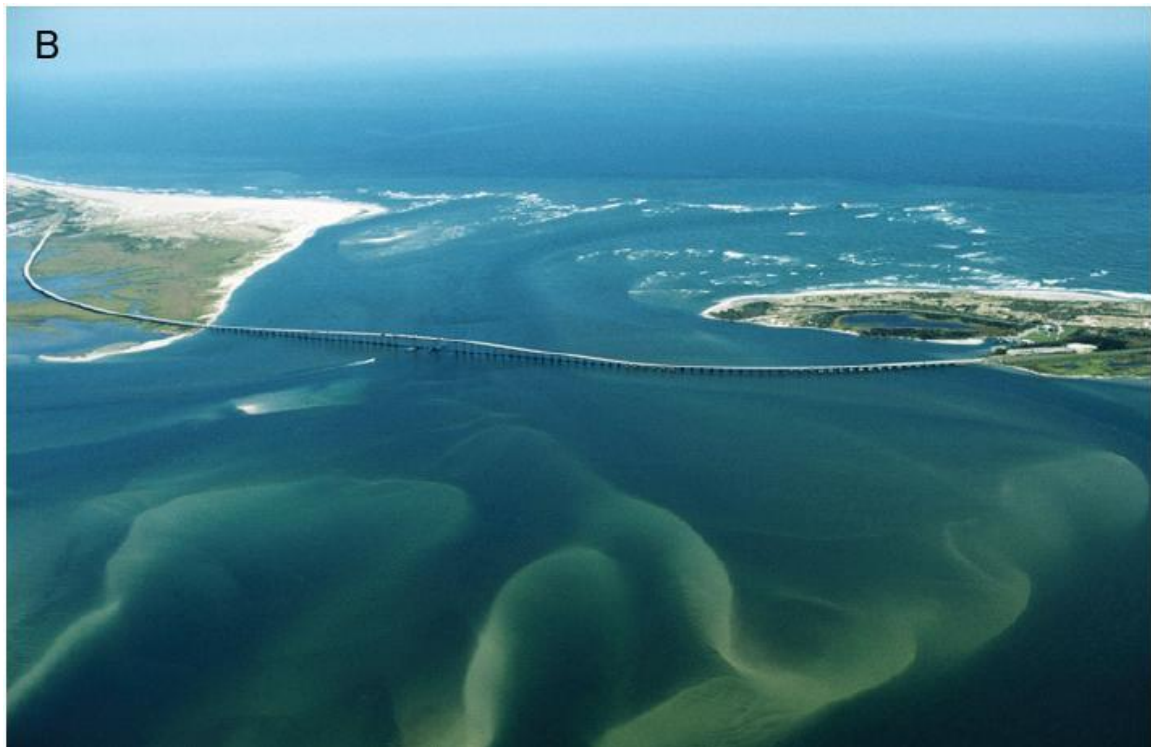
Figure II-5. Aerial Photographs of Oregon Inlet A. Looking Landward (Photograph from Ramanda, Nags Head) and B. Seaward (Photograph by D.A. Harvey)

A 2.4 mile long bridge (Bonner Bridge) connecting Bodie Island to Pea Island was completed in 1963. By the 1980's the southerly migration of Oregon Inlet resulted in a deepening of tidal channels beneath the bridge, which exposed support pilings costing millions of dollars in bridge repairs. Eventually erosion of downdrift Pea Island threatened to separate the end of the bridge from the island, so to prevent this foreseeable disaster, a 3,125-foot long rubble-mound revetment and terminal groin were constructed at the northern end of Pea Island. The revetment wrapped around to the backside of the island and terminated at the Coast Guard facility. The groin projected slightly northward into the inlet and extended seaward to a position parallel to the northern end of Pea Island. The terminal groin was constructed to protect the southern end of the bridge and prevent further southerly migration of the tidal inlet.

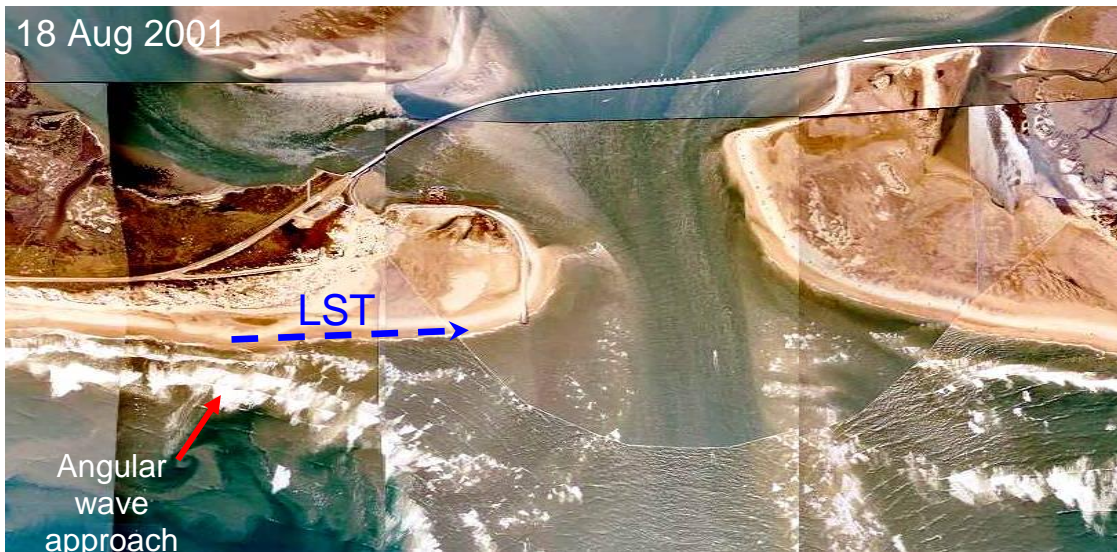
**Figure II-12. 2001 Aerial Photograph of Oregon Inlet Showing Wave Refraction Around Ebb Delta Producing Northerly Transport Along Pea Island Feed Sand to the Fillet Region. Note the sand that has moved past the groin and constructed a beach along the inlet shore**

This same morphology is observed in a 2001 photograph of the region (Figure II-12). This photograph demonstrates that after the beach accretes to the end of the groin, additional longshore transport of sand toward the inlet moves around the groin (as well as over and through the groin during elevated tides and high wave energy events) and is deposited along the inlet shoreline. It should also be noted that sand is also sequestered at the northern end of Pea Island as a consequence of storm overwash into the fillet region. Beach sand blown into the back dunal area also adds to the sand reservoir in this region.

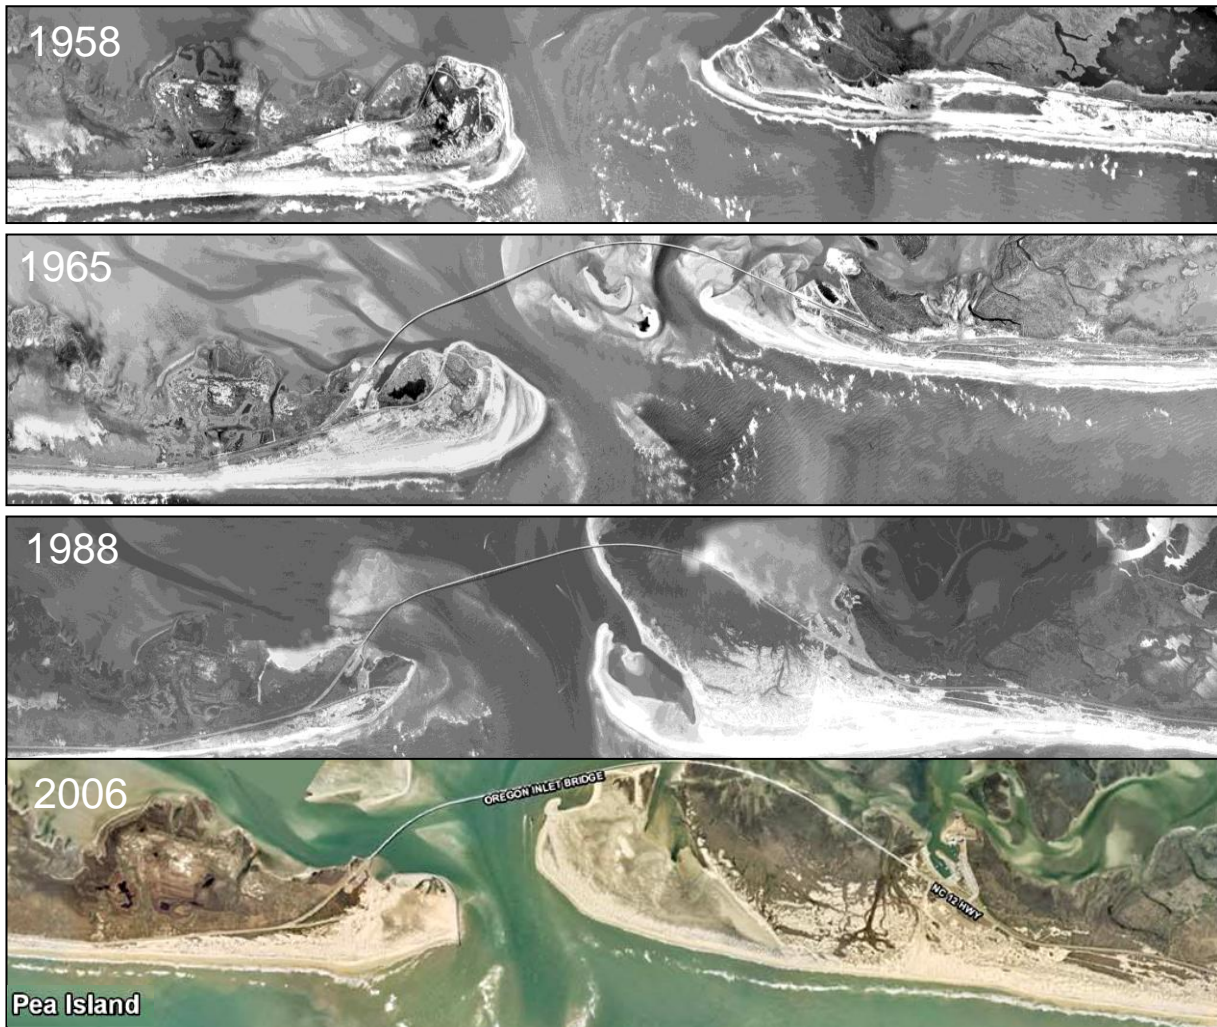
**Figure II-13. Sequential Photographs of Oregon Inlet Depicting the Shoreline Changes Associated with Spit Accretion at Bodie Island and Southerly Migration of Oregon Inlet (Cleary, 2009)**

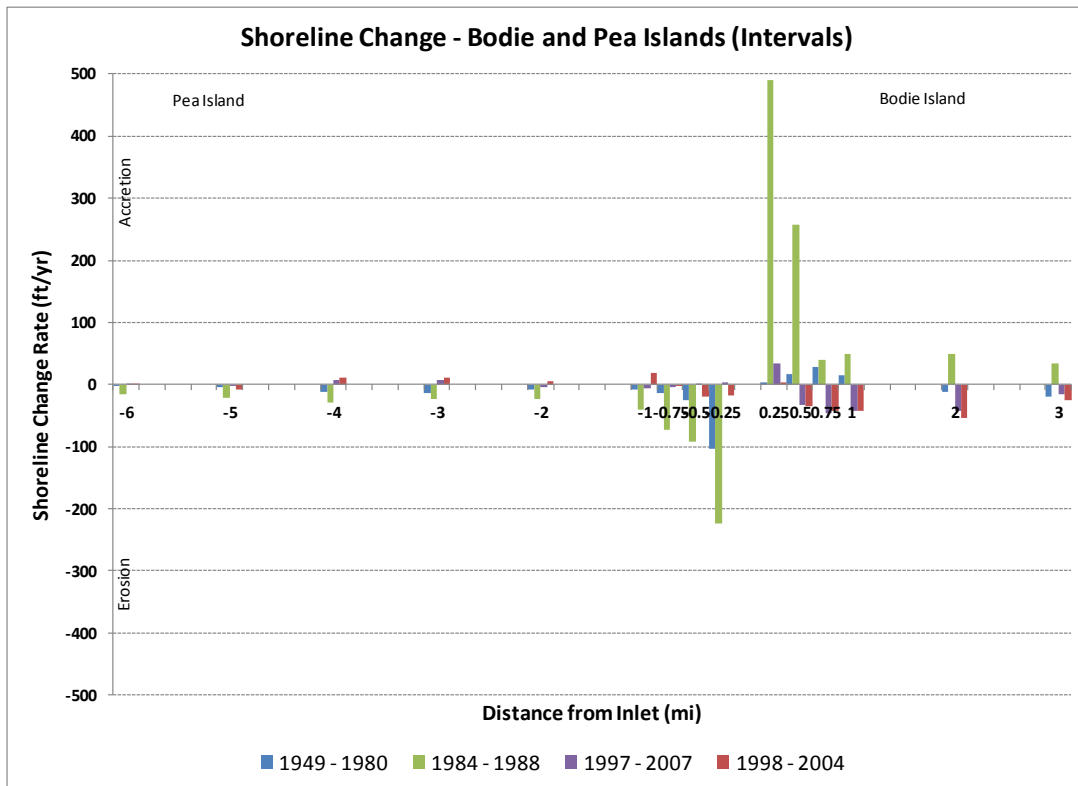
Red values represent shoreline recession (erosion) and black values represent shoreline advancement (accretion)

Figure II-17. Shoreline Change – Bodie and Pea Islands (Intervals)

Prior to terminal groin construction, the Pea Island shoreline was eroding fairly rapidly during both calculation time periods with the 1984-1988 period (when intensive hopper dredging and offshore disposal occurred) being more than double the rate from 1949-1980. After the construction of the terminal groin, the south shoreline was still eroding but at a much lower rate, and even accreting at some locations (intervals). It must be noted, though, that these shorelines include the effects of beach nourishment and dredging activities.

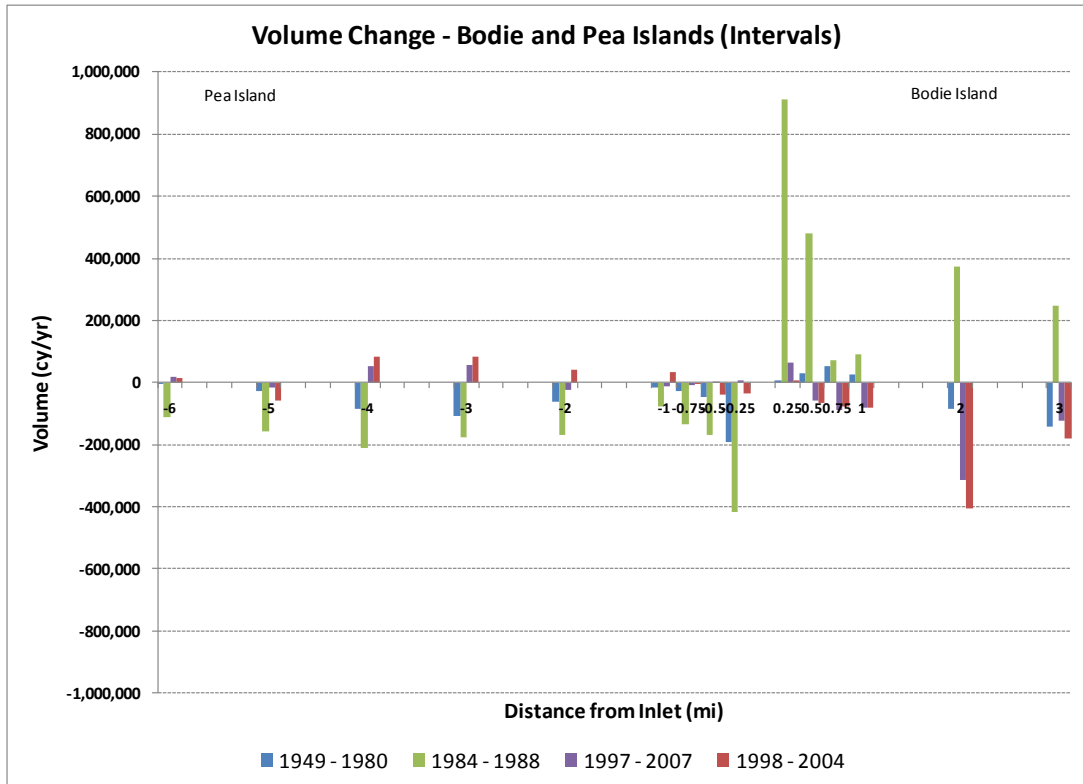
\*Beach volume losses are given in red and beach volume gains in black.

Figure II-19. Beach Volume Changes – Bodie and Pea Islands (Intervals)

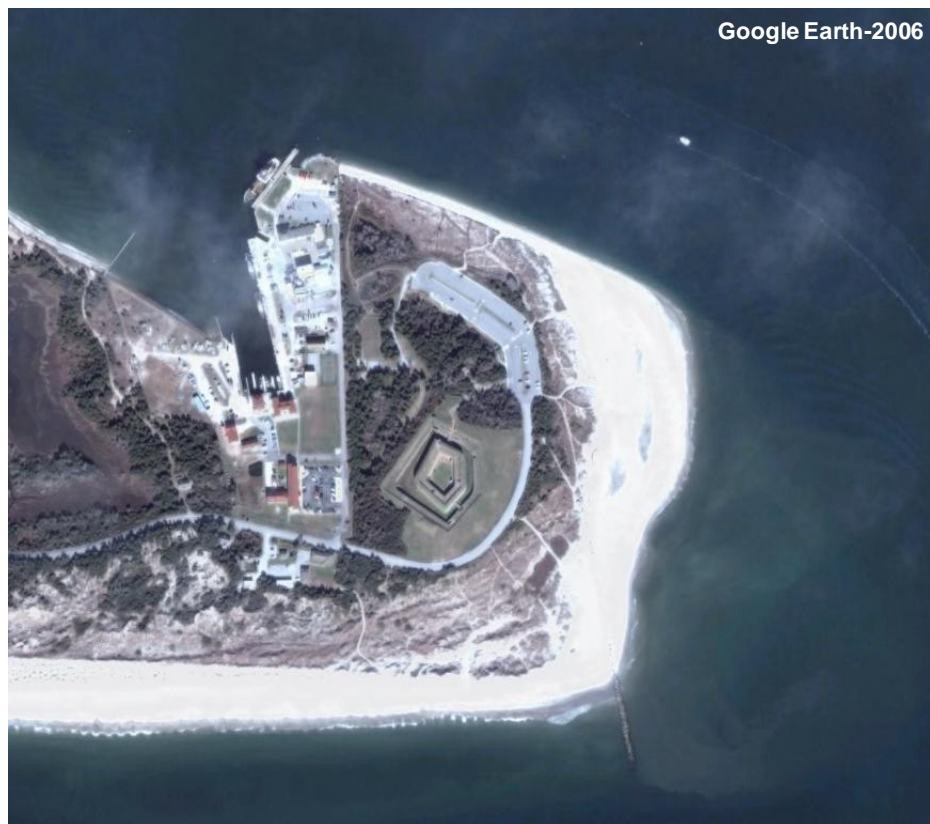
**Figure II-23. Fort Macon Terminal Groin**

The Fort Macon terminal groin (Figure II-23) is located on Bogue Banks on the western side of Beaufort Inlet. Shackleford Banks, an undeveloped barrier island lies to the east of the inlet. Beaufort Inlet, located approximately 9 miles west of Cape Lookout, serves as the connection between the Atlantic Ocean and Morehead City Harbor, North Carolina's second major port. The inlet is utilized by commercial and recreational vessels and is one of two inlets in southeastern North Carolina which have been modified for deep draft commercial traffic.

The terminal groin at Fort Macon was built to protect and preserve the fort from erosion. Fort Macon itself has a long history of being at risk from the Atlantic and shifting of Beaufort Inlet. Fort Macon was built between 1826 and 1834 to defend the inlet and harbor from seaborne attackers. By the very nature of its purpose, the fort was built close to the shoreline on a barrier island adjacent to a major inlet in an area prone to the natural forces that reshape shorelines (Paul Branch, <http://www.clis.com/friends/default.htm>). As early as 1831 wood pilings were laid at right angles to the beach to stop erosion near the fort and in 1840 Captain Robert E. Lee was sent to study the erosion problem at Fort

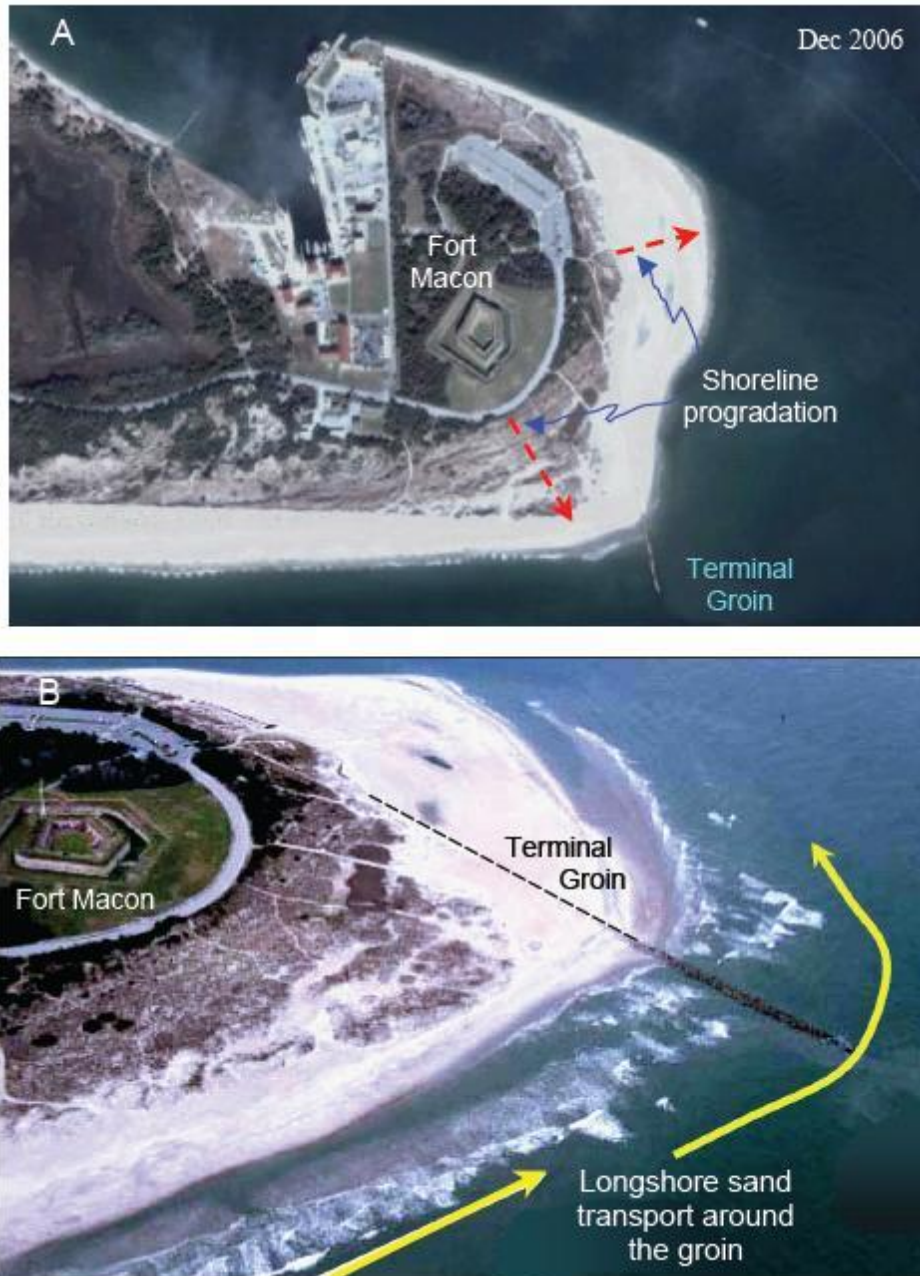
Figure II-27. Photographs Illustrating Progradation of the Beach West of the Groin and Along Inlet Shore.  
Dashed line indicates extent of groin beneath the beach

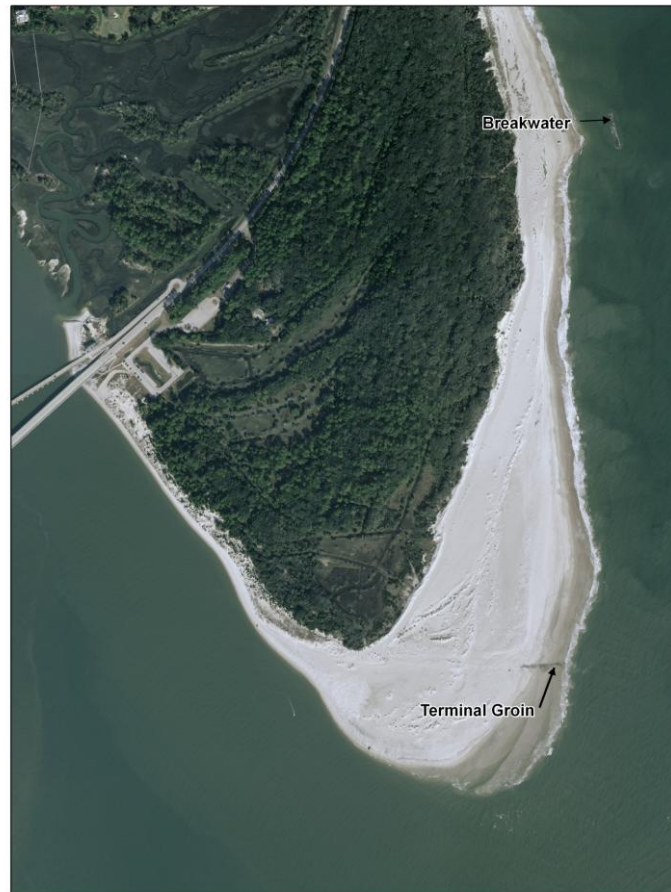
**Figure II-41. Amelia Island Terminal Groin and Breakwater**

The Amelia Island terminal groin (Figure II-40) is located at the south end of the Amelia Island (Nassau County). Two “leaky” rock structures were constructed, a 1,500-foot-long terminal groin and a 300-foot-long detached breakwater, as shown in Figure II-41. The structures were constructed to stabilize the shoreline in this area in order to protect the nearby maritime forest and ecosystem. These partially permeable and low structures were designed to reduce the alongshore transport rate of sand without adversely affecting various land forms in nearby Nassau Sound. The groin and breakwater were built leaky enough to permit some sand to continue to pass into the sound and along the downdrift shoreline.

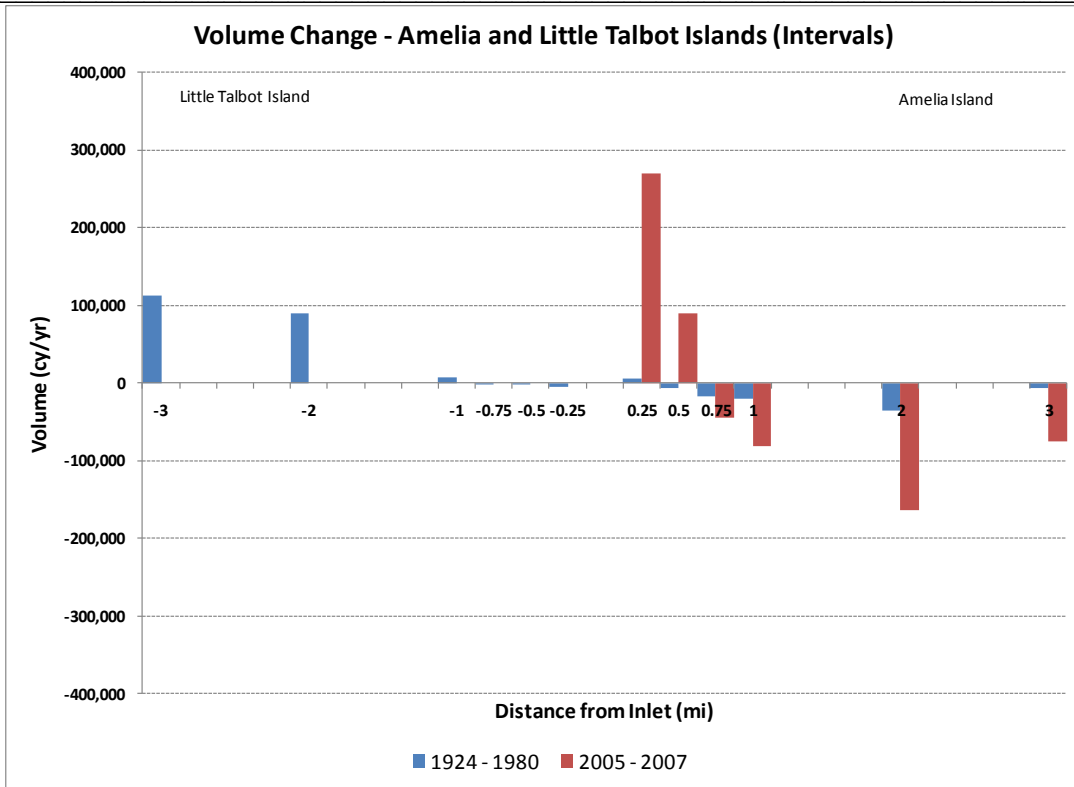
\*Beach volume losses are given in red and beach volume gains in black.

Figure II-49. Beach Volume Changes – Amelia and Little Talbot Islands (Intervals)

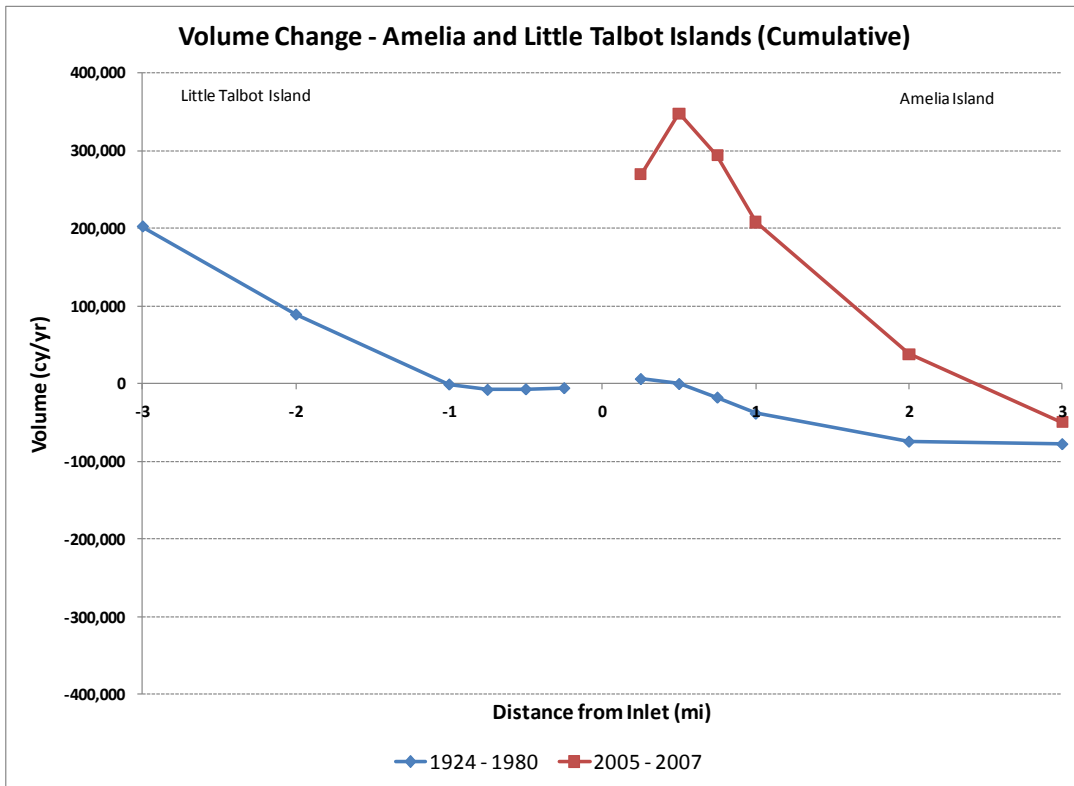
Figure II-50. Beach Volume Changes – Amelia and Little Talbot Island (Cumulative)

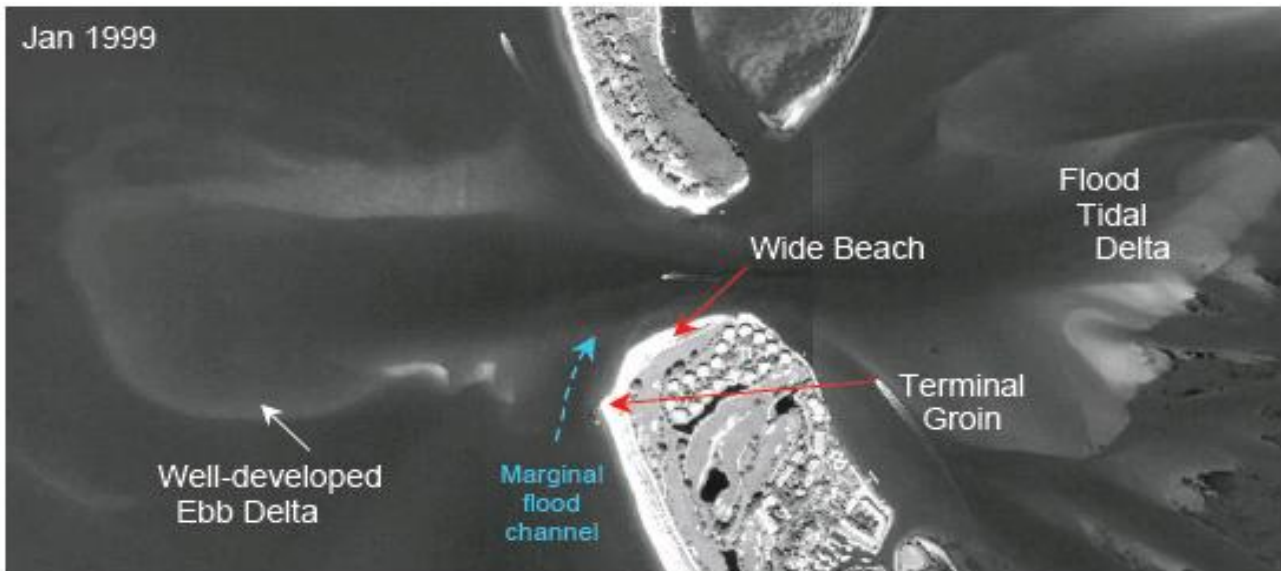
Figure II-55. View of the Ebb-tidal Delta That Has Been Used as a Source of Sand for Nourishing the Beach Along Captiva Island (from Google Earth)

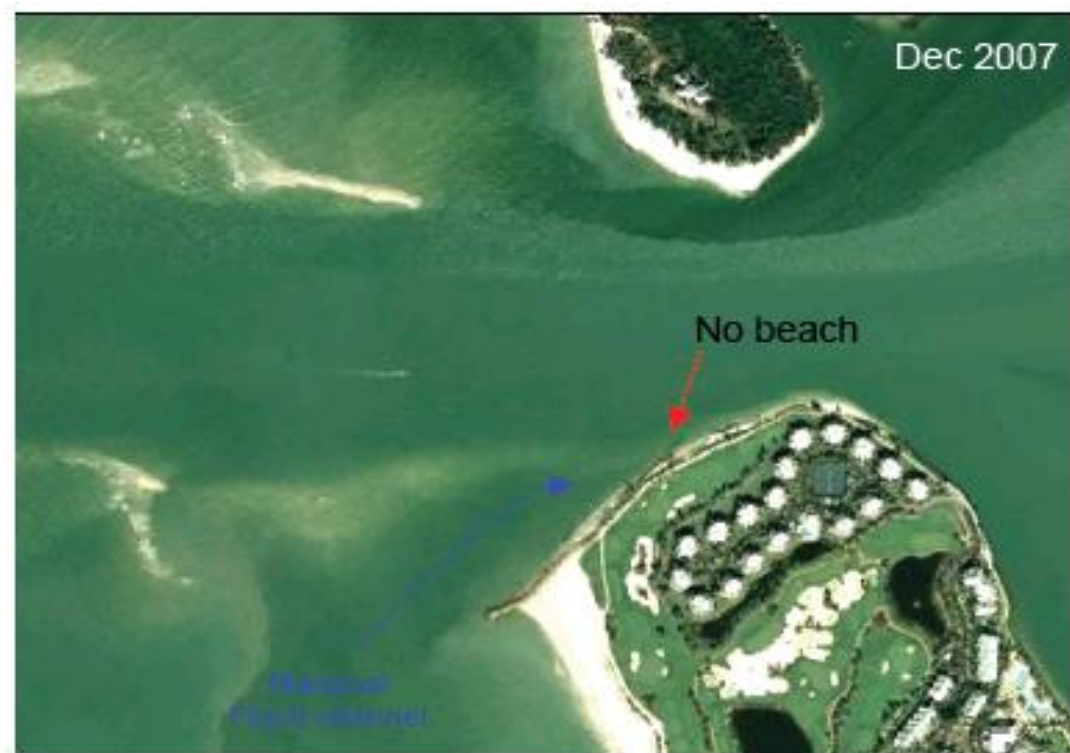
Figure II-56. View of the Terminal Groin at Redfish pass (from Google Earth)

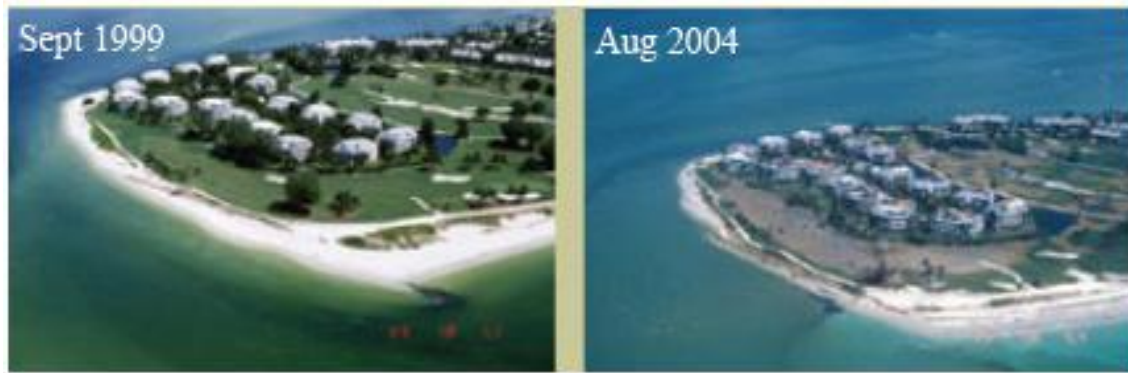
**Figure II-59. Comparison of Photographs Taken Before and Immediately After the Passage of Hurricane Charley Showing Beach Erosion Inside the Inlet**

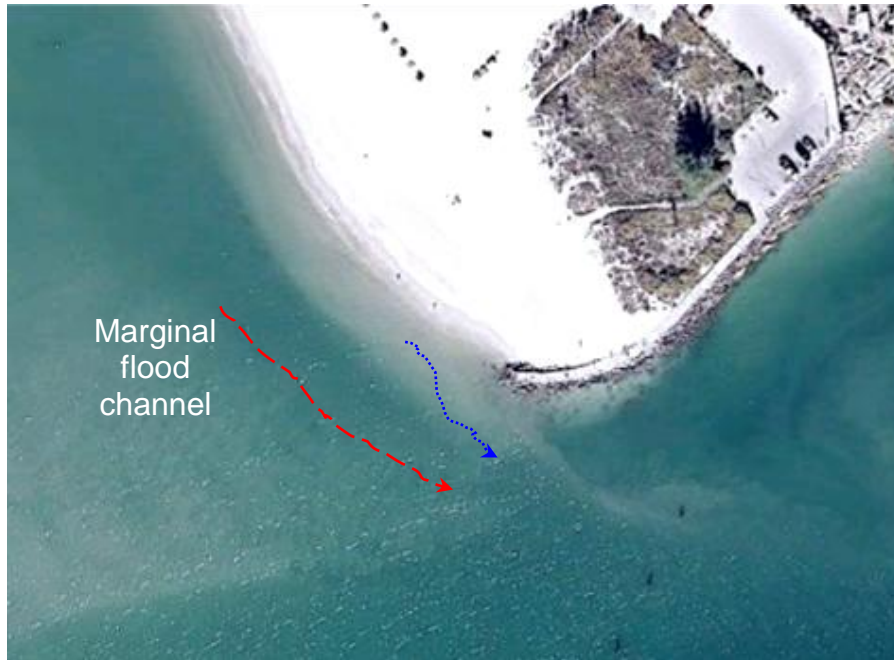
**Figure II-71. Vertical Aerial Photograph of the Terminal Groin at the North Side of John's Pass**

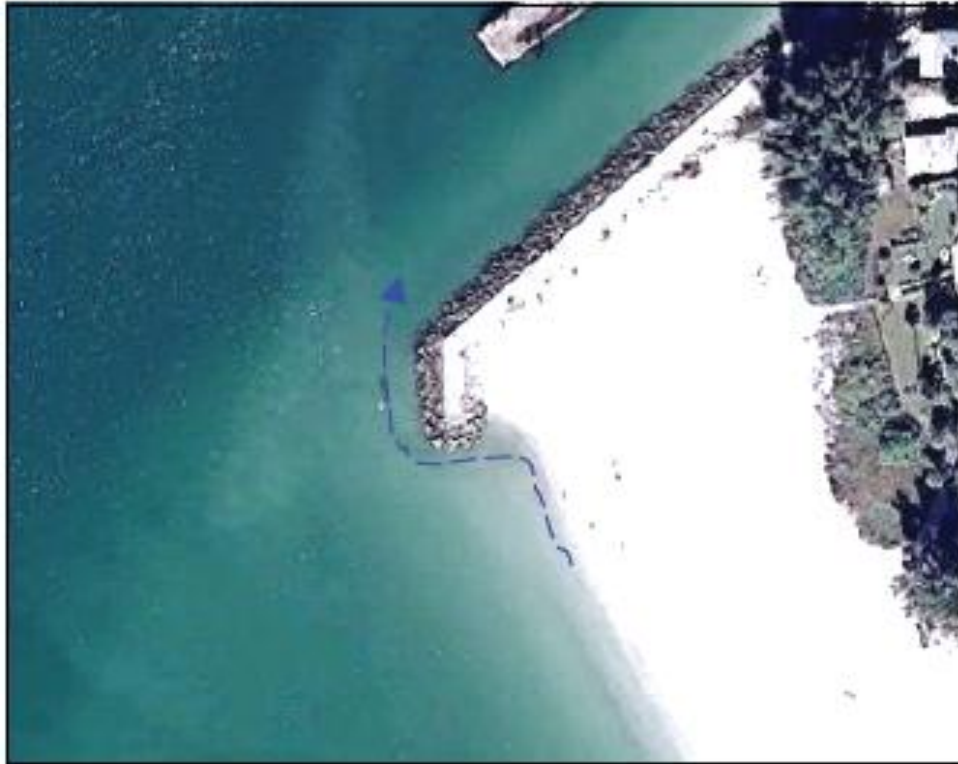
**Figure II-72. Vertical Aerial Photograph of the Terminal Groin at the South Side of John's Pass at the Northern End of Treasure Island (from Google Earth)**

On the opposite side of the inlet, a wide beach flanks the terminal groin, although edge effects are present at the end of the structure (Figure II-72). This type of scalloped shoreline is common around stone structures at the mouth of tidal inlets and estuaries and is a product of wave refraction processes. The shallow nature of the nearshore at the end of the groin and extending into the inlet channel is an indication that sand is entering the waterway (blue arrow in Figure II-72).

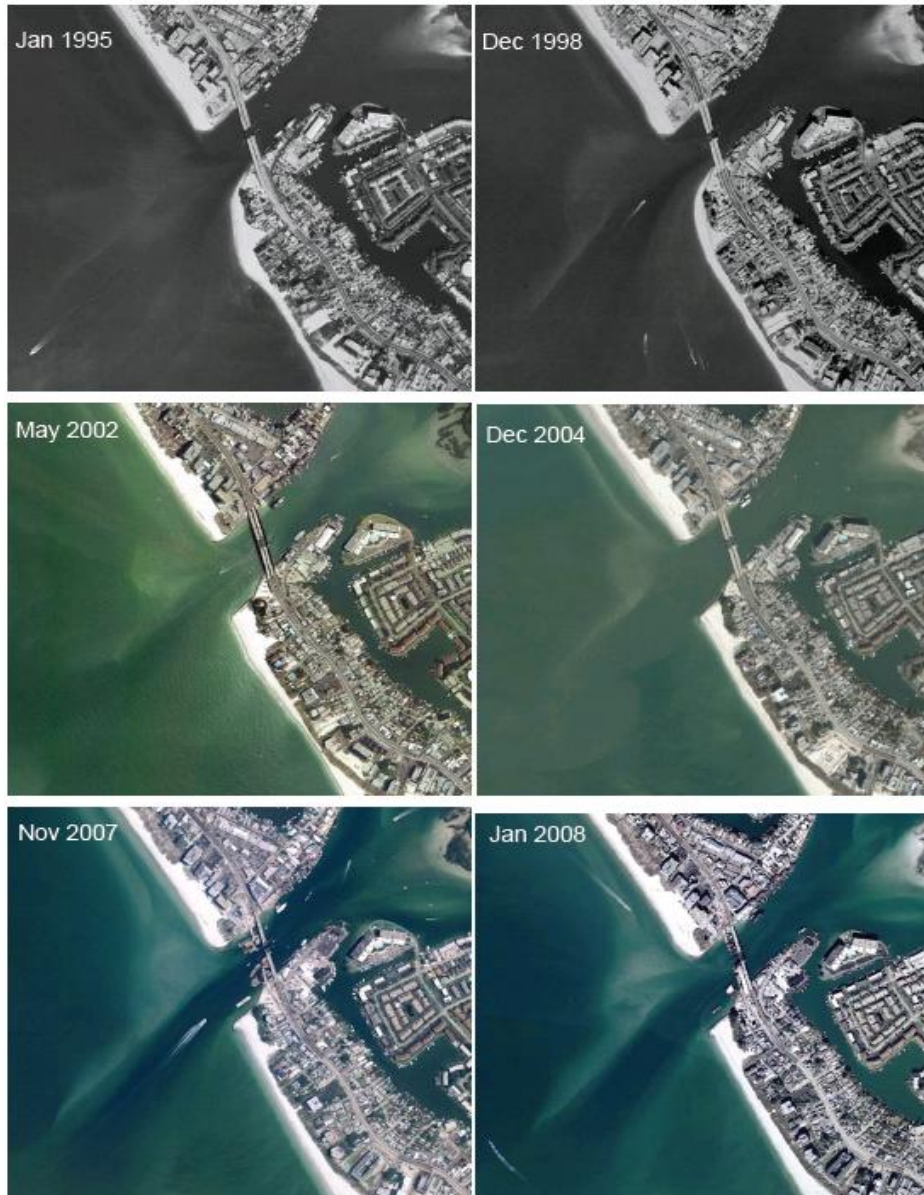
Figure II-73. Sequential Vertical Aerial Photographs of John's Inlet between 1995 and 2008 (from Google Earth)

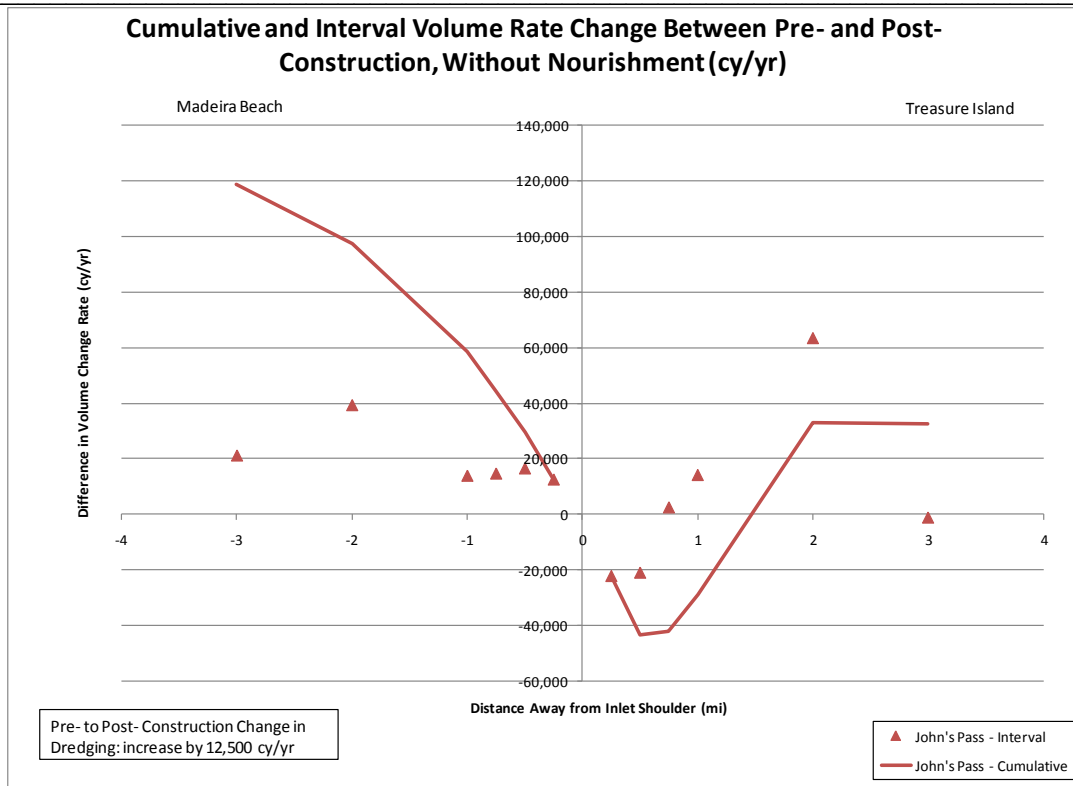
**Figure II-86. Volume Changes Without Nourishment – John’s Pass**
