VI. Initial Construction and Maintenance Costs

B. Development of Terminal Groin Unit Costs

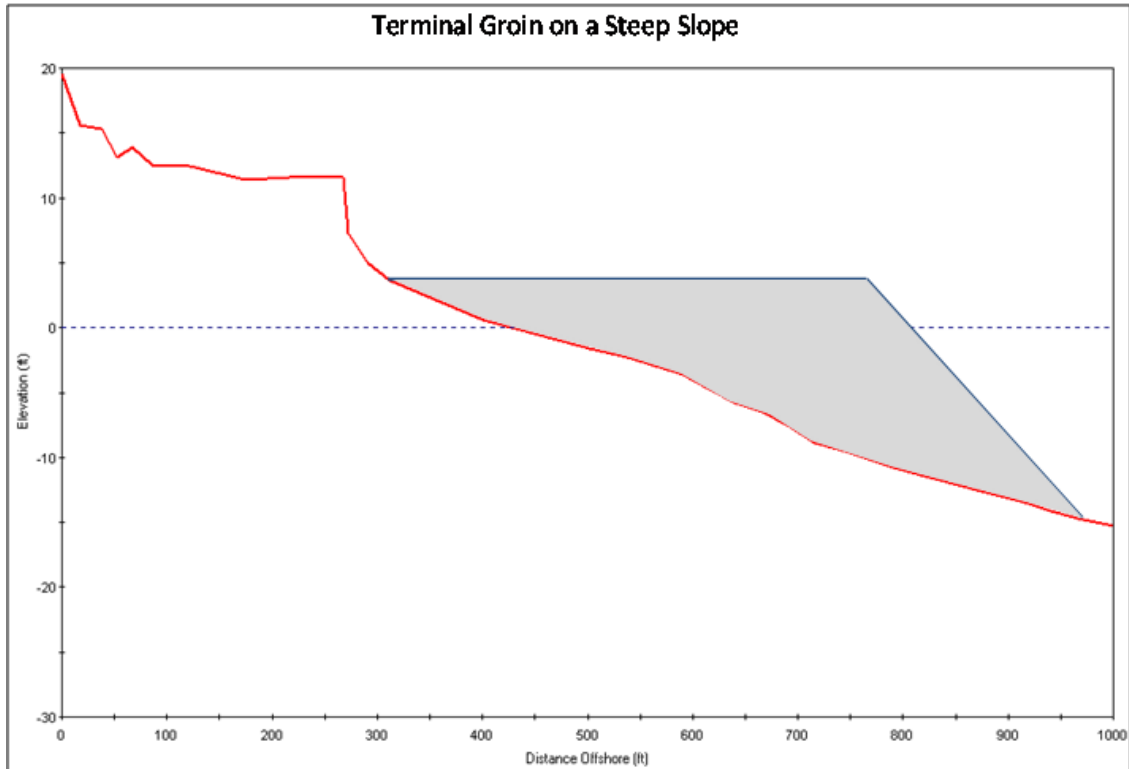
Figure VI-1. Terminal Groin Length along a Steep Slope

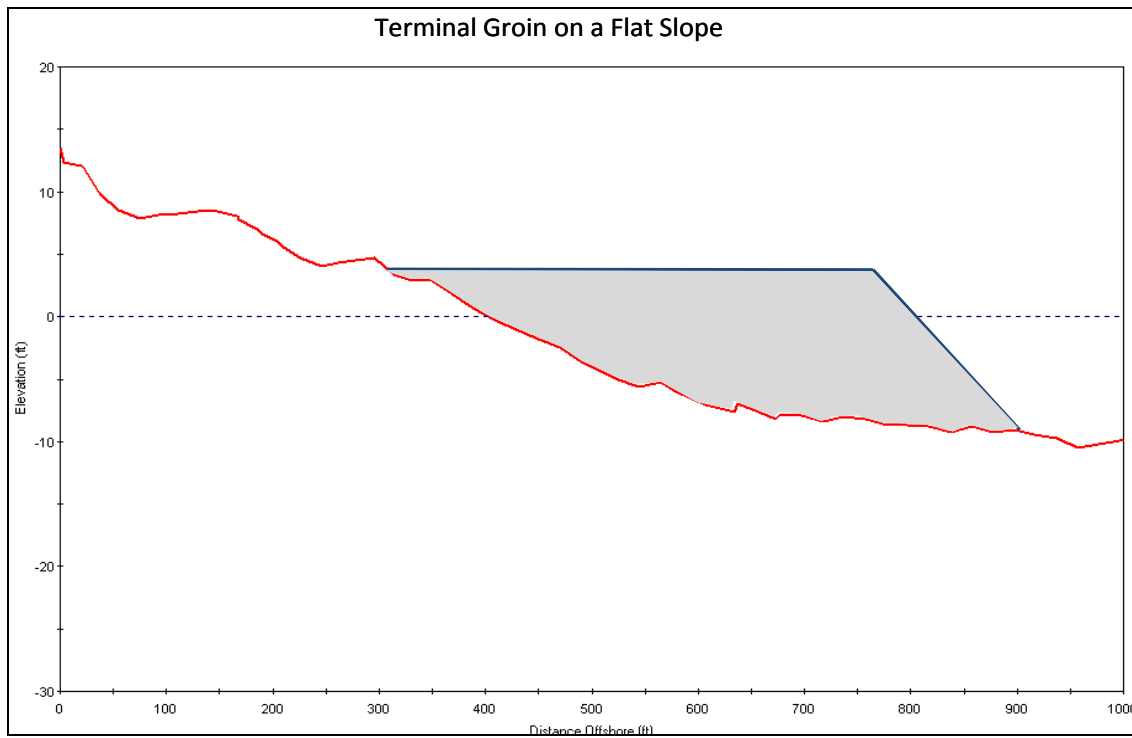
Figure VI-2. Terminal Groin Length along a Flat Slope

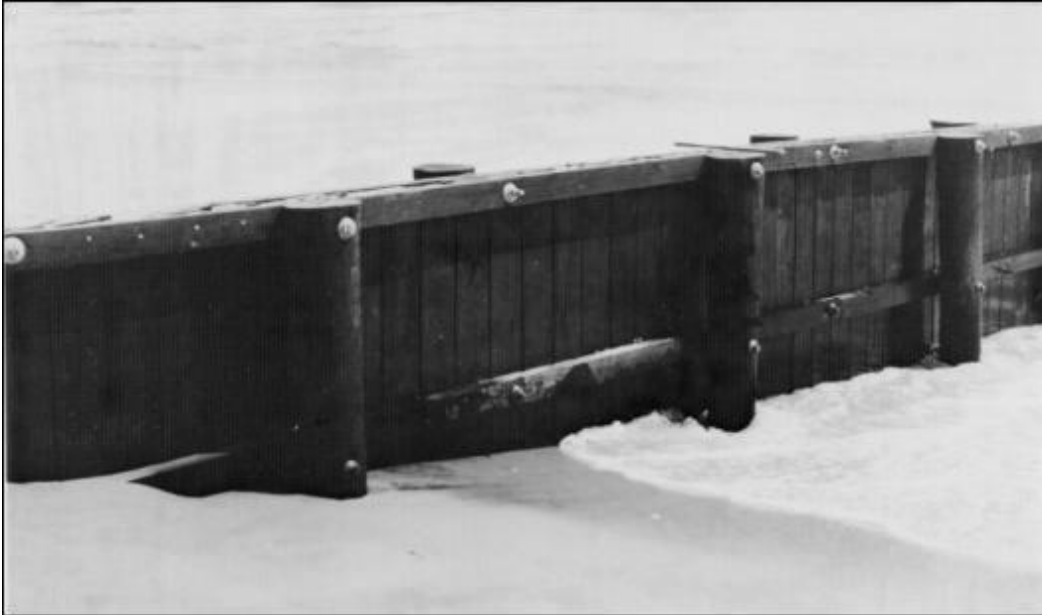
Timber is another viable option for construction material. Generally, timber groins have pilings in single or multiple rows. Timber groins can also have planks between the pilings which may be adjusted depending on the required height for the groin. However, timber cannot withstand the same loads that rock, steel, or concrete groins can; therefore it should not be used for longer groins in deeper water. Typically, a timber groin would only be considered for water depths less than 6-8 feet. A timber pile groin's cost could range from approximately \$3,000 to \$4,000 per linear foot. Figure VI-6 illustrates an example of a timber groin with planks and pilings (taken from the Federal Highway Administration website).

Figure VI-6. Example of a Timber Groin

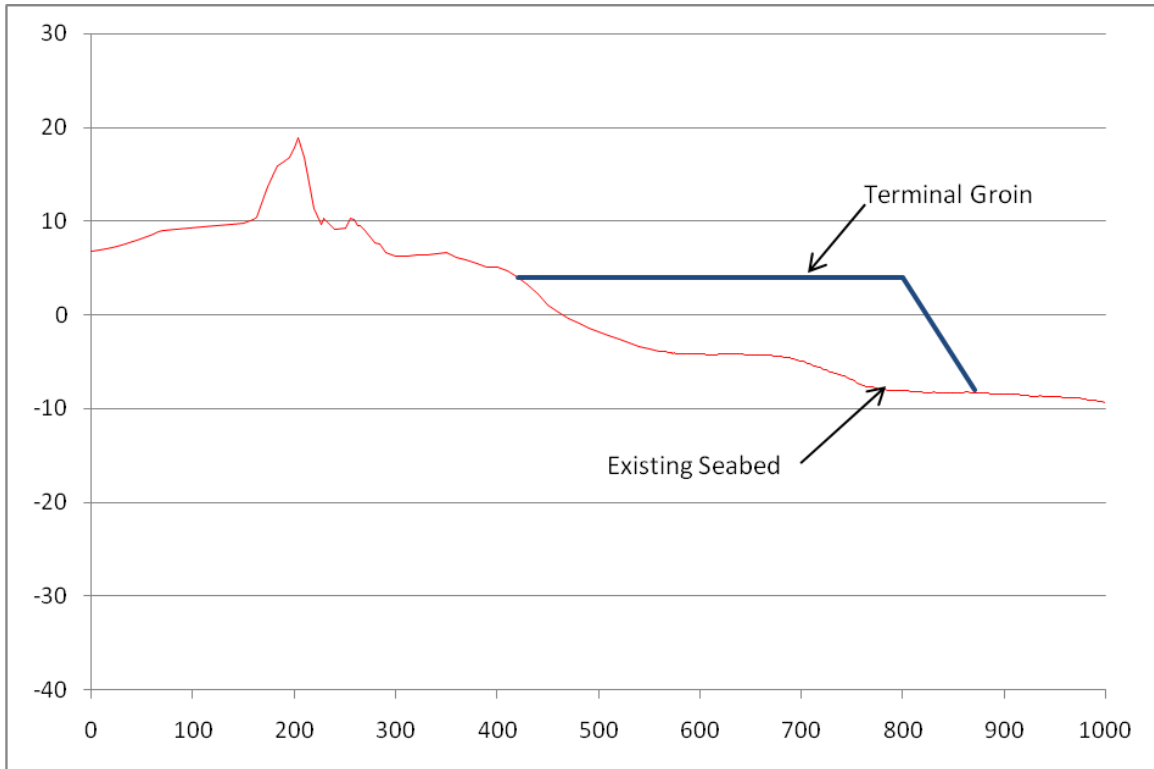
Figure VI-12. Short Groin along a Flat-Sloped Beach

Figure VI-12 and Figure VI-13 show some typical beach slopes for this scenario. **Error! Reference source not found.** shows the ranges of anticipated unit and total costs for the above scenarios. Based on these scenarios, a typical short rock terminal groin initial construction cost may range from \$550,000 - \$1 million, while a short timber, steel or concrete groin initial construction cost may range from \$1.8 – 2.2 million. A short geotextile groin may cost less than \$300,000, but please note that these types of structures would have limited applicability given their likelihood of failure in deeper water and active swash zones.

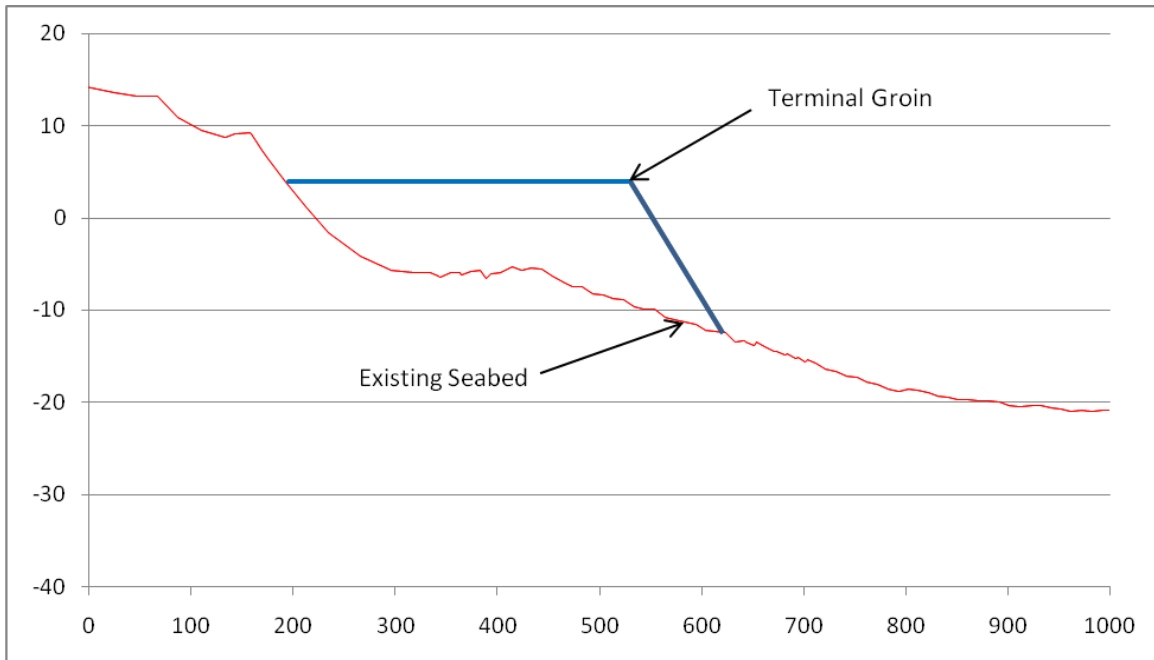
Figure VI-13. Short Groin along a Step-Sloped Beach

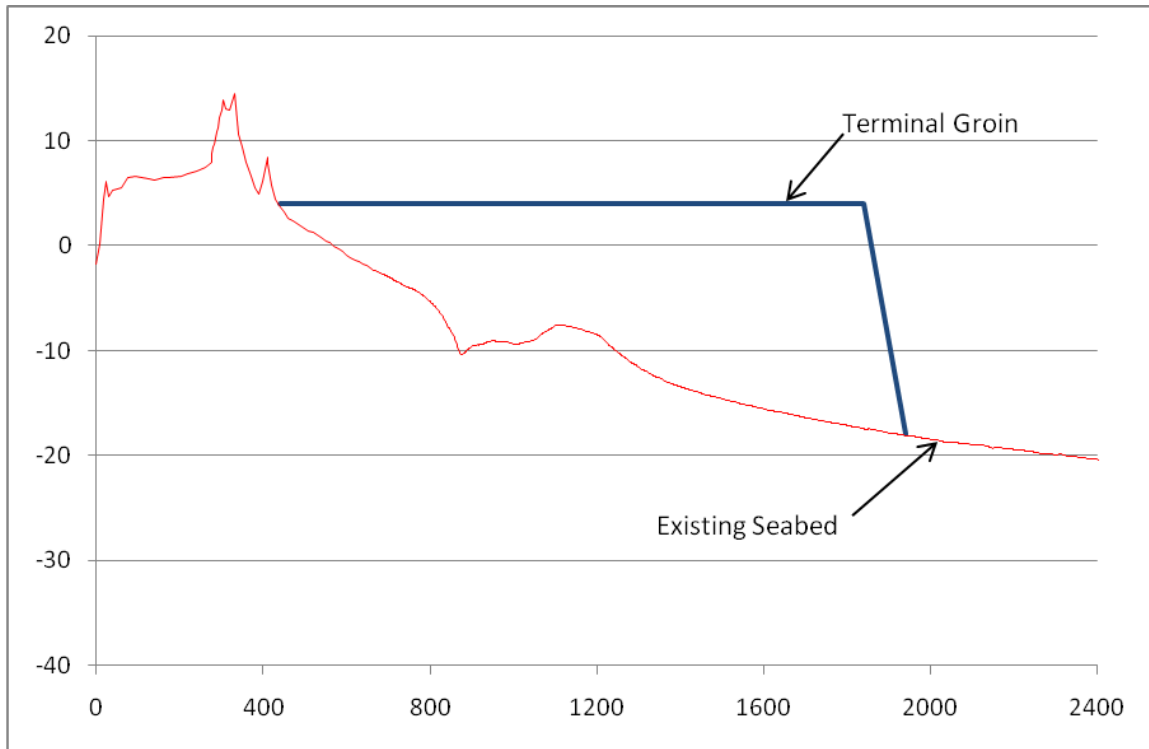
Figure VI-15. Long Groin Cross Section on a Flat-Sloped Beach

The second scenario analyzed a longer groin (1,500 feet) placed on typical North Carolina slopes. The crest elevation remained set at 4 feet (MLW); however the width was widened to 30 feet due to the increased exposure to wave energy. The average groin height ranges from 12 to 19 feet; and the side slopes are set to 2:1. Figure VI-14 illustrates the typical cross-section for the long groin scenario. Figure VI-15 and Figure VI-16 show examples of this groin along various North Carolina beaches.

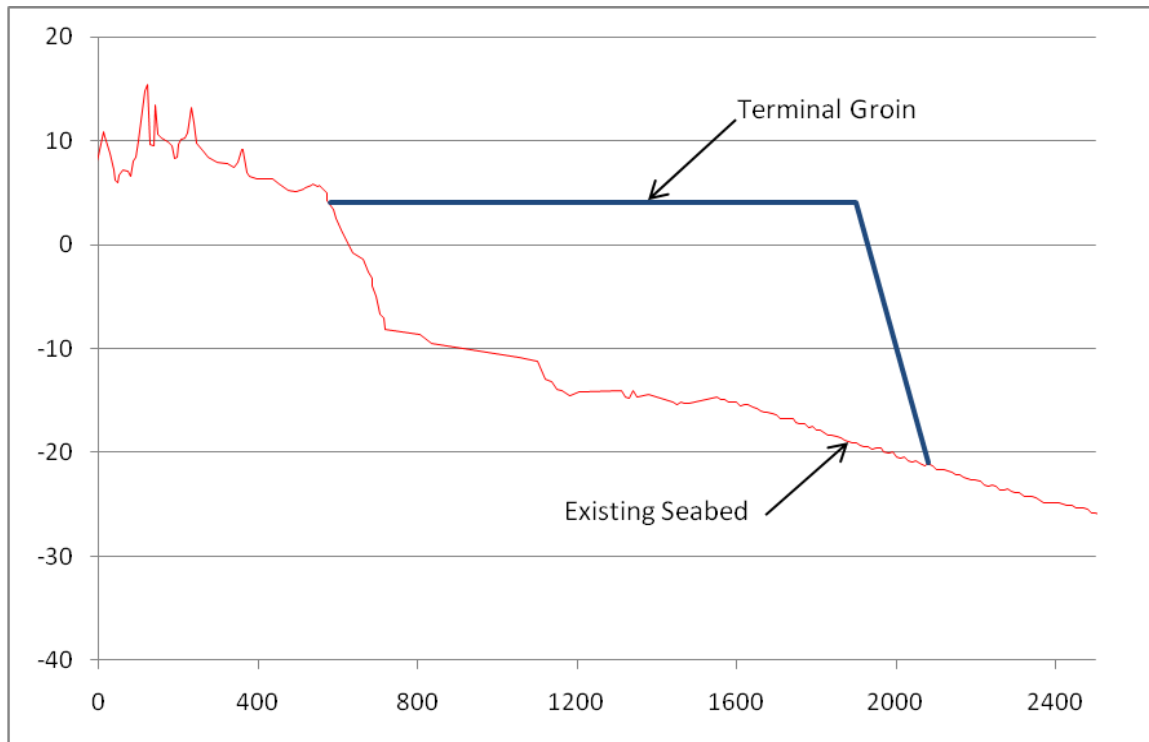
Figure VI-16. Long Groin Cross Section on a Steep-Sloped Beach
