**NC Terminal Groin Study:
Feasibility and Advisability
of the Use of a Terminal Groin
as an Erosion Control Device**

**UPDATE AND DISCUSSION
Science Panel Meeting
January 19, 2010**

**MOFFATT & NICHOL**

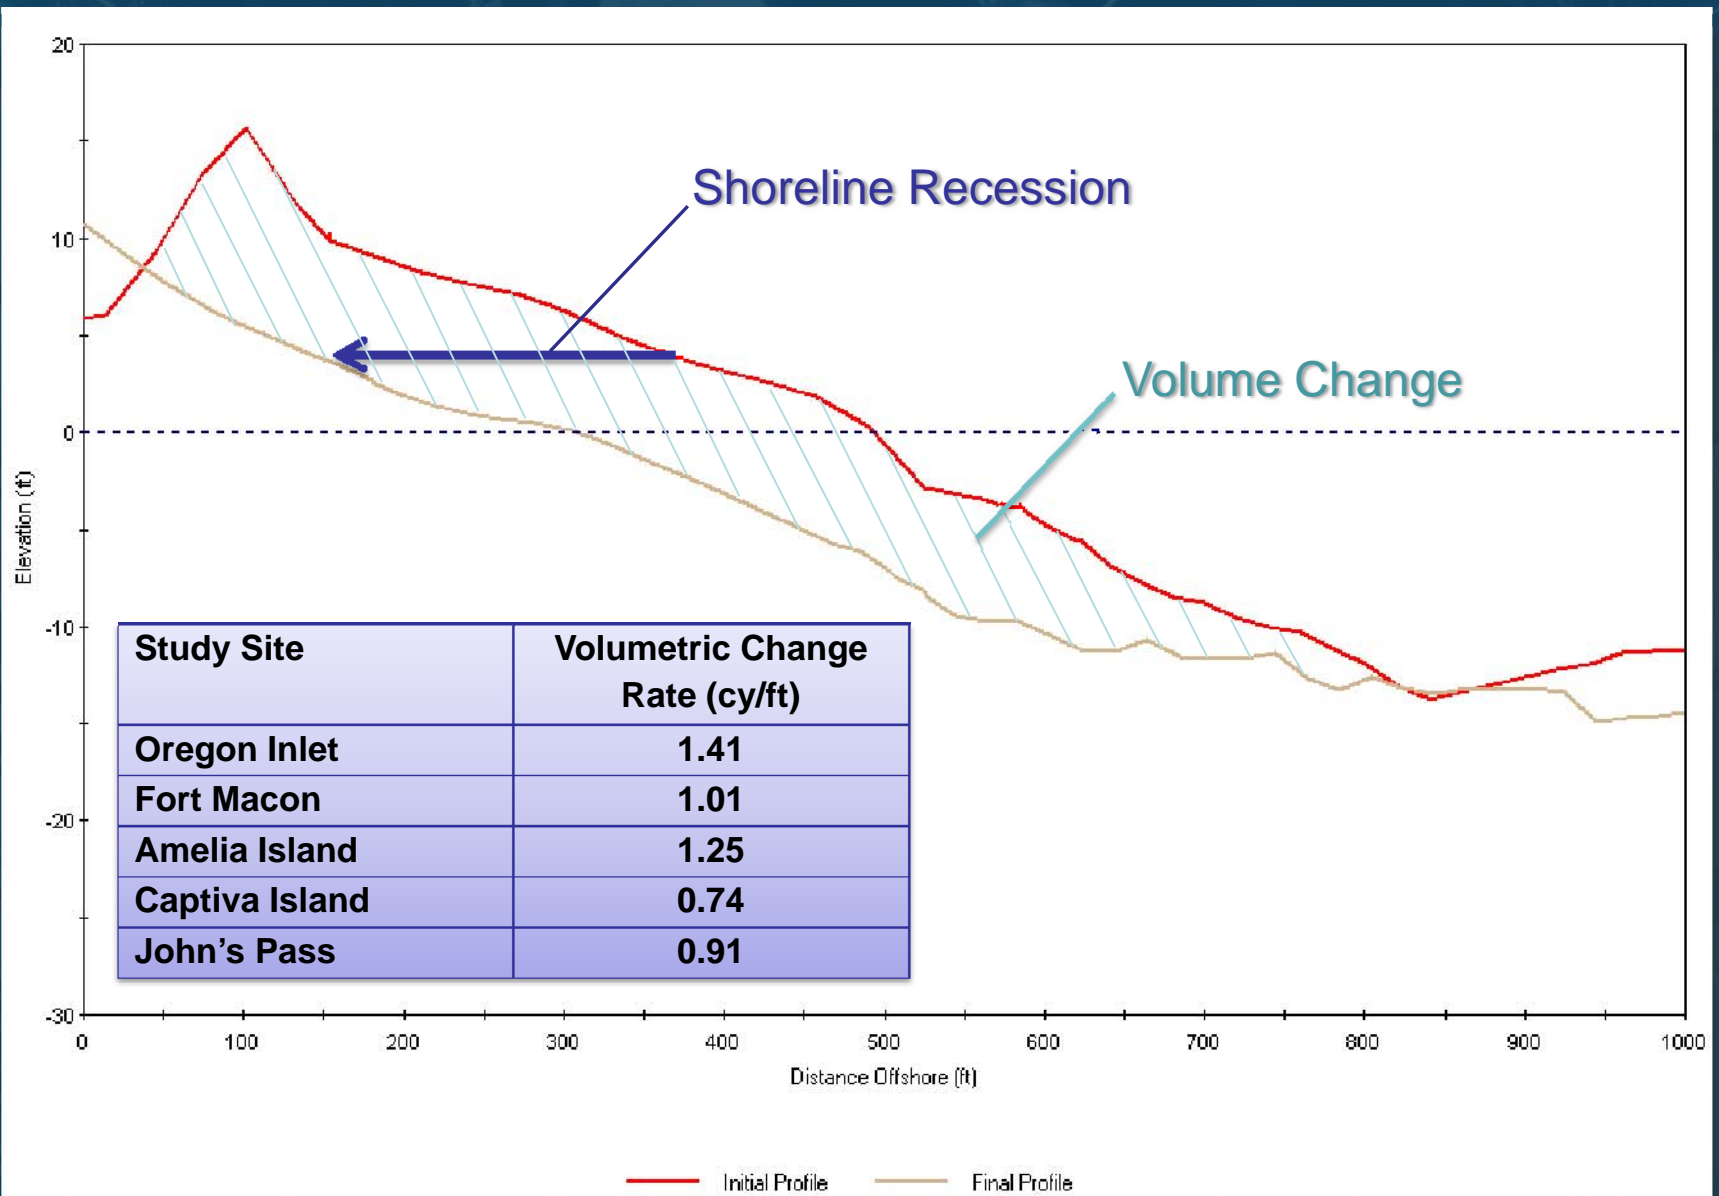
Shoreline Recession and Volume Change

- Examine survey profiles in the vicinity of the five study sites to establish a typical shoreline change (MHW) to beach volume relationship
- Calculate beach volume changes (total, pre- and post-project where possible)
- Compiled dredging, beach nourishment and beach placement data

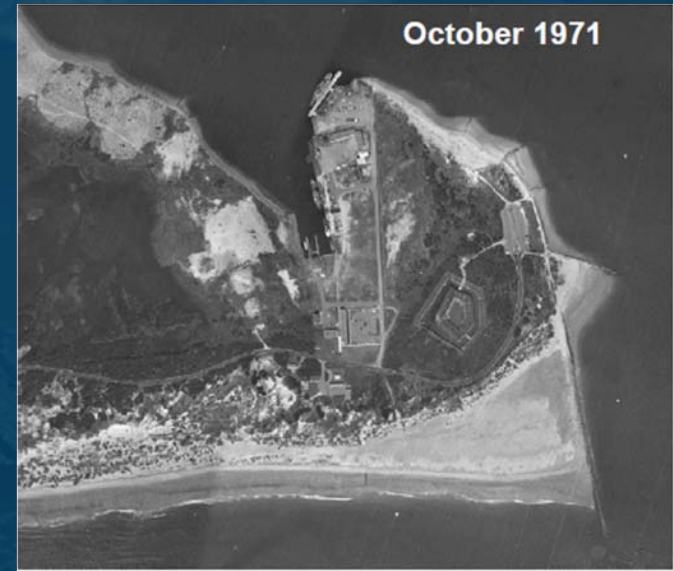
1D – Terminal Groin Structure Characteristics

Length = 1,530 ft
Base Width = 58-66 ft
Crest = 6 ft MLW
(10 ft wide)
Armor = 7.5 – 12.5 ton

Study Site	Structure Plans	Dimensions
Oregon Inlet	NCDOT (undated)	3,125 ft (Crest varies 8-9.5 ft MSL)
Fort Macon	Henry Von Oesen & Associates (5/65 and 10/68)	1,530 ft (Crest at 6 ft MLW)
Amelia Island	Olsen Associates Inc. (10/02)	1,500 ft (5.2 ft NGVD29)
Captiva Island	Some information in reports and articles - no drawings	350 ft
John's Pass	Pinellas County Permit Drawings (10/84 and 4/85)	North – 460 ft (6.7 ft MLW) South – 400 ft

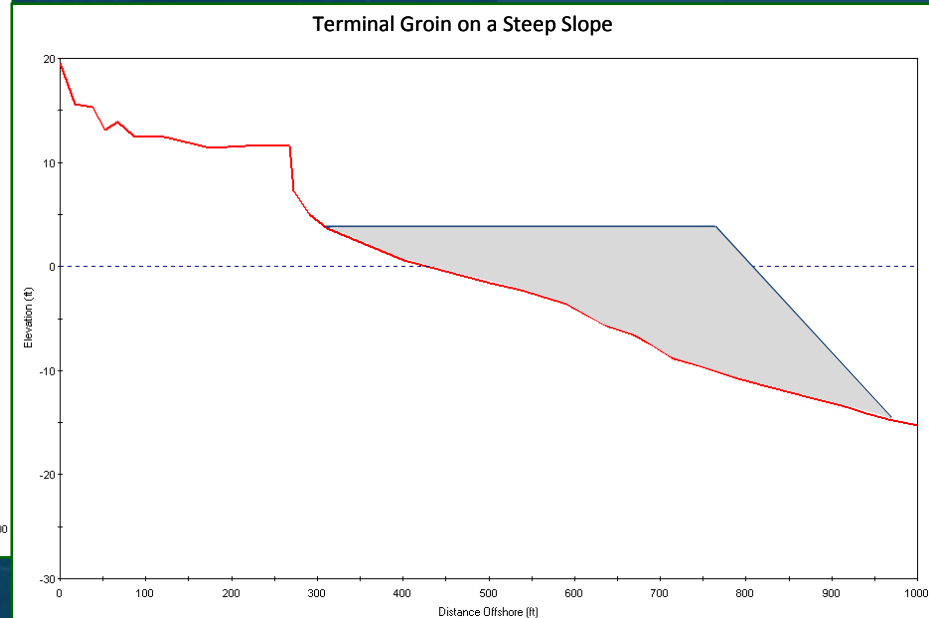
- Review Available Cost Data For Existing Terminal Groins Including Public and Private Costs
- Develop Ranges of Potential Costs Based on Typical Expected Terminal Groin Dimensions and Typical North Carolina Offshore Slopes
