North Carolina Coastal Resources Commission

WORKING DRAFT REPORT TERMINAL GROIN STUDY

February 1, 2010

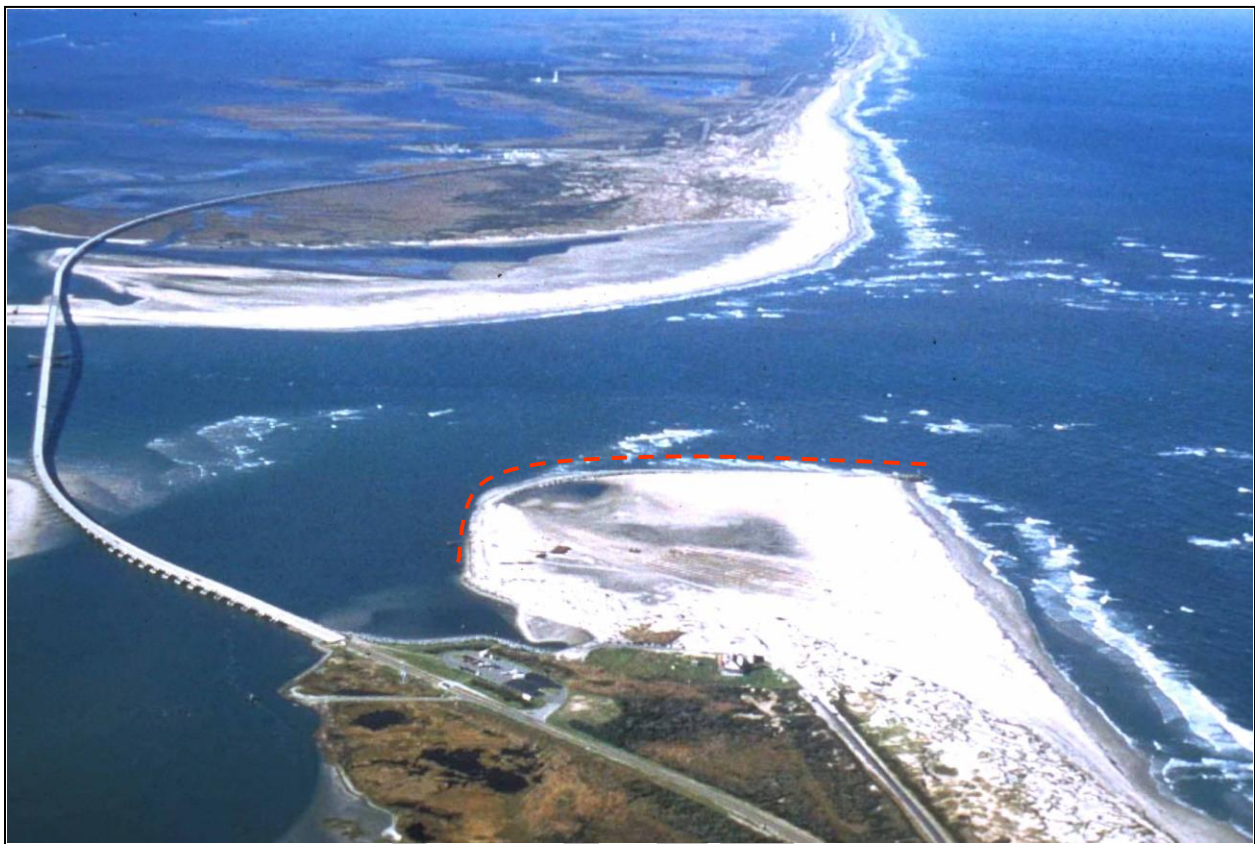
Figure II-1. Oregon Inlet Terminal Groin

The inlet is high energy and has seen dynamic changes since its opening. Between 1846 and 1989, the inlet migrated approximately 2 miles south of its original location (Mallinson et al., 2008). The Herbert Bonner Bridge was constructed across the inlet in 1962 and since then numerous studies have been conducted on stabilizing the inlet. In an effort to help stabilize the inlet and protect the bridge and highway from inlet shifting and severe erosion, a terminal groin was built on the south side of the inlet between 1989 and 1991 (Figure II-1). The shoals and channels continue to shift and the north bank has continued southward spit growth causing Oregon Inlet to narrow and deepen (Mallinson et al., 2008). Changes in volume to the ebb-tidal delta appear to be cyclical and are related to the numerous storms that affect the area (Cleary and Marden, 1999).

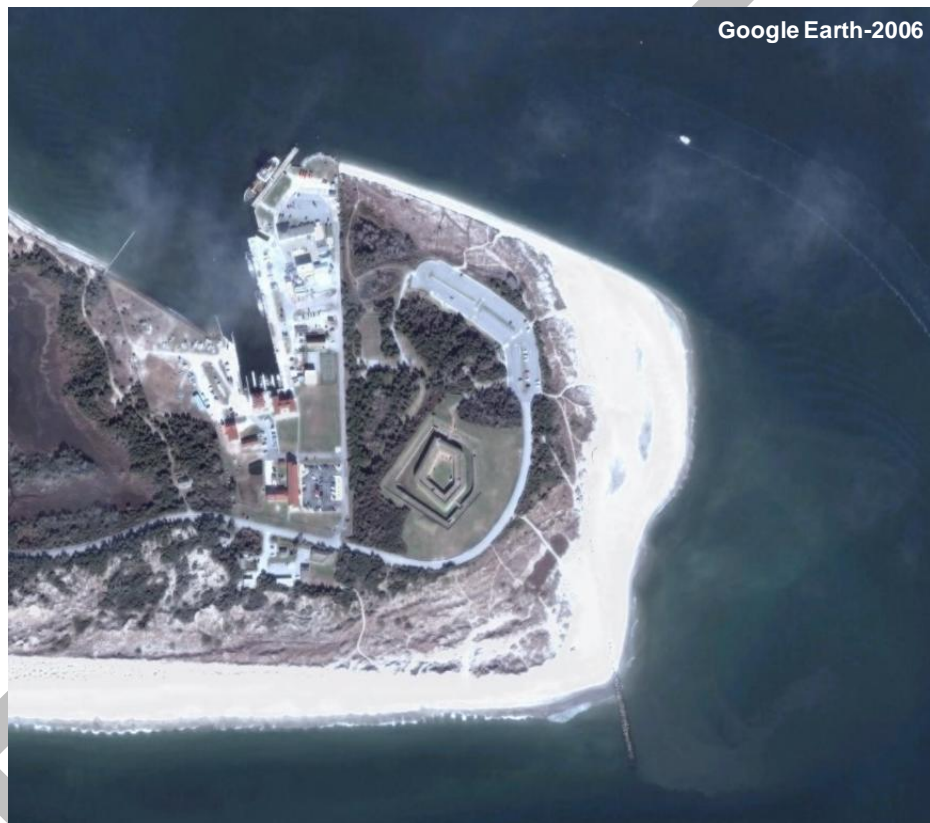
Figure II-13. Fort Macon Terminal Groin

The Fort Macon terminal groin (Figure II-13) is located on Bogue Banks on the western side of Beaufort Inlet. Shackleford Banks, an undeveloped barrier island lies to the east of the inlet. Beaufort Inlet, located approximately 9 miles west of Cape Lookout, serves as the connection between the Atlantic Ocean and Morehead City Harbor, North Carolina's second major port. The inlet is utilized by commercial and recreational vessels and is one of two inlets in southeastern North Carolina which have been modified for deep draft commercial traffic.

The terminal groin at Fort Macon was built to protect and preserve the fort from erosion. Fort Macon itself has a long history of being at risk from the Atlantic and shifting of Beaufort Inlet. Fort Macon was built between 1826 and 1834 to defend the inlet and harbor from seaborne attackers. By the very nature of its purpose, the fort was built close to the shoreline on a barrier island adjacent to a major inlet in an area prone to the natural forces that reshape shorelines (Paul Branch, <http://www.clis.com/friends/default.htm>). As early as 1831 wood pilings were laid at right angles to the beach to stop erosion near the fort and in 1840 Captain Robert E. Lee was sent to study the erosion problem at Fort Macon. He recommended that stone groins be constructed. By 1845 a total of six stone groins were built around the fort which protected the shore for almost 40 years (Paul Branch, <http://www.clis.com/friends/default.htm>). In 1906-11, the Army Corps of Engineers dredged the channel through Beaufort Inlet to a 20-foot depth, which today is

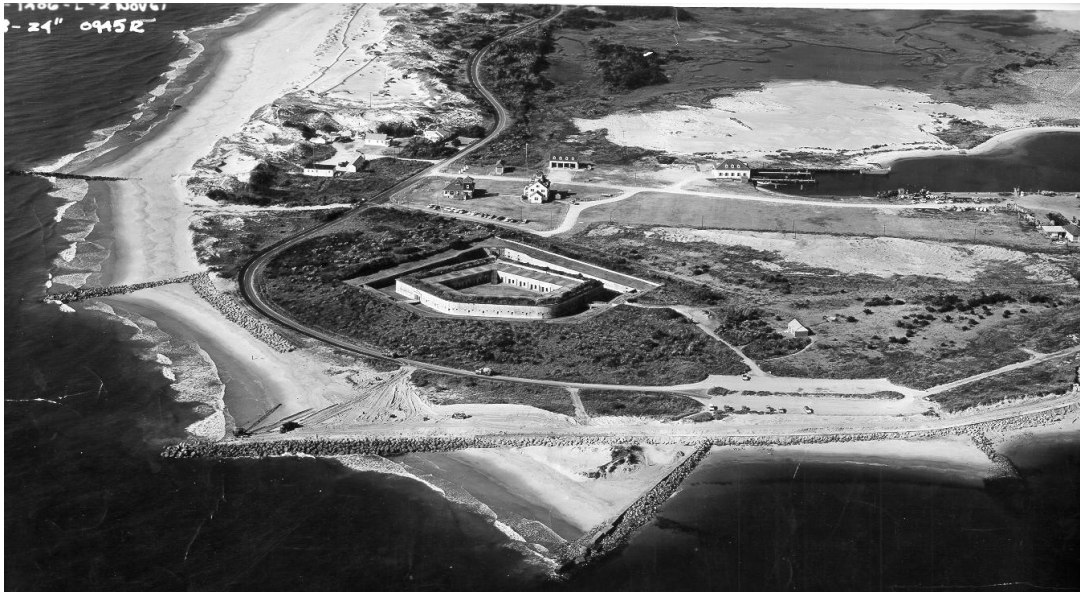
dredged to 47-feet for navigation into Morehead City Harbor. Hurricane Hazel in October 1954 did considerable damage to the beach around the fort and erosion problems worsened. In 1961, a stone seawall and groin system was begun (Figure II-14). Later in 1968 the terminal groin was constructed by extending one of the existing groins. It was further extended in 1970 to its present size.

Figure II-14. Fort Macon Revetment-Groin Protection (1961)

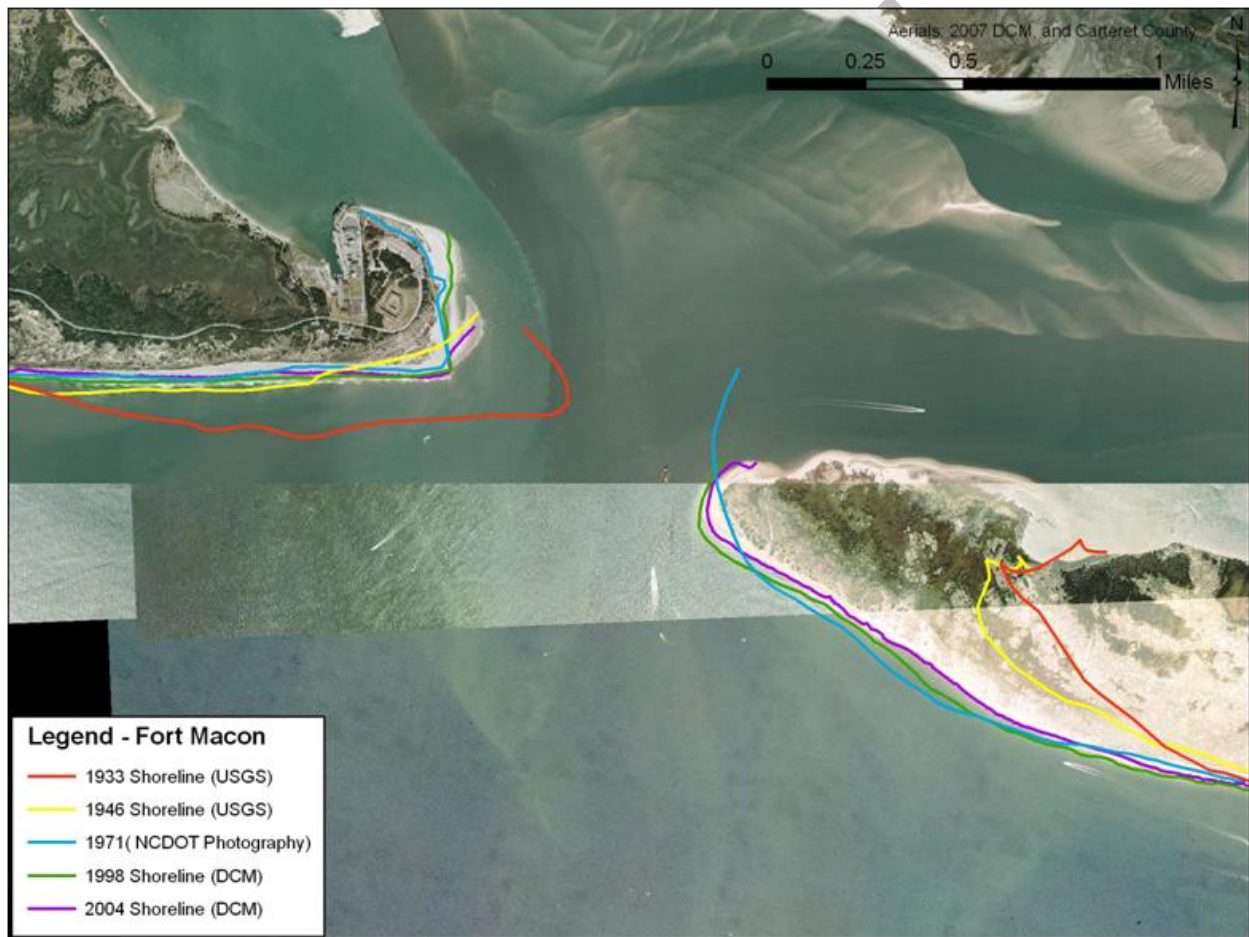
Figure II-18. Historic Shorelines – Fort Macon (Beaufort Inlet)

The shoreline impacts of the terminal groin at Fort Macon on the western side of Beaufort Inlet are assessed by examining the shoreline change prior to, and after, construction of the structure. Historical shoreline data was obtained from the NC Division of Coastal Management (DCM). The differences in shoreline position were calculated at 50 m (164 ft) transects along the shore for a distance of three miles to either side of the inlet. Shoreline data sets selected were chosen which extended three miles to either side of the inlet and to cover the pre-structure and post-structure time periods. Figure II-18 illustrates the shoreline data used in the analysis.

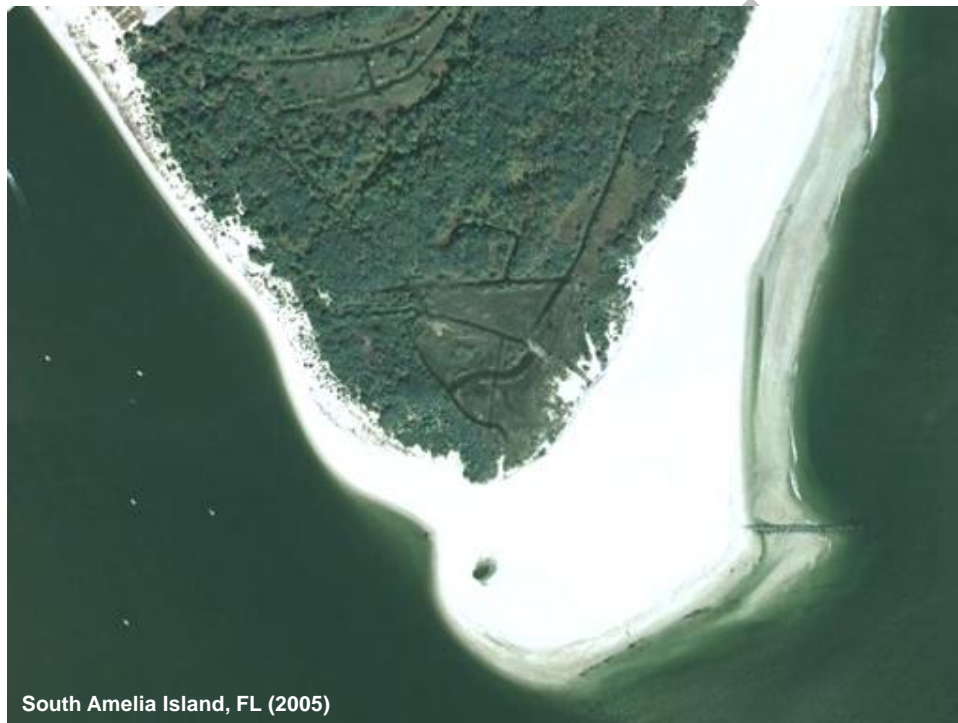
Figure II-26. Amelia Island Terminal Groin

Amelia Island is the southernmost of the string of Sea Islands that stretch along the east coast of the United States from North Carolina to Florida. The Amelia Island terminal groin (Figure II-26) is located at the south end of the Amelia Island (Nassau County). Continuing south of the inlet is the Little Talbot Island (Duval County).

An interesting morphological aspect occurs at the Nassau Sound where historically the tendency exists for the inlet to migrate northward, against the direction of predominant littoral drift, and against the direction of shoal/channel migration. This feature has increased the erosional pressure on the southern end of Amelia Island.

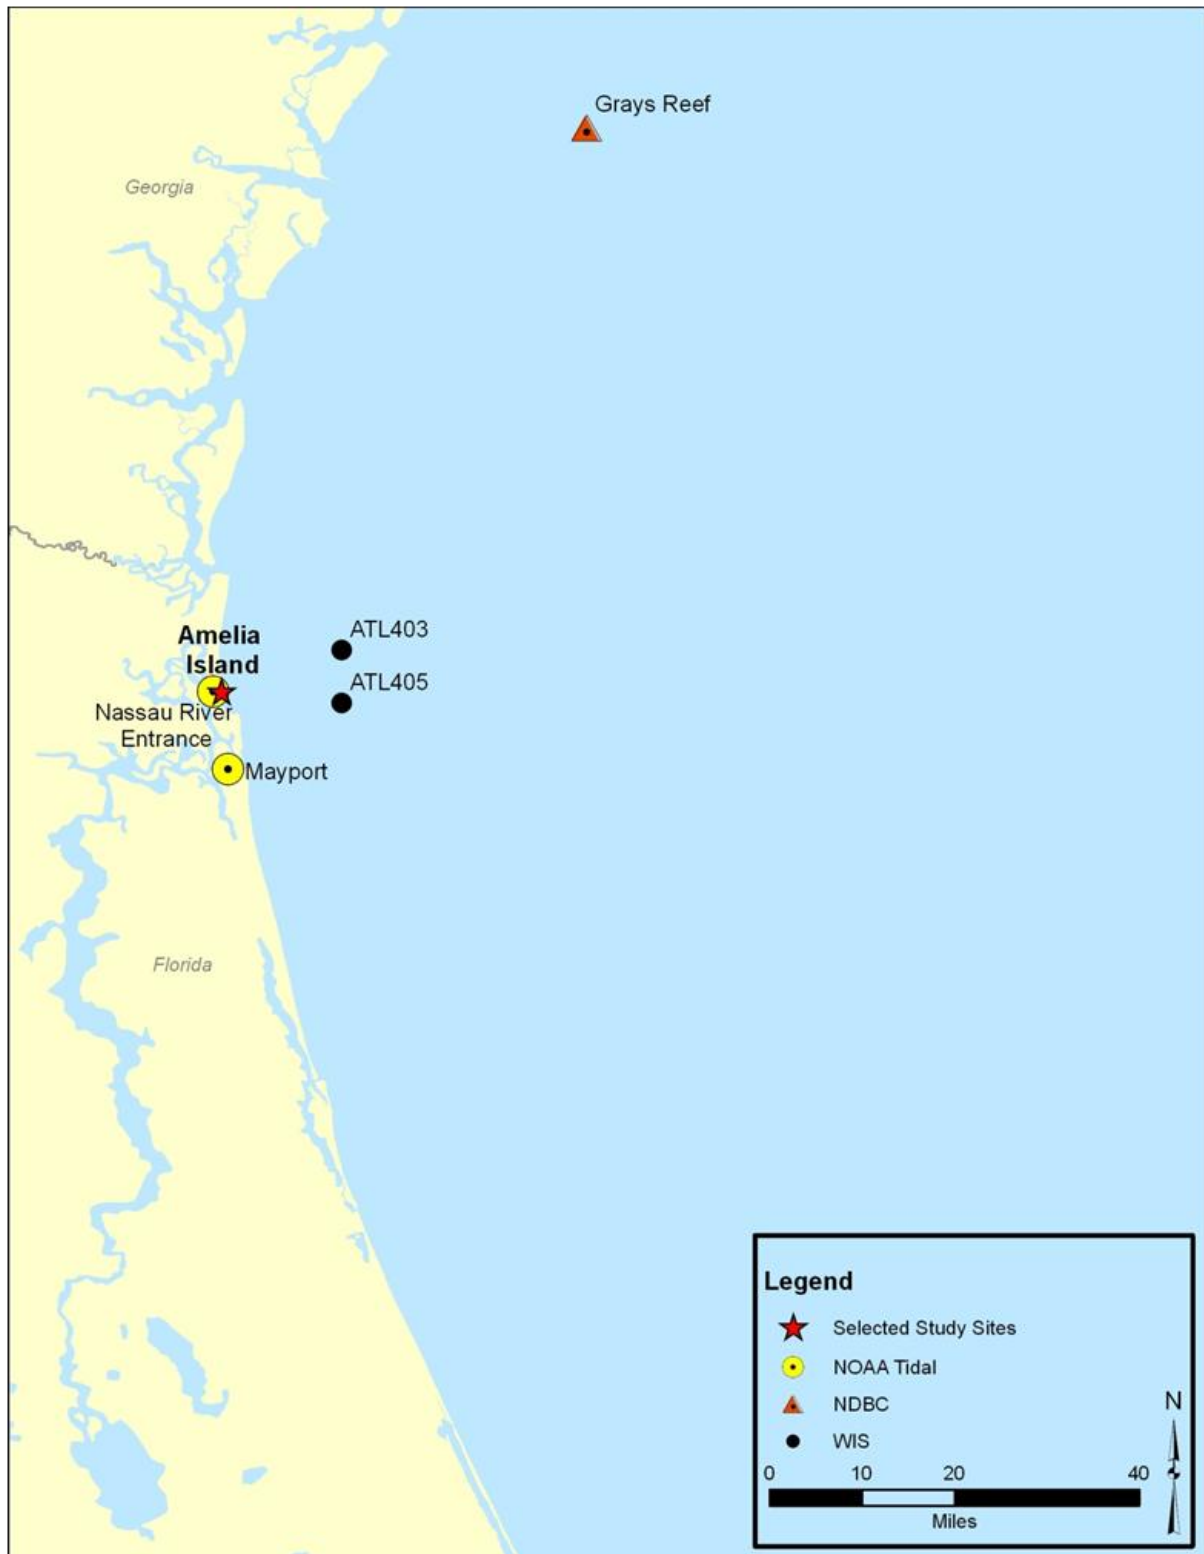
Figure II-28. Wave and Tidal Stations near Amelia Island

The closest NDBC buoys and WIS stations near Amelia Island that represent wave conditions within the immediate area surrounding the terminal groin are shown in Figure II-28 along with nearby NOAA tidal gages. The closest operating tidal gage is located at the Nassau River entrance with a second nearby gage approximately 9 miles south at Mayport. Table II-21 lists the tidal datums for both gages.

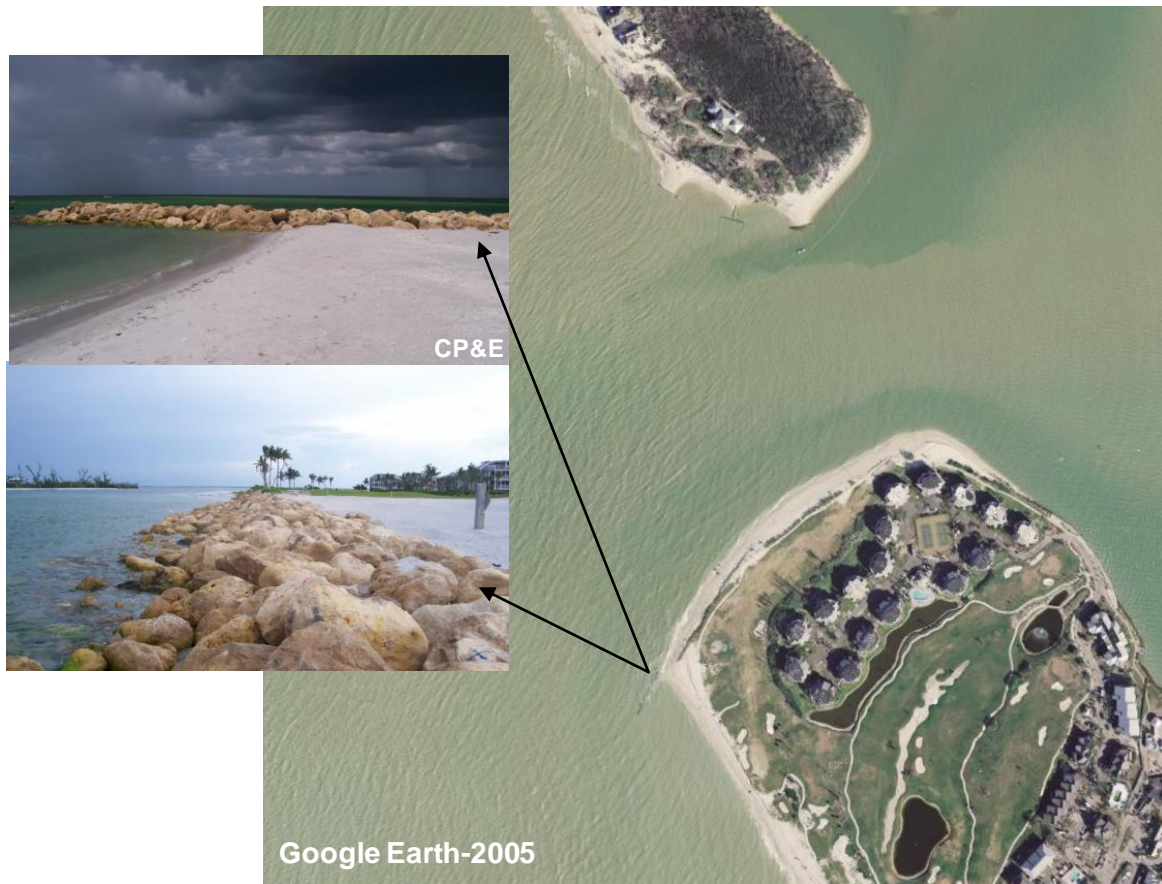
Figure II-40. Terminal Groin Rehabilitation

Many groins and stabilization structures were constructed along Captiva Island in the early years, when this was a common practice; however most of them have been destroyed or removed. For example in 1961, 134 groins were constructed, and in 1962 two timber groins were built in the middle of the Island. Beach nourishment projects have eliminated the need of the groins, timber structures and segmented breakwaters that were constructed on the Island. The first beach nourishment project was built in 1961. The terminal groin at the north end of Captiva Island was constructed in 1977 and rehabilitated in 2006. Figure II-40 shows an aerial view of the Redfish Pass and the rehabilitation of the terminal groin in 2006 (Upper left figure is looking towards the north, and lower left figure is looking towards the Island).

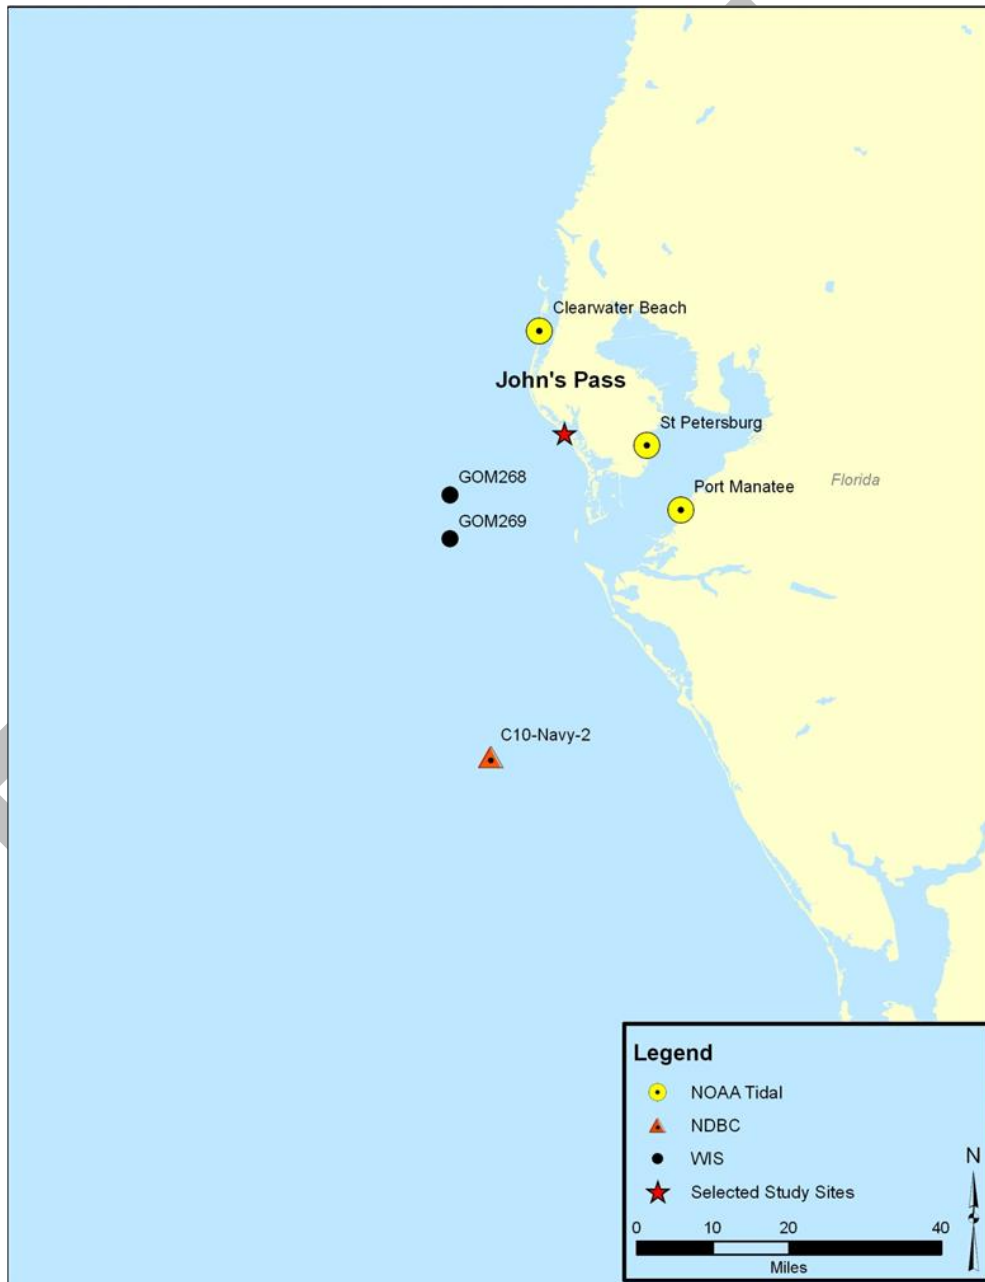
Figure II-53. Wave and Tidal Stations near John’s Pass

The closest NDBC buoys and WIS stations near John’s Pass that represent wave conditions within the immediate area surrounding the terminal groins are shown in Figure II-53 along with nearby NOAA tidal gages. The NOAA tidal gage located at St. Petersburg, inside Tampa Bay is the closest tide gage to John’s Pass. There is a second gage located in Tampa Bay approximately 16 miles south at Port Manatee, Florida. The closest ocean-side tide gage is located approximately 14 miles north at Clearwater Beach, Florida. Table II-35 lists the tidal datums for all three gages.

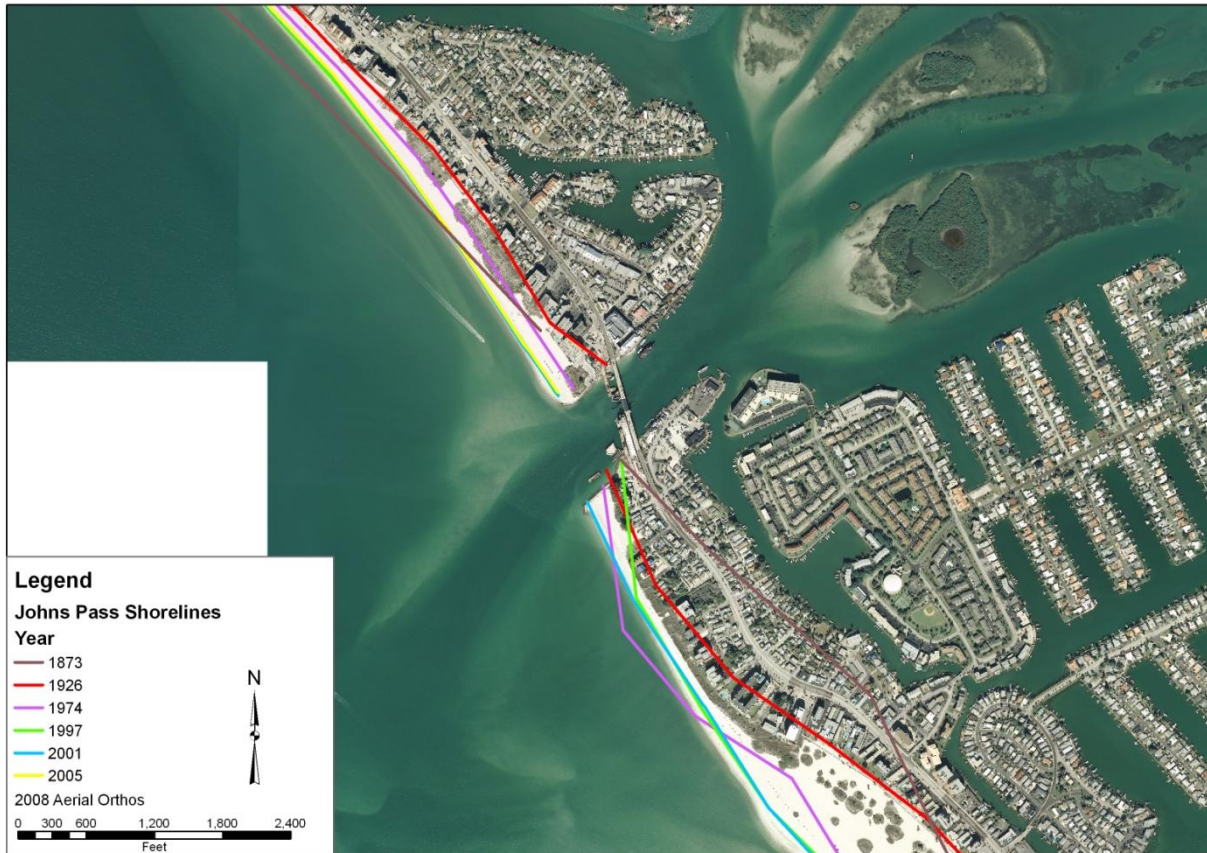
Figure II-56. Historic Shorelines – John’s Pass

The shoreline impacts of the terminal groins at John’s Pass are assessed by examining the shoreline change prior to and after construction. Historical shoreline data was obtained from the Florida Department of Environmental Protection (DEP). The differences in shoreline position were calculated at 50 m transects along the shore for a distance of three miles to either side of the inlet. Shoreline data sets selected were chosen which extended three miles to either side of the inlet and to cover the pre-structure and post-structure time periods. Figure II-56 illustrates the shoreline data used in the analysis.

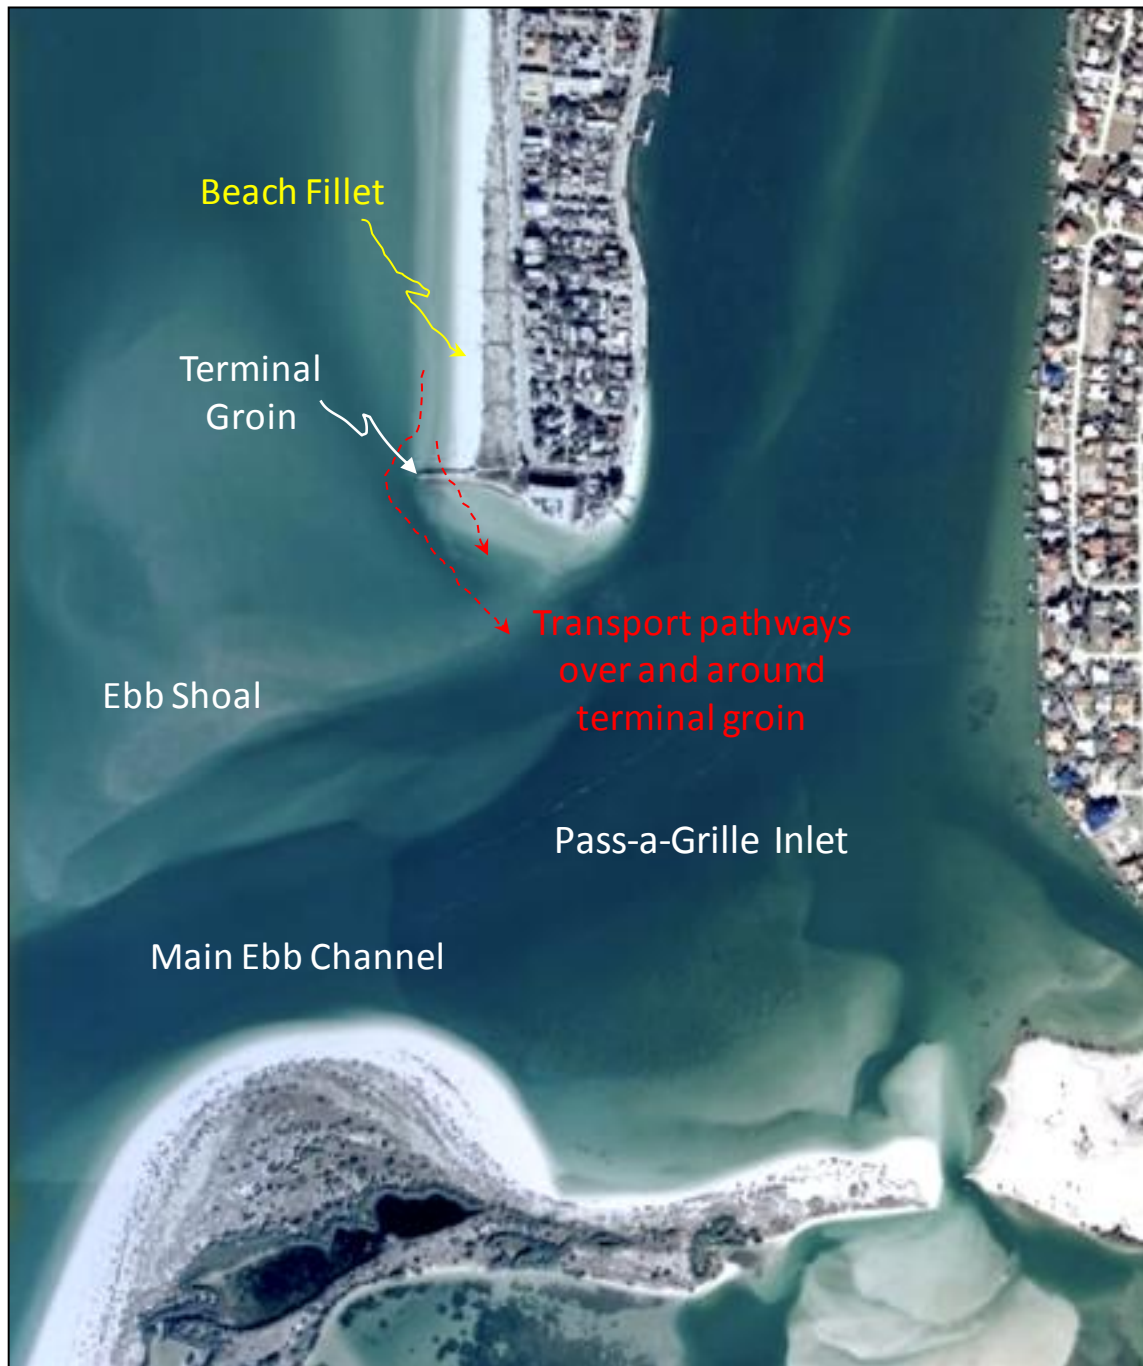
Figure III-1. Terminal Groin at Saint Pete Beach, Florida

Terminal groins are structures built at the end of littoral cells to reduce shoreline erosion and conserve sand along the end of beach or barrier, usually consisting in part of nourishment sand. Like most groins, they are normally constructed of 1 to 4-ton boulders that are fitted together to increase their stability against storm wave attack. They extend into the nearshore zone and act as a dam to the longshore transport of sediment. They are usually constructed at the downdrift end of a barrier on the updrift side of a tidal inlet. However, due to wave refraction around the ebb tidal delta, which causes sand to enter the channel from both sides of the inlet, terminal groins have been built on both sides of an inlet. Jetties are built to prevent sand in the littoral zone from entering the inlet channel and to help maintain navigation depths of dredged channels. Although terminal groins trap sand, they are dissimilar to a jetty, because once the terminal groin fills with sediment (beach accretes to the end of the groin and is called a *fillet*), additional sand bypasses the structure and enters the nearshore and/or the tidal inlet (Figure III-1). Commonly, terminal groin construction is done in combination with beach nourishment so that the groin does not capture existing sand reservoirs. During high wave energy events, the beach along the fillet often erodes and the sand is mobilized. Once depositional wave conditions return and the normal longshore transport system is reestablished, the fillet is reconstructed.

Terminal groins are commonly built at the end of the barrier and extend along the entire length of the tidal inlet. Although most terminal groins are designed primarily to help stabilize a length of oceanfront shoreline, a sometime overlooked consequence when the structure is built on the downdrift side of the inlet, is the stabilization of the inlet by preventing migration of the inlet channel. The groin inhibits erosion of the side of the channel by tidal currents and thus the inlet is not allowed to migrate.

The proper design of a terminal groin permits the longshore transport of sand around and over the structure once the beach has accreted to the end of the groin. During high wave energy events, sand is often transported over the structure. Usually beach nourishment is done in conjunction with groin construction so that sand will not be removed from the normal littoral transport system.

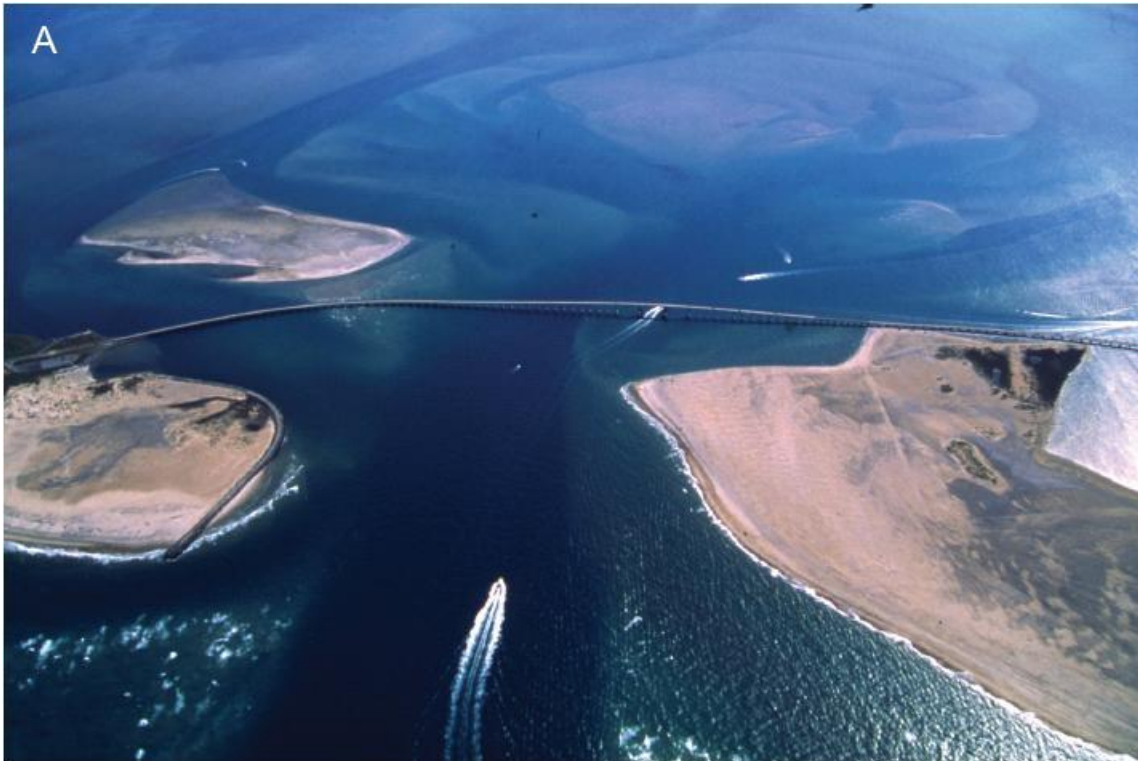
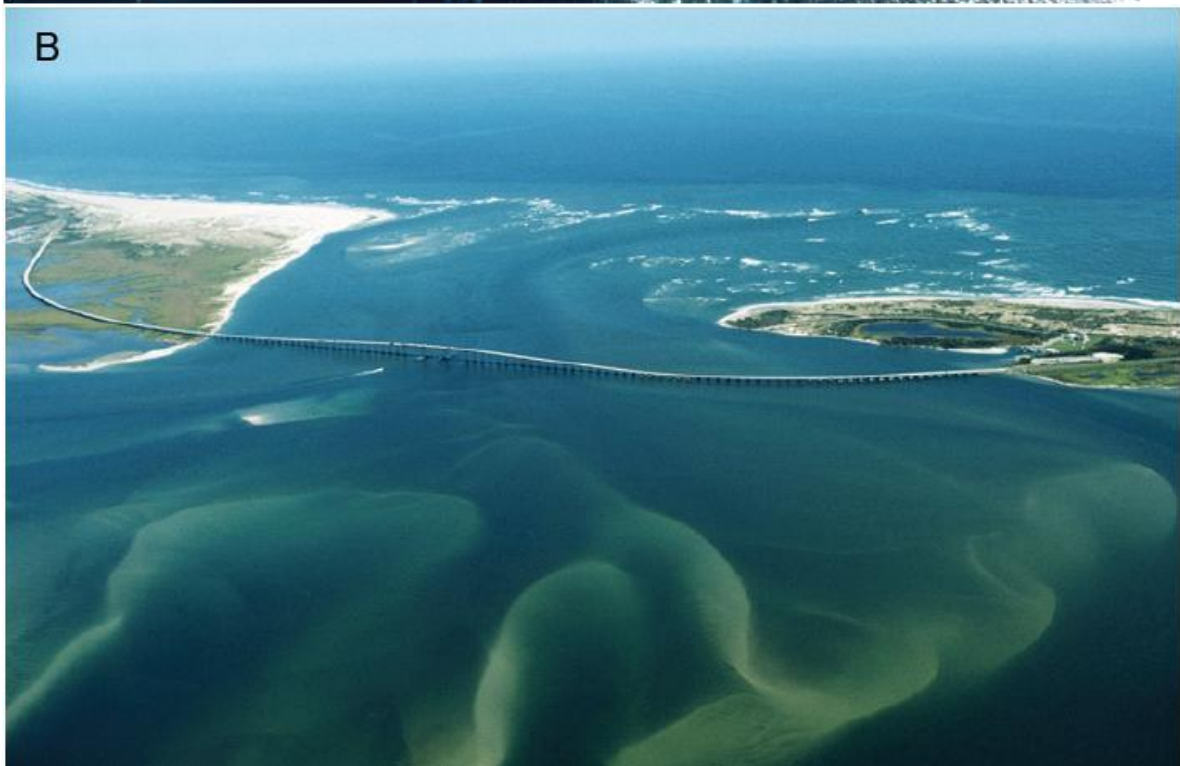
Figure III-3. Aerial Photographs of Oregon Inlet A. Looking Landward (Photograph from Ramanda, Nags Head) and B. Seaward (Photograph by D.A. Harvey)

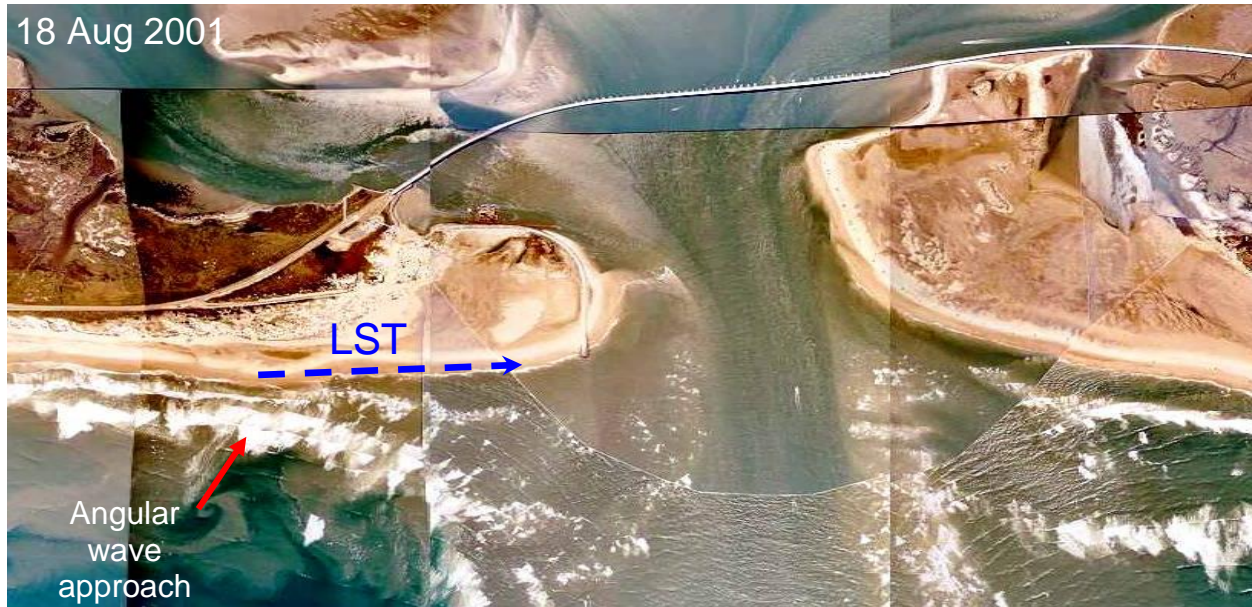
This same morphology is observed in a 2001 photograph of the region (Figure III-9). This photograph demonstrates that after the beach accretes to the end of the groin, additional longshore transport of sand toward the inlet moves around the groin (as well as over and through the groin during elevated tides and high wave energy events) and is deposited along the inlet shoreline. It should also be noted that sand is also sequestered at the northern end of Pea Island as a consequence of storm overwash into the fillet region. Beach sand blown into the back dunal area also adds to the sand reservoir in this region.

Figure III-9. 2001 Aerial Photograph of Oregon Inlet Showing Wave Refraction Around Ebb Delta Producing Northerly Transport Along Pea Island Feed Sand to the Fillet Region. Note the sand that has moved past the groin and constructed a beach along the inlet shore

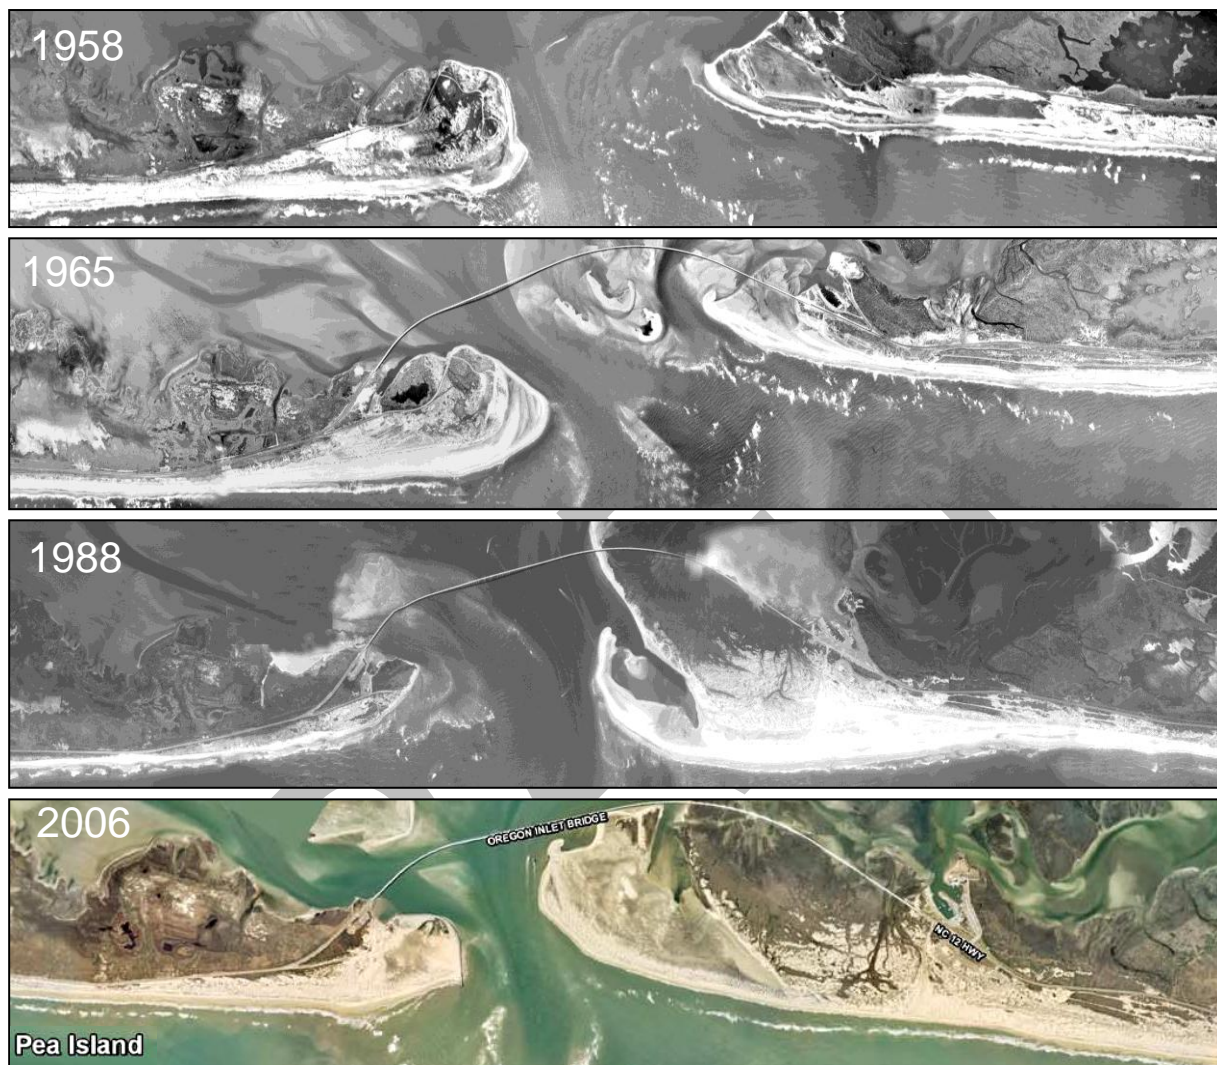
Figure III-10. Sequential Photographs of Oregon Inlet Depicting the Shoreline Changes Associated with Spit Accretion at Bodie Island and Southerly Migration of Oregon Inlet (Cleary, 2009)

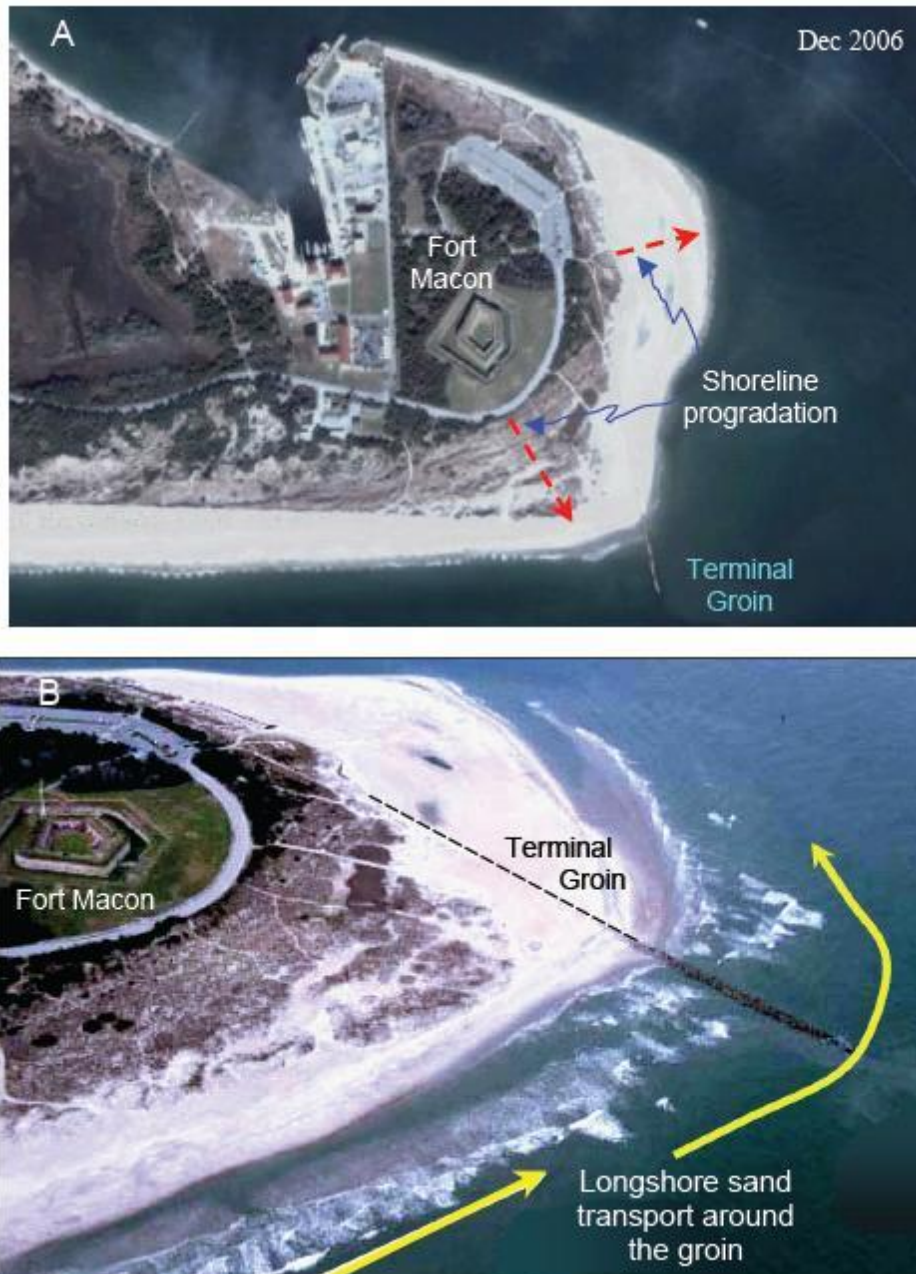
Figure III-20. Photographs Illustrating Progradation of the Beach West of the Groin and Along Inlet Shore. Dashed line indicates extent of groin beneath the beach

It is seen in the historical documentation that since building the groin in 1965, the shoreline has accreted to the end of the structure (Figure III-19). The groin was built to an elevation of approximately nine feet above mean low water and that despite this height, progradation of the beach to near the end of the groin has allowed sediment to be transported around the structure (Figure III-20). During storms and periods of high wave activity, it is likely that sand would have been transported over the structure toward the inlet as well. This process has led to the formation of a sizeable beach (width = 50 to 200 m) along the entire length of the inlet shoreline. Undoubtedly, this process continues to the present time, because as evidenced in October of 2008 (Figure III-19) the beach extends to near the end of the terminal groin and there is a robust beach adjacent to the inlet.

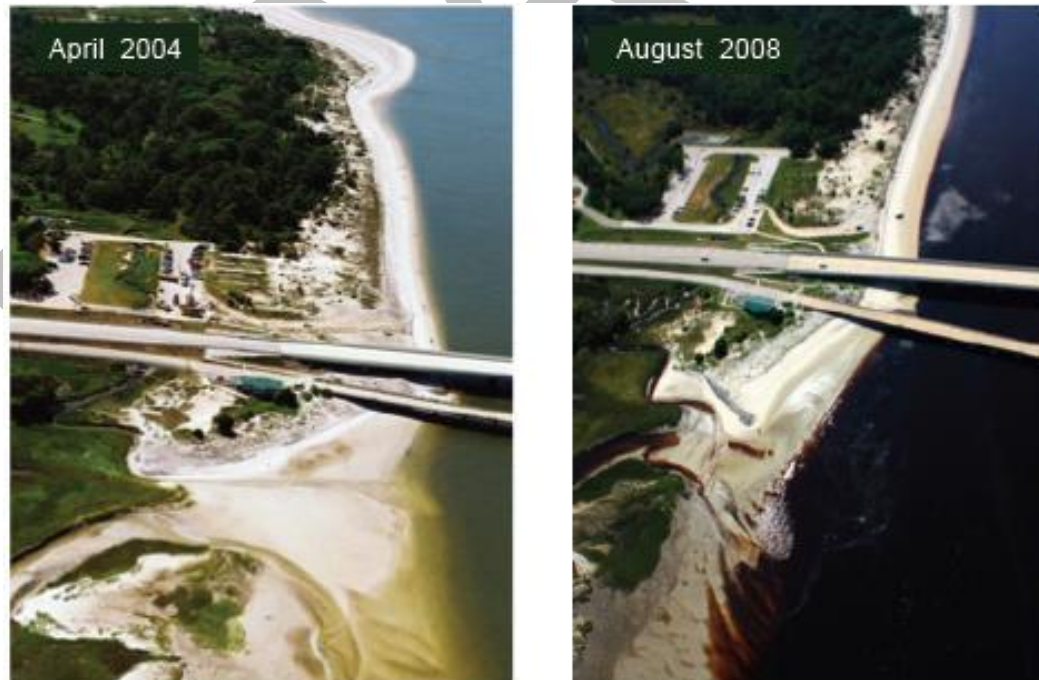
Figure III-29. Photographs Showing Before and After the Construction of the Backside Terminal Groin (Olsen, 2008)

The terminal groin at the southern end of Amelia Island was built to reduce the loss of sand from a 5.6 km updrift beach restoration project without adversely affecting the sediment transport required to maintain the downdrift, inlet-facing shoreline. The structure was designed to be leaky and allow sand to move over and around the structure during the passage of northeast storms. The second, much smaller rock groin was built just north of bridge to prevent large volumes of sand from moving freely into the backbarrier marsh system and to provide protection to the bridge and other Park infrastructure. It was built to trap sand (unleaky), but since the groin does not extend completely across the intertidal beach, some sand continues to bypass the seaward terminus of the structure.

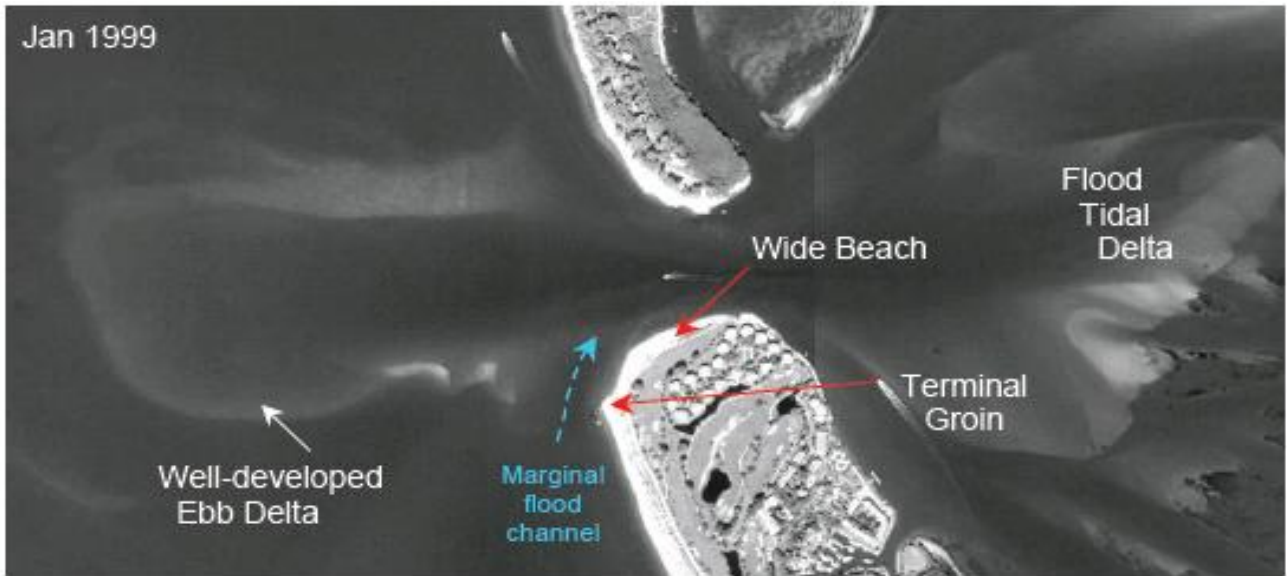
Figure III-34. View of the Ebb-tidal Delta That Has Been Used as a Source of Sand for Nourishing the Beach Along Captiva Island (from Google Earth)

Captiva Island is an 8-km long barrier that had been categorized as a "critically eroding beach" by the Florida Department of Environmental Protection's Bureau of Beaches and Coastal Systems (FL-EPA 2008). Redfish Pass is approximately 220 m wide and has well-developed ebb and flood tidal deltas (Figure III-34).

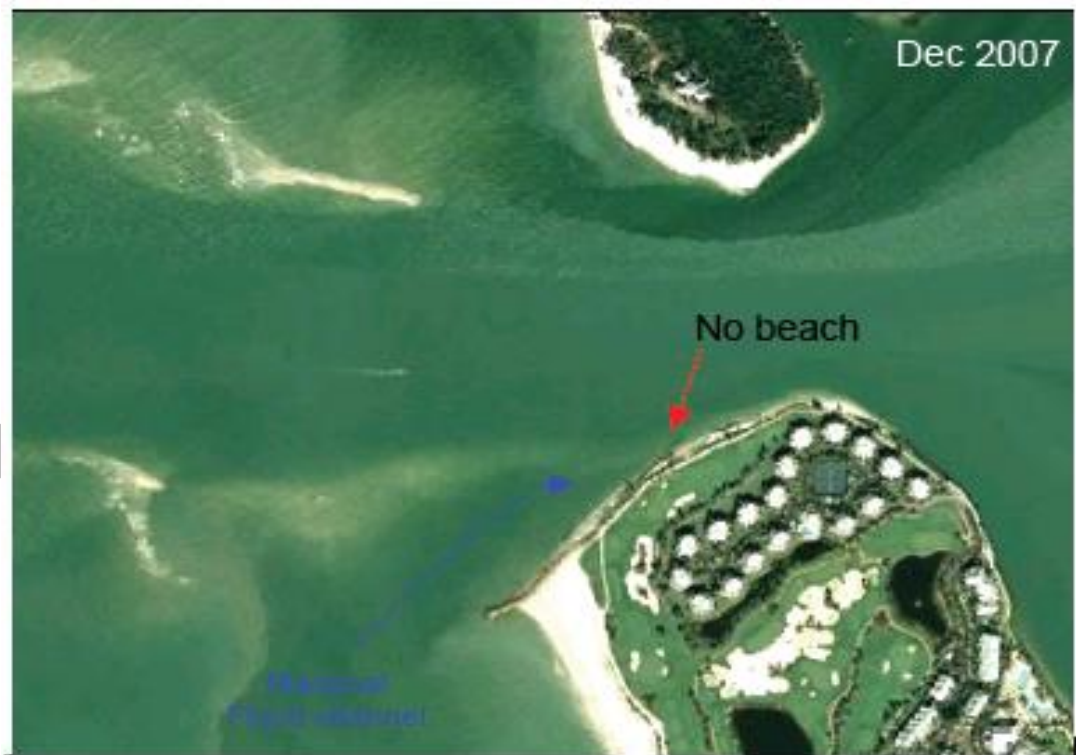
Figure III-35. View of the Terminal Groin at Redfish pass (from Google Earth)

In response to the long-term erosion problems along Captiva Island, construction of a terminal groin at the north end of the island, adjacent to Redfish Pass, was begun in 1977 and completed in 1981 (Figure III-35). The ebb-tidal delta of Redfish Pass was dredged to nourish Captiva Island in 1981, 1988 and 1989 (Table III-5). During the summer of 2006, the groin at the northern end of Captiva Island was extended 100 feet seaward for the purpose of capturing more the sand that otherwise would be moving northward into Redfish Pass. The island was nourished again in 1996 using sand from an offshore borrow area.
