North Carolina Coastal Resources Commission

WORKING DRAFT REPORT TERMINAL GROIN STUDY

February 1, 2010

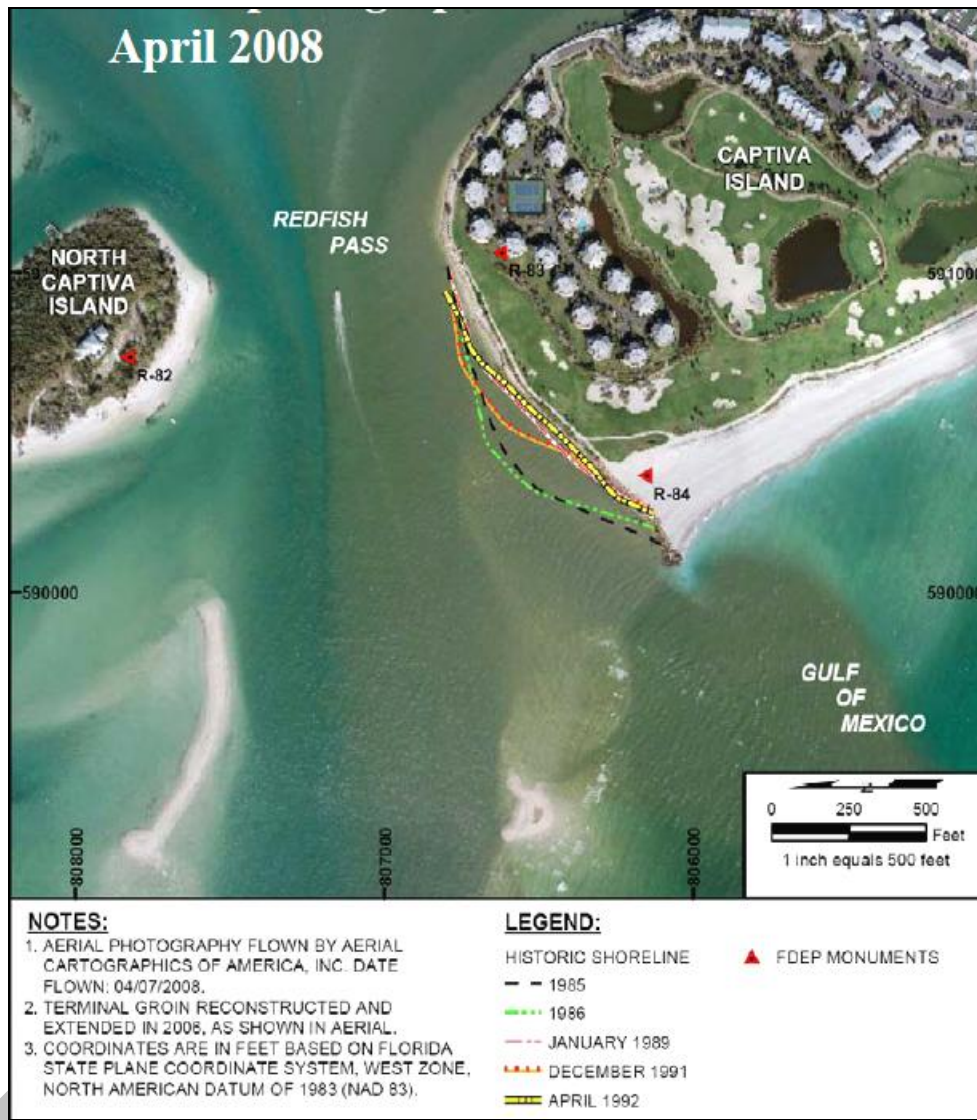
Figure III-36. Shoreline Changes of Beach Inside Redfish Pass
Note that between 1985 and 1992, the shoreline receded (FL-EPA, 2008)

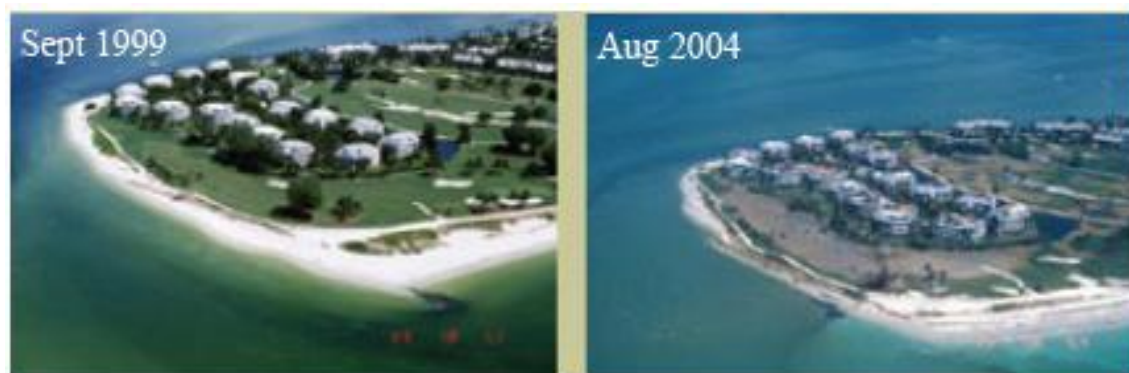
As seen in Figure III-34 and Figure III-35, the beach along northern Captiva Island has built to near the end of the terminal groin. This condition coupled with the existence of the marginal flood channel just offshore from the beach indicates that sand moves around the structure building a beach along the inlet shoreline. Historically, this beach north of the terminal groin and inside the inlet varies in width from 0 to 30 meters. The presence or absence of the beach has been related to storm activity and configurational changes of the ebb-tidal delta allowing the beach to be exposed to variable wave climate. Shoreline change data for the region inside the inlet indicate a period of erosion from 1985 to 1992 and a gradual retreat of the beach (Figure III-36). Also note that the 1992 and 2008 shorelines are in similar locations. Additional shoreline changes in the vicinity of the groin for the 1994 – 2007 period are presented in Figure III-37. In all of the photographs the beach extends to near the end of the groin, especially prior to lengthening the groin by 100 feet in 2006. The beach inside the inlet is relatively narrow in 1994 and 2003, but much wider in 1999 and 2006. In 2004 Hurricane Charley made landfall along northern North Captiva Island causing extensive damage and breaching of the barrier forming a new tidal inlet in the middle of the North Captiva. Along northern Captiva Island the beach inside the inlet was completely destroyed during the hurricane (Figure III-38).

Figure III-38. Comparison of Photographs Taken Before and Immediately After the Passage of Hurricane Charley Showing Beach Erosion Inside the Inlet

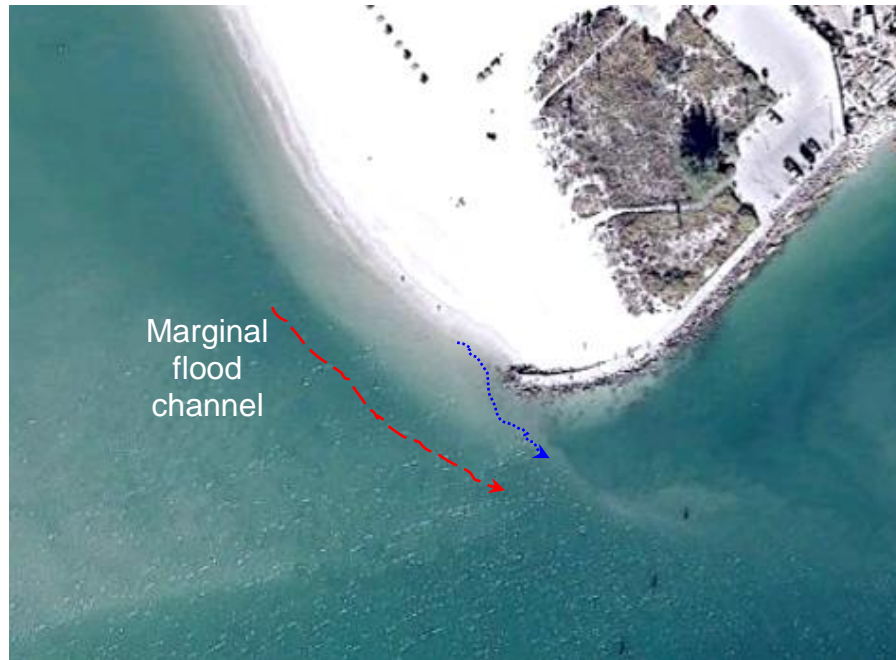
Figure III-41. Vertical Aerial Photograph of the Terminal Groin at the North Side of John's Pass

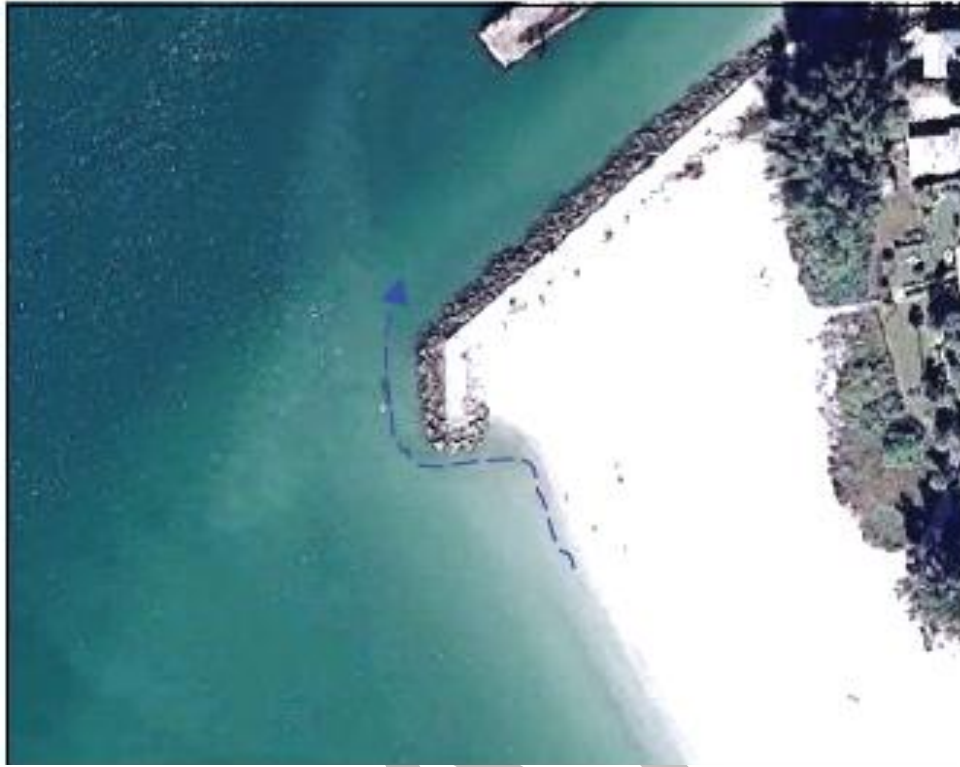
On the opposite side of the inlet, a wide beach flanks the terminal groin, although edge effects are present at the end of the structure (Figure III-42). This type of scalloped shoreline is common around stone structures at the mouth of tidal inlets and estuaries and is a product of wave refraction processes. The shallow nature of the nearshore at the end of the groin and extending into the inlet channel is an indication that sand is entering the waterway (blue arrow in Figure III-42).

Figure III-42. Vertical Aerial Photograph of the Terminal Groin at the South Side of John's Pass at the Northern End of Treasure Island (from Google Earth)

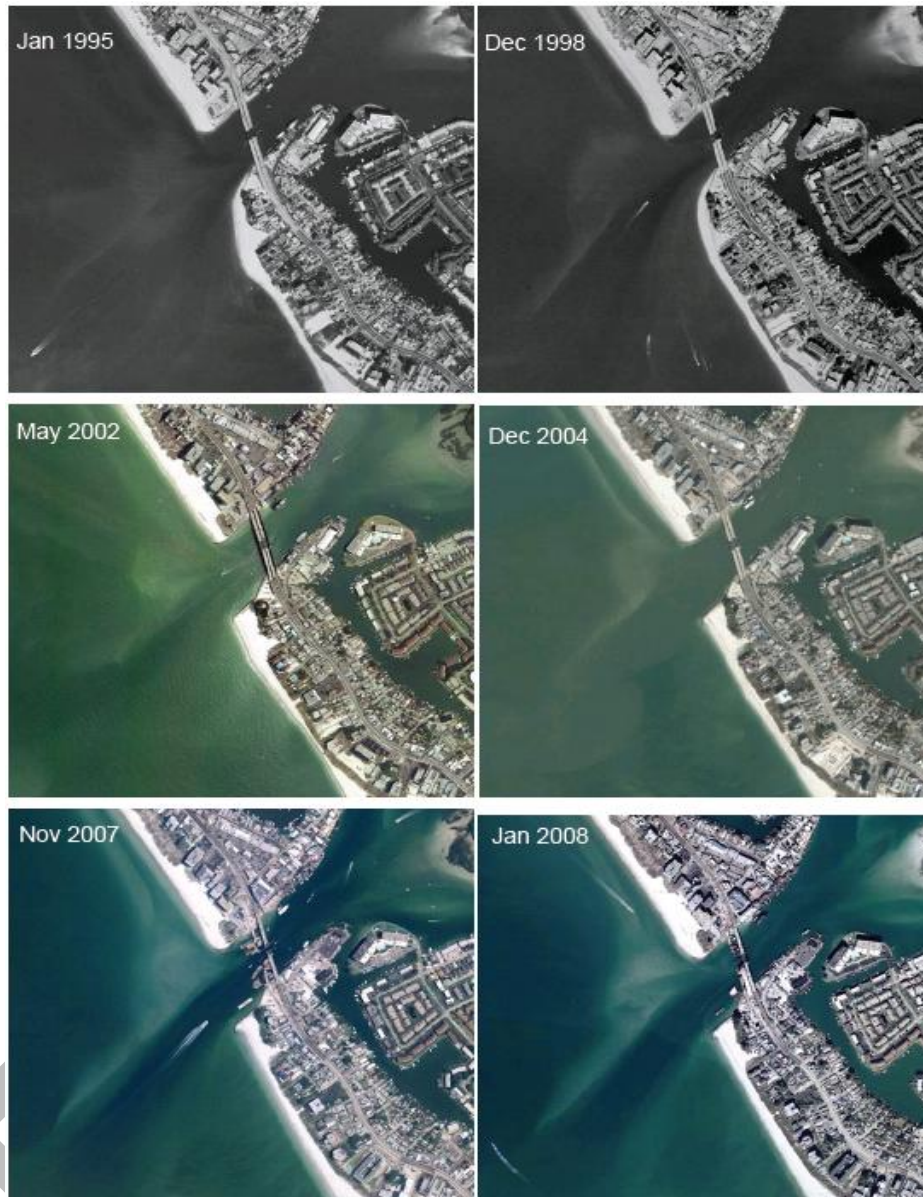
1. The fillets at both terminal groins are filled with sand.
2. The northern side of the ebb delta is shallower and better developed than the southern side of the delta.
3. The northern part of the delta exhibits a well-developed channel-margin linear bar that defines the main ebb channel.
4. The ebb delta elongates with time, as especially seen by the northern channel margin linear bar.
5. The terminal groin constructed at the south side of the inlet has resulted in straighter more uniform shoreline.
6. The northern Treasure Island shore undergoes periods of widening and narrowing. These changes are consistent along the entire shore, but are not reflected along Maderia Beach.
7. The terminal groins do not appear to adversely affect the updrift and downdrift shoreline as evidence by the erosional-depositional historical trends.

Figure III-43. Sequential Vertical Aerial Photographs of John's Inlet between 1995 and 2008 (from Google Earth)

A composite set of historical aerial photographs are presented in Figure III-43, depicting morphological changes at John's Pass from 1995 to 2008. Several points are apparent:

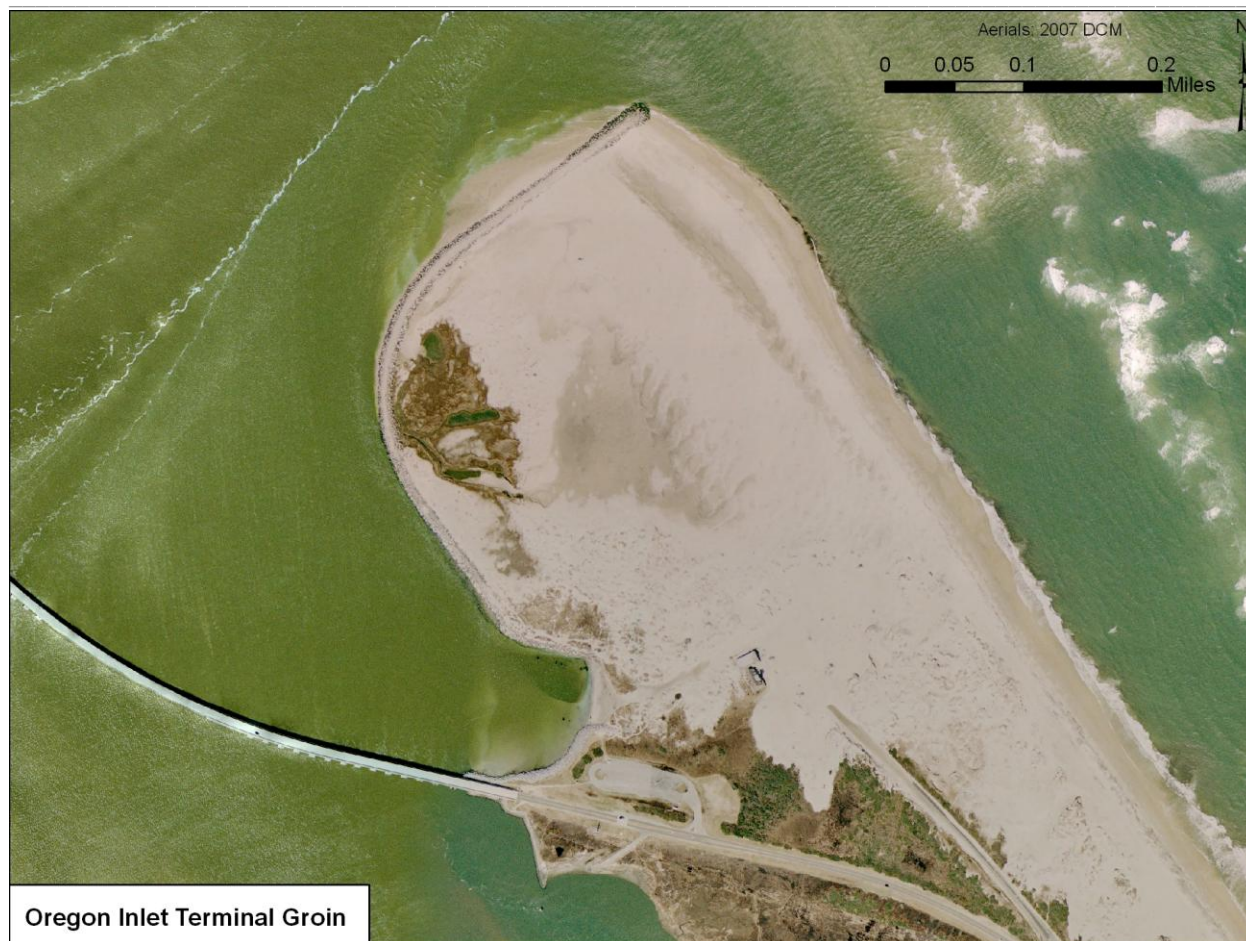
Figure IV-1. Oregon Inlet Terminal Groin

Oregon Inlet was created by a hurricane on 8 September 1846. The inlet separates Bodie Island to the north and Pea Island/Hatteras Island to the south (Figure IV-1). For the purpose of this report, Pea Island/Hatteras Island will be referred to as the Pea Island National Wildlife Refuge (PINWR). As with most natural tidal inlets, Oregon Inlet has had a history of dynamic change and migration since its opening, having migrated more than two miles south of its original location. This highly turbulent area requires the USACE to spend approximately five million dollars per year for maintenance dredging of the Oregon Inlet channel. The USACE is only able to maintain the authorized 14-foot channel depth, on average about 25 percent of the time (Personal communication, B. Dennis, USACE – Wilmington District, November 2009).

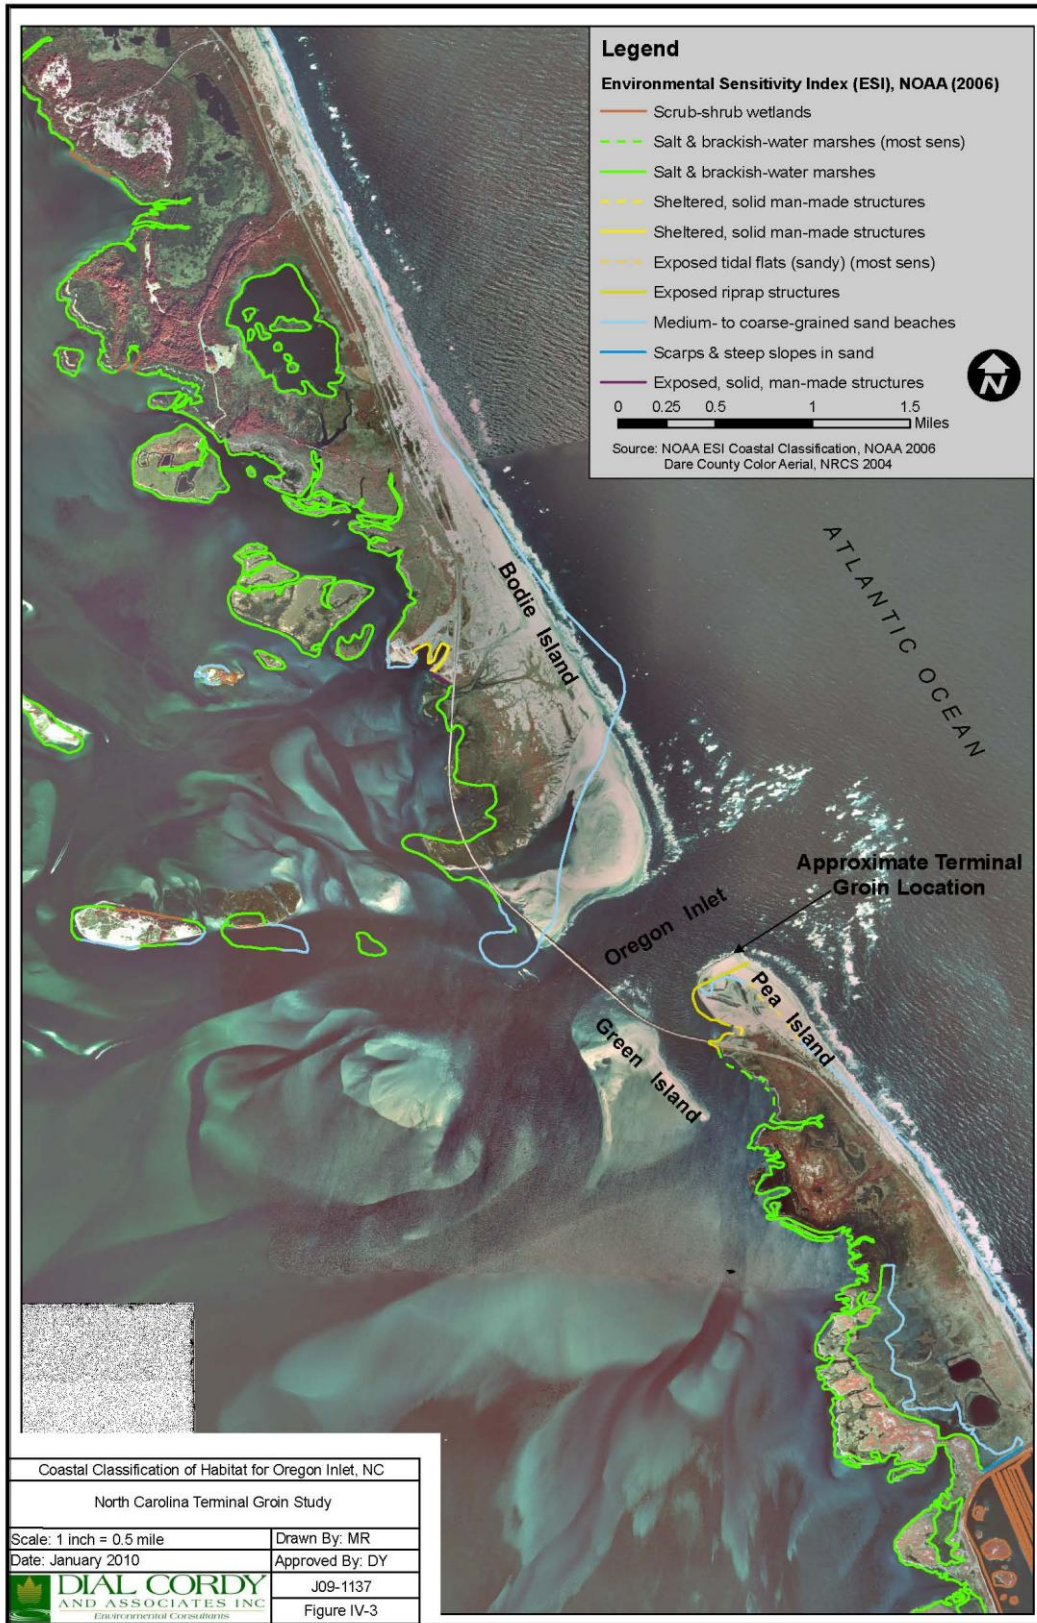
Figure IV-3. Coastal Classification of Habitat for Oregon Inlet, NC

maintenance of the terminal groin (Personal communication, D. Stewart, USFWS, February 2010). The primary purpose of the PINWR is to be a breeding ground for migratory birds and other wildlife. The PINWR is a Section 4(f) resource (NCDOT 2008). In addition, it is a significant publicly owned recreation area and also a significant historic site eligible for inclusion in the National Register of Historical Places (NRHP). The PINWR provides habitat for a wide variety of wildlife (NCDOT 2008). Extensive marine and estuarine systems exist within the vicinity of the Pea Island terminal groin (Figure IV-3), and the sand and mudflats on the south end of Bodie Island attract many shorebirds.

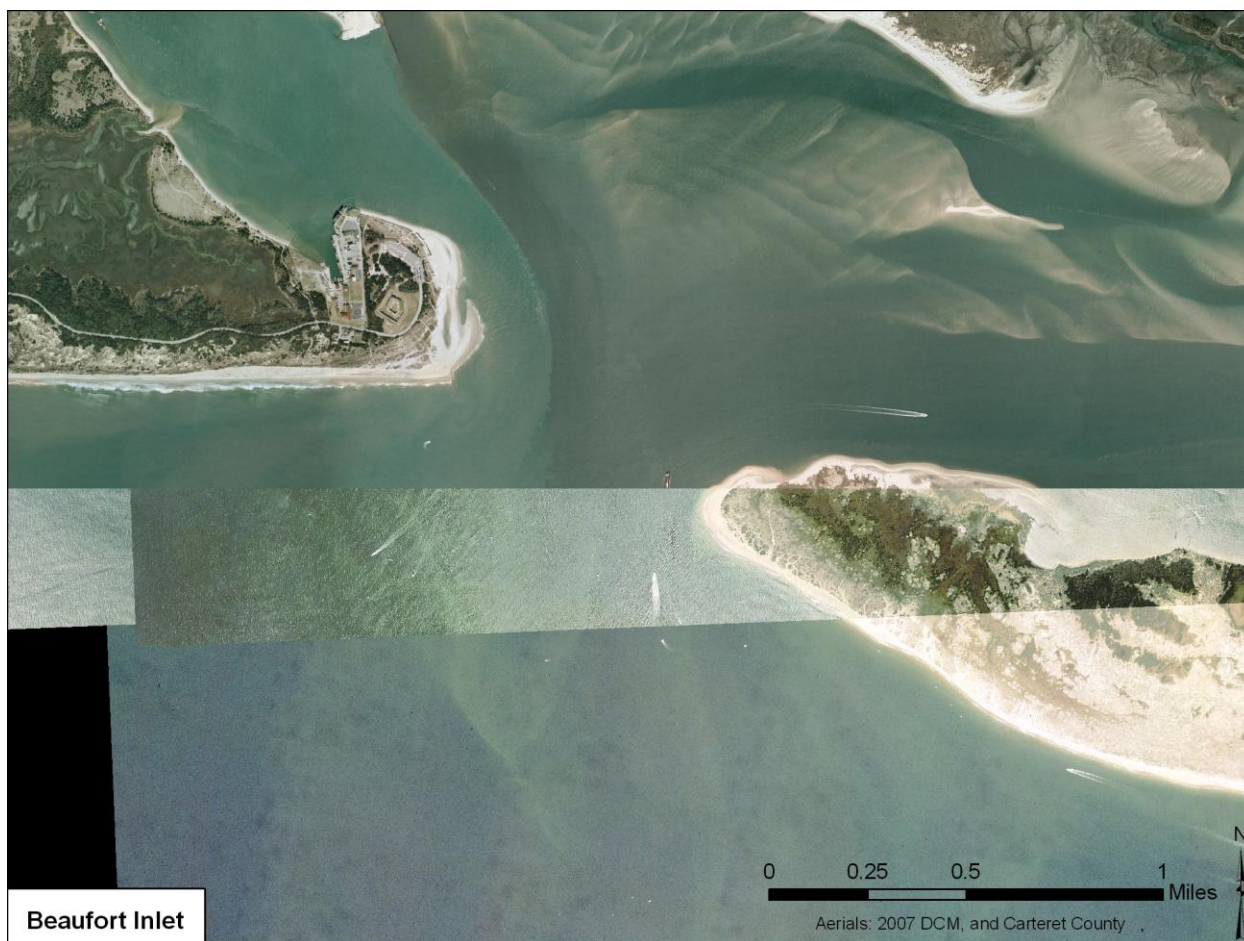
Figure IV-12. Beaufort Inlet

Beaufort Inlet is one of the most managed inlets in North Carolina (Figure IV-12). When discussing environmental resources and potential effects, the number of ongoing projects in this area should be considered. As shown in Figure IV-13, a late 1970's photograph looking east to west towards Beaufort Inlet depicts a historical rock structure on Shackleford Banks. The structure is landlocked as the inlet migrated to the west in the last 50 years (Moslow and Heron 1994). The State Port at Morehead City has a navigational channel approximately 45 feet deep through Beaufort Inlet. The beaches along Fort Macon State Park periodically receive dredged material disposal from maintenance dredging of the navigation channels, most recently during 2007 (Personal communication, R. Rudolph, Carteret County Shoreline Protection Office, March

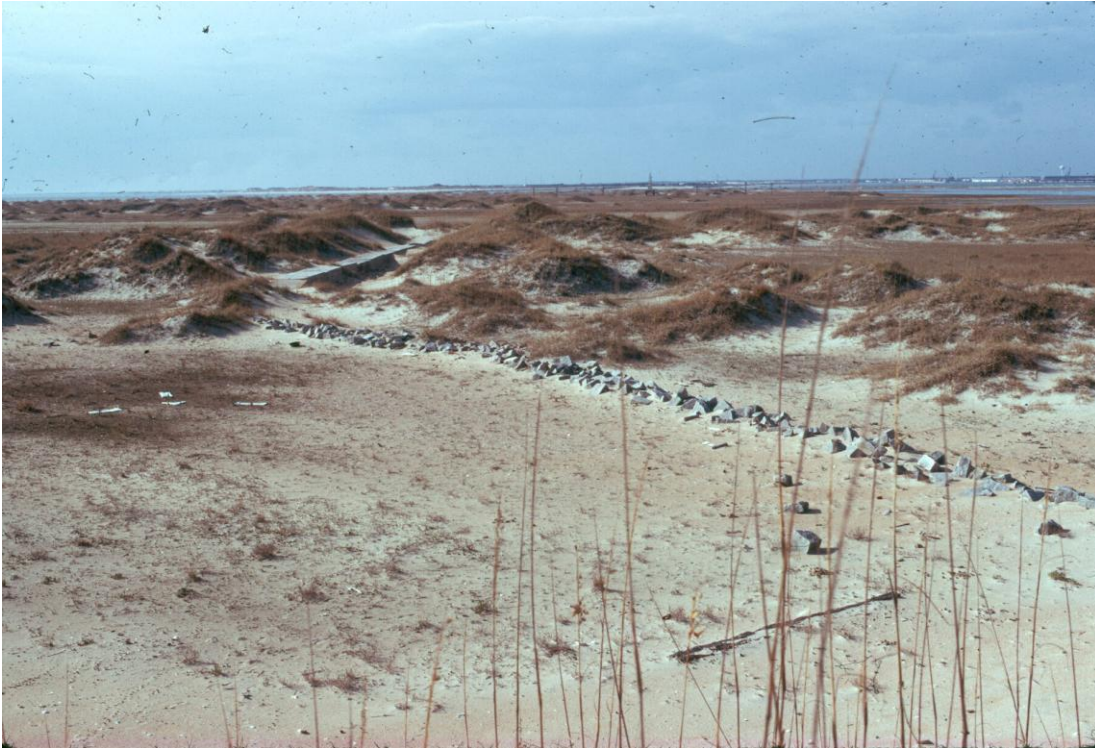
Figure IV-13. Hard Structure Located on Western End of Shackleford Banks

Interior islands have been created by dredged material and/or artificially stabilized. The shoreline at the State Port is entirely bulk-headed and large sections are a result of dredged material fill including significant portions of Radio and Brandt Islands. According to Hay and Sutherland (1988), there are two small jetties near Beaufort Inlet. The Radio Island jetty was built prior to 1939 to prevent the shoaling of Bulkhead Channel leading to Beaufort Harbor. Early surveys suggest that the Shackleford jetty was constructed near the turn of the century in an early attempt to stabilize Beaufort Inlet. Neither of these structures is more than 980 feet in length (Figure IV-13).

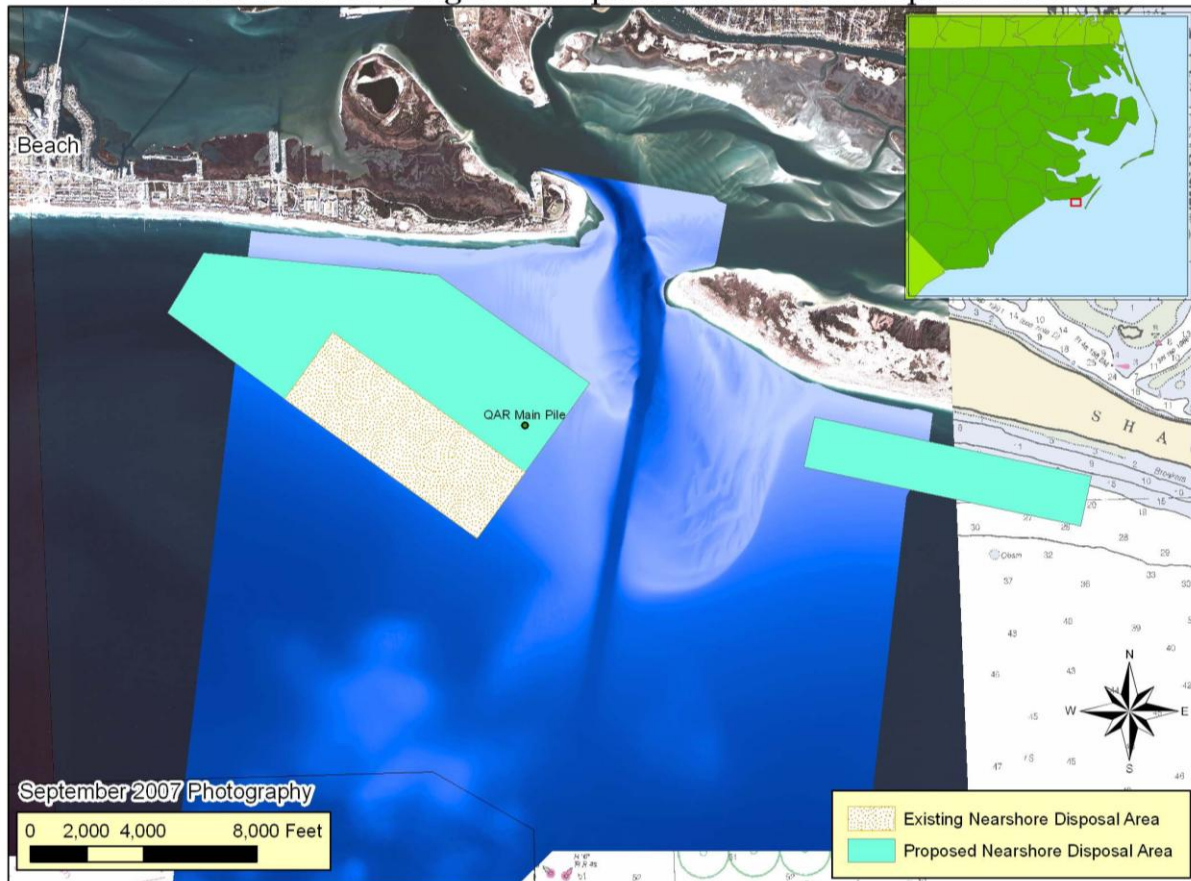
bathymetric contour that was anticipated to reintroduce beach-quality sand into the littoral draft feeding Bogue Banks. The nearshore berm was initially constructed in 1996 and has been used for dredge disposal since that time (Figure IV-14). In the 2001 Section 111 Feasibility Report, the USACE noted that material placed at the nearshore site has exhibited little movement.

Figure IV-14. Existing and Proposed Nearshore Disposal Locations for Beaufort Inlet
Source: USACE – Wilmington District (2009)

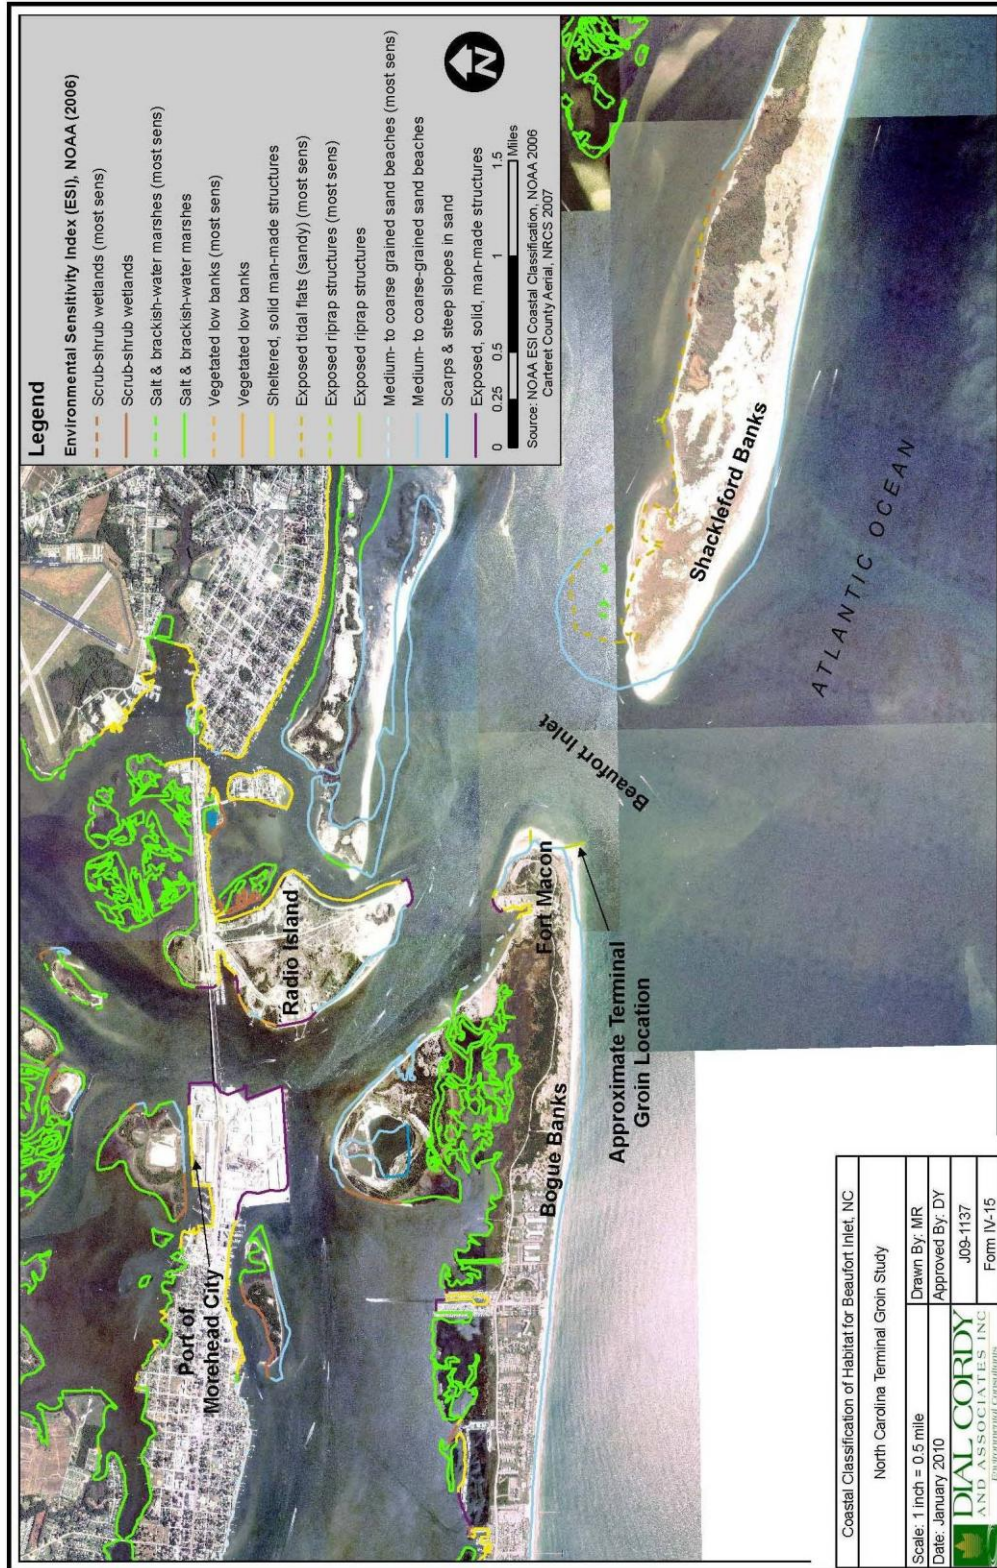
Figure IV-15. Coastal Classification of Habitat for Beaufort Inlet, NC

Tidal inlets including Beaufort Inlet have also been designated as Habitat Areas of Particular Concern (HAPC) for red drum, penaeid shrimp and the snapper-grouper complex by the SAFMC (NCDMF 2000). The USFWS has designated critical habitat for overwintering piping plovers at the Rachel Carson NERR and Shackleford Banks (2002). Shackleford Banks forms the southernmost portion of Cape Lookout National Seashore (CLNS) and has also been designated a Wilderness Area. The United States Congress has designated Fort Macon State Park and portions of Beaufort Inlet as covered by the Coastal Barrier Resources Act (CBRA) or within a CBRA zone, coincident with the boundaries of the NERR and CLNS. Figure IV-15 depicts the numerous coastal resources present within the vicinity of Beaufort Inlet and the Fort Macon terminal groin.

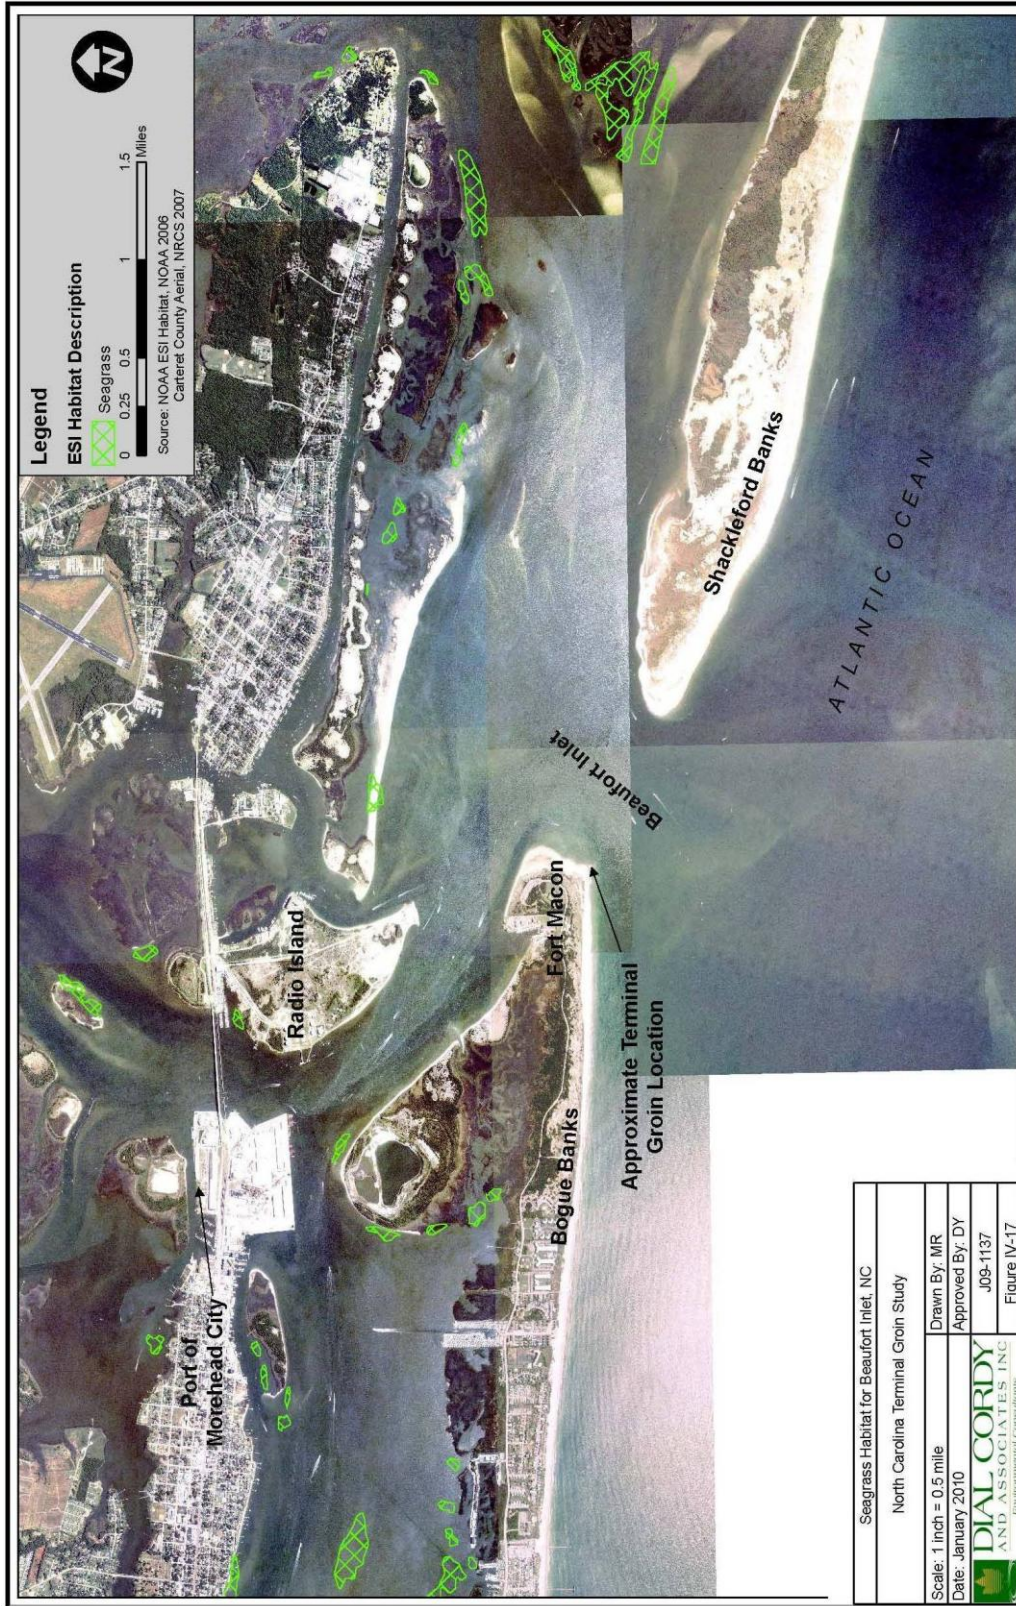
Figure IV-17. Seagrass Habitat for Beaufort Inlet, NC

In 1981, visible SAV in Core and Bogue sounds covered 19,458 acres [8.4 million square feet (ft²)] within a total water area of 104,840 acres (19 percent SAV coverage; Carraway and Priddy 1983). However, acreage for these areas may be underestimated, particularly in low salinity riverine areas, since aerial photography at the scale utilized (1:24,000) may not be able to detect some SAV due to the relatively small patch size and high turbidity of the water (Street et al. 2005). In contrast, considerable SAV loss may have occurred in Morehead City when the port access channels were originally dredged, given that nearby, similar yet undredged areas within Bogue Sound support SAV. As indicated by Street et al. (2005), because almost all of the eastern shoreline of Core Sound and the southern shoreline of Back Sound are undeveloped (Shackleford and Core Banks), the seagrass beds in that area have not been highly effected by channel dredging, marinas, or docks. As seen in Figure IV-17, seagrass is not present in Beaufort Inlet; however, it is present on the sound side of Fort Macon and within the inner part of Carrot Island, approximately 1.2 miles away from the inlet (Personal communication, D. Field, NOAA, February 2010; Personal communication, S. Chappell, NCDMF, February 2010).

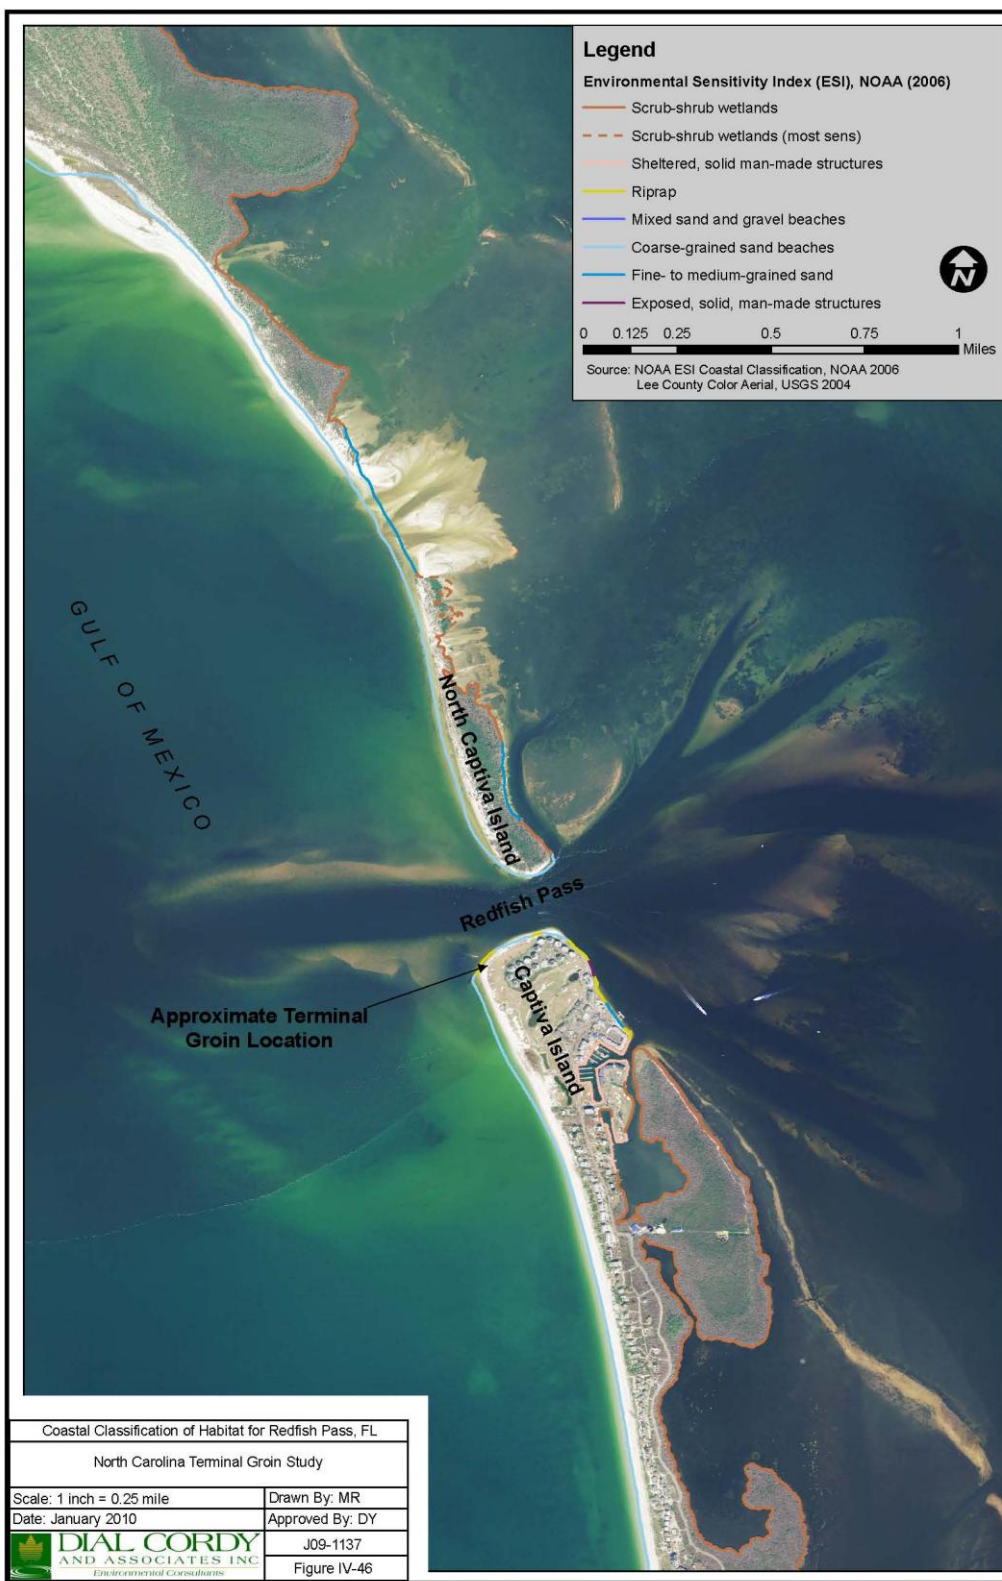
Figure IV-40. Coastal Classification of Habitat for Redfish Pass, FL

Redfish Pass, which has a history of slow migration and tidal shoaling, greatly influences the surrounding estuarine and marine environment (CPE 1993). The presence of the pass allows for the mixing of gulf and estuarine waters. The tides that occur at the pass greatly influence the currents, water quality, salinity, and temperature regimes within the pass and the surrounding estuarine waters. The pass also provides migratory marine-estuarine species with ready access to their spawning and nursery grounds (Figure IV-40).

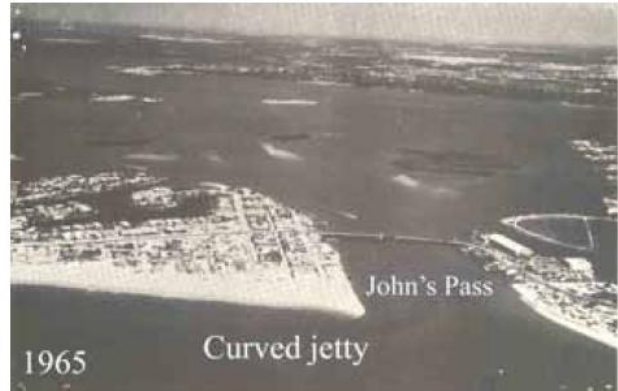
In 1961, the City of Madeira Beach constructed the 460-ft curved terminal groin on north side of John's Pass and nourished the beach, as shown in this 1965 photo, above right. Federally-authorized dredging of John's Pass began in 1966. In 2000, Pinellas County constructed another terminal groin on the south side of John's Pass, as shown in the photograph below.

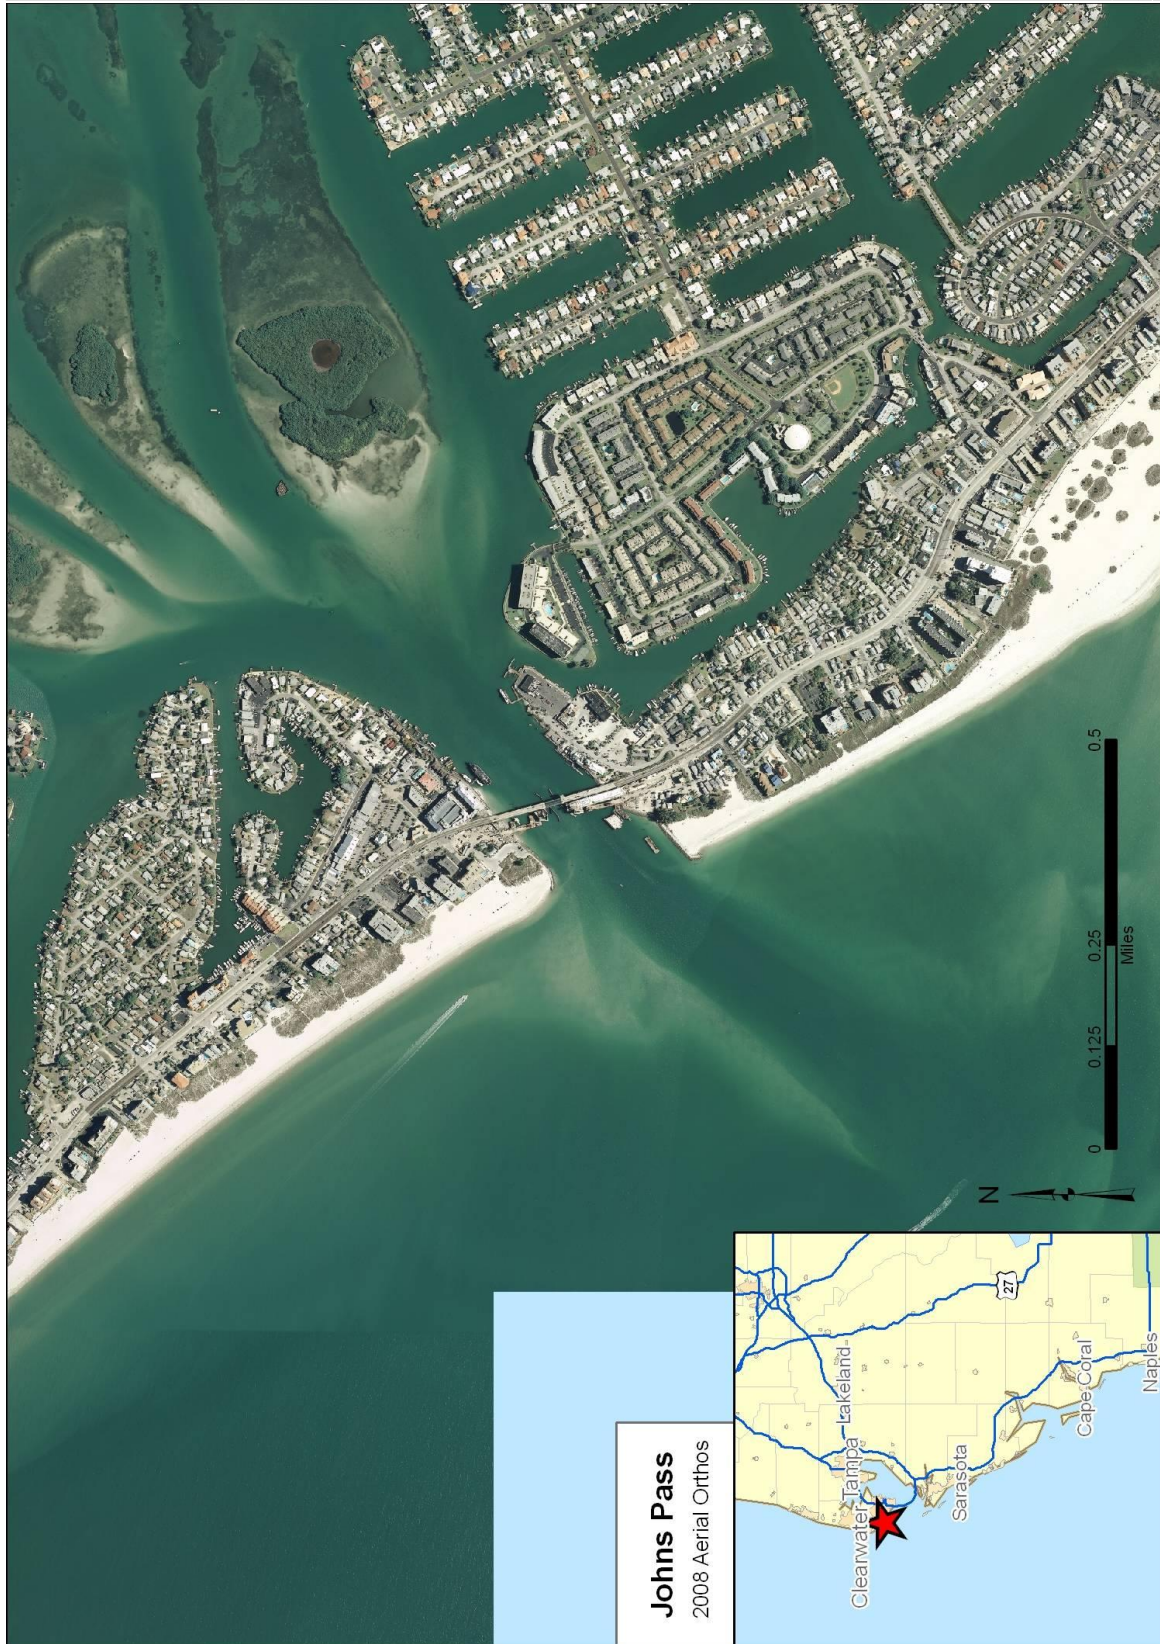
Figure IV-45. John's Pass, Florida

John's Pass, approximately 2,100 feet long and 600 feet wide, is located on the west coast of Florida and separates Sand Key on the north from Treasure Island to the south (Vincent 1992). Created by a hurricane in 1848, John's Pass connects Boca Ciega Bay to the Gulf of Mexico. The community immediately to the north is Madeira Beach, which prior to the construction of the terminal structure on the south end of Sand Key was experiencing a chronic erosion problem (Dean 1993). A tide-dominated inlet, John's Pass has extensive ebb- and flood-tidal deltas (Davis and Gibeaut 1990) and a federally maintained navigation channel. In an attempt to alleviate the chronic erosion problem, a field of adjustable groins was constructed in 1957 and the terminal structure on the north side of John's Pass shown in Figure IV-45 was constructed in 1961 (Pinellas County Department of Environmental Management 2008). The 1958 postcard, below left, looks north at John's Pass prior to construction of the curved terminal groin. Note the inlet's shoreline has been hardened by seawalls.

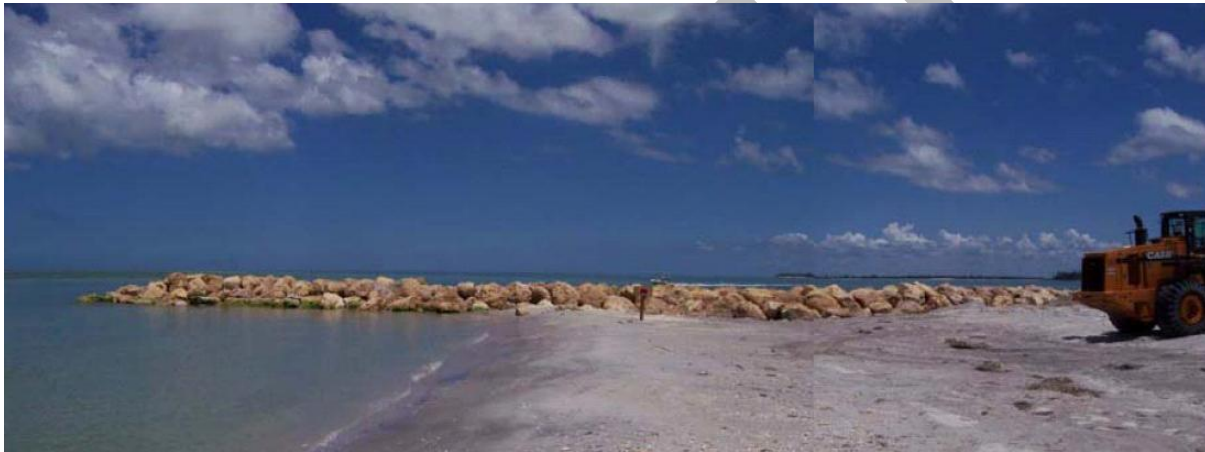
Figure V-7. 2006 Terminal Groin at Captiva Island

Hurricane Charley, in 2004, severely damaged the groin. Between 2005 and 2006, beach nourishment and groin rehabilitation increased the stability of the beach. The groin reconstruction was completed in 2006 with 9,036 tons of limestone boulders and a total length of 340 feet. The new armor layer unit sizes ranged between 2 to 7 tons (Hagerup, 2006 & Coastal Planning & Engineering, Inc., 2008). Figure V-7 shows the 2006 reconstructed groin. Figure V-8 shows the Captiva Island terminal groin in 2008.

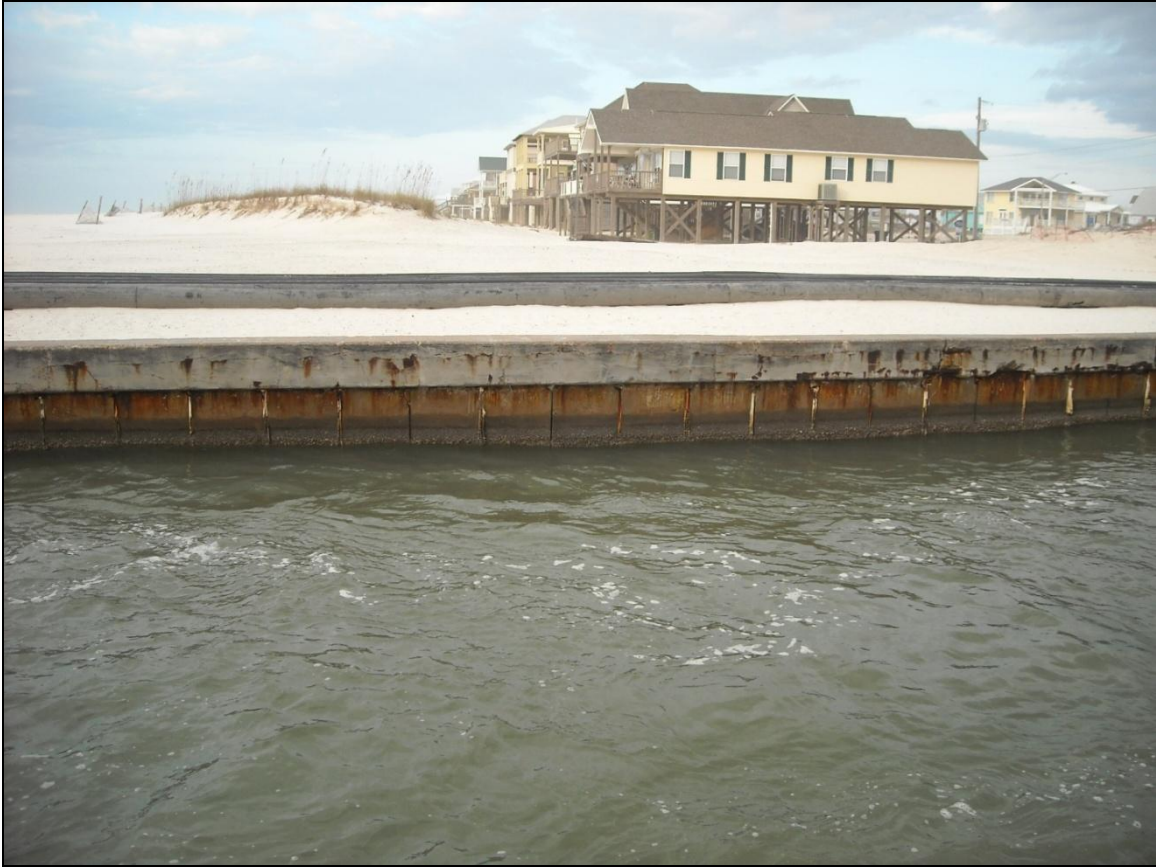
Figure V-26. Example of Concrete Sheet Piles

Sea water, which is rich in chlorides and sulphates, can corrode the reinforcement. Deterioration can also occur from alkali aggregate reactivity. Admixtures should be added to the concrete to counteract these effects; however, care should be taken when selecting the admixtures so they do not adversely affect the performance of the concrete.
