North Carolina Coastal Resources Commission

WORKING DRAFT REPORT TERMINAL GROIN STUDY

February 1, 2010

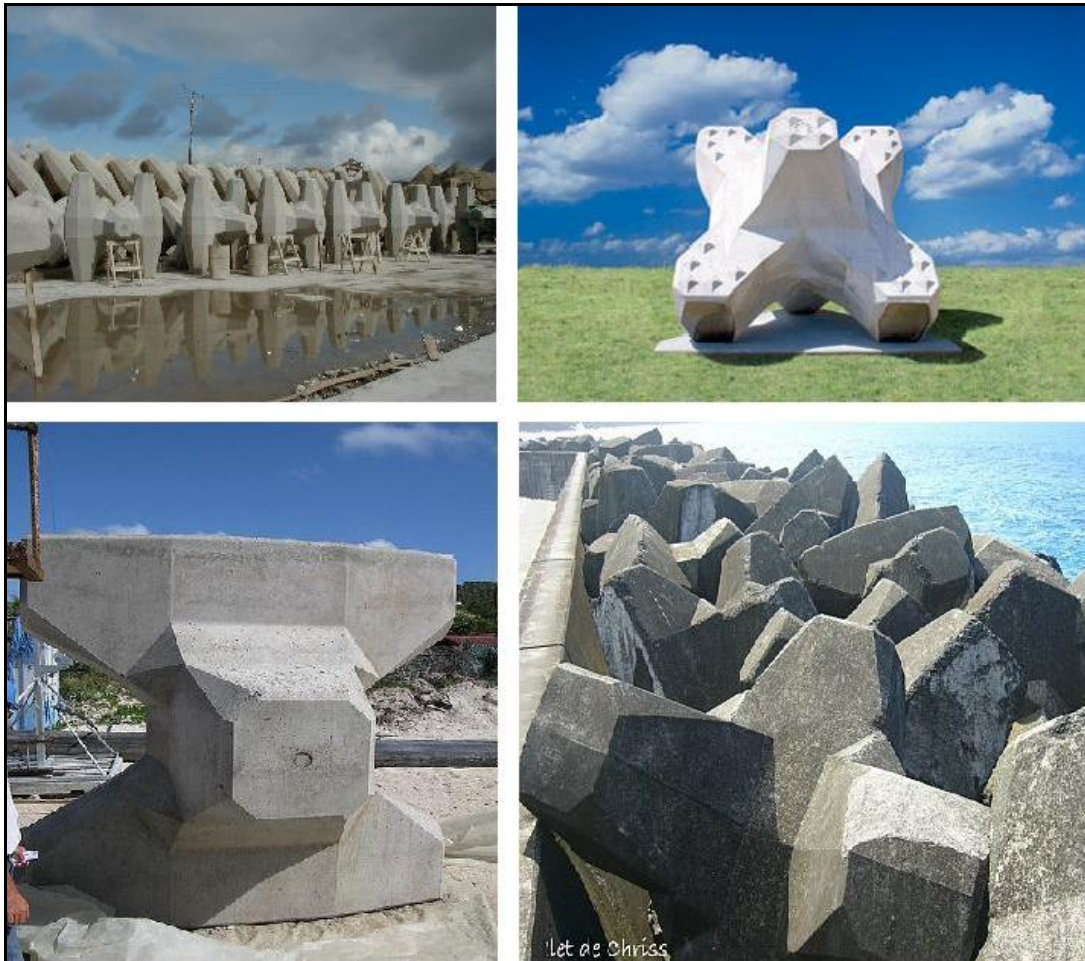
Figure V-27. Examples of Concrete Armor Units

Concrete armor units are man-made concrete objects designed to resist the action of waves on coastal structures. The armor units are applied in a single layer. The performance of these units greatly depends on accurate positioning of the individual blocks to enable the full interlocking potential. Specific placing must be strictly maintained during construction to ensure stability of the armor layer. Breakage can occur if the units are not installed properly (Boorman, 1996; Bunker, 1996; & USACE, 2002). Figure V-27 shows some examples of different concrete armor units.

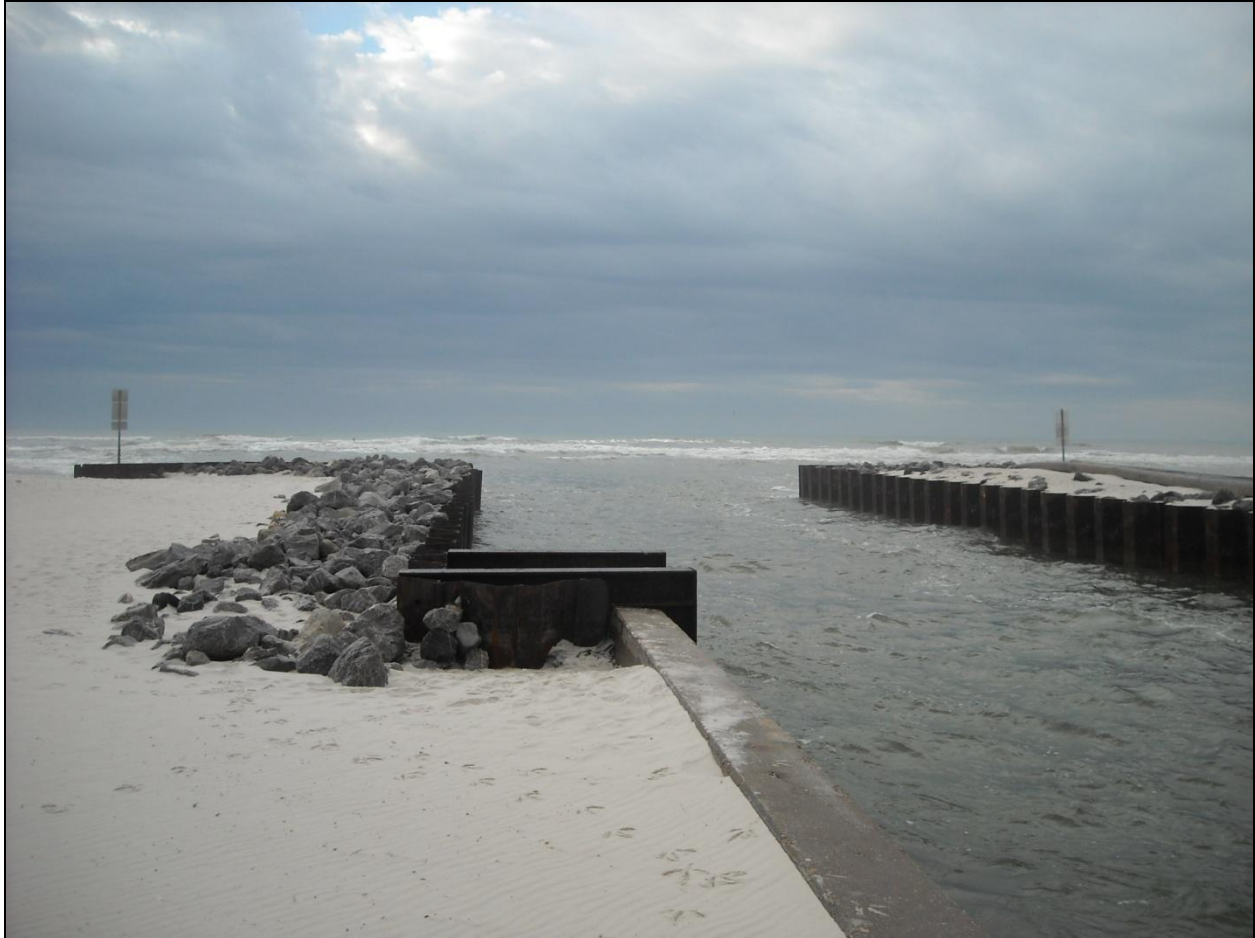
Figure V-28. Example of Steel Sheet Pile Terminal Groin

Steel groins may be comprised of sheet pilings, H-piling, waling, and sheeting; or a combination of all of the above. Steel sheeting, pilings, and sheeting are fairly quick and simple to install with pile drivers or vibratory equipment. Factory-produced materials can be delivered onsite with known properties, making quality control more reliable than other building materials. Steel has high strength and stiffness, with good ductility; however, it readily corrodes in a marine environment. Steel must be coated with an epoxy finish to keep it from corroding in saltwater. Steel groins can also have concrete fascias and caps to prevent corrosion (Spragg, 1993). Figure V-28 illustrates an example of a steel sheet pile terminal groin.

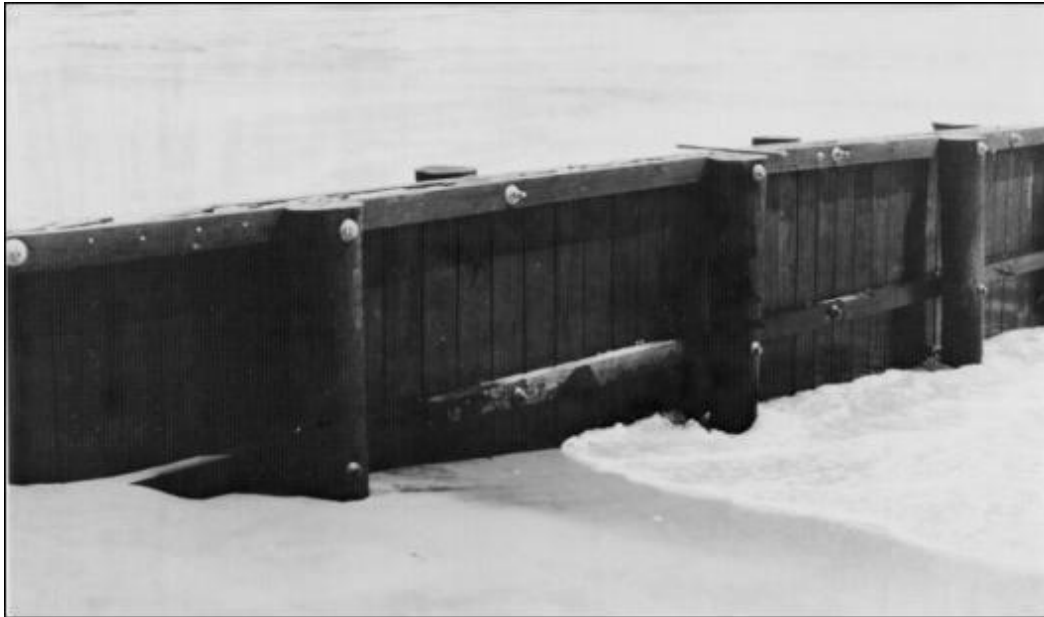
Figure V-29. Example of a Timber Groin

A potential low-cost material available for construction is timber. Timber groin configurations can have single or multiple rows of pilings. Timber groins can also have planks between the pilings which can be removed easily to vary the height of the groin with the beach level, making the groin adjustable in different beach conditions without having to rebuild or remodel the groin. Timber groins are relatively easy to construct, have a smaller footprint, and are more aesthetically pleasing than some of their counterparts (Perdok, 2003).

Timber does have several disadvantages, including, attack from physical damage, fungal decay, rotting, and marine borers. Timber also has a very limited structural application; that is where applied loads are low. Timber cannot withstand the same forces that rock, steel, or concrete groins can, and should not be used for construction of deep water groins (Spragg, 1993).

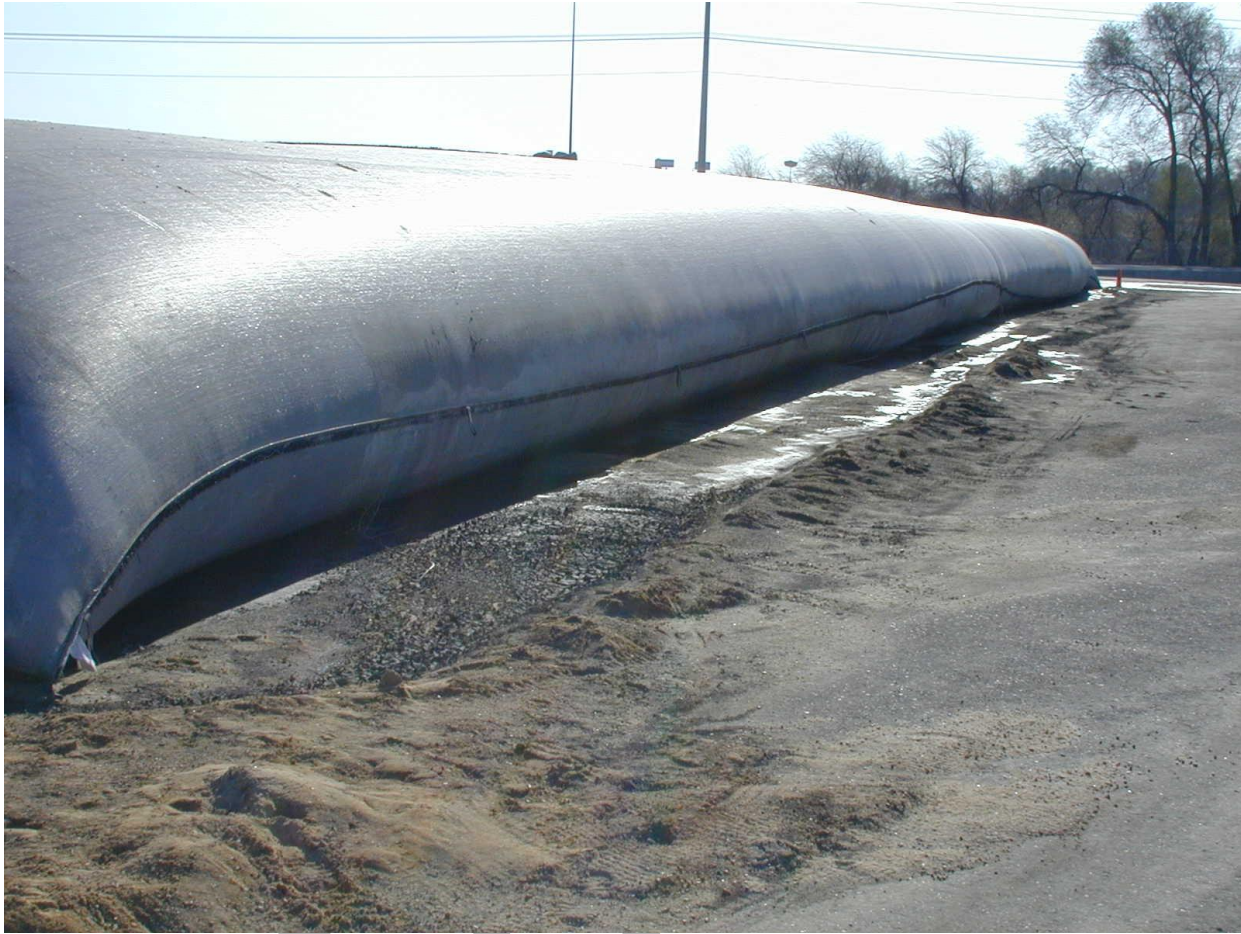
Figure V-30. Example of a Geotextile Tube

The major disadvantage to geotextiles is the ease of tearing or puncturing of the fabric during and after construction. Geotextiles also tend to degrade in UV light. Repairing damaged portions of geotextile tubes usually requires replacing or rebuilding the damaged sections. Patching geotextiles has proven ineffective in the past; however new technologies such as chemical seaming and HDPE covers may prove to be viable options to repair punctures and tears (Heilman, 2003). Another disadvantage to geotextile groins is, like timber, they cannot withstand larger loads and should not be used for deep water groins.

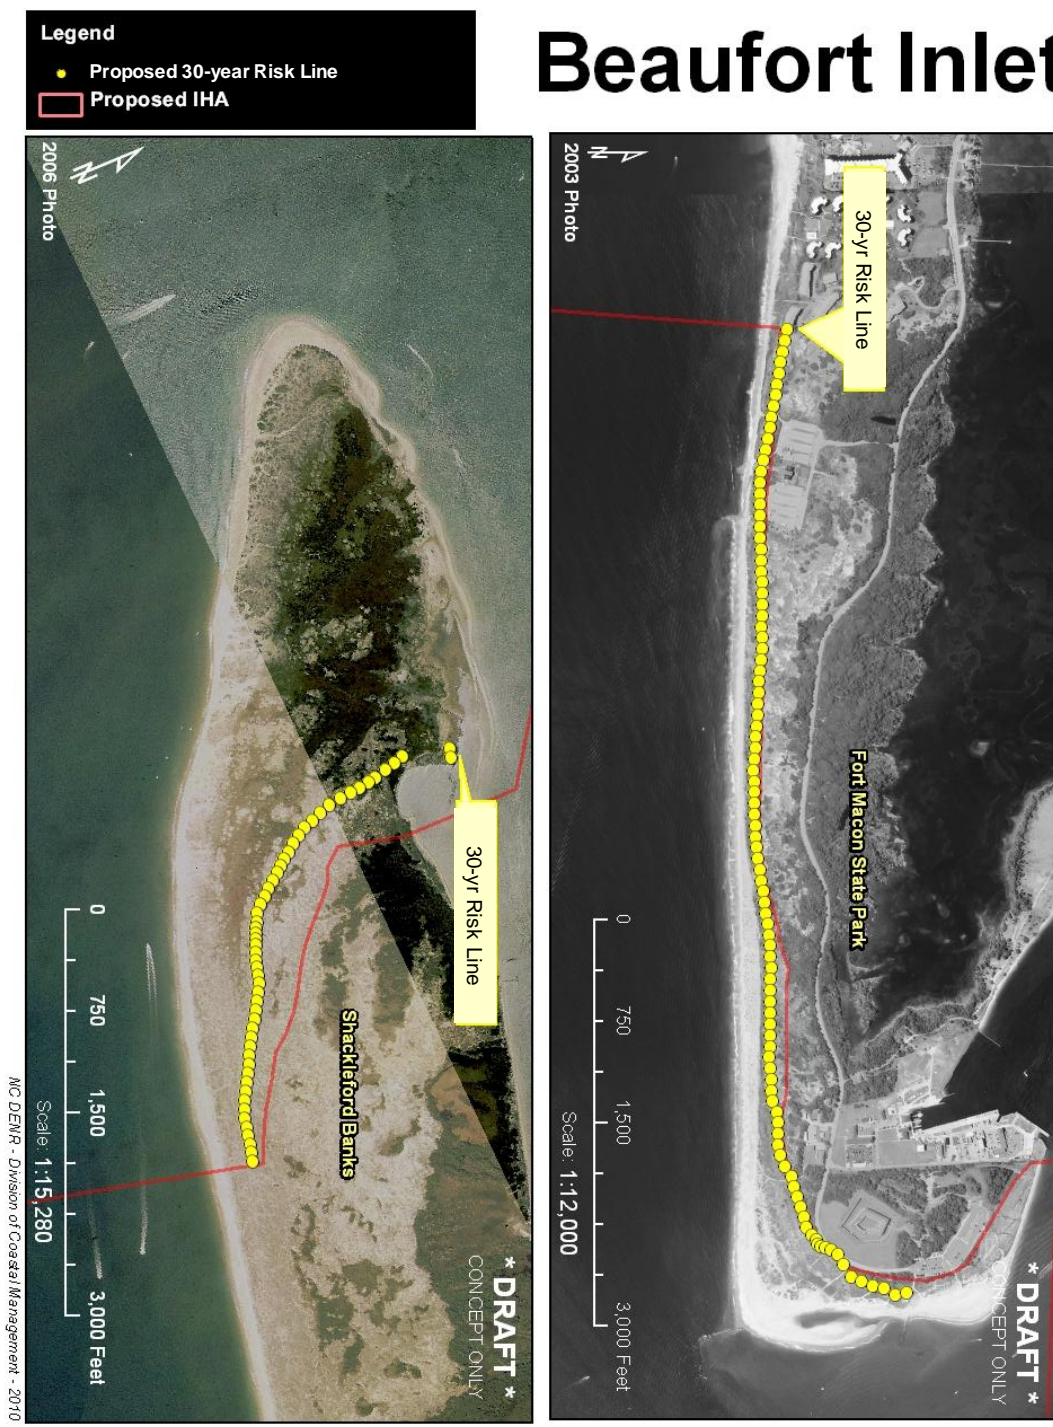
Figure VI-1. 30-yr Risk Line at Beaufort Inlet

Length (ft)	300	-----
Replacement Cost / ft	\$568	-----
Total Value	\$170,000	-----
<i>Waterline Infrastructure Value</i>		
Type	Typical	None (undeveloped island)
Length (ft)	300	-----
Replacement Cost / ft	\$55	-----
Total Value	\$17,000	-----
<i>Sewer Infrastructure Value</i>		
Type	None known. (Park on package system outside 30-yr risk line.)	None (undeveloped island)
Length (ft)	-----	-----
Replacement Cost / ft	-----	-----
Total Value	-----	-----
GRAND TOTAL VALUE	\$187,000	None (undeveloped island)

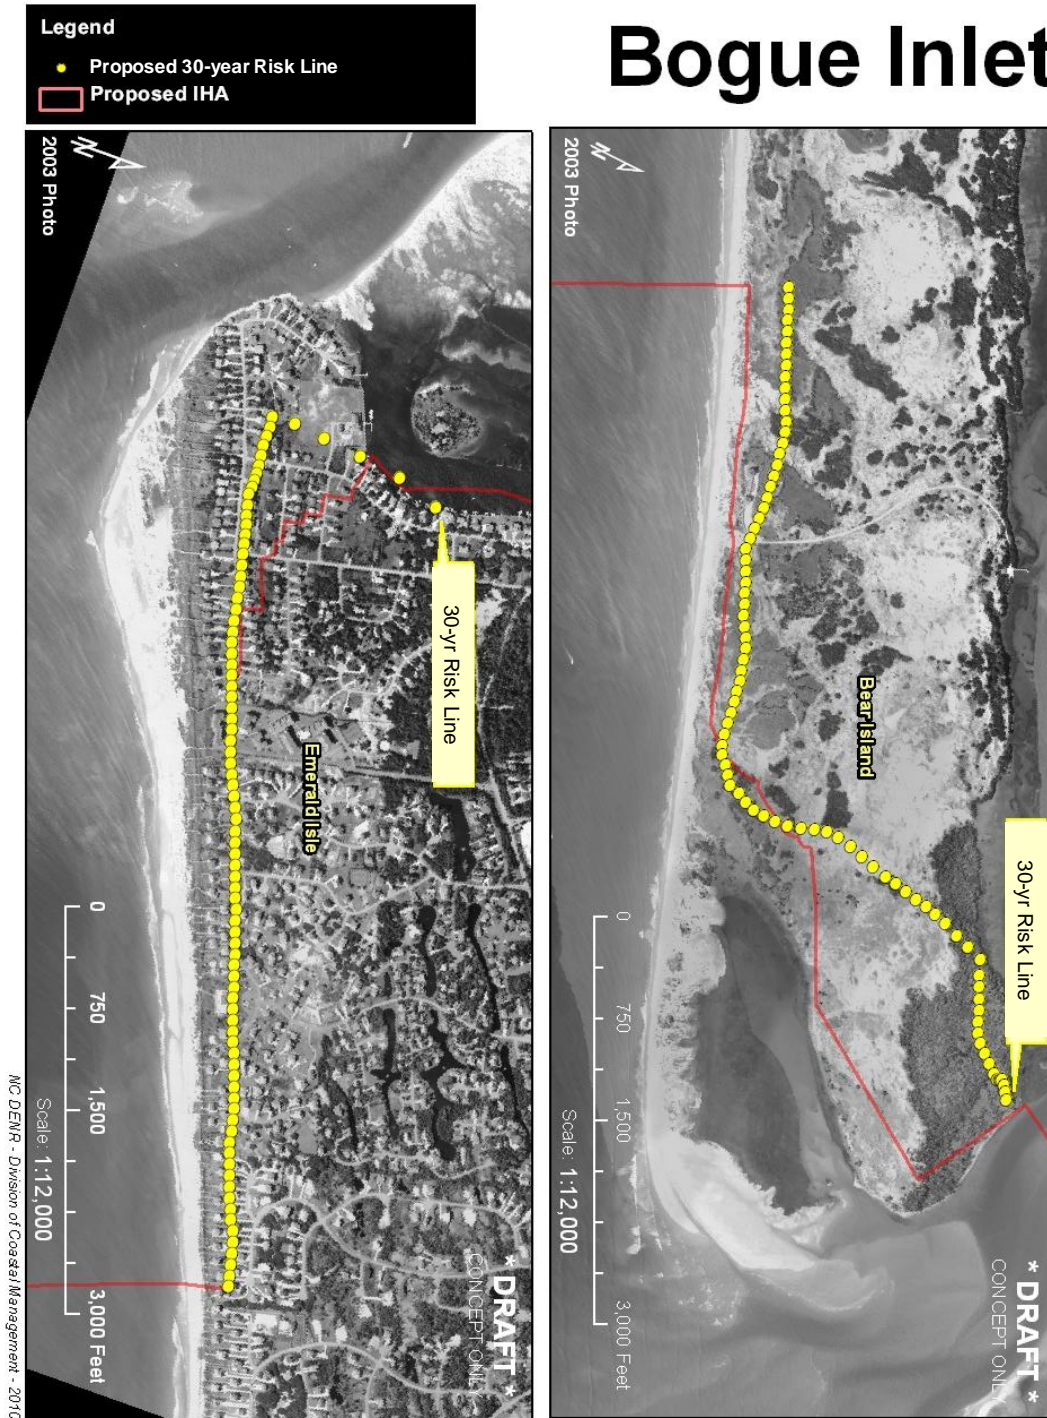
Figure VI-2. 30-yr Risk Line at Bogue Inlet

<i>Waterline Infrastructure Value</i>		
Type	None (undeveloped island)	Typical
Length (ft)	-----	5818
Replacement Cost / ft	-----	\$55
Total Value	-----	\$319,990
<i>Sewer Infrastructure Value</i>		
Type	None (undeveloped island)	Typical
Length (ft)	-----	5818
Replacement Cost / ft	-----	\$150
Total Value	-----	\$872,700
GRAND TOTAL VALUE	None (undeveloped island)	\$93,947,314

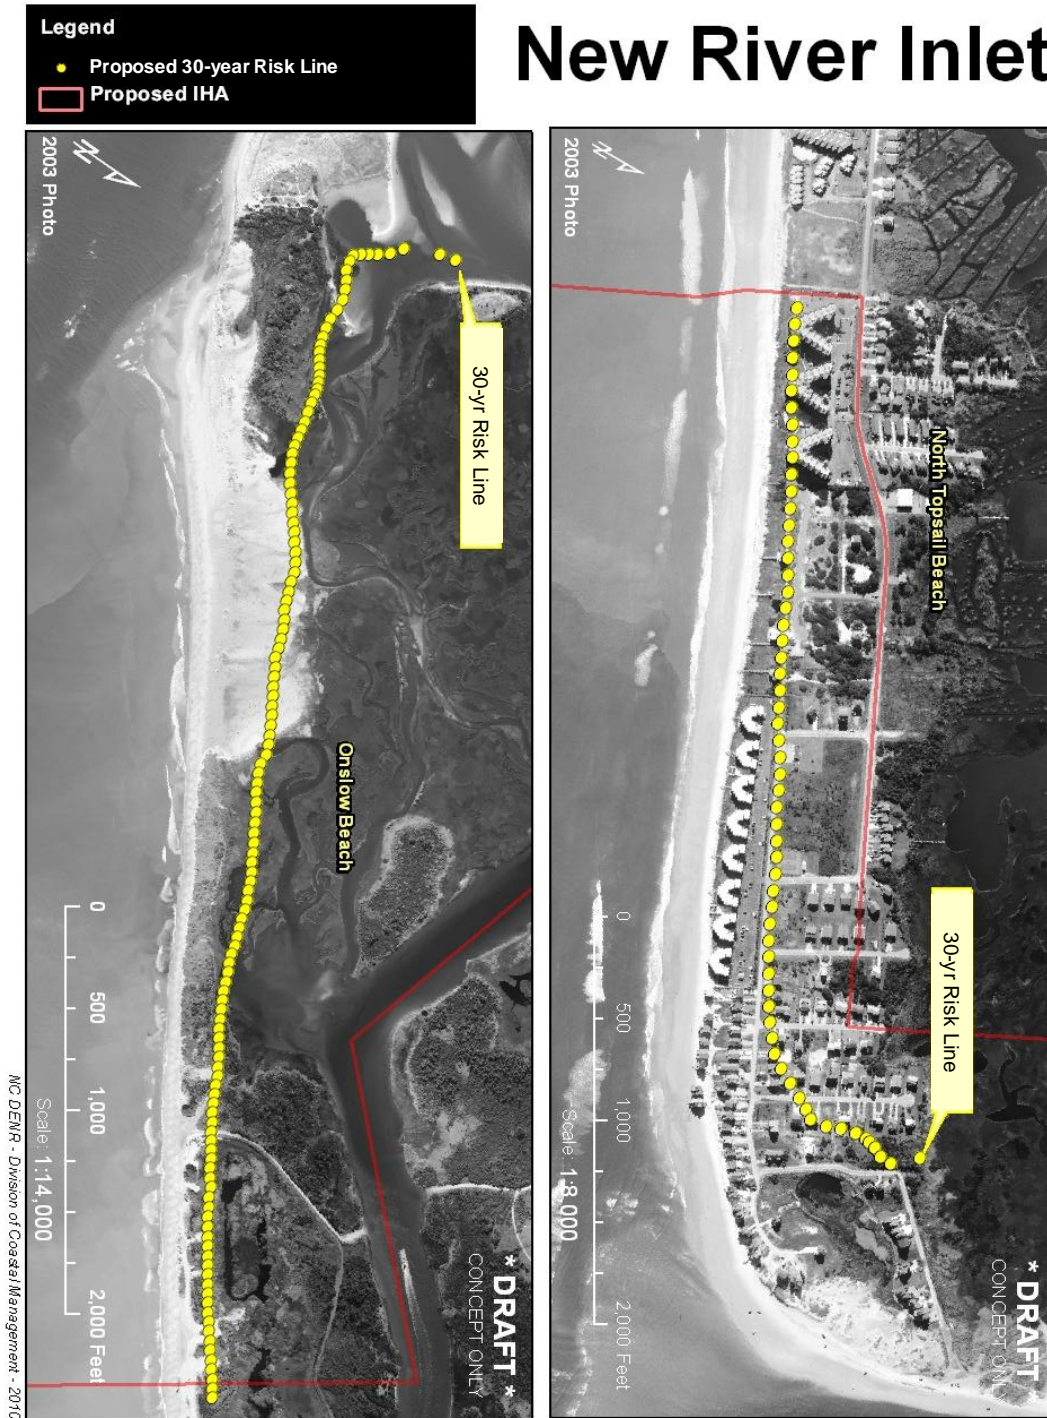
Figure VI-3. 30-yr Risk Line at New River Inlet

Value Type	North Side of Inlet (Onslow Beach side)	South Side of Inlet (North Topsail Beach Side)
<i>Residential Property Value</i>		
Number of Parcels	None (undev. military land)	136 residential single fam. 240 condo units
Land Value	-----	\$24,773,765
Structure Value	-----	\$41,666,597
Other Value	-----	\$377,331
Total Value	-----	\$66,817,693
<i>Commercial Property Value</i>		
Number of Parcels	None (undev. military land)	None known.
Land Value	-----	-----
Structure Value	-----	-----
Other Value	-----	-----
Total Value	-----	-----
<i>Government Property Value</i>		
Number of Parcels	None (undev. military land)	None known.
Land Value	-----	-----
Structure Value	-----	-----
Other Value	-----	-----
Total Value	-----	-----
<i>Road Infrastructure Value</i>		
Type	None (undev. military land)	2-lane road w. 2' paved shoulders (no curb, gutter, parking or sidewalk)
Length (ft)	-----	4480
Replacement Cost / ft	-----	\$568

Total Value	-----	\$2,545,455
<i>Waterline Infrastructure Value</i>		
Type	None (undev. military land)	Typical
Length (ft)	-----	4480
Replacement Cost / ft	-----	\$55
Total Value	-----	\$246,400
<i>Sewer Infrastructure Value</i>		
Type	None (undev. military land)	Typical
Length (ft)	-----	4480
Replacement Cost / ft	-----	\$150
Total Value	-----	\$672,000
GRAND TOTAL VALUE	None (undev. military land)	\$70,281,548

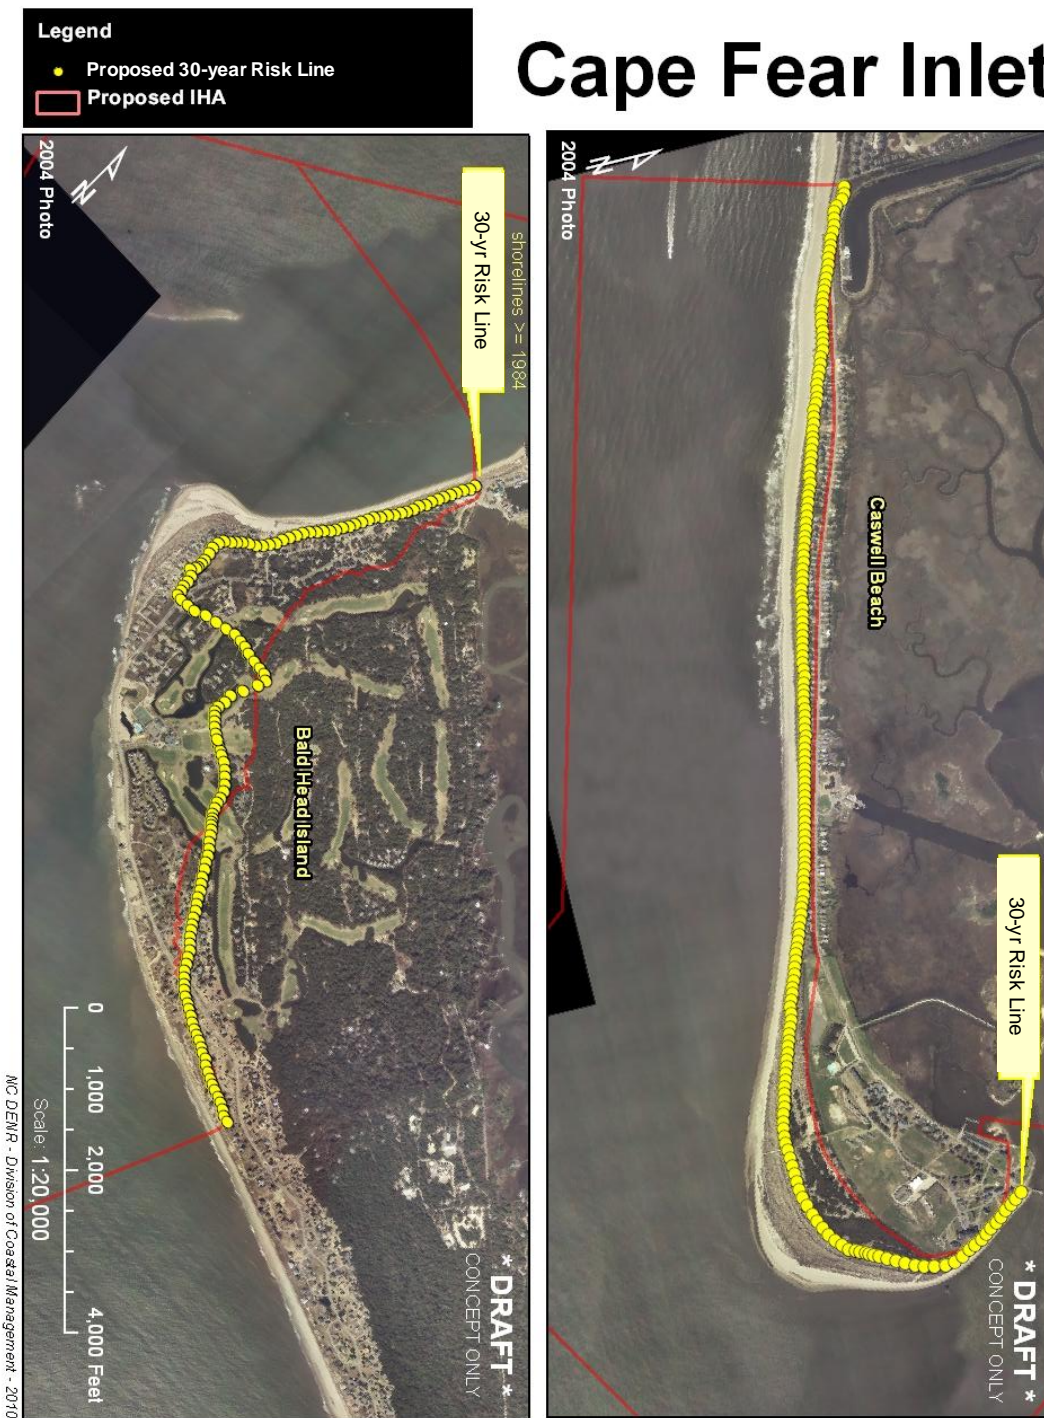
Figure VI-9. 30-yr Risk Line at Cape Fear Inlet

Value Type	West Side of Inlet (Caswell Beach side)	East Side of Inlet (Baldhead Island Side)
<i>Residential Property Value</i>		
Number of Parcels	100 residential	323 residential
Land Value	\$84,014,000	\$195,274,000
Structure Value	\$19,327,000	\$114,625,000
Other Value	\$877,000	\$833,000
Total Value	\$104,218,000	\$310,732,000
<i>Commercial Property Value</i>		
Number of Parcels	1 (Progress Energy)	2 (Bald Head Island Club)
Land Value	\$4,650,000	\$963,000
Structure Value	\$0	-----
Other Value	\$5000	\$525,000
Total Value	\$4,655,000	\$1,488,000
<i>Government Property Value</i>		
Number of Parcels	1 (Town of Caswell Beach) 1100 Caswell Beach Rd.	None known.
Land Value	\$8,280,000	-----
Structure Value	\$0	-----
Other Value	\$0	-----
Total Value	\$8,280,000	-----
<i>Road Infrastructure Value</i>		
Type	2-lane road w. 2' paved shoulders (no curb, gutter, parking or sidewalk)	2-lane road w. 2' paved shoulders (no curb, gutter, parking or sidewalk)

Length (ft)	1032	11990
Replacement Cost / ft	\$568	\$568
Total Value	\$586,000	\$6,813,000
<i>Waterline Infrastructure Value</i>		
Type	Typical	Typical
Length (ft)	1032	3750
Replacement Cost / ft	\$55	\$55
Total Value	\$57,000	\$659,000
<i>Sewer Infrastructure Value</i>		
Type	Typical	Typical
Length (ft)	1032	3750
Replacement Cost / ft	\$150	\$150
Total Value	\$155,000	\$1,799,000
GRAND TOTAL VALUE	\$117,951,000	\$321,491,000

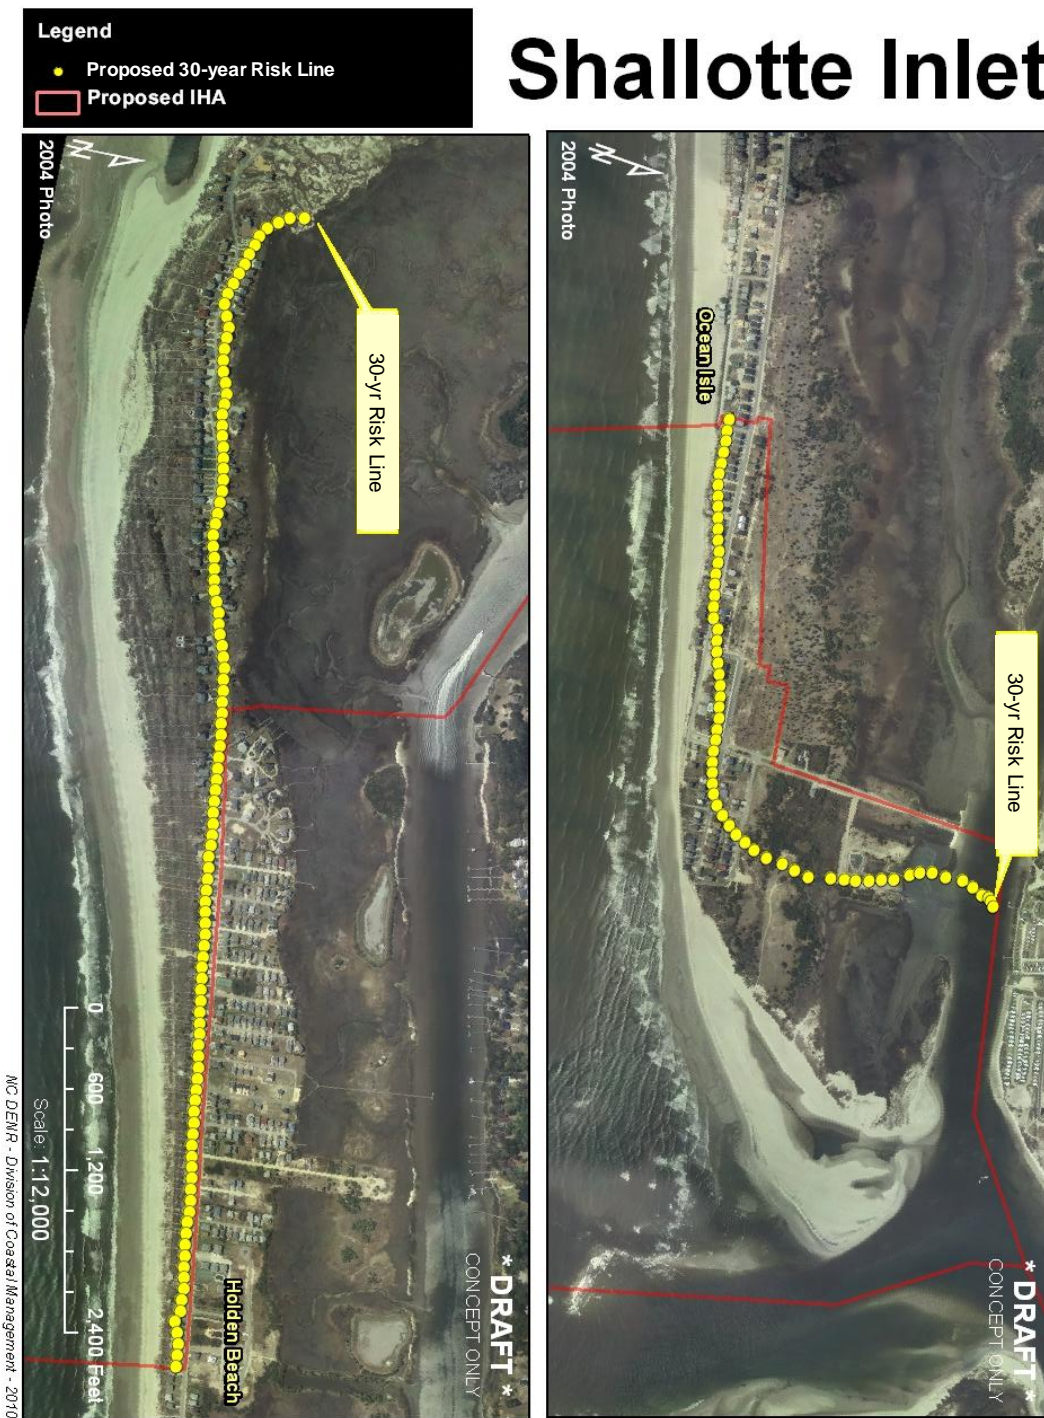
Figure VI-11. 30-yr Risk Line at Shallotte Inlet

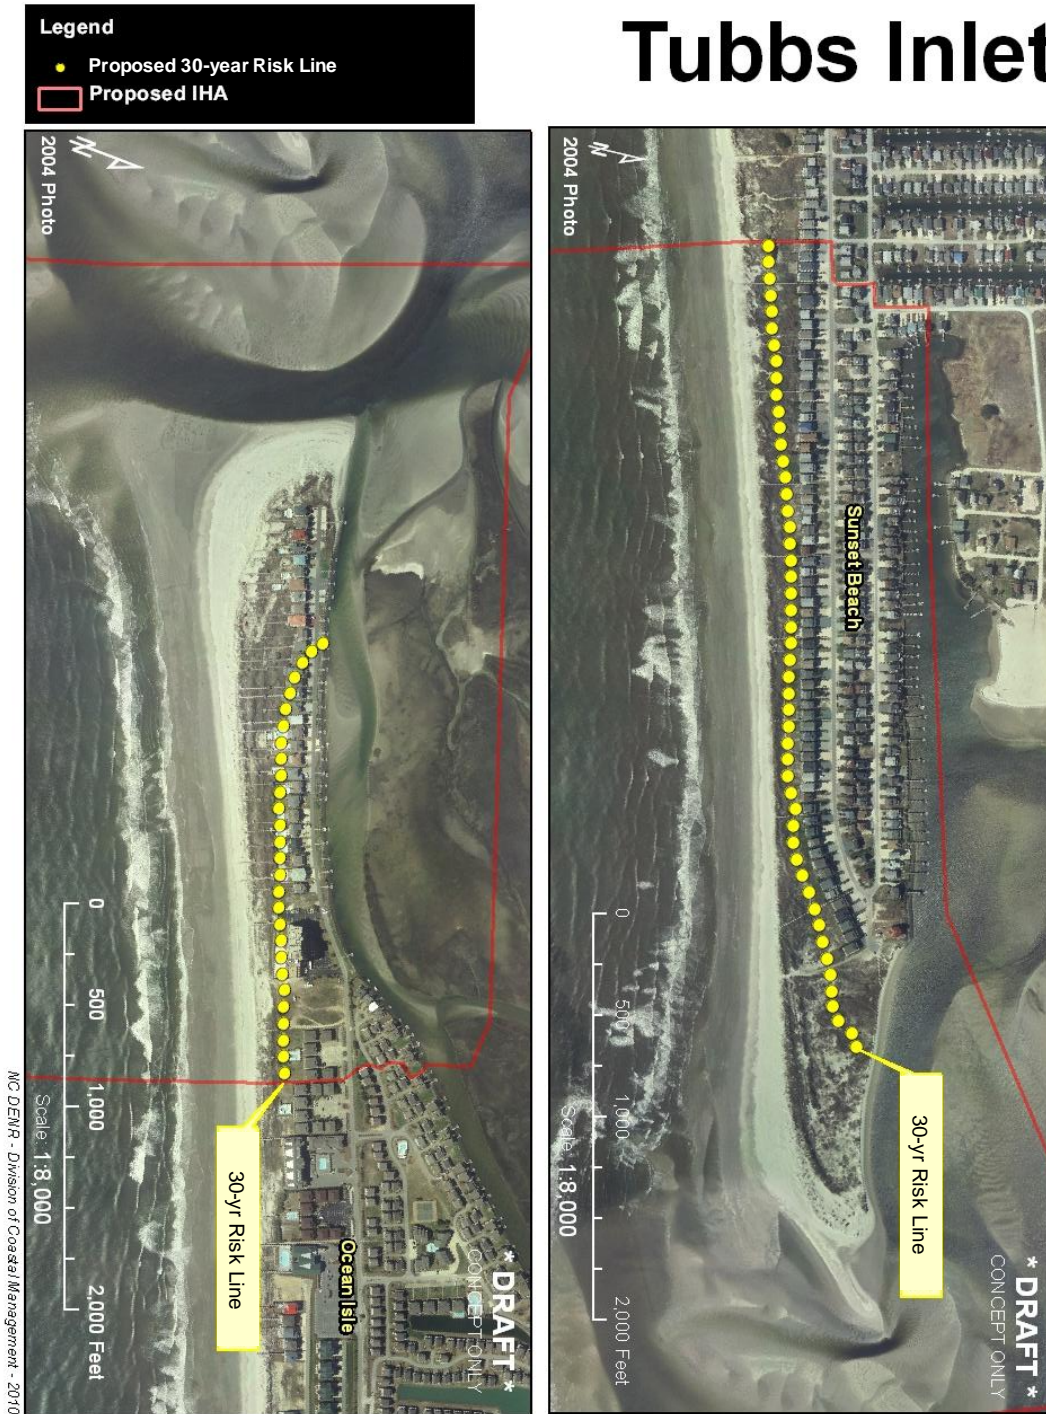
Figure VI-12. 30-yr Risk Line at Tubbs Inlet

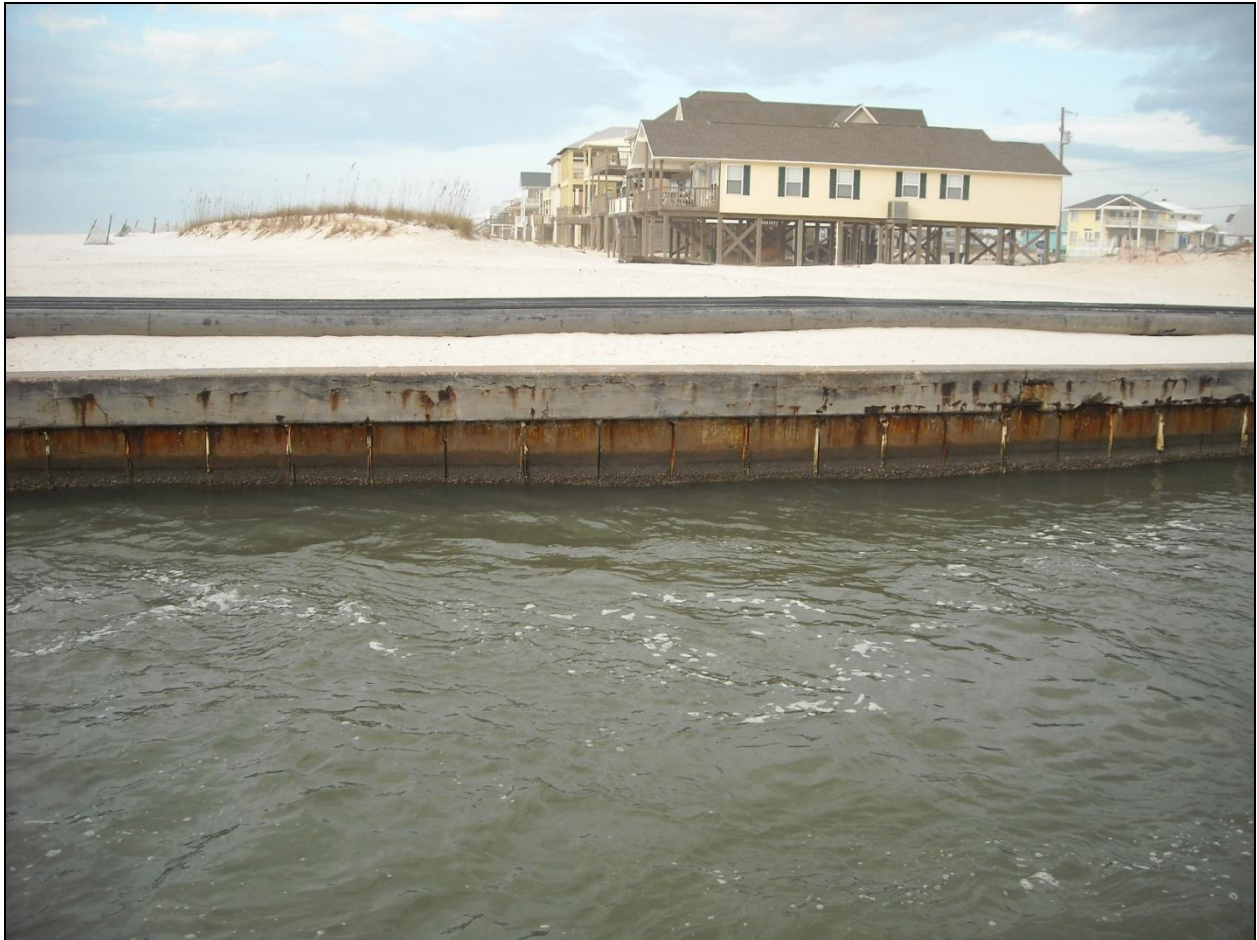
For a tied back concrete sheet pile groin, the unit cost is approximately \$4,600 per linear foot up to a height of 16 feet. Typically, concrete groins would not be used for greater heights. Figure VII-4 illustrates an example of concrete sheet piles.

Figure VII-4. Example of Concrete Sheet Piles

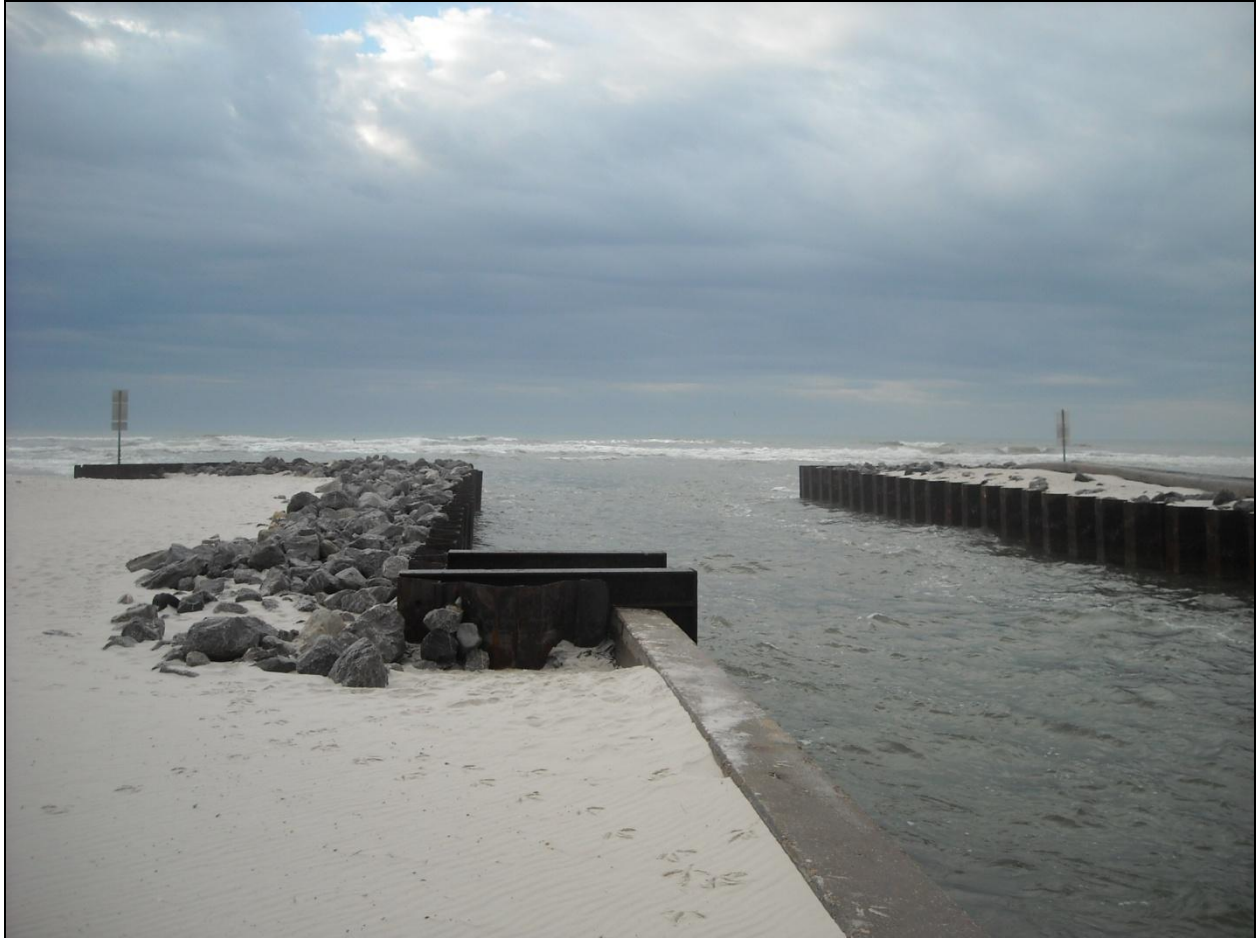
Steel groins may be as simple as a line of sheet piling, or a combination of H-piling, waling, and sheeting. Steel groins with sheeting can be adjusted in the field by removing or adding panels to optimize the groin performance. Steel groins usually must be coated with epoxy finish to prevent deterioration from salt water or use concrete fascia and caps. A steel groin with concrete fascia and cap is approximately \$4,000 per linear foot for groins up to 16 feet in height. Steel groins can be reinforced for use in greater depths of water; however, this is typically cost prohibitive to use for depths greater than 20 feet. Figure VII-5 illustrates an example of a steel sheet pile groin.

Figure VII-5. Example of Steel Sheet Pile Terminal Groins

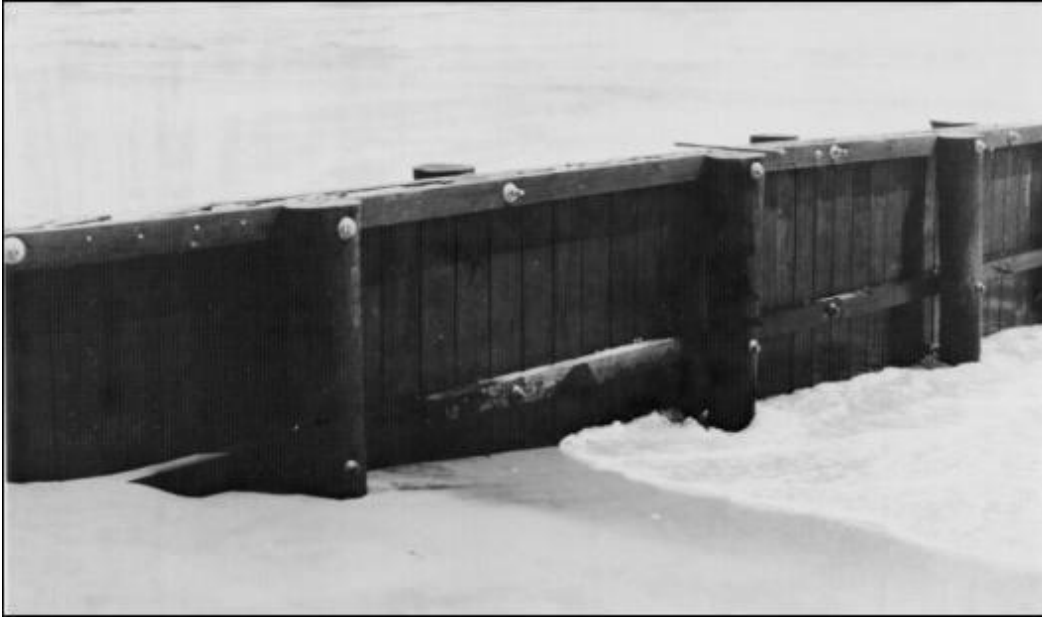
Timber is another viable option for construction material. Generally, timber groins have pilings in single or multiple rows. Timber groins can also have planks between the pilings which may be adjusted depending on the required height for the groin. However, timber cannot withstand the same loads that rock, steel, or concrete groins can withstand; therefore it should not be used for longer groins in deeper water. Typically, a timber groin would only be considered for water depths less than 10 feet. A timber pile groin's cost could range from approximately \$4,000 to \$5,000 per linear foot. Figure VII-6 illustrates an example of a timber groin with planks and pilings (taken from the Federal Highway Administration website).

Figure VII-6. Example of a Timber Groin

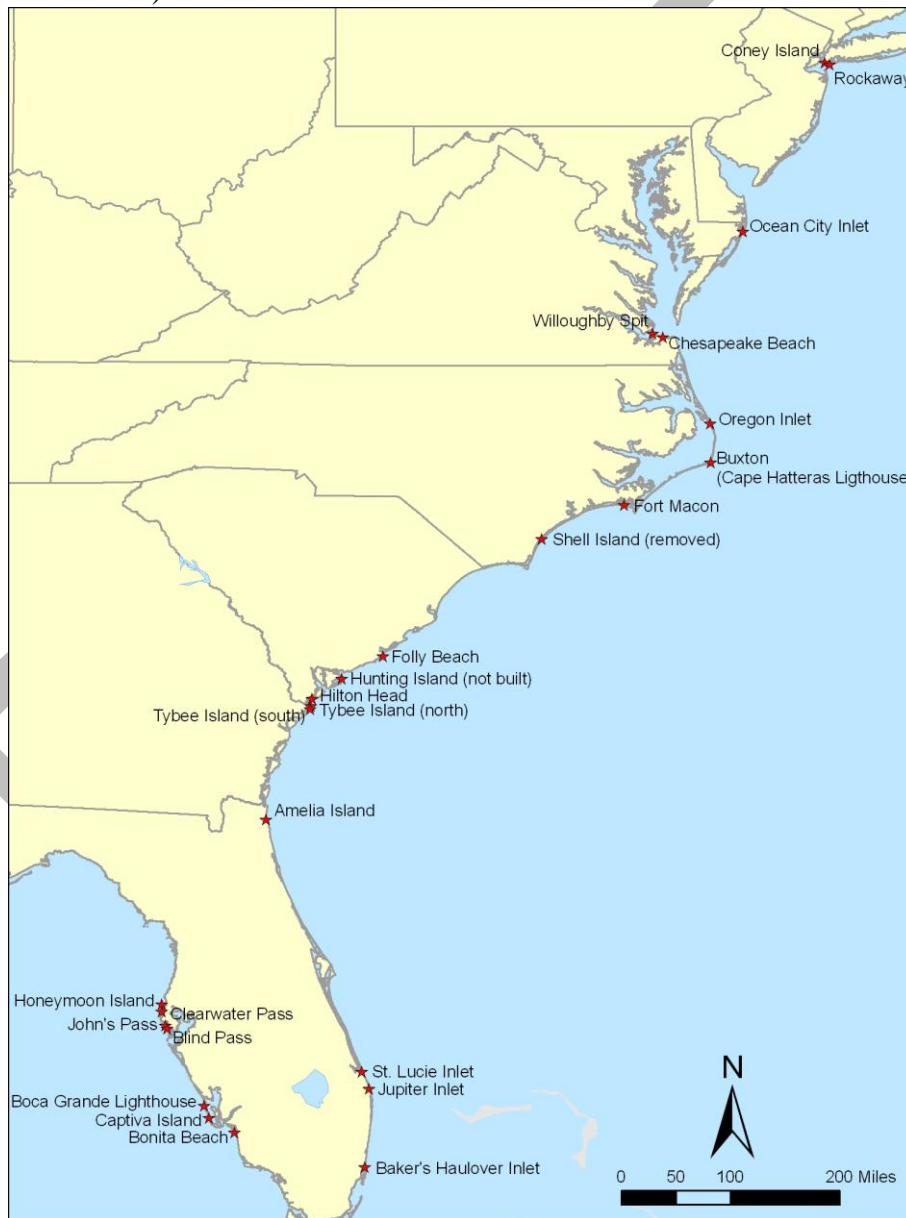
One of the first steps completed for this study was the documentation of terminal groin sites along the East and Gulf Coasts (Figure VIII-1). After an exhaustive review of the literature and multiple contacts with leading coastal experts, the following list of terminal structures was developed (Table VIII-1).

Figure VIII-1. Potential Study Sites
