Erosion Rates on Ocracoke at Hatteras Inlet

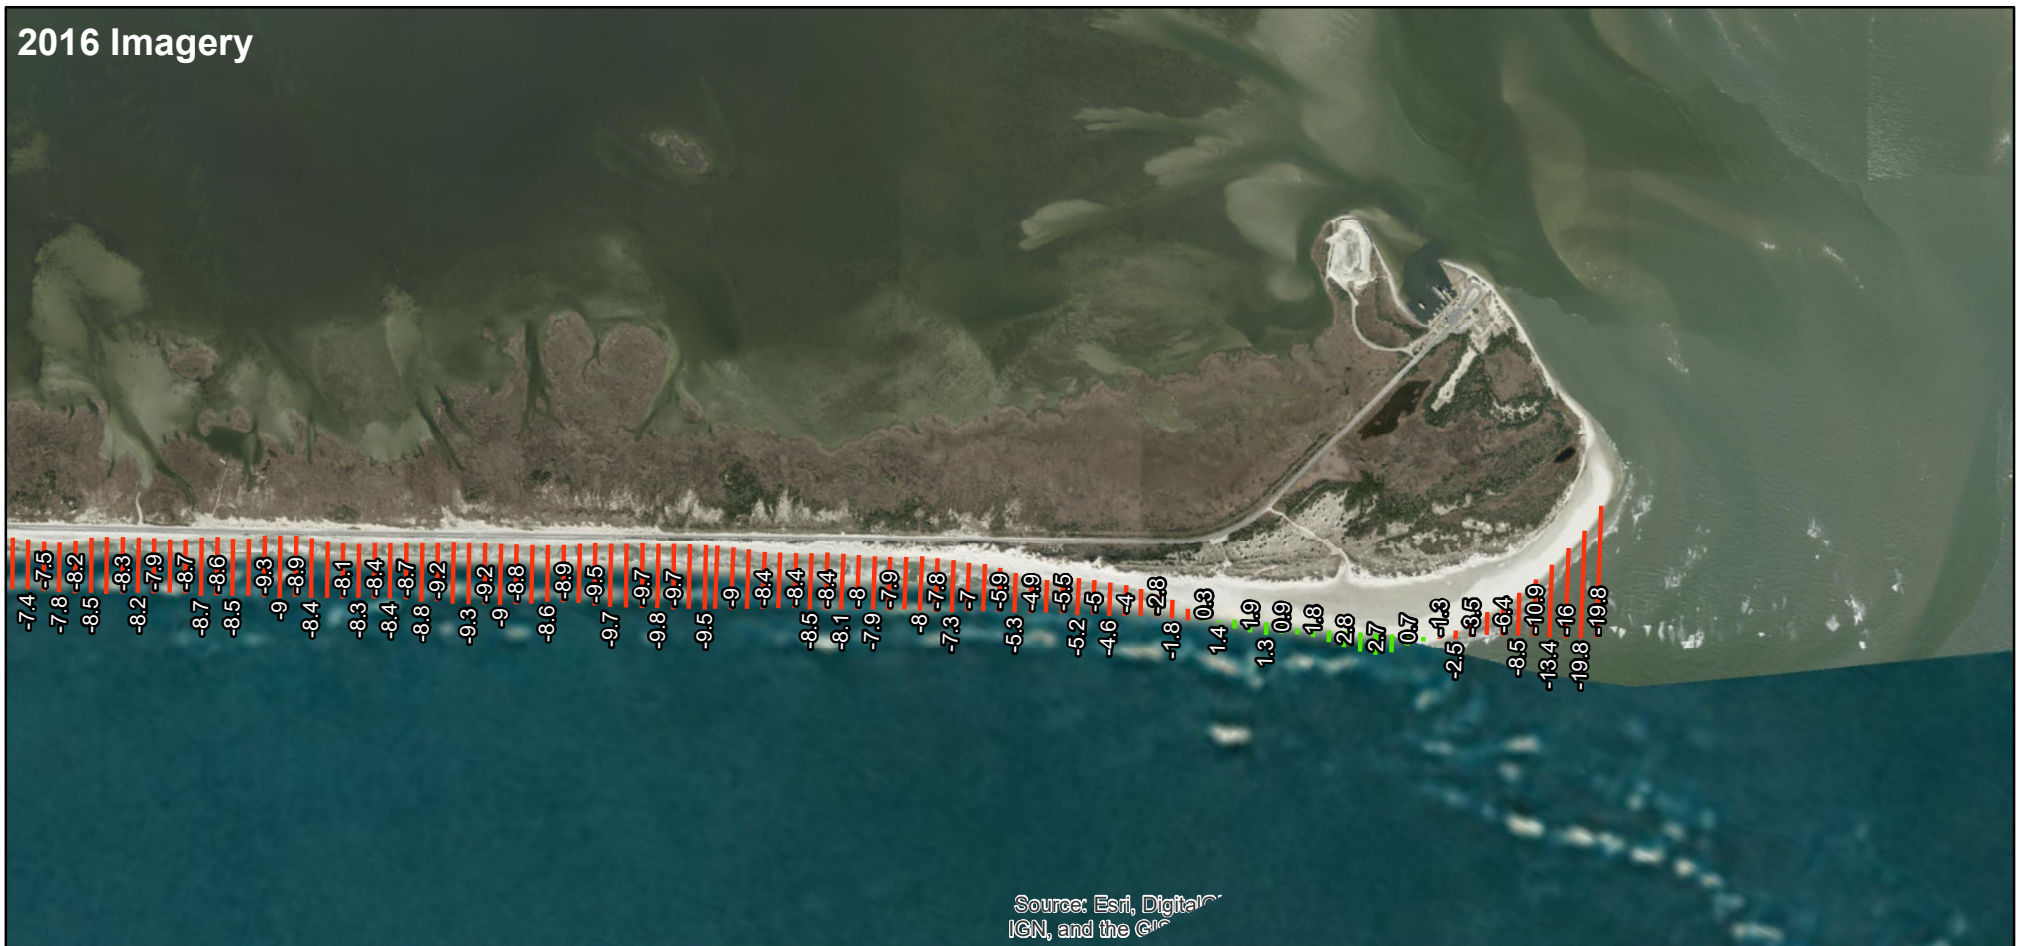
2016 Imagery

Along the Outer Banks, erosion rates can change significantly (increase or decrease) within a small geographic area. The area adjacent to Hatteras Inlet (see attached map) is one of those areas where the most recent erosion rate study measured the average erosion rate to be -6.6 feet per year with a maximum rate of -19.8 feet per year. These results are very consistent with those from the 2013 and 2004 studies that measured average annual erosion rates to be -6.7 ft/yr and -5.6 ft/yr respectively.

2020 Erosion Rates (feet/year)

Based on DCM's most recent oceanfront erosion rate study (effective April 1, 2020), Ocracoke's oceanfront is undeveloped, and its shoreline is approximately 16.3 miles in length. Approximately 11.5 miles (70.9%) of its shoreline resulted in measured erosion, while 4.2 miles (26.1%) resulted in measured accretion. The long-term average annual shoreline erosion rate for the entire Ocracoke oceanfront is -3.2 feet per year, with a measured maximum rate of -19.8 feet per year.
