RE: **Variance Request by the Town of North Topsail Beach (14-16)**

**Statement by Tom Jarrett, P.E., NC License No. 005545**  
**Subject: Erosion of the north end of North Topsail Beach**

NORTH TOPSAIL BEACH - PHASE 1 MONITORING  
BEACH PROFILES

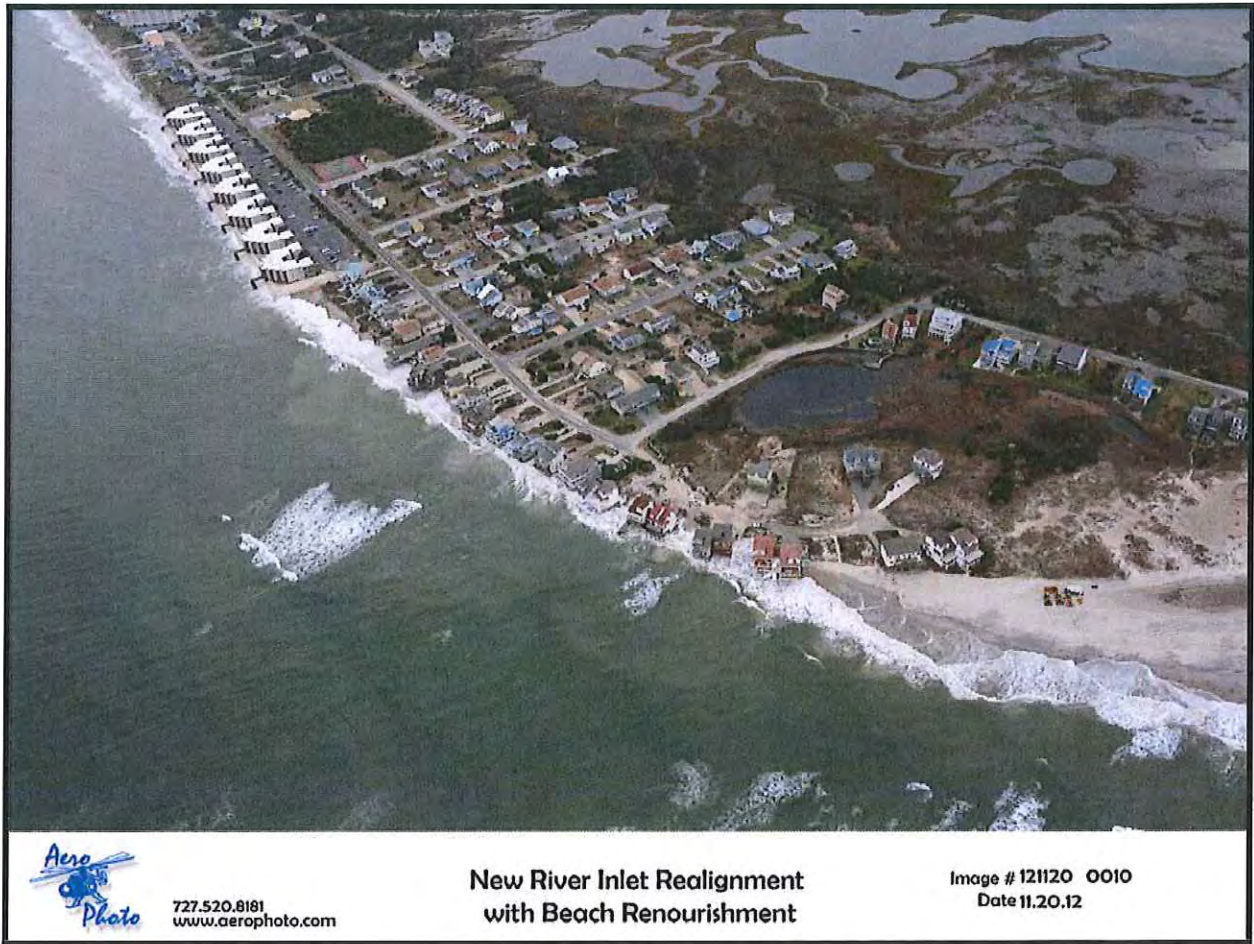
**EXHIBIT 1: Pre-Nourishment – November 2012. The eight buildings in the upper left of the photo are the Topsail Reef Condominiums.**

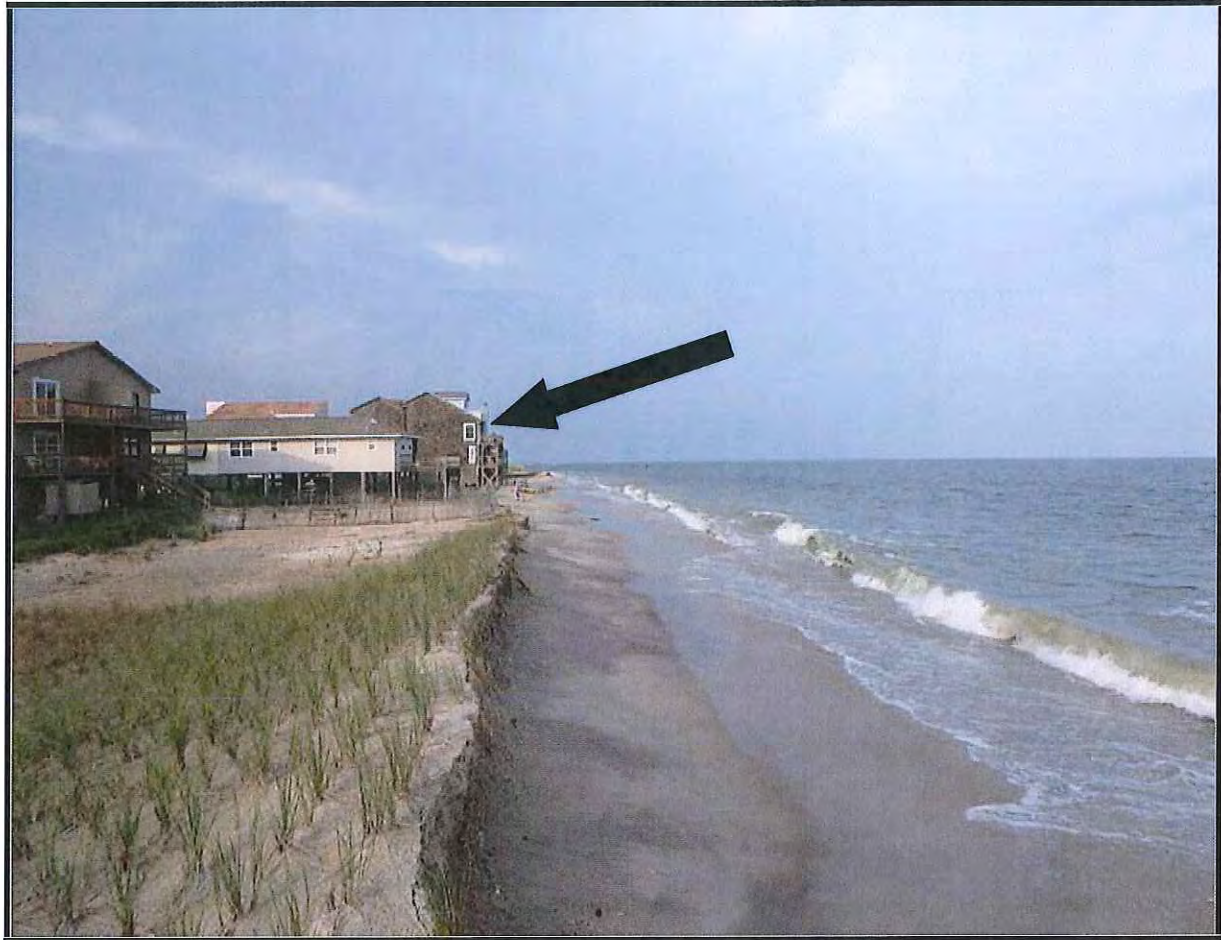
**EXHIBIT 3: View looking north of Topsail Reef Building #1 – August 7, 2014. Arrow identifies house shown in Photo No. 4.**

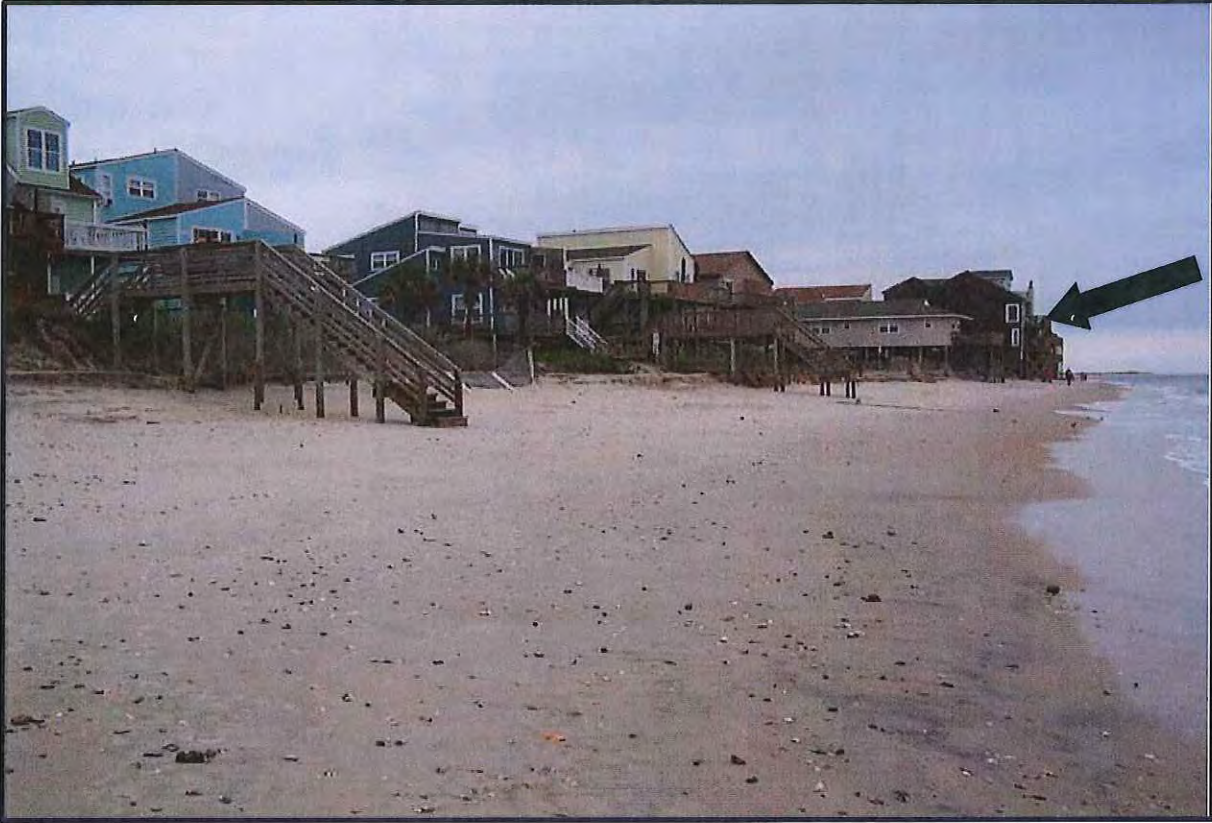
EXHIBIT 3a: Condition as of September 14, 2014

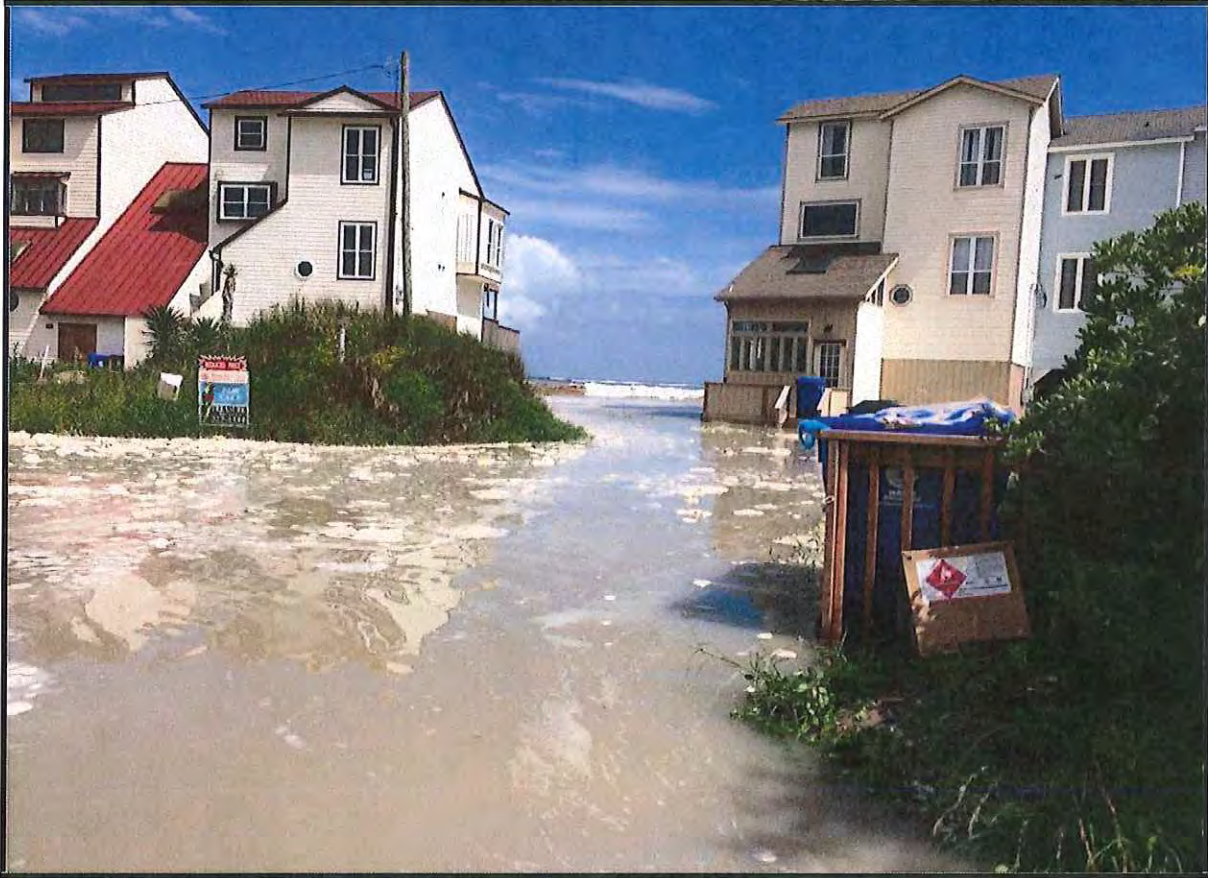
**EXHIBIT 6: Flooding on north end of North Topsail Beach – August 5, 2014.**

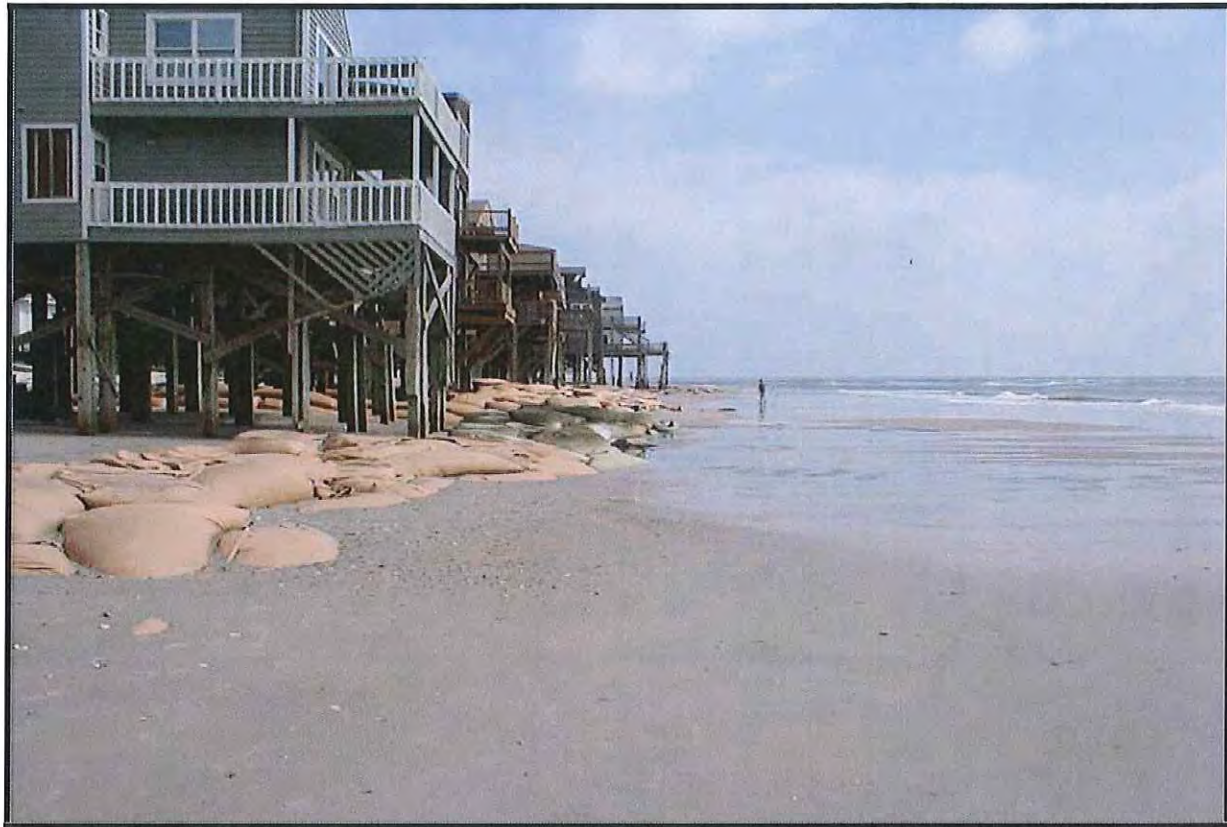
**EXHIBIT 7: Example of failed sandbag revetment on north end of North Topsail Beach. Photo taken in September 2005. All of these sandbags and structures, which were located seaward of the present row of homes north of Topsail Reef, have been removed.**

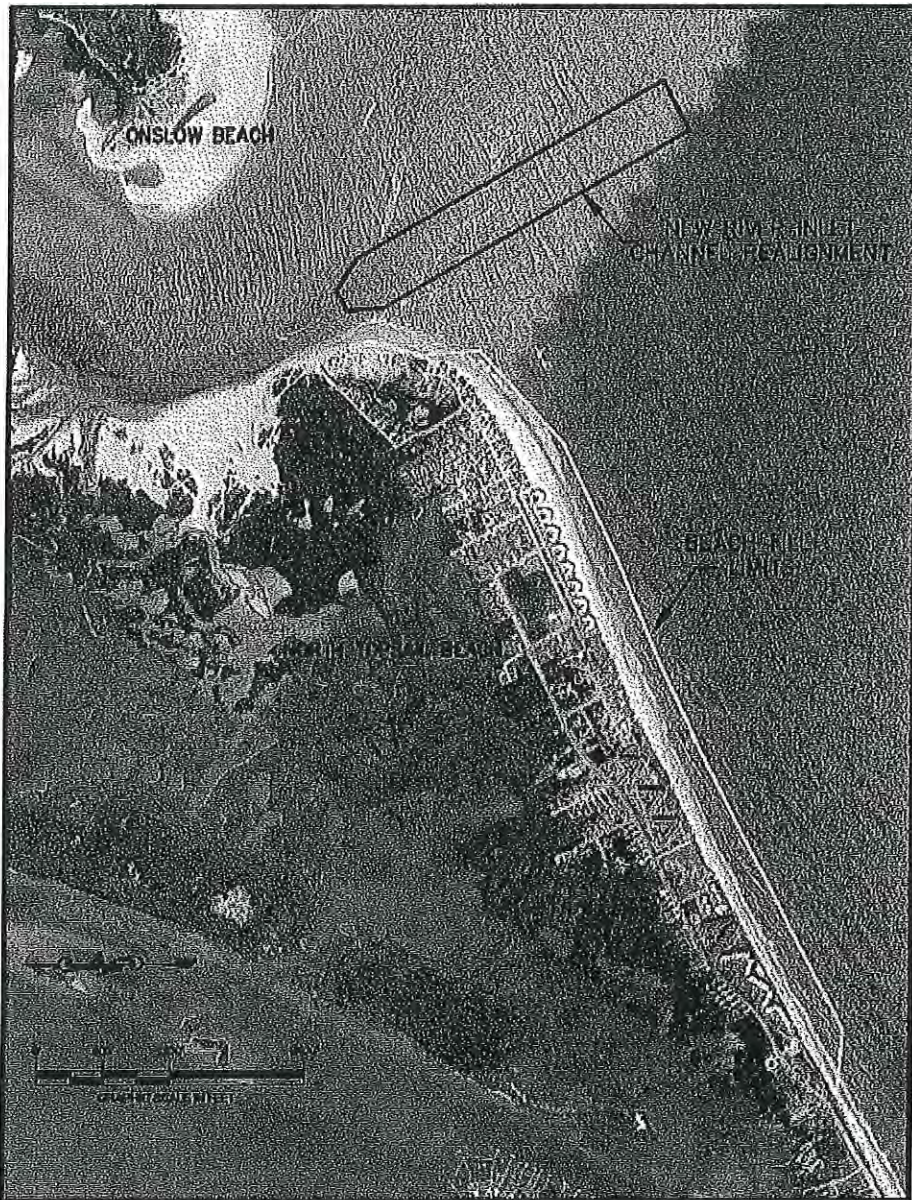
**Figure 1. Plan view of Phase 1 of the North Topsail Beach Shoreline and Inlet Management Plan.**

The Town of North Topsail Beach completed Phase 1 of its multifaceted inlet and shoreline management plan in February 2013 with the repositioning of the New River Inlet ocean bar channel to a more central location between the south end of Onslow Beach and the north end of North Topsail Beach. The location of the new channel and the area nourished by with the material removed to relocate the channel is provided on Figure 1. The conditions of the north end of North Topsail Beach before and after the construction of Phase 1 are shown on Figures 2 and 3, respectively.

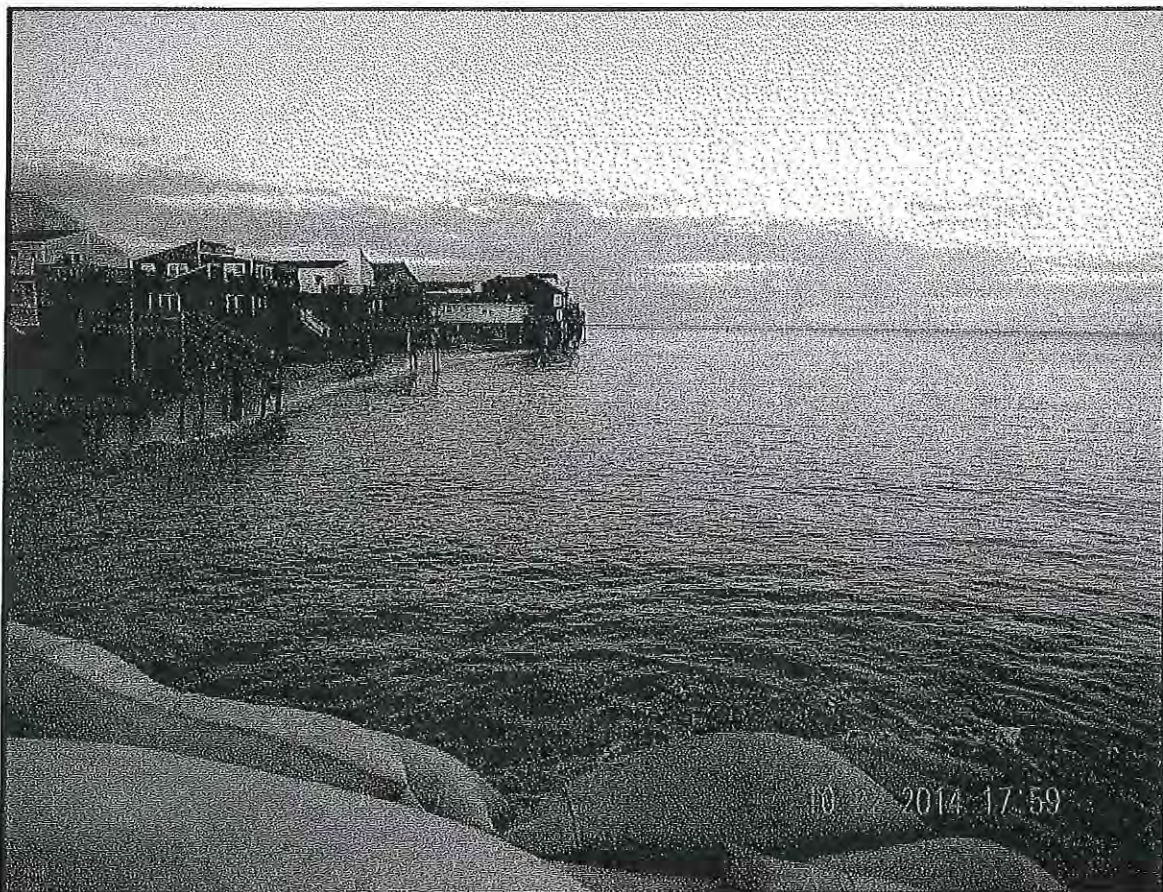
Figure 12. October 22, 2014 photo looking north from Building #1 of Topsail Reef.

Monitoring of the inlet has demonstrated some of the expected results are taking place with sand accumulating on the south side of the inlet, however, the rate of build-up, as predicted, has been relatively slow. As a result, the north end of North Topsail Beach has continued to experience high rates of erosion. As of October 2014, most of the fill placed north of the Topsail Reef Condominiums has been lost Figure 12.

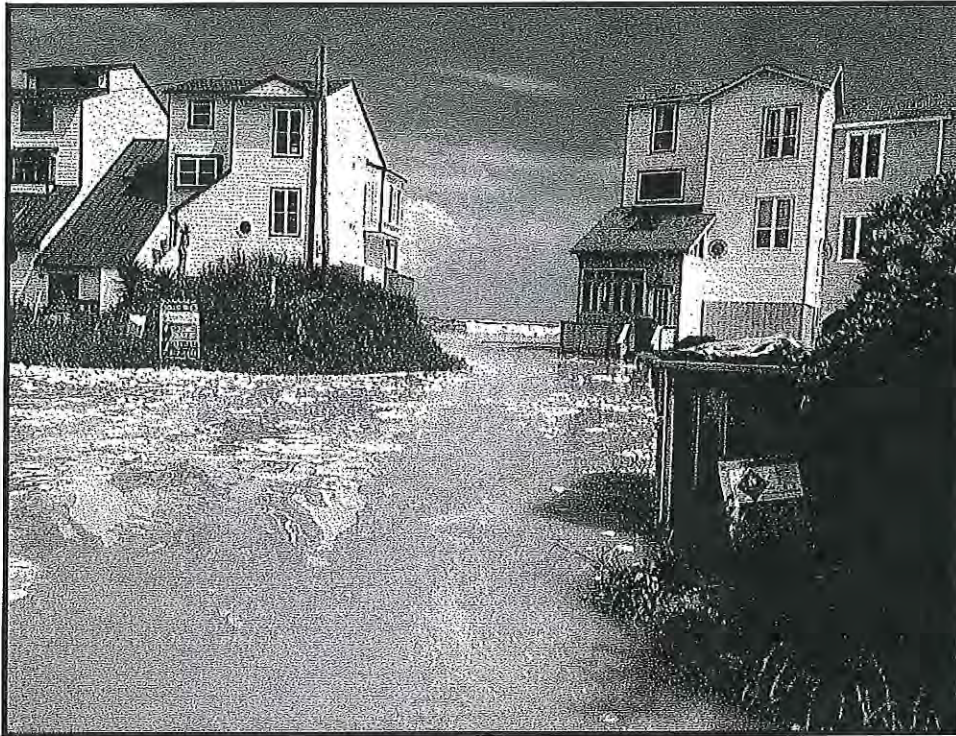
**Figure 13. Flooding on north end of North Topsail due to wave overwash.**

The loss of the beach fill has placed approximately 20 homes located north of Topsail Reef in imminent danger of being severely damaged or possibly destroyed. In addition to the threat to the homes, flooding of the area has been exasperated with flood waters spilling on to New River Inlet Road and side streets (Figure 13).

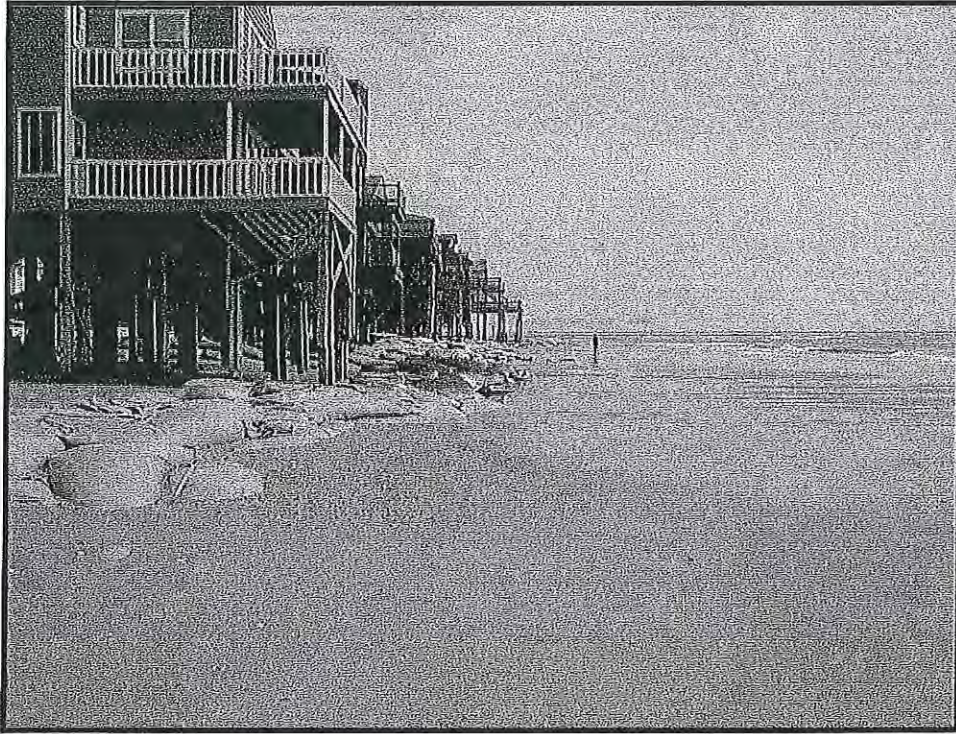
Figure 14. Example of failed sandbag revetment on north end of North Topsail Beach.

The temporary sand bag revetment allowed under CAMA (15A NCAC 7H.1700), which is limited to a height of 6 feet above the existing ground and a maximum bottom width of 20 feet, in my opinion, is not adequate to provide the degree of protection deemed necessary to protect the 20 homes for the next 2.5 years. This is evident by the history of failure of previously permitted sandbag revetment in the area as demonstrated in Figure 14. The homes shown in Figure 14, which have since been removed, were positioned seaward of the 20 structures presently being threatened.

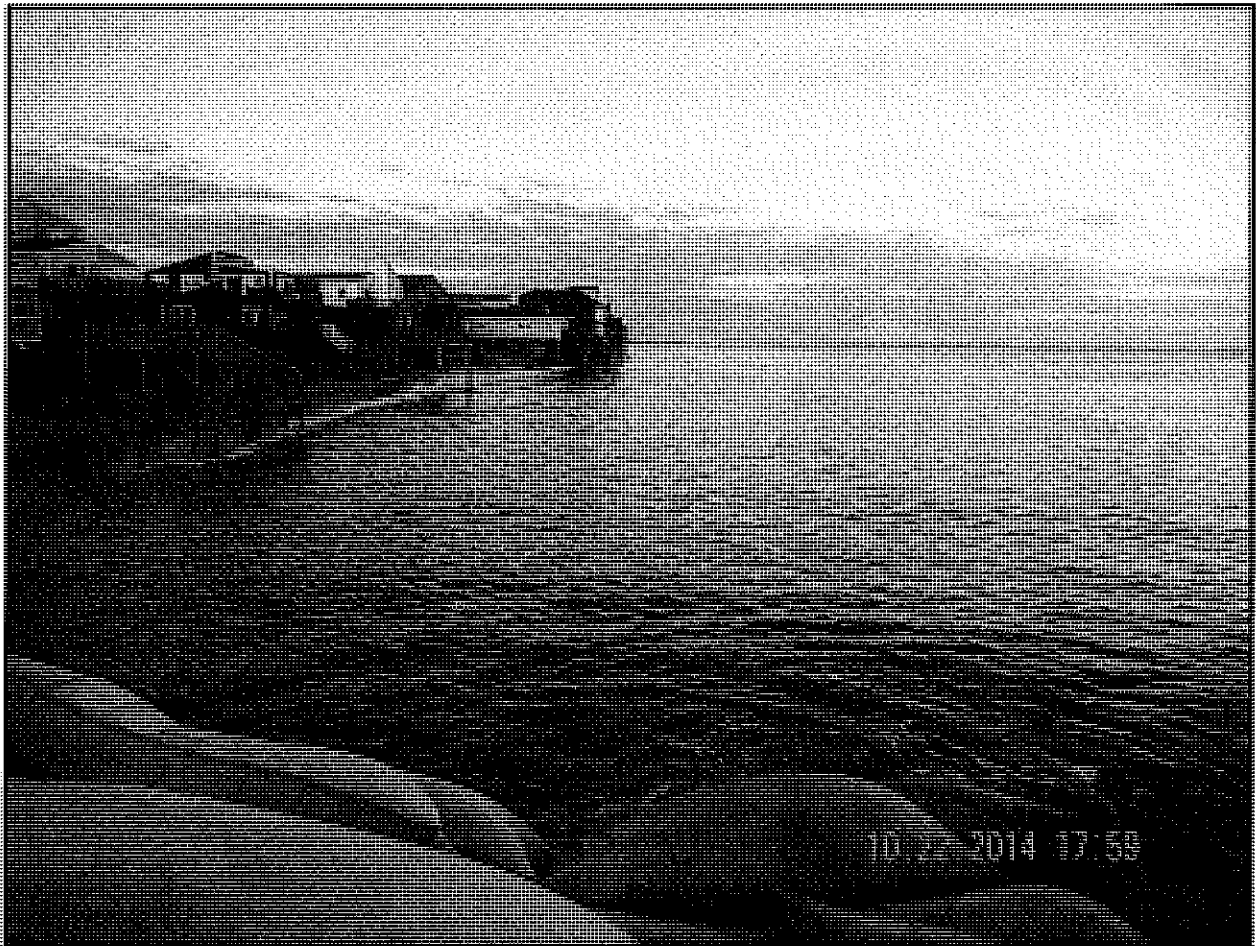
**Figure 12. October 22, 2014 photo looking north from Building #1 of Topsail Reef.**

Monitoring of the inlet has demonstrated some of the expected results are taking place with sand accumulating on the south side of the inlet, however, the rate of build-up, as predicted, has been relatively slow. As a result, the north end of North Topsail Beach has continued to experience high rates of erosion. As of October 2014, most of the fill placed north of the Topsail Reef Condominiums has been lost Figure 12.

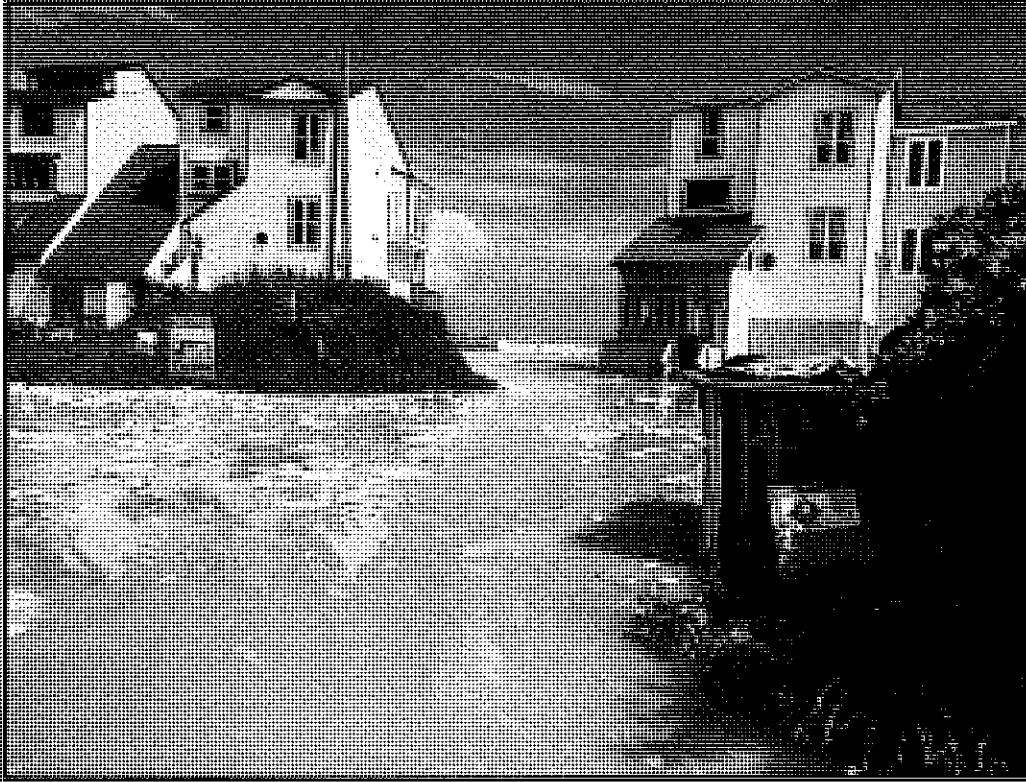
**Figure 13. Flooding on north end of North Topsail due to wave overwash.**

The loss of the beach fill has placed approximately 20 homes located north of Topsail Reef in imminent danger of being severely damaged or possibly destroyed. In addition to the threat to the homes, flooding of the area has been exasperated with flood waters spilling on to New River Inlet Road and side streets (Figure 13).

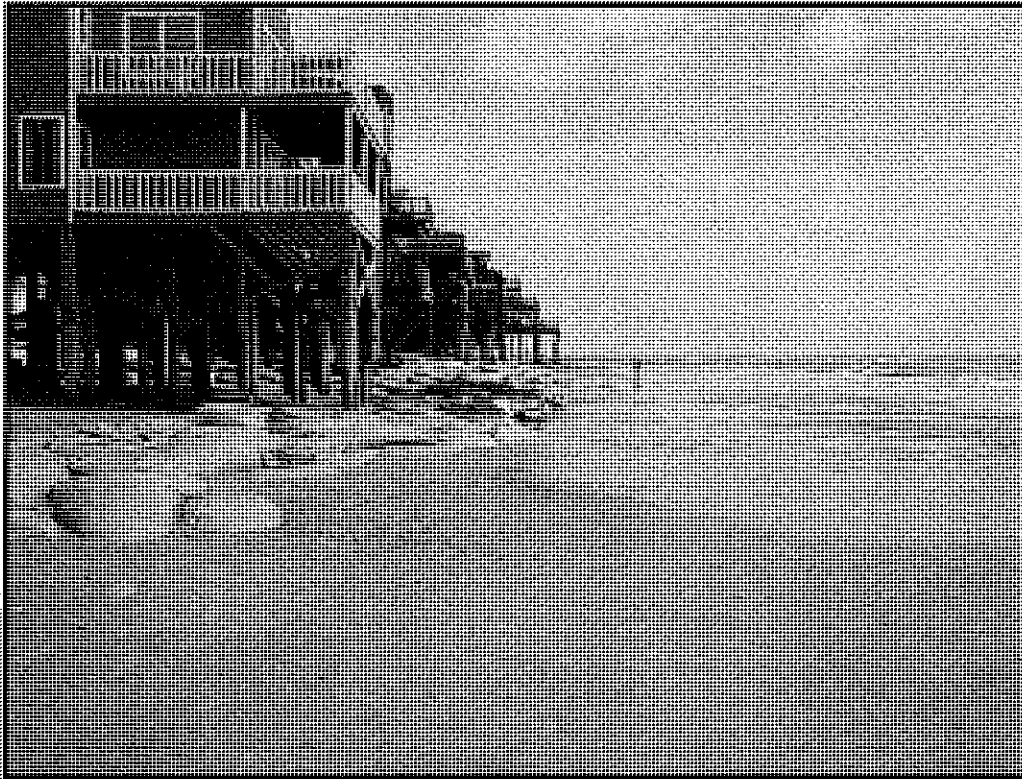
**Figure 14. Example of failed sandbag revetment on north end of North Topsail Beach.**

The temporary sand bag revetment allowed under CAMA (15A NCAC 7H.1700), which is limited to a height of 6 feet above the existing ground and a maximum bottom width of 20 feet, in my opinion, is not adequate to provide the degree of protection deemed necessary to protect the 20 homes for the next 2.5 years. This is evident by the history of failure of previously permitted sandbag revetment in the area as demonstrated in Figure 14. The homes shown in Figure 14, which have since been removed, were positioned seaward of the 20 structures presently being threatened.

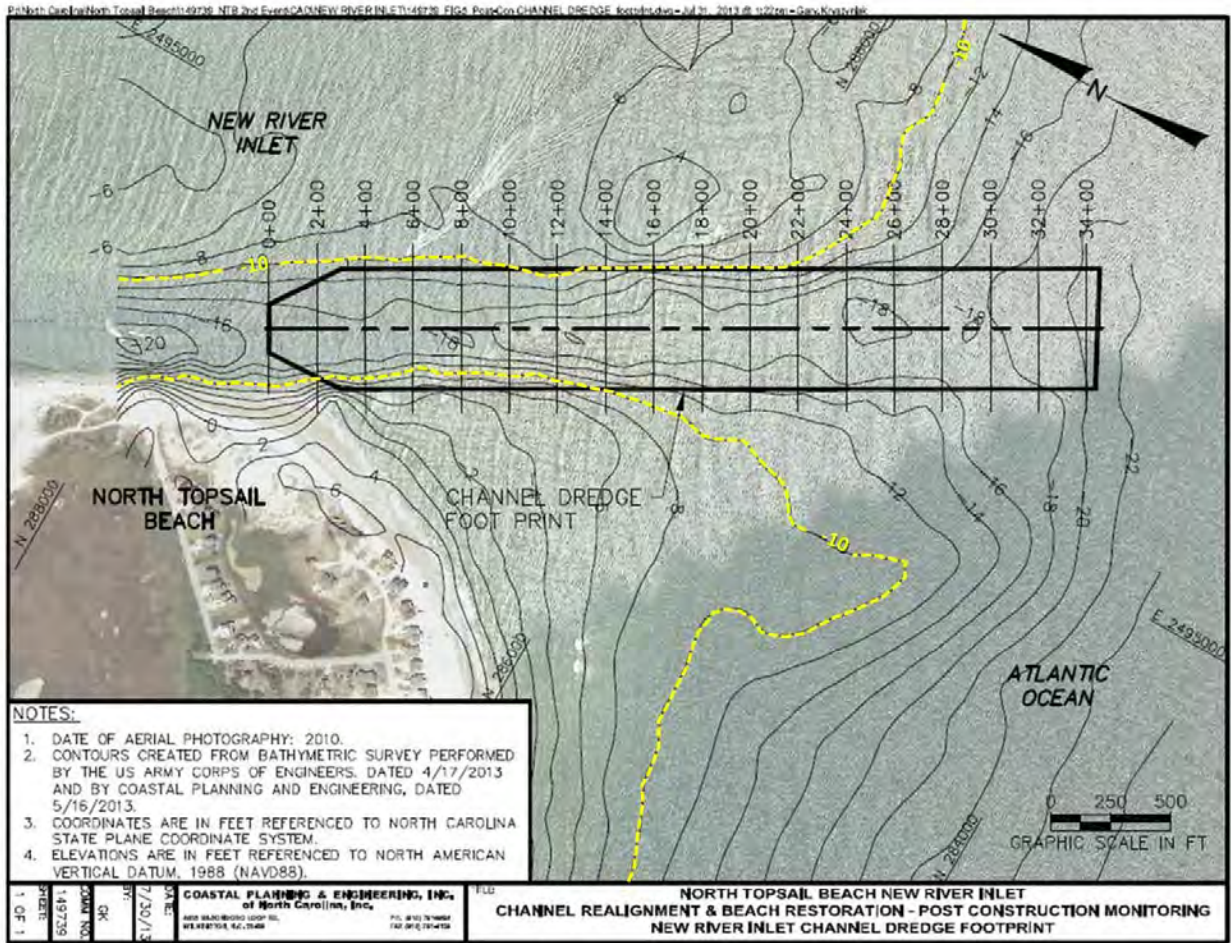
**Figure 2 – New River Inlet Realigned Channel Contour Map (April 2013)**

Monitoring of the channel area was performed through analysis of updated survey data collected by the USACE Wilmington District and by CPE-NC. The channel survey conducted by the USACE Wilmington District was performed in January 2014, approximately one (1) year after the channel was dredged. CPE-NC performed a survey of the channel in April 2014 as part of the on-going post-construction monitoring program. Those surveys were compared with the January 2013 Record Survey performed by Marinex Construction, Inc. that documented the as-built condition of the channel. These three (3) survey events were used to complete an updated volume change analysis for the realigned channel. The channel footprint with the respective stations used in the volume analysis is shown in Figure 2. The channel profiles are shown in Appendix B. The elevation contours shown in Figure 2 illustrate the location of the realigned channel in April 2013. The -10 ft. NAVD88 contour is highlighted in yellow and serves as a reference contour to assist in delineating the changes of the ebb tide delta.

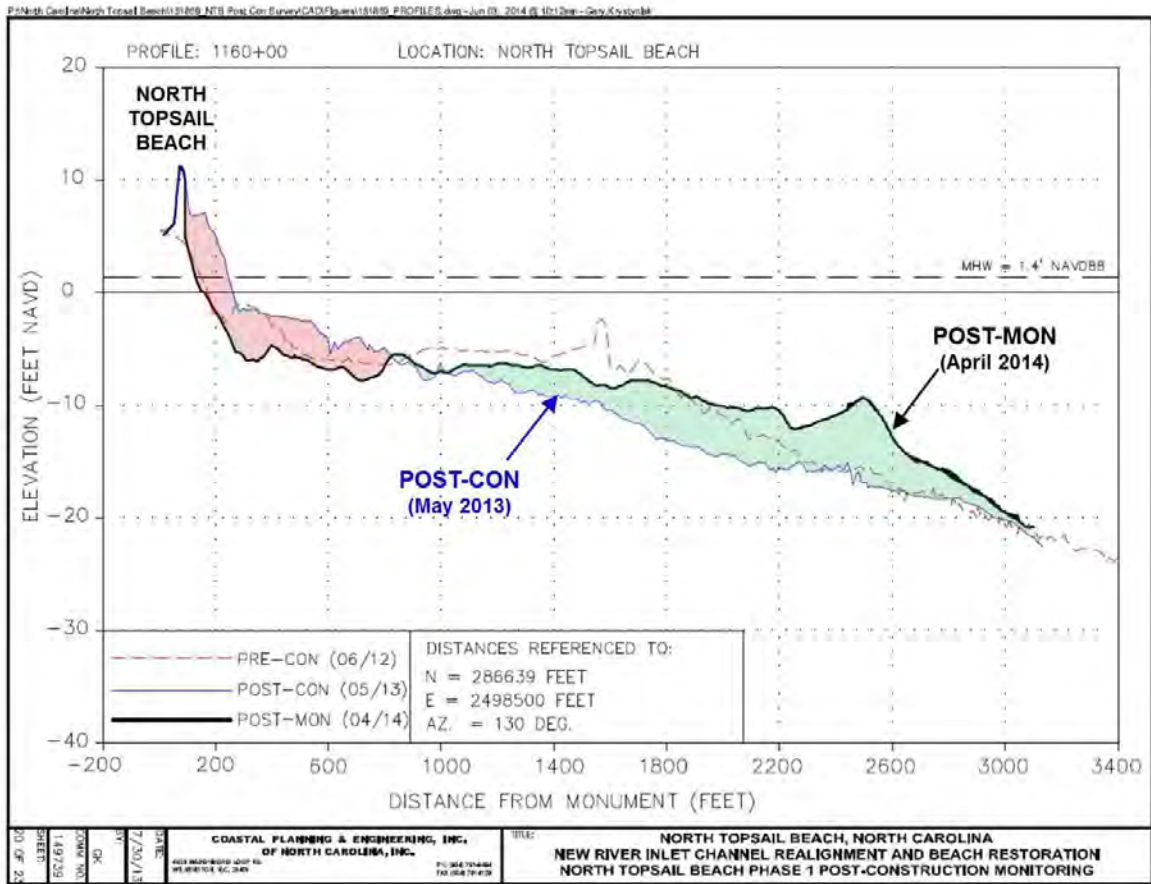
Changes to the ebb shoal south of the inlet are shown on the comparison plot of the beach profiles at station 1160+00 in Figure 8. Station 1160+00 is located at the northern end of the project, southeast of the realigned channel, extending from the beach across the southern lobe of the ebb tide delta (refer to Figure 6). In general, the comparison plot shows the erosion that occurred along the beach (red shaded area) from May 2013 to April 2014 and the increase in the amount of sediment on the offshore portion of the profile (green shaded area) between May 2013 and April 2014. The erosion at this location is attributed to the effects of a nodal zone or localized area of erosion caused by waves refracting around the ebb shoal. The increase in sediment on the offshore profile extends 2,000 ft. with increases of 5 ft. to 7 ft. of sand in some areas and indicates that sediment carried seaward by the ebb tidal currents through the realigned channel is being deposited on the south side of the New River Inlet.

**Figure 8 – North Topsail Beach Inlet Shoulder – Ebb Shoal Profile**

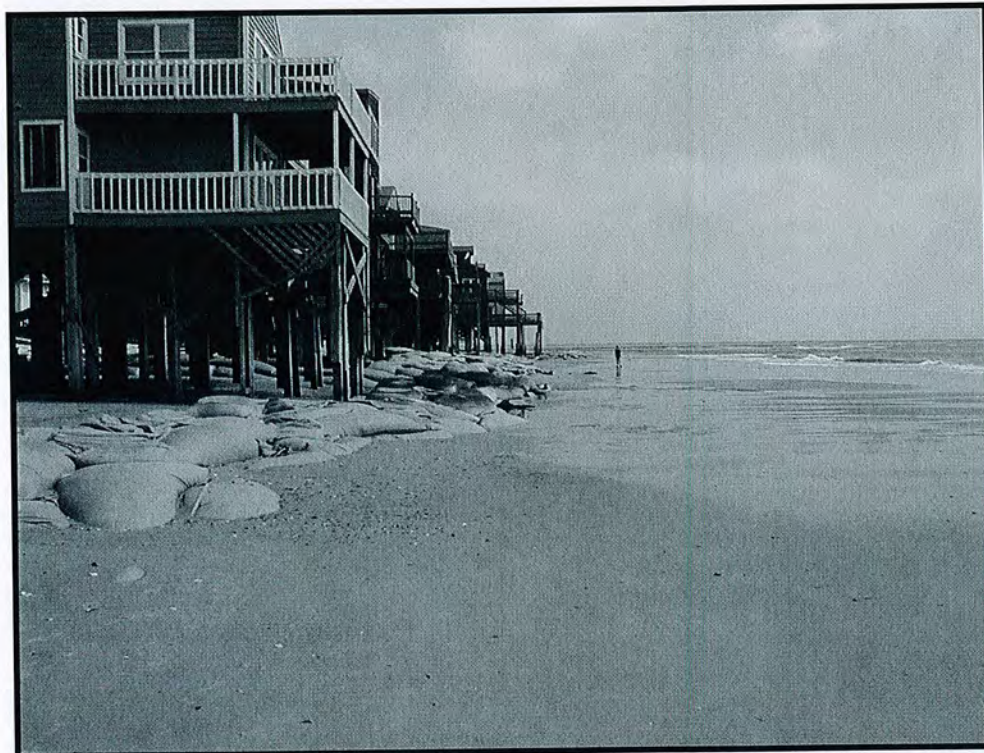
Figure 1. Sandbags at north end of North Topsail Beach (Sep 2005). (Note these sandbags no longer exist as they fronted buildings that were located seaward of the present structures north of Topsail Reef that were subsequently demolished.)

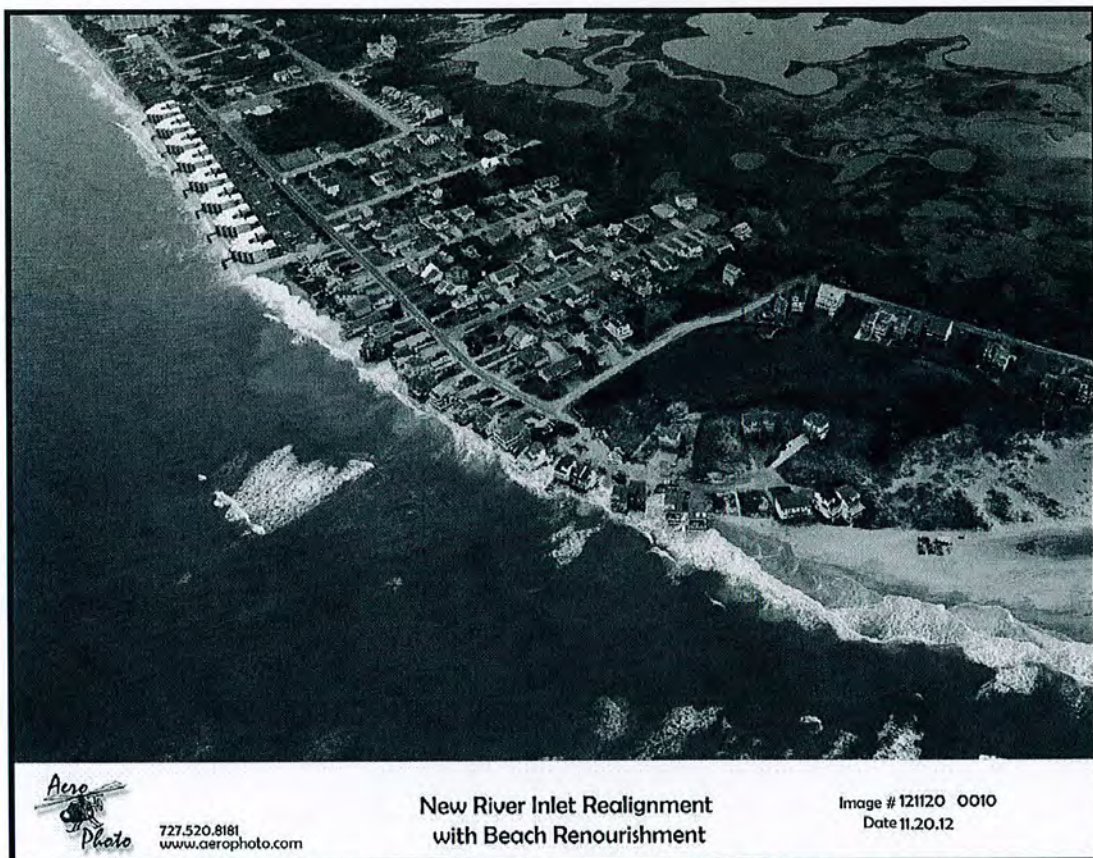
Photo 1. Pre-Nourishment – November 2012. The eight buildings in the upper left of the photo are the Topsail Reef Condominiums.

The condition of the north end of North Topsail Beach prior to construction of the Phase 1 beach fill project is shown in Photo 1 with the condition immediately after construction provided in Photo 2.

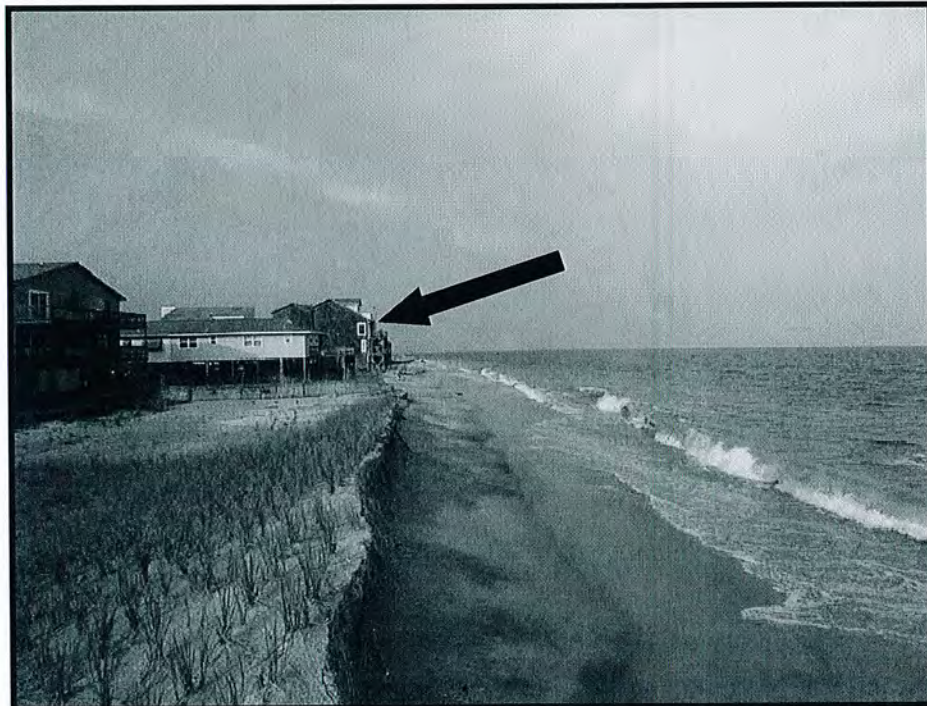
Photo No. 3. View looking north of Topsail Reef Building #1 – August 7, 2014. Arrow identifies house shown in Photo No. 4.

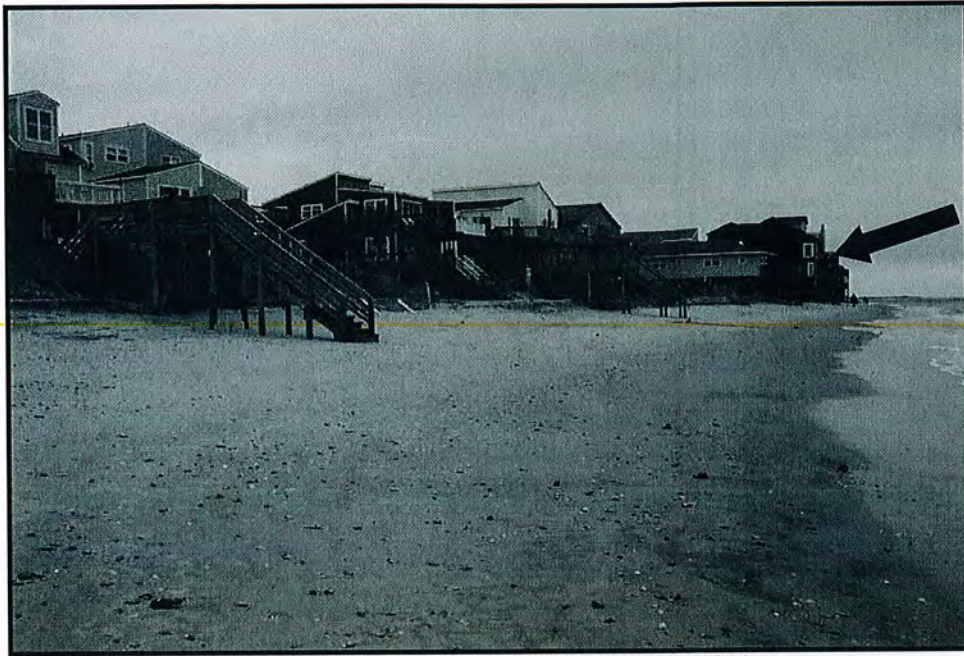
Photo No. 3a. Condition as of September 14, 2014.

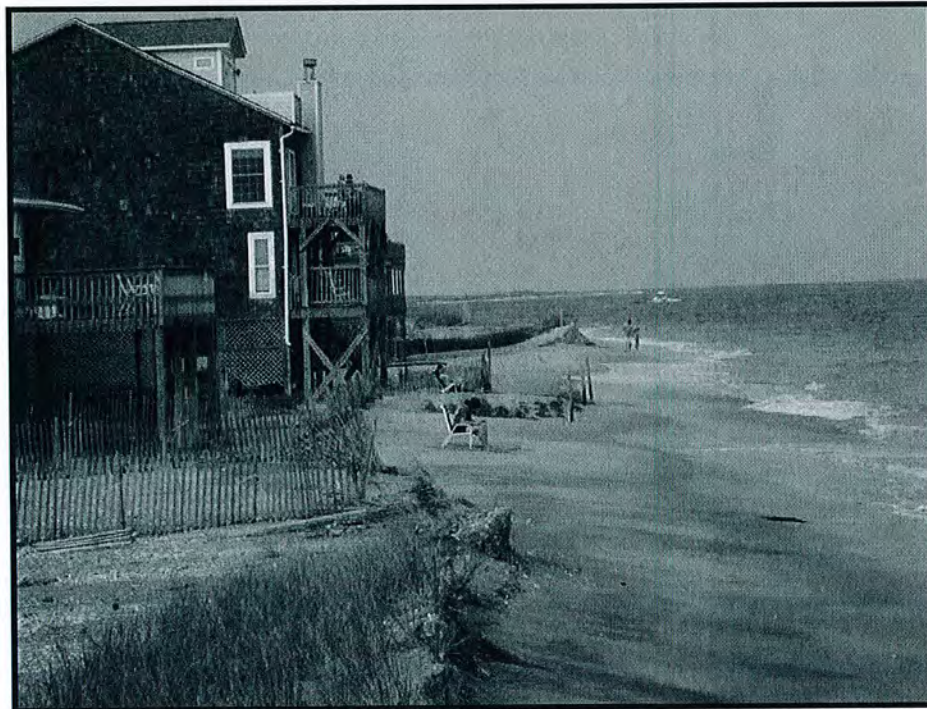
Photo No. 4. House north of Topsail Reef Building #1. View looking north toward New River Inlet. – August 7, 2014.

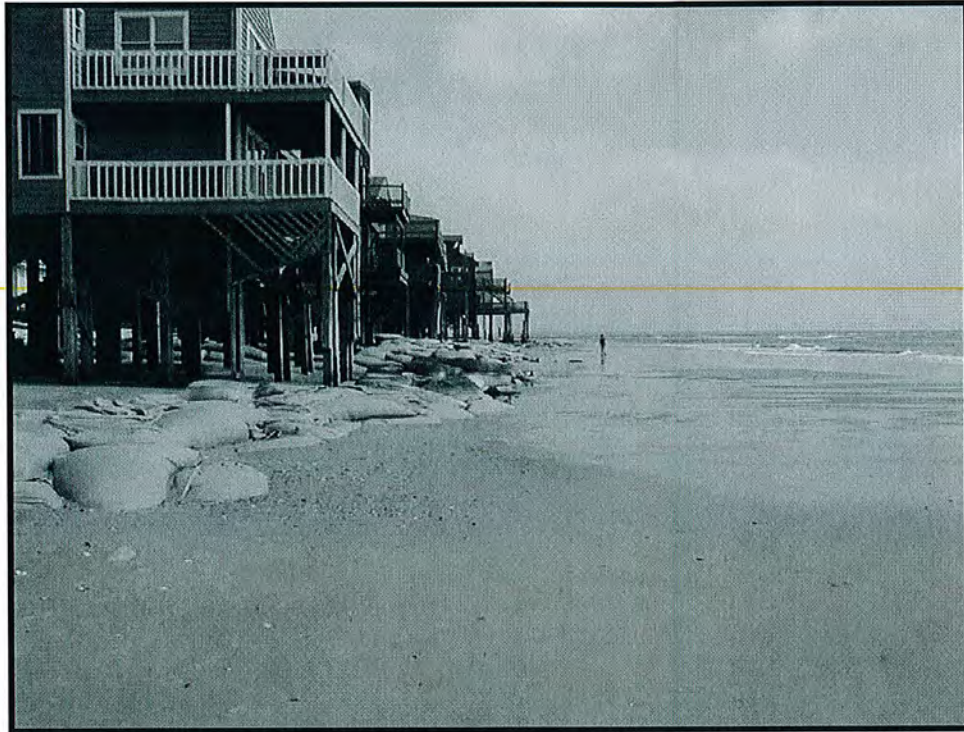
**Photo 7. Example of failed sandbag revetment on north end of North Topsail Beach. Photo taken in September 2005. All of these sandbags and structures, which were located seaward of the present row of homes north of Topsail Reef, have been removed.**

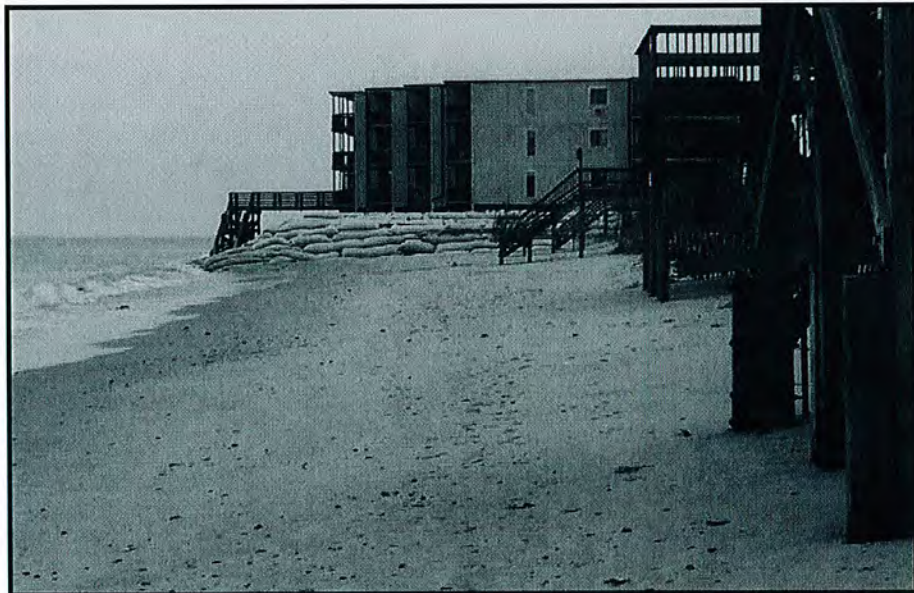
**Photo 8. Sandbags revetment at Topsail Reefs Building 1 (Sep 2014).**
