DAN RIVER COAL ASH SPILL

VA Roanoke River Basin Advisory Committee

April 21, 2014

John Kennedy, Office of Ecology & Infrastructure

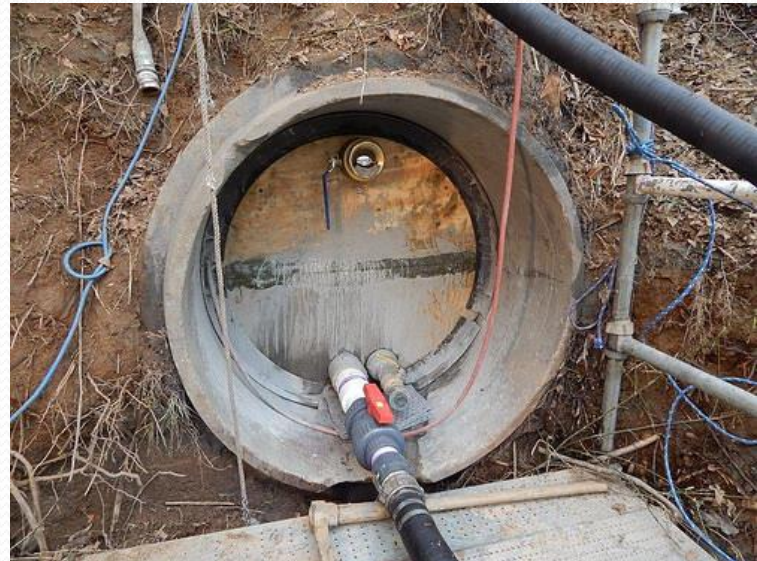
- Immediately began river water monitoring at drinking water intakes.
- All drinking water has met standards; monitoring continues.
- Saturday, 2/8 – Duke plugged damaged 48” storm water pipe.
- Friday, 2/21 - second, 36” pipe discharging arsenic-contaminated groundwater was plugged.
- Water quality, sediment and fish monitoring ongoing by DEQ, North Carolina, and EPA contractor.

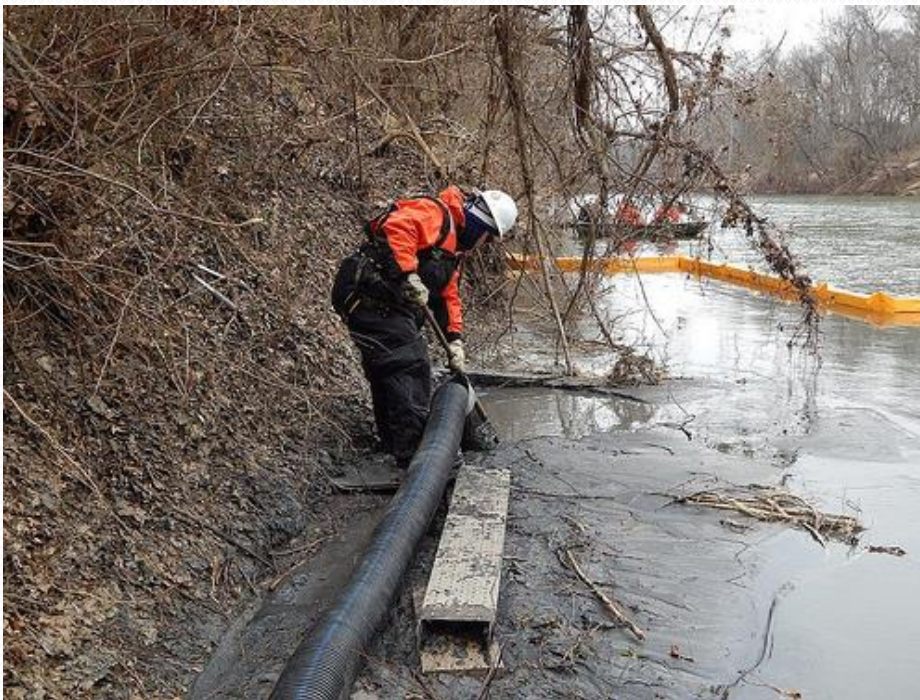
- Crews recovered coal ash deposit just below discharge.
- Ash recovery at two additional sites planned:
 - west of Schoolfield Dam
 - near Towns Creek, downstream of Eden, NC
- VA Health Dept. posted signs along Dan River advising limited contact with coal ash; adverse health effects not likely.

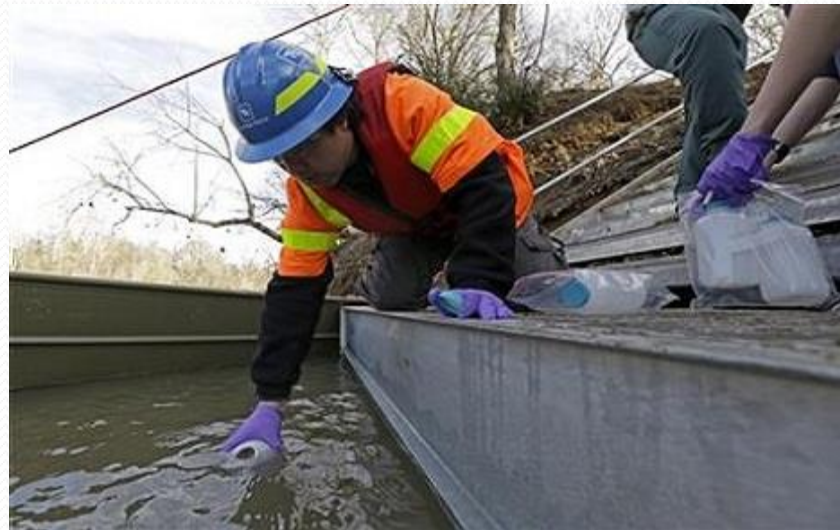
- 2/11 – VADEQ collected water and sediment samples at 4 sites from state line to halfway between Danville and South Boston.
- Samples analyzed for metals:
 - Water sample concentrations did not exceed VA Water Quality Standards.
 - No sediment levels above freshwater screening values.
- Preliminary review of all other Virginia water quality data collected by EPA contractor shows no exceedances of VA Water Quality Standards.

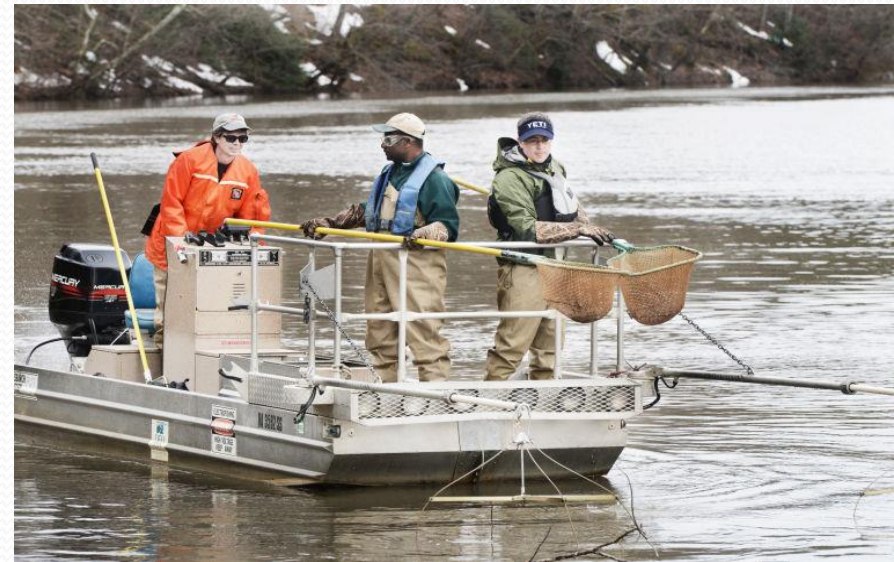
- 2/20 – fish collected upstream of Schoolfield Dam.
- 25 fish tissue samples analyzed for 23 metals:
 - Arsenic level not elevated; per VA Health Dept., no reason found to change current advisory.
 - Mercury concentration below VA Health Dept. level of concern.
 - Levels of other 21 metals either:
 - Below detection limit, or
 - Screening value not available
- Too soon for fish to take up recently spilled coal ash metals.
