# DWR - Coal Ash Activities Update

North Carolina Delegation

Roanoke River Basin Bi-State Commission

December 18, 2014

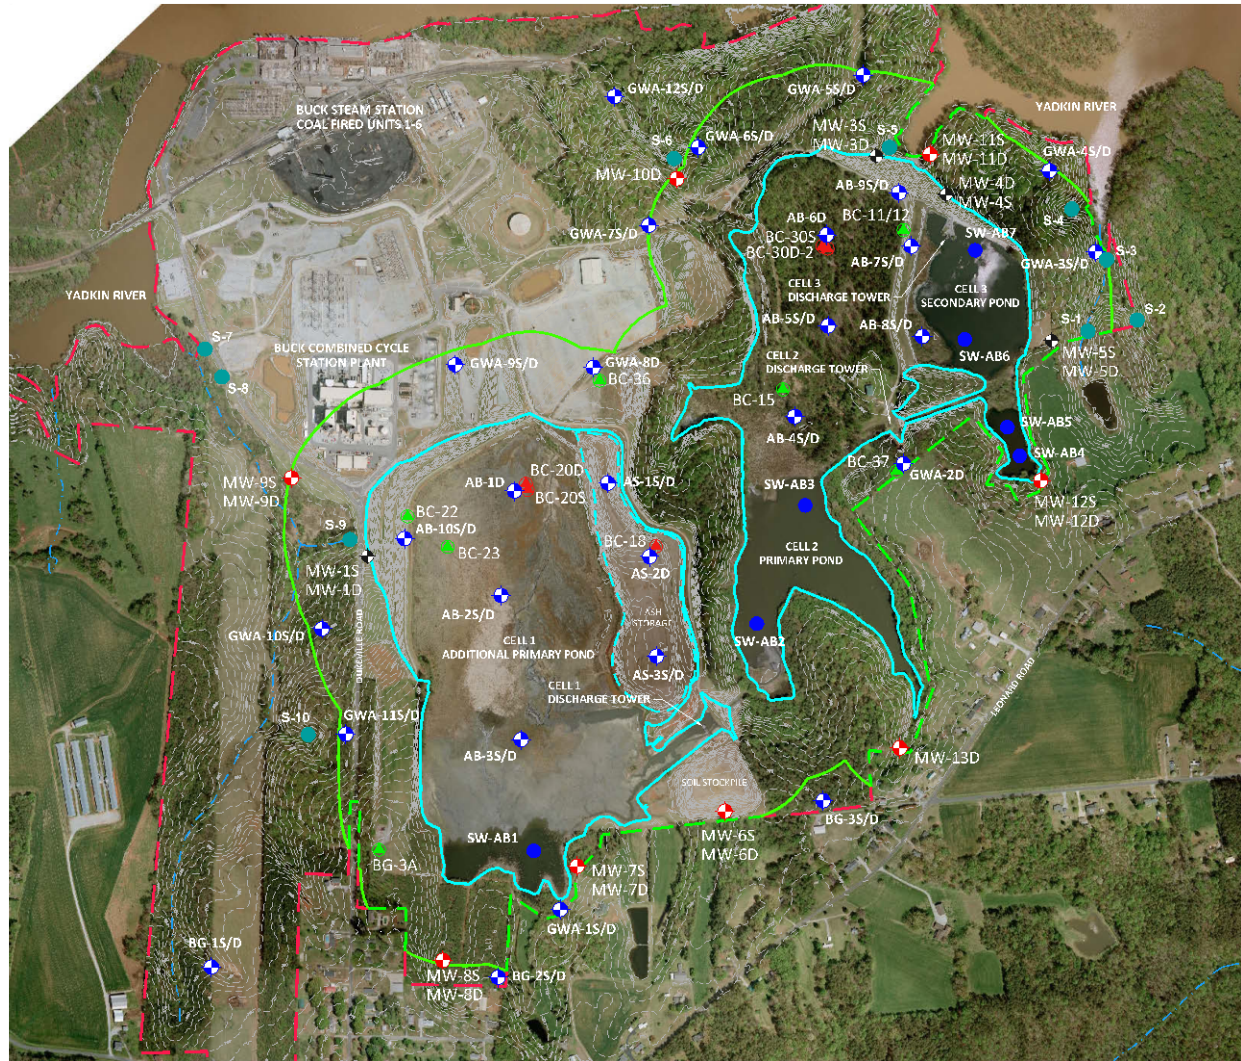
FIGURE  
3

- Critical component of overall coal ash effort
- Used to determine vertical and horizontal extent of groundwater contamination underneath facilities
- This information is currently unknown
- Impossible to make classification/prioritization decisions on coal ash ponds without this info
- Used to determine if impacts to wells are from coal ash
- Used to determine extent groundwater contamination beyond compliance boundaries

**PROPOSED WELL AND SAMPLE LOCATIONS**  
**DUKE ENERGY CAROLINAS, LLC**  
**BUCK COMBINED CYCLE STATION ASH BASIN**  
**NPDES PERMIT NO. NC0004774**  
 ROWAN COUNTY, NORTH CAROLINA

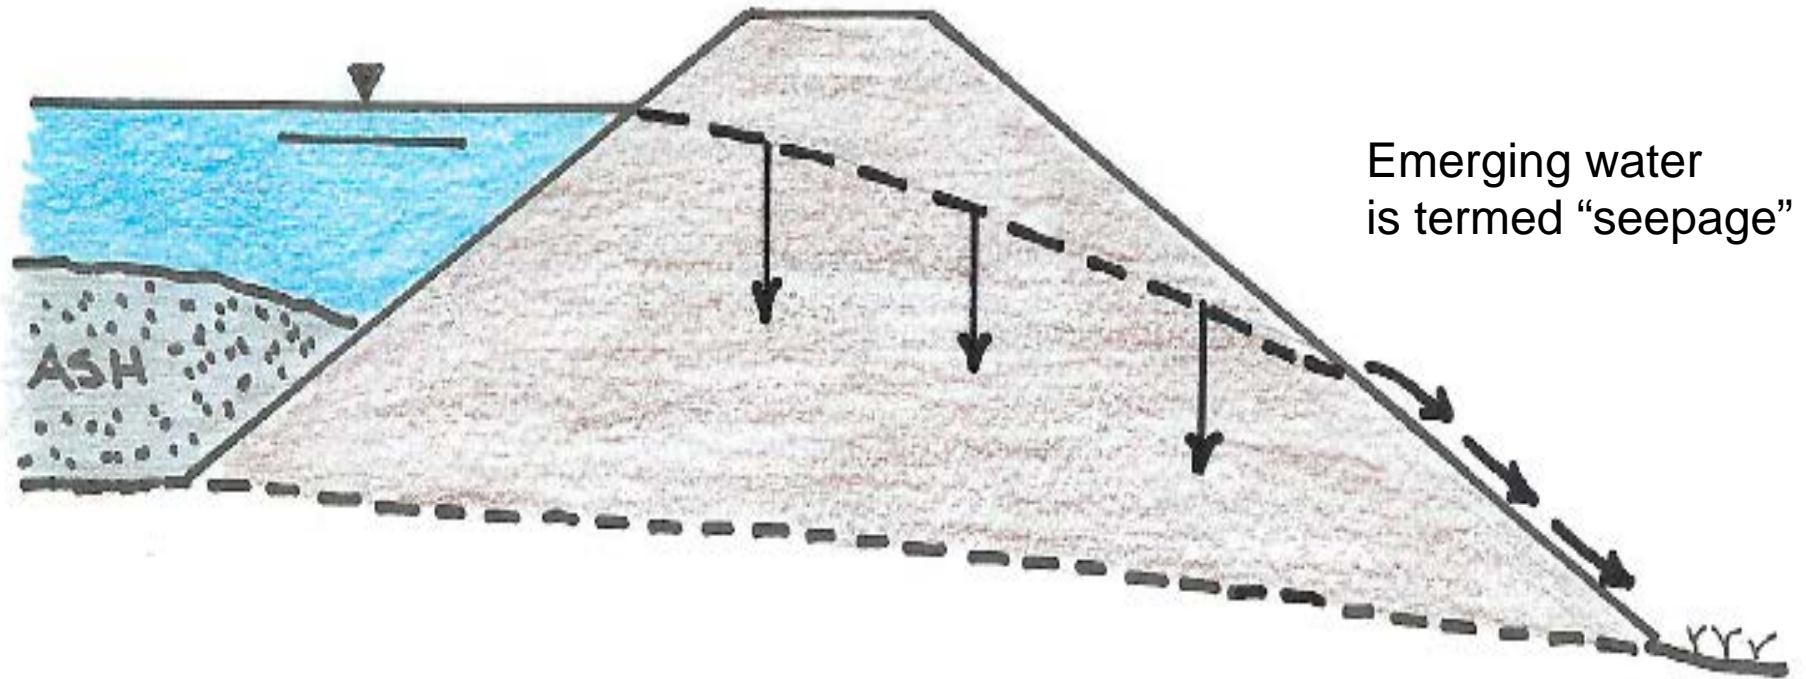
# Basic Seep Diagram

- Unauthorized surface discharges include seeps, weeps, and engineered drains of coal ash dams
- These surface discharges are not presently included in discharge permits for these facilities
- Duke requesting modification of all NPDES Discharge Permits for all 14 facilities

Emerging water  
is termed "seepage"

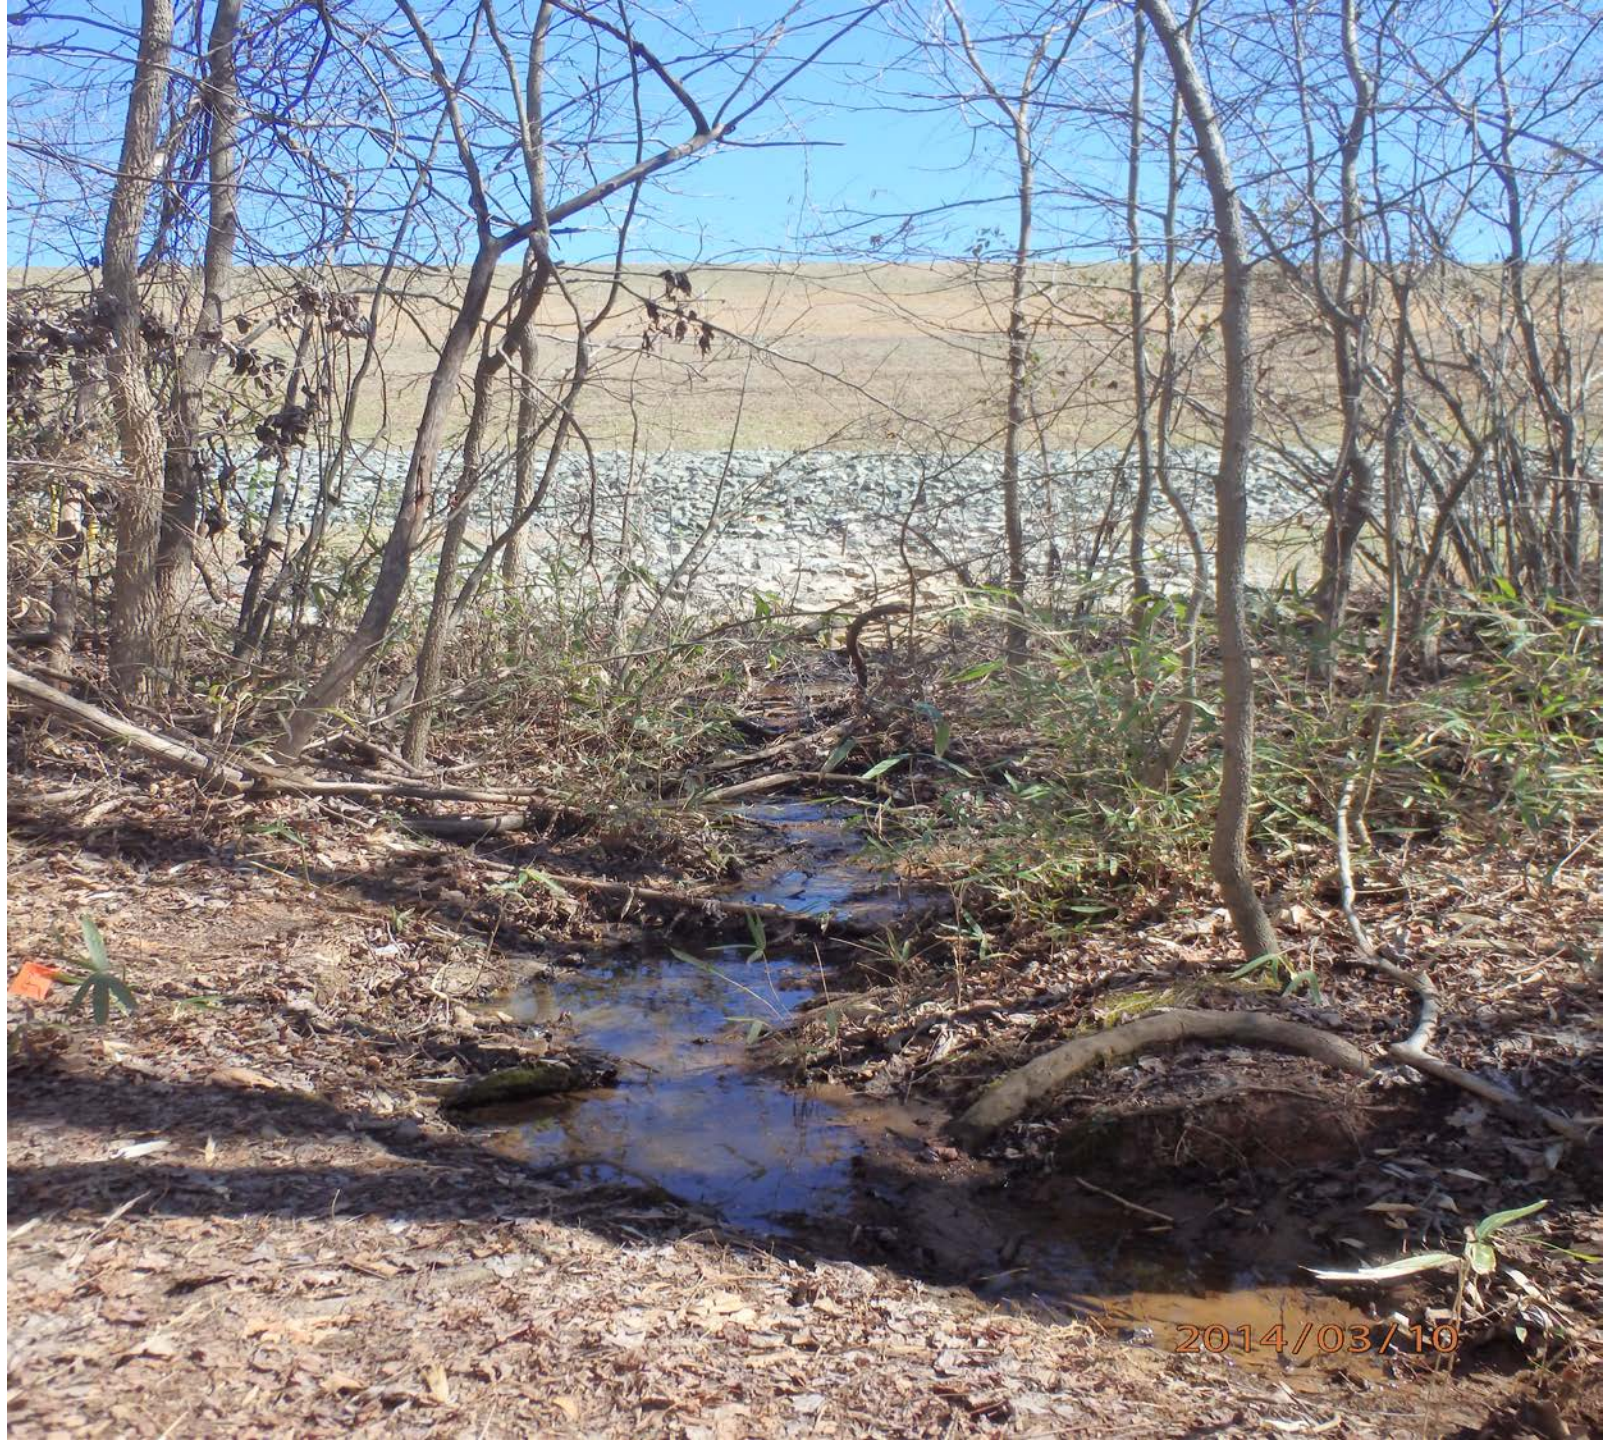
# Toe Drain

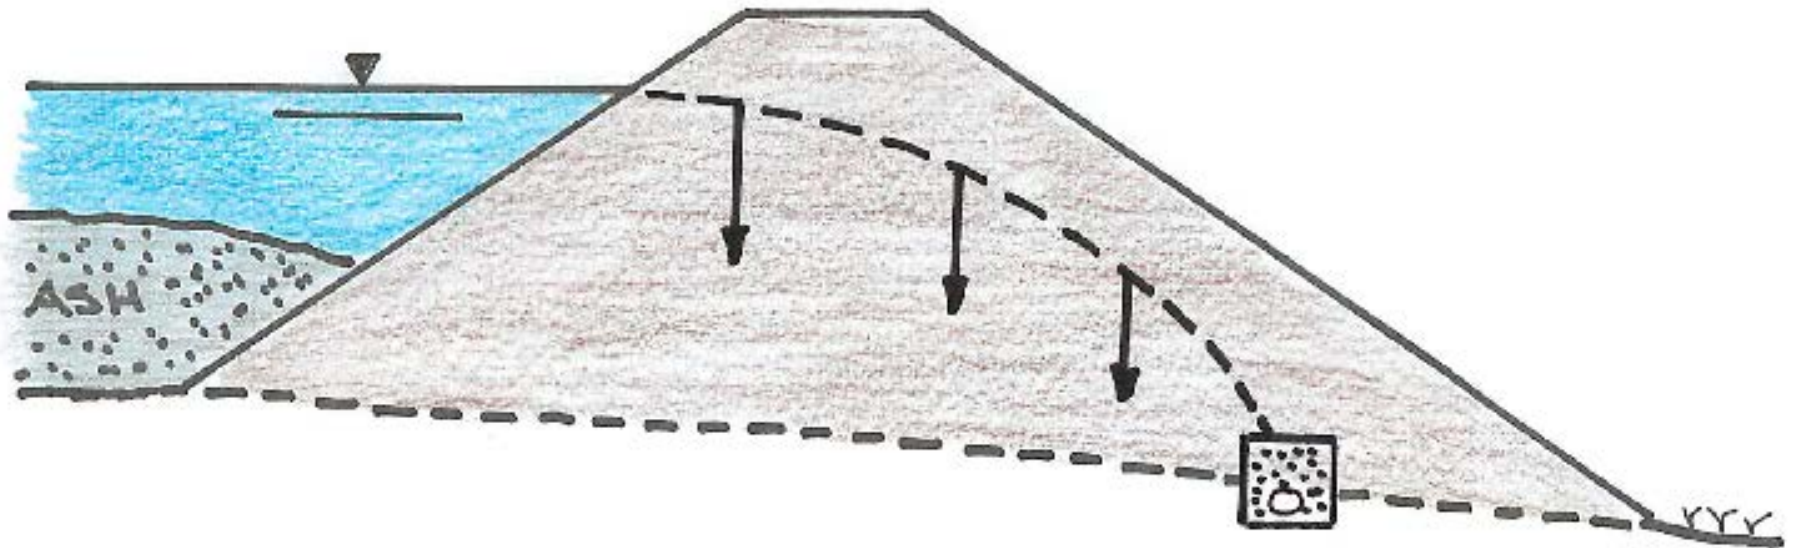
- An aggregate encased perforated collector pipe system
- With solid pipe outfall
- Often referred to as a “toe drain”

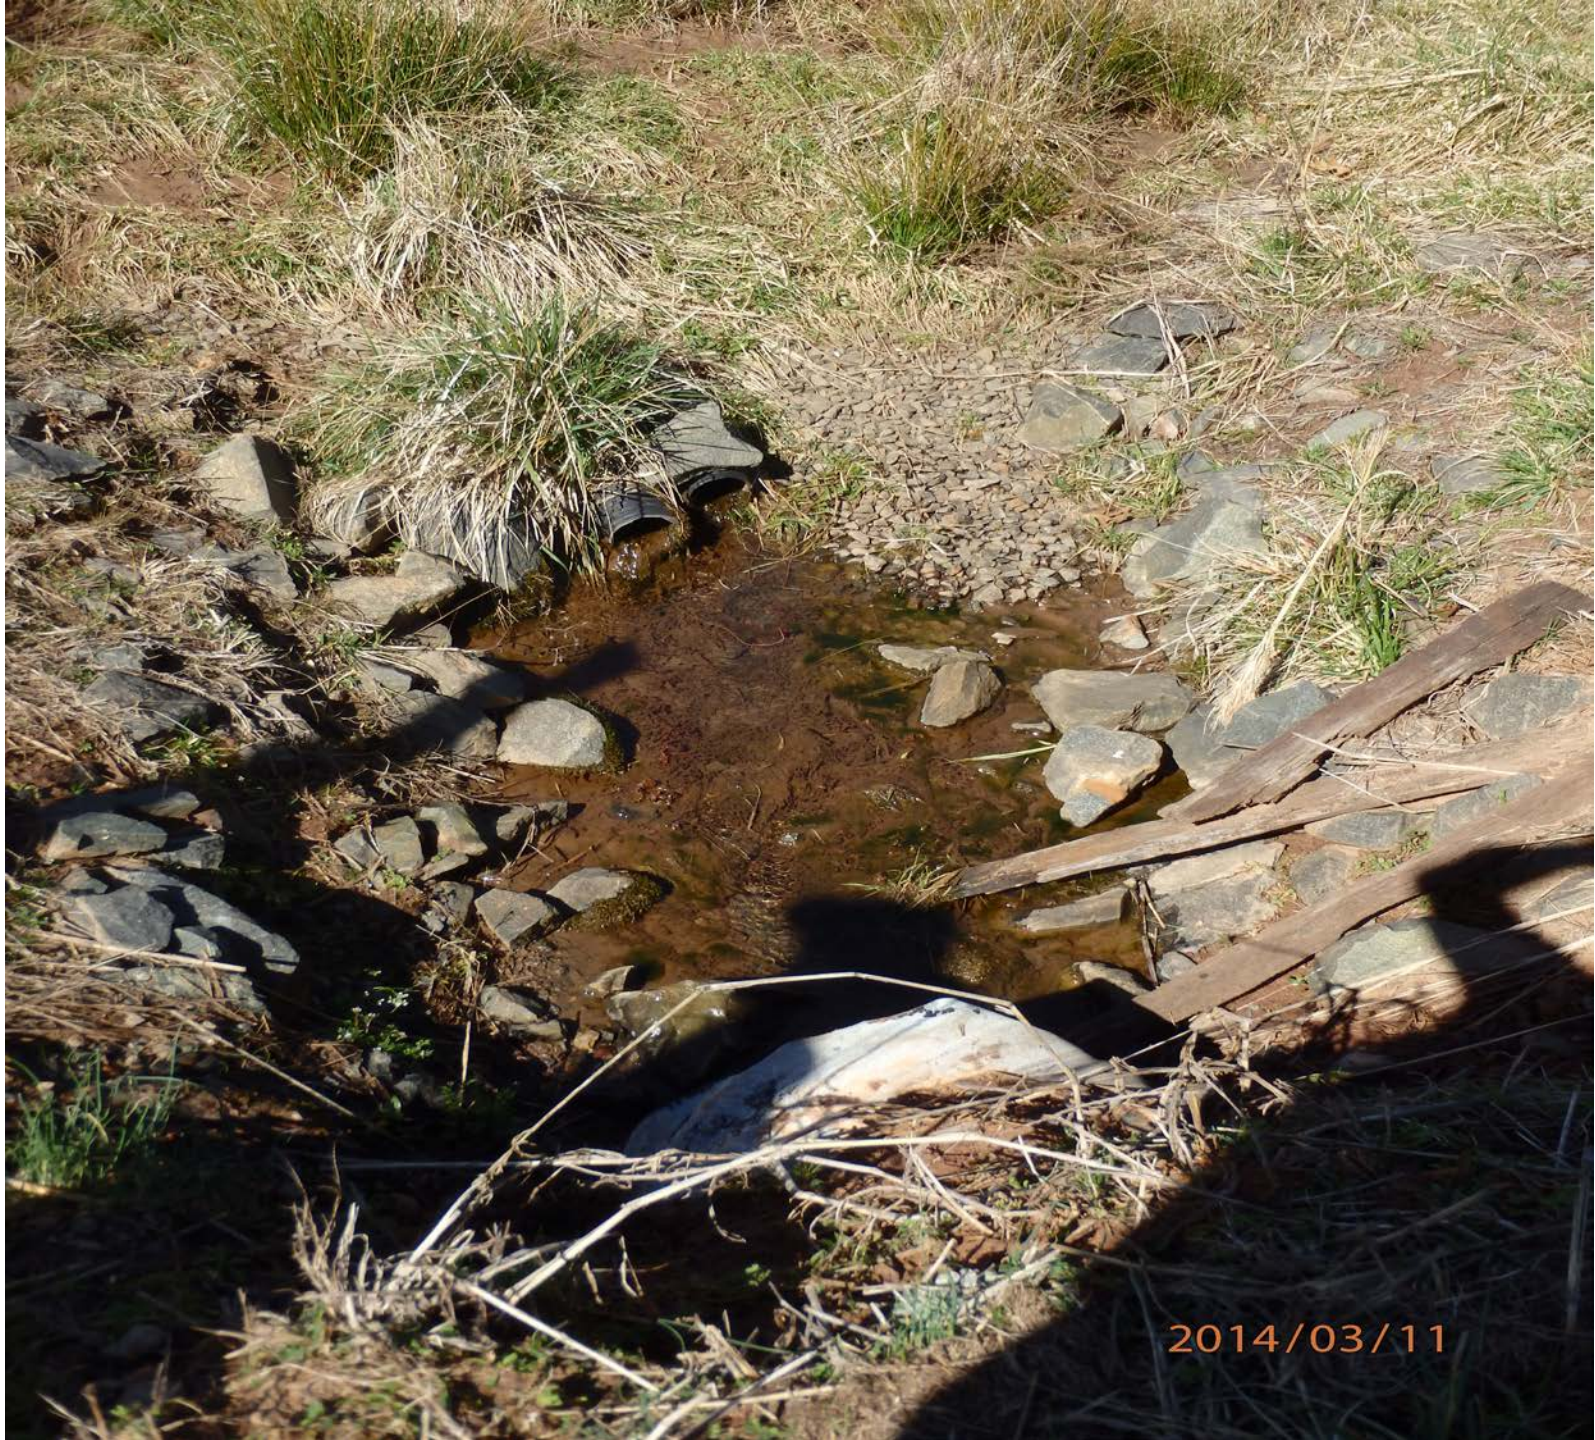
2014/03/11

## Internal Drain System

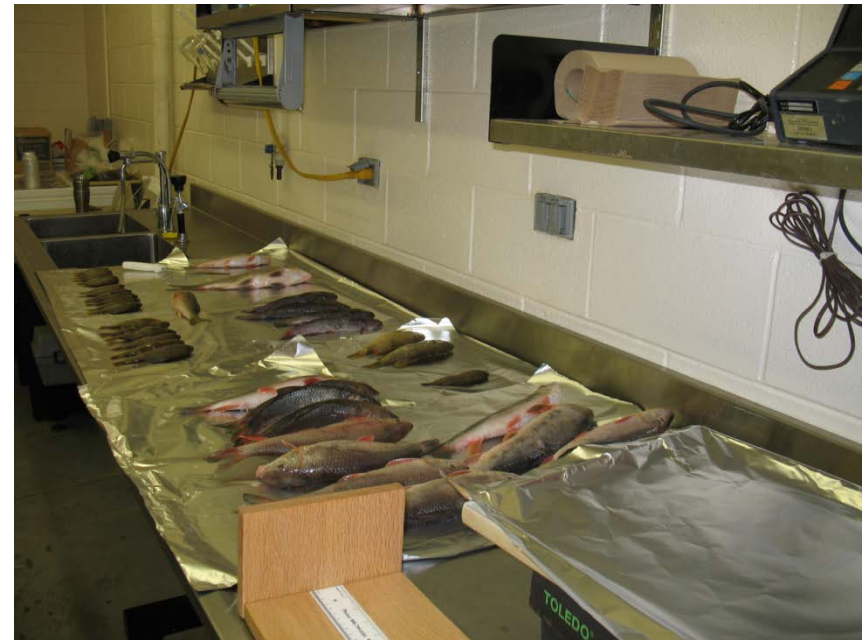
# Fish Tissue Sampling

- Background analyses complete – no surprises
- Mercury elevated - statewide
- All similar to historic data

Water Sciences Staff  
 First round of background monitoring showed nothing above state guidelines.  
 Second round of extended background monitoring showed  
     10% of samples exceeded mercury fish consumption advisory action levels (NCDPH)  
     12% of samples exceeded arsenic fish tissue screening levels (NCDPH)  
 Third round of tissue collection is under way.

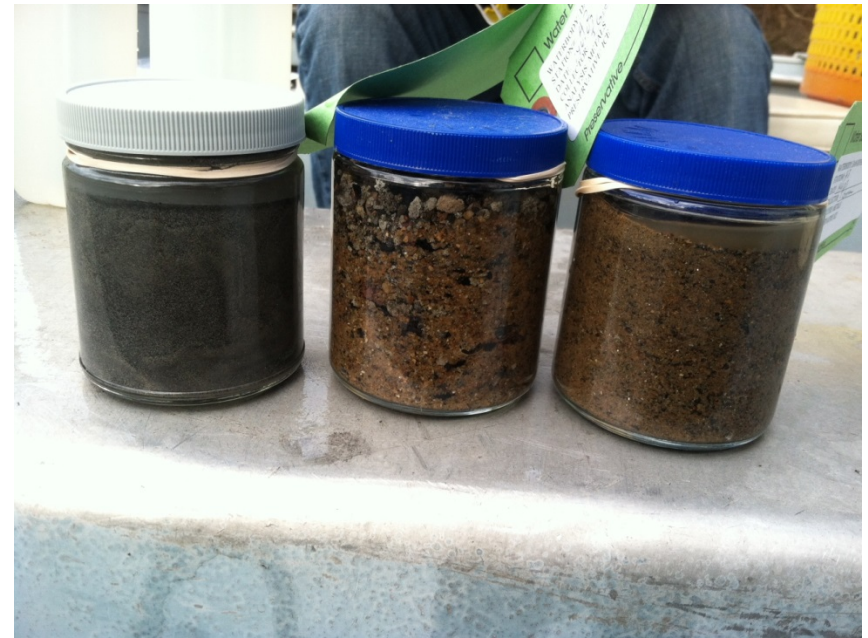
# Sediment Sampling

- Sediment
  - 100 yards from release:
    - Aluminum, Arsenic, Barium, Copper, Iron, Mercury Above EPA Screening Values
  - Danville:
    - Aluminum, Boron, Iron & Strontium Above EPA Screening Values

Water Sciences Staff  
*100yds downstream of spill* Aluminum, arsenic, barium, copper, iron and mercury were above EPA screening values.  
*Danville* Aluminum, boron, iron, and strontium were above EPA screening values.

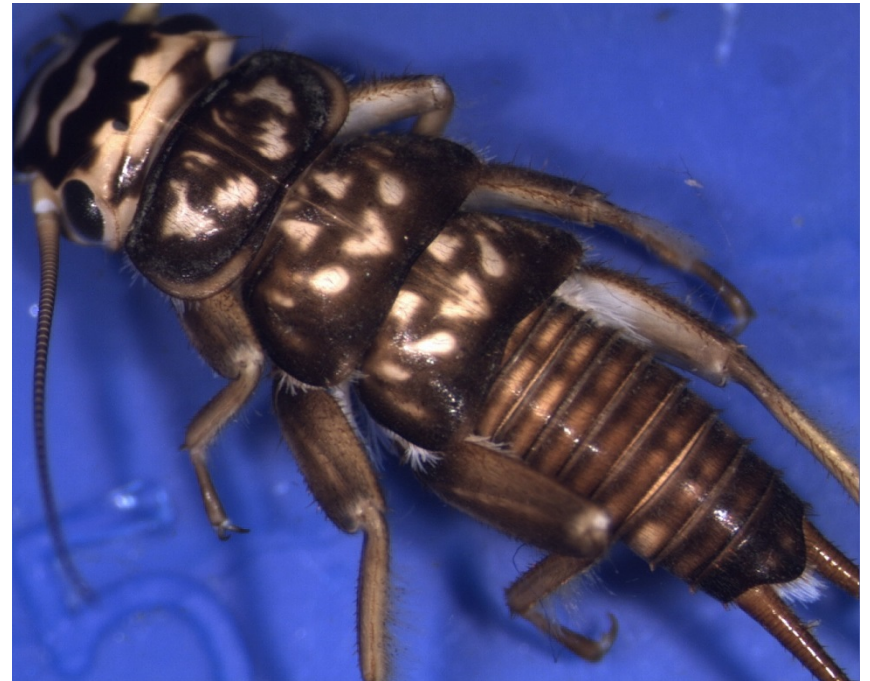
# October 28<sup>th</sup> Benthic Macroinvertebrate Sampling Results

- Upstream ~1/2 mile above release
- Downstream ~ 2 miles below release
- Similar habitats
- Excellent Water Quality

Water Sciences Staff  
 Data suggest no significant difference between upstream of spill site and downstream of spill site benthic communities.

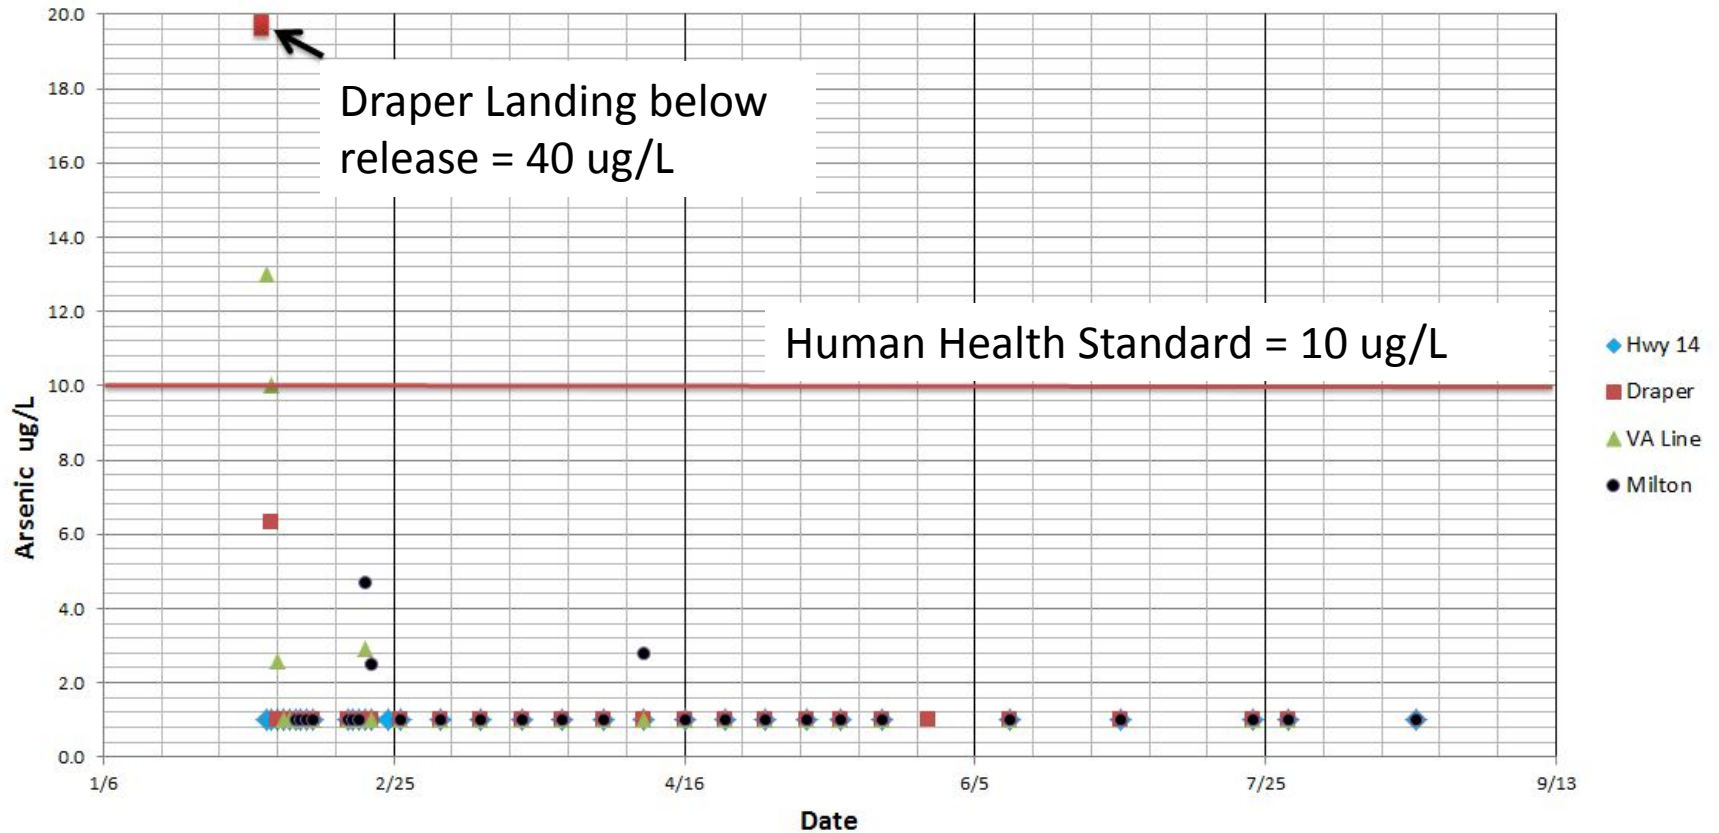
# Water Quality Sampling Results - Arsenic

All values below 2 ug/L were reported as non-detect

Winston Salem Regional Office and Water Sciences Staff  
 Arsenic decreased from 40µg/L to <2.0µg/L by mid March 5 miles downstream of spill.  
 Aluminum and iron remain high due to natural watershed conditions.

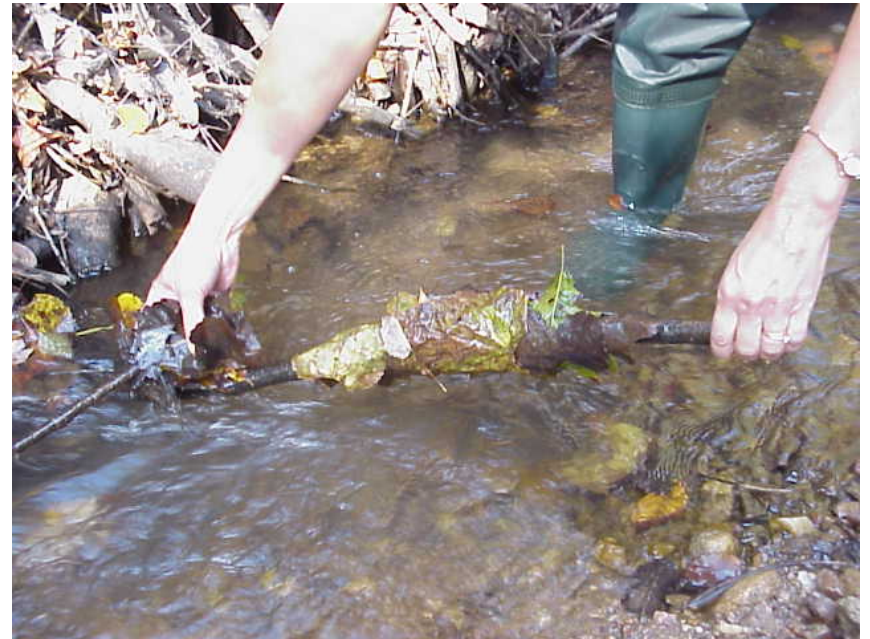
# On-Going Monitoring

- NC
  - 3 Stations – Hwy 14, VA Line & Milton
    - Monthly surface water
    - Yearly fish tissue
    - Yearly benthos
