FORESTRY BMP IMPLEMENTATION SURVEY

NORTH CAROLINA FOREST SERVICE

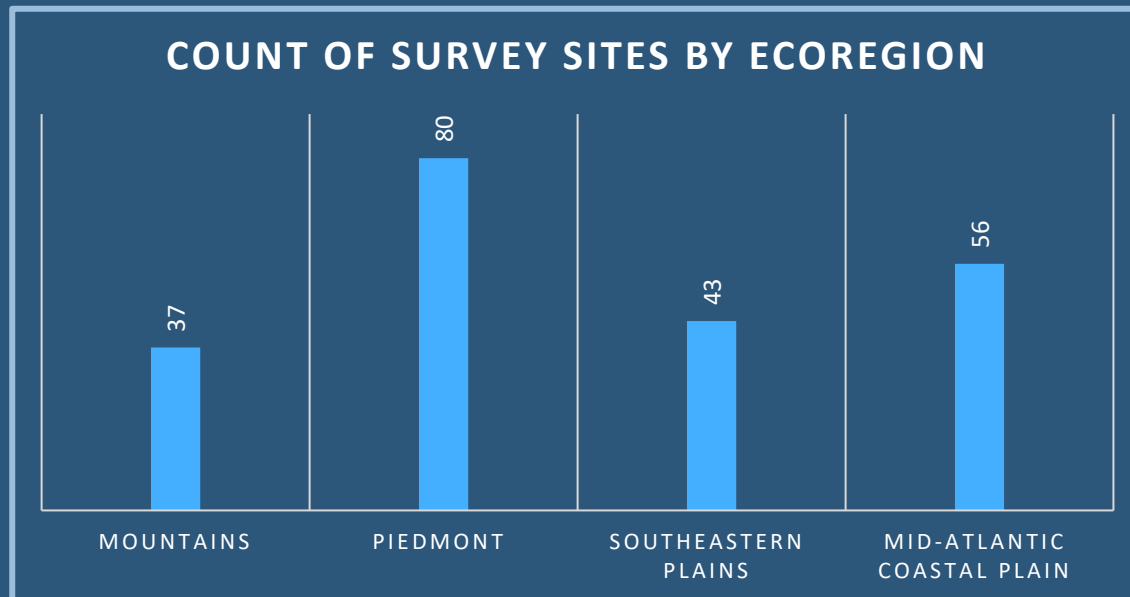
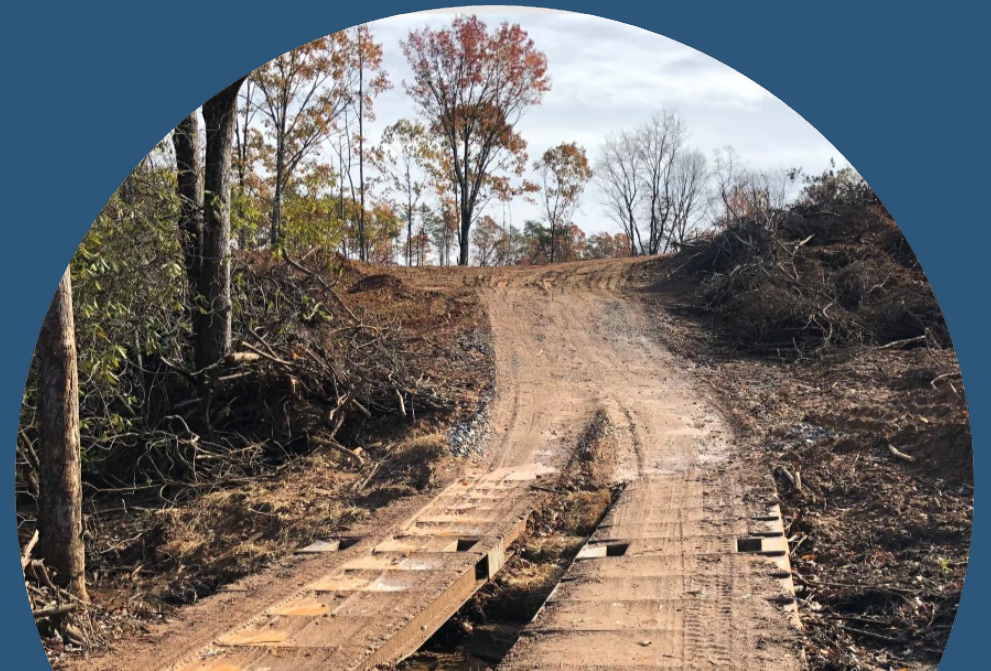
RESULTS: STATEWIDE OVERVIEW

- ❖ A total of 31,472 BMPs were assessed statewide.
- ❖ The statewide implementation rate was 83%.
- ❖ Almost no recorded risks to water quality with proper BMP implementation.
- ❖ When BMPs were not implemented or implemented improperly there was risk to water quality in 13% of cases.

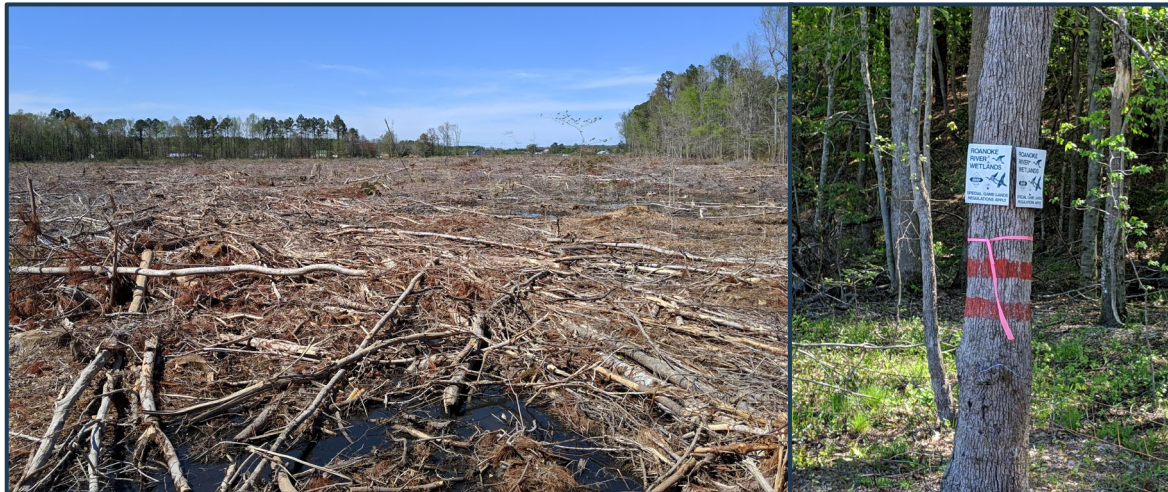
STATEWIDE OVERVIEW: HIGH PERFORMING CATEGORIES

- ❖ Categories with implementation rates above 90%:
 - ❖ Decks
 - ❖ Streamside Management Zones

- ❖ Categories with frequency of risk under 1%:
 - ❖ Decks
 - ❖ Logging Systems
 - ❖ Skid Trails
 - ❖ Controlling Erosion & Runoff
 - ❖ Site Preparation*
 - ❖ Wetlands*

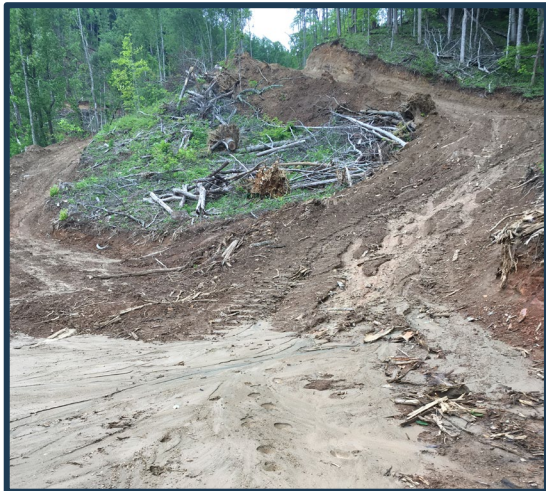
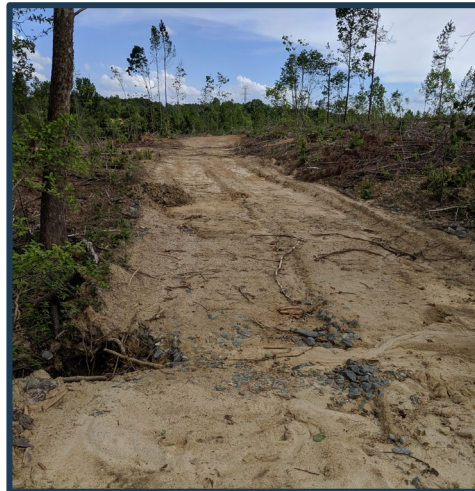
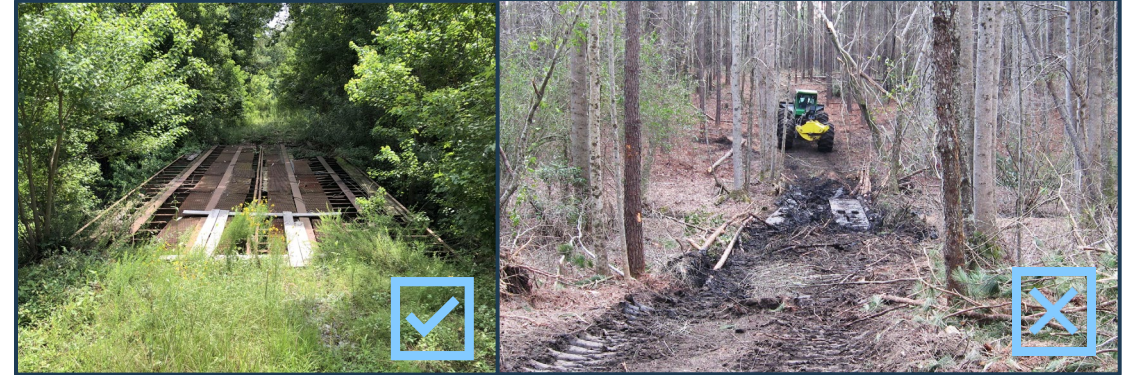
STATEWIDE OVERVIEW: LOW PERFORMING CATEGORIES

- ❖ The categories with 30 or more observations and implementation rates below 80%:
 - ❖ Capturing sediment and runoff
 - ❖ Skid trails

- ❖ Categories associated with the highest frequency of risk:
 - ❖ Stream crossing
 - ❖ Rehabilitation
 - ❖ SMZs when BMPs improperly implemented.

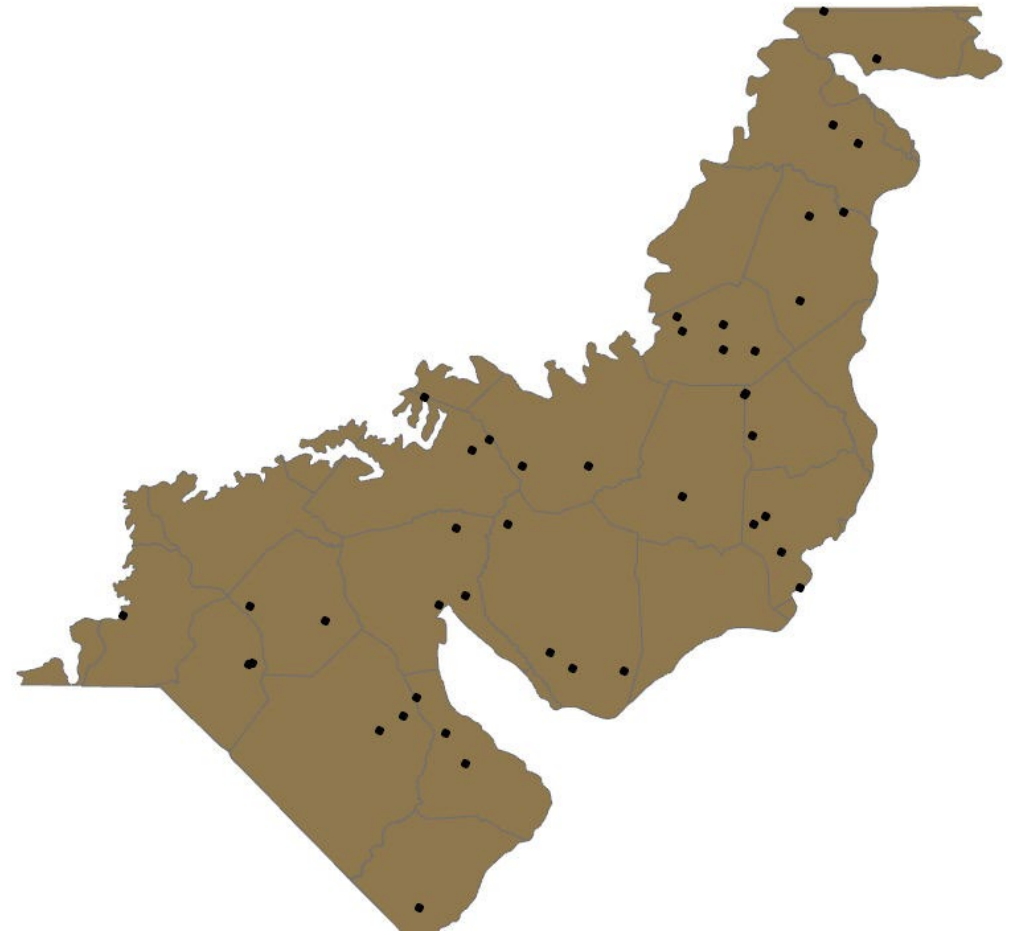
RESULTS: SOUTHEASTERN PLAINS

- ❖ Highest overall implementation of 89%.
- ❖ Second lowest rate of risk both overall (1%) and from improperly implemented BMPs (10.5%).
- ❖ Site rehabilitation scored lowest on implementation (81%)*.
 - ❖ Debris in channels at stream and ditch crossings.
 - ❖ Fine sand and silts common in this region can be problematic as a road base, especially when not properly compacted.

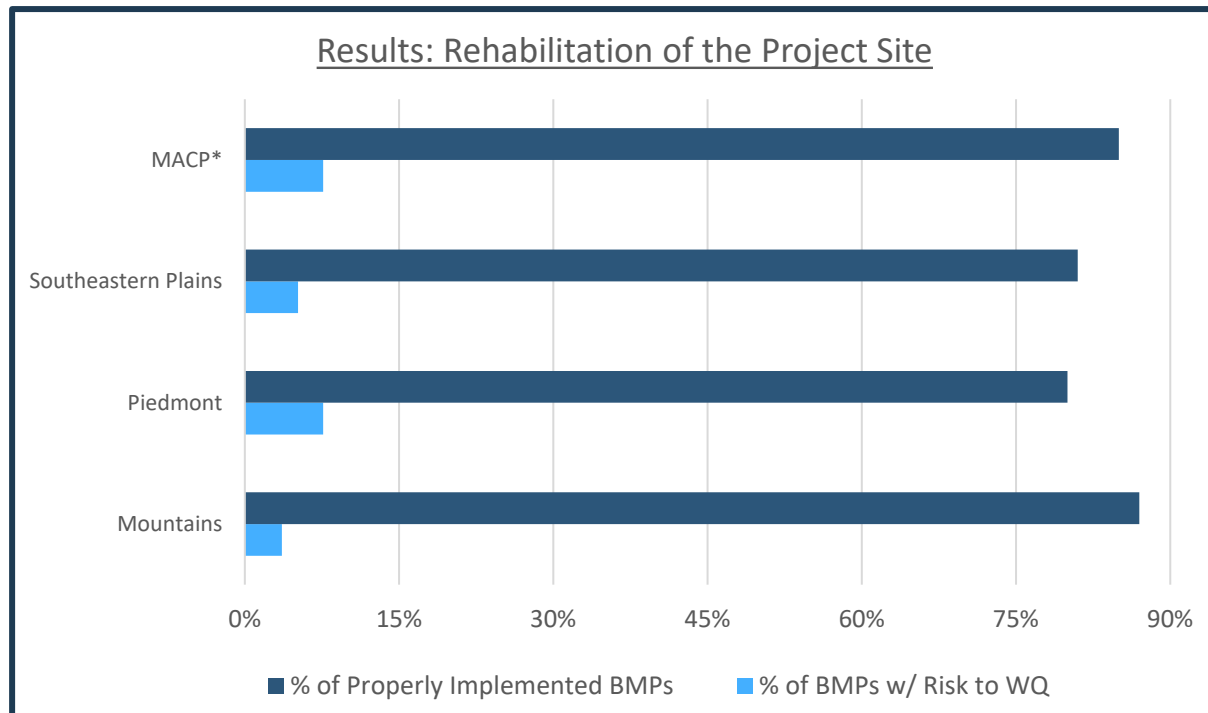
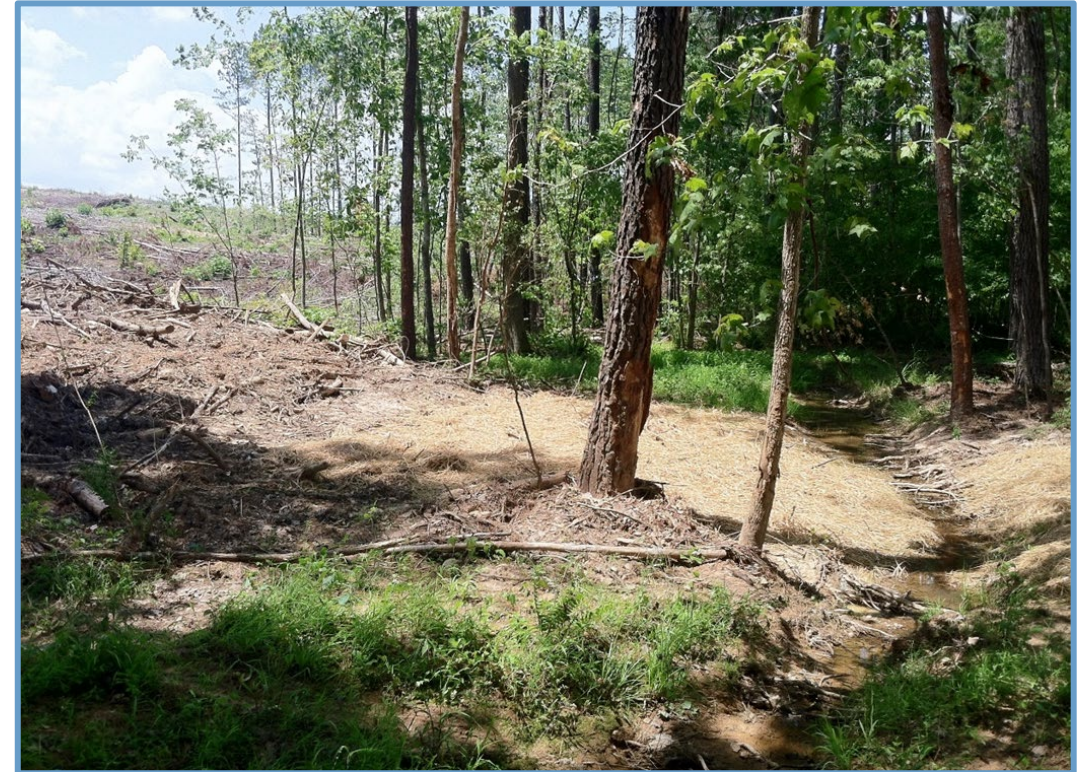
RESULTS: SITE REHABILITATION

- ❖ 1,778 individual BMPs assessed for this category.
- ❖ When rehab BMPs were properly implemented there was no risk to water quality 99% of the time.
- ❖ When not implemented there was risk 36% of the time.

Areas for Improvement:

- ❖ Removing debris from the channel at stream crossings.
- ❖ Stabilizing bare soil areas in order to prevent sedimentation at and around stream crossings.

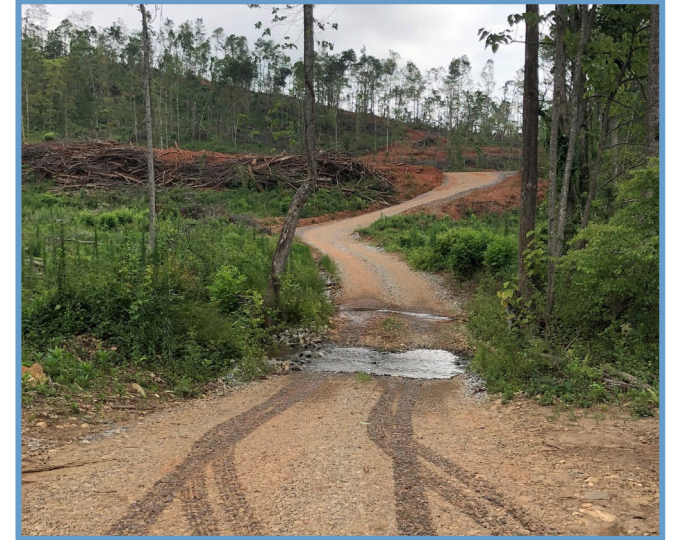
RESULTS: STREAM CROSSINGS

- ❖ 4,624 BMPs were assessed statewide.
- ❖ Soil erosion was estimated from stream crossing approach ways and published separately in a peer-reviewed journal article (Lang et al. 2022).
- ❖ Implementation for this category was 87%.
- ❖ Highest risk category when BMPs were improperly implemented. No risks when BMPs were properly implemented.

- ❖ Culverts had highest count of risk, but intermediate frequency of risk.
- ❖ Ford crossings had the highest frequency of risk.
- ❖ Allow floodwaters to flow around crossing structure.
- ❖ Stabilize approach ways

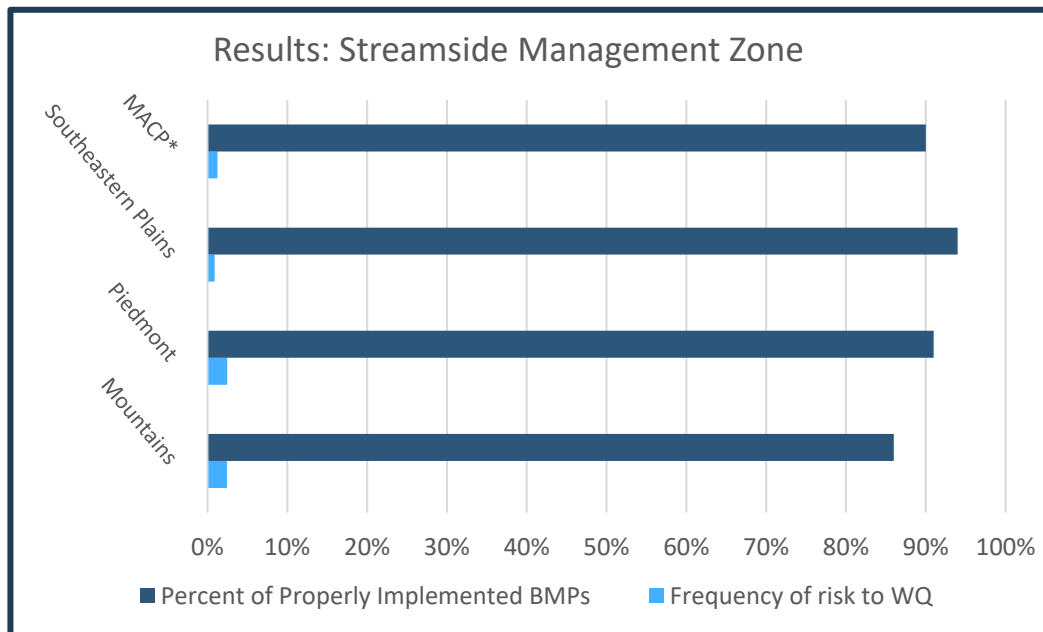
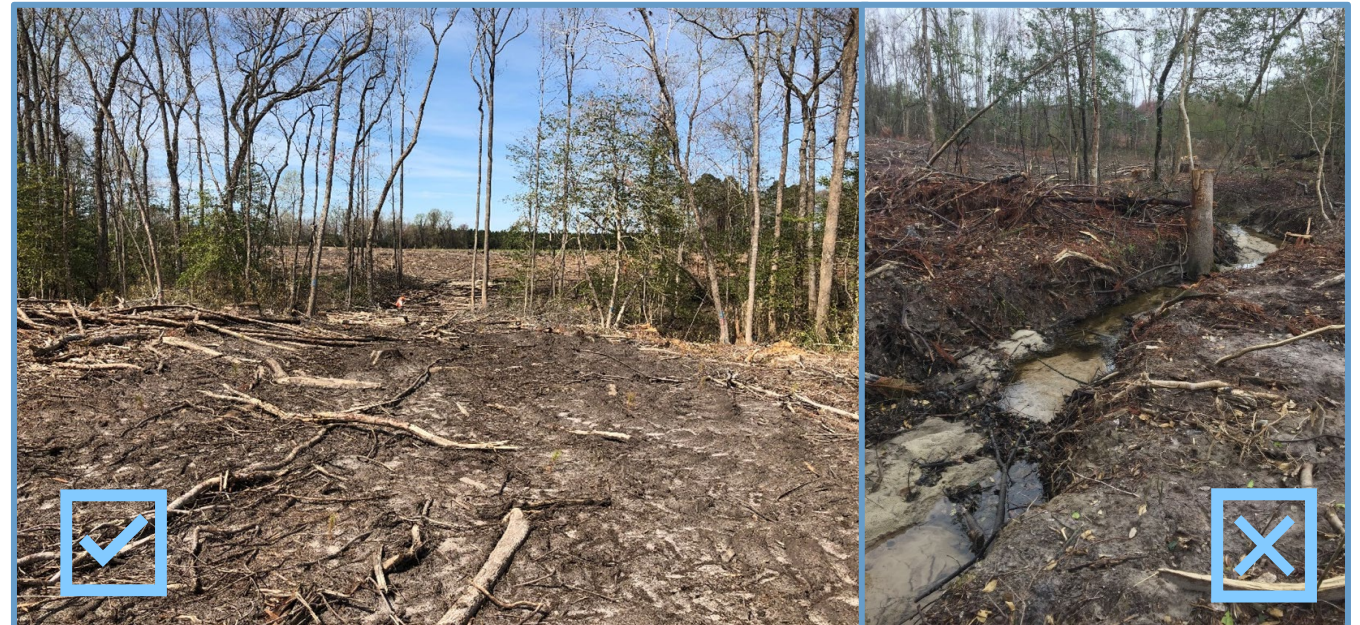
RESULTS: STREAMSIDE MANAGEMENT ZONES (SMZ)

- ❖ 8,086 BMPs assessed statewide.
- ❖ No risks when BMPs properly implemented. When not implemented, there was risk 21% of the time.
- ❖ Successful SMZs were wider on average than those where risks to water quality were observed.

- ❖ Minimize disturbance of soil / groundcover within ephemeral channels.
- ❖ Maintain half of pre-harvest canopy cover within SMZ.
- ❖ Avoid roads, skid trails, decks, and portable sawmills in the SMZ.
