Southwestern Offsite Seeps Assessment

Memorandum

Date: December 31, 2019
To: The Chemours Company FC, LLC
From: Geosyntec Consultants of NC, PC
Subject: Southwestern Offsite Seeps Assessment

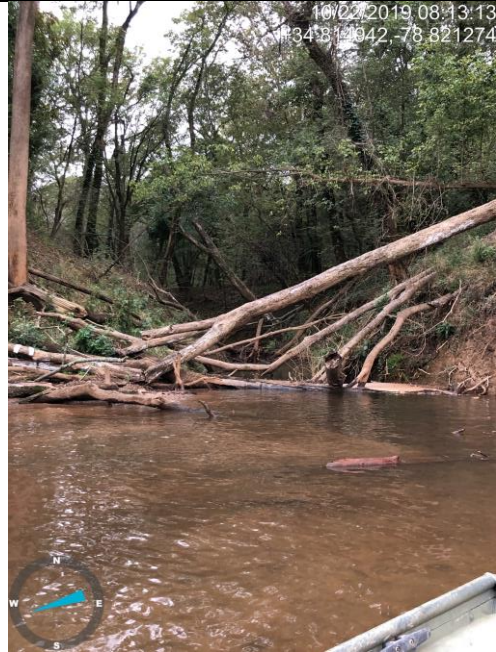
Photograph 1

Comments: Facing West; Collector coordinates: 34.814662, -78.821366; Sample not collected; Site identified as Georgia Creek

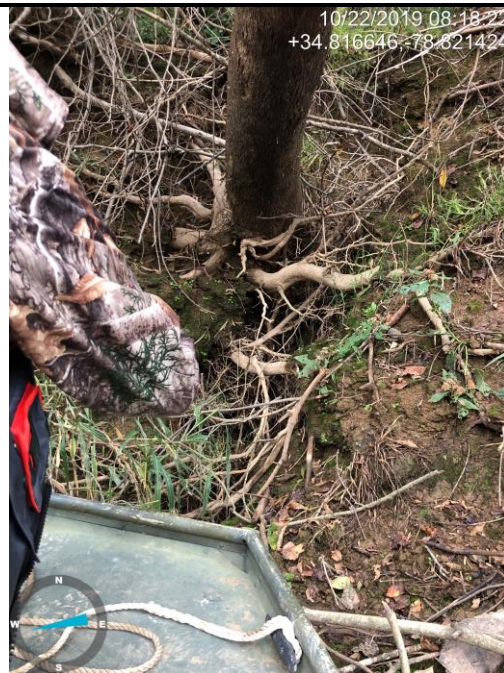
Photograph 2

Comments: View West; Collector coordinates: 34.816773, -78.820992; Sample ID: "Seep M"

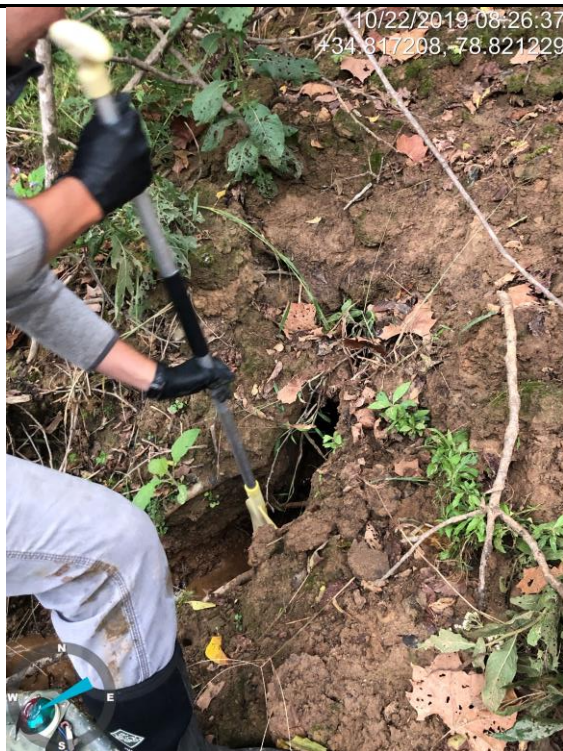
Photograph 3

Comments: View Southwest;
Collector coordinates: 34.817228, -
78.820863; Sample ID: "Seep L"

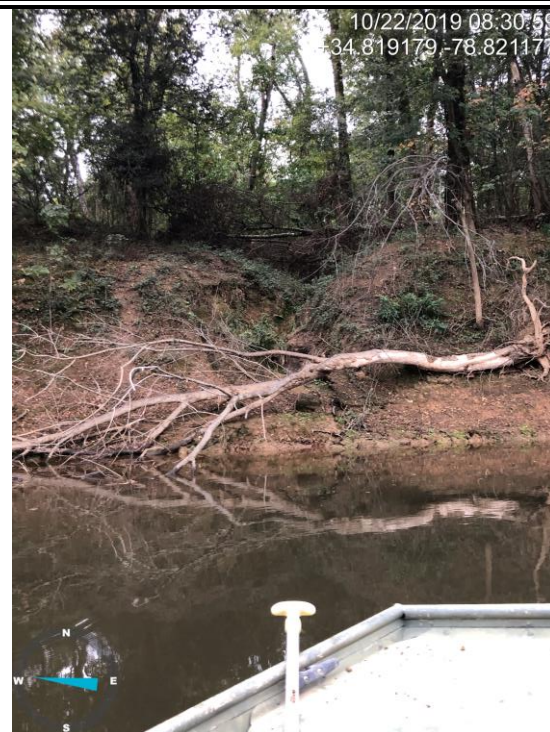
Photograph 4

Comments: View West; Collector
coordinates: 34.819482, -78.820947;
No sample collected because seep
was dry. Possibly caused by erosion
but maybe water upland.

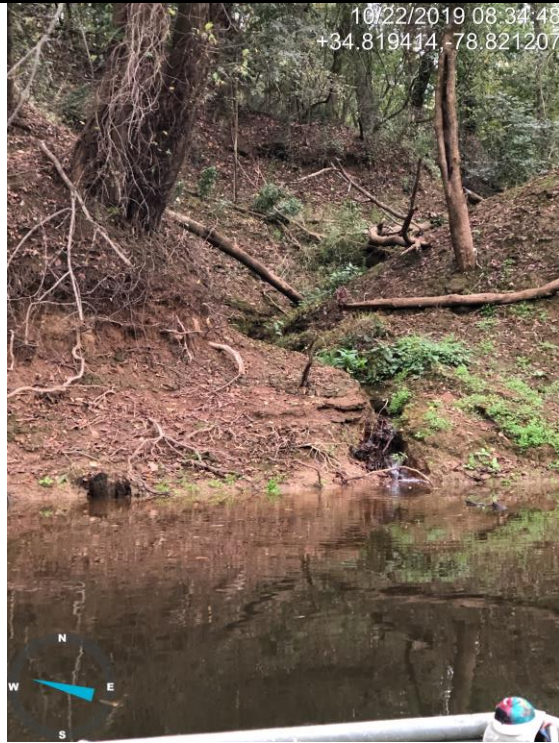
Photograph 5

Comments: View West;
Collector coordinates:
34.820384, -78.820955; Sample
ID: "Seep K"

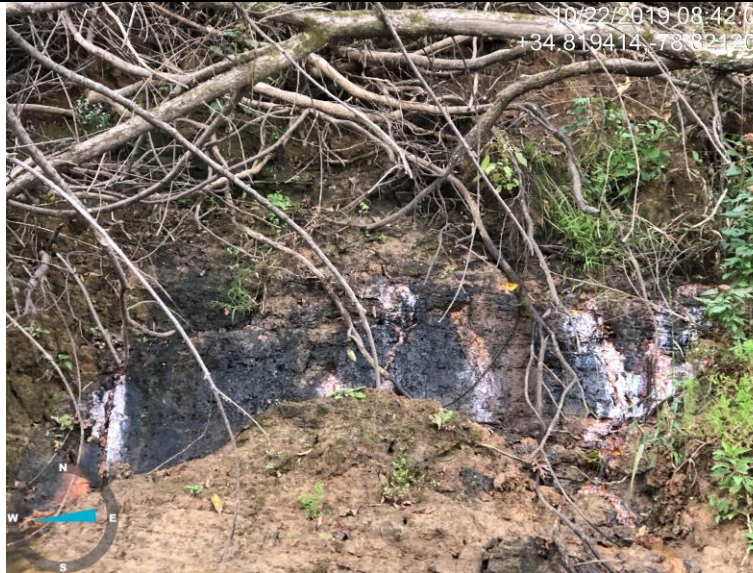
Photograph 6

Comments: View West;
Collector coordinates:
34.823835, -78.821307; Sample
ID: "Seep J"; Samples are
composite of multiple slow
flowing holes and uphill there
is a pool of water. Coordinates
on picture are incorrect.

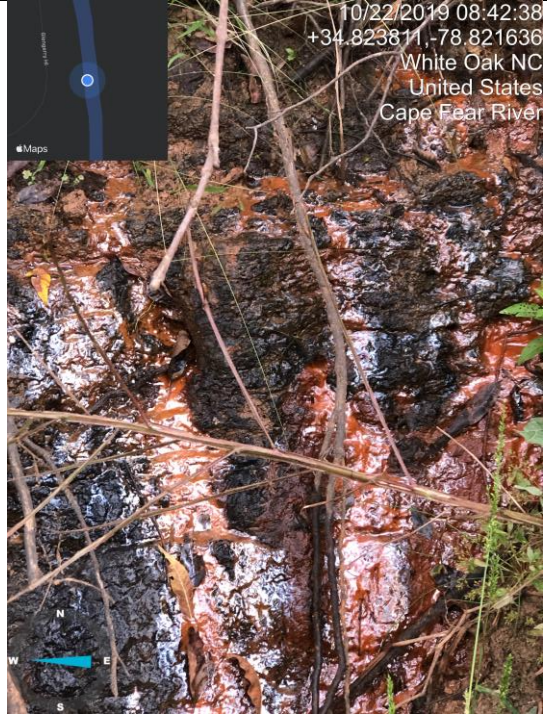
Photograph 7

Comments: View West;
Collector coordinates:
34.823835, -78.821307; Sample
ID: "Seep J"; Samples are
composite of multiple slow
flowing holes and uphill there is
a pool of water.

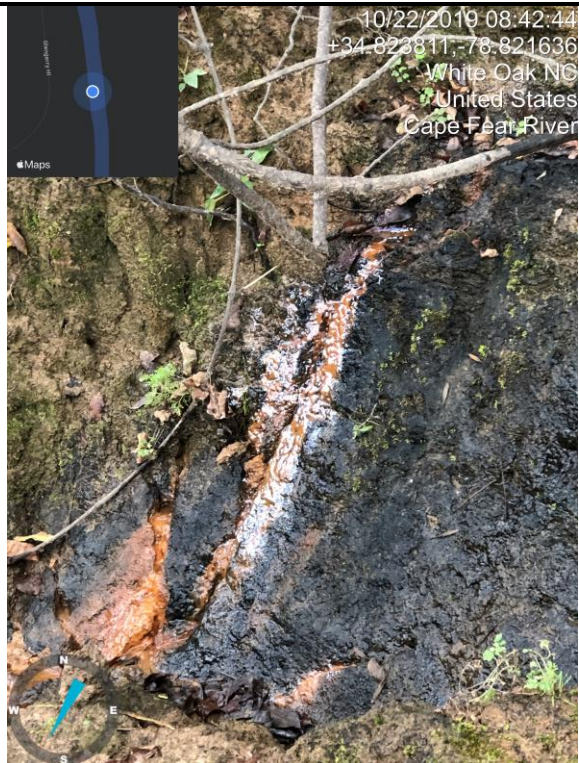
Photograph 8

Comments: View Southwest;
Collector coordinates:
34.823835, -78.821307; Sample
ID: "Seep J"; Samples are
composite of multiple slow
flowing holes and uphill there is
a pool of water.

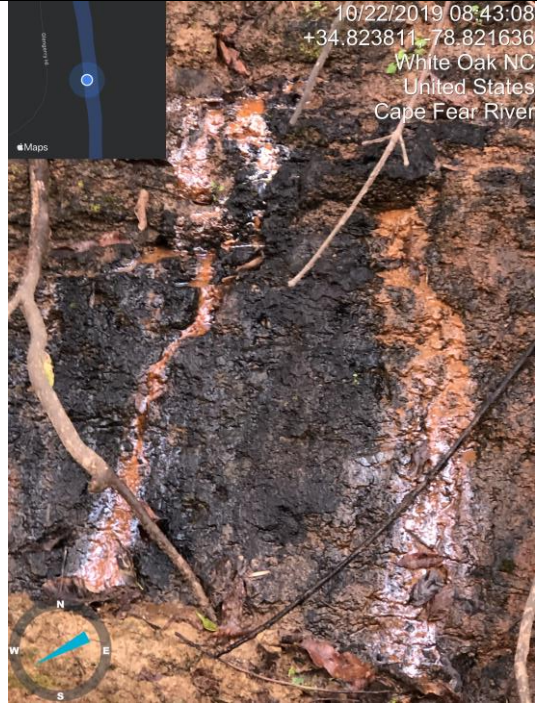
Photograph 9

Comments: View West;
Collector coordinates:
34.823835, -78.821307; Sample
ID: "Seep J"; Samples are
composite of multiple slow
flowing holes and uphill there is
a pool of water.

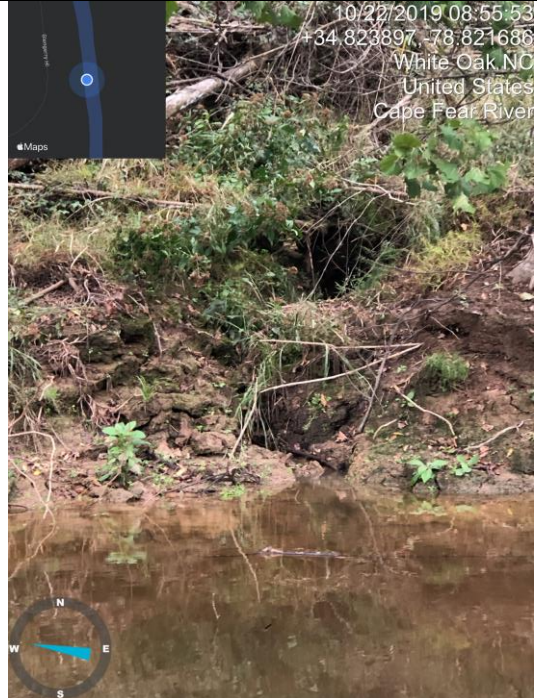
Photograph 10

Comments: View West;
Collector coordinates:
34.824900, -78.821701;
Sample ID: "Seep I".
Coordinates on pictures are
incorrect.

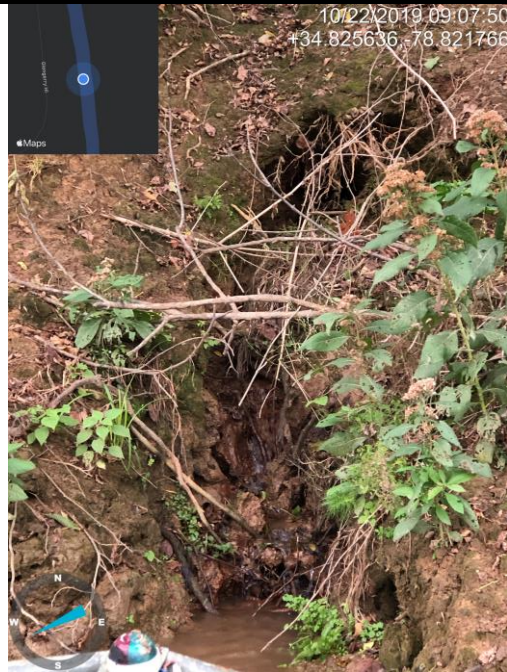
Photograph 11

Comments: View West;
Collector coordinates:
34.825611, -78.821655; Sample
ID: "Seep H"

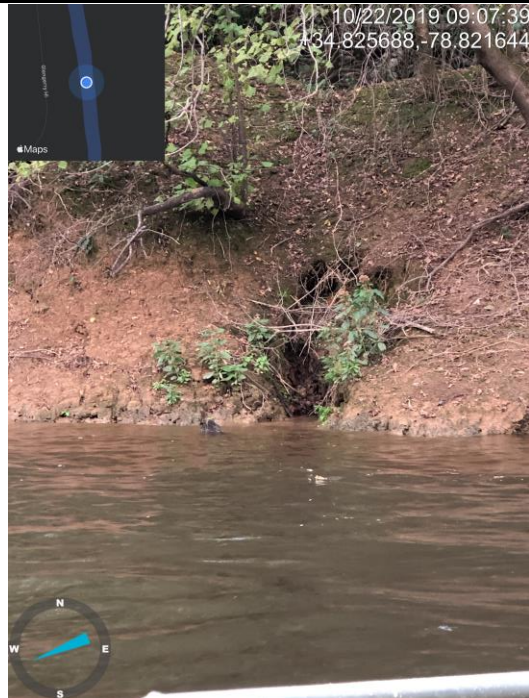
Photograph 12

Comments: View West;
Collector coordinates:
34.825611, -78.821655;
Sample ID: "Seep H"

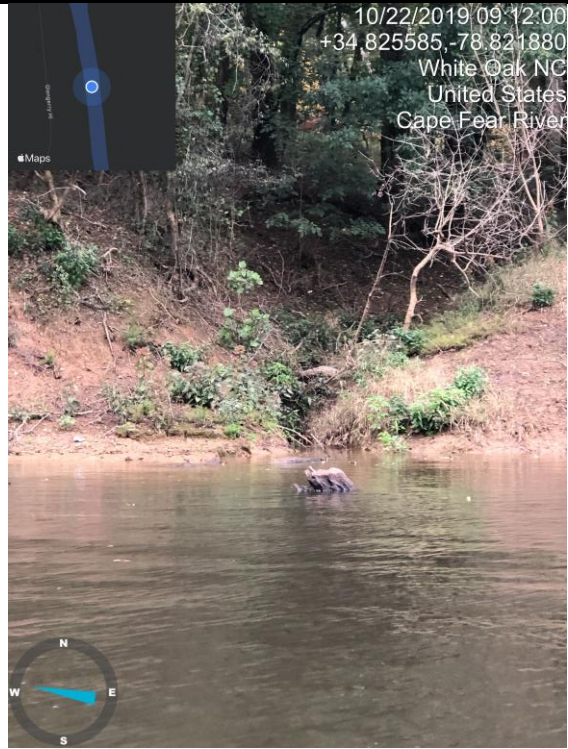
Photograph 13

Comments: View West;
Collector coordinates:
34.826967, -78.821884;
Sample ID: "Seep G".
Coordinates on picture are
incorrect.

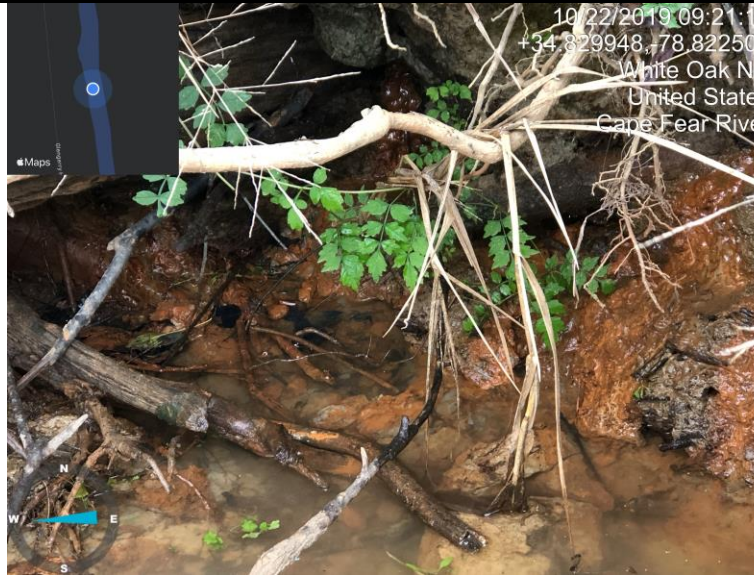
Photograph 14

Comments: View West;
Collector coordinates:
34.829940, -78.822158; Sample
ID: "Seep F"; Sample collected
~20ft uphill in channel
positioned parallel to the Cape
Fear River.

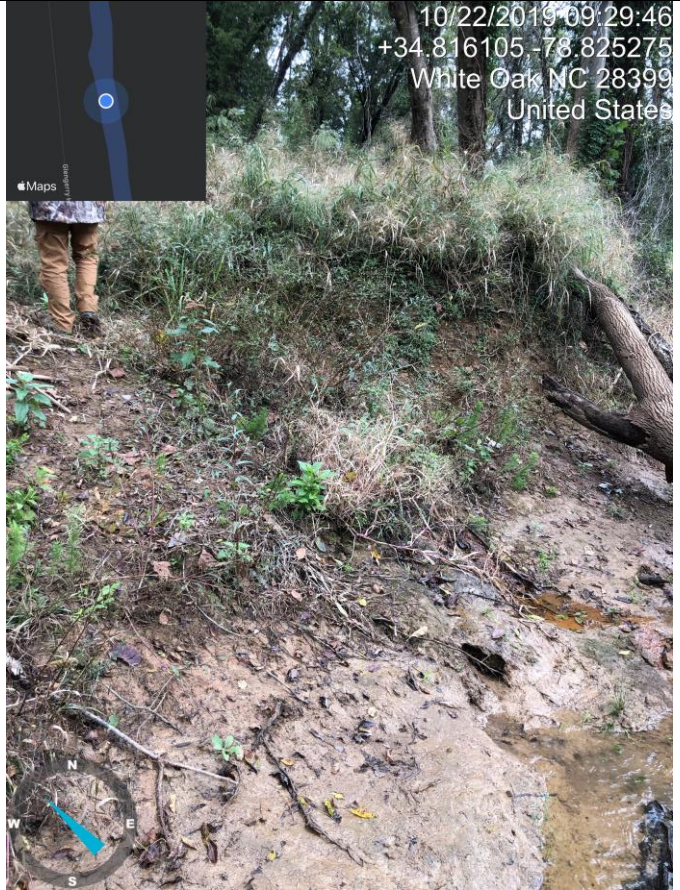
Photograph 15

Comments: View Northwest;
Collector coordinates:
34.830635, -78.822418; Sample
ID: "Seep E". Sample collected
~10ft uphill in iron pool.
Coordinates on picture are
incorrect.
