*2021 Coastal Habitat Protection Plan:
Priority Habitat Issue – Protecting SAV with a Focus on Water Quality*

Trish Murphey | CHPP Steering Committee | May 11, 2020

Submerged Aquatic Vegetation

Issue

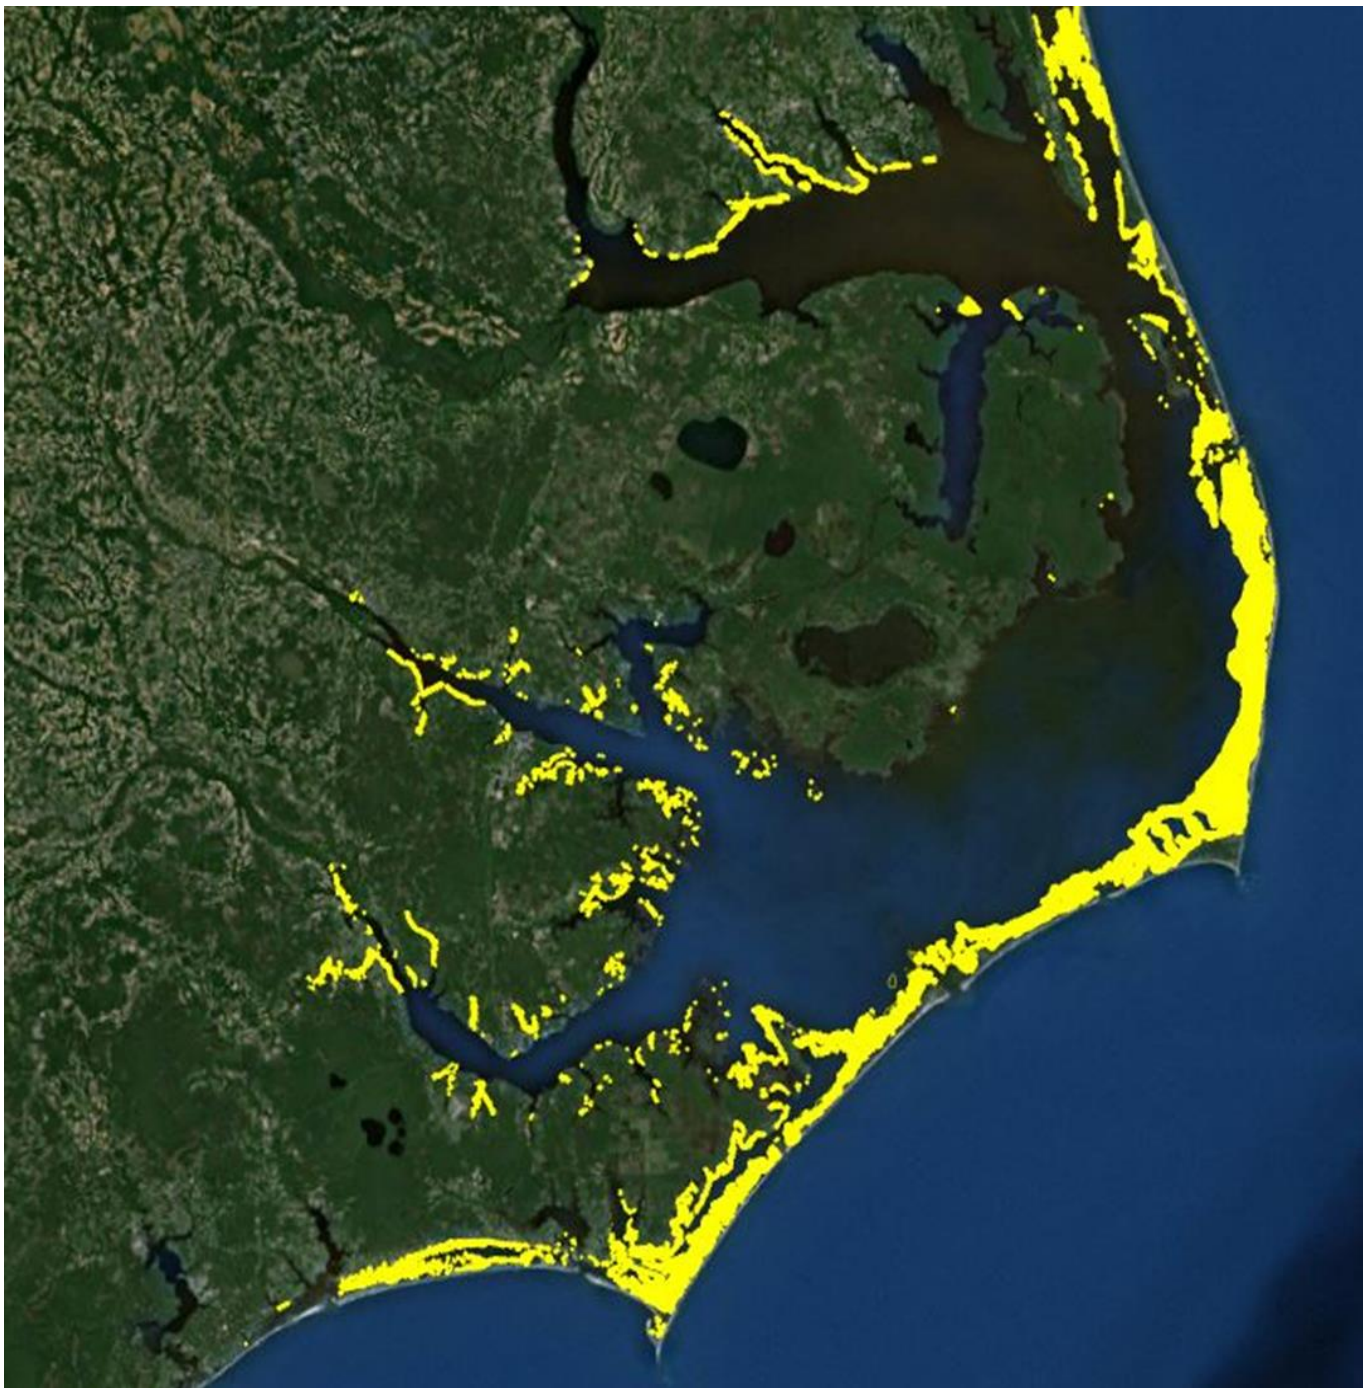
APNEP Indicator Report: Extent of Submerged Aquatic Vegetation, High-Salinity Estuarine Waters

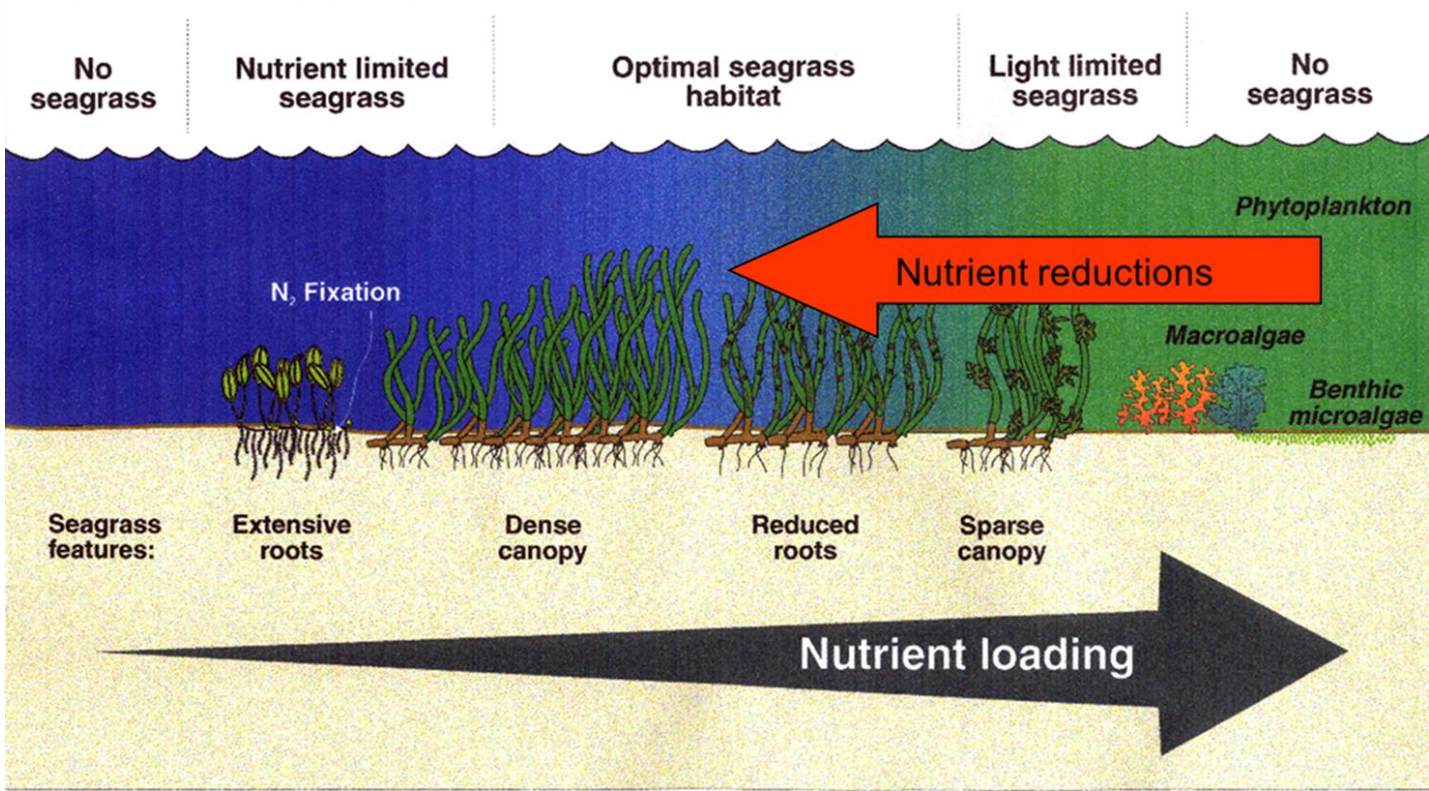
Water Quality Impacts

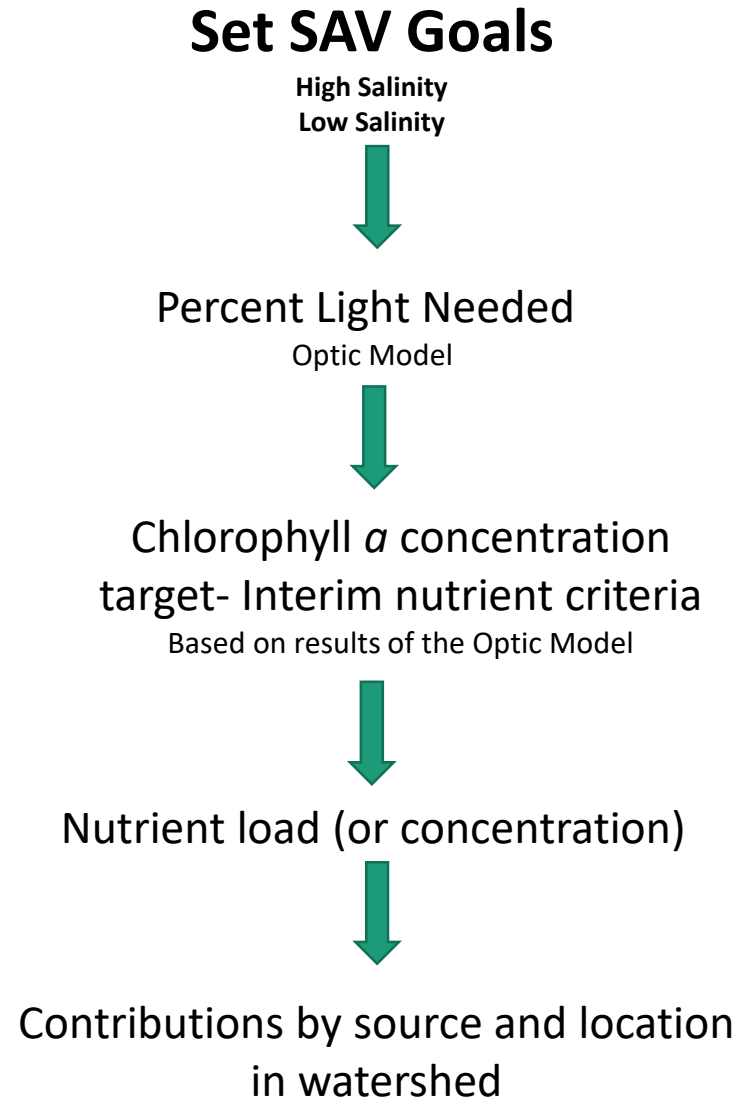
Setting NC SAV Goals and Connecting to Nutrient and Sediment Load Reductions
